Loss of Pitch Control on Takeoff
Emery Worldwide Airlines, Flight 17
McDonnell Douglas DC-8-71F, N8079U
Rancho Cordova, California
February 16, 2000

Aircraft Accident Report

NTSB/AAR-03/02

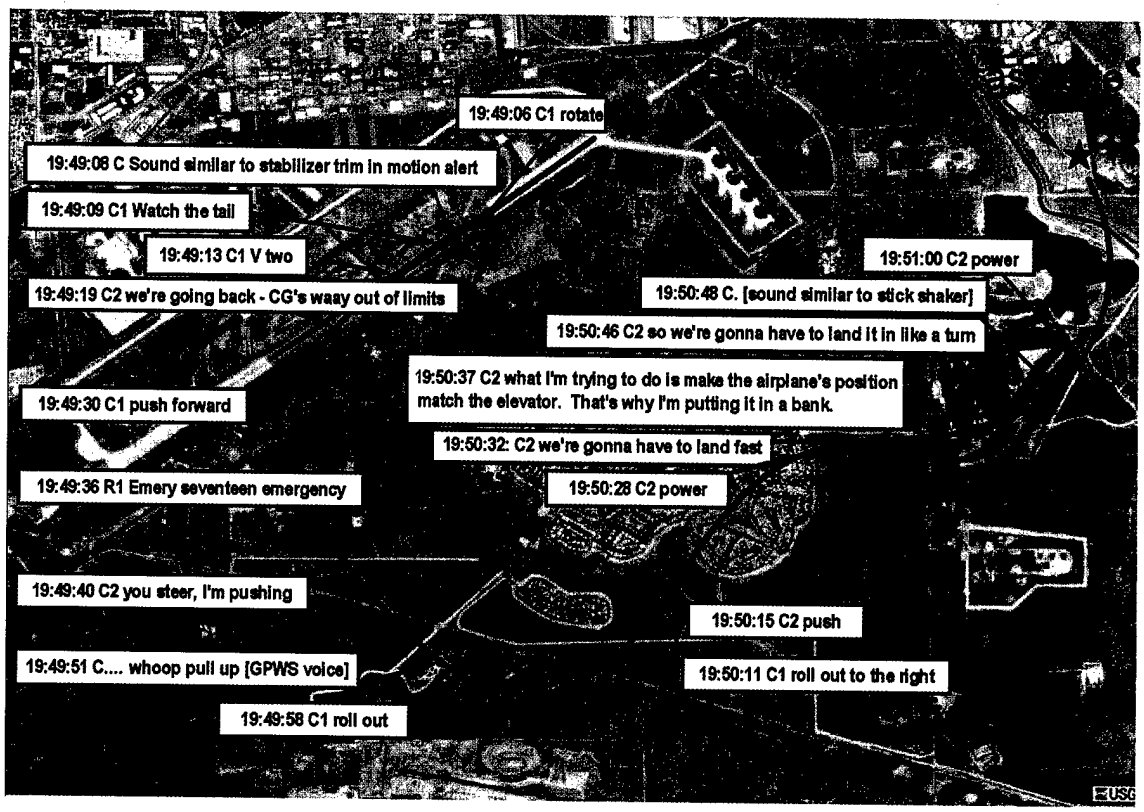
The airplane impacted the ground in a left-wing-low, slightly nose-up attitude in an automobile salvage yard, about 1 mile east of the departure runway. Figure 1 shows the airplane's ground track, with selected CVR comments, during the accident flight. (For additional information regarding CVR comments, see the CVR transcript in appendix B).

Figure 1. The airplane's ground track, with selected CVR comments, during the accident flight.

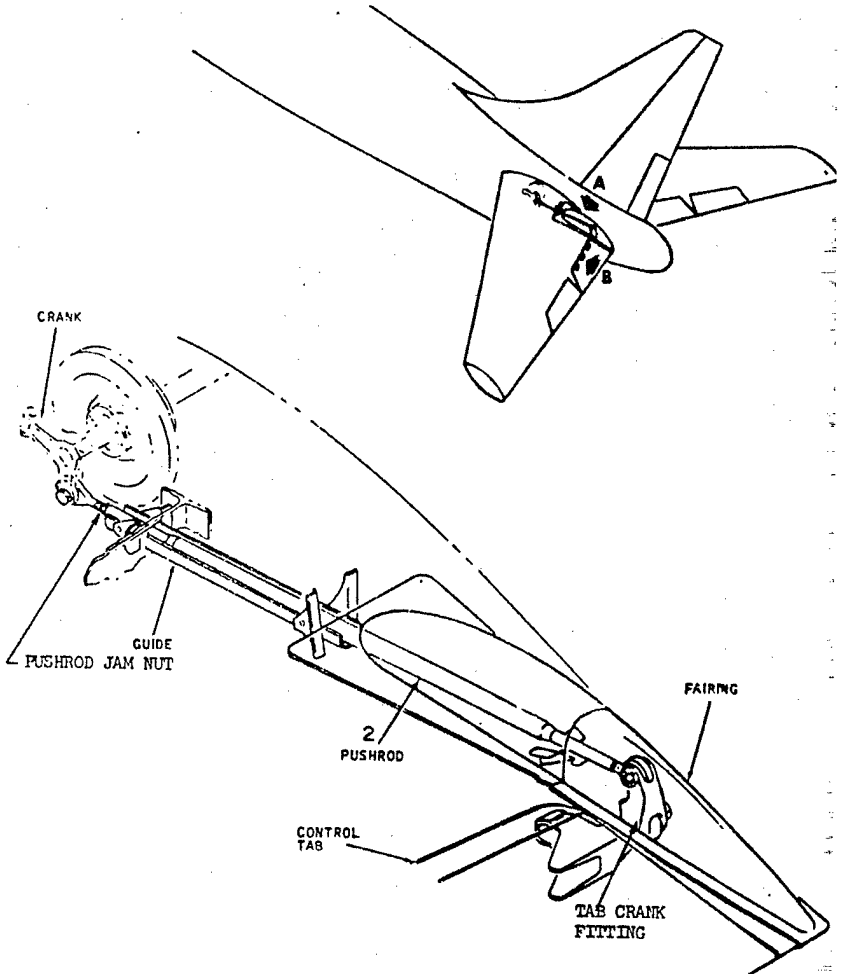
Each elevator control tab is hinged to the inboard trailing edge of the associated elevator surface, then connected by a mechanical linkage (including a crank fitting, pushrod, and bellcrank assembly) at the inboard edge of the tab to the flight control system on that side of the airplane. Figure 2 is a diagram of the elevator control tab installation. The elevator control tabs are in their neutral position when they are in line with the elevator surfaces and should have a maximum TEU deflection of 8.5° ± 0.5° and a maximum TED deflection of 26.5° ± 0.5° from that neutral position.

Figure 2. A diagram of the elevator control tab installation.

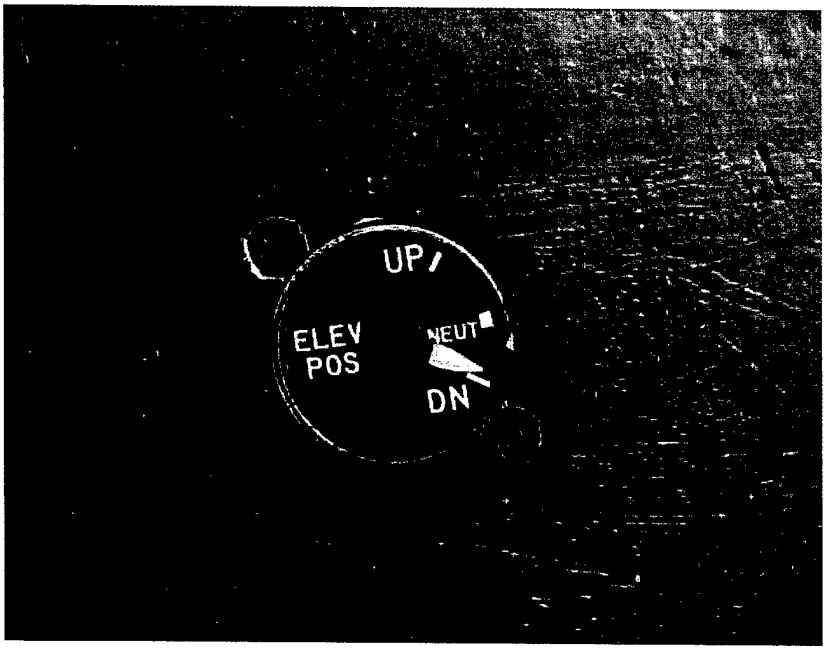
The DC-8 EPI is a 1-inch diameter circular cockpit gauge with a pointer needle and index markings for UP, DN (down), and NEUT (neutral) positions to indicate the position of the elevators. When the EPI is properly calibrated, the up index mark should correspond to the maximum TEU elevator surface position of 27° and the down index mark should correspond to the maximum TED elevator surface position of 16.5° TED. A narrow white band adjacent to the NEUT index mark indicates an elevator surface position between 0° and 5° TEU. Figure 3 is a photograph of an EPI gauge similar to that on the accident airplane.

Figure 3. A photograph of an EPI gauge similar to the gauge installed on the accident airplane.

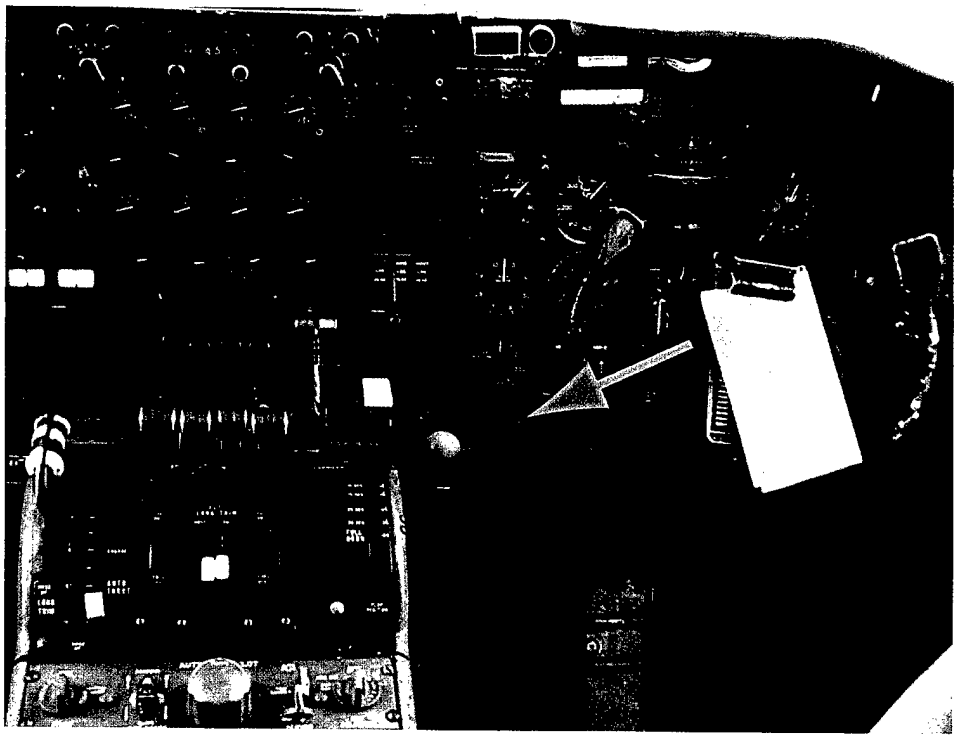
AD 78-01-15 specified that operators install the EPI gauge on the first officer's instrument panel such that full forward movement of the control column and wheel would not obstruct the first officer's view of the gauge. The AD did not comment regarding visibility of the gauge from the captain's seat. As a result, DC-8 operators installed the EPI where they found room for it and where the first officer could see it on an airplane's existing instrument panel. Because Emery purchased its DC-8s from several other operators and EPI placement was not standardized, EPI gauges in Emery's fleet were installed in several different locations; according to Emery personnel, however, they were generally installed on the lower portion of the first officer's instrument panel.

Figure 4. EPI installation on the lower left side of the first officer's instrument panel (shown by the yellow arrow), similar to that on the accident airplane.

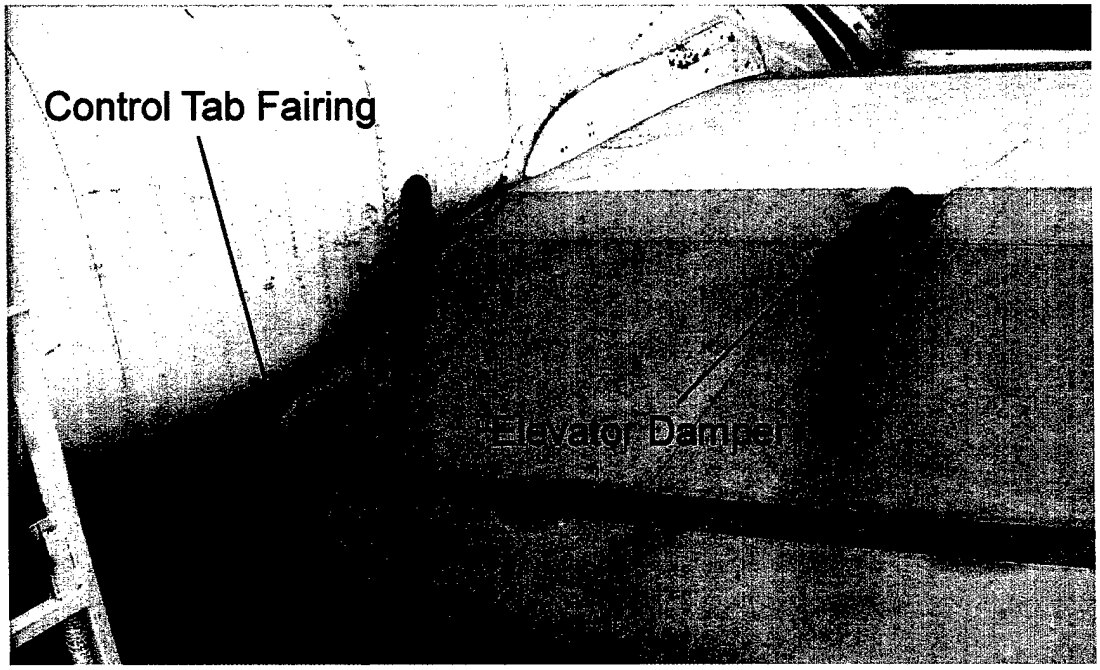
The accident airplane's maintenance records revealed that on November 25, 1999, eight days after the D inspection was completed (which included the installation of the elevator assemblies), a pilot reported that he had to apply "more back pressure than normal" on the control column to flare during the preceding landing and during the elevator check before the previous takeoff. The corrective action for this pilot report (performed by Emery maintenance personnel) was described in the accident airplane's maintenance logbook as follows: "Found [left/right] elevator dampers reversed, moved [left to right] side, [right to left] side, ops ck'd good, no defects noted." Figure 5 shows the elevator damper's location on the right elevator of a DC-8.

Figure 5. Photograph showing the elevator damper's location on the right elevator of a DC-8.

Emery's third-shift lead mechanic at DAY described the troubleshooting efforts that led to the discovery of the reversed dampers. He stated, in part, that he and another Emery mechanic moved the control column in the airplane through its range of motion while other maintenance personnel (including his supervisor) watched the elevator assembly's motion from the ground at the rear of the airplane. The lead mechanic told investigators that during this exercise, his supervisor "noted that there was a problem with the [elevator] dampers and that the mechanical operation wasn't correct." Maintenance personnel confirmed that the dampers were installed in the wrong positions and removed and swapped the dampers. According to the lead mechanic, maintenance personnel did not check cable tensions, access the elevator control tab pushrod fairing, rig the elevator control or geared tabs, or discover any obstructions to control column movement during the troubleshooting efforts.

Maintenance personnel reported that after the damper exchange, they noted no excessive control column forces or elevator binding; the damper exchange was examined by an inspector and signed off, and the airplane was returned to service. The maintenance logbooks contained no further pilot complaints regarding this anomaly.

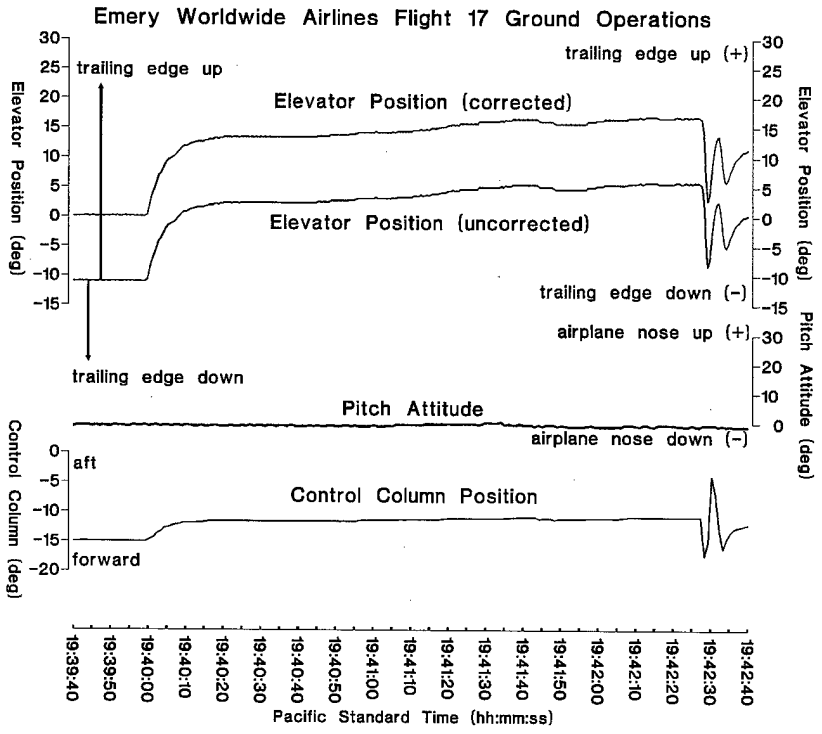
Figure 6 shows the elevator, pitch, and control column plots recorded by the accident airplane's FDR during ground operations before the accident flight. On this plot, the uncorrected data on the far left side of the plot shows an 11° TED elevator deflection when the gust lock was engaged (and the elevator was in its neutral, or 0°, position).

Figure 6. Elevator, pitch, and control column plots recorded by the accident airplane's FDR during ground operations before the accident flight. The first 20 seconds of data were recorded while the gust lock was engaged.

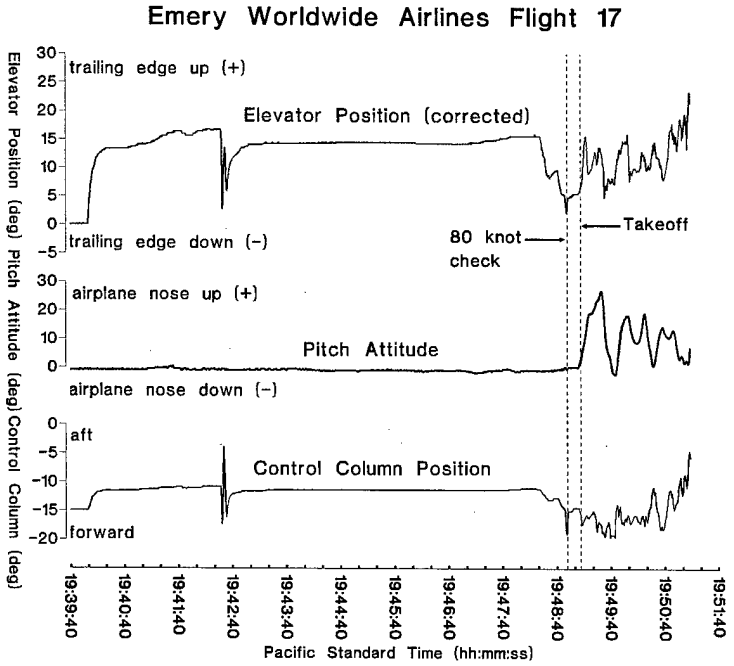
The Safety Board's examination of the corrected elevator position data revealed that the airplane's elevator never traveled below its neutral position to a TED deflection during the accident flight, although recorded forward control column inputs should have resulted in a TED elevator deflection. For example, although the FDR data indicated that, during the 80-knot elevator check at MHR, the control columns were moved to about 6° forward of their rigged neutral position, the elevators did not deflect below 2.2° TEU. In contrast, during the 80-knot elevator check on the previous takeoff (at RNO) the FDR recorded elevator movement to 8° TED, with less forward control column movement. Figure 7 shows plots of the pitch attitude, control column position, and elevator position FDR data for the accident flight. Elevator position is shown using the conversion that corrected for the 11° offset. Figure 7 also shows when the 80-knot elevator check and takeoff occurred. Figure 8 shows the same information for the takeoff from RNO.

Figure 7. Pitch attitude, control column position, and (corrected) elevator position FDR data from the accident flight. About the first 20 seconds of data were recorded while the gust lock was engaged.

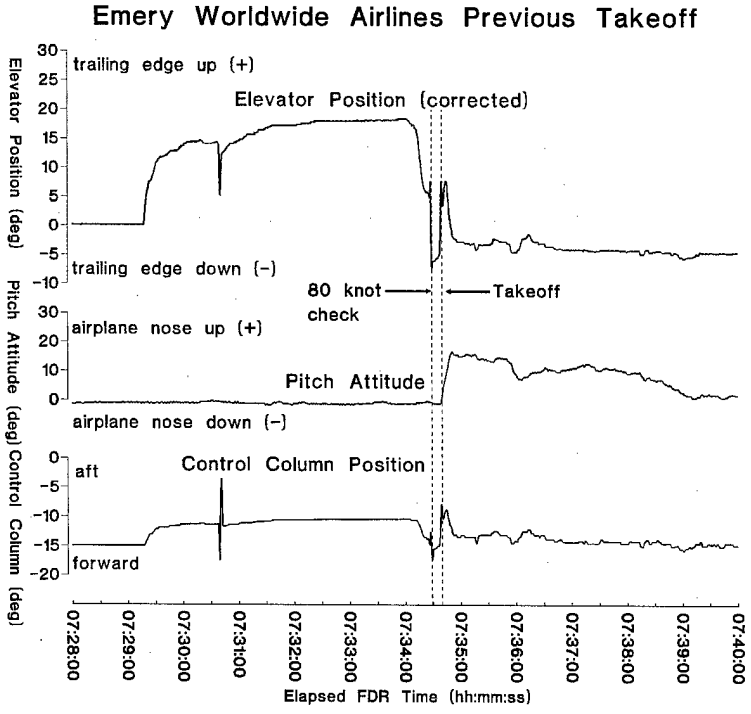
Figure 8. Pitch attitude, control column position, and (corrected) elevator position FDR data for the previous takeoff from RNO. About the first 1 minute 20 seconds of data were recorded while the gust lock was engaged.

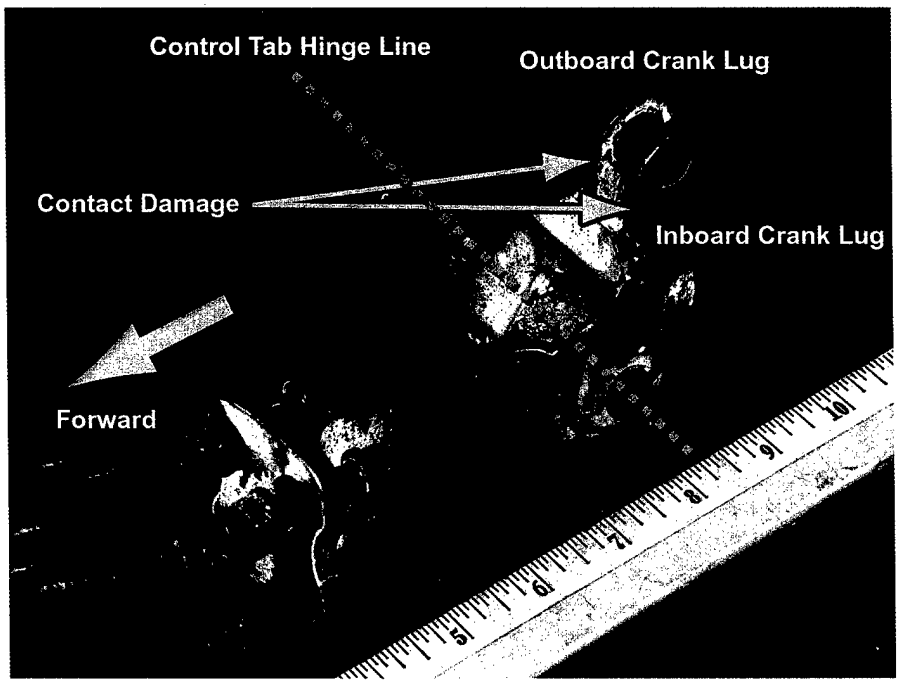
(See figure 2, in section 1.6.2, for a diagram of the elevator control tab installation.) The right control tab pushrod was recovered separately, with its aft rod end (which would normally have been bolted to the tab crank fitting) intact. Examination of the forward edges of the elevator control tab crank fitting lugs revealed evidence of repeated contact damage (including gouge marks and indentations). (Figure 9 is a photograph of damage to this area.) The internal surfaces of the pushrod aft rod end bearing and the bushings in the crank fitting lugs showed no visible signs of damage or deformation. The bolt and associated hardware that normally secures the right elevator control tab pushrod to the tab crank fitting[61] was missing and not recovered.

Although the inboard portions of the left elevator, control tab, crank fitting, and attachment hardware were not recovered and were presumed consumed by postcrash fire, the left elevator control tab pushrod was recovered. Unlike the right control tab pushrod, the left control tab pushrod's aft rod end (normally attached to the tab crank fitting) was fractured and about 75 percent of it and its associated bearing were missing. The forward end of this pushrod was fractured at its rod end attachment holes, and the pushrod had about an approximately 90° bend at its midpoint. No fire damage was observed on the left control tab pushrod assembly.

Figure 9. A photograph of the accident airplane's right elevator control tab crank fitting. Note damage on forward face of control tab crank fitting lugs.

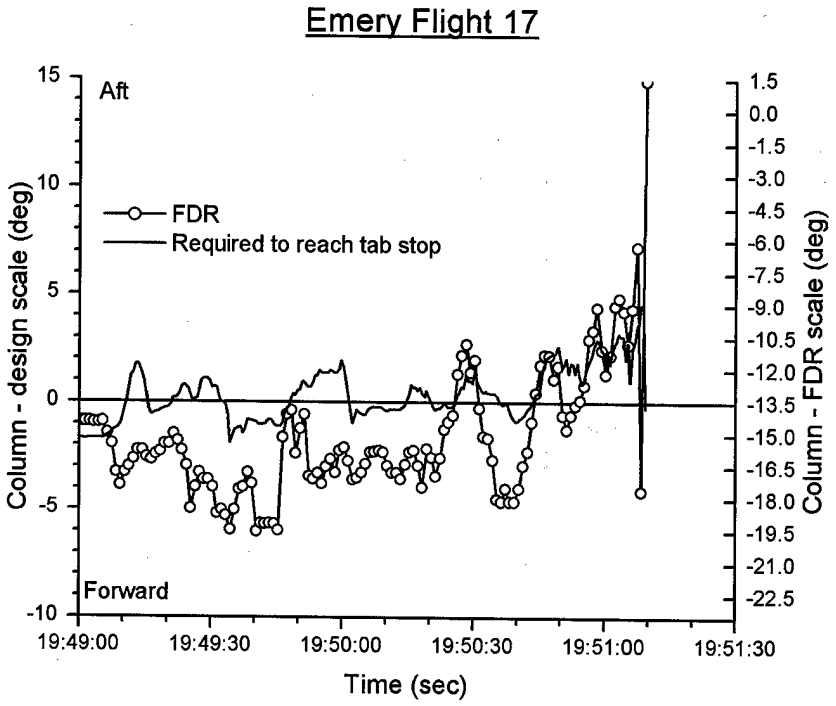
Figure 12 shows the control column position required for the left elevator control tab to reach its TEU physical stop (with no cable stretch) and the recorded control column position for the recorded elevator position during the accident flight. The plot indicates that at most points during the accident flight, the flight crew was trying to command additional forward control column.

The Safety Board's examination of the FDR data for the flights preceding the accident flight revealed that a change in the relationship of control column movement to elevator response occurred about 8 minutes and 20 seconds before the accident airplane landed at MHR. The Board's performance study derived the control tab positions at the time of this change. The study showed that the change in FDR data could be explained by a shift of about 3° to 4° in the TEU direction of the right control tab, assuming that the right control tab's pushrod to crank fitting attachment bolt separated at this time. This change in the FDR data was evident until the airplane landed at MHR. As previously discussed, a scenario in which a disconnected pushrod remained between the lugs of the aft crank fitting (shown in figure 11) resulted in a 3° to 4° control tab shift in the TEU direction.

Figure 12. The control column position required for the left elevator control tab to reach its TEU physical stop (for the recorded elevator position) and the actual recorded control column position for the accident flight.

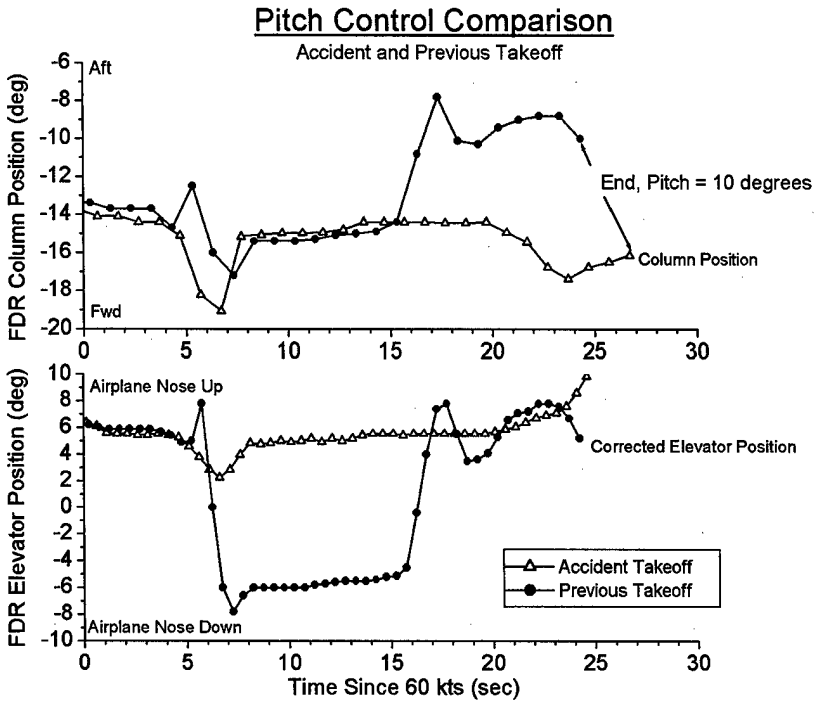
Figure 13. Plots of the control column and corrected elevator position recorded by the accident FDR during the accident takeoff roll and the previous takeoff roll (from RNO).
