United States Coast Guard

Report of Investigation into the Fire Onboard the CARNIVAL SPLENDOR which occurred in the Pacific Ocean off the Coast of Mexico on November 8, 2010, which Resulted in Complete Loss of Power

MISLE Incident Investigation Activity Number: 3897765

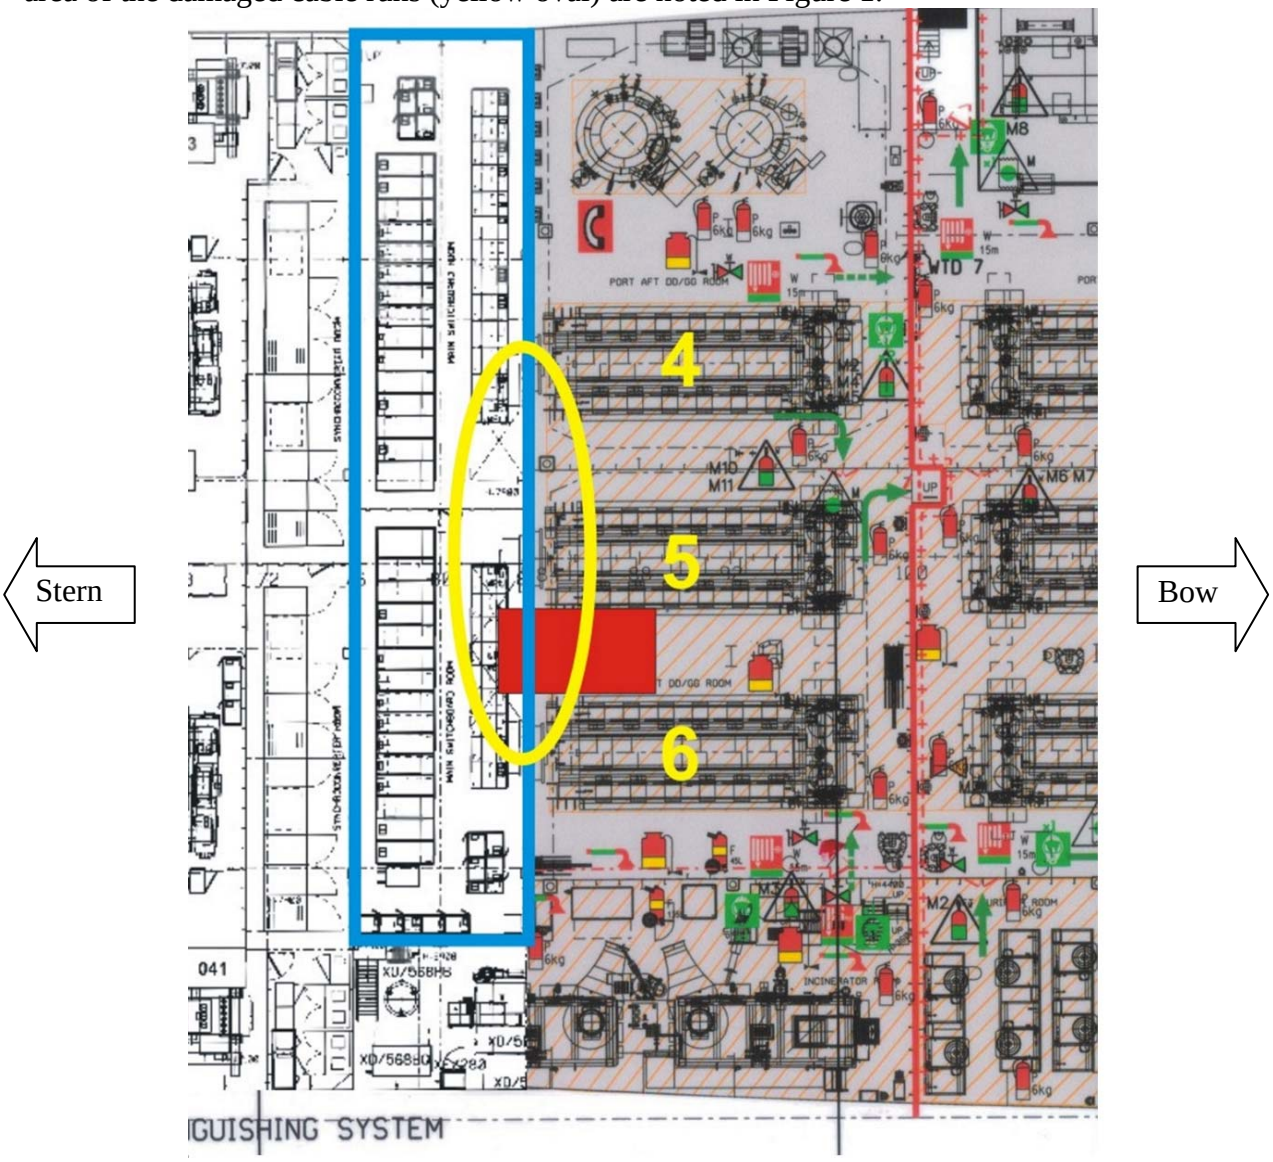
Figure 1 - Excerpt from Fire Control Plan showing aft engine room; annotated by Coast Guard.

The Carnival Splendor has two engine rooms: the forward engine room and aft engine room. Diesel Generators (DGs) 1, 2 and 3 are located in the forward engine room. DGs 4, 5 and 6 are located in the aft engine room. The engine rooms are separated by a watertight bulkhead. The figure below shows the arrangement of the aft engine room. The Engine Control Room (enclosed in blue rectangle), the location of the fire (red solid rectangle), location of the watertight bulkhead between the forward and aft engine rooms (red vertical line) and general area of the damaged cable runs (yellow oval) are noted in Figure 1.

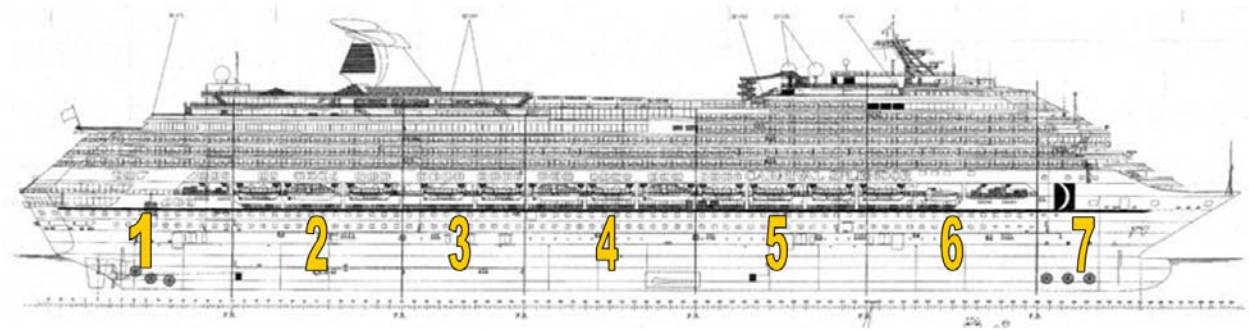
Figure 2 - Profile view of vessel showing location of Fire Zones

The Carnival Splendor is divided into seven fire zones numbered one through seven, aft to forward and separated by the dark vertical lines in the figure below. The aft engine room is located in fire zone two.

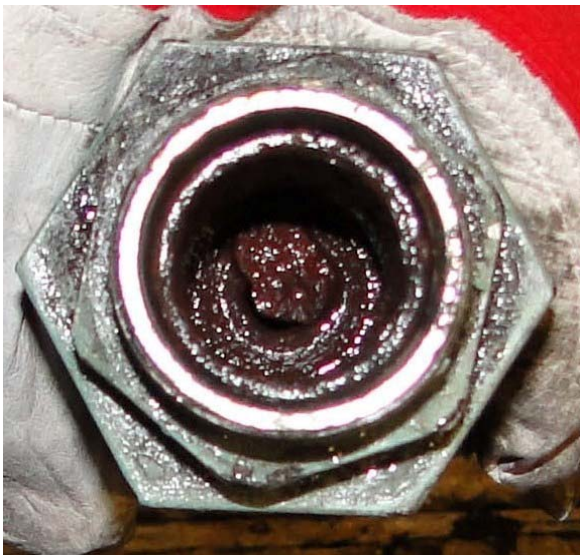
Post-casualty inspection of the DG5 air coolers revealed significant quantities of ferrous oxide scaling and rust in the air cooler base area and outlet areas of the B side of DG 5 air cooler, as shown in Photograph 9 and Photograph 10. The heat exchangers were tested and found not to be leaking. The receiver runs the length of the engine and connects to the air inlets of both banks of heads. In Photograph 11, scale is shown in a drain valve connection on the pressure side of the orifice when the engine is running. There is no evidence of screens or other devices to protect against the clogging of the drains by rust particles within the air cooler. Photograph 12 provided by Carnival shows the sight glass of the B1 cooler. The sight glass developed a visible haze over the inspection port which obstructed the viewing port and made observation of water flow very difficult.

Photograph 11 - DG5 air cooler, drain valve connection.

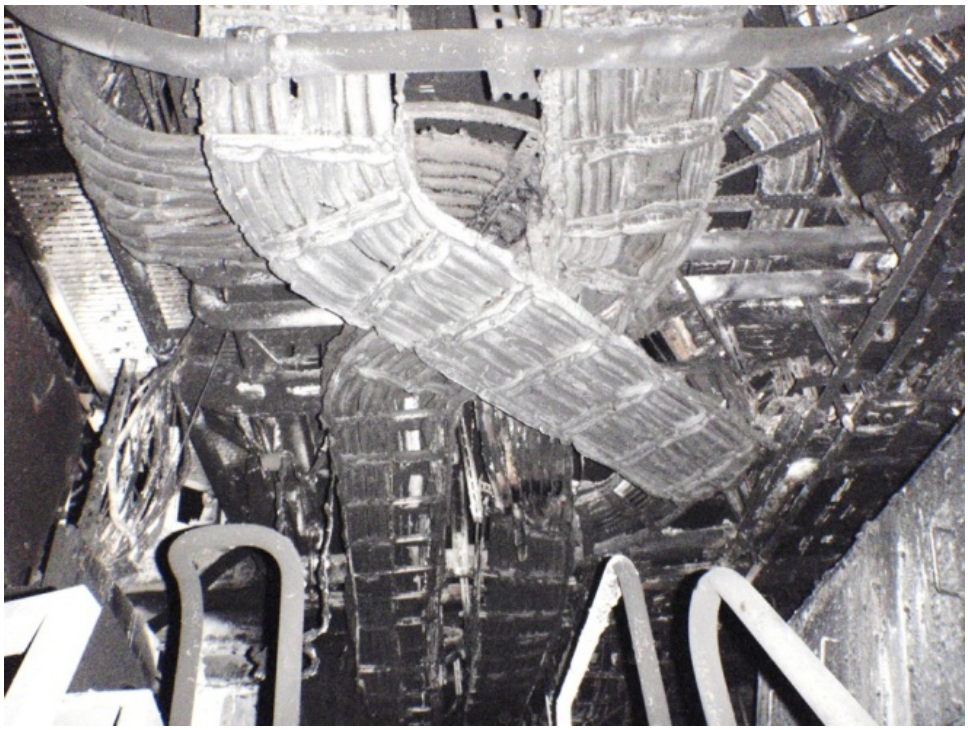
Photograph 17 – Overhead cable runs between DG5 and DG6

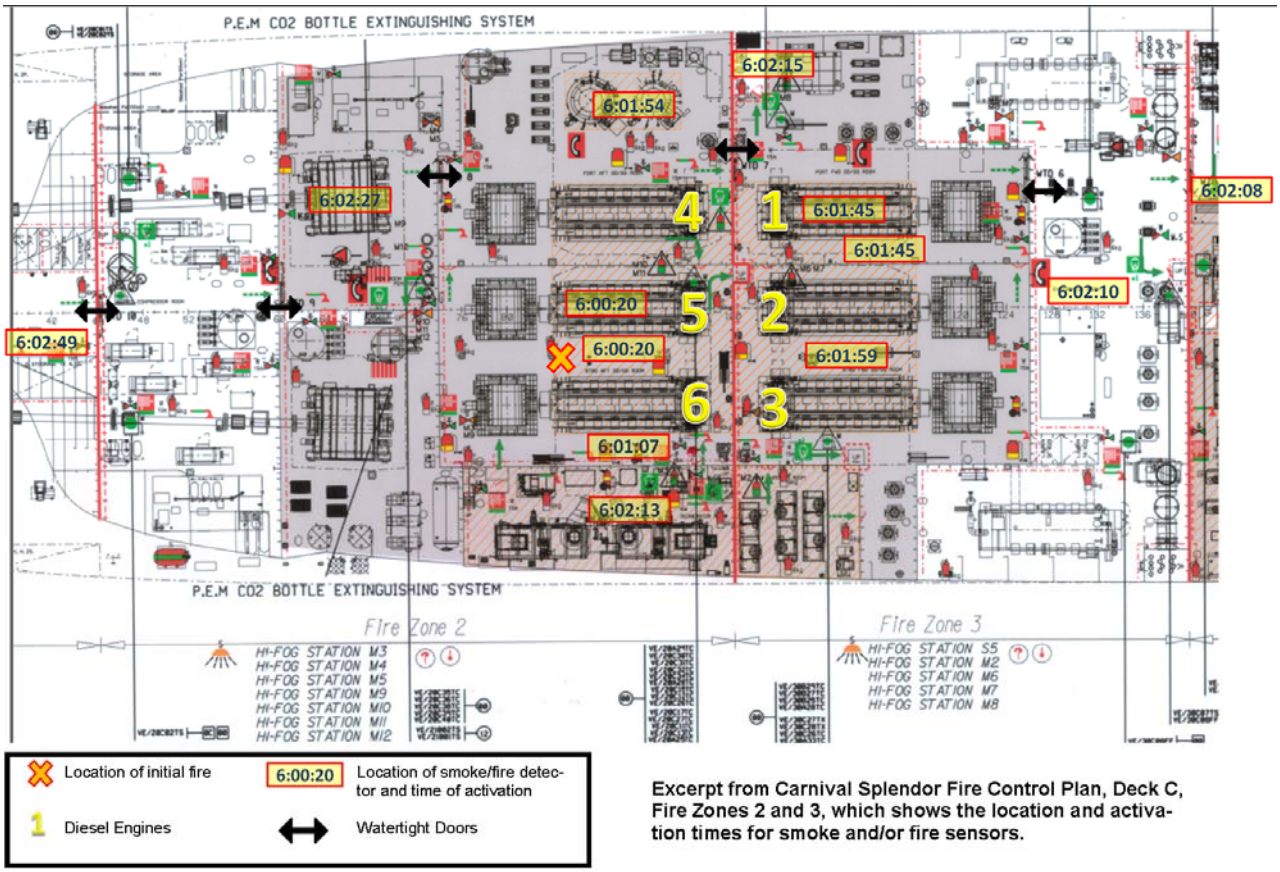
Figure 1 - Excerpt from the Carnival Splendor Fire Control Plan showing Deck C, Fire Zones 2 and 3 Plan annotated by USCG

As a result of the intervention by the bridge watch officer, the activation of the Hi-Fog local protection system for DG 5 and 6 was delayed by approximately 15 minutes. By the time the Hi-Fog system was activated, the fire had spread to the cable runs over DG 5 and 6. Since the Hi-Fog system was designed for local protection, the nozzles were positioned below the cables runs and the Hi-Fog system was not effective in suppressing or extinguishing the fire in the cable runs.
