**Assessment of Paint Layers by FE-SEM and
EDS Examination**

ARL-TR-3232

June 2004

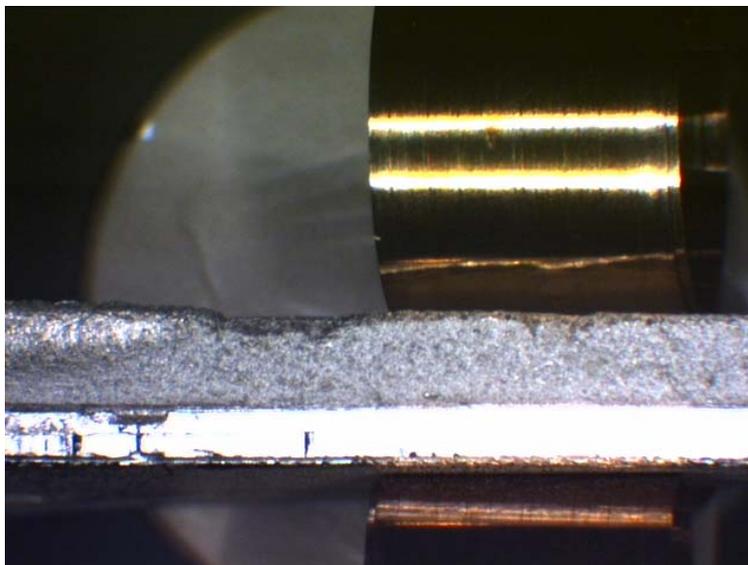
Figure 1. Panel 7 fracture face. Coating film is the thin light line across the upper quarter of the field. The thick bright bar running across the lower portion is the back-scored area.

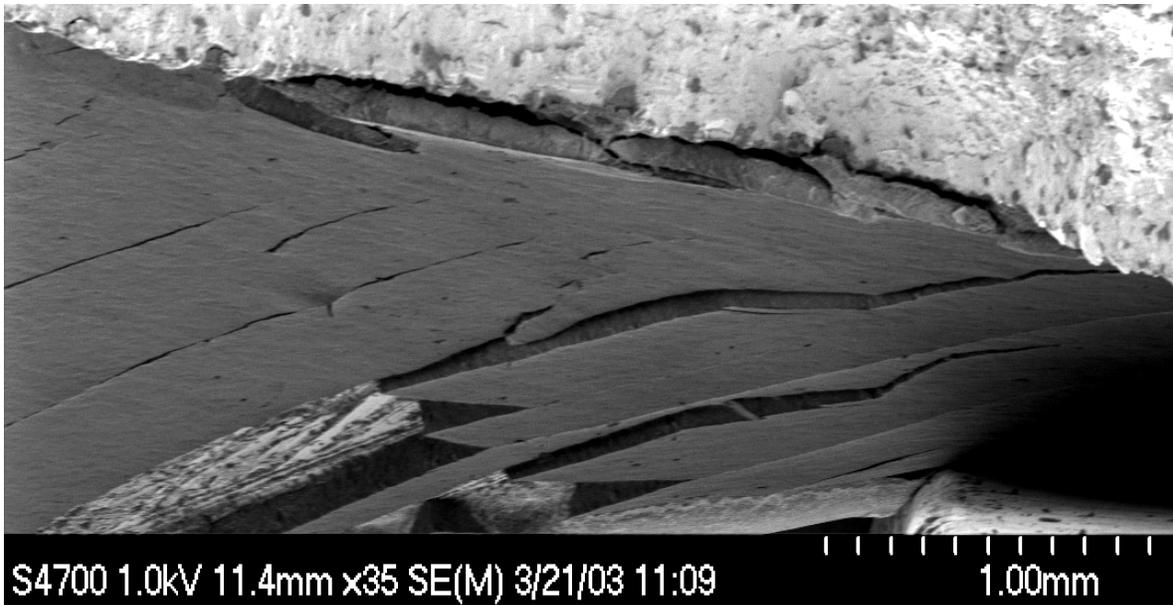
The segment from panel 7 could not be oriented to properly image the film cross section at higher magnifications above 1 KX. The way the surface coating shattered (figure 5) added to the orientation problem by inhibiting some surface electron drain, thereby increasing the surface charging at higher magnifications.

Figure 5. Panel 7 at 35× FE-SEM. Coating film is the darker area.

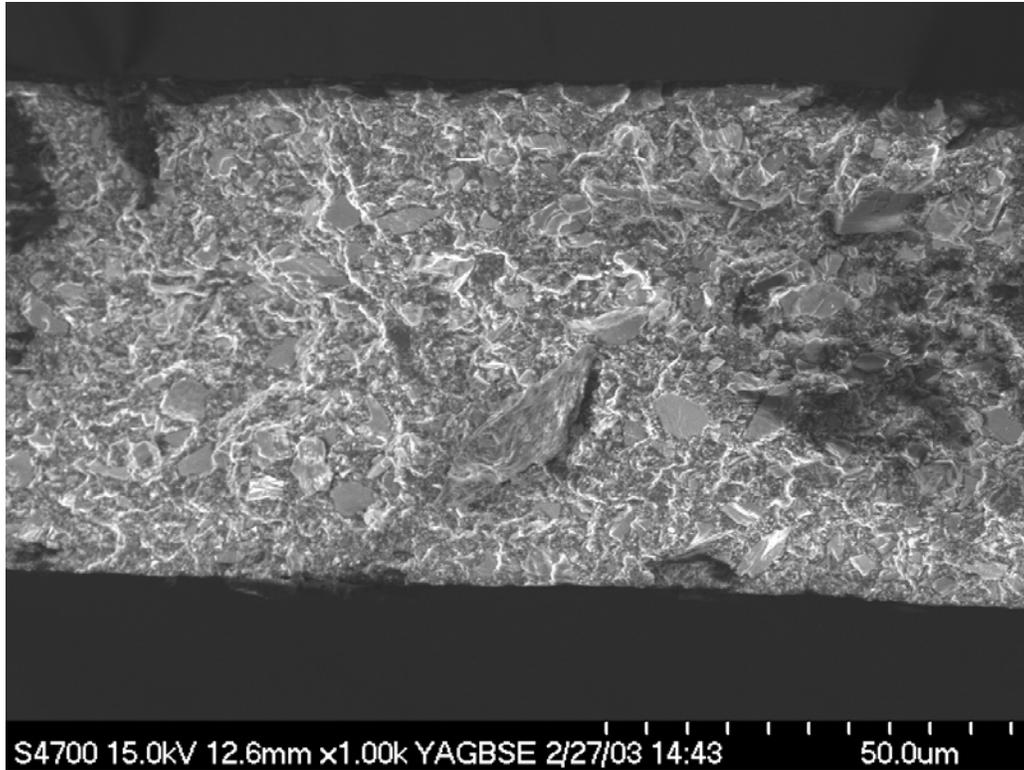
Figure 14. YAGBSE image at 15 KeV. Note charging.

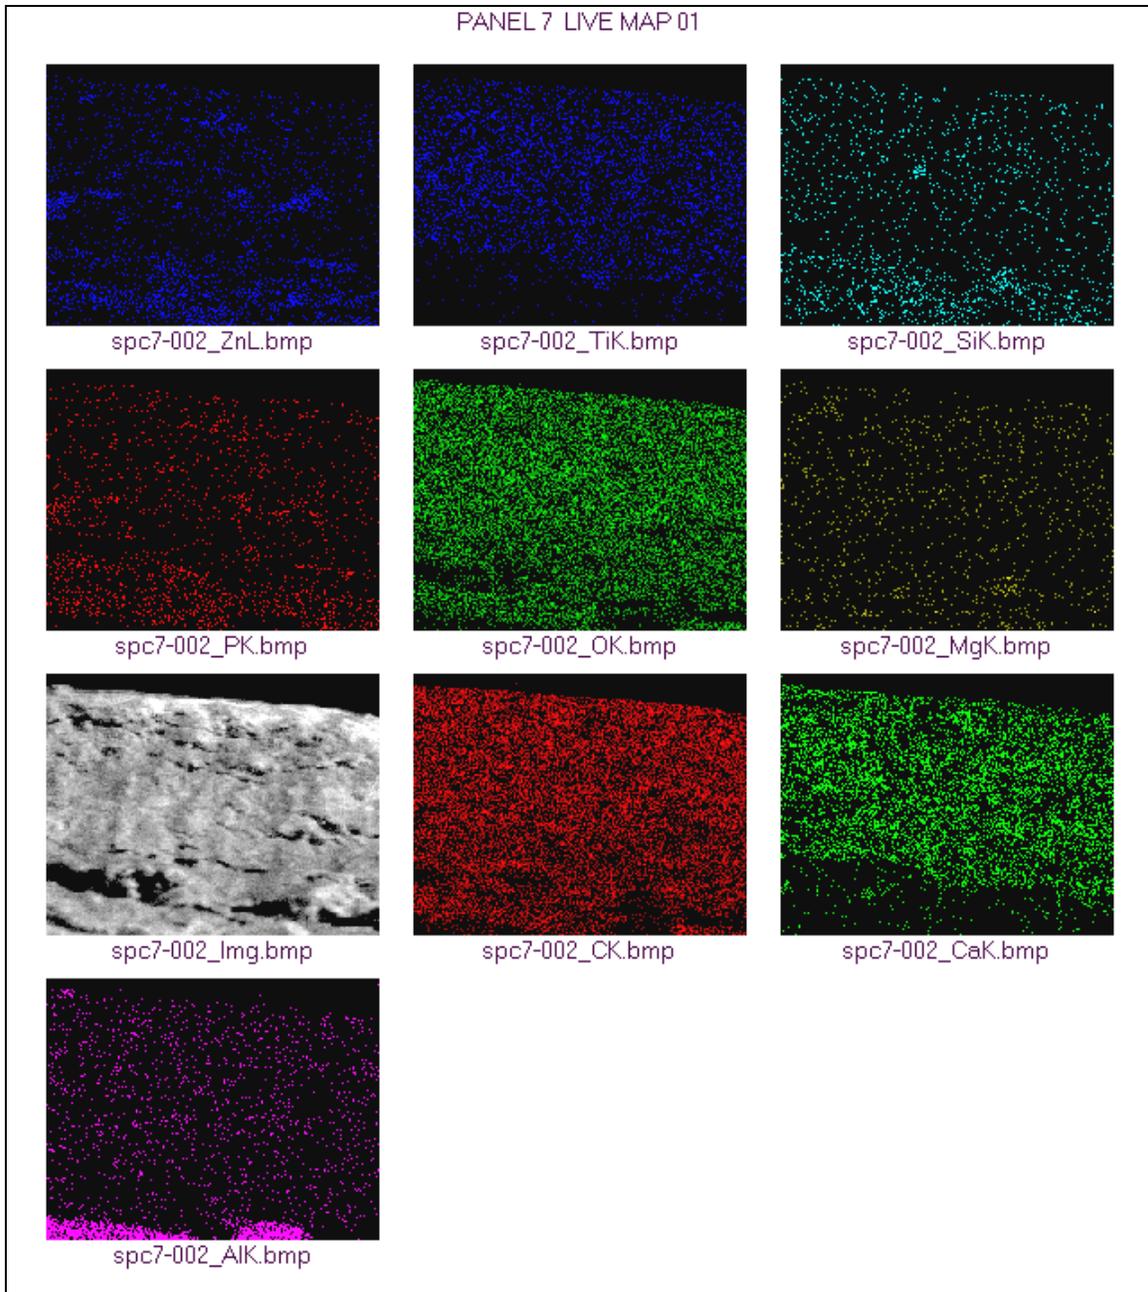
Then a Live elemental map was captured at 500-ms dwell time/frame of 256×200 pixels. The spectrum and mapping were performed at 15-KeV and 10- μ A emission current. The elemental maps were allowed to build so that titanium distributions were readily evident. Figure 19, Live map 01, is at 1.5 KX, and figure 20, Live map 03, at 2 KX. Comparing the two Al K maps shows an alignment error between the S-4700 and the EDAX external control module. Note the total absence of a chromium response. Because of the sample handling problems and the failure to see any changes in distribution with the panel 7 sample, it was decided to work with the free film from panel 5.

Figure 19. Live map of panel 7 film at 15 KeV and 1.5 KX.

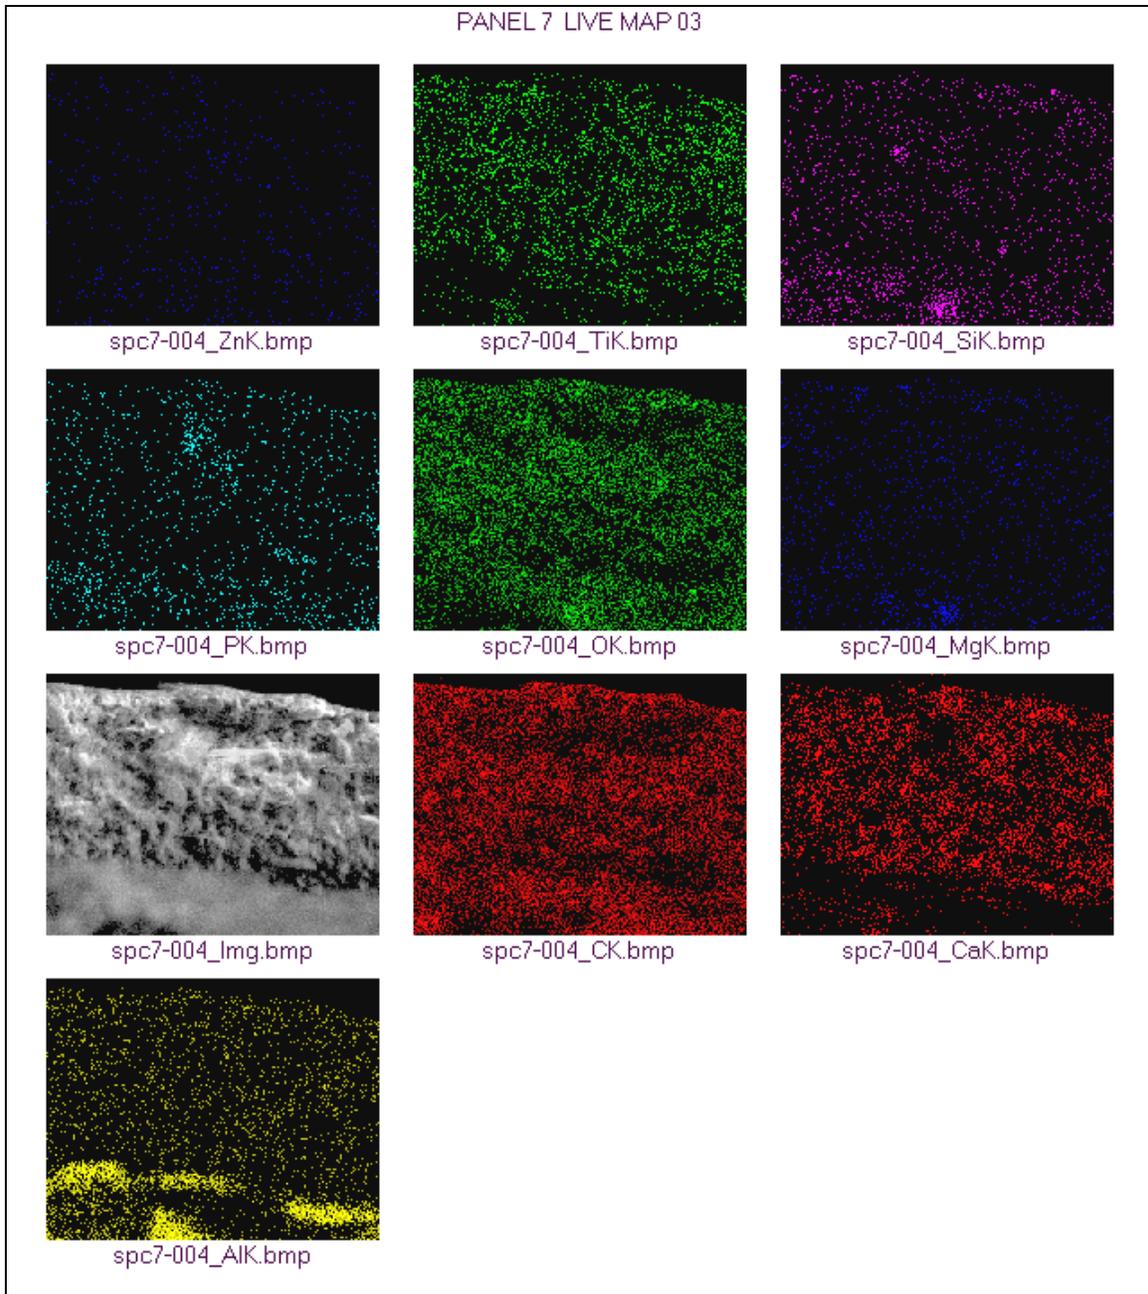
Figure 20. Elemental mapping of panel 7 at 2 KX magnification.

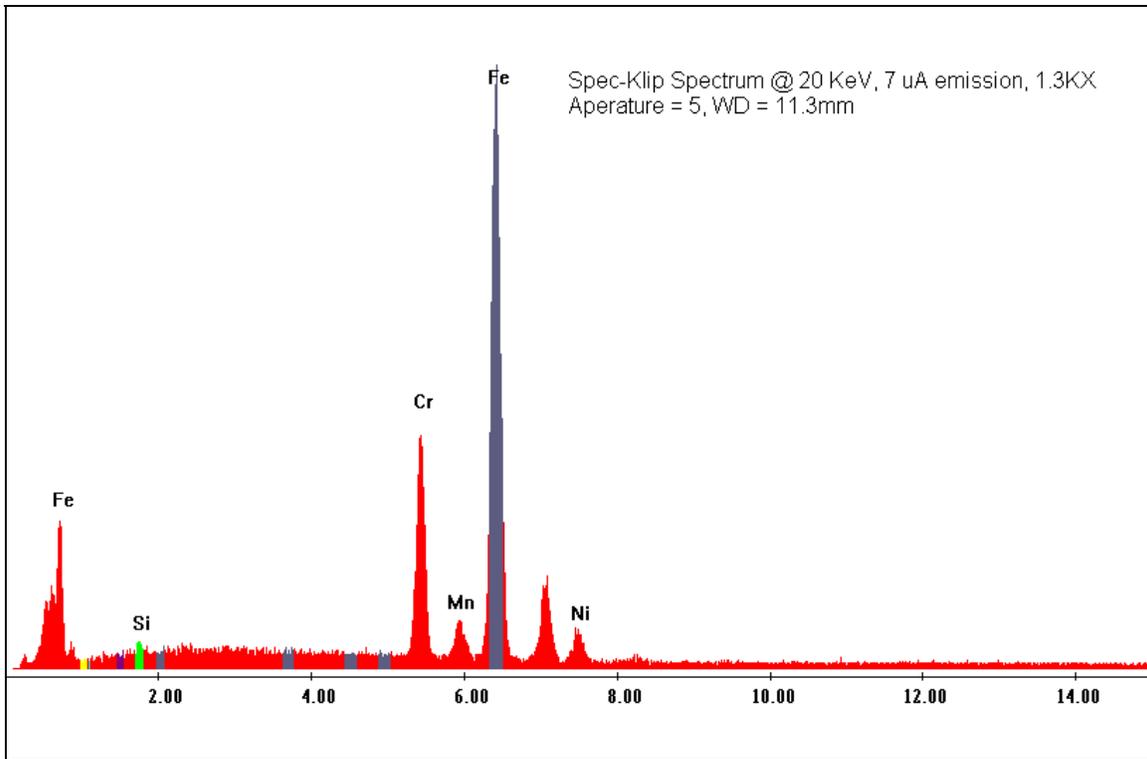
response probably arose from the clip (figures 22 and 23), which was on either side of the film. The film-to-clip contact area was ~ 2 mm below the surface being examined.

Figure 22. Metal spring clip spectrum.

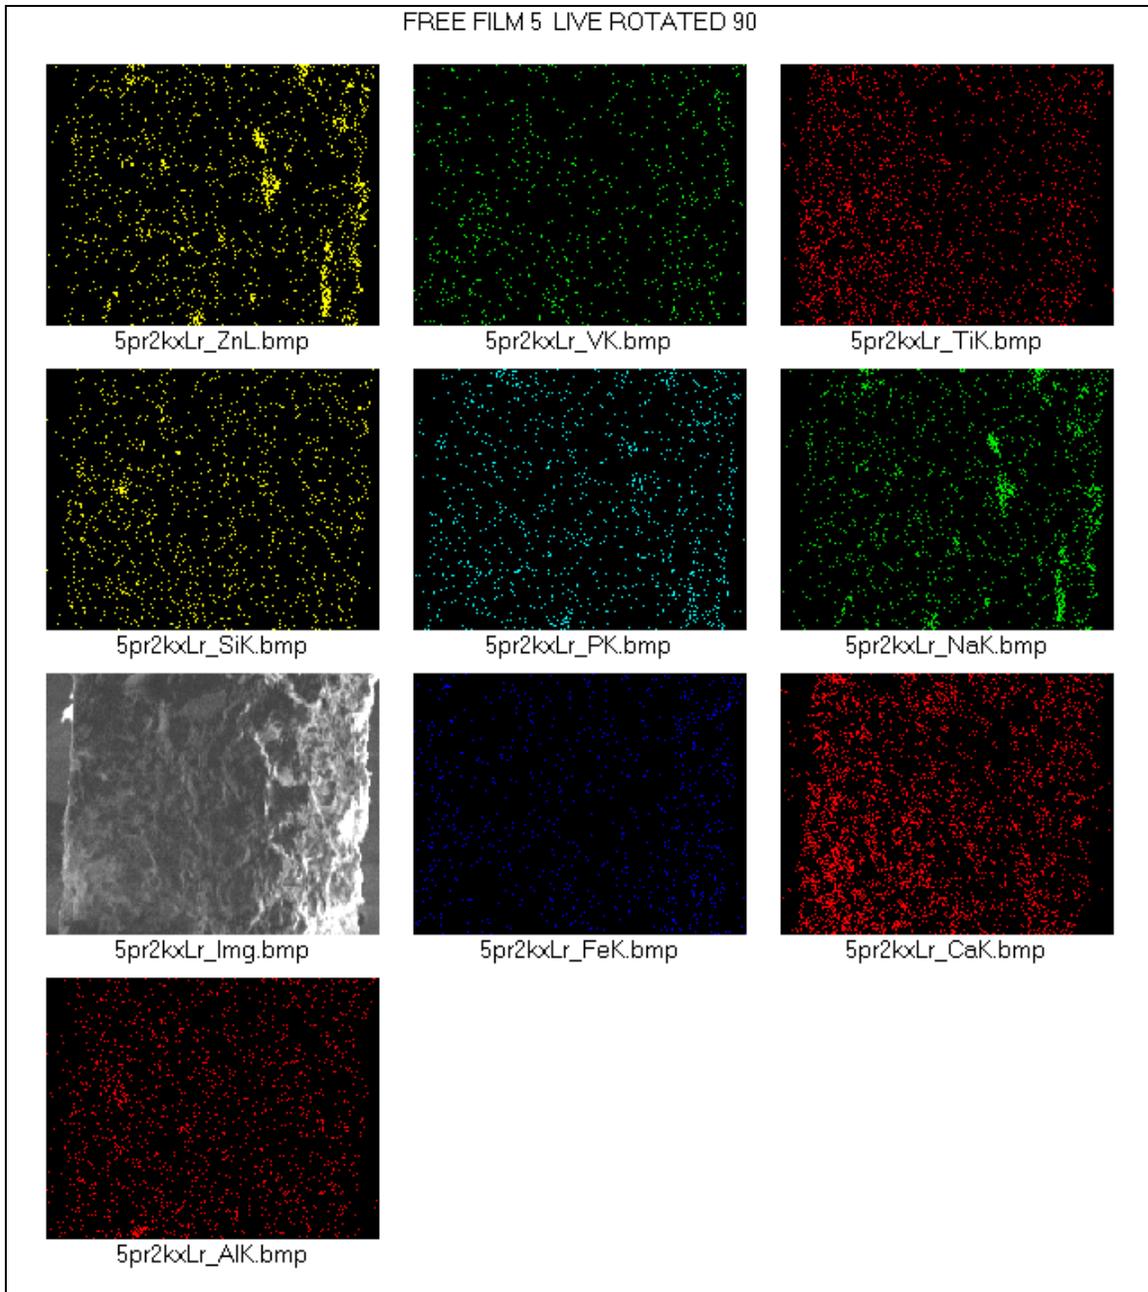
A Live mapping of this same region is shown in figure 25. For the Live mapping the dwell time was 100 ms/256 × 200 pixels frame, and 32 frames were captured. Note the loss of response for the P K peak.

Figure 25. Live mapping of figure 24 region post Quant mapping.

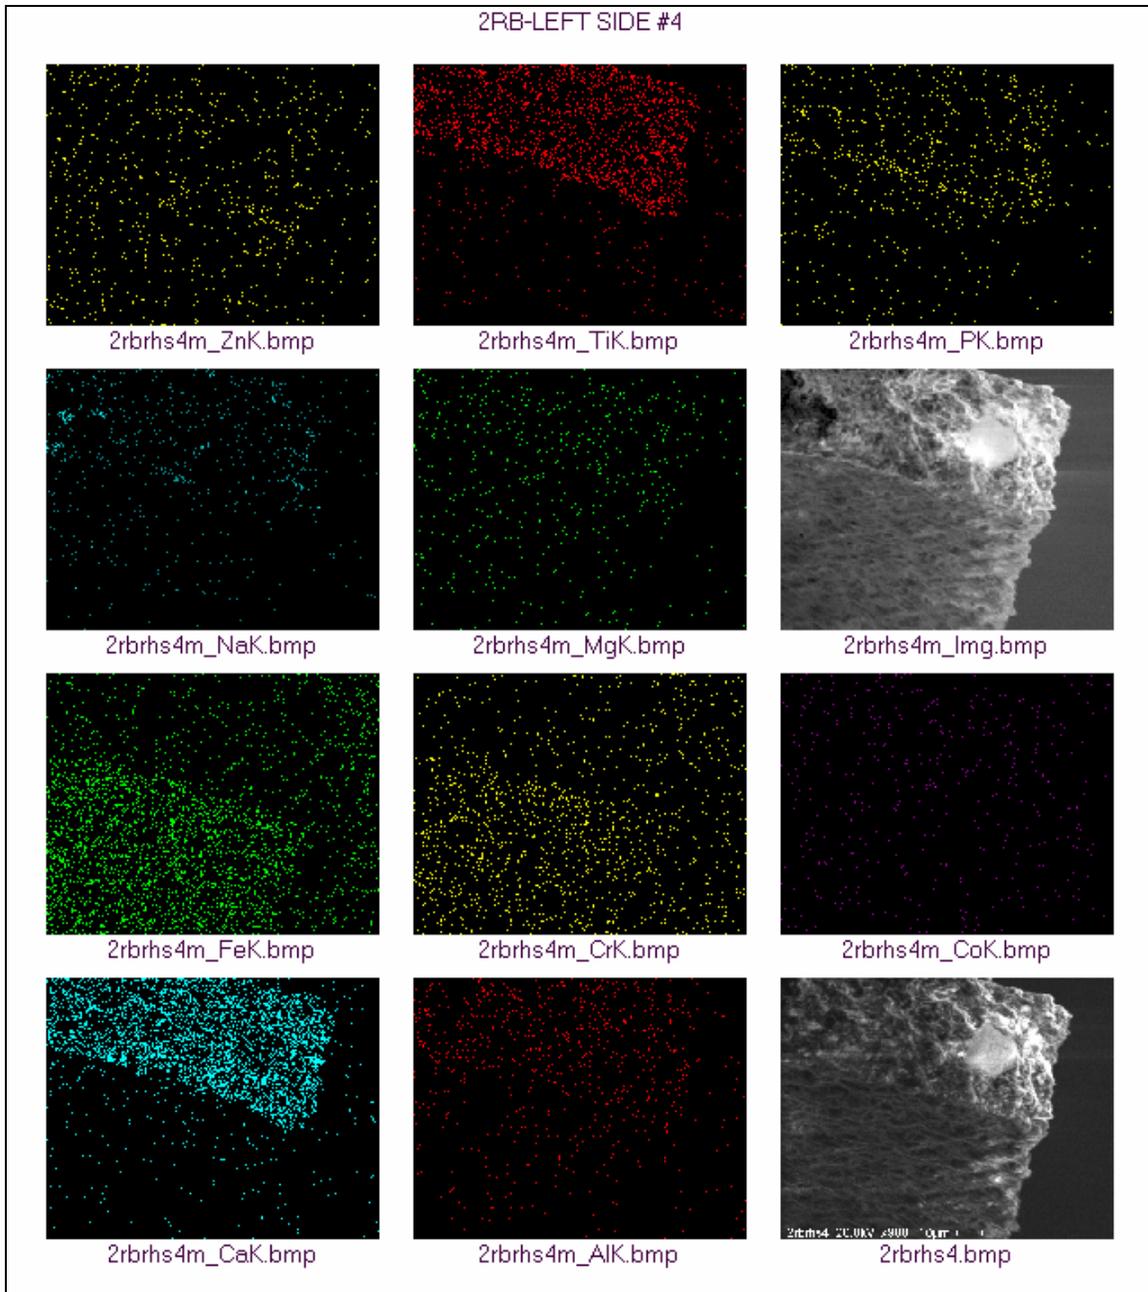
The Cr K maps in figures 29 and 30 appear to be similar for each edge. This may be a result of stacking the panels coated face to chromated face. These Live maps don't have sufficient information to identify a panel interface surface (figure 31).

Figure 31. Repeat of Live elemental map from figure 29.

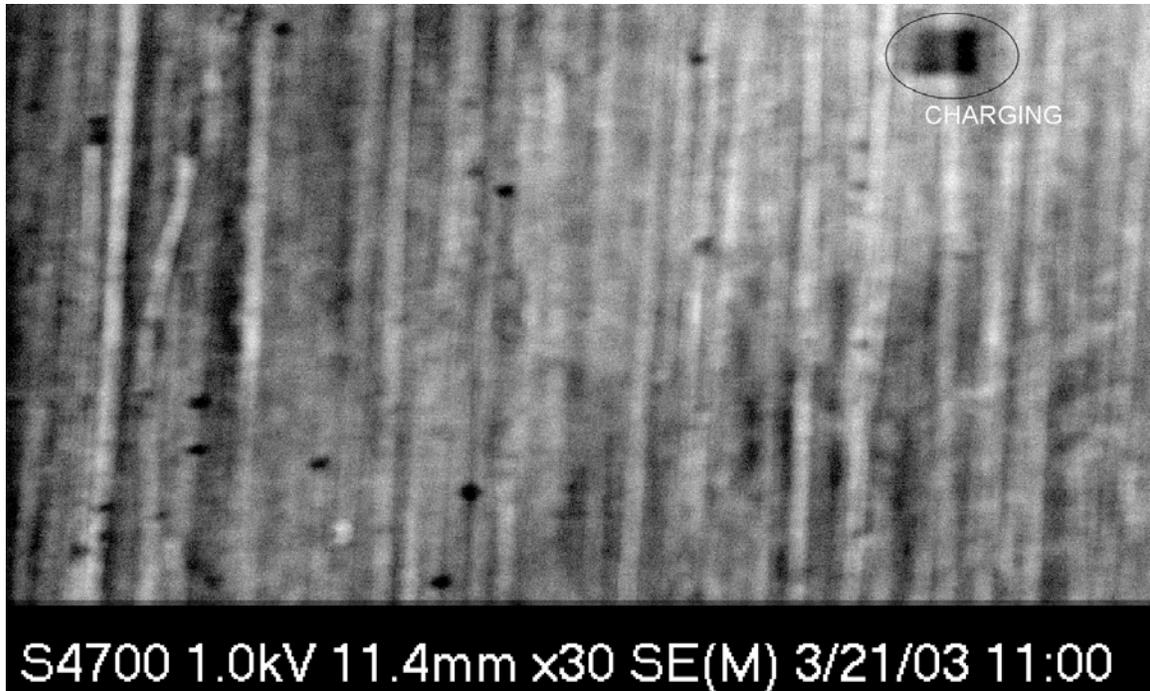
mount were insufficient to the required task. One result of this problem is seen in figure 32, where surface charging is obvious on the aluminum micro-vise mount. The emission current was 2 μA , and the numerical aperture value was 5.5.

Figure 32. Surface charging on surface of aluminum micro-vice.

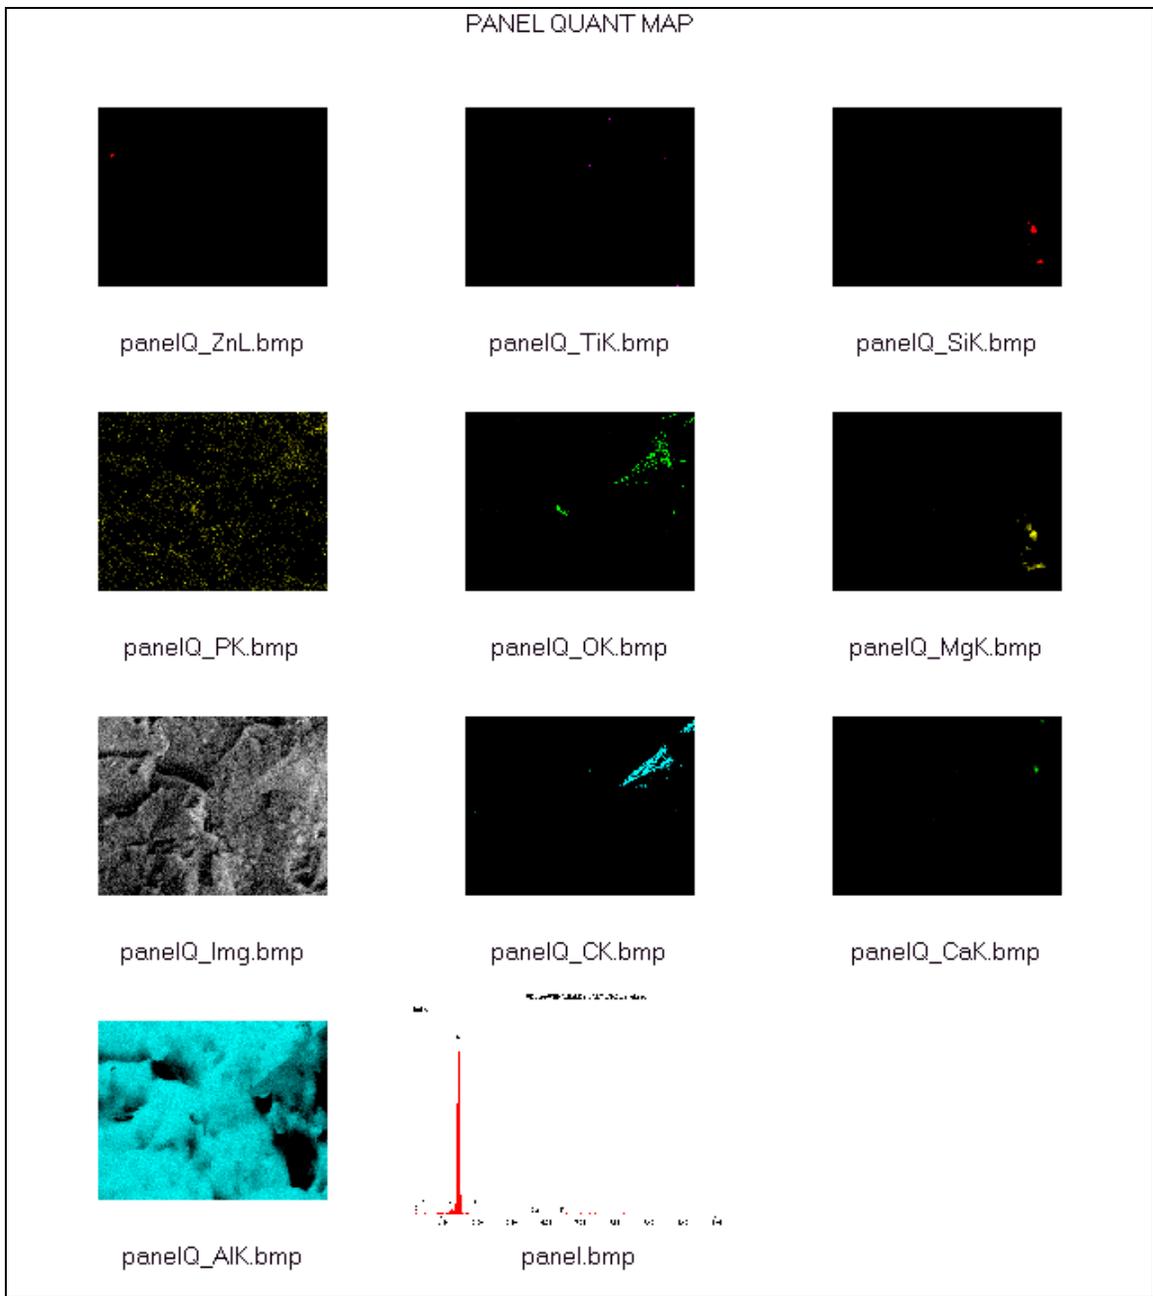
Finally, a spectrum and a Quant map were taken of the aluminum fracture face of panel 7 (figure 34). The panel with coating spectrum and the panel spectrum are presented in figure 35 for comparison.

Figure 34. Elemental mapping of the fracture face from panel 7.
