NASA/TM—2011–216477

A Damage Tolerance Comparison of Composite Hat-Stiffened and Honeycomb Sandwich Structure for Launch Vehicle Interstage Applications

A.T. Nettles

Marshall Space Flight Center, Huntsville, Alabama

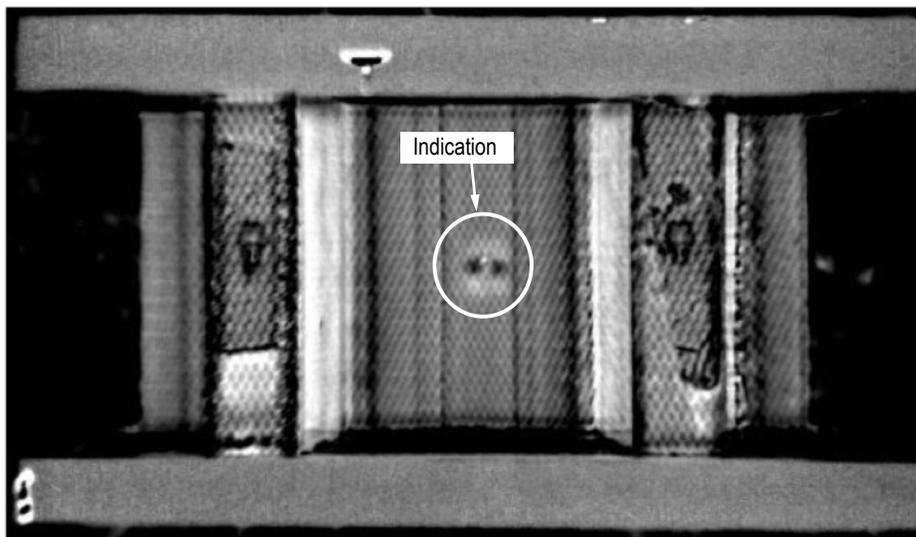
Figure 3. Example of an IRT indication on an impacted specimen.

After impact testing, the specimens were assessed for damage using IRT. This NDE technique utilizes a burst of heat from a quartz lamp and a very sensitive infrared camera monitors the dissipation of heat from the specimen. The heat will emit at a different rate at locations where damage exists and the infrared camera shows these areas (termed 'indications') on a digital computer. An example of an IRT indication is shown in figure 3.

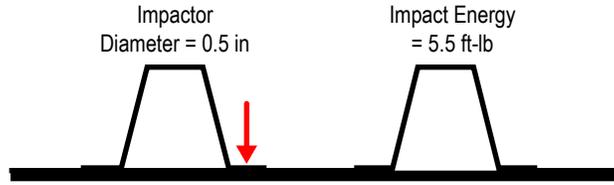
Figure 6. Location of impact on specimen double 2.

This specimen had hat stiffeners that were precured and then bonded to the face sheet in a secondary bonding operation. The specimen was impacted on the foot of a web, towards the center of the specimen, with a 0.5-in-diameter impactor at impact energy of 5.5 ft-lb as shown schematically in figure 6.

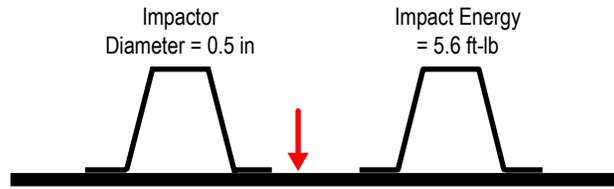
Figure 10. Location of impact on specimen double 3.

This specimen had hat stiffeners that were precured and then bonded to the face sheet in a secondary bonding operation. This specimen was impacted at the center of the specimen, directly onto the face sheet between the two hats, with a 0.5-in-diameter impactor with an impact energy of 5.6 ft-lb as shown schematically in figure 10.

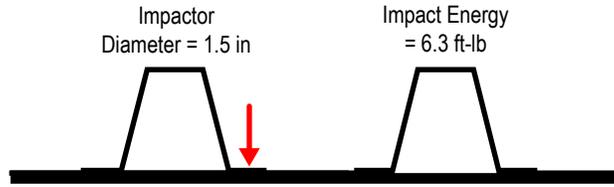
Figure 12. Location of impact on specimen double 4.

This specimen had hat stiffeners that were precured and then bonded to the face sheet in a secondary bonding operation. The specimen was impacted on the foot of one of the webs with a 1.5-in-diameter impactor with an impact energy of 6.3 ft-lb as shown schematically in figure 12. This is a similar impact to that on specimen double 1 except that a larger impactor with 14% more energy was used.

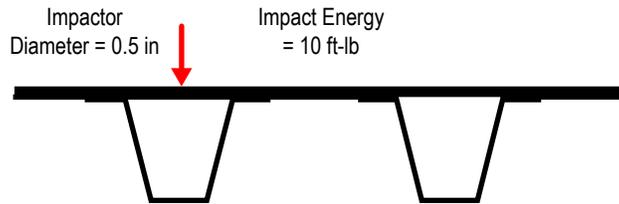
Figure 16. Location of impact on specimen double 5.

This specimen had hat stiffeners that were precured and then bonded to the face sheet in a secondary bonding operation. This specimen was impacted on the face sheet directly behind a crown with a 0.5-in-diameter impactor with an impact energy of 10 ft-lb as shown schematically in figure 16.

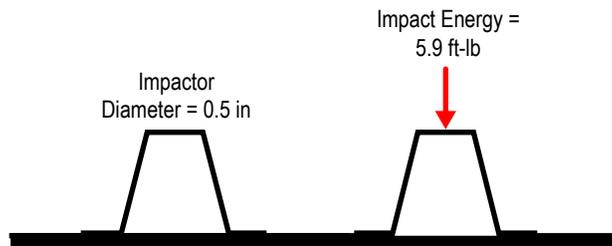
Figure 19. Location of impact on specimen double 6.

This specimen, and all subsequent specimens, had hat stiffeners that were co-cured to the face sheet in a single cure/bonding operation. This specimen was impacted at the center of one of the crowns with a 0.5-in-diameter impactor with an impact energy of 5.9 ft-lb as shown schematically in figure 19.

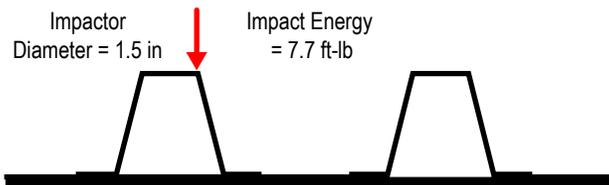
Figure 23. Location of impact on specimen double 7.

This specimen was impacted at the intersection of the web/crown area of one of the hat stiffeners with a 1.5-in-diameter impactor with an impact energy of 7.7 ft-lb as shown schematically in figure 23. This was to determine if the location of impact on the crown was a critical parameter by comparison to specimen double 6.

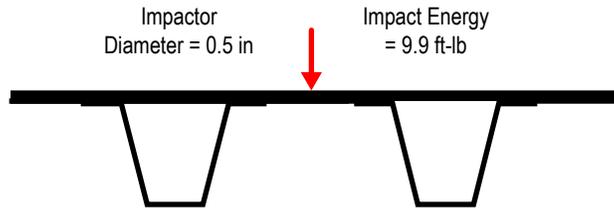
Figure 26. Location of impact on specimen double 8.

This specimen was impacted on the face sheet from the rear at the midpoint between hat stiffeners with a 0.5-in-diameter impactor with an impact energy of 9.9 ft-lb as shown schematically in figure 26.

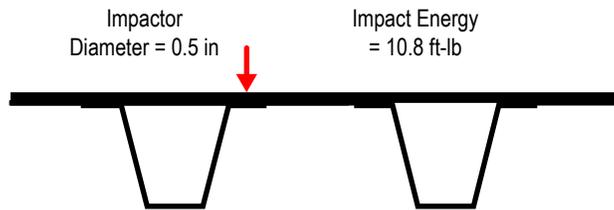
Figure 30. Location of impact on specimen double 9.

This specimen was impacted on the face sheet behind a foot of one of the hat stiffeners with a 0.5-in-diameter impactor with an impact energy of 10.8 ft-lb as shown schematically in figure 30.

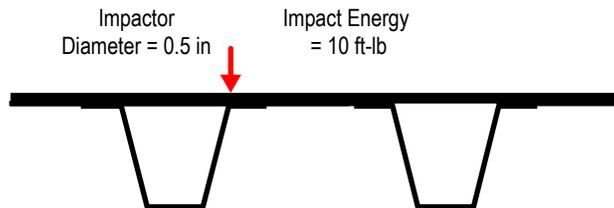
Figure 33. Location of impact on specimen double 10.

This specimen was impacted on the face sheet directly behind one of the ‘noodles’ with a 0.5-in-diameter impactor with an impact energy of 10 ft-lb as shown in figure 33.

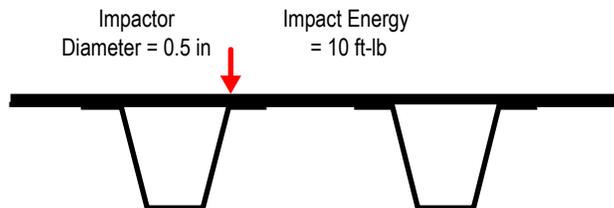
Figure 37. Location of impact on specimen double 11.

This specimen was impacted identically to specimen double 10. Impact was on the face sheet directly behind one of the ‘noodles’ with a 0.5-in-diameter impactor with an impact energy of 10 ft-lb as shown in figure 37.

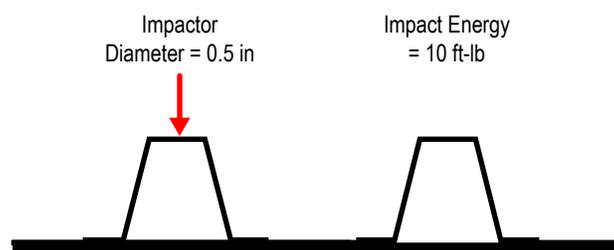
Figure 39. Location of impact on specimen double 12.

This specimen was impacted on one of the crowns with a 0.5-in-diameter impactor with an impact energy of 10 ft-lb as shown schematically in figure 39. This impact was similar to the impact on specimen double 6, the main difference being that the impact energy used on specimen double 12 was 70% larger than that used on specimen double 6.

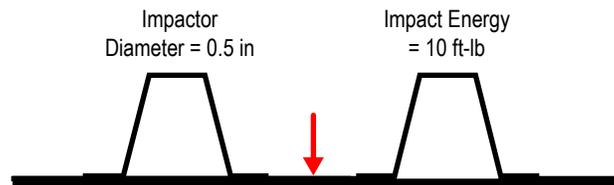
Figure 43. Location of impact on specimen double 13.

This specimen was impacted on the face sheet between the two hats with a 0.5-in-diameter impactor with impact energy of 10 ft-lb as shown schematically in figure 43. This impact is similar to that on specimen double 3, however, that specimen was manufactured with precured face sheets and hit with 44% less impact energy.

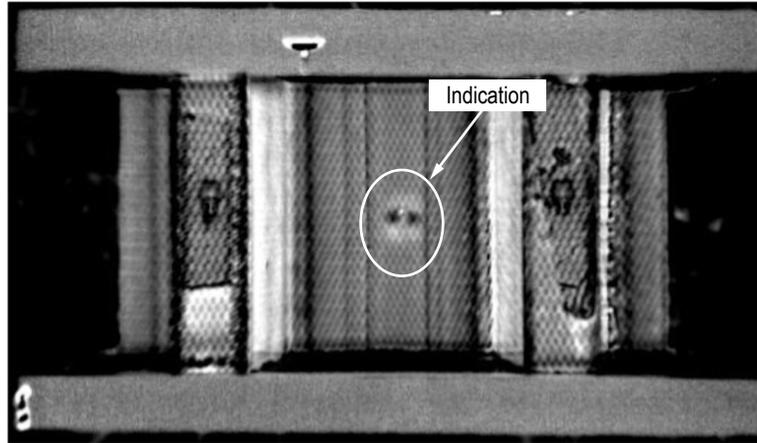
Figure 44. IRT for specimen double 13.

A photograph of an IRT image of the impacted specimen is presented in figure 44. The IRT image for this specimen is larger than that on specimen double 3, which is expected since this specimen was hit in the same location but with more impact energy.

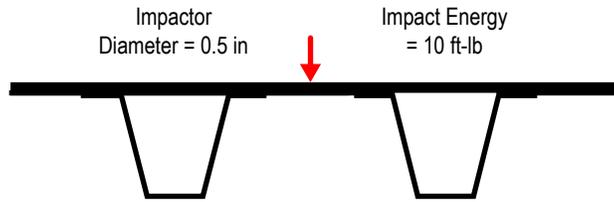
Figure 46. Location of impact on specimen double 14.

This specimen was impacted on the face sheet from the rear, directly between the two hat stiffeners with a 0.5-in-diameter impactor with impact energy of 10 ft-lb as shown schematically in figure 46. This impact was very similar to the impact inflicted upon specimen double 8.

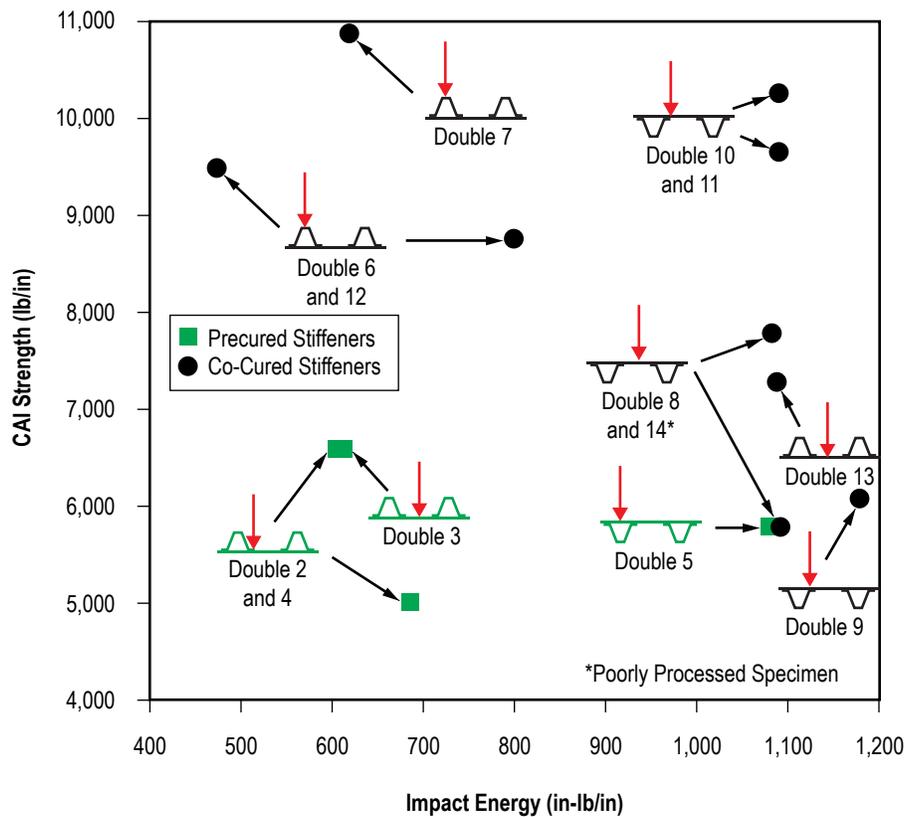
Figure 49. Residual strength versus impact energy for hat-stiffened specimens.

The data in table 1 are represented graphically in figure 49. A curve fit or other type of data comparison is not possible since the impacts were in different locations on the hat-stiffened panel, which completely change the damage mechanics involved. The data of the co-cured, hat-stiffened panels on the plot are noted as to what part of the specimen the impact took place at.

Specimen	Impact Energy	CAI Strength (in-lb/in)
Double 1	0	7,500
Double 2	602	6,600
Double 3	609	6,600
Double 4	682	5,000
Double 5	1,094	5,800
Double 6	472	9,500
Double 7	617	10,900
Double 8	1,082	7,800
Double 9	1,178	6,100
Double 10	1,091	10,300
Double 11	1,091	9,700
Double 12	800	8,800
Double 13	1,088	7,300
Double 14*	1,091	5,800

*Poorly processed specimen

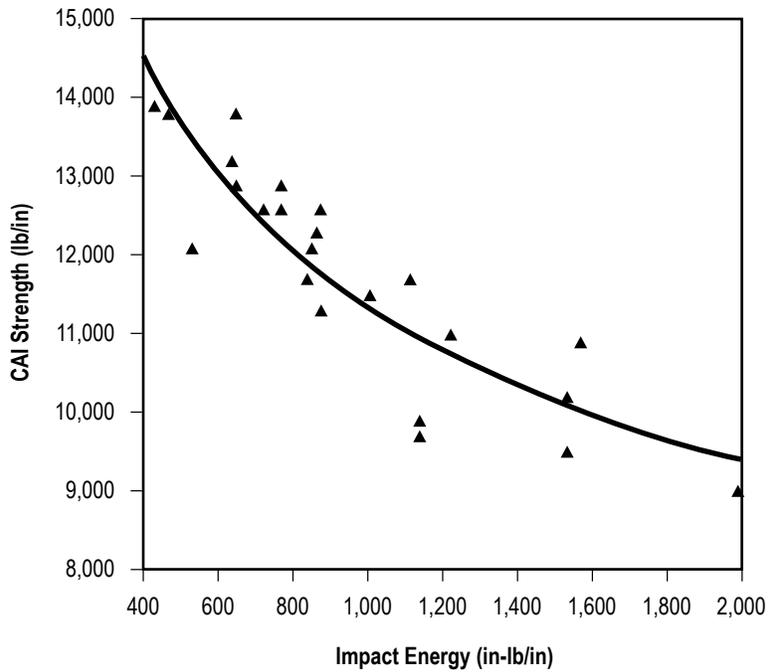
Figure 50. Residual strength versus impact energy sandwich specimens.

The data in table 2 are represented graphically in figure 50. A power curve is fitted to the data since the impacts for these specimens were independent of location; i.e., the sandwich structure is continuous.
