Preservation Tech Notes

NUMBER 21

Replacement Wood Sash Utilizing True Divided Lights and An Interior Piggyback Energy Panel

BEATTY'S MILL (CORAL STREET ARTS HOUSE) Philadelphia, Pennsylvania

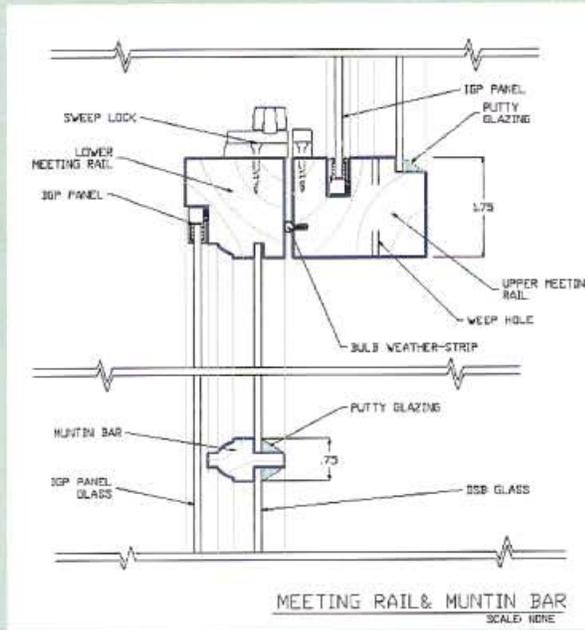
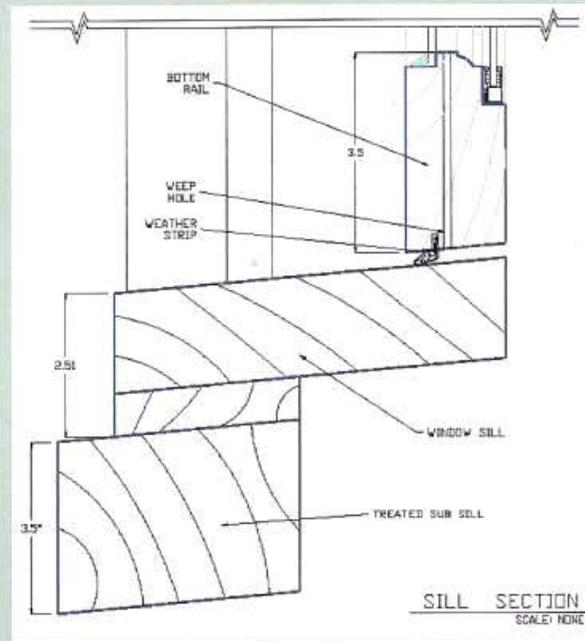
Figure 5. For the new windows to meet ASTM Standards, the face width of the meeting rail was increased 1/2 inch. To both accommodate the piggyback energy panel and match the historic muntins, the thickness of the wood sash was increased from 1 3/8" to 1 3/4". These two changes had minimal visual impact, considering the size of the windows. Drawings: Courtesy of Seaquay Architectural Millwork.

Somewhat more problematic was how close the bottom rail (meeting rail) of the new upper sash could match the narrow width of the existing window. Specifications for the project required that the replacement window meet three ASTM Standards: ASTM E283, the standard test for determining the rate of air leakage through an exterior window; ASTM E331, the test of water penetration; and ASTM E330, the standard test for structural performance of an exterior window. To meet ASTM E330 with the design pressure rating for the window set by the architect, a 1 3/4" wide meeting rail was needed (see figure 5). This was an increase of 1/2 inch over the historic sash. Fortunately because of the size of the window, this increase was considered acceptable, as the meeting rail still appeared relatively narrow even with the 1/2 inch increase.
