SSME 0523

TEST 902-772

FAILURE INVESTIGATION

FINAL REPORT

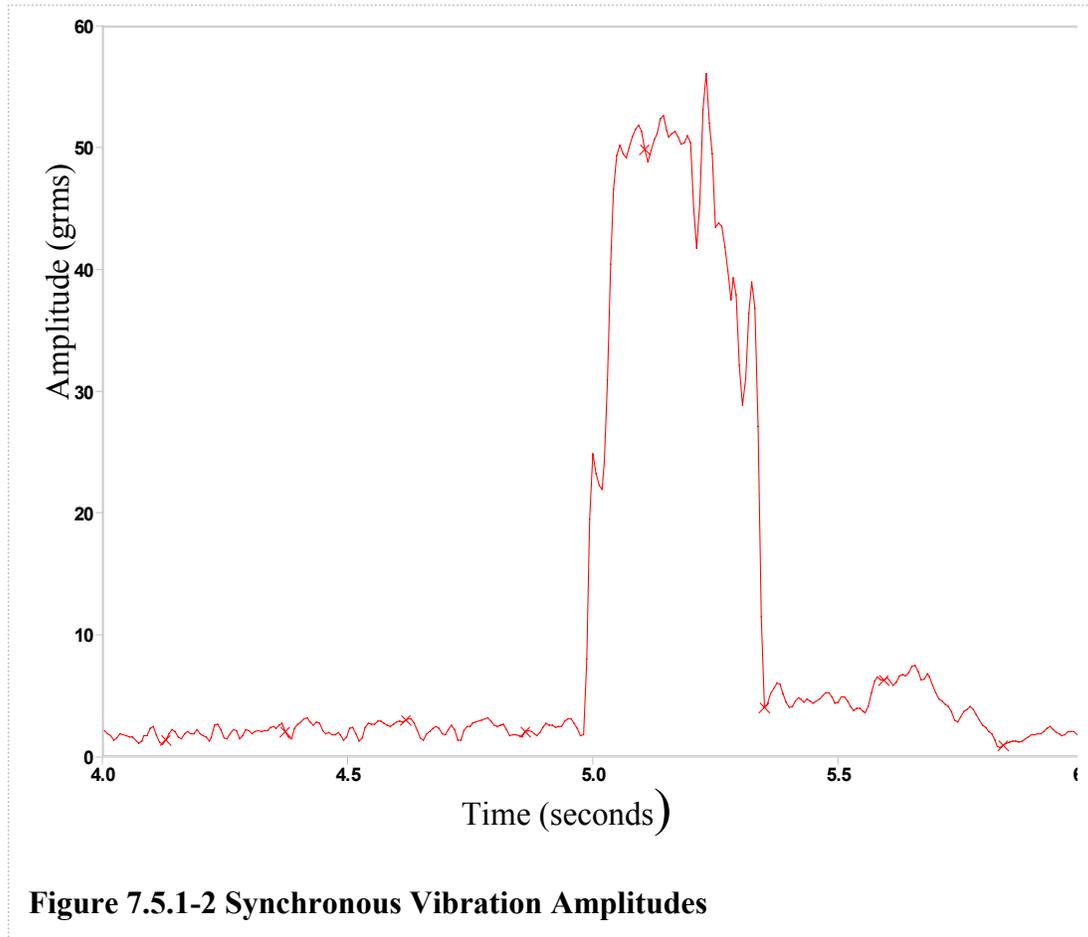
The second event was characterized by a sharp increase in synchronous vibration amplitude at 4.97 seconds, followed by a loss of HPFTP/AT power. The vibration amplitude increase, shown in Figure 7.5.1-2, was caused by a loss of turbine rotor material.

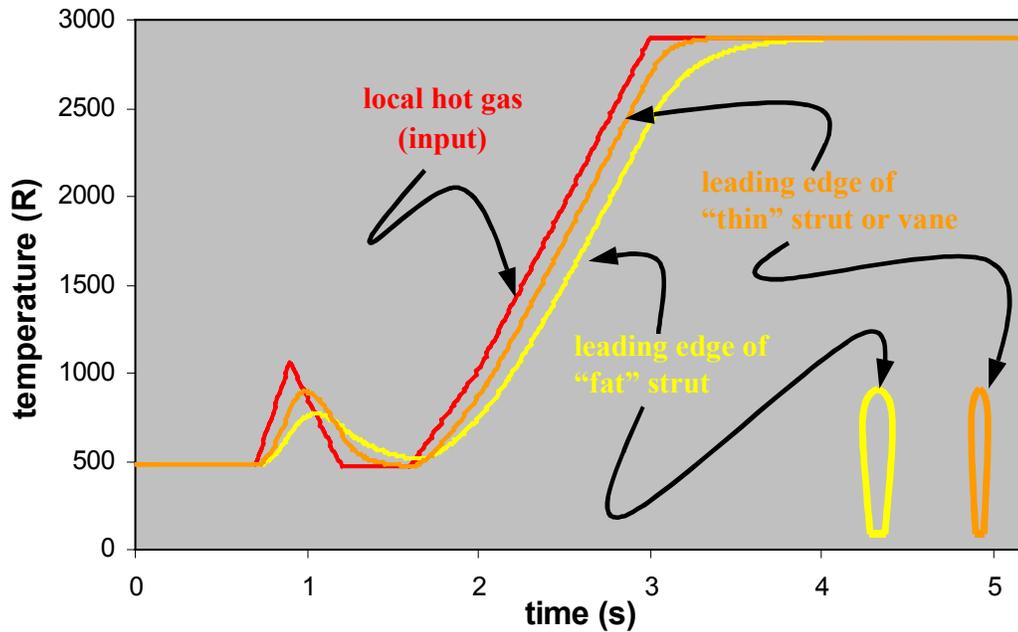
Figure 7.5.3-3 Transient Thermal Analysis of a HPFT Inlet Strut or Vane

According to a material survey generated by Pratt & Whitney, the metal of the HPFT vanes will begin to melt when the local metal temperature reaches approximately 2900R and the struts shortly thereafter.

A simple transient thermal analysis of the leading edges of the HPFT inlet structures was assembled to examine the time lag between local hot gas temperature and the heating of the metal. The results for a single hypothetical situation are presented in Figure 7.5.3-3. What is shown is a varying local hot gas temperature that represents actual extrapolated data from the 902-772 test and an assumed rise to the 2900R metal melting temperature between 2 and 3 seconds. Also plotted in Figure 7.5.3-3 are two lines representing the temperature of the leading edge of a “fat” strut and a “thin” strut or a vane as described in Figure 7.5.3-1.

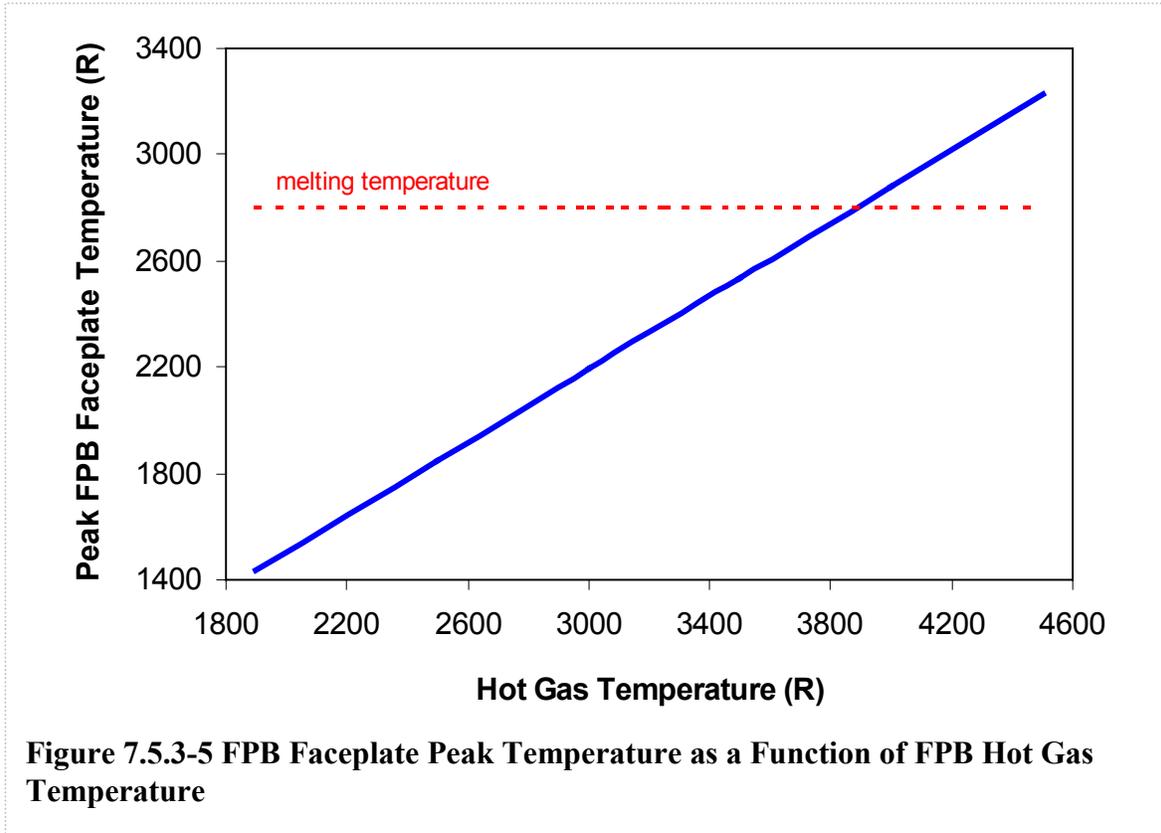
Figure 7.5.3-5 FPB Faceplate Peak Temperature as a Function of FPB Hot Gas Temperature

Figure 7.5.3-5, presents the results from a series of runs of the FPB faceplate transient thermal model. Plotted here is the peak temperature within the hottest layer of the faceplate material as a function of the local hot gas temperature. The faceplate would be at the point of incipient melting when the local hot gas temperature is approximately 3900R.

Thus, the peak local temperature within the FPB can be narrowed to a range of between 2900R, the temperature necessary to melt the HPFT inlet structures, and 3900R, the temperature beyond which the FPB faceplate would be expected to melt and experience significant damage.

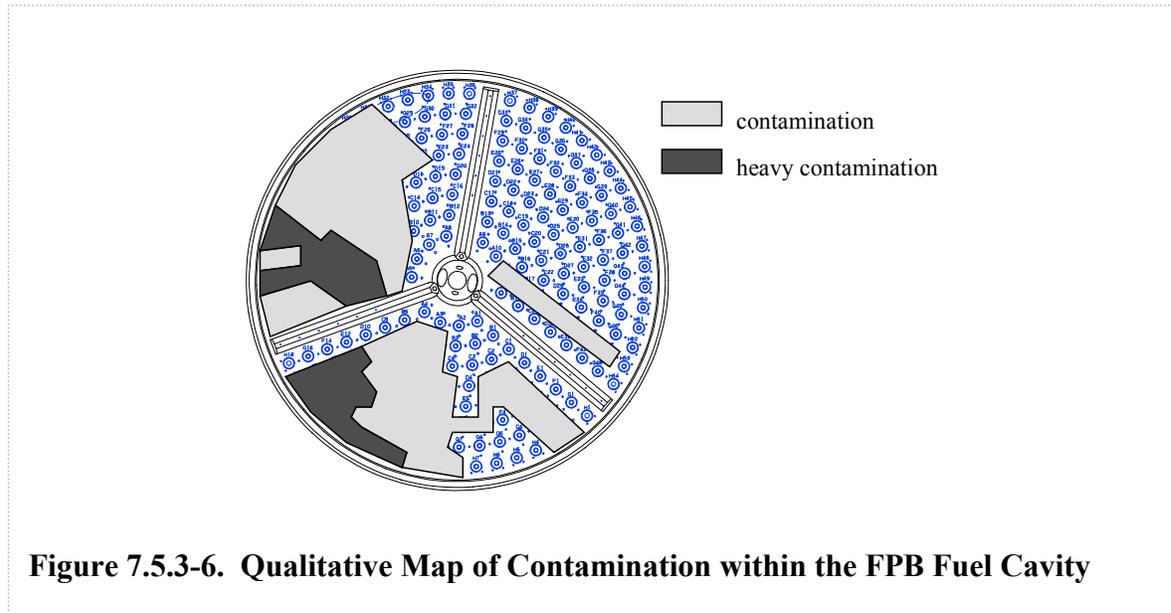
The contamination within the FPB fuel cavity observed post-test 902-772 is mapped out qualitatively in Figure 7.5.3-6.

After several runs of the model, it was determined that a maximum effective flow blockage of between 55% and 70% corresponding to the mapped regions of “heavy contamination” will result in localized regions of combustion temperatures between 2900R and 3900R. This level of blockage is consistent with the narrative descriptions of the hardware given by the engineers and technicians performing the engine disassembly inspections at Rocketdyne, Canoga Park, CA.

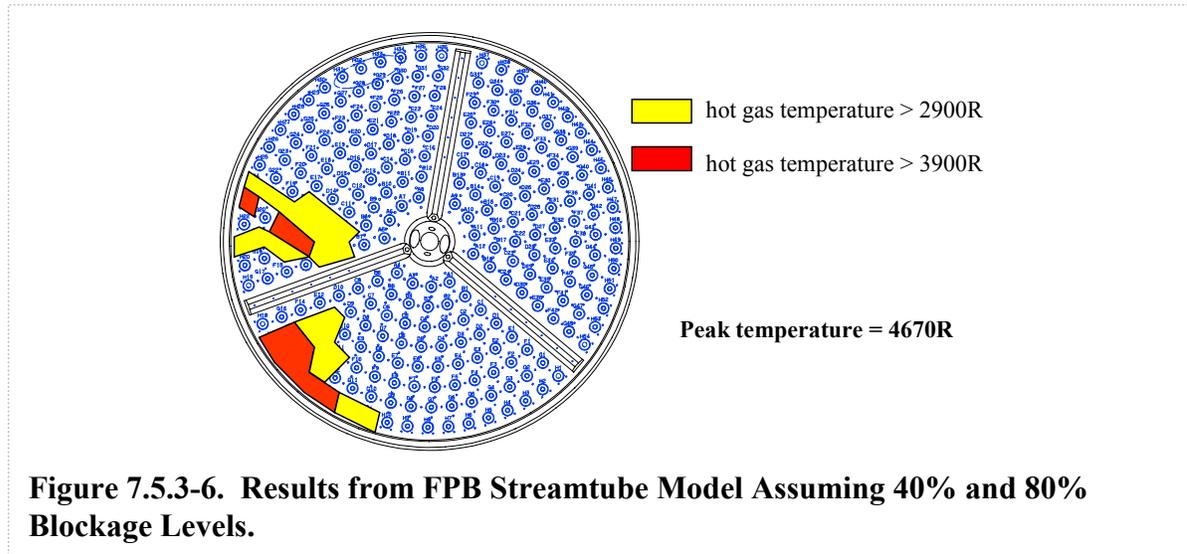
from one of these runs is presented in Figure 7.5.3-7. Here it was assumed that “contamination” corresponded to 40% effective flow blockage and “heavy contamination” corresponded to 80% effective flow blockage.

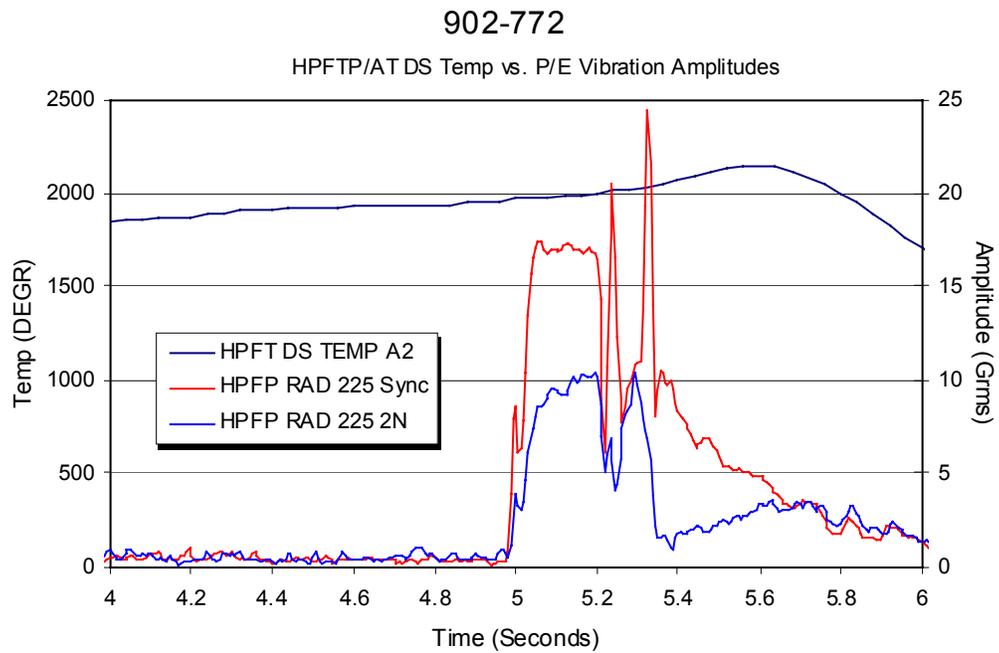
Figure 7.5.4-1 HPFTP/AT Pump-End 1N and 2N Amplitude Trackings with Turbine Discharge Temperature

The accelerometer data exhibited yet another large amplitude change in the 1N and 2N response amplitudes, primarily in the T/E data, approximately 0.044 seconds later. At this point (E/S + 5.012 seconds), the T/E 1N response spiked to 15.2 grms with the 2N response spiking to 50.2 grms. Heavier rubbing occurred at this time in the HPFTP/AT with more blade material being liberated and the balance of the rotor continuing to degrade.

The accelerometers exhibited the final amplitude increase at E/S + 5.1995 seconds (0.1875 seconds after the second amplitude spiking observation) where the T/E 1N amplitude spiked to 83.4 grms. At this point, the majority of the damage to the turbine blades had been incurred and rotordynamic balance of the HPFTP/AT had been grossly affected. It is also at this point where failure of the HPFTP/AT roller bearing occurred due to the large radial load which was imparted to the bearing. All of the previous amplitude observations can be seen in Figures 7.5.4-1 and 7.5.4-2. These figures show both the P/E and T/E 1N and 2N amplitude data cross-plotted with the HPFT discharge temperature (HPFT DS T) data.

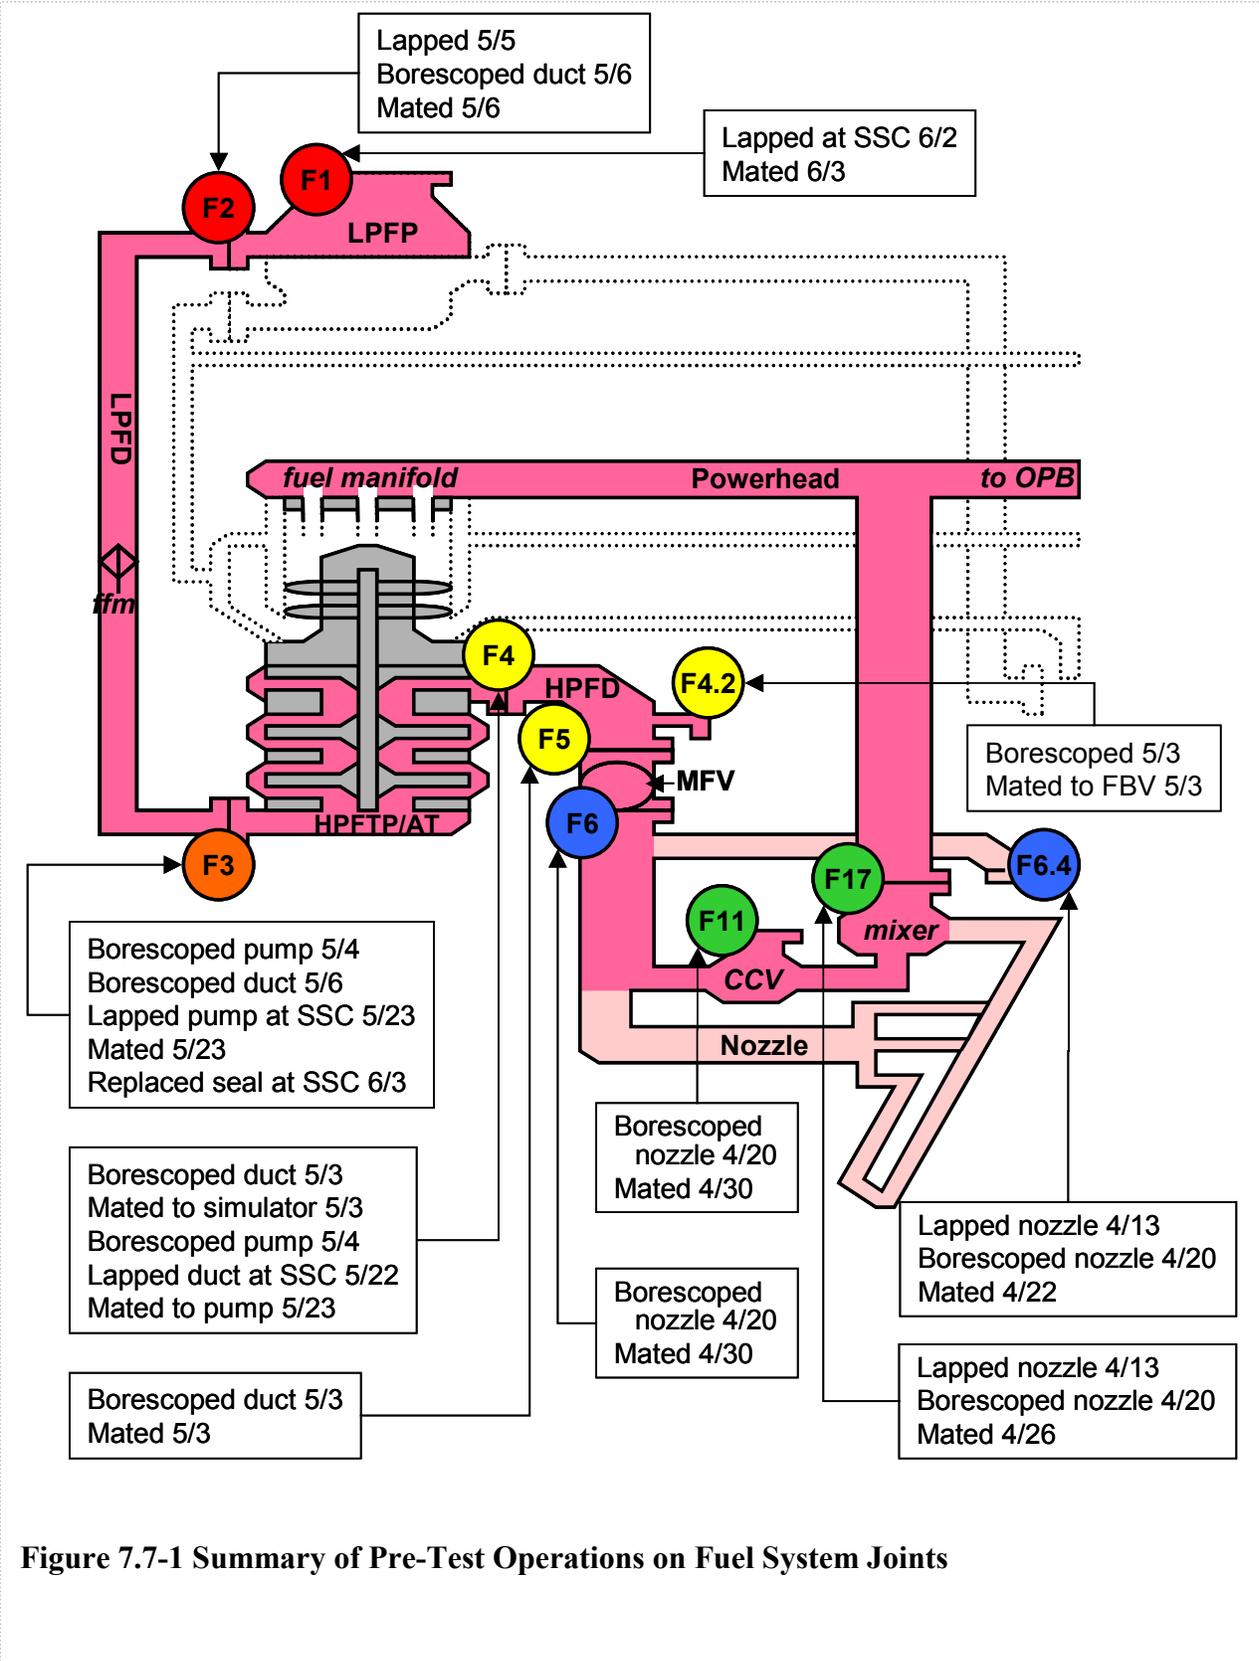
Figure 7.7-1 Summary of Pre-Test Operations on Fuel System Joints

The Low Pressure Fuel Duct (LPFD), High Pressure Fuel Duct (HPFD), and Coolant Control Valve (CCV) had been removed, but remained allocated to SSME 0523. Pump simulators were removed at SSC and high pressure pumps were installed prior to test. During SSC pre-test processing, fuel joints F1, F3, and F4 were lapped utilizing internal tape and Aclar barriers. A list of fuel joints affected during engine operations at SSC is included in Figure 7.7-1.

It was determined by the team that several items from Rocketdyne, Canoga Park, had been shipped to SSC as open items. Specifically joints F3 and F4 were delivered on the engine with open paper work. It was discovered that these joints were shipped with simulator turbopumps attached and the paperwork was subsequently closed at SSC with no anomalies found. In all areas of the engine where tape was used, paperwork indicates removal was verified by borescope inspection, visual inspection, or both.

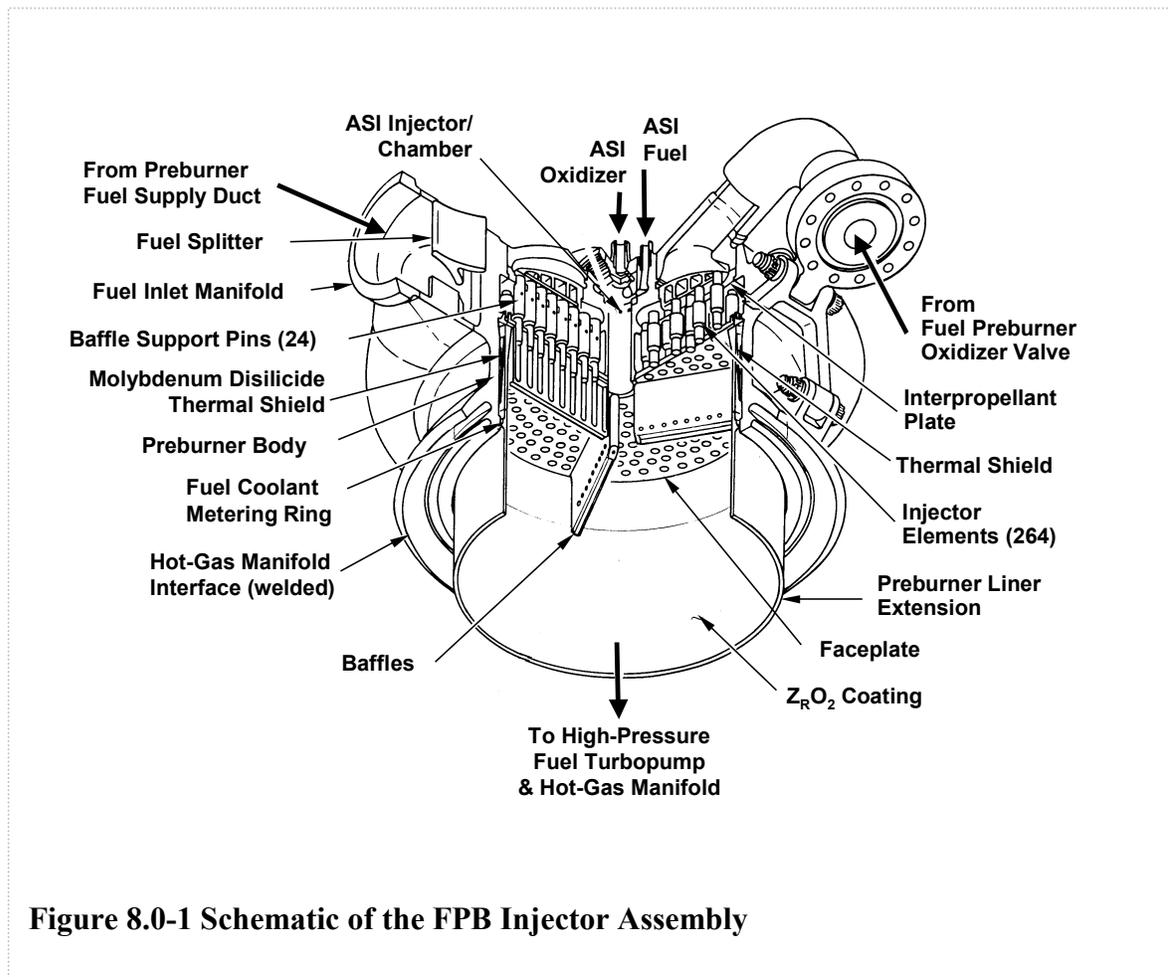
Figure 8.0-1 Schematic of the FPB Injector Assembly

On June 16, 2000, Stennis Space Center conducted test 902-772. SSME 0523 was to be tested for a scheduled duration of 200 seconds. At engine start the tape contamination was forced downstream in the fuel system, eventually coming to rest as debris in both the Fuel Preburner (FPB) injector and Oxidizer Preburner (OPB) injector. The amount of debris in the FPB was sufficient to block multiple fuel inlet holes of several FPB injector elements in localized areas.
