OFFICE OF SURFACE MINING
REPORT ON OCTOBER 2000
BREAKTHROUGH AT THE BIG BRANCH SLURRY IMPOUNDMENT

Martin County Coal Corporation
Big Branch Slurry Impoundment
Martin County, Kentucky

March 2002

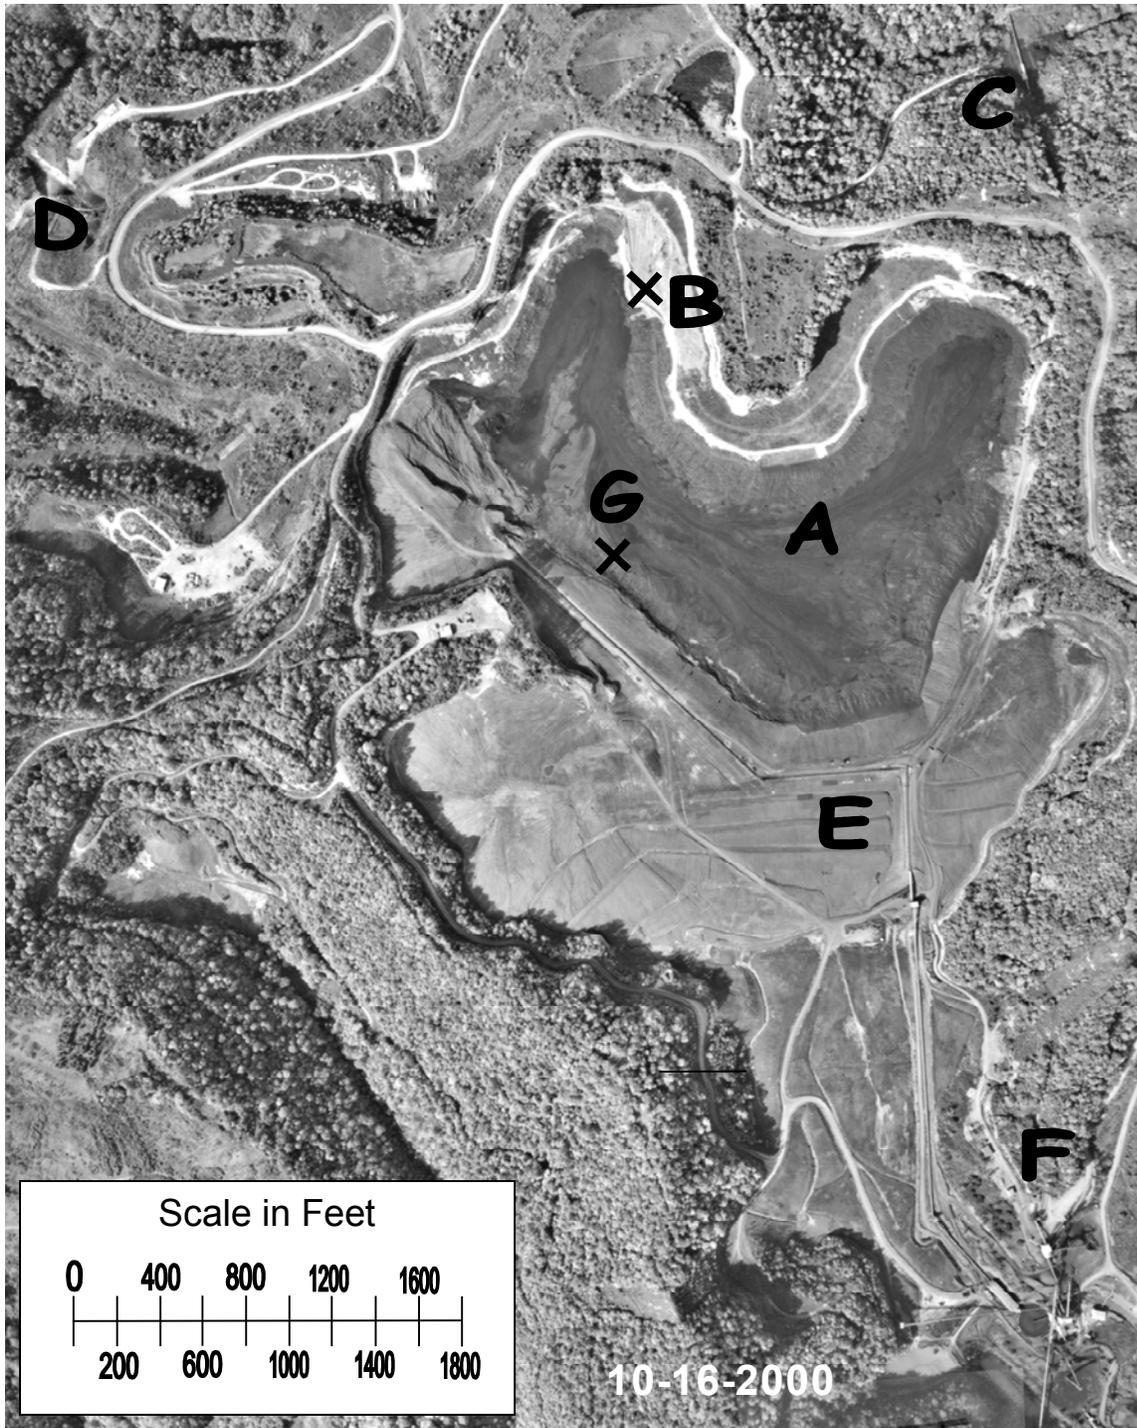
Photo 1. Aerial Photograph of Big Branch Slurry Impoundment - October 16, 2000. Source: Photo Science, Inc. A) Impoundment. B) 2000 breakthrough location. C) Number 2 North Mains Portals. D) South Mains Portal. E) Embankment (dam). F) Preparation plant. G) 1994 breakthrough location.

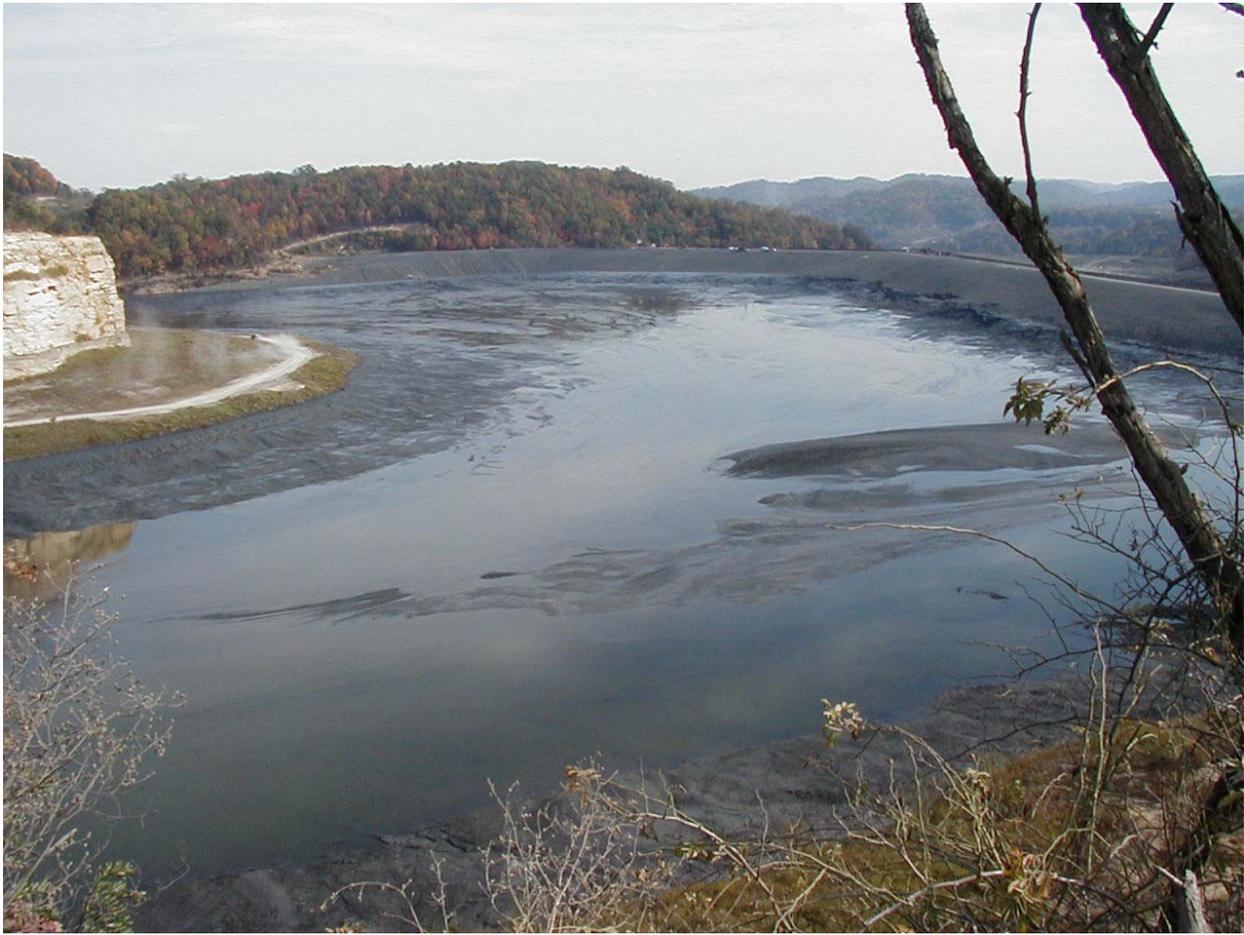
**Photo 3. General View of Impoundment and Embankment - October 16, 2000.
Source: OSM. 2000 breakthrough area to left of photo, out of view.**

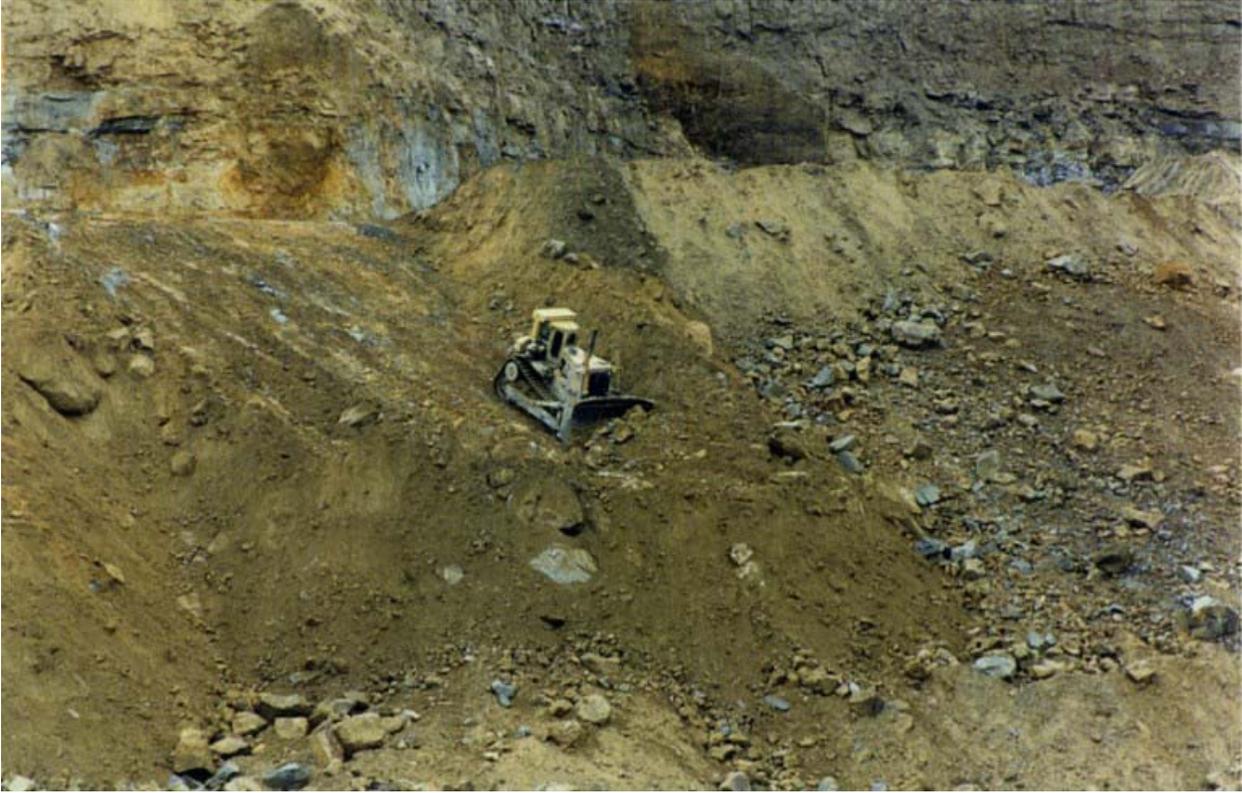
Research conducted by the Bureau of Mines found flow rates through spoil derived from massive gray sandstone ranged from 1.2×10^{-3} to 4.9×10^{-3} cm/sec (3.37 to 13.82 feet per day or 0.3 to 0.07 days per foot) (Hawkins and Aljoe, 1991). The Triad investigation independently confirmed high permeability of the seepage barrier material, which was largely sandstone-derived spoil.

Photo 9. Construction of Seepage Barrier (Dozer Work) - March 6, 1995. Source: GAI. The work is being conducted at the southwest side of the impoundment.

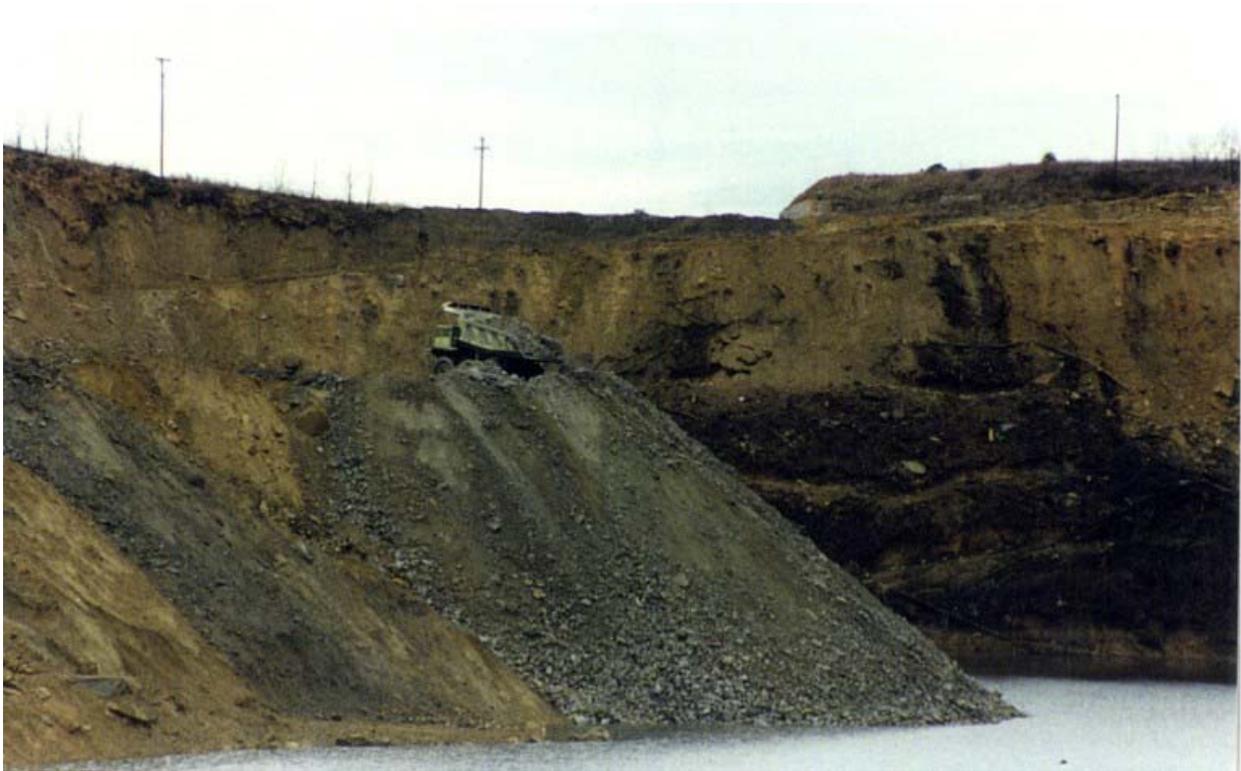
Photo 10. Construction of Seepage Barrier (End Dumping by Rock Truck) - March 6, 1995. Source: GAI. The work is being conducted at the southwest side of the impoundment.

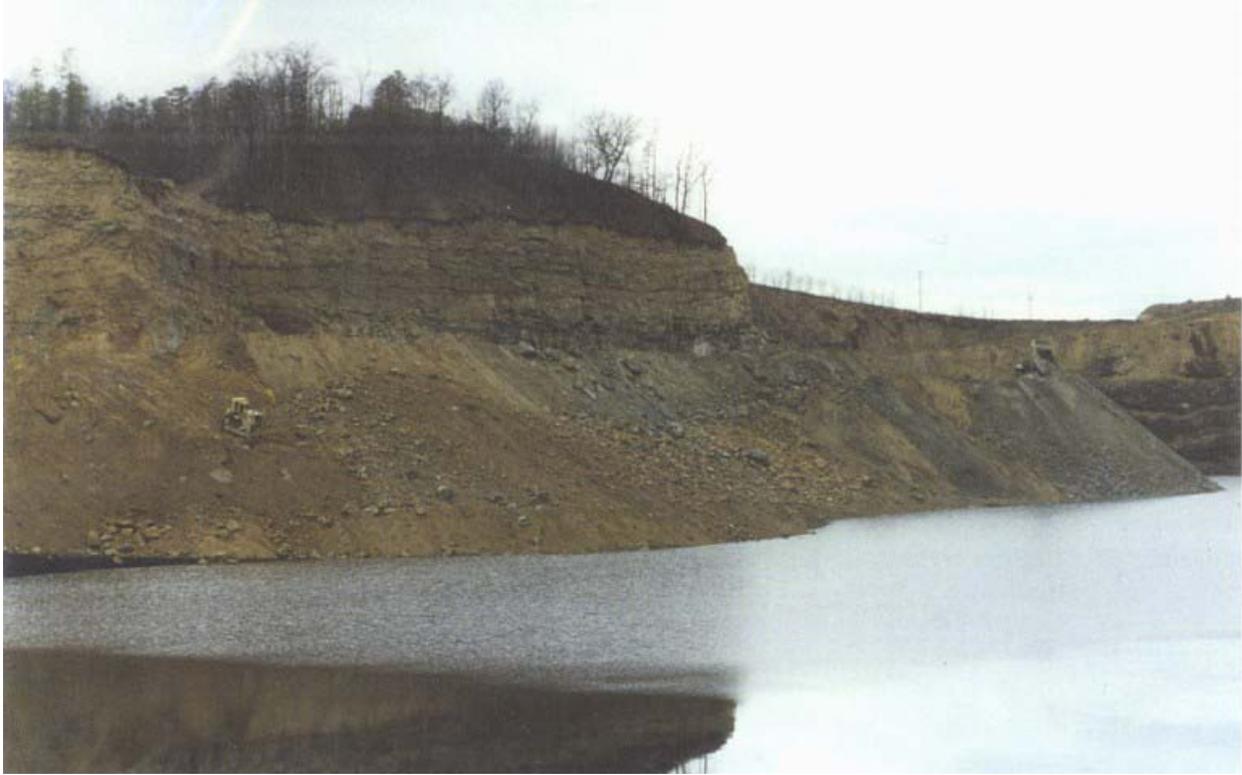
Photo 11. Construction of Seepage Barrier (Long View of Dozer and Truck) - March 6, 1995. Source: GAI. The work is being conducted at the southwest side of the impoundment. Pool elevation 1,000 feet msl. Mine roof elevation 964 feet msl.
