Section 6 Inspection and Evaluation of Common Timber Superstructures

Topic 6.1 Solid Sawn Timber Bridges

6.2	Glulam Timber Bridges	6.2.1
6.2.1	Introduction.....	6.2.1
6.2.2	Design Characteristics.....	6.2.2
	Multi-beam Bridges	6.2.2
	Truss Bridges	6.2.3
	Arch Bridges.....	6.2.4
	Primary and Secondary Members	6.2.5
6.2.3	Overview of Common Defects	6.2.6
6.2.4	Inspection Procedures and Locations.....	6.2.7
	Procedures	6.2.7
	Visual	6.2.7
	Physical.....	6.2.7
	Advanced Inspection Techniques	6.2.7
	Locations	6.2.7
	Bearing Areas.....	6.2.7
	Shear Zones.....	6.2.8
	Tension Zones.....	6.2.9
	Areas Exposed to Drainage.....	6.2.10
	Areas of Insect Infestation	6.2.10
	Areas Exposed to Traffic	6.2.10
	Areas Previously Repaired.....	6.2.10
	Secondary Members.....	6.2.10
	Fasteners and Connectors	6.2.11
6.2.5	Evaluation	6.2.12
	NBI Rating Guidelines	6.2.12
	Element Level Condition State Assessment.....	6.2.12

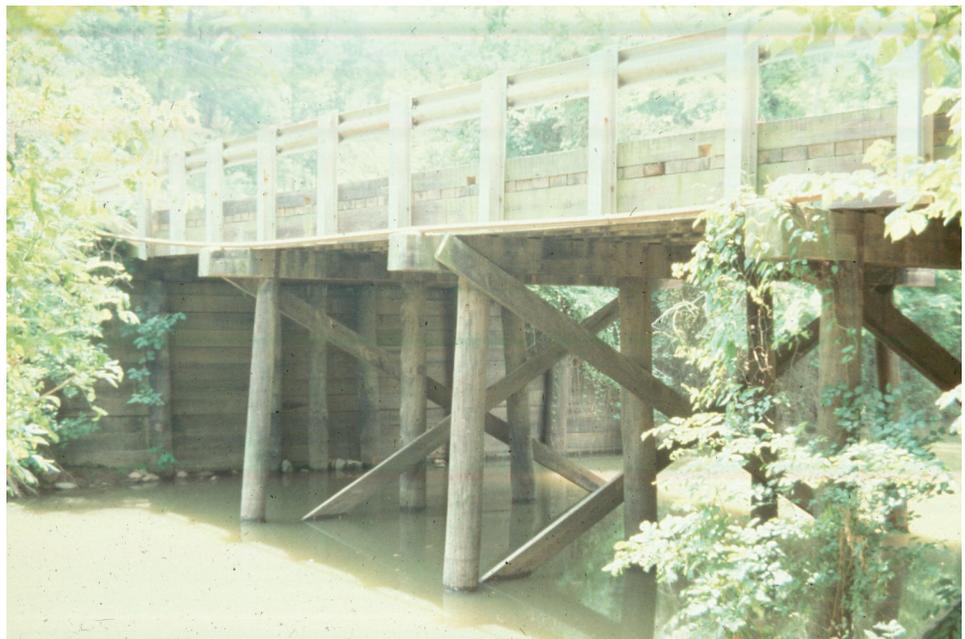
Timber bridges are gaining a resurgence in popularity throughout the United States. There are two basic classifications in timber construction: solid sawn and glued-laminated (glulam). A solid sawn beam is a section of tree cut to the desired size at a saw mill. Solid sawn multi-beam bridges are the simplest type of timber bridge (see Figure 6.1.1).

Figure 6.1.1 Elevation View of a Solid Sawn Multi-Beam Bridge

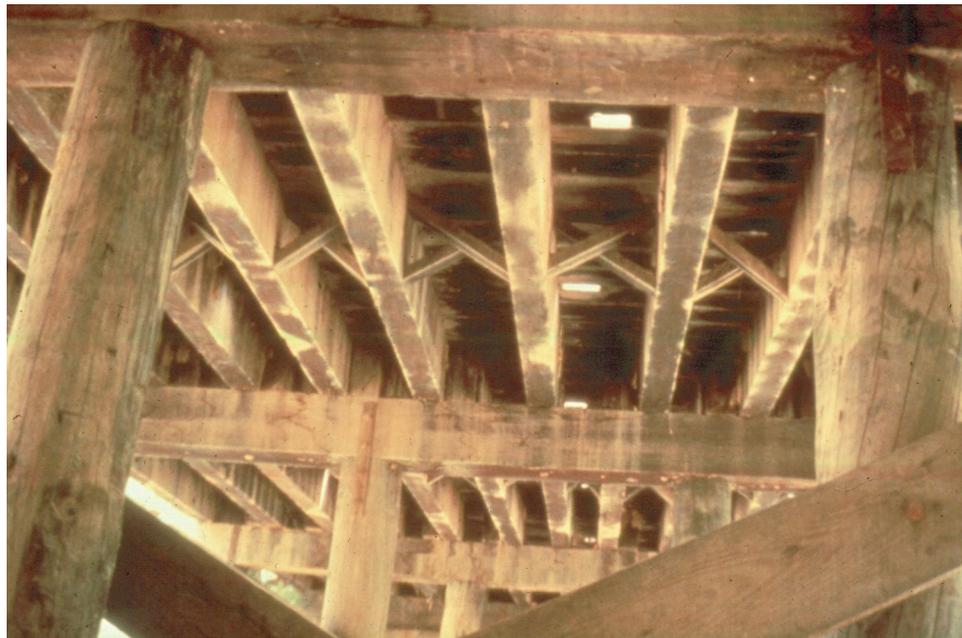
Solid sawn multi-beam bridges consist of multiple solid sawn beams spanning between substructure units (see Figure 6.1.2). The deck is typically comprised of transversely laid timber planks, and longitudinally laid planks called runners which are supported by the beams. Sometimes a bituminous wearing surface is placed on the deck planks to provide a skid resistant riding surface for vehicles, as well as a protective surface for the planks. Beam sizes typically range from about 150 mm by 300 mm (6 inches by 12 inches) to 200 mm by 400 mm (8 inches by 16 inches), and the beams are usually spaced about 600 mm (24 inches) on center.

Figure 6.1.2 Underside View of a Solid Sawn Multi-Beam Bridge

The primary members of solid sawn multi-beam bridges are the beams, and the secondary members are the diaphragms or cross bracing if present (see Figure 6.1.2). These bridges usually have timber diaphragms or cross bracing between beams at several locations along the span.

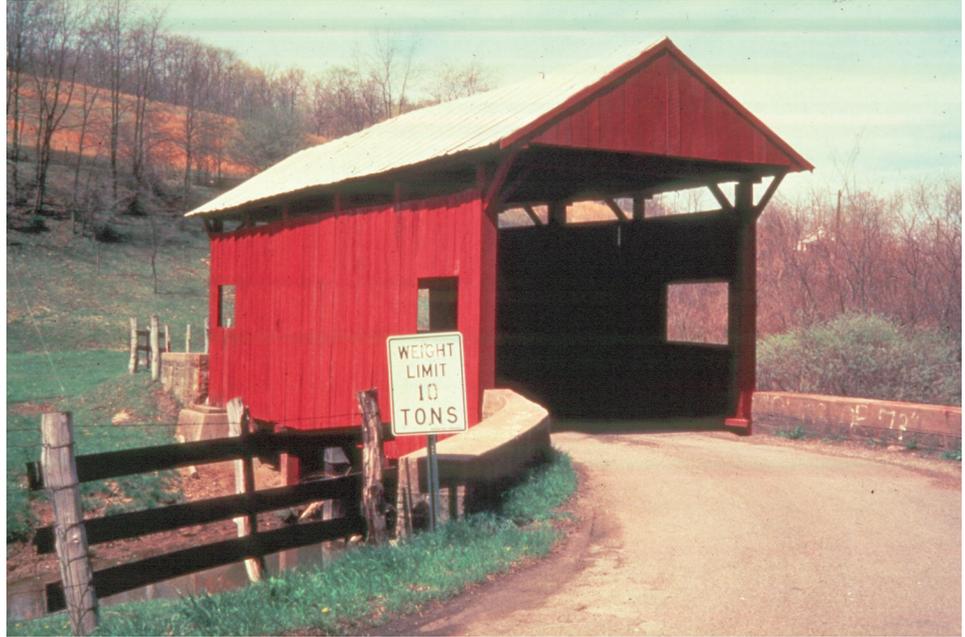
Covered bridges are generally found along rural roads and get their name from the walls and roof which protect the bridge superstructure (see Figures 6.1.3 and 6.1.4). Covered bridges are usually owned by local municipalities, although some are owned by states or private individuals. Some still carry highway traffic, but many are only open to pedestrians or light weight vehicles. While most covered bridges were built during the 1800's and early 1900's, there are a number of covered bridges being built today as historic reconstruction projects.

Figure 6.1.3 Elevation View of Covered Bridge

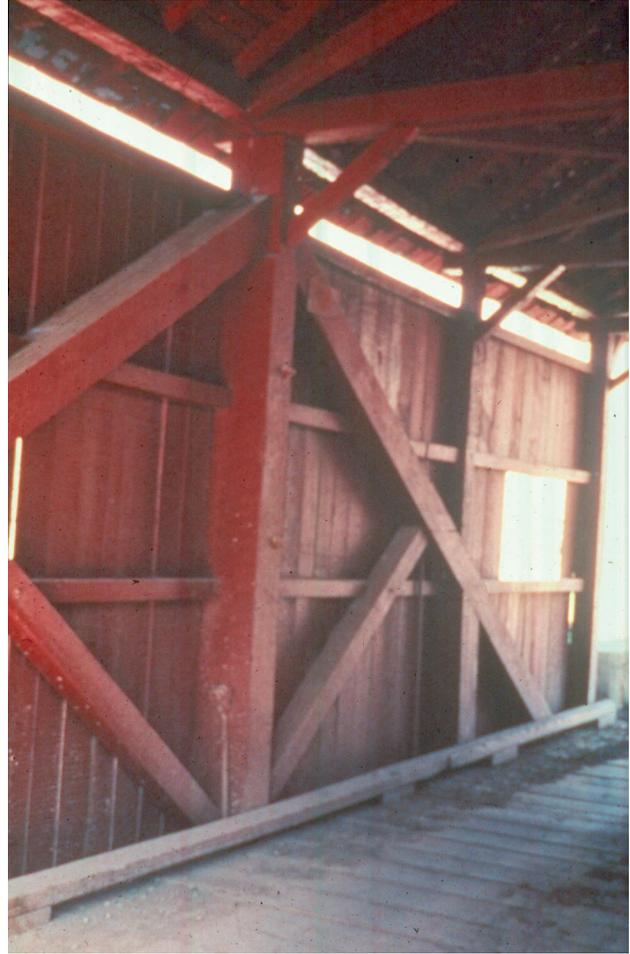
Figure 6.1.4 Inside View of Covered Bridge Showing King Post Truss Design

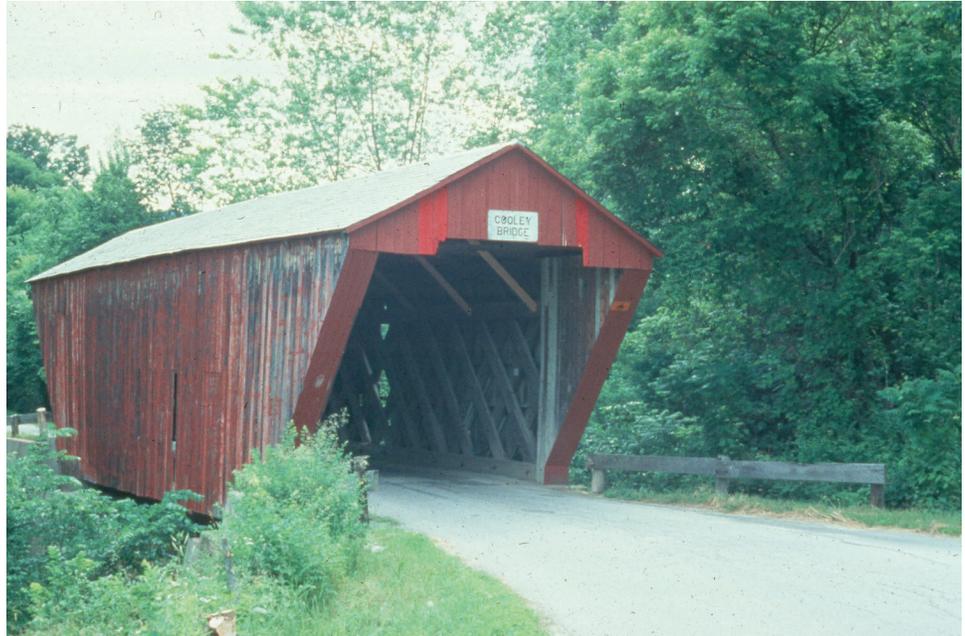
The majority of covered bridges are essentially truss bridges (see Figure 6.1.5). Solid sawn timber members make up the trusses of these historic structures. The covers on the bridges prevent decay of the truss and are responsible for their longevity. Typical truss types for covered bridges include the king post, queen post, Town, Warren, and Howe (see Figure 6.1.6). The floor system consists of timber deck planks, stringers, and floorbeams. The span lengths of covered bridges generally range from 15 to 30 m (50 to 100 feet), although many are well over 30 m (100 feet) and some span over 61 m (200 feet).

Figure 6.1.5 Town Truss Covered Bridge

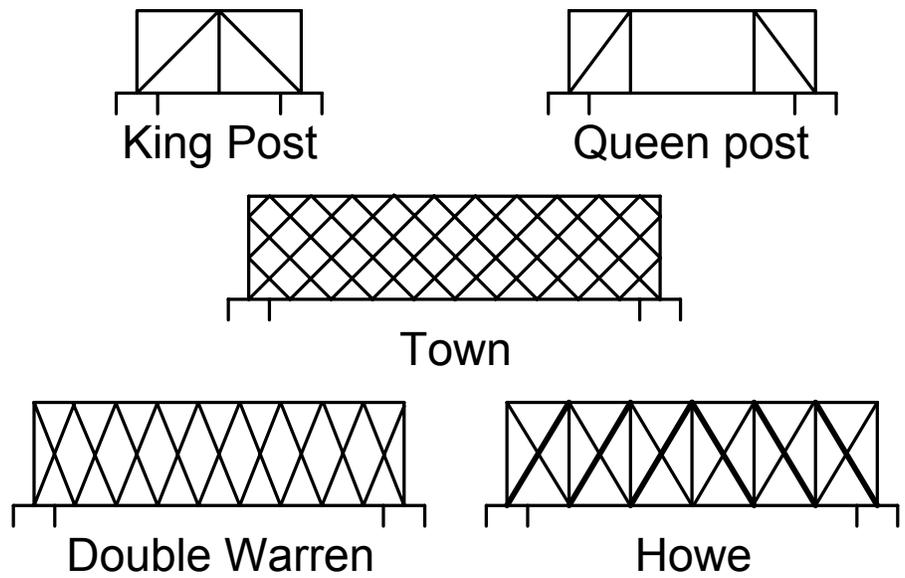
Figure 6.1.6 Common Covered Bridge Trusses

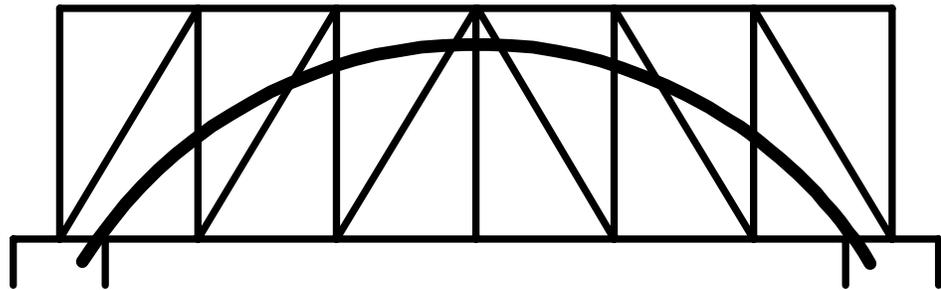
Timber arches were first used in covered bridges by Theodore Burr to strengthen the series of truss configurations normally used in covered bridges. These became known as Burr arch-trusses (see Figures 6.1.7, 6.1.8 and 6.1.9). The arch served as the main supporting element, and the king posts simply strengthened the arch. The span lengths for Burr-arch truss bridges generally range from 15 to 53 m (50 to 175 feet). Because of their greater strength, many of these structures still exist today.

Figure 6.1.7 Schematic of Burr Arch-truss Covered Bridge

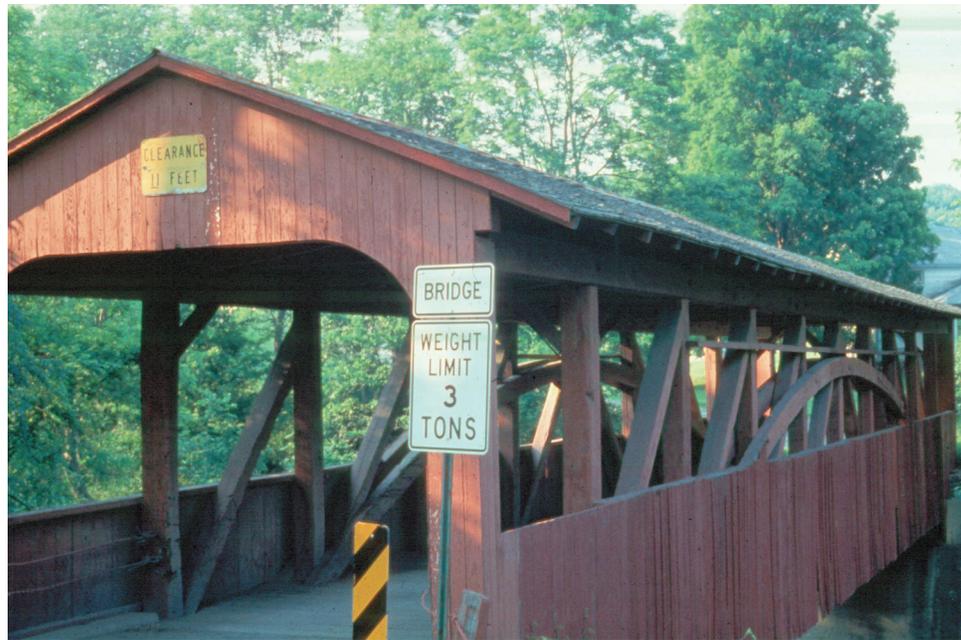
Figure 6.1.8 Burr Arch-truss Covered Bridge

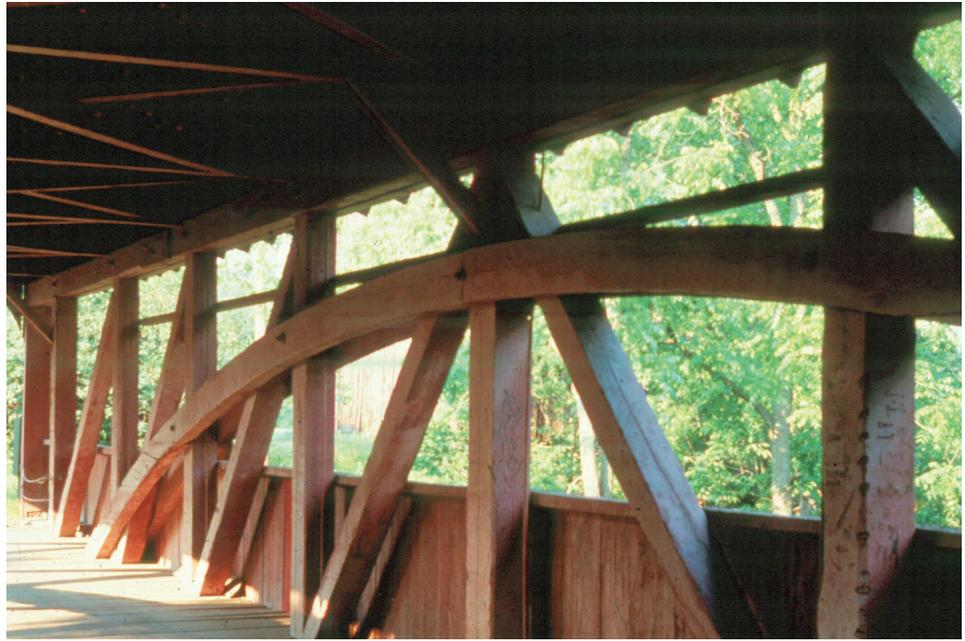
Figure 6.1.9 Inside View of Covered Bridge with Burr Arch-truss Design

The primary members in truss and arch structures are the truss members (chords, diagonals, and verticals), arch ribs, stringers, and floorbeams (see Figures 6.1.9 and 6.1.10). The secondary members are the diaphragms and cross bracing between stringers, the upper and lower lateral bracing, sway bracing, and the covers on the roof and sides when present.

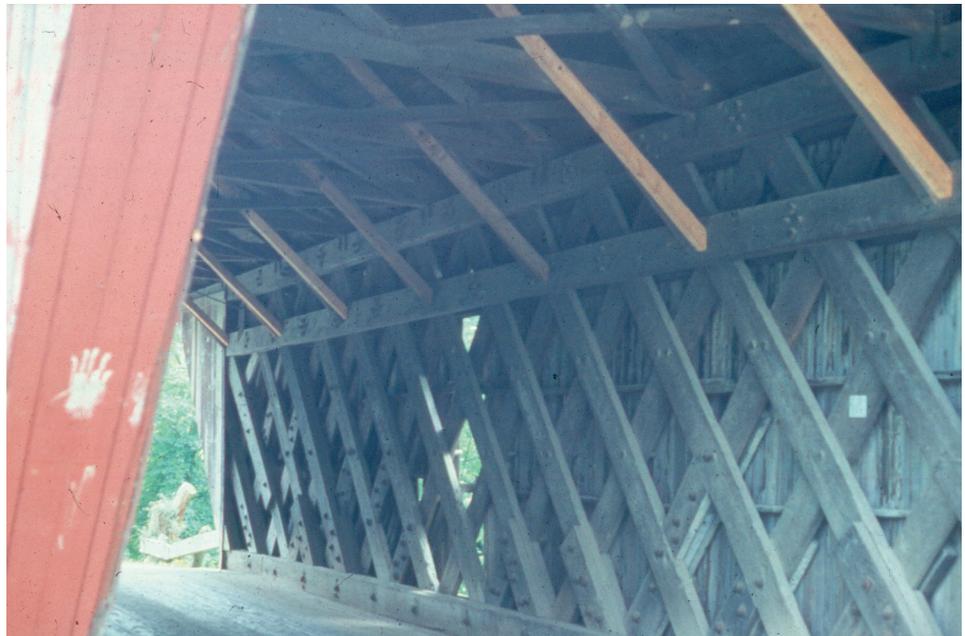
Figure 6.1.10 Town Truss Design

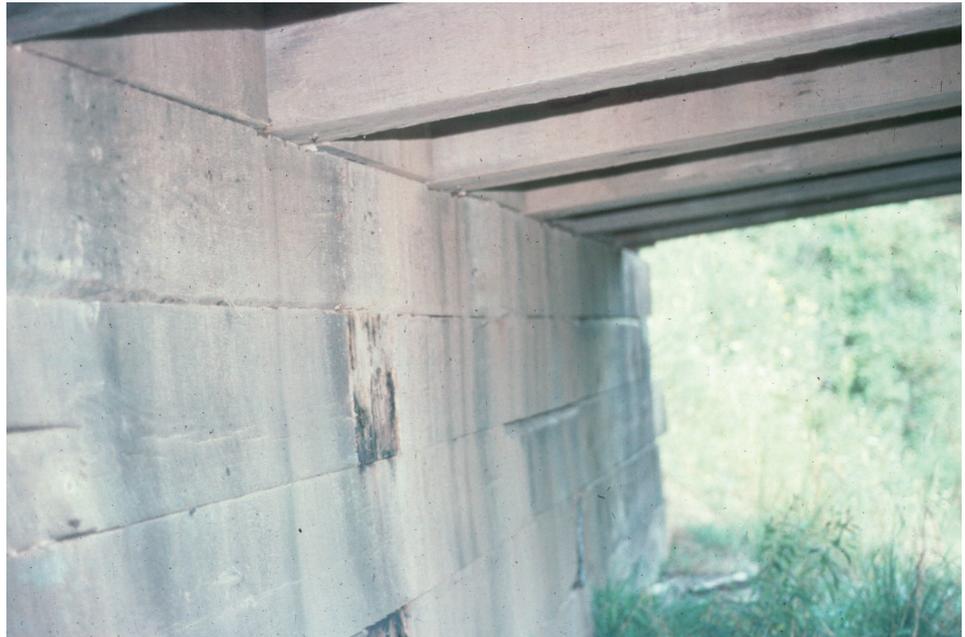
Check the bearing areas for crushing of the beams near the bearing seat (see Figure 6.1.11). Investigate for decay and insect damage by visual inspection and sounding and/or probing at the ends of the beams where dirt, debris, and moisture tend to accumulate. Also verify the condition and operation of the bearing devices, if they are present (see Topic 9.1).

Figure 6.1.11 Bearing Area of Typical Solid Sawn Beam

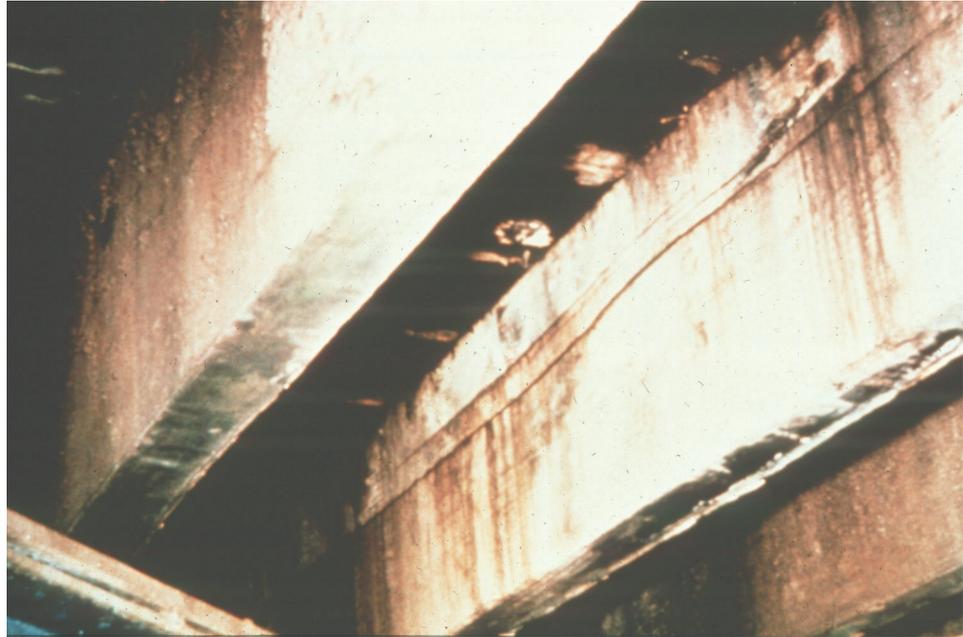
Investigate the area near the supports for the presence of horizontal shear cracking. The presence of transverse cracks on the underside of the girders or horizontal cracks on the sides of the girders indicate the onset of shear failure. These cracks can propagate quickly toward midspan and represent lost moment capacity of up to 75% (see Figure 6.1.12). Measure these cracks carefully for length, width, and if possible, the depth.

Figure 6.1.12 Horizontal Shear Crack in a Timber Beam

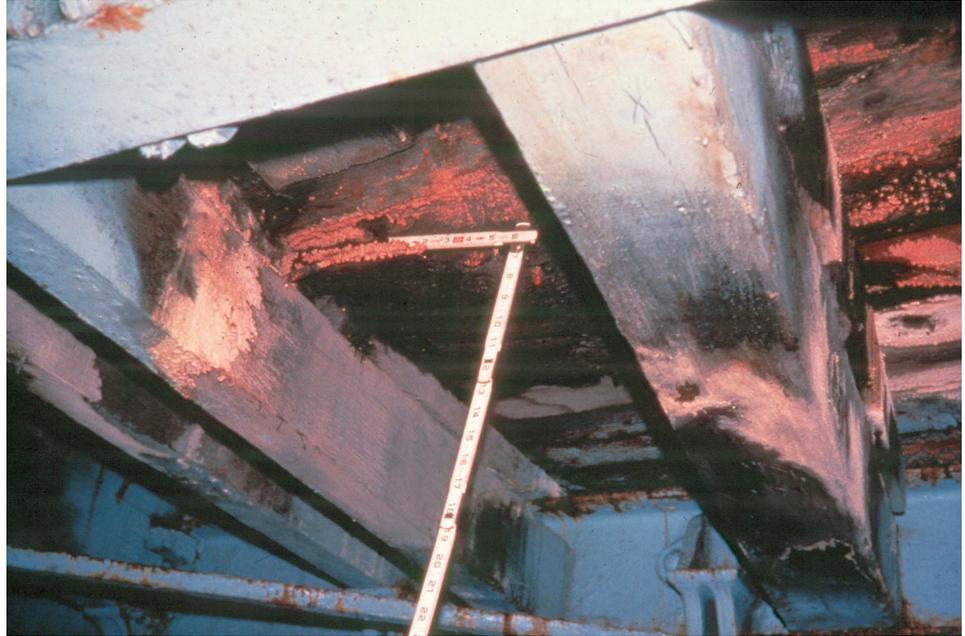
Investigate for signs of decay along the full length of the beam but especially where the beam is subjected to continual wetness and areas that trap moisture. These include member interfaces between deck planks and stringers, deck planks and beams, beams and bearing seats, stringers and floorbeams, floorbeams and trusses, truss member connections, arch connections, and all fastener locations. (see Figure 6.1.13).

Decay and chemical attack may be evidenced by discolored wood, brown and white rot, the formation of fruiting bodies (the result of fungal attacks, which

Figure 6.1.13 Decay in a Timber Beam

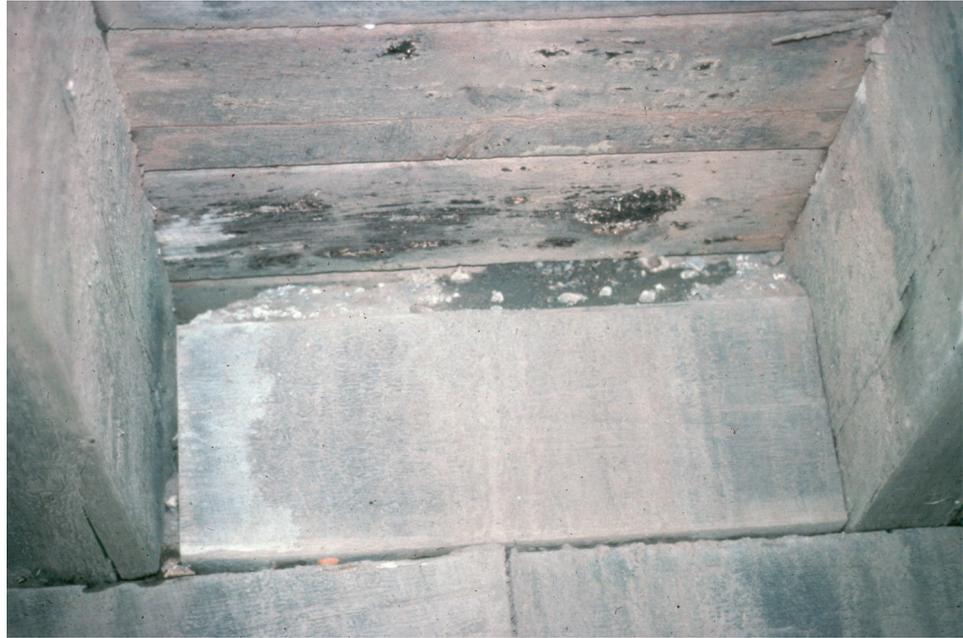
Inspect bracing members for decay and fire damage. Examine connections of bracing to beams for tightness, cracked or split members, and corroded, loose, or missing fasteners (see Figure 6.1.14). Deteriorated secondary members may indicate problems in the primary members.

Figure 6.1.14 Typical Timber End Diaphragm

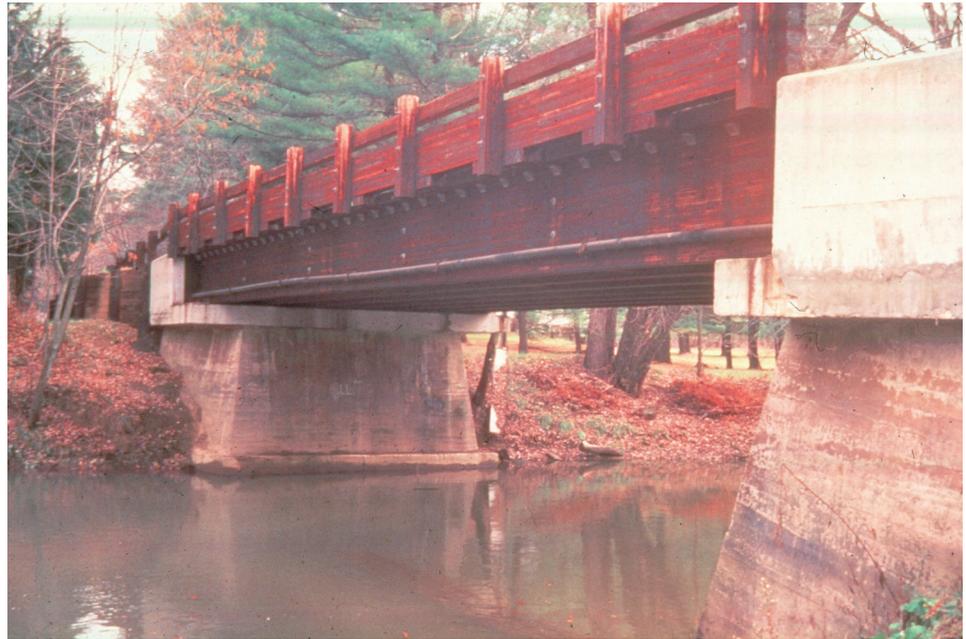
A glued-laminated (glulam) member is made by gluing strips of wood together to form a structural member of the desired size. An advantage of glulam members is that they allow for a higher utilization of the wood, since a lower grade of material can be used in of lower stress. Many strength reducing characteristics of wood, such as knots and checks, are minimized due to relatively small laminate dimensions. Also, the size and length of a glulam member is not limited by the size or length of a tree. Strips of wood used in glulam members are generally 20 to 40 mm (3/4 to 1-1/2 inches) thick (see Figures 6.2.1 and 6.2.2).

Figure 6.2.1 Elevation View of a Glulam Multi-beam Bridge

Glulam multi-beam bridges are very similar to solid sawn multi-beam bridges, but they generally use larger members to span greater distances. Glulam multi-beam bridges are typically simple span designs (see Figure 6.2.1). They usually support a deck consisting of glulam panels with a bituminous wearing surface. Beam sizes typically range from 150 mm by 610 mm (6 inches by 24 inches) to 310 mm by 1525 mm (12-1/4 inches by 60 inches), and the beams are usually spaced 1.7 m to 2.0 m (5'-6" to 6'-6") on center (see Figure 6.2.2).

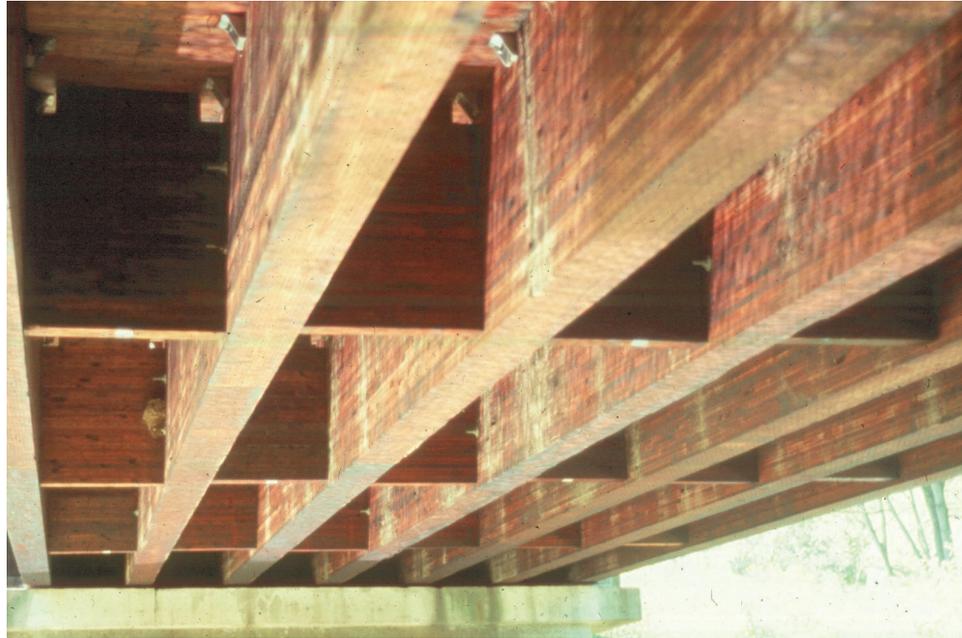
Figure 6.2.2 Underside View of a Glulam Multi-beam Bridge

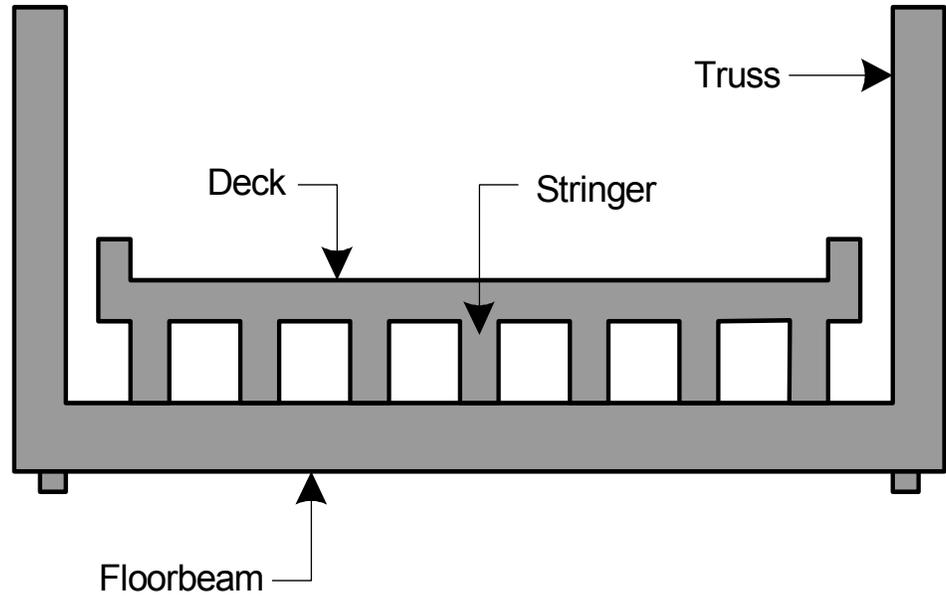
Trusses may be of the through-type or of the deck-type. Usually the floor system consists of a timber deck supported by timber stringers and floorbeams, all of which are supported by the trusses (see Figures 6.2.3 and 6.2.4). Timber trusses are generally used for spans that are not economically feasible for timber multi-beam bridges. Timber trusses are practical for spans that range from 46 to 76 m (150 to 250 feet) (see Figure 6.2.5).

Figure 6.2.3 Timber Through Truss Typical Section

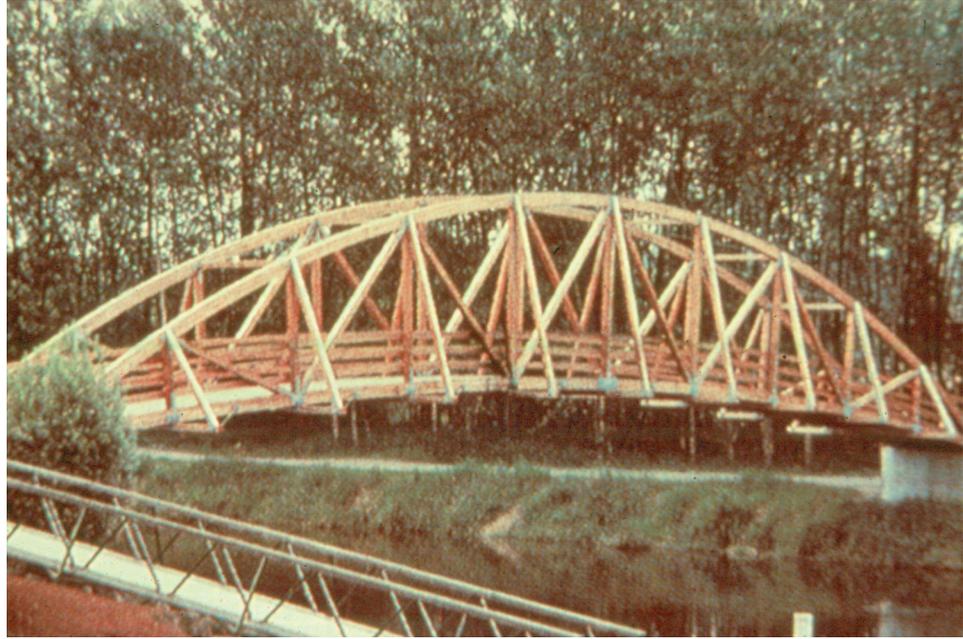
Figure 6.2.4 Bowstring Truss Pedestrian Bridge

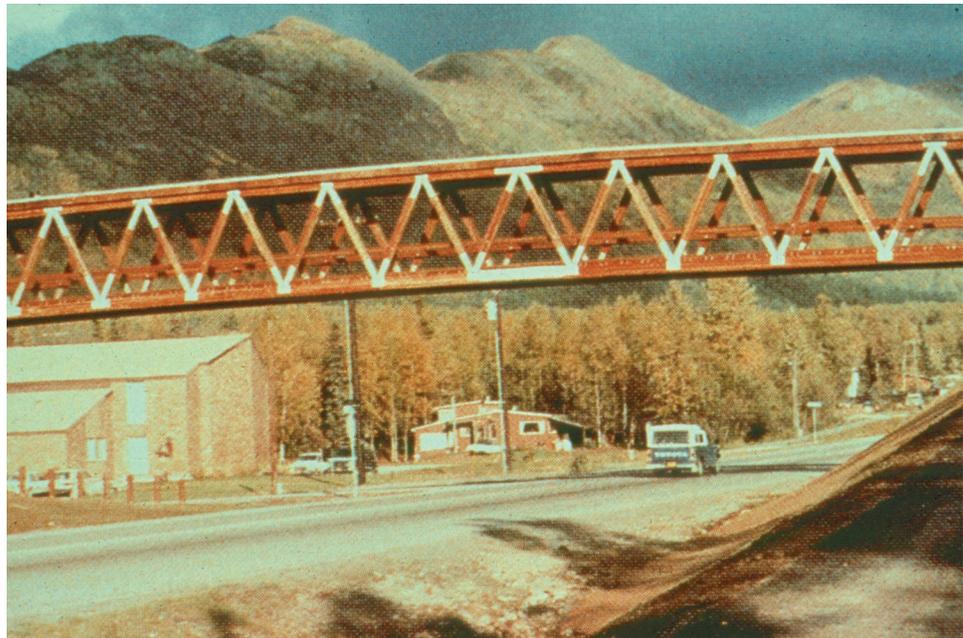
Figure 6.2.5 Parallel Chord Truss Pedestrian Bridge (Eagle River, Alaska)

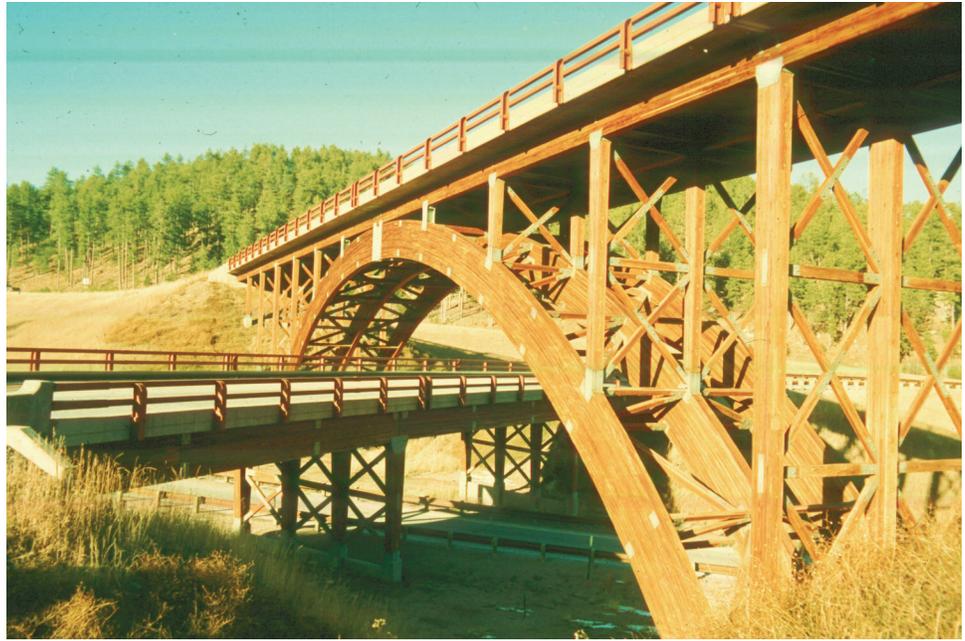
Glulam arch bridges usually consist of two- or three-hinged deck arches, which support a glulam deck and floor system (see Figures 6.2.6 and 6.2.7). Glulam arches are practical for spans of up to about 91 m (300 feet). Although they are not widely used for highway bridges, they are frequently used for pedestrian overpasses and in locations such as parks where aesthetics is important.

Figure 6.2.6 Glulam Arch Bridge over Glulam Multi-beam Bridge (Keystone Wye interchange, South Dakota)

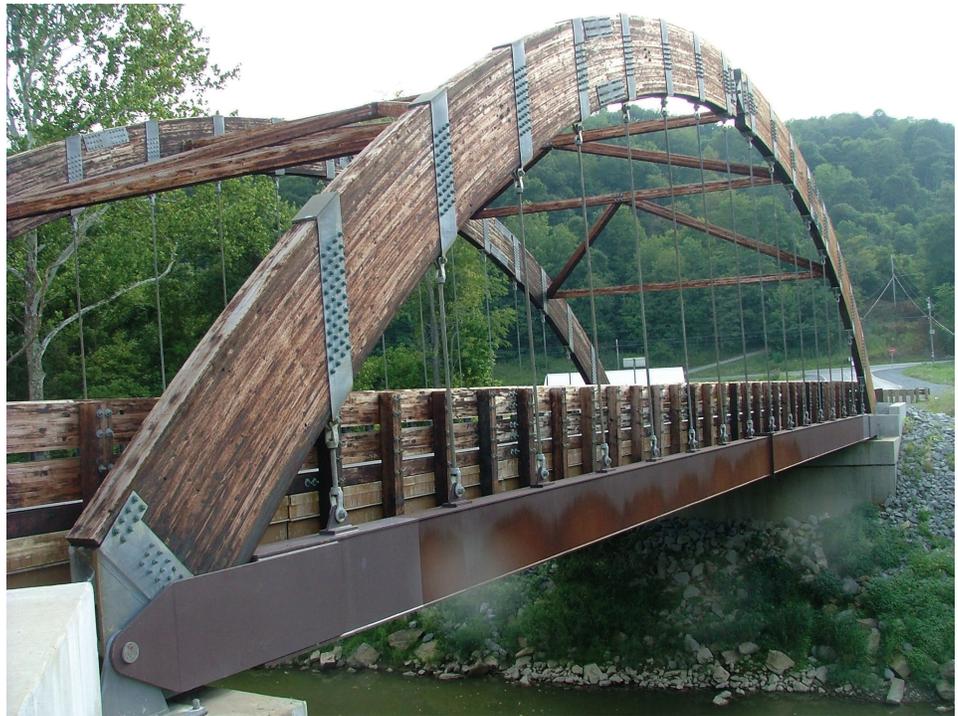
Figure 6.2.7 Glulam Arch Bridge (West Virginia)

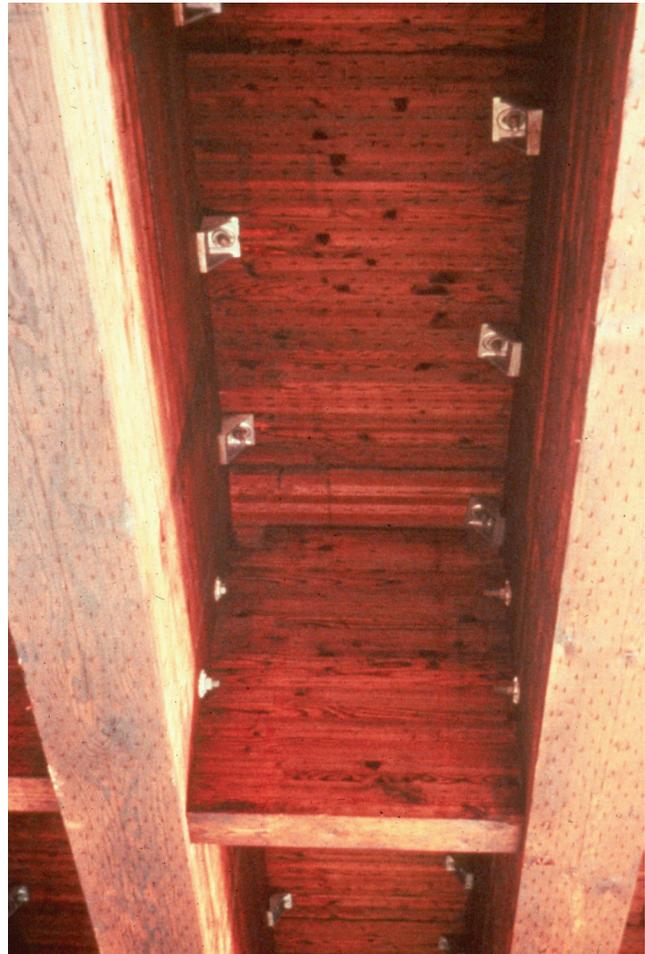
The primary members of glulam multi-beam bridges are the beams, and the secondary members are the diaphragms or cross bracing (see Figure 6.2.8). Due to the larger depth of the glulam beams, diaphragms or cross bracing should always be present. Diaphragms are usually constructed of short glulam members, and cross bracing is usually constructed of steel angles.

Figure 6.2.8 Typical Glulam Diaphragm

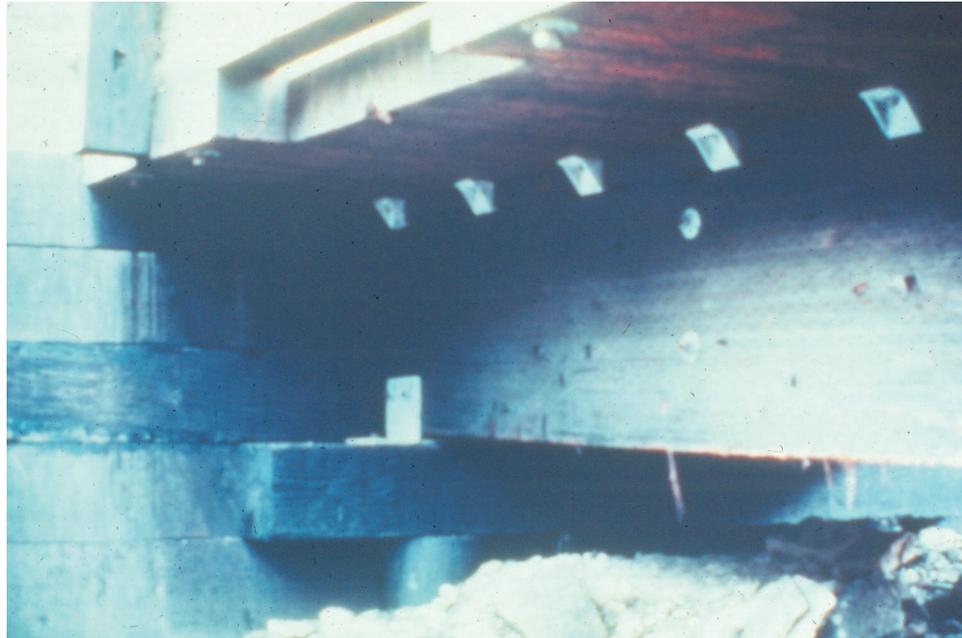
Inspect the bearing areas for crushing of the beams (see Figure 6.2.9). Investigate for decay and insect damage by visual inspection, sounding, and/or probing at the ends of the beams. Also check the condition and operation of the bearing devices

Figure 6.2.9 Bearing Area of Typical Glulam Beam

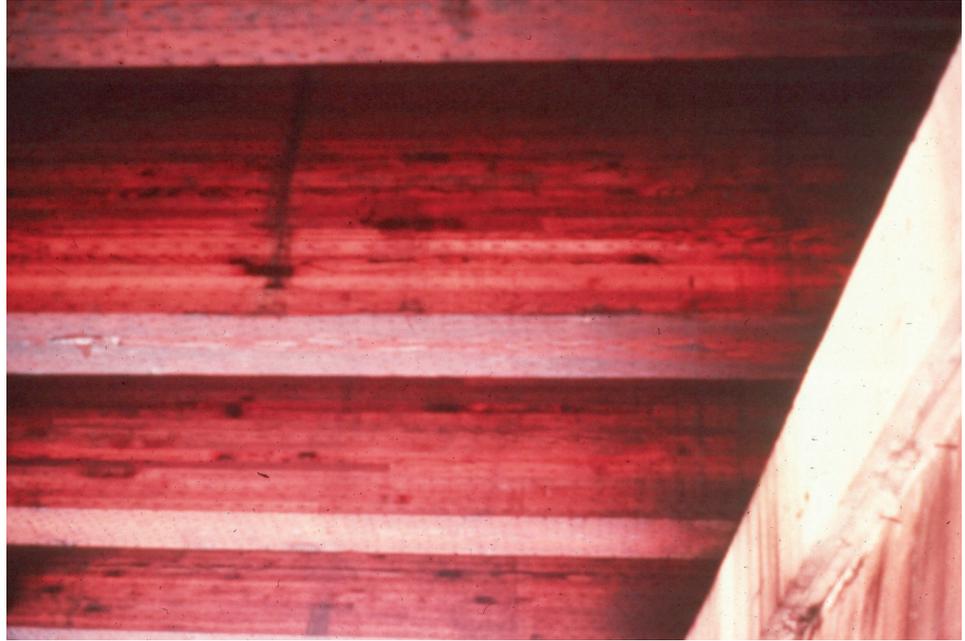
Examine for horizontal shear cracks and delaminations near the ends of the beam. Delaminations (i.e., separations in the laminations) can occur due to either failure of the glue or failure at the bond between the glue and the lamination (see Figure 6.2.10). Delaminations that extend completely through the cross section of the member are the most serious since this makes the member act as two smaller members. Delaminations that are located near the center of the cross section are more serious than those near the top or bottom of the beam. Delaminations directly through a connector are also undesirable.

Figure 6.2.10 Close-up View of Glulam Bridge Showing Laminations

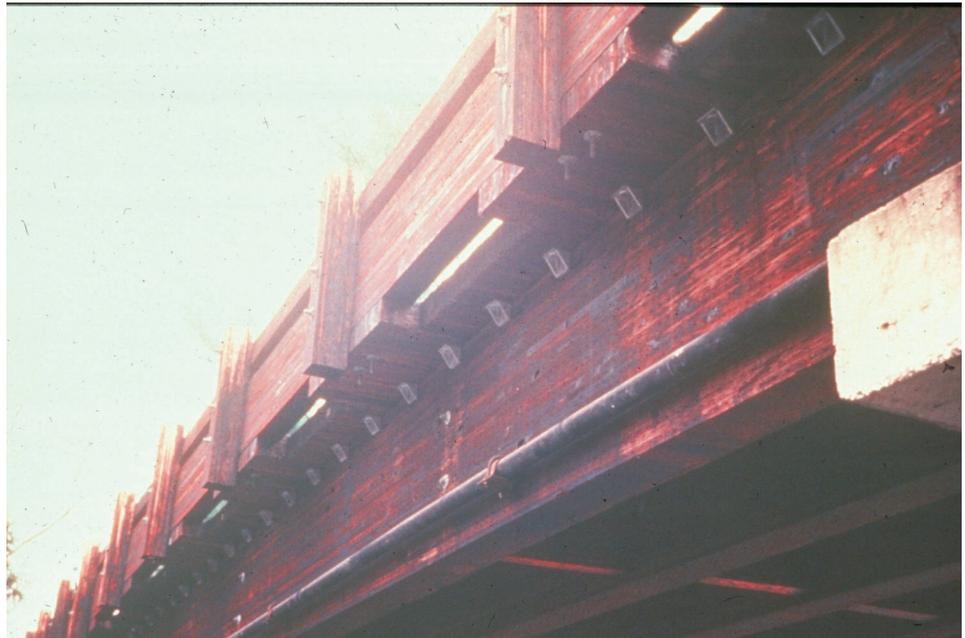
Examine the zone of maximum tension for signs of structural distress (see Figure 6.2.11). The maximum tension generally occurs at the bottom half of the middle third of the beam span. Investigate for section loss due to decay or fire, especially near mid-span. Inspect for excessive deflection or sagging in the beams.

Figure 6.2.11 Elevation View of Beam of Glulam Multi-beam Bridge

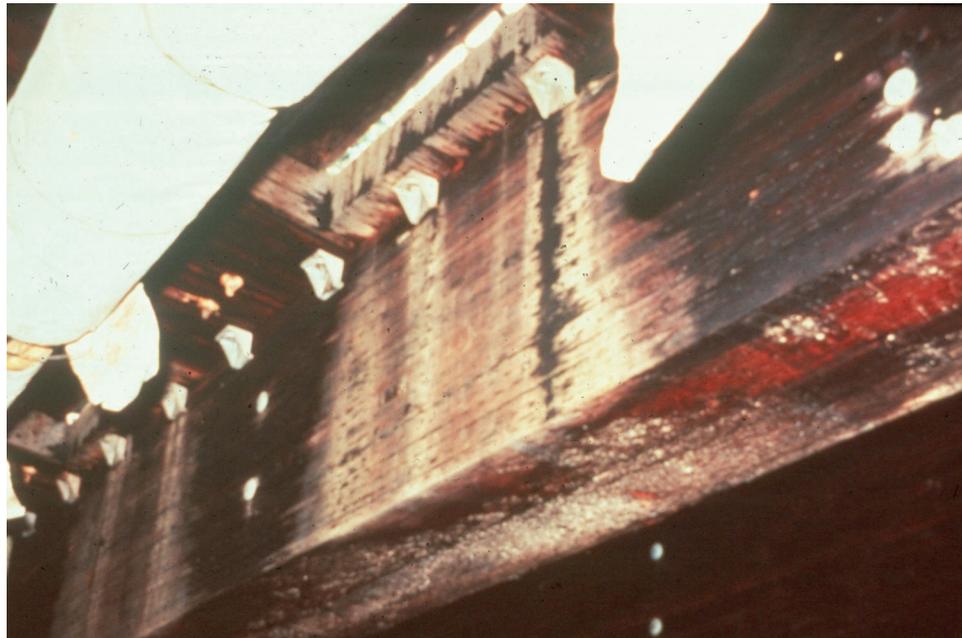
Investigate for signs of decay along the full length of the member but especially where the beam is subjected to continual wetness or prolonged exposure to moisture (see Figure 6.2.12). Decay and chemical attack may be evidenced by discolored wood, brown and white rot, the formation of fruiting bodies (the result of fungal attacks, which produce disc-shaped bodies that distribute reproductive spores), "sunken" faces in the wood, or the soft "punky" texture of the wood.

Figure 6.2.12 Decay on Glulam Beam

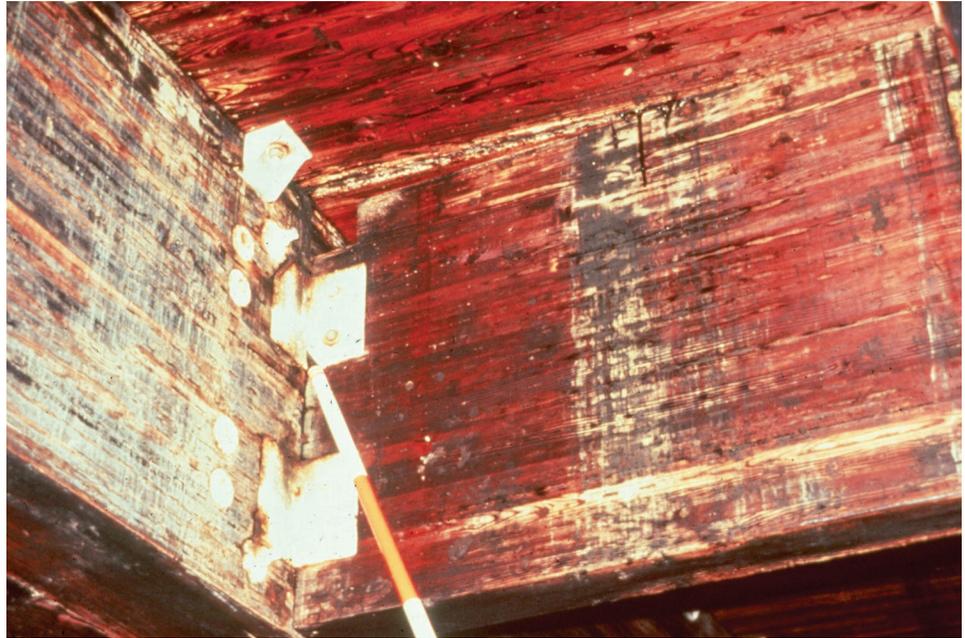
Examine diaphragms for decay, fire damage, and insect damage (see Figure 6.2.13). Check steel cross bracing for corrosion, bowing, or buckling (see Figure

Figure 6.2.13 Typical Diaphragm for a Glulam Multi-beam Bridge

Inspect all fasteners for corrosion, tightness, and missing parts (see Figure 6.2.13).

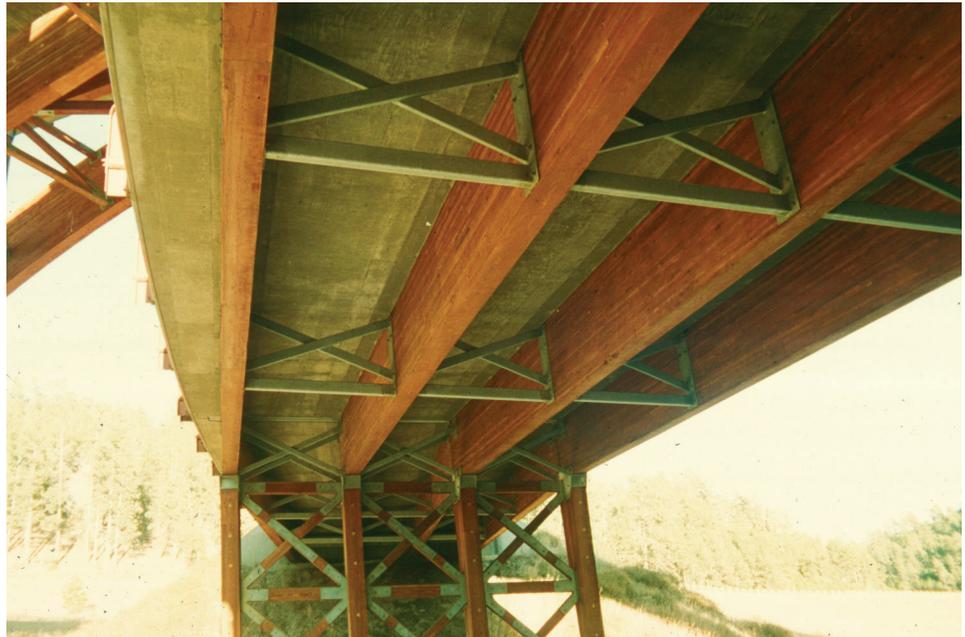
6.2.14). Examine connections for tightness, cracks and splits, and corroded, loose, or missing fasteners. Deteriorated secondary members may indicate problems in the primary members.

Figure 6.2.14 Glulam Beams with Numerous Fastener Locations

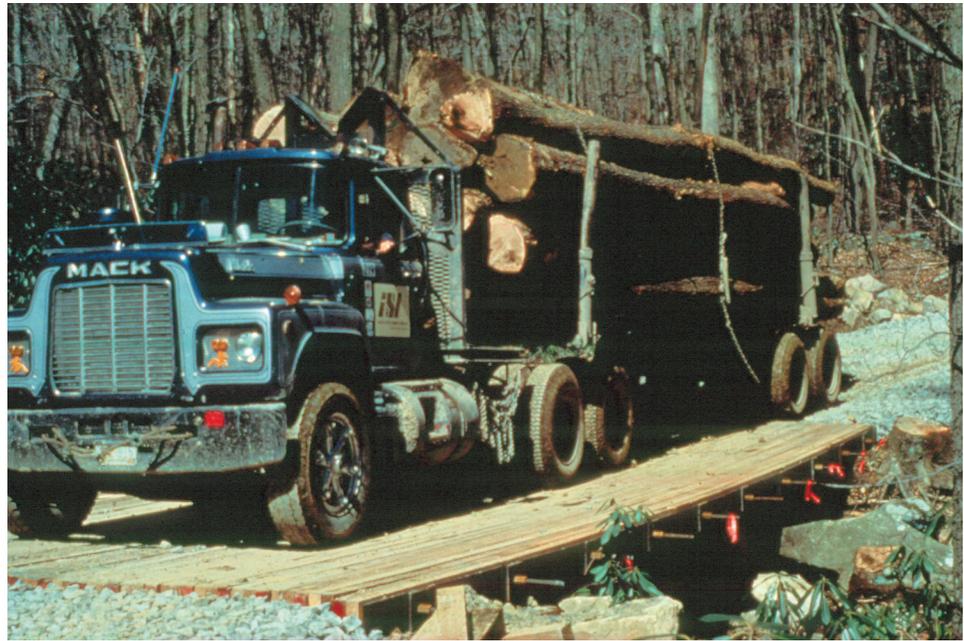
Stress-laminated timber bridges were first developed in Canada, in 1976, by the Ontario Ministry of Transportation and Communications. These bridges consist of multiple planks mechanically clamped together using metal rods to perform as one unit (see Figure 6.3.1). The compression induced frictional resistance within the timber laminations is the mechanism that makes this structural system effective.

Figure 6.3.1 Stress-Laminated Timber Slab Bridge Carrying a 90,000-Pound Logging Truck (Source: Barry Dickson, West Virginia University)

Stress-laminated timber slab bridges can be used for simple spans of up to 15 m (50 feet) and are capable of carrying modern highway loadings (see Figures 6.3.1 and 6.3.3). Stressed deck bridges have also been constructed using glulam members. Combining glulam technology with stress-lamination increases practical span lengths to 19 m (63 feet) (see Figure 6.3.4).

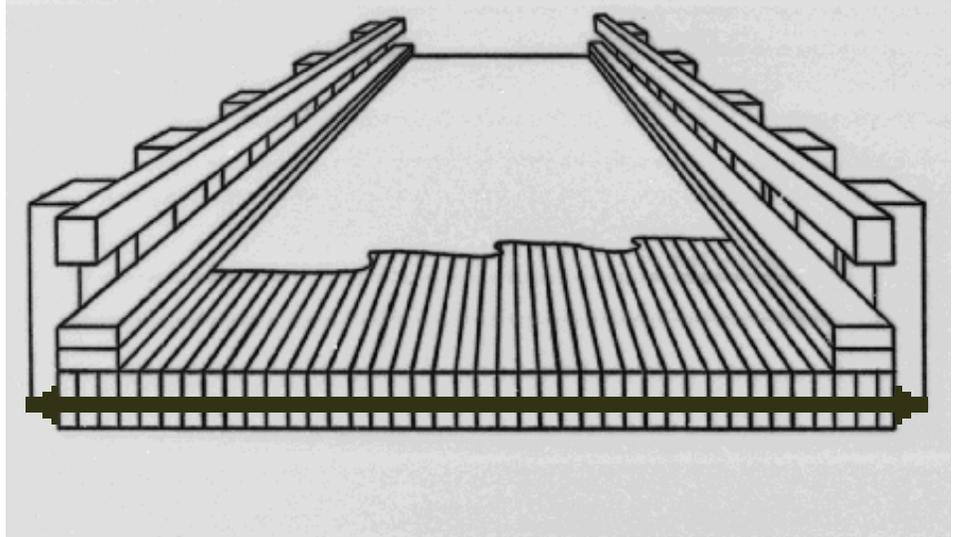
Figure 6.3.2 Typical Section of a Stress-Laminated Timber Slab Bridge

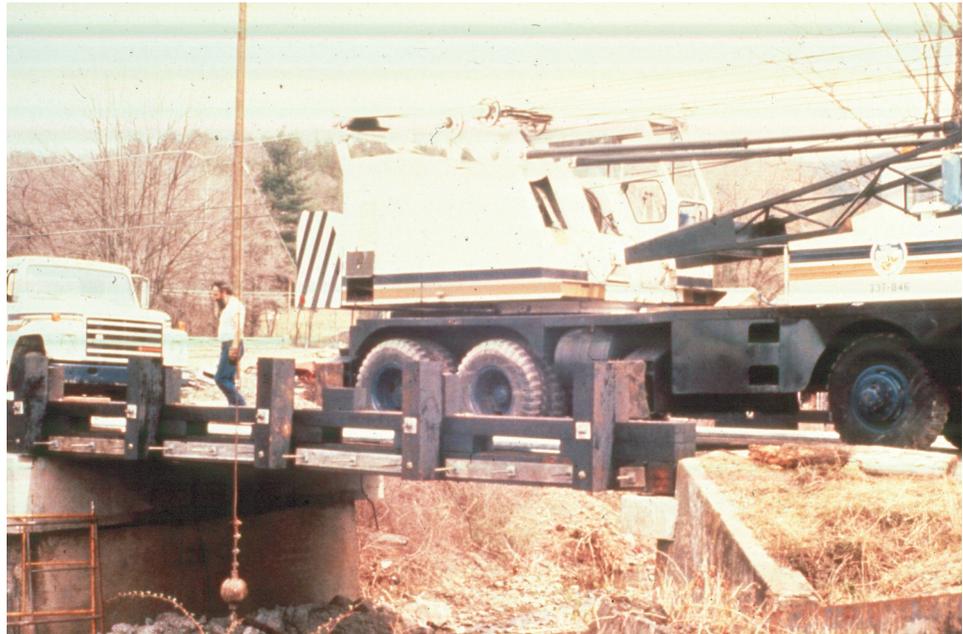
Figure 6.3.3 Stress-Laminated Timber Slab Bridge

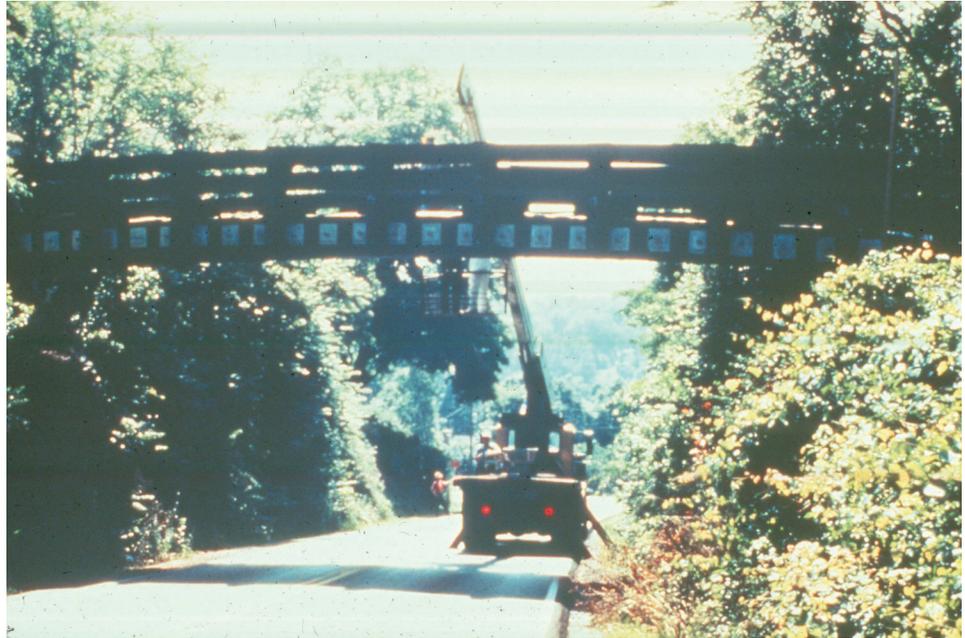
Figure 6.3.4 Glulam Stress-Laminated Timber Slab Bridge
