Section 6 Inspection and Evaluation of Common Timber Superstructures

Topic 6.1 Solid Sawn Timber Bridges

6.2	Glulam Timber Bridges	6.2.1
6.2.1	Introduction.....	6.2.1
6.2.2	Design Characteristics.....	6.2.2
	Multi-beam Bridges	6.2.2
	Truss Bridges	6.2.3
	Arch Bridges.....	6.2.4
	Primary and Secondary Members	6.2.5
6.2.3	Overview of Common Defects	6.2.6
6.2.4	Inspection Procedures and Locations.....	6.2.7
	Procedures	6.2.7
	Visual	6.2.7
	Physical.....	6.2.7
	Advanced Inspection Techniques	6.2.7
	Locations	6.2.7
	Bearing Areas.....	6.2.7
	Shear Zones.....	6.2.8
	Tension Zones.....	6.2.9
	Areas Exposed to Drainage.....	6.2.10
	Areas of Insect Infestation	6.2.10
	Areas Exposed to Traffic	6.2.10
	Areas Previously Repaired.....	6.2.10
	Secondary Members.....	6.2.10
	Fasteners and Connectors	6.2.11
6.2.5	Evaluation	6.2.12
	NBI Rating Guidelines	6.2.12
	Element Level Condition State Assessment.....	6.2.12

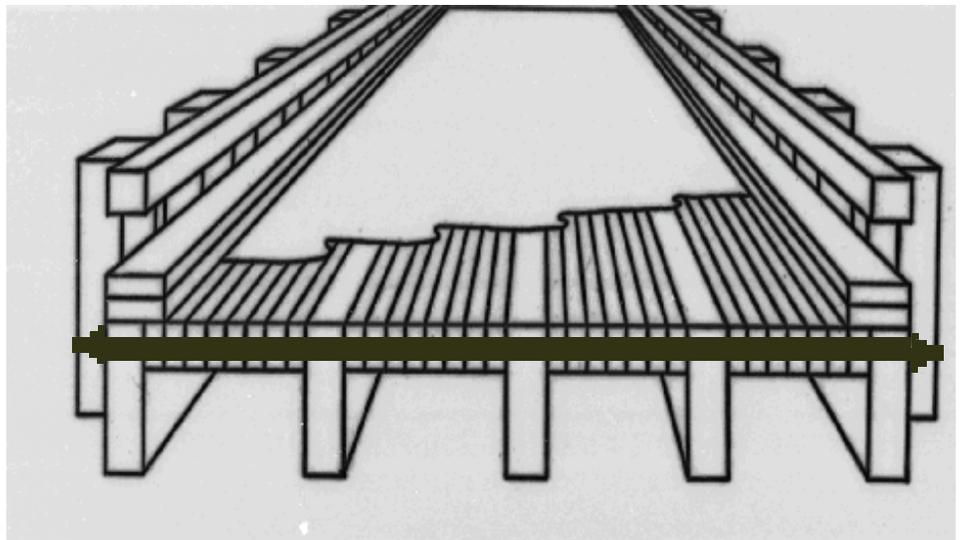
The idea for stress-laminated timber tee beam bridges was developed at West Virginia University. These bridges consist of a stress-laminated deck and glulam beams (see Figure 6.3.5). High strength steel rods are used to join the stress-laminated deck and glulam beams together to form stress-laminated timber tee beams. The first structure of this type was built in 1988, near Charleston, West Virginia. It is 23 m (75 feet) long and has stressing rods spaced at two feet. It has performed well, and stressed tee beams will likely be used in the future to achieve even longer span lengths (see Figure 6.3.6).

Figure 6.3.5 Typical Section of a Stress-Laminated Timber Tee Beam Bridge
(Source: Barry Dickson, West Virginia University)

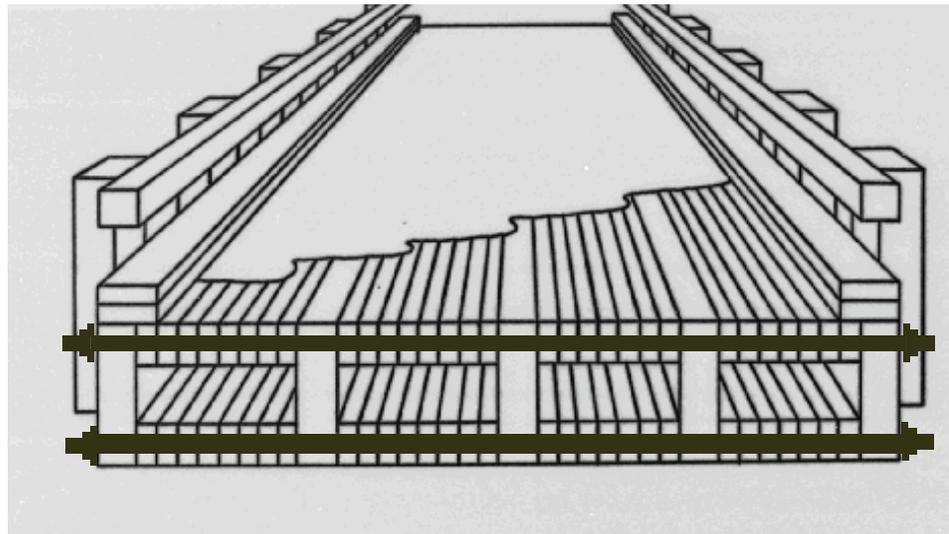
Stress-laminated timber box beam bridges represent further development of timber bridges by West Virginia University. These bridges consist of adjacent box beam panels individually comprised of stress-laminated flanges and glulam beam webs (see Figure 6.3.7). This bridge type is also known as a cellular stressed deck. Span lengths of up to 18 m (60 feet) have been designed, and there is a potential for longer spans (see Figure 6.3.8).

Figure 6.3.7 Typical Section of a Stress-Laminated Timber Box Beam (Source: Barry Dickson, West Virginia University)

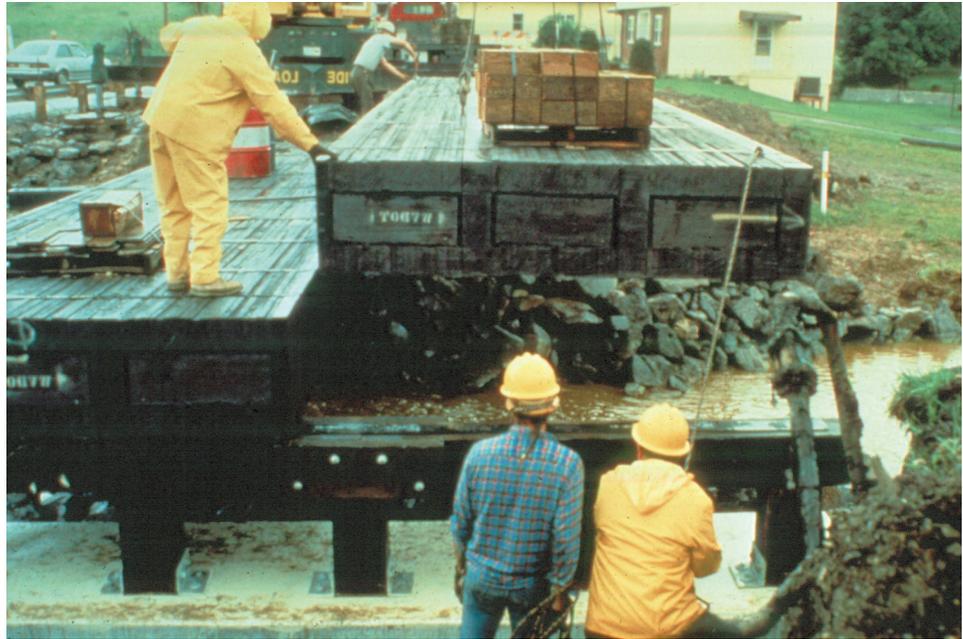
Figure 6.3.8 Stress-Laminated Timber Box Beam Bridge Being Erected

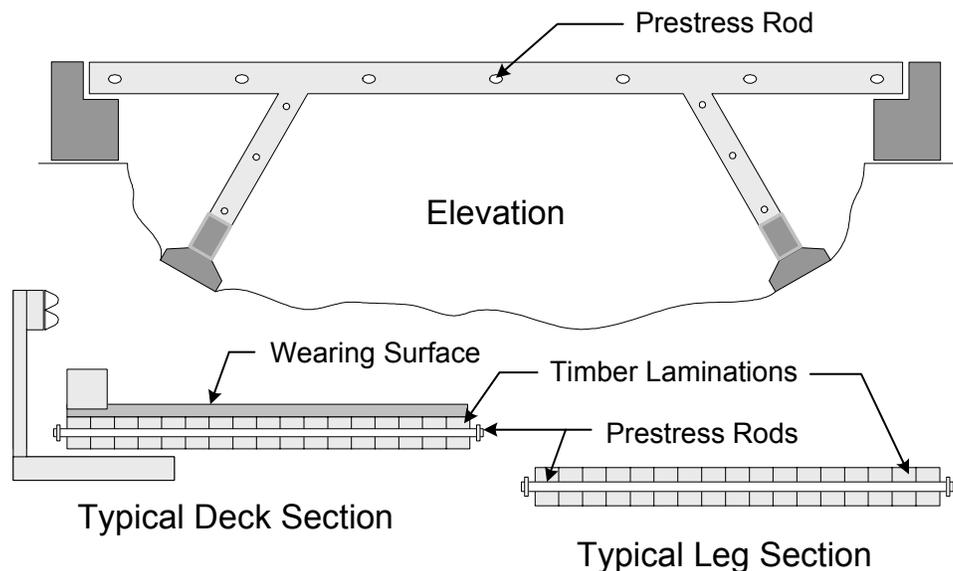
Stressed K-frame bridges represent further development of the stressed deck bridge by the Ontario Ministry of Transportation and Communications. These bridges consist of three spans in which the stressed deck is supported at two intermediate points by stressed laminated timber struts (see Figure 6.3.9). This bridge type has been used for a bridge with a total length of 13 m (43 feet), and it has a potential for span lengths over 15 m (50 feet).

Figure 6.3.9 Stress-Laminated Timber K-frame Bridge

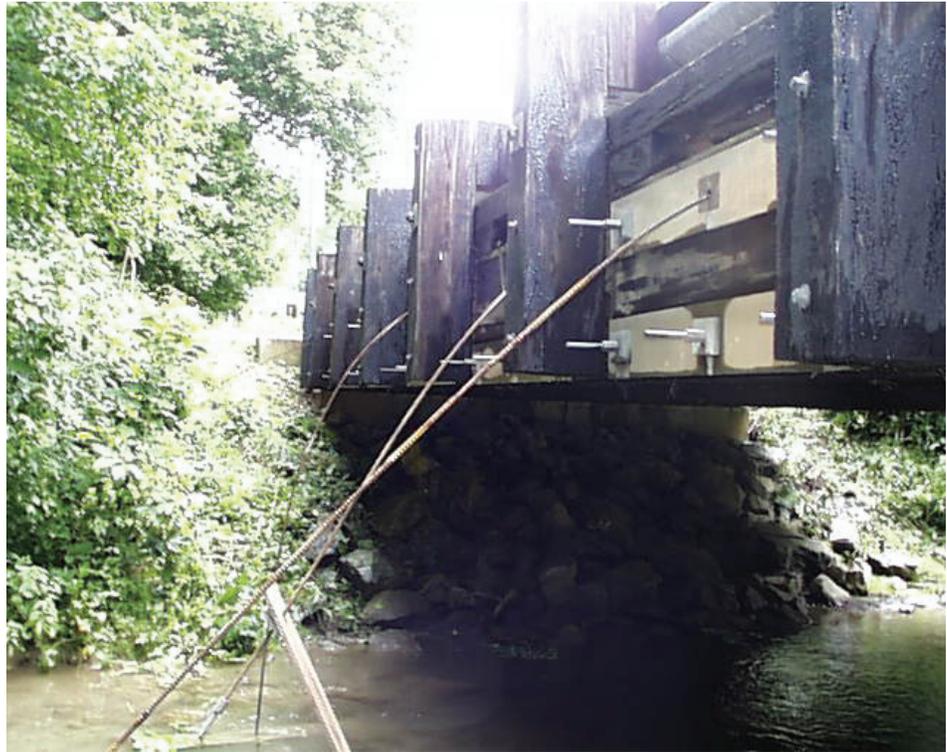
Examine the condition of the steel stressing rods, and inspect for crush and splits in the fascia members. Check for loss of prestress in the rods, which would be indicated by shifted planks in the stress-laminated timber element and excessive deflection or loose rods. This may be observed when the bridge is subject to a moving live load.

Figure 6.3.10 Broken Stressing Rods

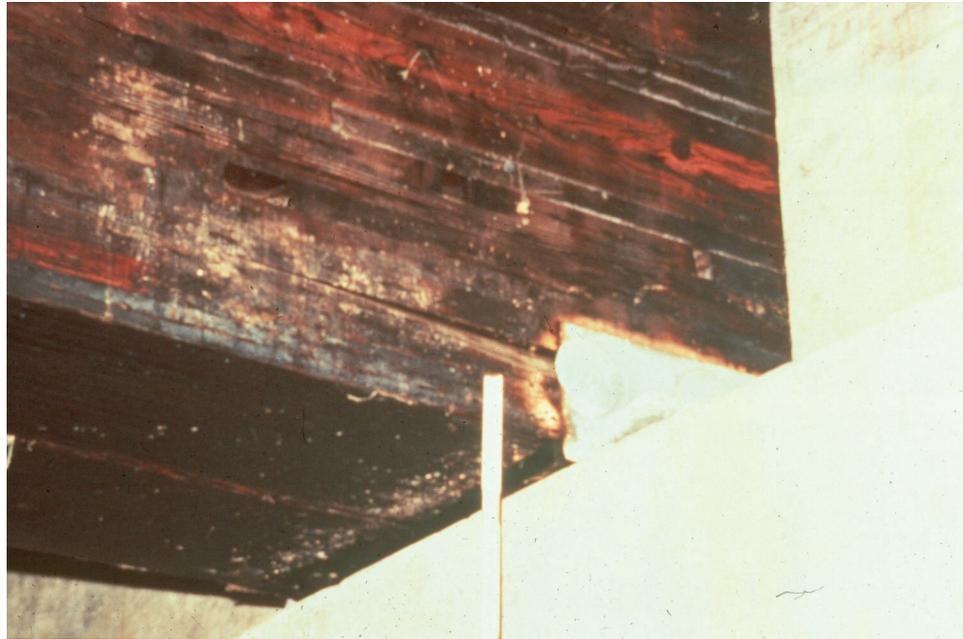
Examine for horizontal shear cracks and delaminations near the ends of the beam. Delaminations (i.e., separations in the laminations) can occur due to either failure of the glue or failure at the bond between the glue and the lamination (see Figure 6.3.11). Delaminations that extend completely through the cross section of the member are the most serious since this makes the member act as two smaller members.

Figure 6.3.11 Close-up View of End of a Stress-Laminated Timber Bridge Showing Laminations
