**EPA Supplemental Guidance for
I/M Programs:**

**Vehicle Repair, Technical
Assistance, Performance
Monitoring, and Technician
Education and Certification**

Emission Planning and Strategies Division
Office of Mobile Sources
U.S. Environmental Protection Agency
Final -- September, 1994

IM240 Repair Verification: An
Inexpensive Dynamometer Method

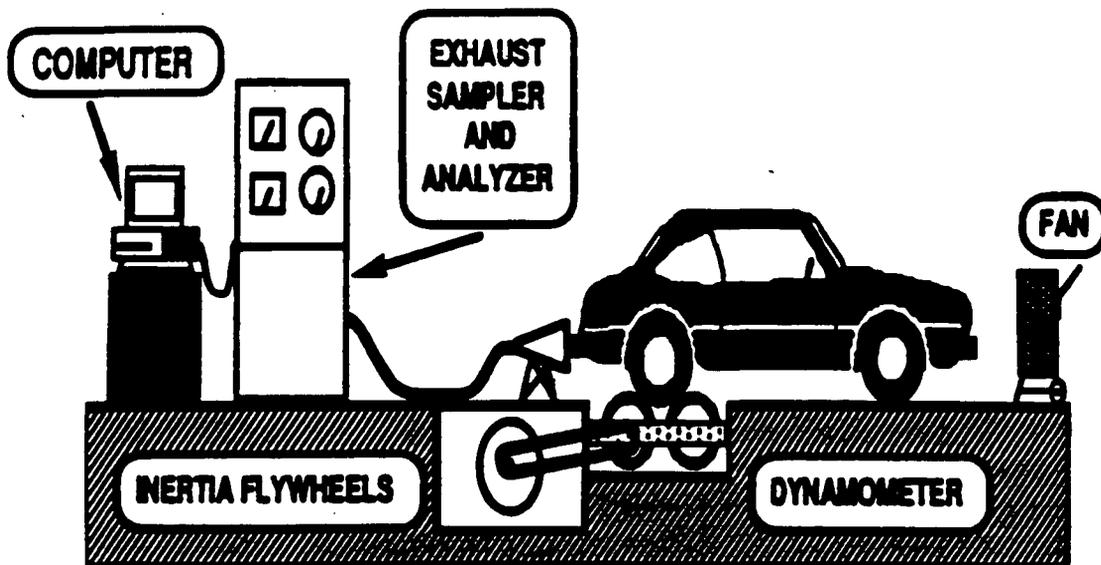
Figure 1

There are many equipment similarities between the two tests in that the IM240 is designed to produce similar power loading as the FTP (Figure 1). Mass emissions are also measured during the IM240, instead of emissions concentrations used by current idle and steady state I/M tests. The IM240 mass emission measurement uses a constant volume sampling system (CVS) like the FTP, and a new generation of gas analyzers which allow real time exhaust analysis resulting in emission values for each second of the IM240.

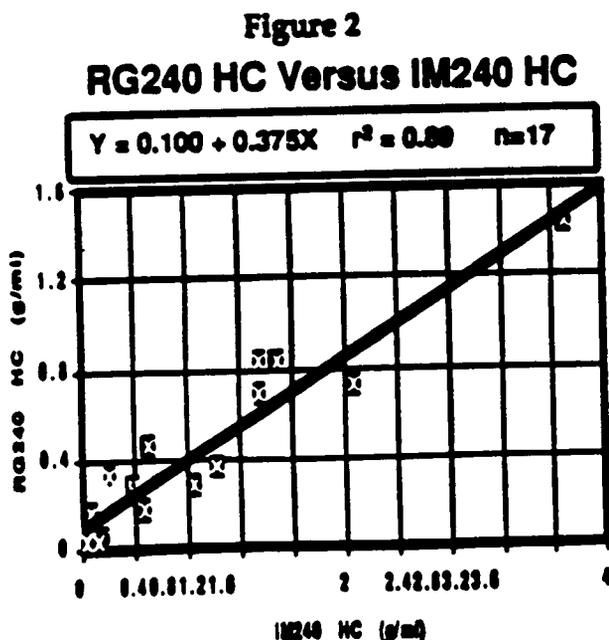
causes are the substantial differences in relative HC sensitivity in the NDIR used by the RG240 versus the more accurate FID used in the IM240, which has a better response to the many different hydrocarbon compounds present in motor vehicle exhaust. Also, the RG240 system may have a substantially slower response time than an IM240 system, and therefore this could possibly flatten the emission spikes.

that adequate emissions reductions were achieved after repairs, it was useful to evaluate any correlation of the RG240 with the IM240. The correlative plots, Figures 2, 3, and 5, were plotted using both the before and after-repair data for HC, CO, and NOx (NO). Figure 4 is a comparison of the two RG240 NO sensors, which shows excellent agreement and linearity between the two different NO sensors. Because of this excellent agreement, only data from RG240 NO sensor number 1 will be used in this analysis, as the characteristics will also apply to RG240 NO sensor number 2. No analysis was performed for CO₂ because it is not a regulated emission.

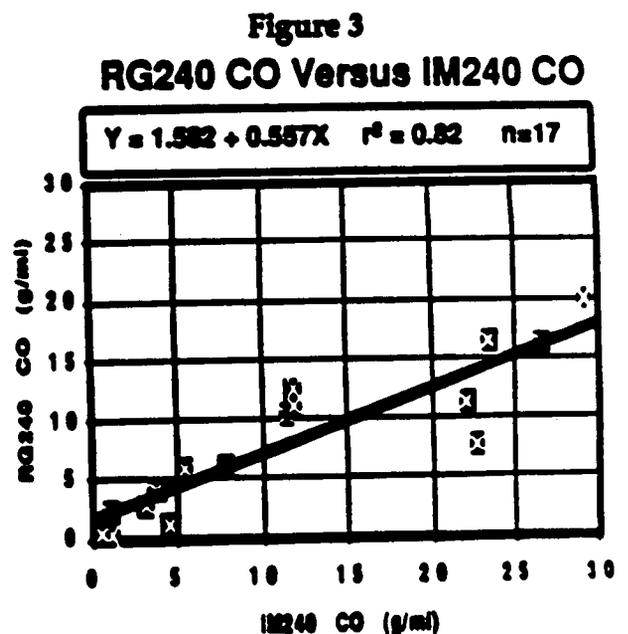
A comparison in Figure 3 of results for CO shows reasonably good correlation of the RG240 to the IM240. The slope of the line indicates that the RG240 is measuring about half of the CO in relation to the IM240.

The differences between the RG240 and the IM240 in this case could also be due to the different response times of the RG240 and IM240 CO gas analyzers. Because instantaneous transient test emissions change rapidly, an analyzer with a slow response time may not measure the entire quantity of emissions present during a period of rapid emission change. Particularly when time correlating emission quantities with distance

traveled on the driving cycle. While both tests use NDIR analyzers, the IM240 is a dedicated CO unit (with an optimized cell length) while the RG240 analyzer also measures HC and CO₂. Another cause for lower RG240 CO values may be under loading of the vehicle during acceleration portions of the RG240 due to the lower inertia weight in the RG240 dynamometer.

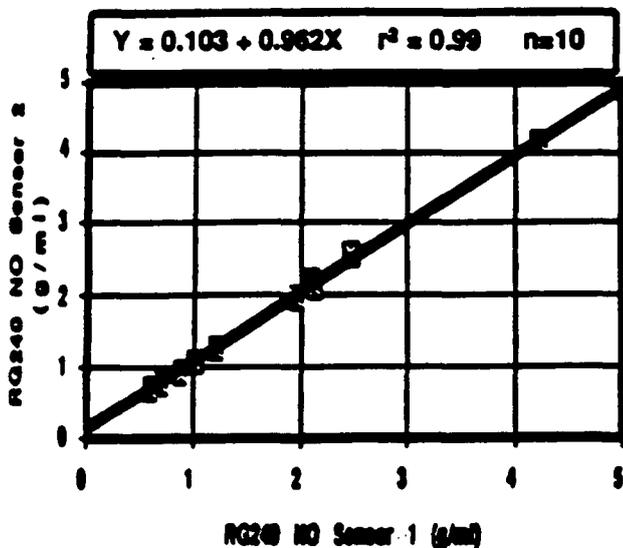
Figure 4

As discussed before, a comparison between the two different RG240 NO sensors (Figure 4) shows excellent correlation between the two NO sensors.

RG240 NO Sensor 1 Versus Sensor 2

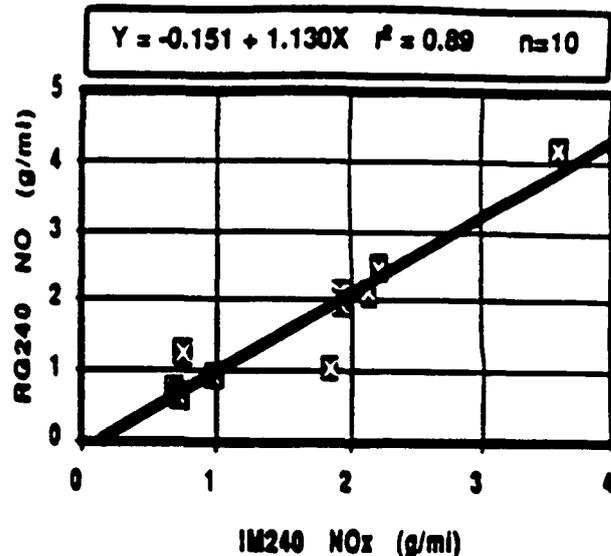
A comparison between RG240 NO and IM240 NO_x (Figure 5) shows good correlation between the two. The linear fit line equation shows that the RG240 NO sensors are actually measuring slightly more NO than is measured by the more accurate IM240 NO_x analyzer. This was a surprising result. One explanation for the high NO values recorded may be analyzer interference on the RG240 analyzer. Both RG240 NO analyzers follow the same trend of over measuring the quantity of NO.

RG240 NO Versus IM240 NO_x

program did not cover the range of inertia weights expected in an I/M program. In fact, almost all of the vehicles tested, by happenstance, had the same inertia weight of 3000 pounds. The testing of vehicles with different inertia weights to fully develop the relationship between the RG240 and the IM240 is important because NO_x is generated under higher engine loads and its formation is dependent on the amount of inertia weight applied during a test. Future test programs will need to cover a broader range of vehicle inertia weights before the agreement between the RG240 and the IM240 in Figure 5 is considered to be fully valid.

In this preliminary method, the RG240 NO target score is capped at 2.1 g/mi due to the better overall agreement with the IM240 values. The 2.1 g/mi value was obtained by the using IM240 NOx cutpoint (2.0 g/mi) in the linear fit equation of Figure 5.

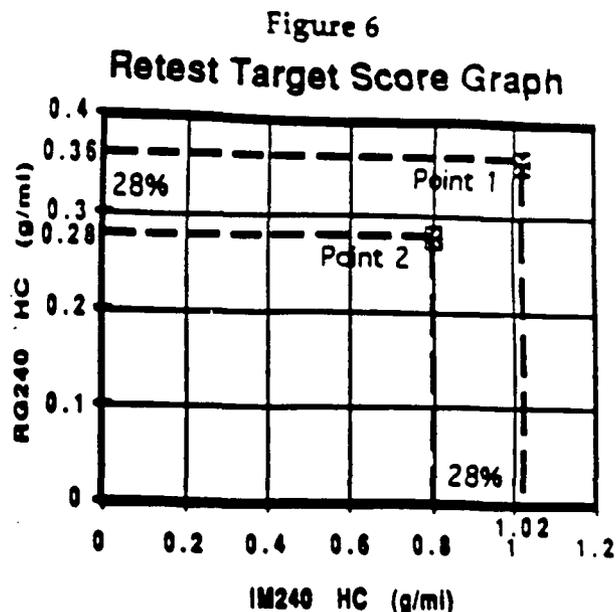
This example is also illustrated graphically in Figure 6. Point number 1 is the initial (before repair) RG240/IM240 coordinate. Point number 2 is the target RG240/IM240 cutpoint coordinate. The IM240 percentage reduction is calculated based on the initial IM240 and the IM240 emission cutpoint. This percentage reduction is then applied to the initial RG240 value to determine the target RG240

value. If the vehicle had emissions below the target RG240 on the retest after repairs, then it would also be expected to be below the IM240 cutpoint.

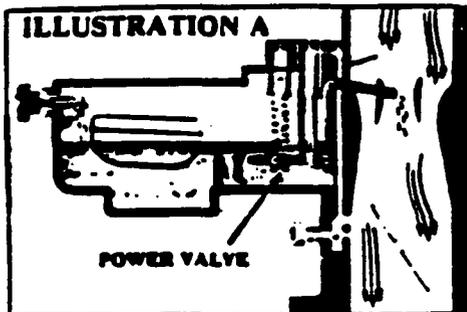
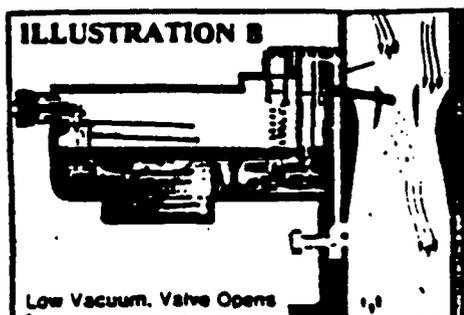
At idle speed, the intake manifold vacuum is high but will decrease as the load on the engine increases. The vacuum is then used to overcome the force of a spring to hold the power valve closed. When the vacuum decreases to a set value, the spring forces open the valve, (see illustration B, below), and allows more gasoline to flow into the carburetor.

In the case of mechanically operated power circuits, gasoline flows into the carburetor by means of a stepped metering rod, which is raised in a jet of fixed size whenever the accelerator pedal is depressed. As the metering rod is raised up, the cross-section of the rod becomes smaller within the fixed jet and more gasoline will be allowed into the carburetor.

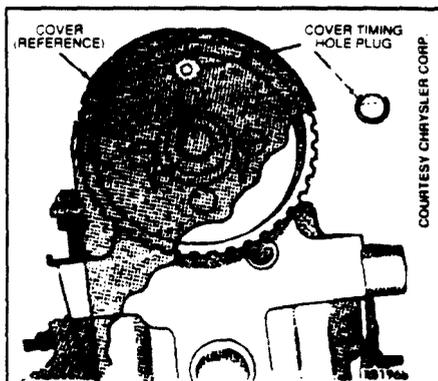
Along with these common problems, Aspire diagnosticians have noted that some timing belts have jumped, or been installed improperly, and are out of time. Incorrect cam-timing changes valve timing in relationship to piston position. This results in low engine vacuum, which affects MAP sensor voltage output. Unfortunately, the incorrect MAP sensor voltage may lead some technicians to overlook the timing belt as a cause, especially when doing quick diagnostic checks.

Aspire recommends the following quick method of checking timing belt alignment, by the use of an in-

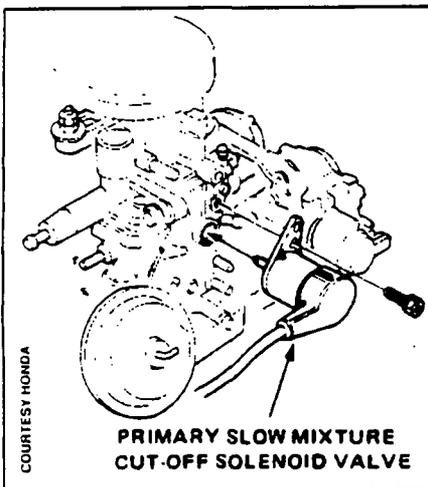
If the carburetor is equipped with an idle cut off solenoid, Aspire recommends checking its operation. The solenoid's function is to cut off the idle circuit passage way. It is used in a number of ways on many different models to prevent dieseling or post ignition. As a de-cel solenoid, it is used to prevent high exhaust emissions and backfiring on deceleration.

Some solenoids use a single electric wire feed of 12 volts for activation. Usually the 12 volts is supplied by the ignition switch. Others have two wires, a 12 volt feed wire, again from the ignition circuit, and a second wire which the feedback computer would ground to control the solenoid operation. All solenoids can be checked on or off the car, by looking for a mechanical operation, while 12 volts and a ground are supplied.

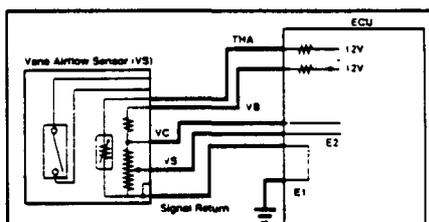
Many Toyota model vehicles use a Bosch-style mechanical air flow sensor. This meter is part of the air induction system to the engine

Toyota uses two types of air flow meter designs. Both designs overlapped in model years of use. See 2nd design late-model schematic above.

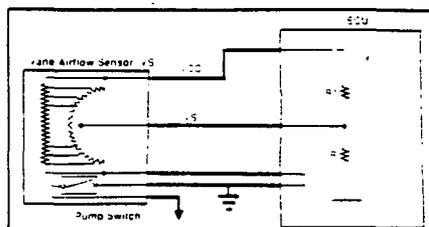
test a few times to locate a possible glitch or problem. When in doubt of the readings, Aspire recommends a voltage check of the airflow meter under actual working conditions. This means back prodding or using a break-out box to measure the voltage output. We can now see on our voltmeter exactly what the ECU sees. The voltage should change gradually, and increase or decrease without skips or spikes as the door moves. With late-model airflow meters, the voltage sweep decreases as the door opens; in early model the voltage sweep increases.

This 2nd design was first used in the 1985 5M-GE engine and is used in many TCCS vehicles. Check vehicle service spec for correct application.
