DEPARTMENT OF THE INTERIOR
UNITED STATES GEOLOGICAL SURVEY

BULLETIN 370

THE FIRE-RESISTIVE PROPERTIES OF
VARIOUS BUILDING MATERIALS

RICHARD L. HUMPHREY

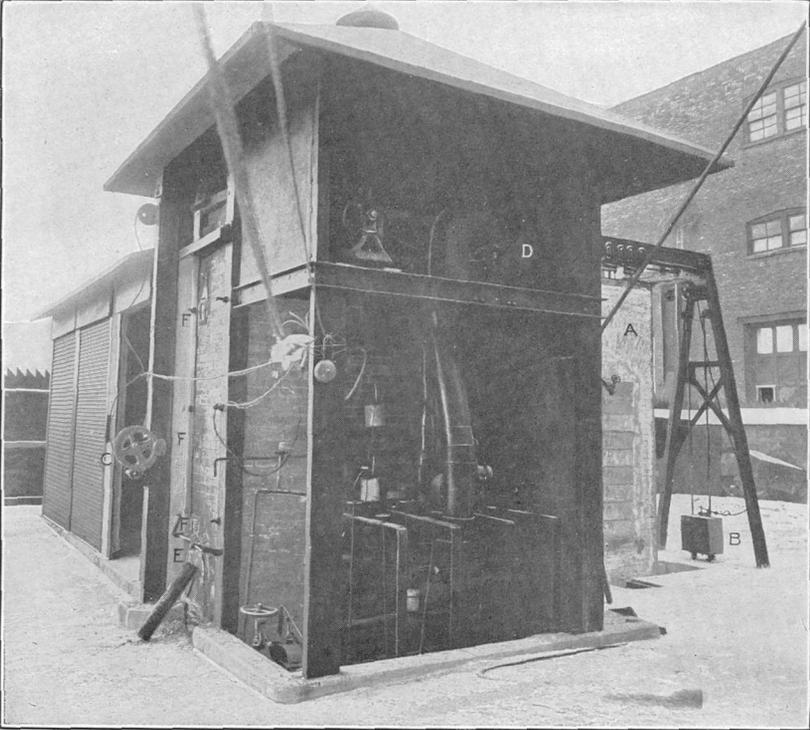
A. WEST VIEW OF FURNACE, SHOWING RADIATION CHAMBER AND PANEL (A) IN POSITION FOR QUENCHING.

When a panel is ready for testing it is drawn into position in front of the main wall by a hand winch (C, Pl. I, A) and held there by a latch. The opening around the edges is sealed by fire clay. Then the gas is turned on and lighted by a torch inserted through a small door (E, Pl. I, A). The observer can watch the behavior of the furnace and the materials under test through three small mica peep holes in the sides of the furnace (F, Pl. I, A).

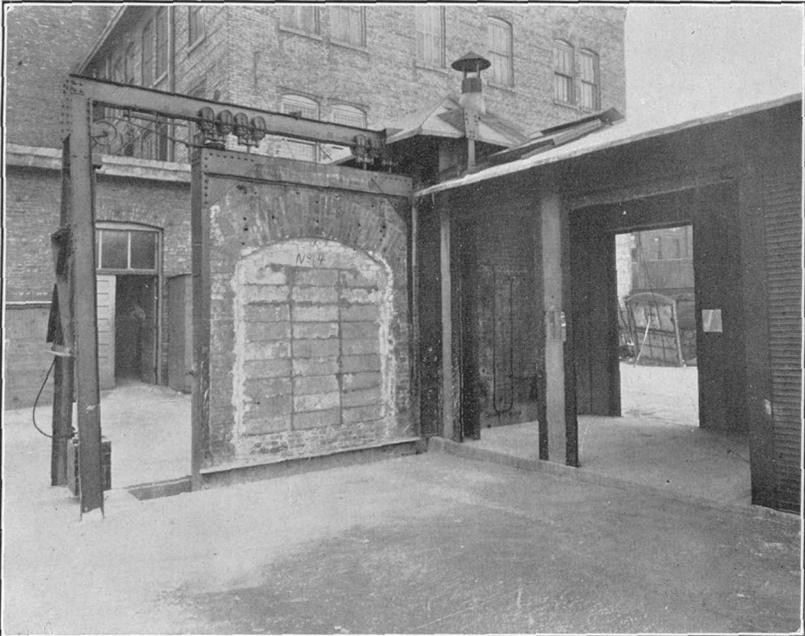
B. SOUTHEAST VIEW OF FURNACE, SHOWING FIRE CHAMBER AND PANEL BUILT UP IN MOVABLE WALL.

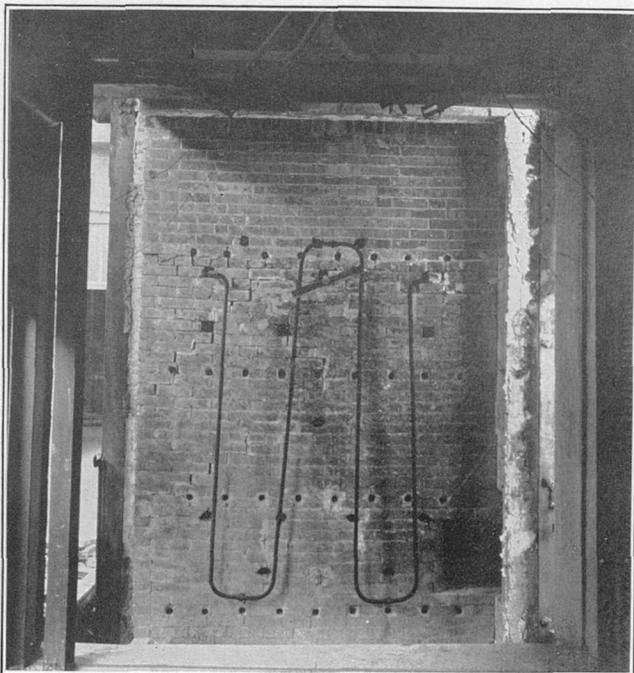
A. VIEW OF FURNACE WITH PANEL REMOVED, SHOWING SECONDARY AIR INLETS AND WATER PYROMETER.

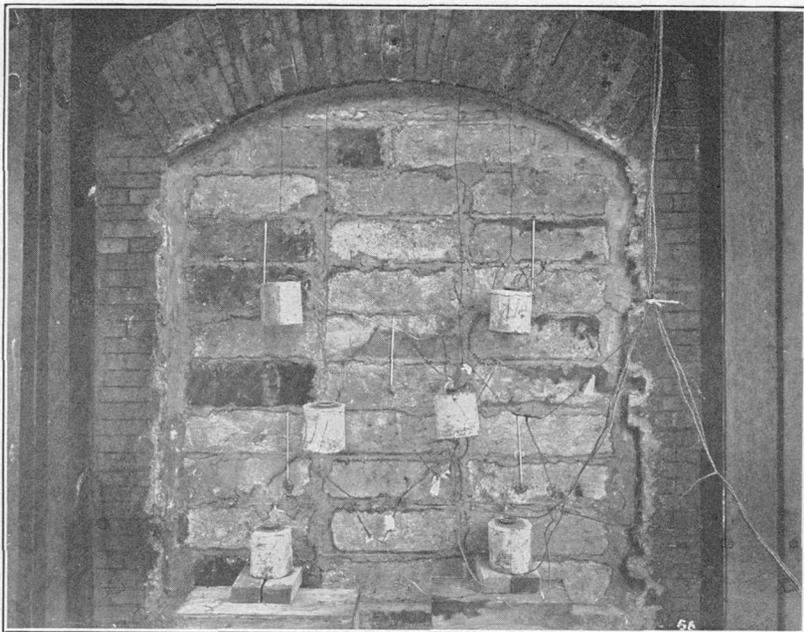
B. VIEW OF BACK OF PANEL, SHOWING THE COLD JUNCTION BOTTLES AND THERMOMETERS IN PLACE.

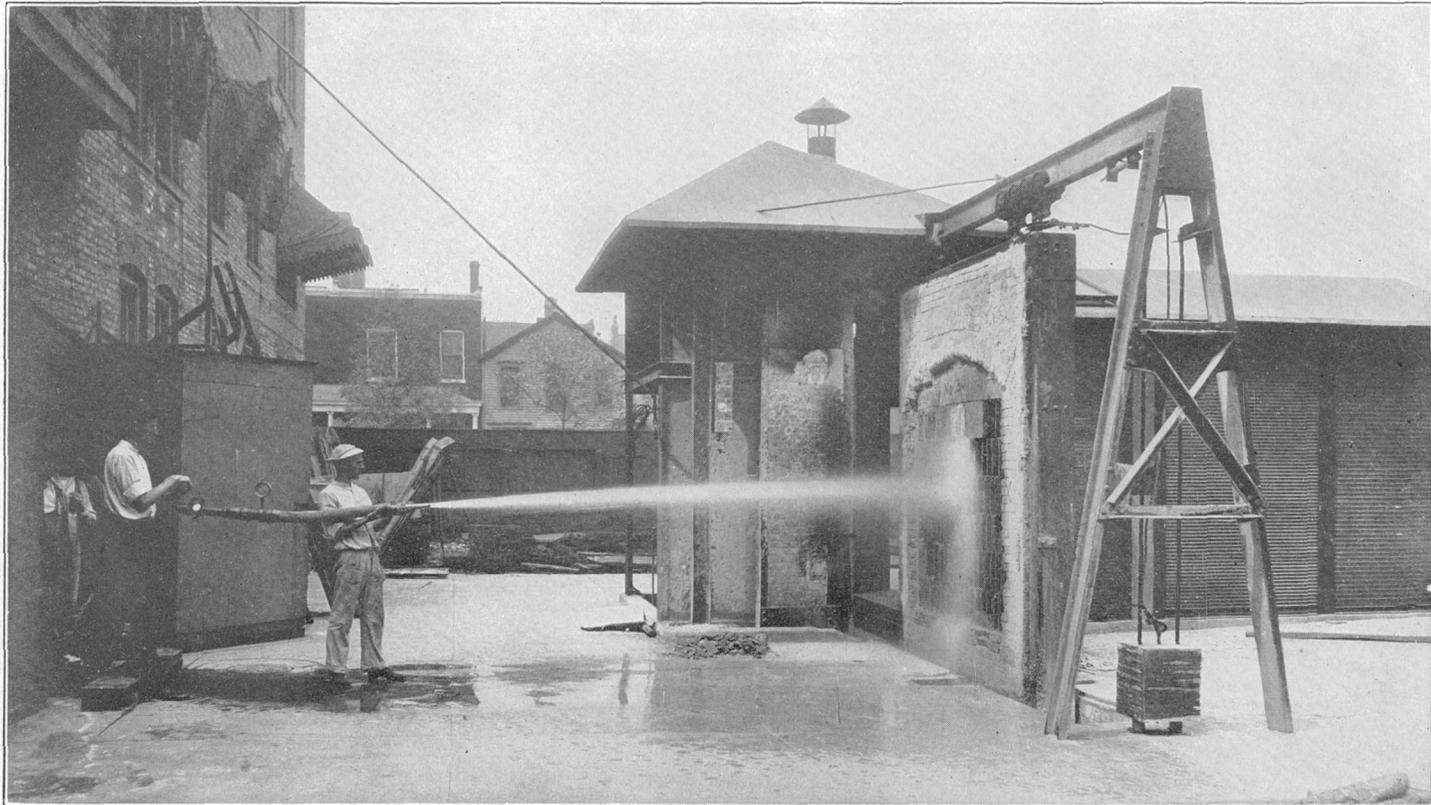
VIEW SHOWING THE METHOD OF QUENCHING A PANEL AFTER BEING SUBJECTED TO FIRE.

At the end of the heat treatment the latch is released and the weight at once draws the wall from the furnace. In a regular test the material in the panel is immediately quenched with water from a nozzle.

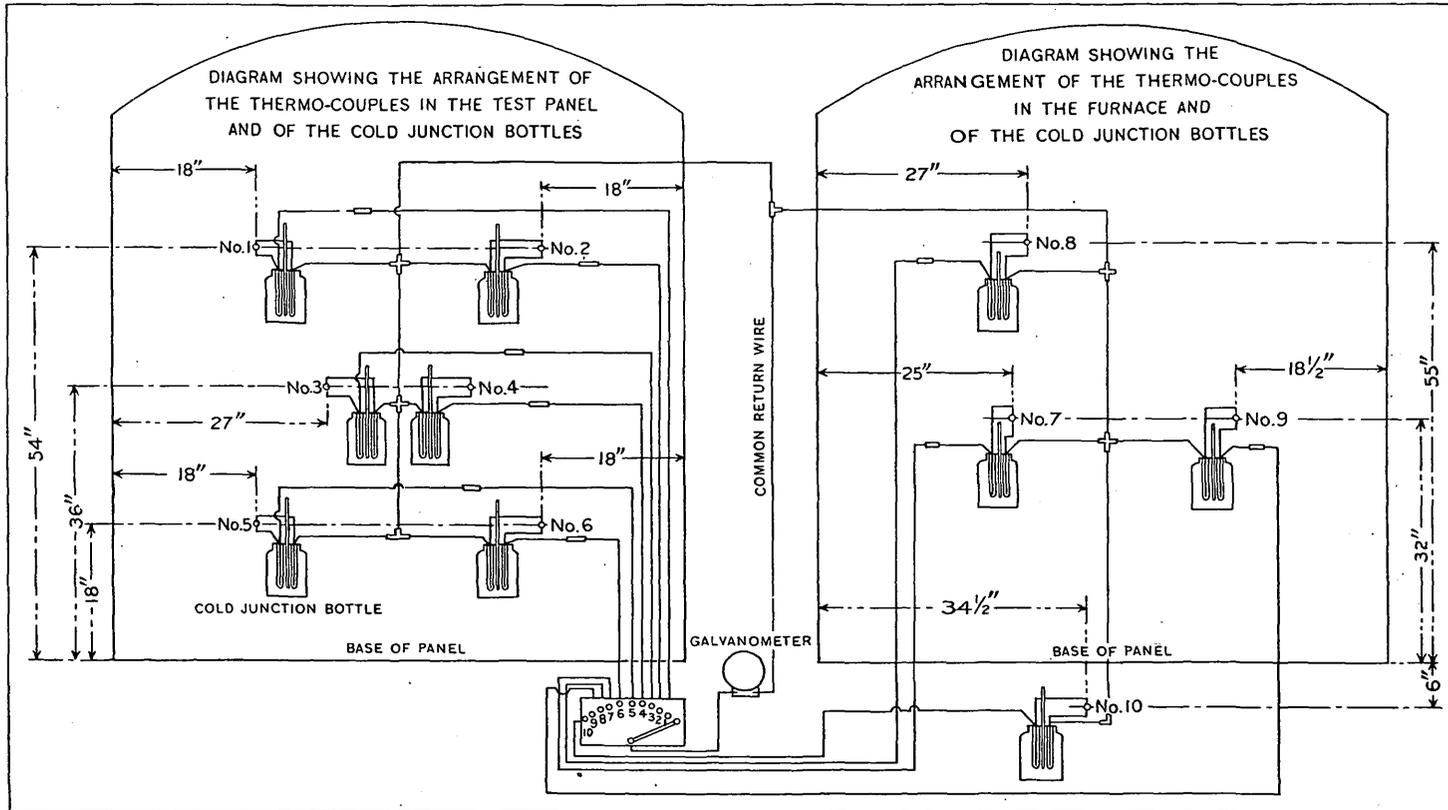
DIAGRAM SHOWING THE ARRANGEMENT OF THERMOCOUPLES, COLD JUNCTION BOTTLES, AND GALVANOMETER.

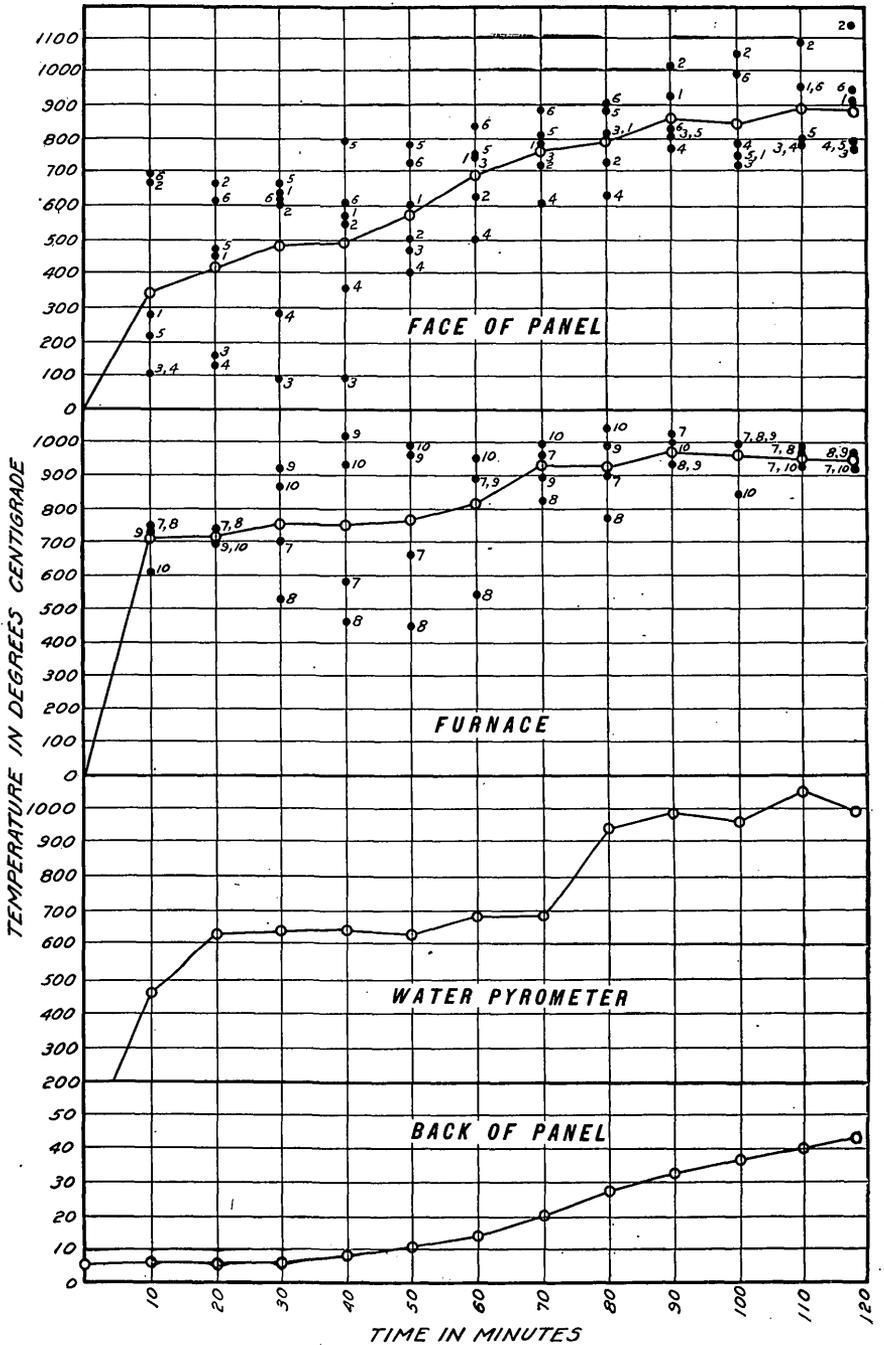
FIGURE 1.—Diagram showing temperature conditions in the furnace and on the back of panel 1. Temperature: Maximum, 34°; minimum, 28°; mean, 31°. Relative humidity: 7 a. m., 95; 7 p. m., 86. Direction of prevailing wind, east.

The variations of temperature of the furnace, determined by the water pyrometer and the thermocouples, of the temperature of the face and back of the panel, and of the cold junction bottles are shown in figure 1.

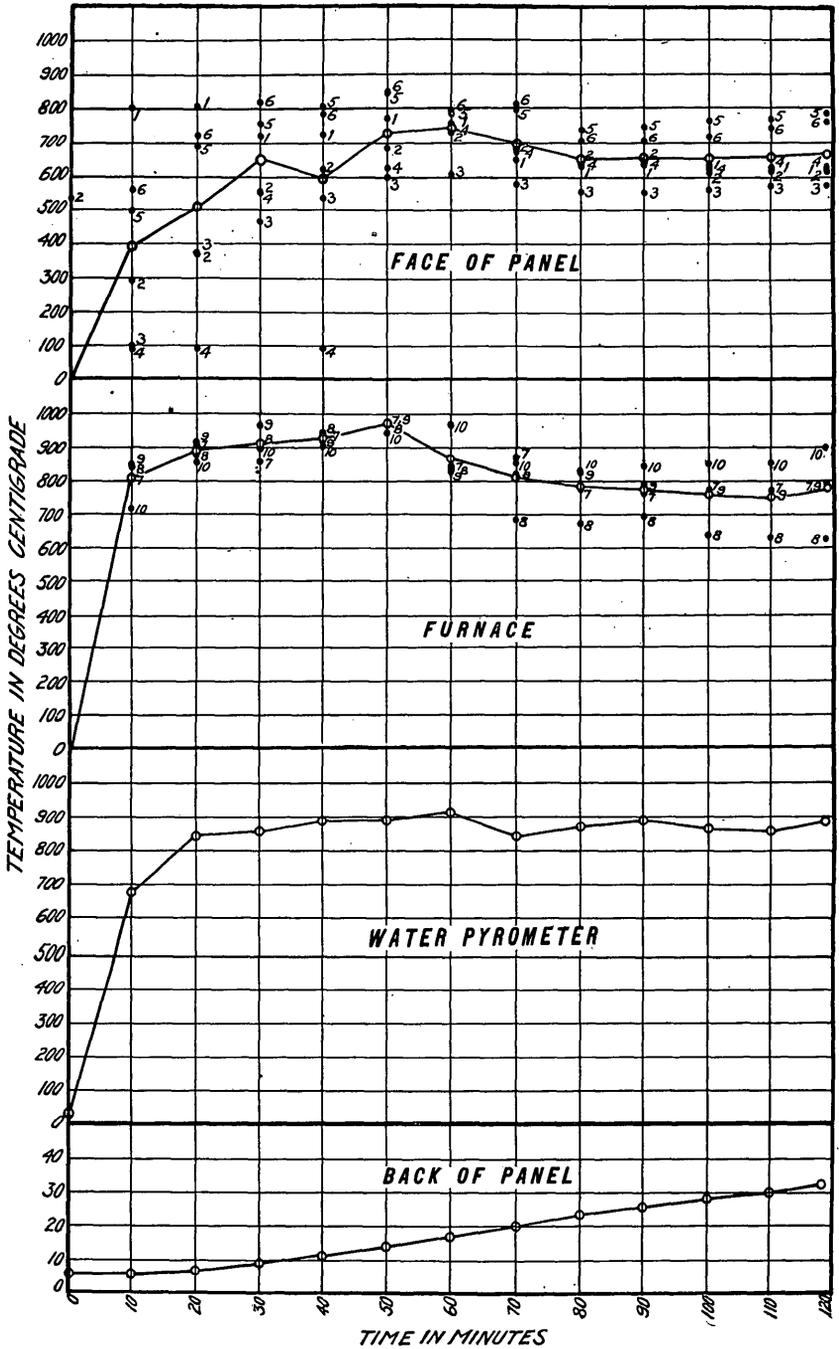
FIGURE 2.—Diagram showing temperature conditions in the furnace and on the back of panel 2. Temperature: Maximum, 37°; minimum, 34°; mean, 36°. Relative humidity: 7 a. m., 91; 7 p. m., 94. Direction of prevailing wind, southeast.

Curves showing the variations of the temperature are given in figure 2.

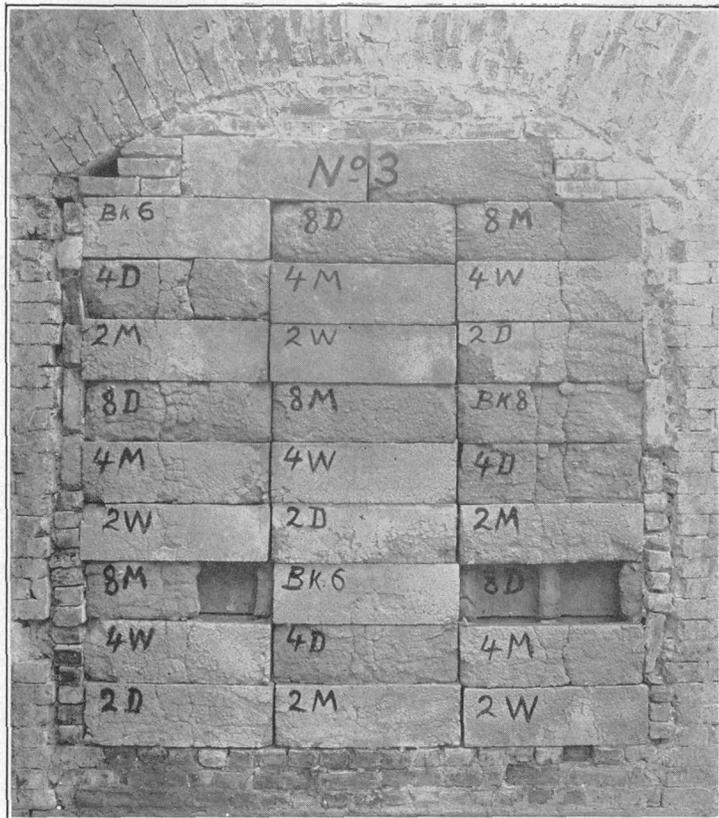
A. FACE OF PANEL 3, CEMENT MORTAR BUILDING BLOCKS, AFTER FIRING AND QUENCHING.

Results.—Vertical cracks on each side of the center webs showed plainly before the application of the water. Plate VI, *A*, shows the face and Plate VI, *B*, the back of the panel after quenching. These views show clearly how different blocks met the tests, the richer wet

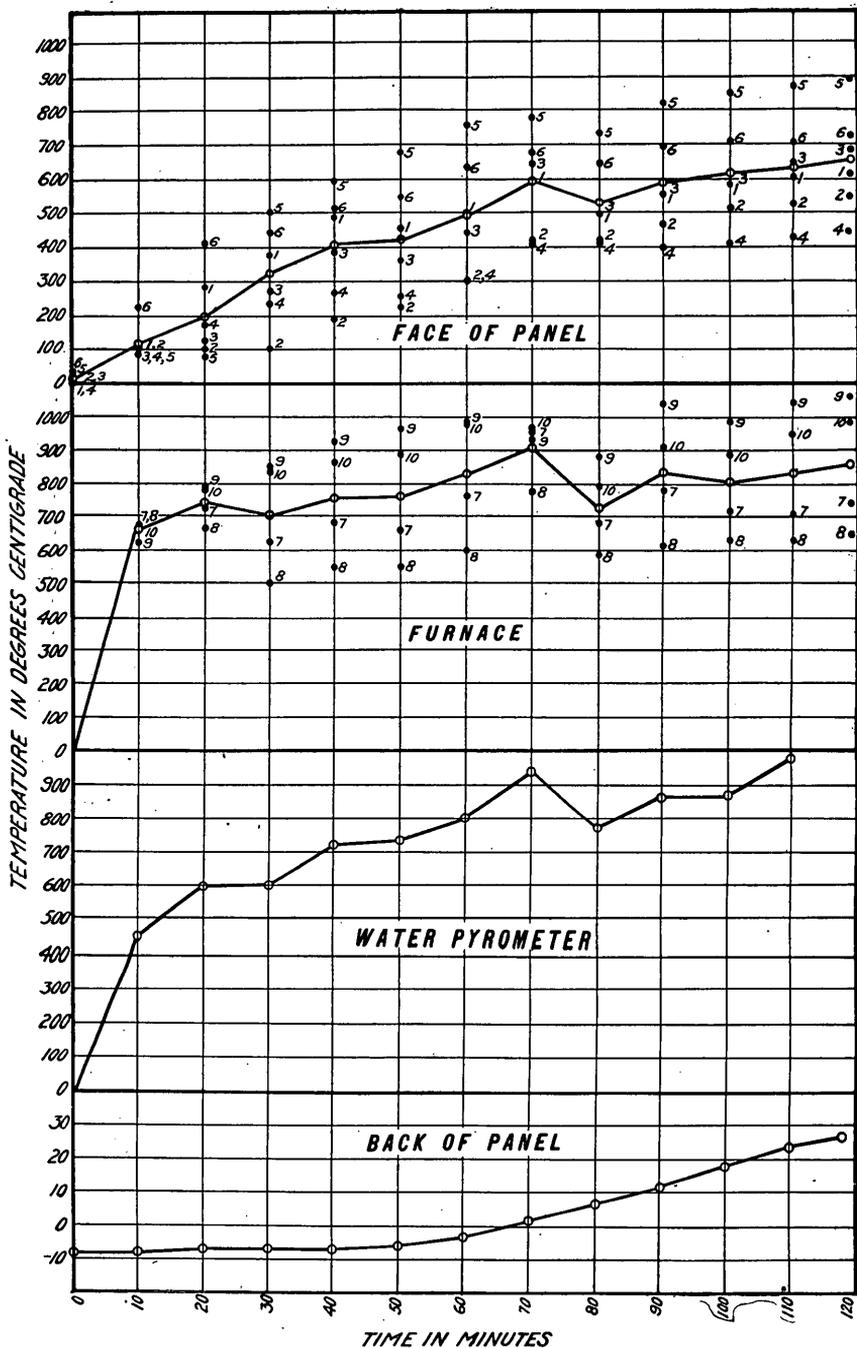
FIGURE 3.—Diagram showing temperature conditions in the furnace and on the back of panel 3. Temperature: Maximum, 27°; minimum, 4°; mean, 16°. Relative humidity: 7 a. m., 86; 7 p. m., 83. Direction of prevailing wind, southeast.

Curves showing the variations of the temperature throughout the test are given in figure 3.

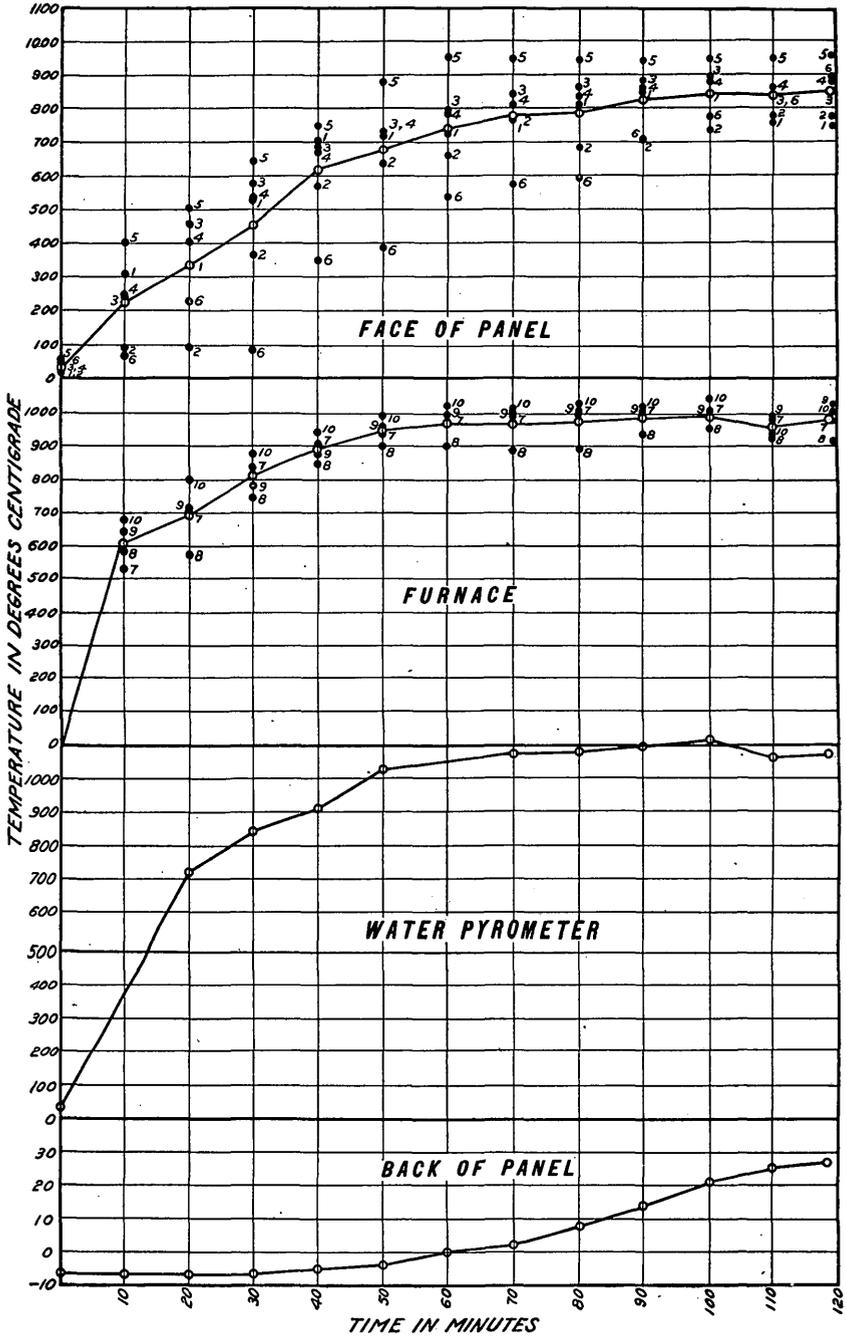
FIGURE 4.—Diagram showing temperature conditions in the furnace and on the back of panel 4. Temperature: Maximum, 22°; minimum, 6°; mean, 14°. Relative humidity: 7 a. m., 83; 7 p. m., 85. Direction of prevailing wind, northwest.

The curves showing the variations of the temperature throughout the test are given in figure 4.

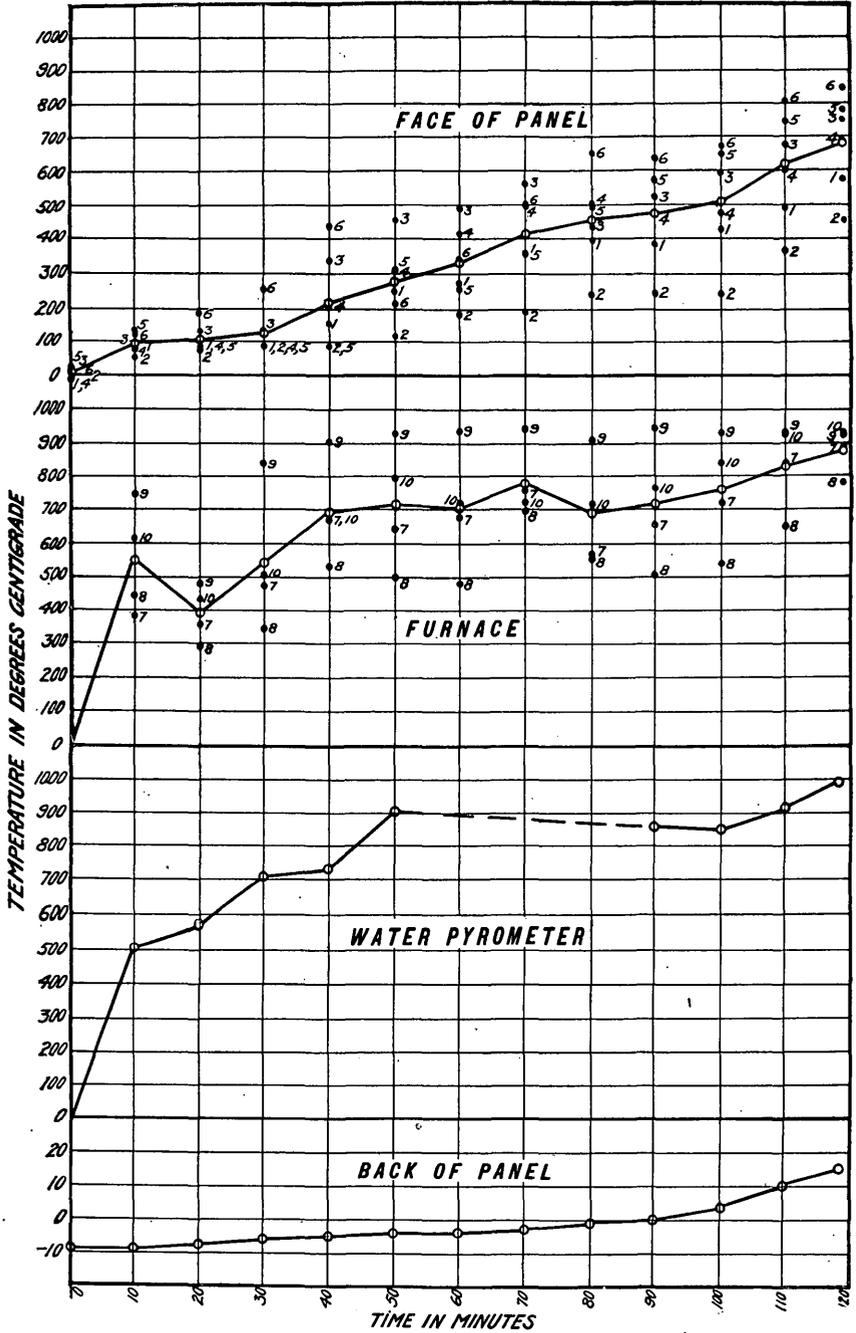
FIGURE 5.—Diagram showing temperature conditions in the furnace and on the back of panel 5. Temperature: Maximum, 24°; minimum, -1°; mean, 12°. Relative humidity: 7 a. m., 82; 7 p. m., 62. Direction of prevailing wind, northwest.

Curves showing the variations of the temperature throughout the test are given in figure 5.

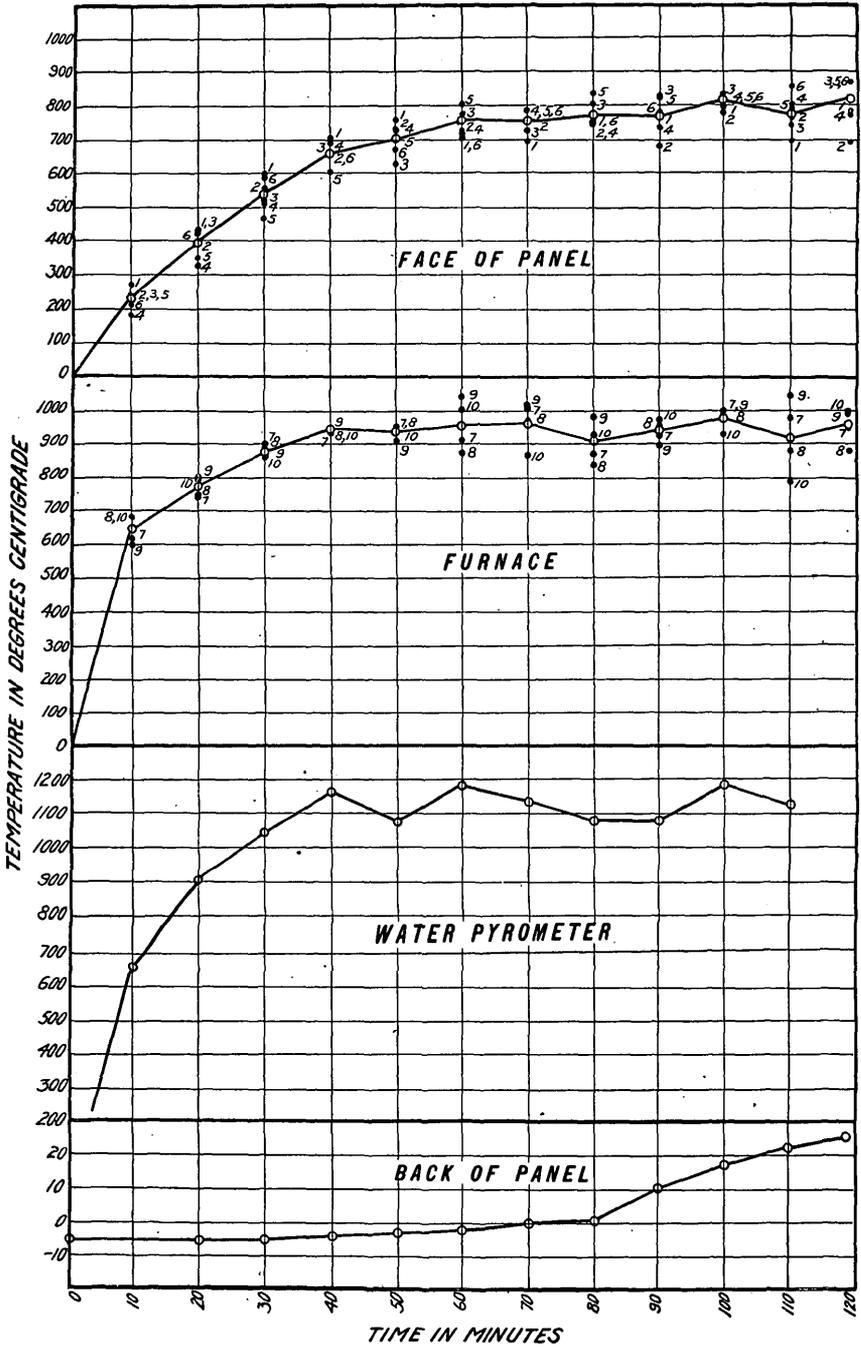
FIGURE 6.—Diagram showing temperature conditions in the furnace and on the back of panel 6. Temperature: Maximum, 28°; minimum, 17°; mean, 22°. Relative humidity: 7 a. m., 92; 7 p. m., 100. Direction of prevailing wind, southeast.

Curves showing the variations of the temperature throughout the test are given in figure 6.

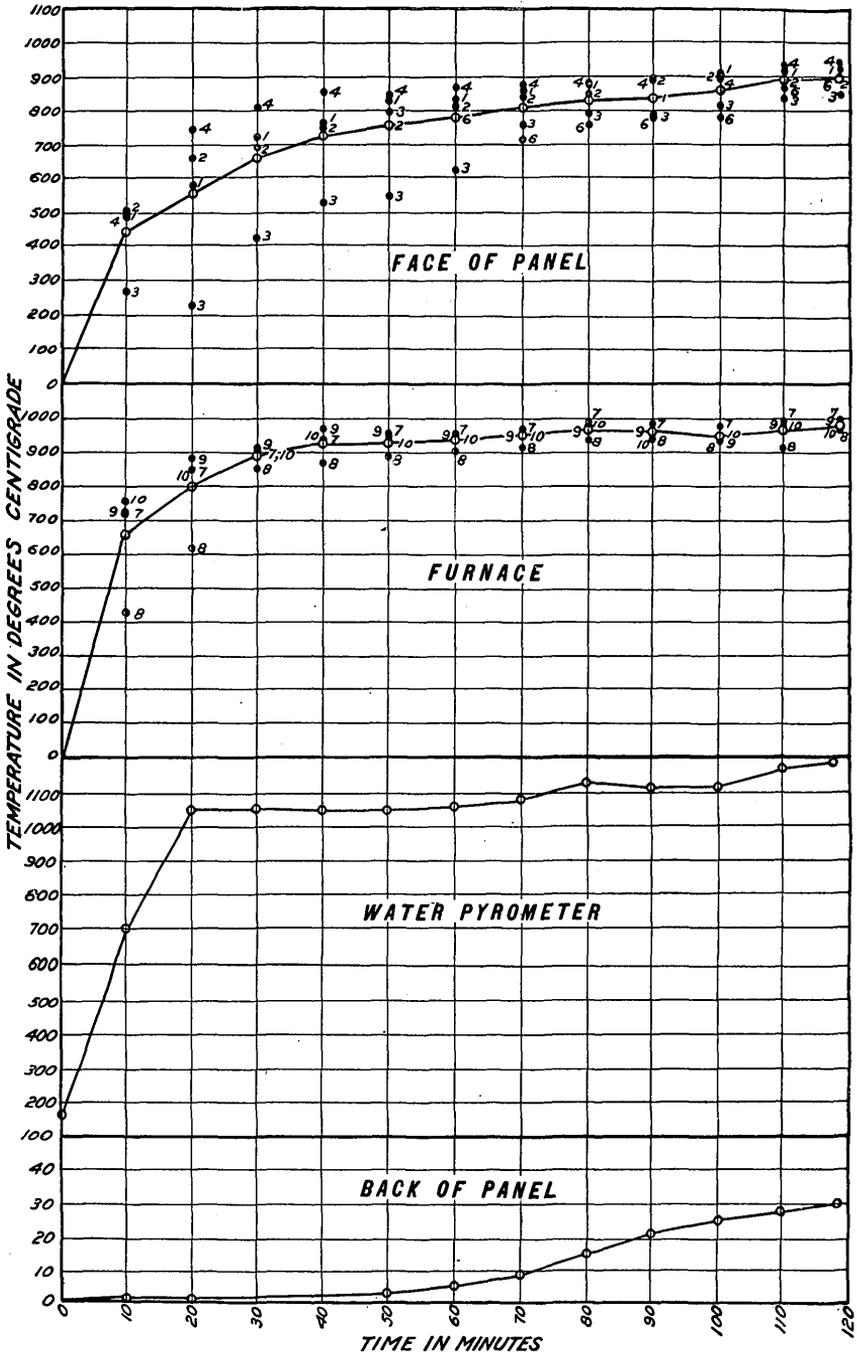
FIGURE 7.—Diagram showing temperature conditions in the furnace and on the back of panel 7. Temperature: Maximum, 37°; minimum, 27°; mean, 32°. Relative humidity: 7 a. m., 91; 7 p. m., 85. Direction of prevailing wind, southwest.

Curves showing the variation of the temperature throughout the test are given in figure 7.

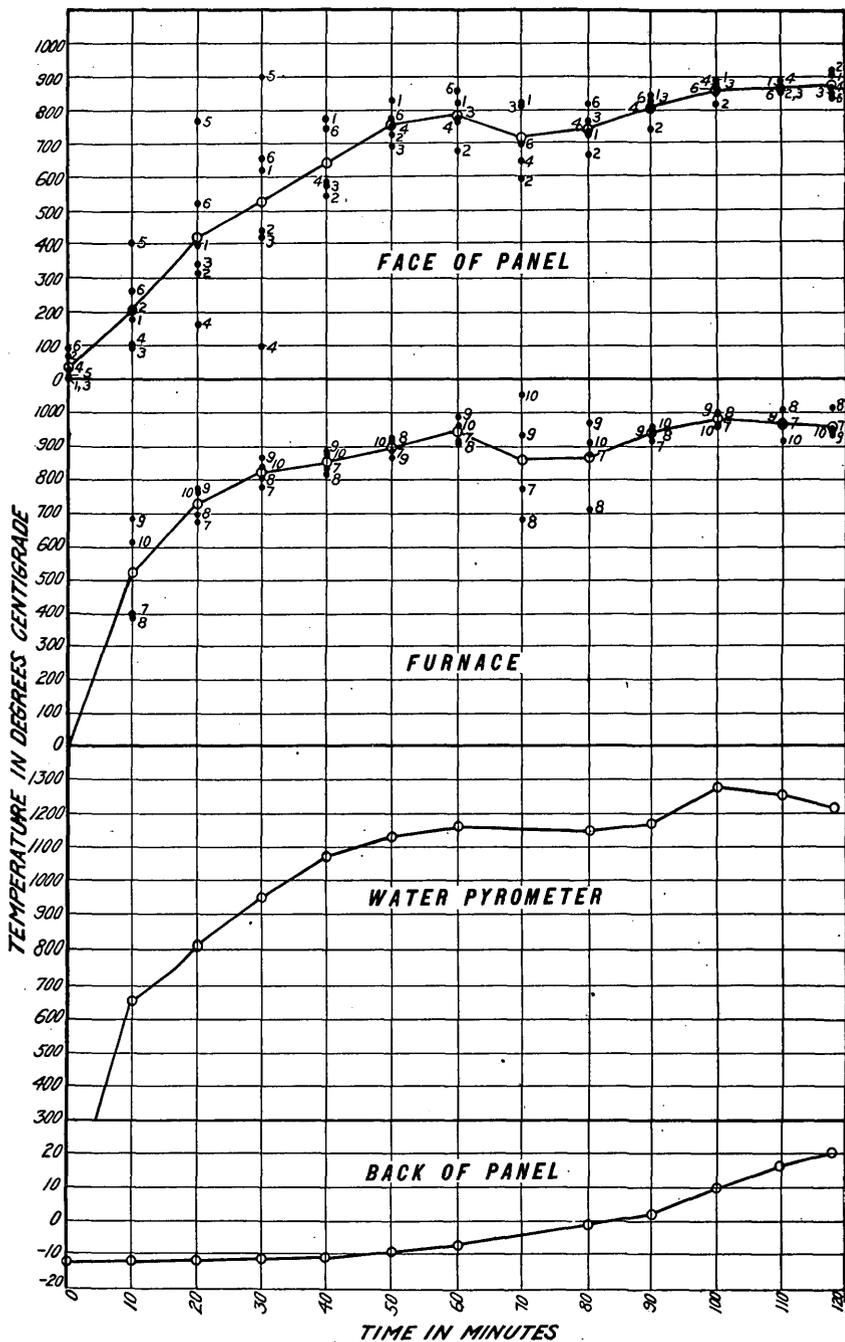
FIGURE 8.—Diagram showing temperature conditions in the furnace and on the back of panel 8. Temperature: Maximum, 17°; minimum, 2°; mean, 8°. Relative humidity: 7 a. m., 88; 7 p. m., 90. Direction of prevailing wind, northwest.

The temperature curves are shown in figure 8.

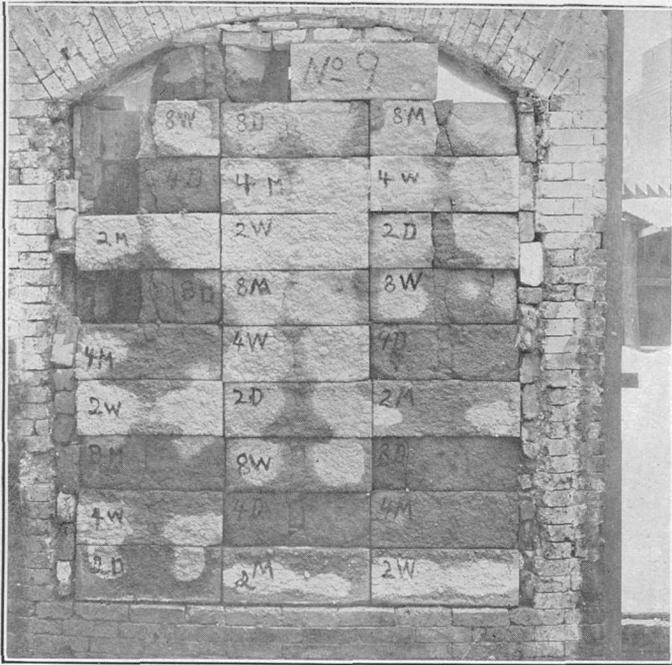
A. FACE OF PANEL 9, CEMENT MORTAR BUILDING BLOCKS, AFTER FIRING AND QUENCHING.

Results.—Plate XIII, *A*, shows the face and Plate XIV, *A*, the back of the panel after the test, and Plate XIV, *B*, the condition of the blocks during removal. On removing the panel from the furnace the blocks appeared to be smooth and no cracks were noticeable. After the application of the water all the blocks were cracked through on each side of the center webs with the exception of the 1:2 mixtures on the bottom row. The surfaces were rough and pitted and washed away from ¼ to ½ inch on the 1:2 blocks, from ½ to ¾ inch on the 1:4 blocks, and from 1 inch to 2 inches on the 1:8 blocks.

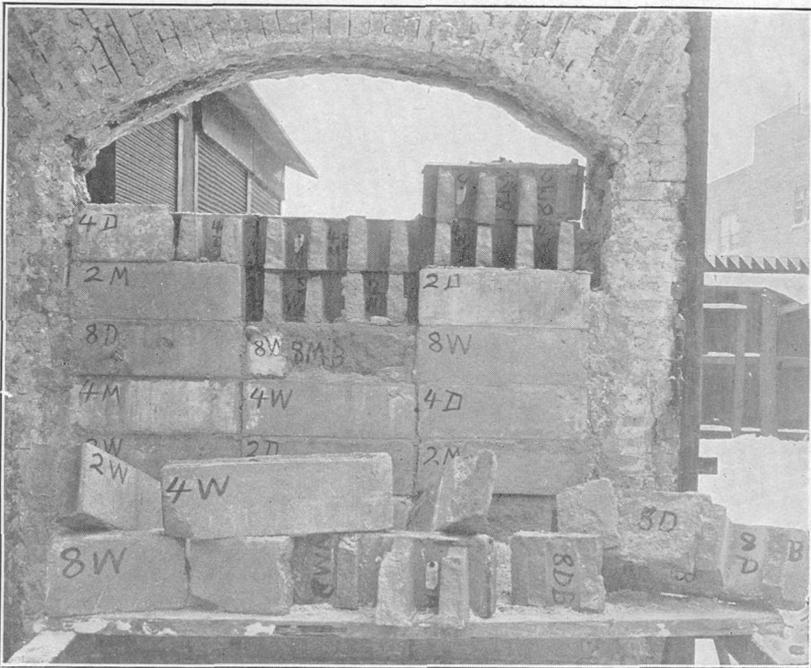
B. PANEL 8, CEMENT MORTAR BUILDING BLOCKS, DURING DISMANTLING.

Results.—Plate XII, *B*, shows the face of the panel after cooling in air; a photograph of the back showed no noticeable damage. Plate XIII, *B*, shows the condition of the blocks while being removed from the panel. On cooling, irregular hair cracks were found over the surface of the blocks, which were largest and most numerous on the 1:8 blocks. No vertical cracks were observed. The surfaces of most of the blocks, as may be seen in the photographs, were found more or less spalled, especially the 1:8 mixtures. The surfaces could be easily broken off on the 1:8 blocks. The 1:4 blocks were not so badly spalled, but the surfaces could be crumbled with the fingers. The 1:2 damp blocks were slightly spalled on the edges. The 1:2 medium and wet blocks showed no signs of spalling, but to a depth of $\frac{1}{4}$ inch the faces were soft. The concrete was discolored by heat to a depth of $1\frac{1}{2}$ to $1\frac{3}{4}$ inches in the 1:8, $\frac{3}{4}$ inch to $1\frac{1}{2}$ inches in the 1:4, and $\frac{1}{2}$ to 1 inch in the 1:2. The different consistencies of any one proportion suffered about equally.

On dismantling the panel, it was found that every block had failed across the web. As a rule the failure was near the face, but one or two webs cracked off at the back and remained attached to the fired side. In the case of one block the face cracked across its center web, one half coming loose from the web and the other remaining attached to the web on the other end of the block. The small linen marking tags, one of which was fastened against the back of each block in one of the core holes, were not damaged at all by the test. Three of these tags may be seen in Plate XIII, *B*.

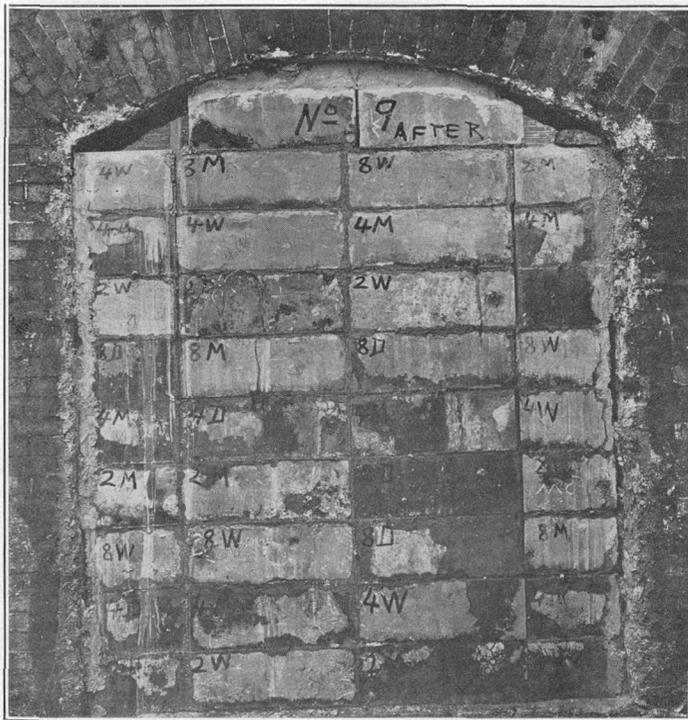
A. BACK OF PANEL 9, CEMENT MORTAR BUILDING BLOCKS, AFTER FIRING AND QUENCHING.

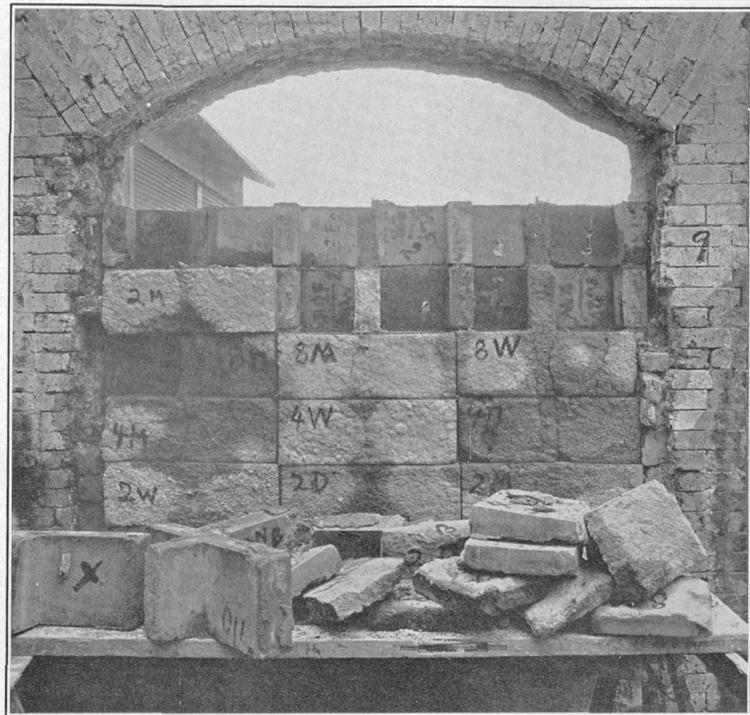
B. PANEL 9, CEMENT MORTAR BUILDING BLOCKS, DURING DISMANTLING.

On dismantling the wall it was found that all the blocks had cracked away from their webs or the blocks had cracked on either

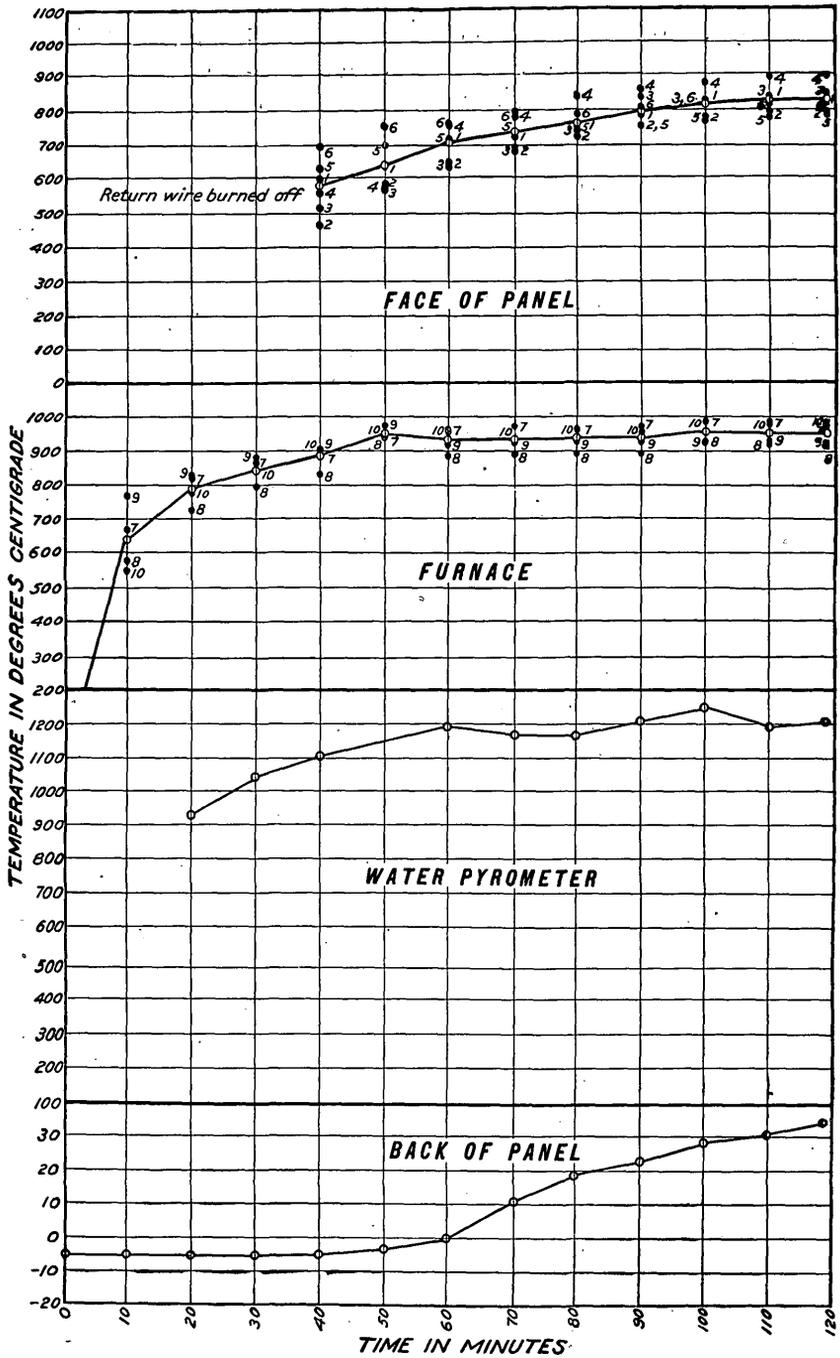
FIGURE 9.—Diagram showing temperature conditions in the furnace and on the back of panel 9. Temperature: Maximum, 24°; minimum, 16°; mean, 20°. Relative humidity: 7 a. m., 95; 7 p. m., 85. Direction of prevailing wind, southeast.

The temperature curves are given in figure 9.

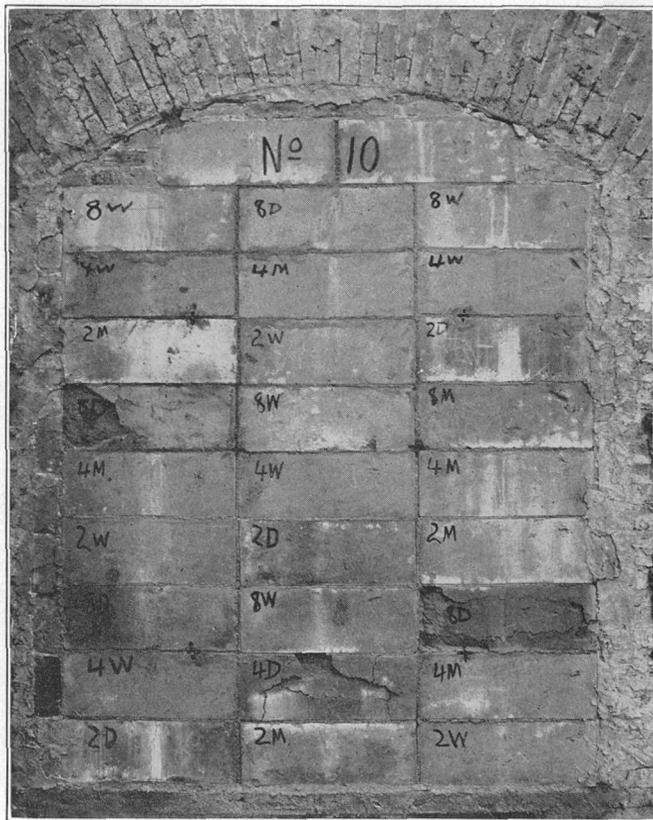
A. FACE OF PANEL 10, CEMENT MORTAR BUILDING BLOCKS, AFTER COOLING IN AIR.

Results.—Plate XV, *A* and *B*, shows the face and back of the panel after the test, and Plate XVI, *A*, the condition of the blocks during the dismantling. On removing the panel from the furnace it was found that, with the exception of the blocks that had already spalled, the surface was comparatively smooth. In about 5 minutes many hair cracks developed over the surface of the blocks. They were more pronounced in the lean mixtures than in the rich ones. As cooling progressed these cracks became more pronounced and covered more of the surface. Vertical cracks running along the webs were not present in this panel. The surfaces of the blocks were found to be very soft, especially in the 1:8 blocks, which could be easily rubbed away with the finger. In the 1:2 blocks the surface could be easily scratched with a tool to the depth of $\frac{1}{2}$ inch, in the 1:4 blocks to a

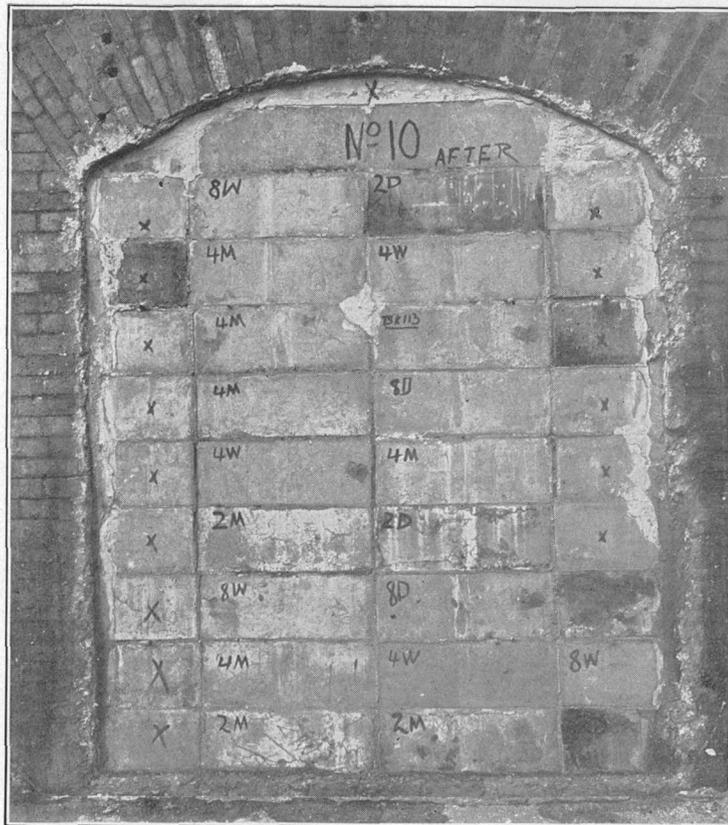
B. BACK OF PANEL 10, CEMENT MORTAR BUILDING BLOCKS, AFTER COOLING IN AIR.

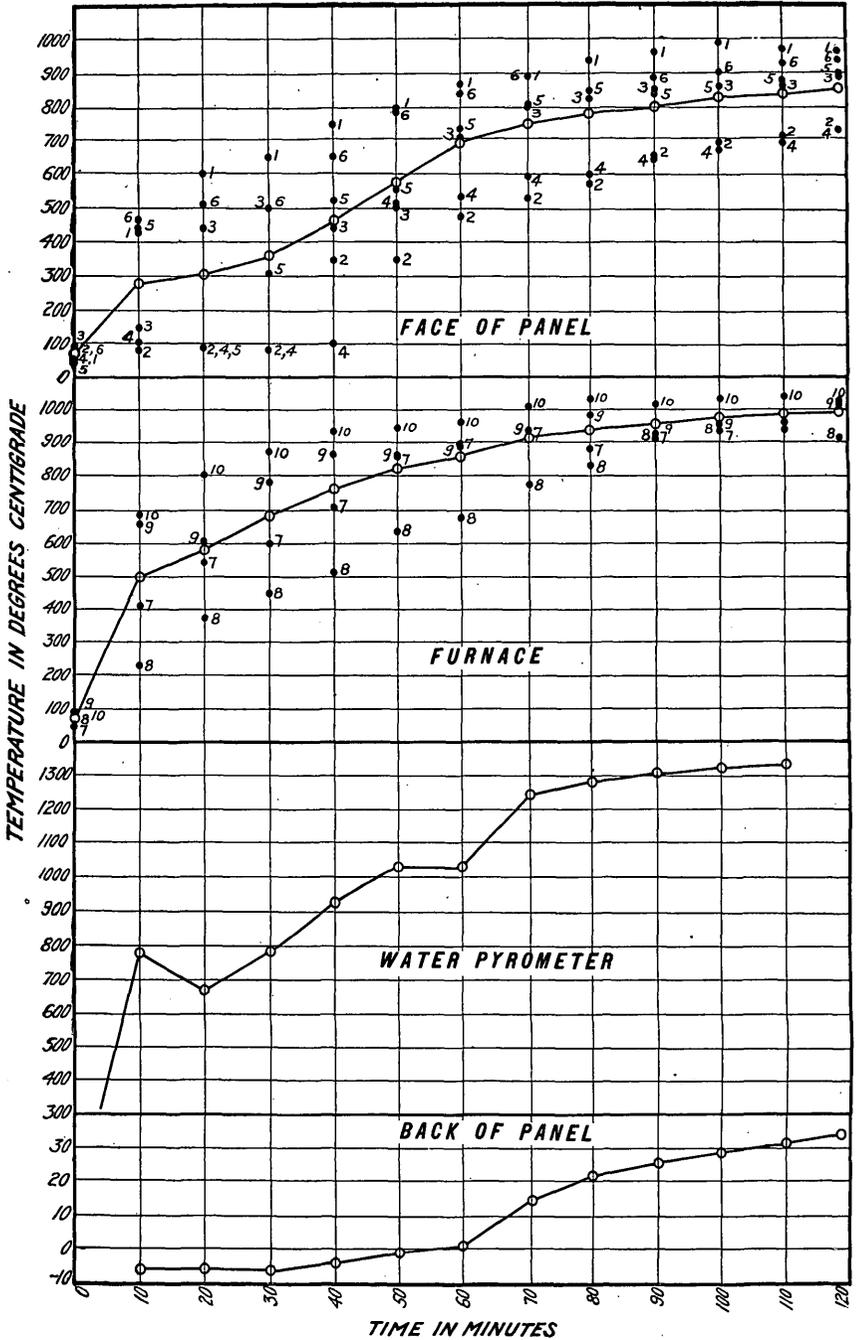
FIGURE 10.—Diagram showing temperature conditions in the furnace and on the back of panel 10. Temperature: Maximum, 33°; minimum, 18°; mean, 26°. Relative humidity: 7 a. m., 71; 7 p. m., 64. Direction of prevailing wind, south.

The temperature curves are shown in figure 10.

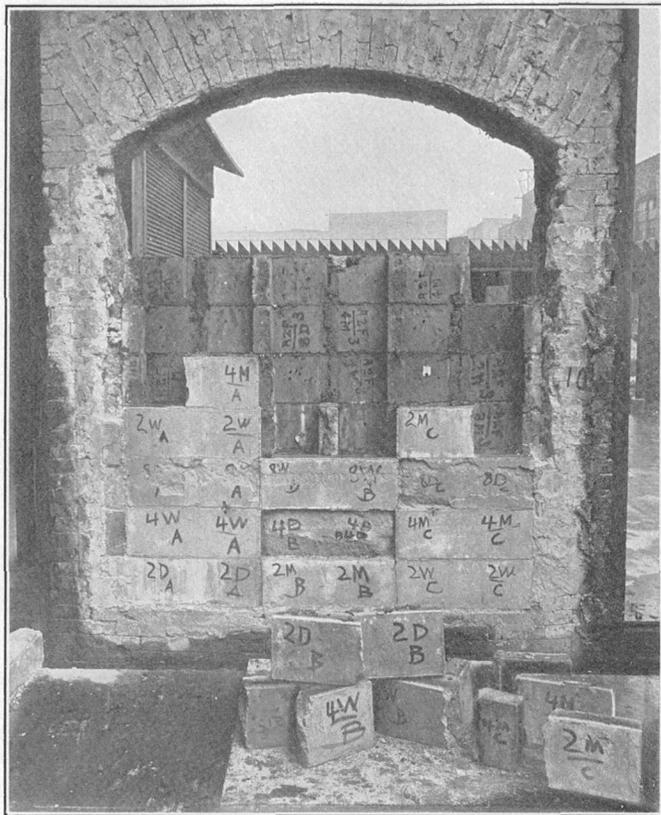
A. PANEL 10, CEMENT MORTAR BUILDING BLOCKS, DURING DISMANTLING.
