DEPARTMENT OF THE INTERIOR
UNITED STATES GEOLOGICAL SURVEY

BULLETIN 370

THE FIRE-RESISTIVE PROPERTIES OF
VARIOUS BUILDING MATERIALS

RICHARD L. HUMPHREY

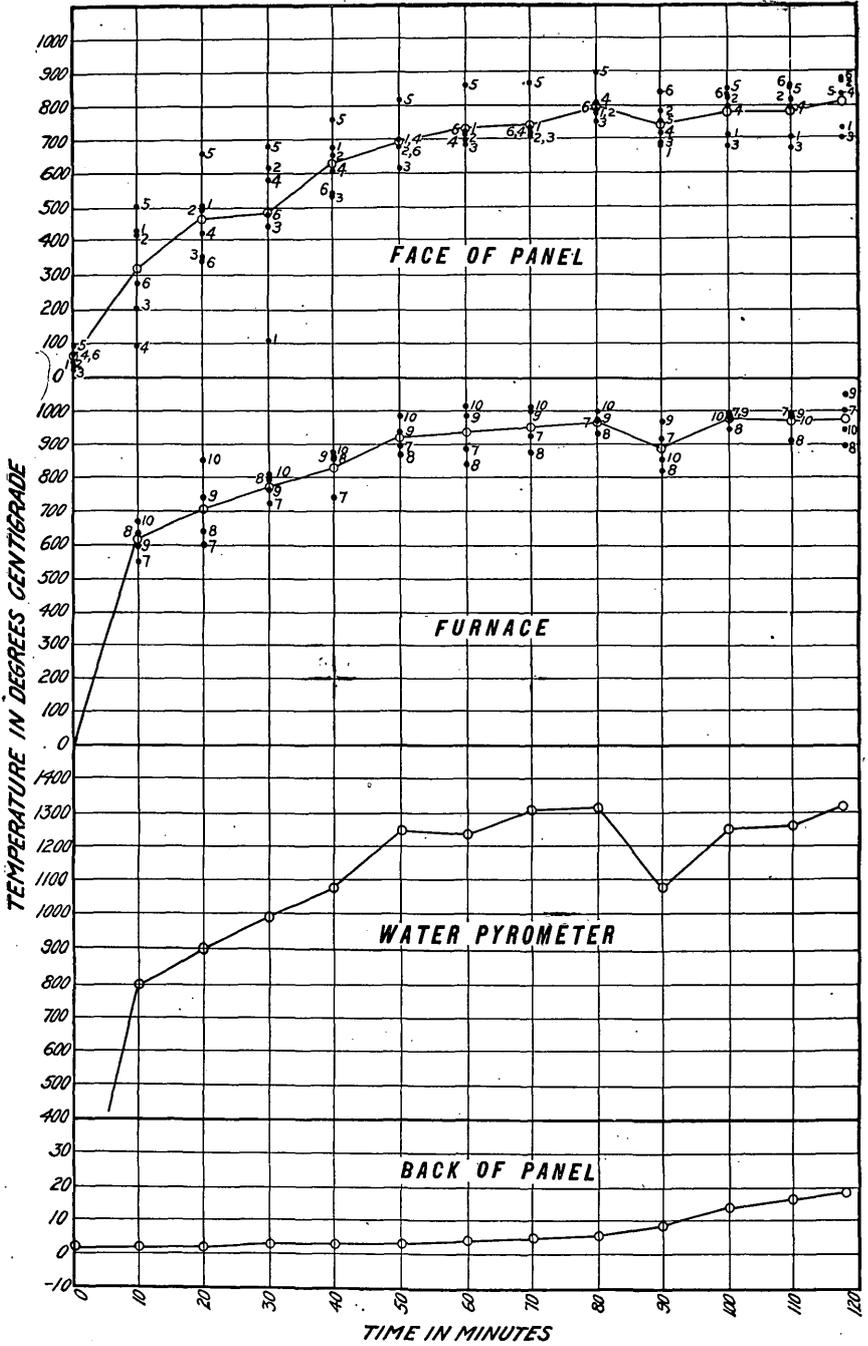
FIGURE 11.—Diagram showing temperature conditions in the furnace and on the back of panel 11. Temperature: Maximum, 50°; minimum, 25°; mean, 38°. Relative humidity: 7 a. m., 76; 7 p. m., 61. Direction of prevailing wind, southwest.

The temperature curves are given in figure 11.

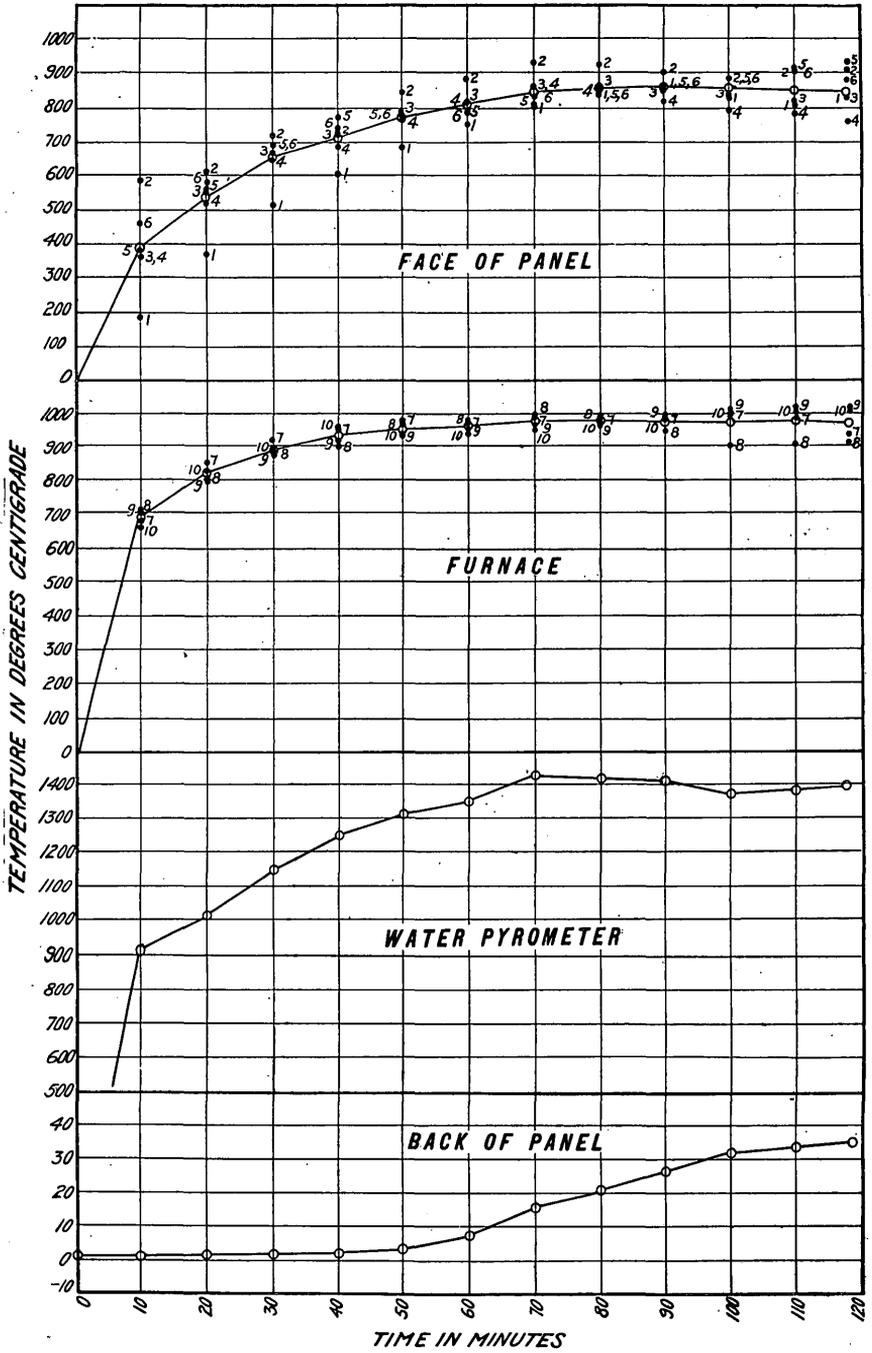
FIGURE 12.—Diagram showing temperature conditions in the furnace and on the back of panel 12. Temperature: Maximum, 45°; minimum, 32°; mean, 38°. Relative humidity: 7 a. m., 70; 7 p. m., 53. Direction of prevailing wind, west.

Curves showing the variations in temperature are given in figure 12.

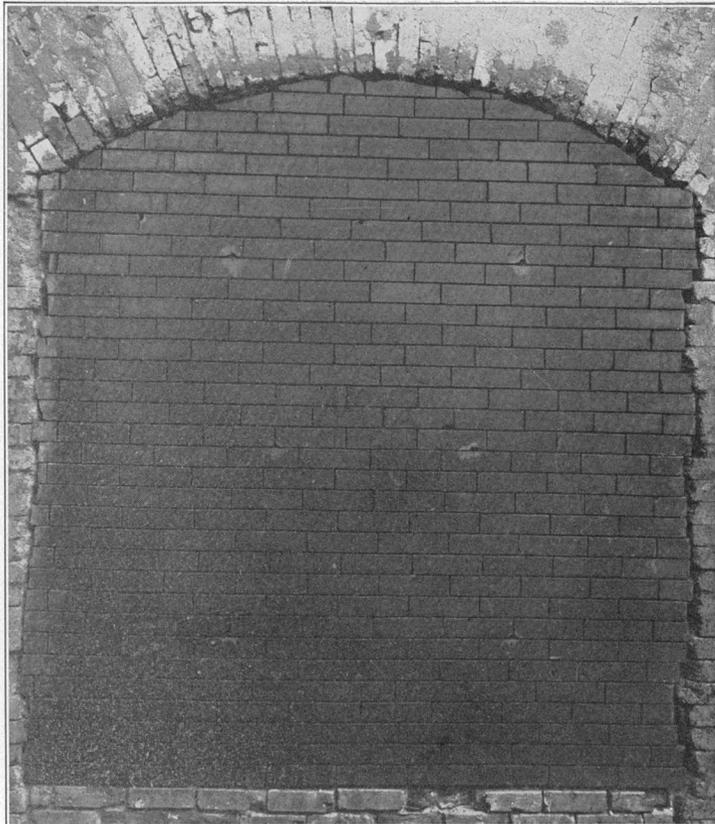
A. FACE OF PANEL 12, HYDRAULIC PRESSED BRICK, AFTER FIRING AND QUENCHING.

Results.—Plate XVII, A, shows the face of the wall after the test. On removal from the furnace one-third of the bricks were badly discolored. Only seven were seen to be cracked or pitted before the application of the water, and these defects were on the corners and

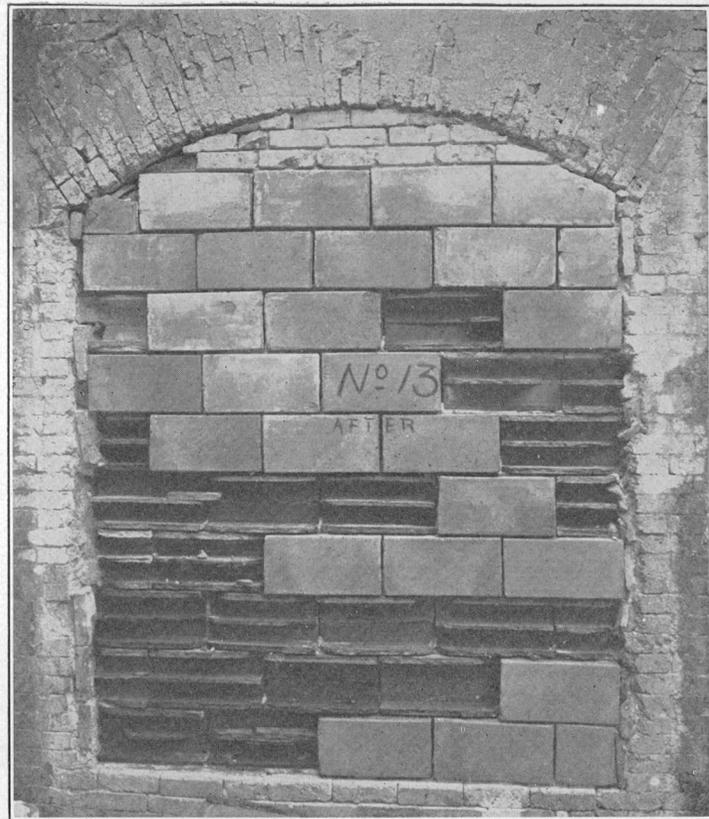
B. FACE OF PANEL 13, BUILDING TILE, AFTER FIRING AND QUENCHING.

Results.—Plates XVII, *B*, and XVIII, *A*, show the face and back of the panel after quenching. On removing the panel from the furnace none of the faces were apparently cracked, but in the quenching about 45 per cent of the faces fell off. During the first 2 minutes of the water treatment the tiles snapped and crackled appreciably, but not until about 2 minutes had elapsed did any of the faces actually fall from the panel.

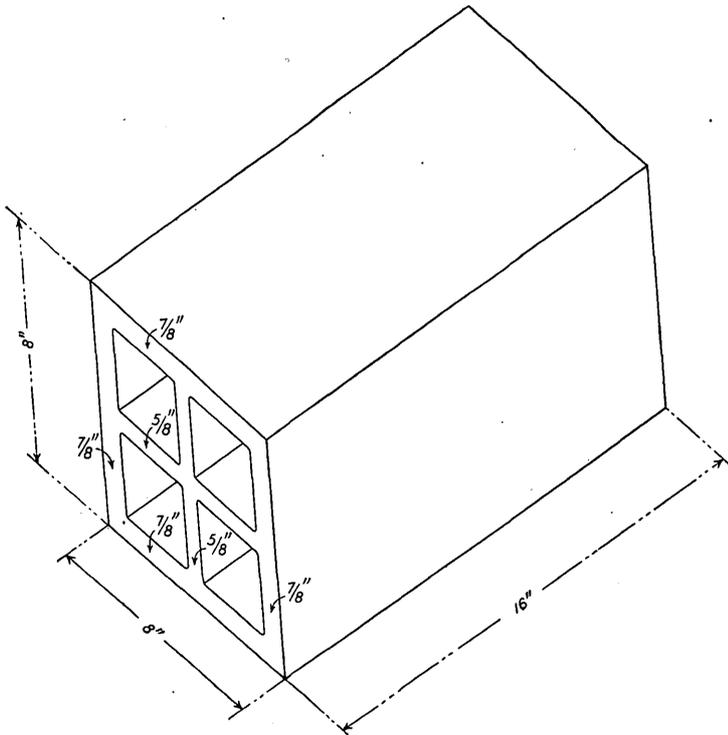
FIGURE 13.—Sketch of glazed building tile used in panel 13.

Material.—Panel 13 consisted of semiporous glazed building tile (figure 13), of a light-brown color, but of several shades. The webs

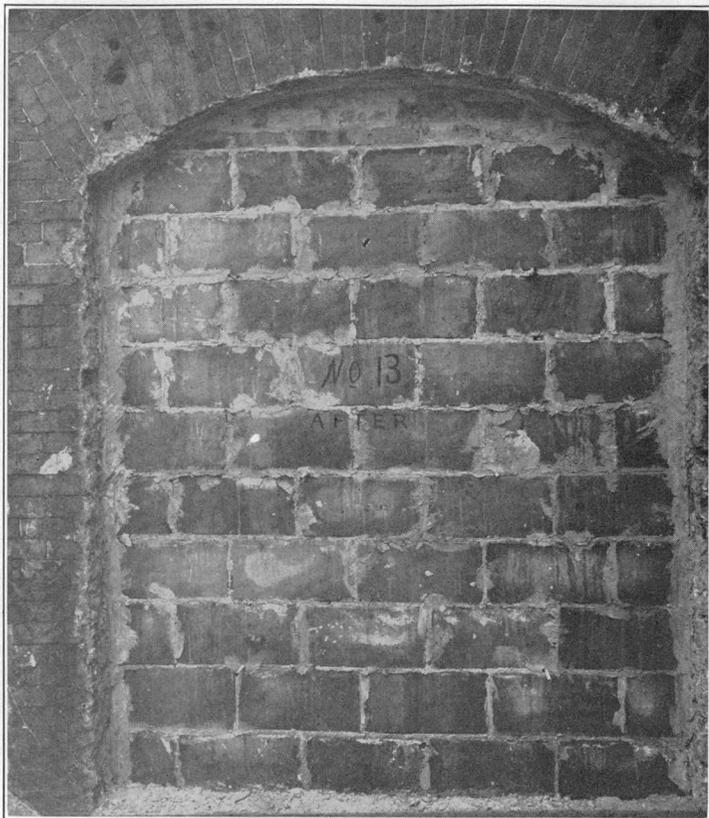
A. BACK OF PANEL 13, BUILDING TILE, AFTER FIRING AND QUENCHING.

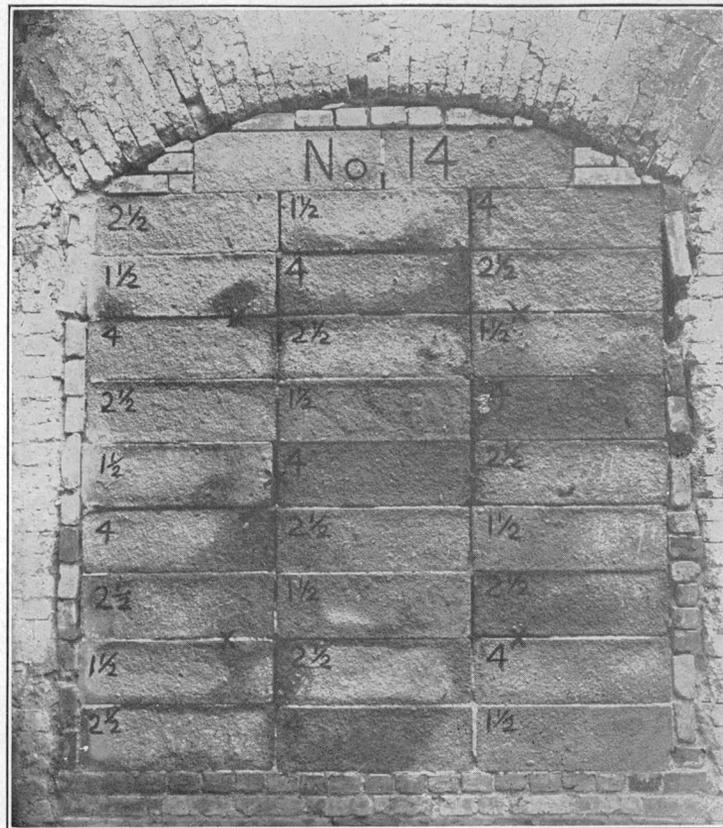
B. FACE OF PANEL 14, CEMENT MORTAR BUILDING BLOCKS, AFTER FIRING AND QUENCHING.

Results.—On removal of the panel from the furnace, before the water was applied, there were no cracks or spalled places observed. The face of the panel was badly smoke stained, especially at the bottom and about halfway up the panel at the center. The effect of the water was to wash the spalled portion away to the depth of about $\frac{1}{4}$ to $\frac{3}{8}$ inch on the 1:1 $\frac{1}{2}$ mixtures, $\frac{1}{2}$ to $\frac{5}{8}$ inch on the 1:2 $\frac{1}{2}$ mixture, and $\frac{1}{2}$ to $\frac{3}{4}$ inch on the 1:4 mixture. The resulting surfaces were rough and pitted, but were nearly as hard as the unaffected portions of the block. That the 1:1 $\frac{1}{2}$ proportion had not been as well mixed as the others was shown by small lumps of cement appearing on the surface.

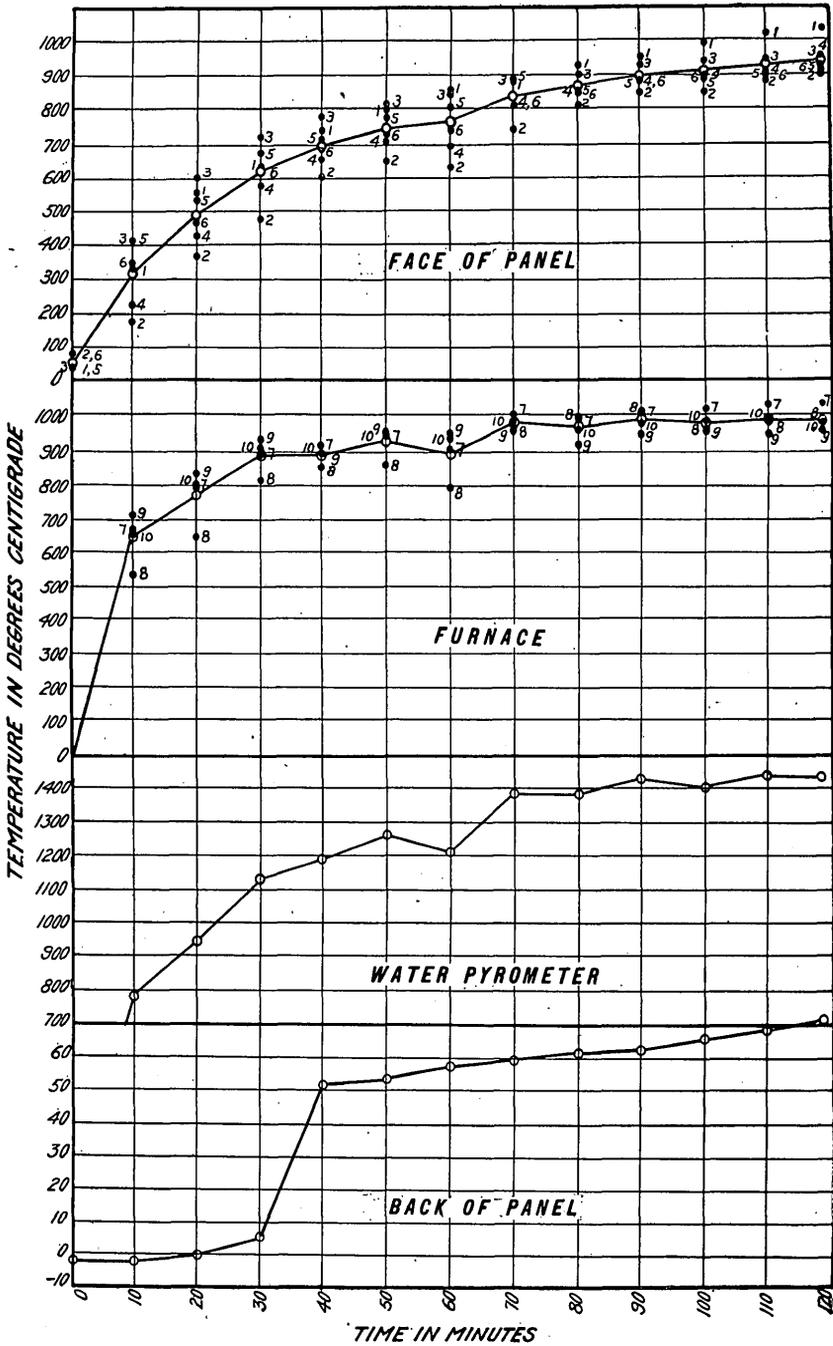
FIGURE 14.—Diagram showing temperature conditions in the furnace and at the back of panel 13. Temperature: Maximum, 37°; minimum, 26°; mean, 32°. Relative humidity: 7 a. m., 79; 7 p. m., 78. Direction of prevailing wind, southeast.

The temperature curves are given in figure 14.

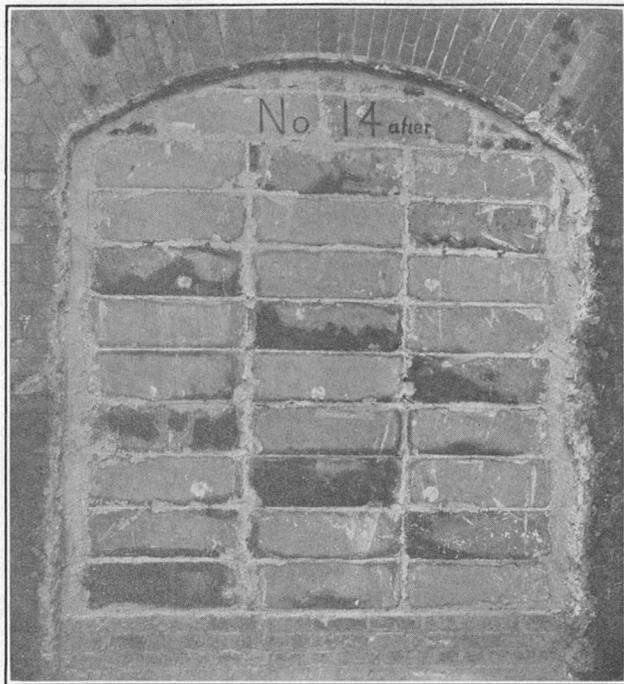
A. BACK OF PANEL 14, CEMENT MORTAR BUILDING BLOCKS, AFTER FIRING AND QUENCHING.

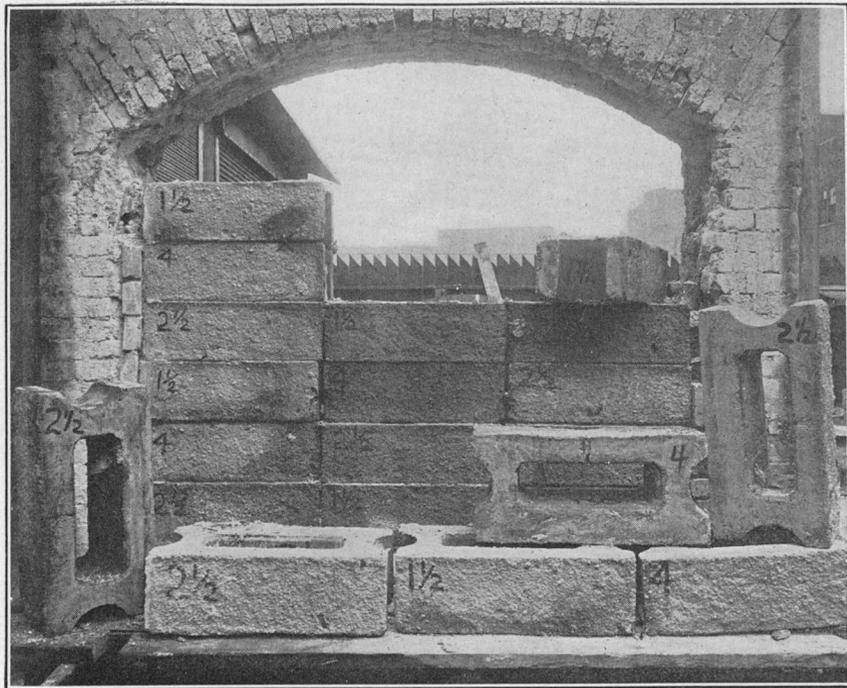
B. PANEL 14, CEMENT MORTAR BUILDING BLOCKS, DURING DISMANTLING.

Only one block, a 1:4 mixture, had split through the webs; the cracks developed across the webs close to the fired side. The face of this block which had been exposed to the fire was apparently uncracked and was lifted from the wall intact. The remainder of the blocks were strong enough to be handled and were later tested for transverse and compressive strength.

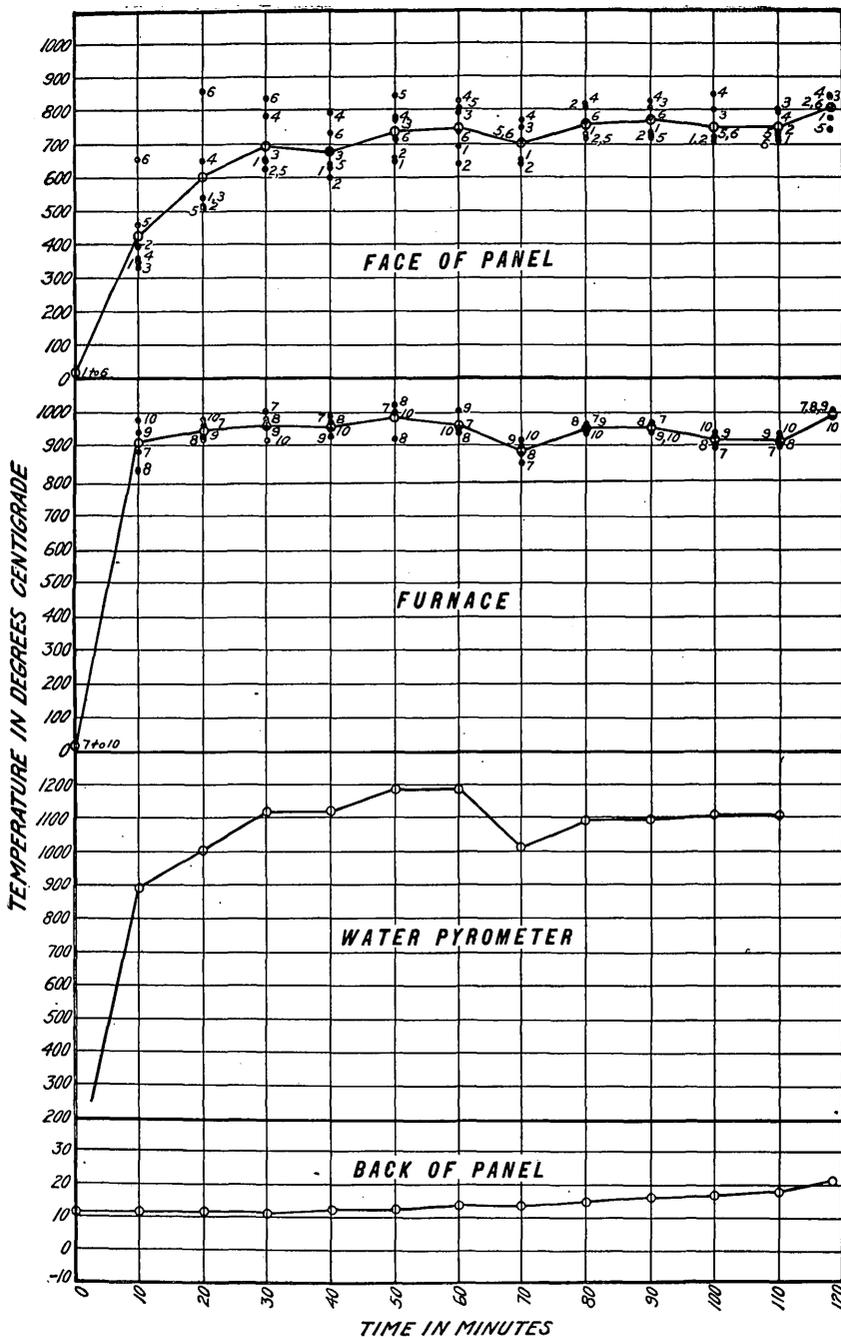
FIGURE 15.—Diagram showing temperature conditions in the furnace and at the back of panel 14. Temperature: Maximum, 51°; minimum, 46°; mean, 48°. Relative humidity: 7 a. m., 97; 7 p. m., 94. Direction of prevailing wind, northeast.

the various temperatures recorded during the test are given in figure 15.

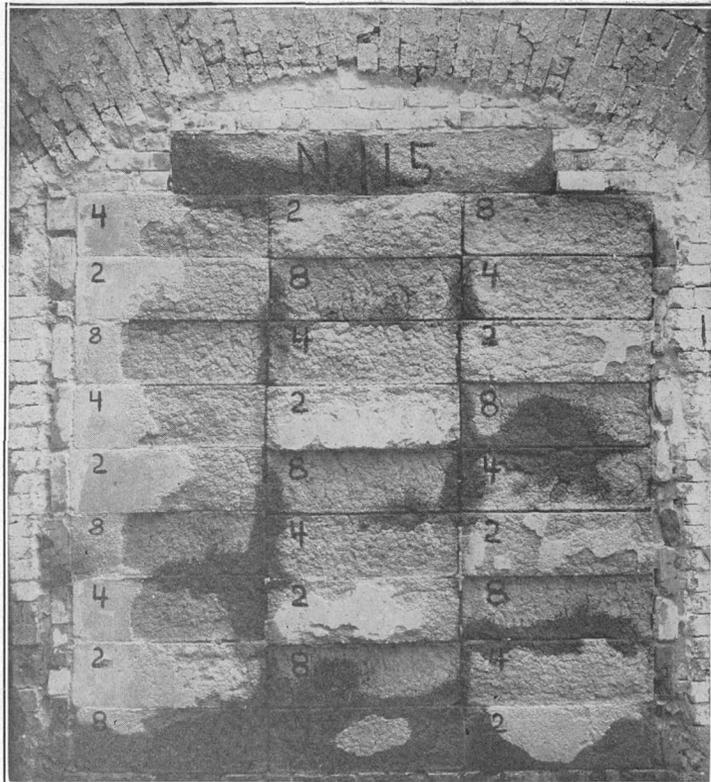
A. FACE OF PANEL 15, CEMENT MORTAR BUILDING BLOCKS, AFTER FIRING AND QUENCHING.

Plate XX, *A*, shows the face of the wall after firing, and Plate XX, *B*, shows the condition of the wall while being dismantled. On taking down the panel it was found that all the blocks except one 1:8 block had cracked across the web at the fired side. One web of this block was cracked on the fired side, while the other cracked across to the back side of the block. The faces of all the 1:8 blocks crumbled and fell to pieces when removed from the panel, and a few of the 1:4 blocks were found to be cracked through the fired side. This was also found to be the case with one of the 1:2 blocks. The portions of the blocks on the fired side were seemingly intact and hard, but on gentle tapping could be broken into very small pieces. The back surfaces and the attached webs were as hard as before the fire treatment, and there was apparently no change in their condition.

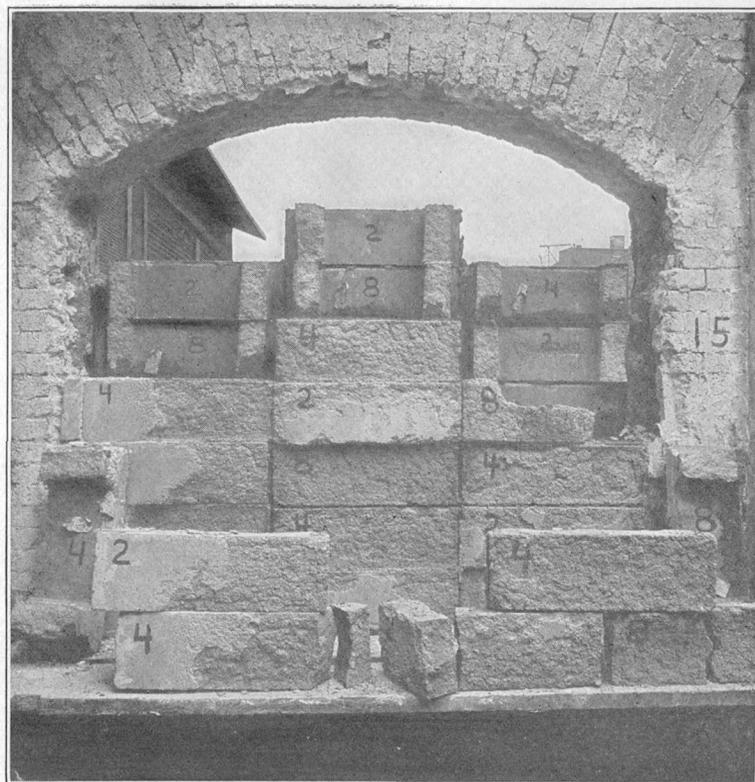
B. PANEL 15, CEMENT MORTAR BUILDING BLOCKS, DURING DISMANTLING.

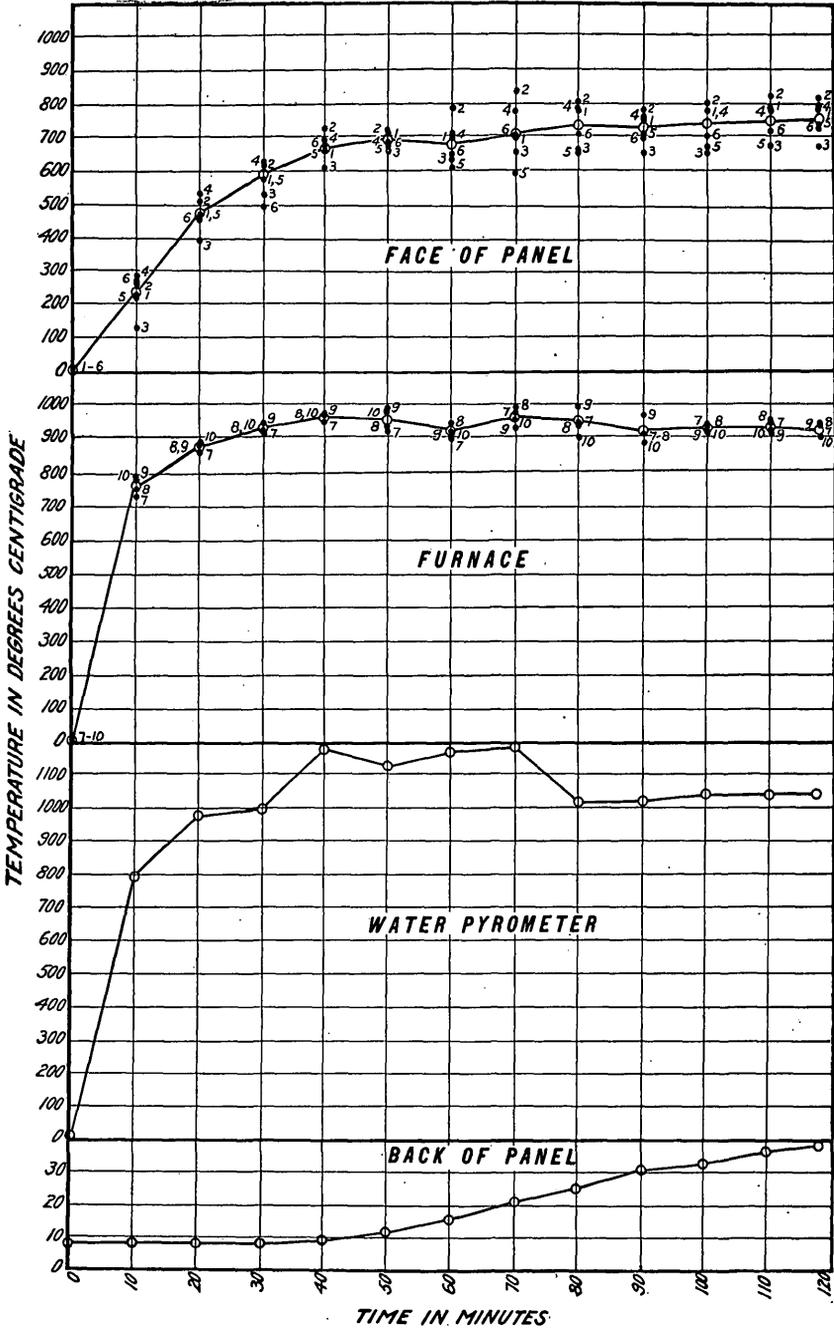
FIGURE 16.—Diagram showing temperature conditions in the furnace and on the back of panel 15. Temperature: Maximum, 52°; minimum, 38°; mean, 45°. Relative humidity: 7 a. m., 83; 7 p. m., 64. Direction of prevailing wind, northwest.

Curves showing the variations of temperature observed during the test are given in figure 16.

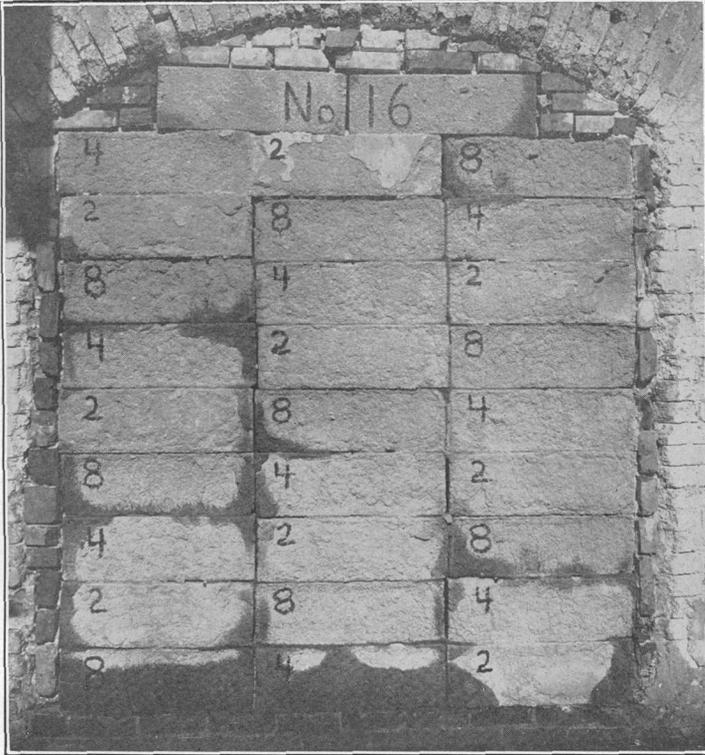
A. FACE OF PANEL 16, CEMENT MORTAR BUILDING BLOCKS, AFTER FIRING AND QUENCHING.

Plate XXI, *A*, shows the face of the panel after the test. Plate XXI, *B*, shows the panel being removed from the door. On the application of water the face of the 1:4 and 1:8 blocks spalled to the depths of $\frac{3}{4}$ to 1 inch and 1 inch to 2 inches, respectively. On two of the 1:2 mixtures part of the face was left apparently intact, but on examination it was found that this part crumbled easily in the hand. With the exception of the surface the remaining concrete was found to be quite hard. There were apparently no vertical cracks running through any of the blocks.

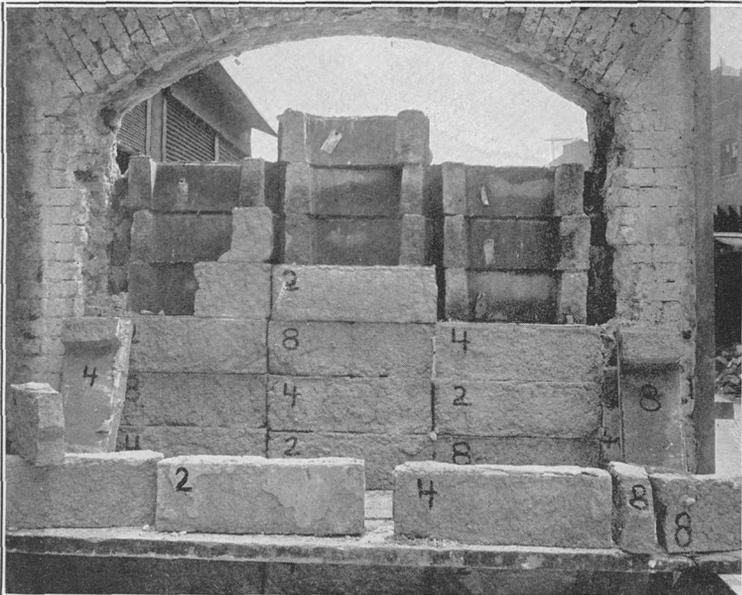
B. PANEL 16, CEMENT MORTAR BUILDING BLOCKS, DURING DISMANTLING.

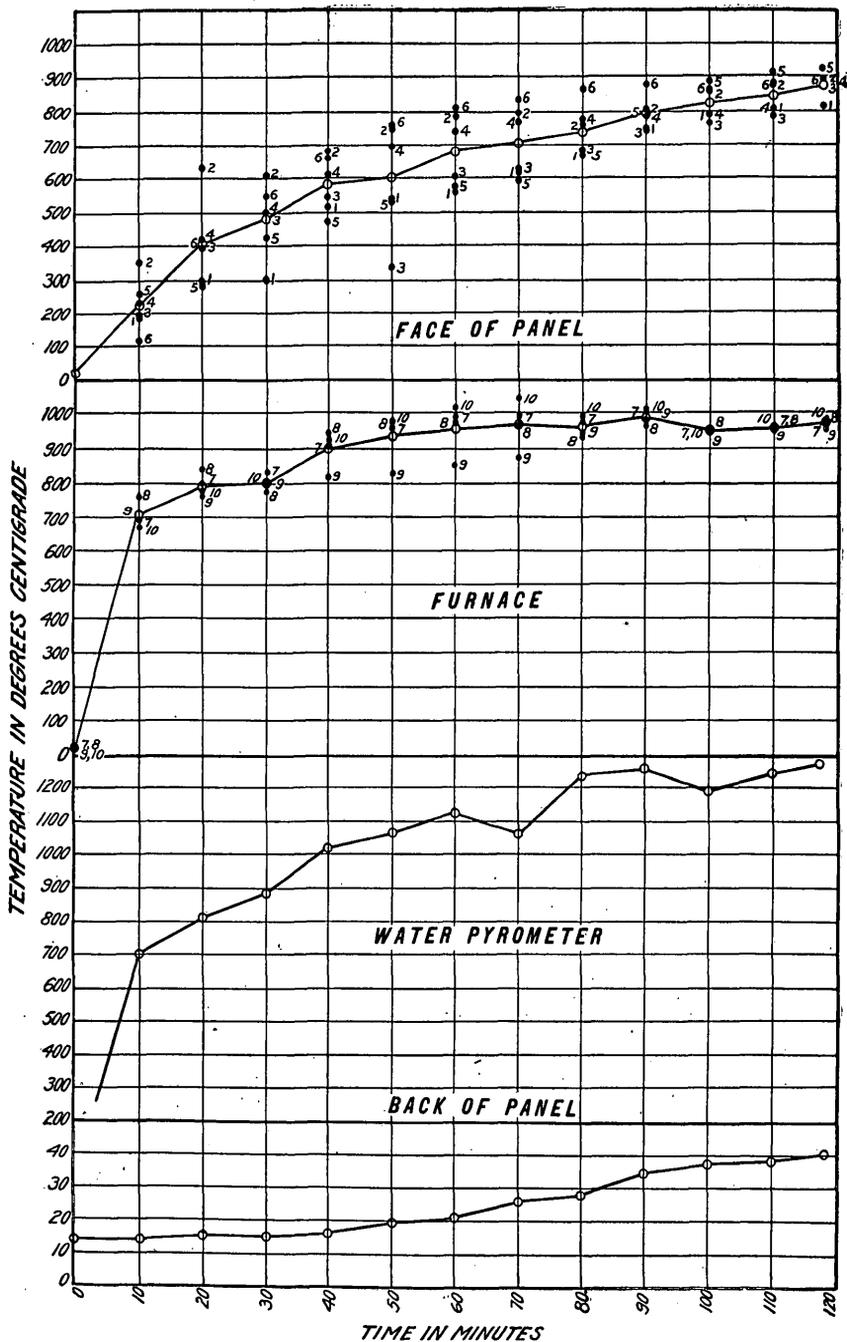
FIGURE 17.—Diagram showing temperature conditions in the furnace and on the back of panel 16. Temperature: Maximum, 65°; minimum, 45°; mean, 55°. Relative humidity: 7 a. m., 66; 7 p. m., 51. Direction of prevailing wind, southwest.

Curves showing the variations of temperature observed during the test are given in figure 17.

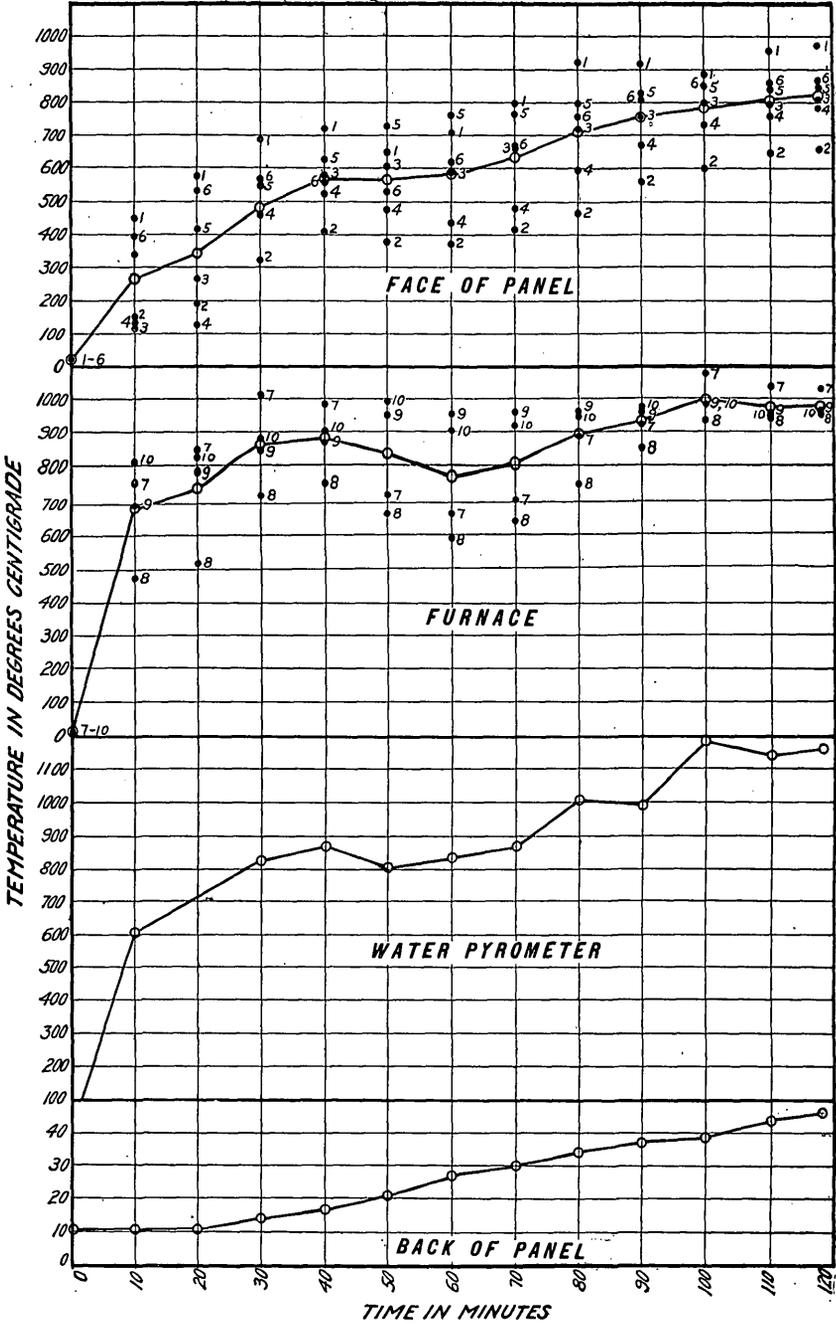
FIGURE 18.—Diagram showing temperature conditions in the furnace and on the back of panel 17. Temperature: Maximum, 56°; minimum, 50°; mean, 53°. Relative humidity: 7 a. m., 94; 7 p. m., 100. Direction of prevailing wind, northeast.

Curves showing the variations of temperature observed during the test are given in figure 18.

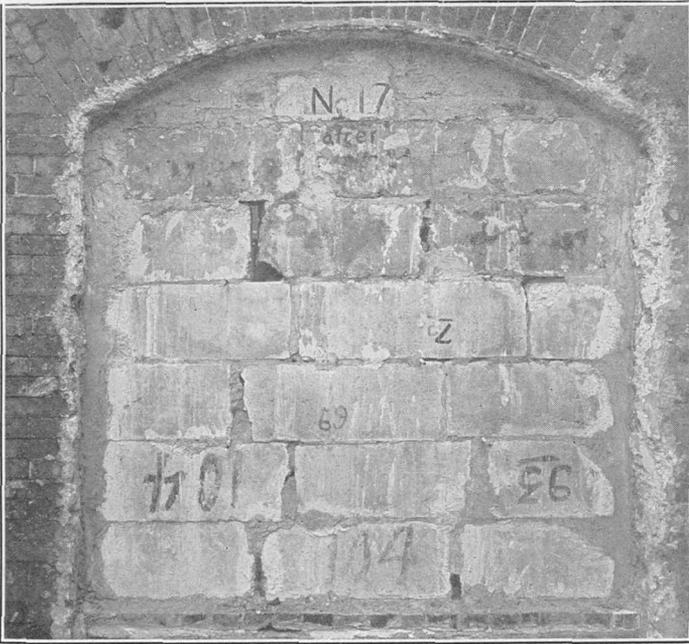
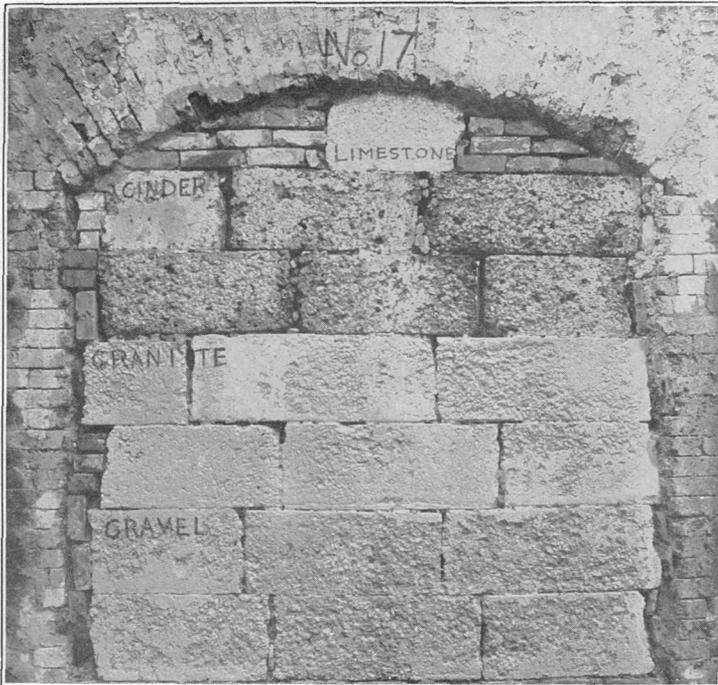
A. BACK OF PANEL 17, CONCRETE WITH DIFFERENT AGGREGATES, AFTER FIRING AND QUENCHING.

B. FACE OF PANEL 17, CONCRETE WITH DIFFERENT AGGREGATES, AFTER FIRING AND QUENCHING.

Plate XXII shows the face and the back after quenching.

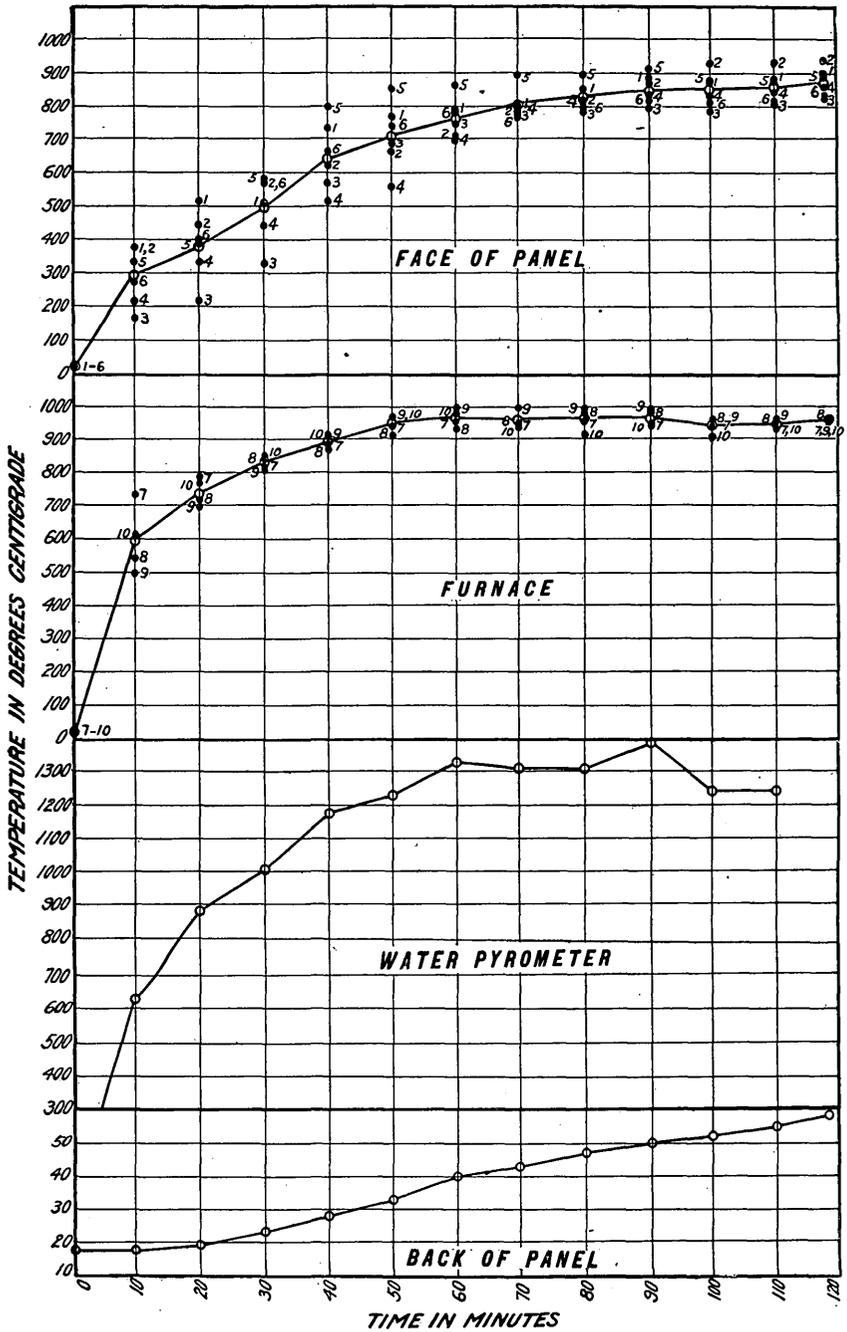
FIGURE 19.—Diagram showing temperature conditions in the furnace and on the back of panel 18. Temperature: Maximum, 79°; minimum, 58°; mean, 68°. Relative humidity: 7 a. m., 78; 7 p. m., 79. Direction of prevailing wind, southeast.

Curves showing the variations in temperature observed during the test are given in figure 19.

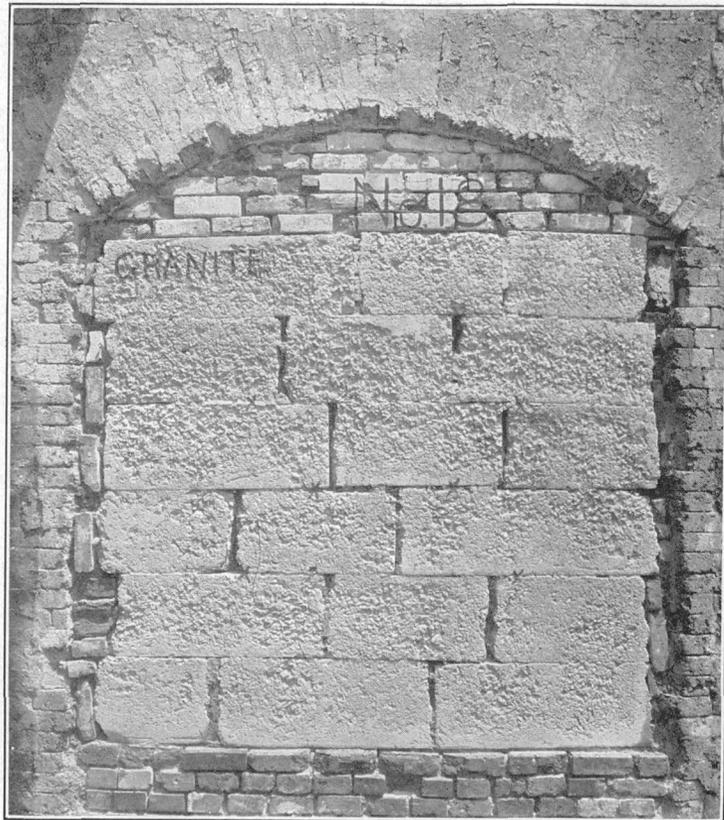
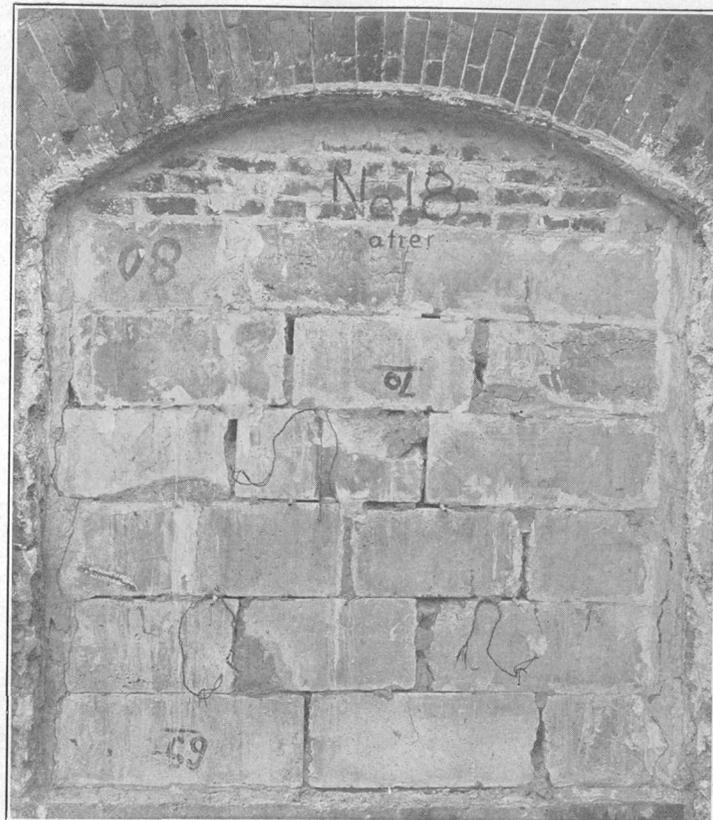
A. FACE OF PANEL 18, GRANITE CONCRETE, AFTER FIRING AND QUENCHING.

B. BACK OF PANEL 18, GRANITE CONCRETE, AFTER FIRING AND QUENCHING.

Plate XXIII, *A* and *B*, shows the face and back of the panel after firing.

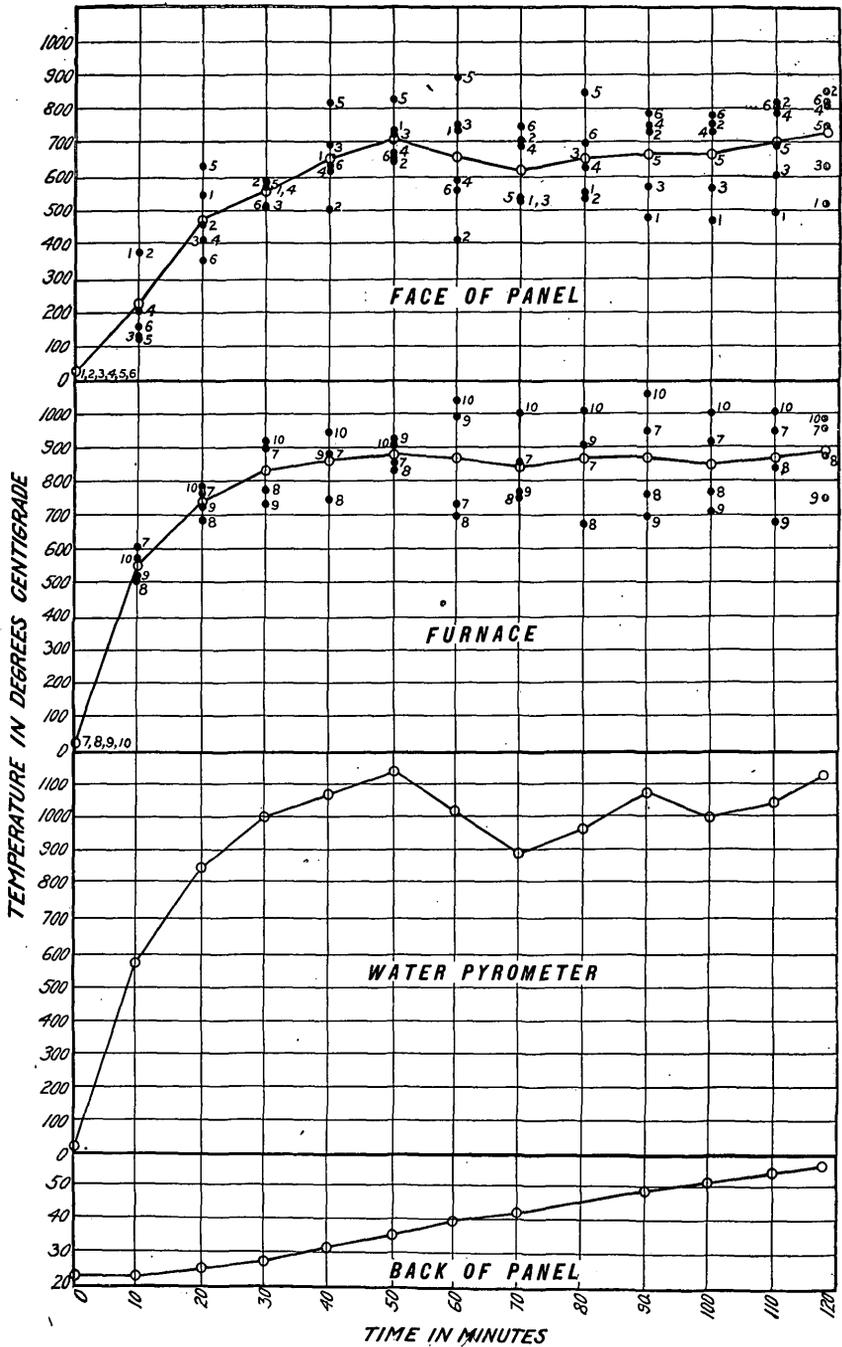
FIGURE 20.—Diagram showing temperature conditions in the furnace and on the back of panel 19. Temperature: Maximum, 78°; minimum, 59°; mean, 68°. Relative humidity: 7 a. m., 75; 7 p. m., 96. Direction of prevailing wind, west.

Curves showing the variations in temperature observed during the test are given in figure 20.

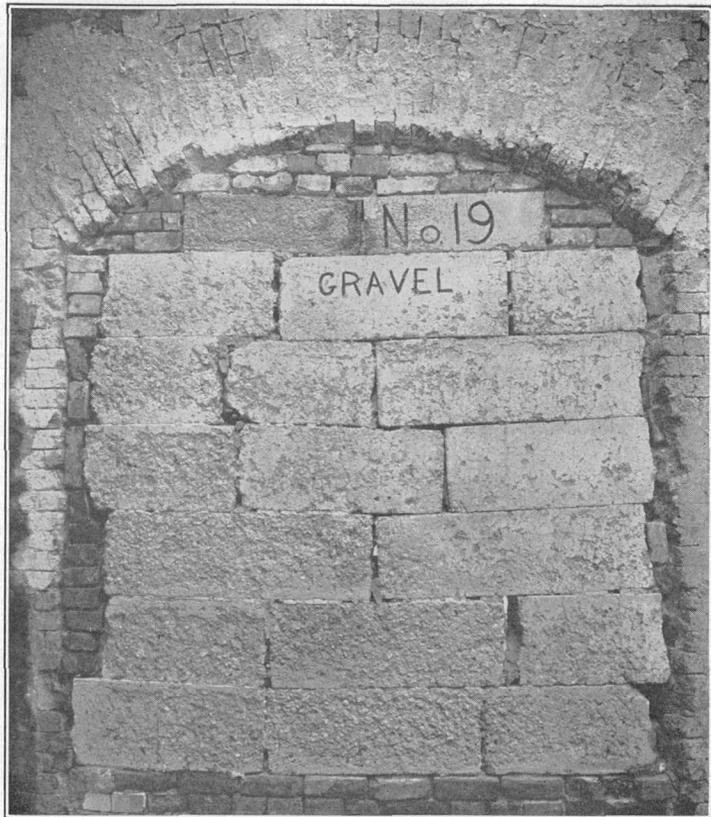
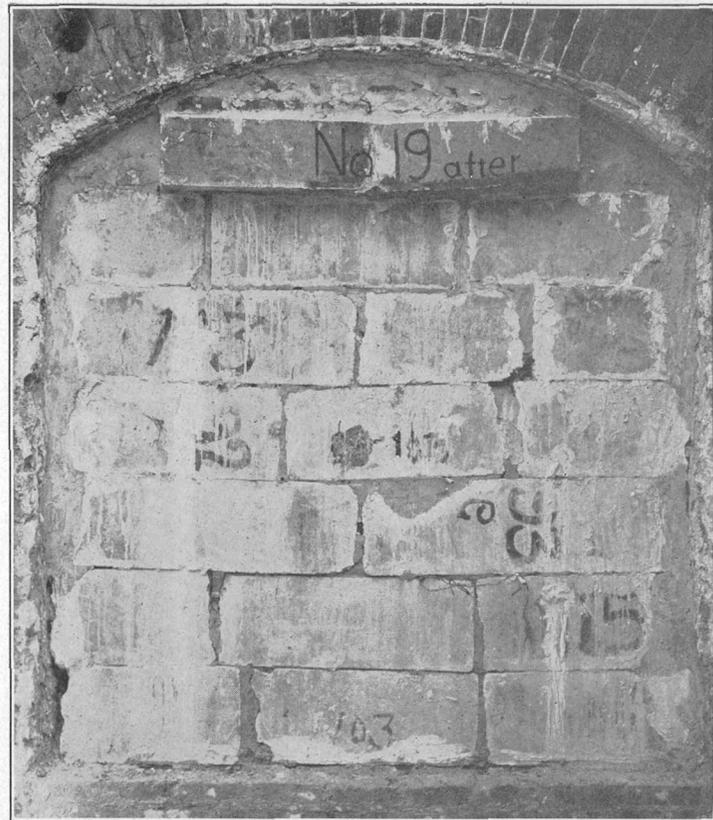
A. FACE OF PANEL 19, GRAVEL CONCRETE, AFTER FIRING AND QUENCHING.

B. BACK OF PANEL 19, GRAVEL CONCRETE, AFTER FIRING AND QUENCHING.

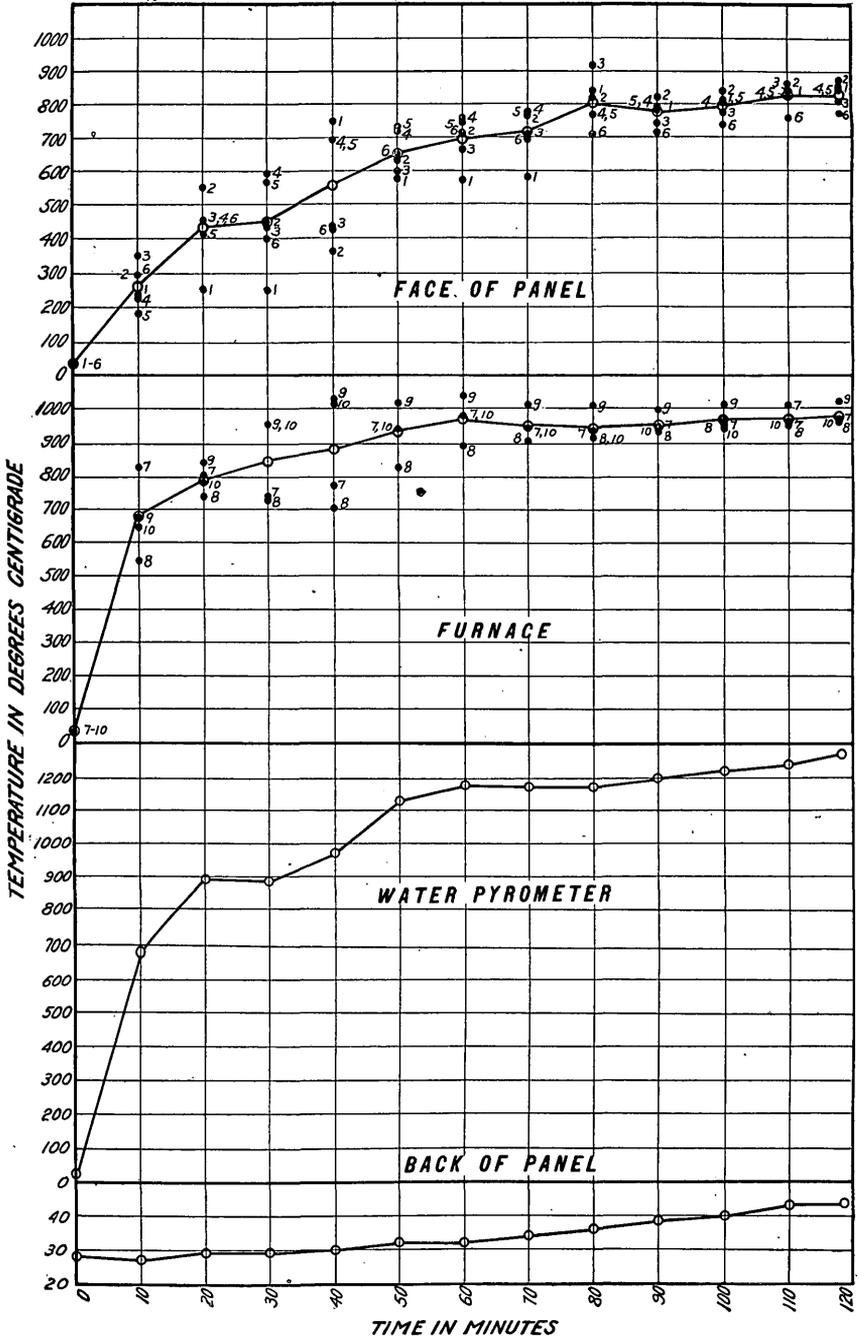
FIGURE 21.—Diagram showing temperature conditions in the furnace and on the back of panel 20. Temperature: Maximum, 91°; minimum, 70°; mean, 80°. Relative humidity: 7 a. m., 58; 7 p. m., 41. Direction of prevailing wind, southwest.

Curves showing the variations in temperature observed during the test are given in figure 21.
