DEPARTMENT OF THE INTERIOR
UNITED STATES GEOLOGICAL SURVEY

BULLETIN 370

THE FIRE-RESISTIVE PROPERTIES OF
VARIOUS BUILDING MATERIALS

RICHARD L. HUMPHREY

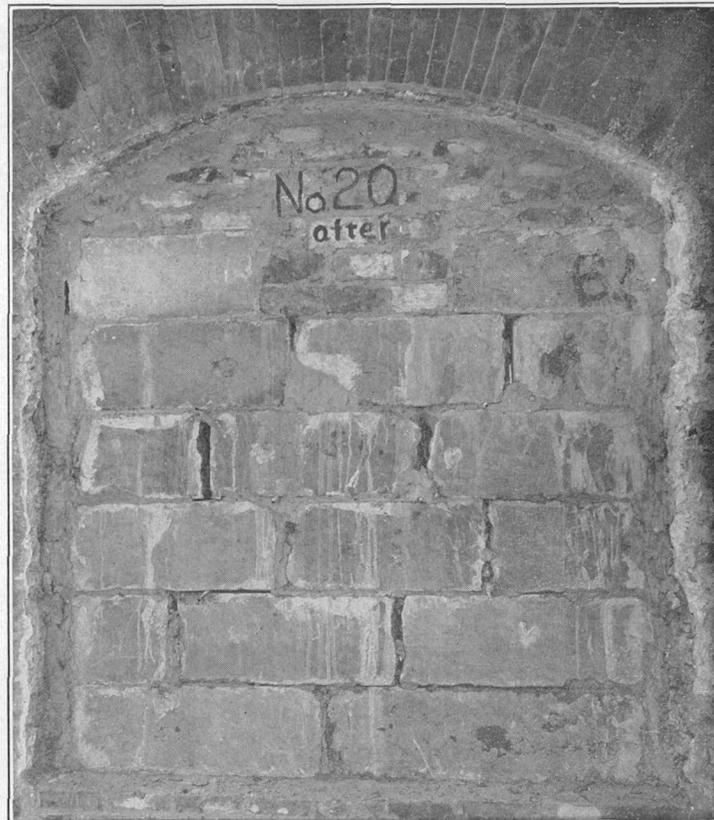
A. FACE OF PANEL 20, CINDER CONCRETE, AFTER FIRING AND QUENCHING.

B. BACK OF PANEL 20, CINDER CONCRETE, AFTER FIRING AND QUENCHING.

Plate XXV, *A* and *B*, shows the face and back of the panel after testing. A few vertical cracks running back from the face of the beams were not very regular and did not open up readily when

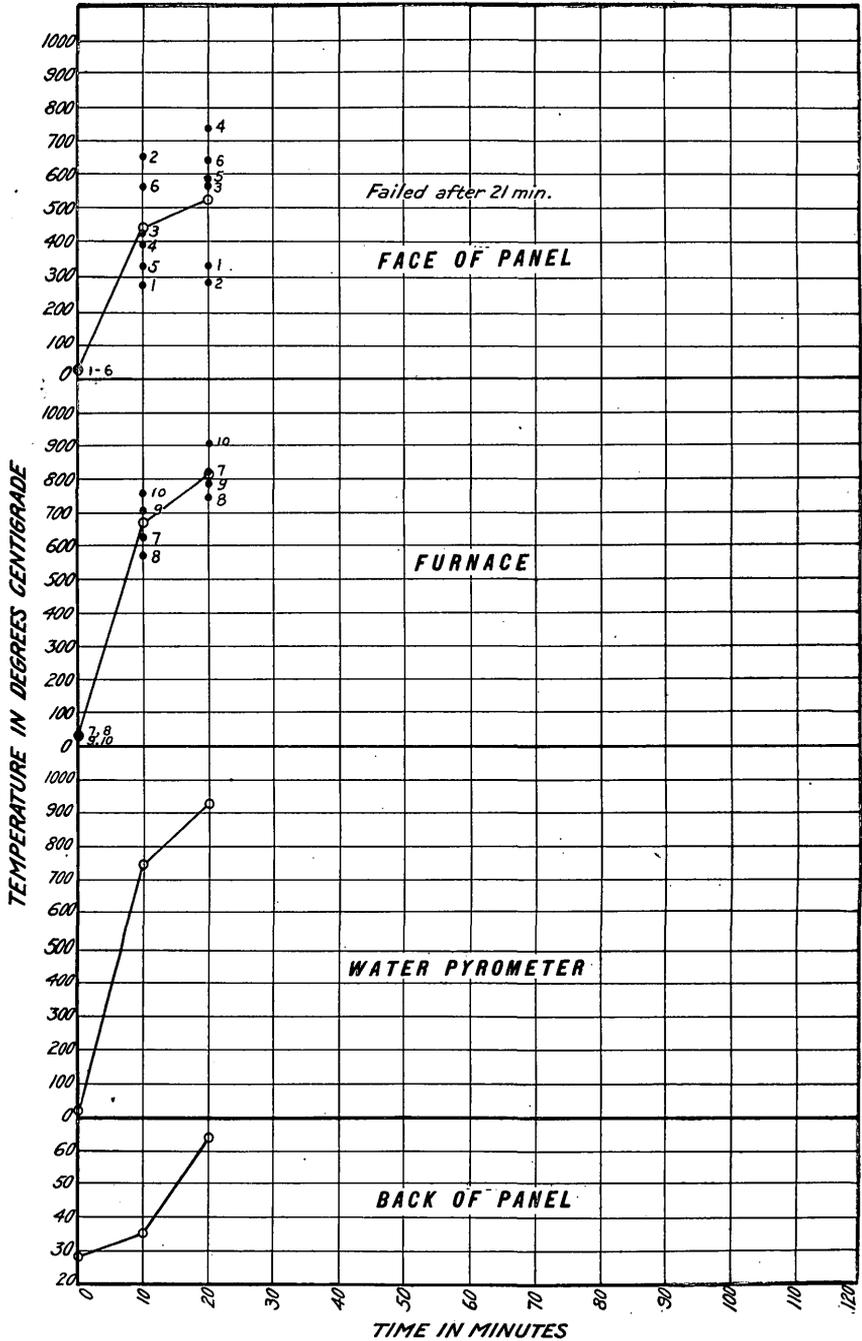
FIGURE 22.—Diagram showing temperature conditions in the furnace and on the back of panel 21. Temperature: Maximum, 88°; minimum, 67°; mean, 78°. Relative humidity: 7 a. m., 73; 7 p. m., 63. Direction of prevailing wind, southwest.

Curves showing the variations in temperature observed during the test are given in figure 22.

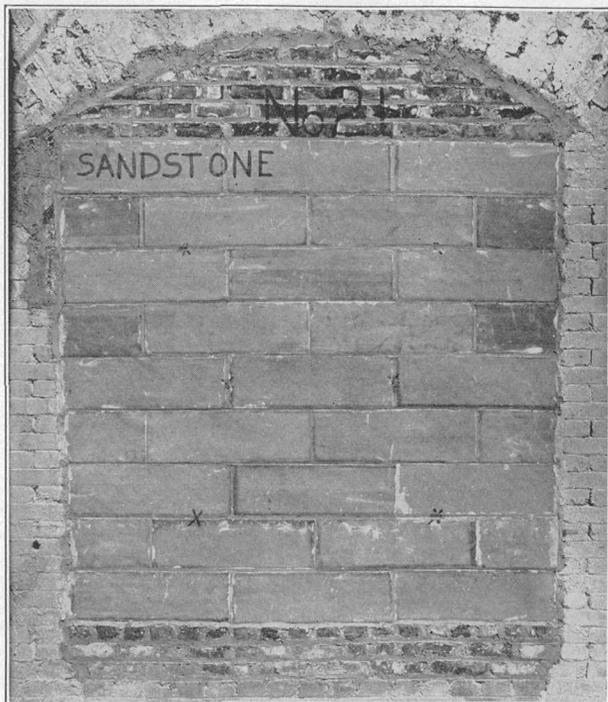
A. FACE OF PANEL 21, DRESSED SANDSTONE, BEFORE FIRING.

along the bedding of the stone, and also in lines vertical to this direction. No irregular hair cracks were observed. Plate XXVI, *A*, shows the face before testing. Plate XXVI, *B*, shows the wall after its collapse.

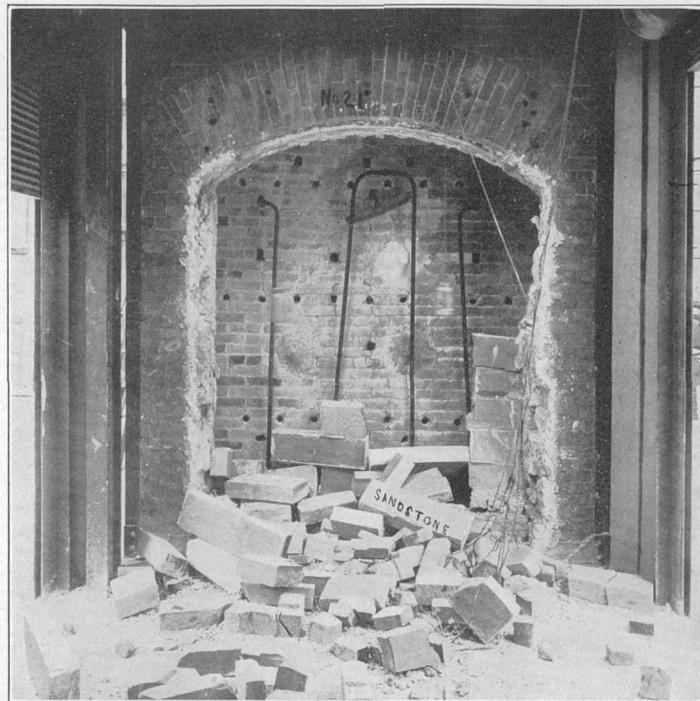
B. PANEL 21, DRESSED SANDSTONE, AFTER COLLAPSE.

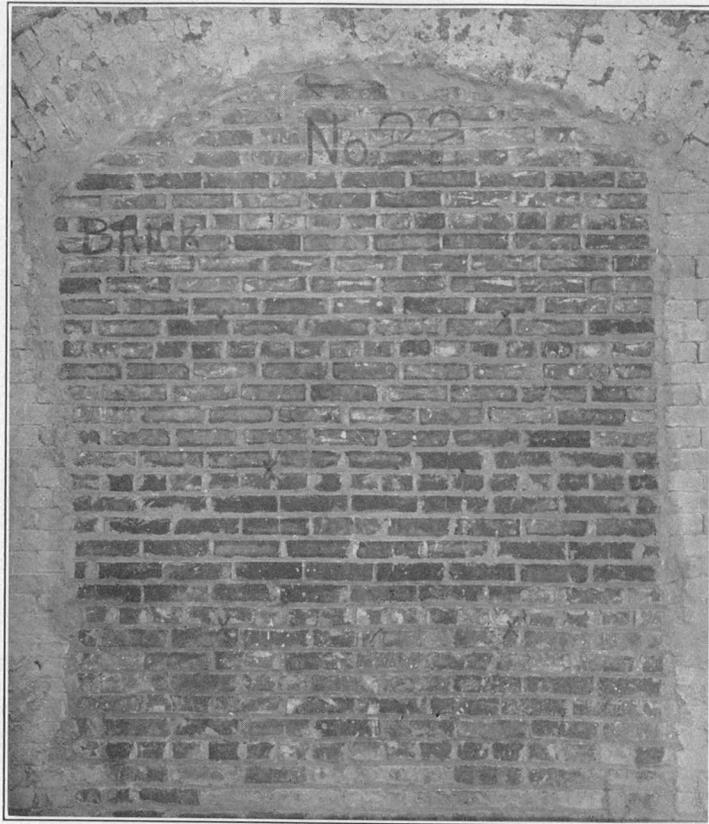
A. FACE OF PANEL 22, COMMON BRICK, BEFORE FIRING.

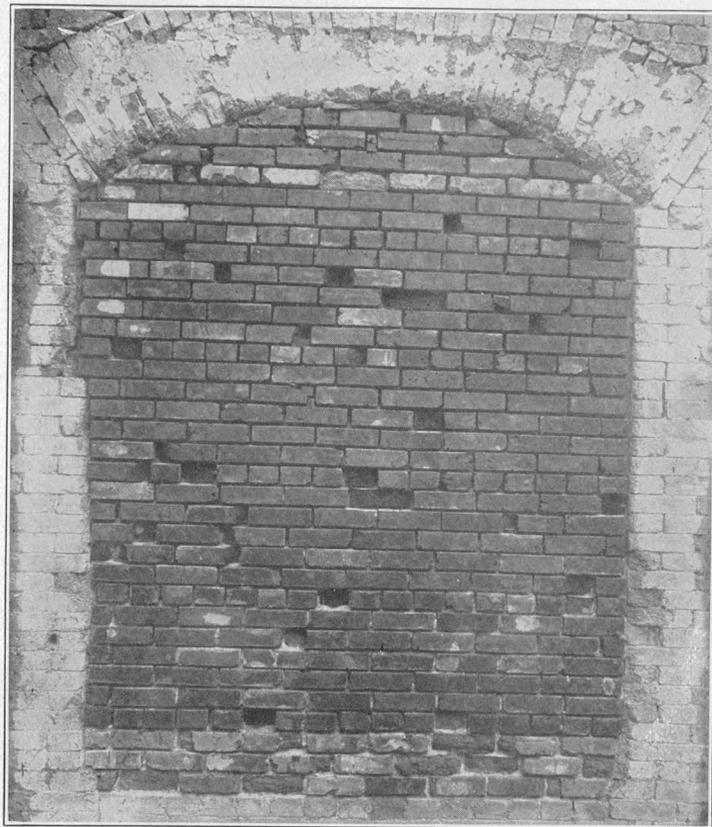
B. FACE OF PANEL 22, COMMON BRICK, AFTER FIRING AND QUENCHING.

Results.—About 15 per cent of the faces of the brick cracked and washed off during the application of the water. After cooling, it was found that about 50 per cent of the faces were cracked and were easily pulled off with the fingers, or by prying gently with a screw-driver. The headers which seemed most damaged were split back about 1 inch. Some were cracked to a depth of $2\frac{1}{2}$ inches. The faces of all the bricks were checked and cracked, and wherever a piece fell out it was usually about 1 inch in thickness. The entire wall was discolored to a depth of about 1 inch, the faces of the bricks turning almost black. The bricks on the back of the wall were apparently uninjured, no cracks being observed in any of them.

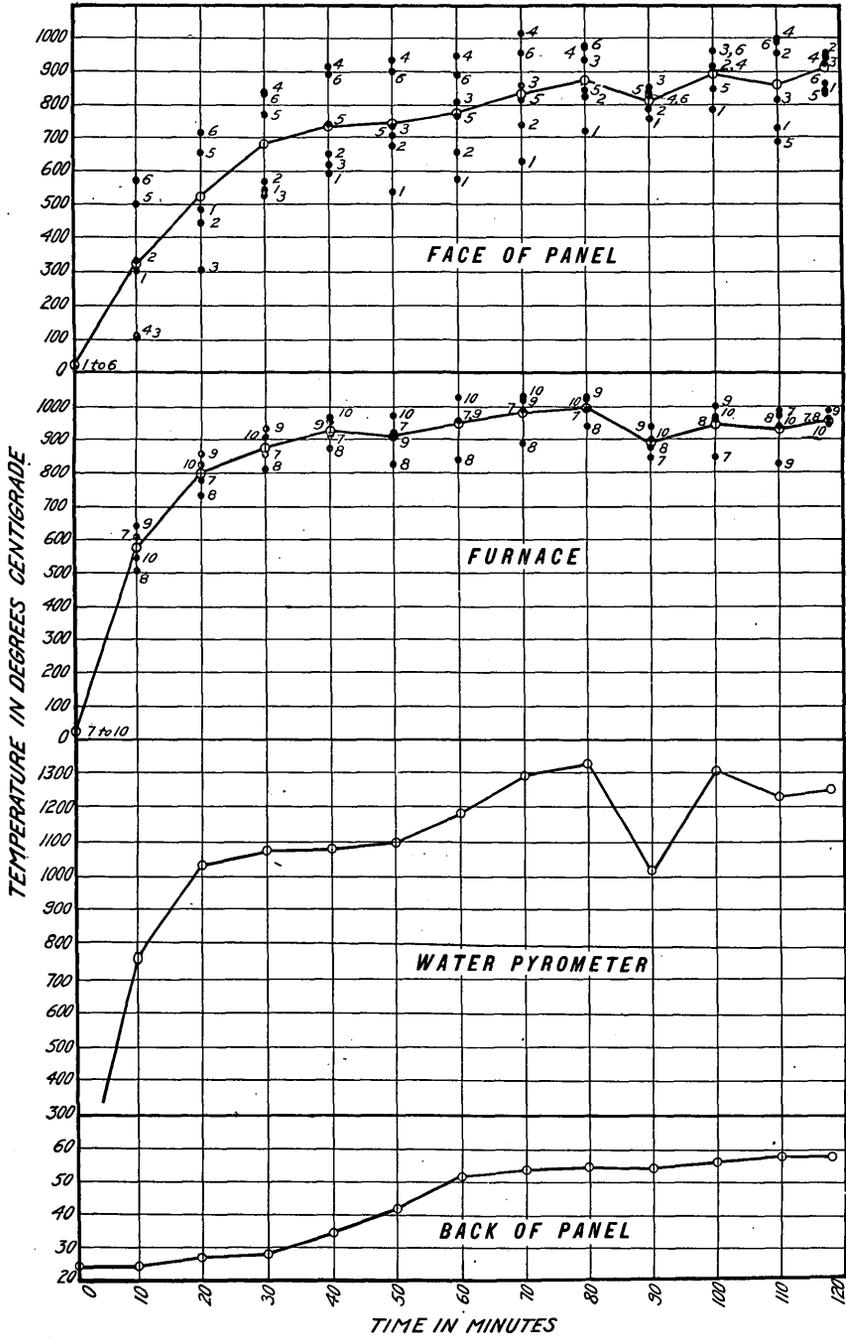
FIGURE 23.—Diagram showing temperature conditions in the furnace and on the back of panel 22. Temperature: Maximum, 80°; minimum, 69°; mean, 74°. Relative humidity: 7 a. m., 90; 7 p. m., 63. Direction of prevailing wind, southwest.

Curves showing the variations in temperature observed during the test are given in figure 23.

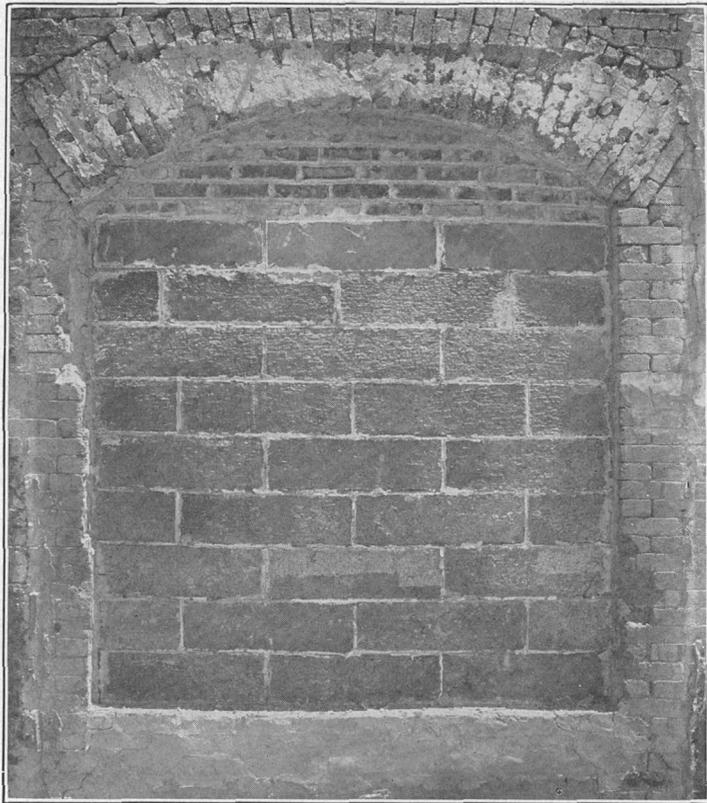
A. FACE OF PANEL 23, DRESSED GRANITE, AFTER FIRING BUT BEFORE QUENCHING.

Plate XXVIII, *A*, shows the face of the panel after firing but before quenching. Plate XXVIII, *B*, shows the face after firing and quenching. Plate XXIX, *A*, shows the condition of the stone on being removed from the furnace.

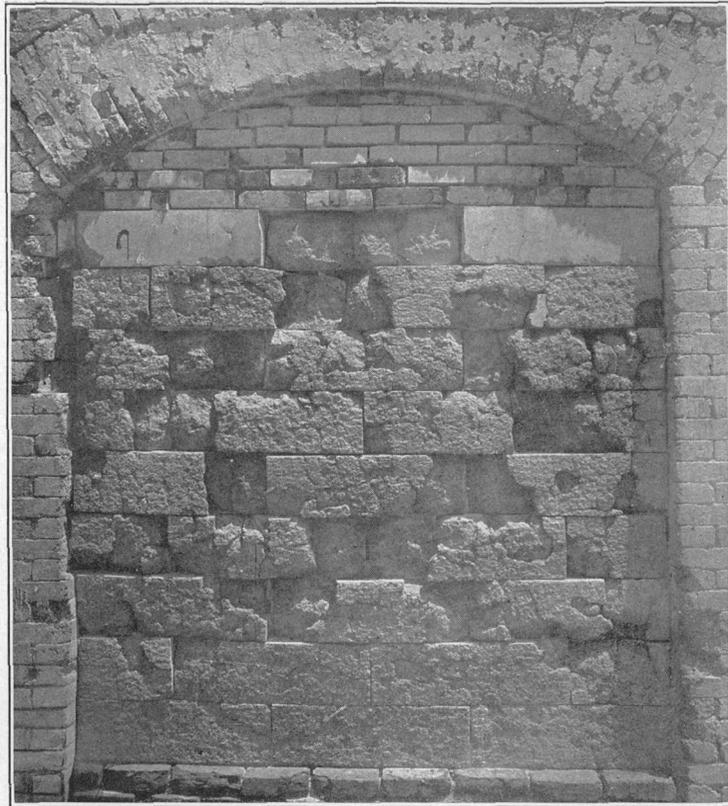
B. FACE OF PANEL 23, DRESSED GRANITE, AFTER FIRING AND QUENCHING.

Results.—After the water treatment the panel was $2\frac{3}{4}$ inches out of plumb. The stones on the face were of a reddish-gray color and were very badly cracked, and the surface that remained intact could be easily crumbled in the fingers. The portions back about 1 inch to $1\frac{1}{2}$ inches from the face which had been uncovered were more or less hard, but badly split and spalled. The back of the panel was also changed in color, but not so much as the face.

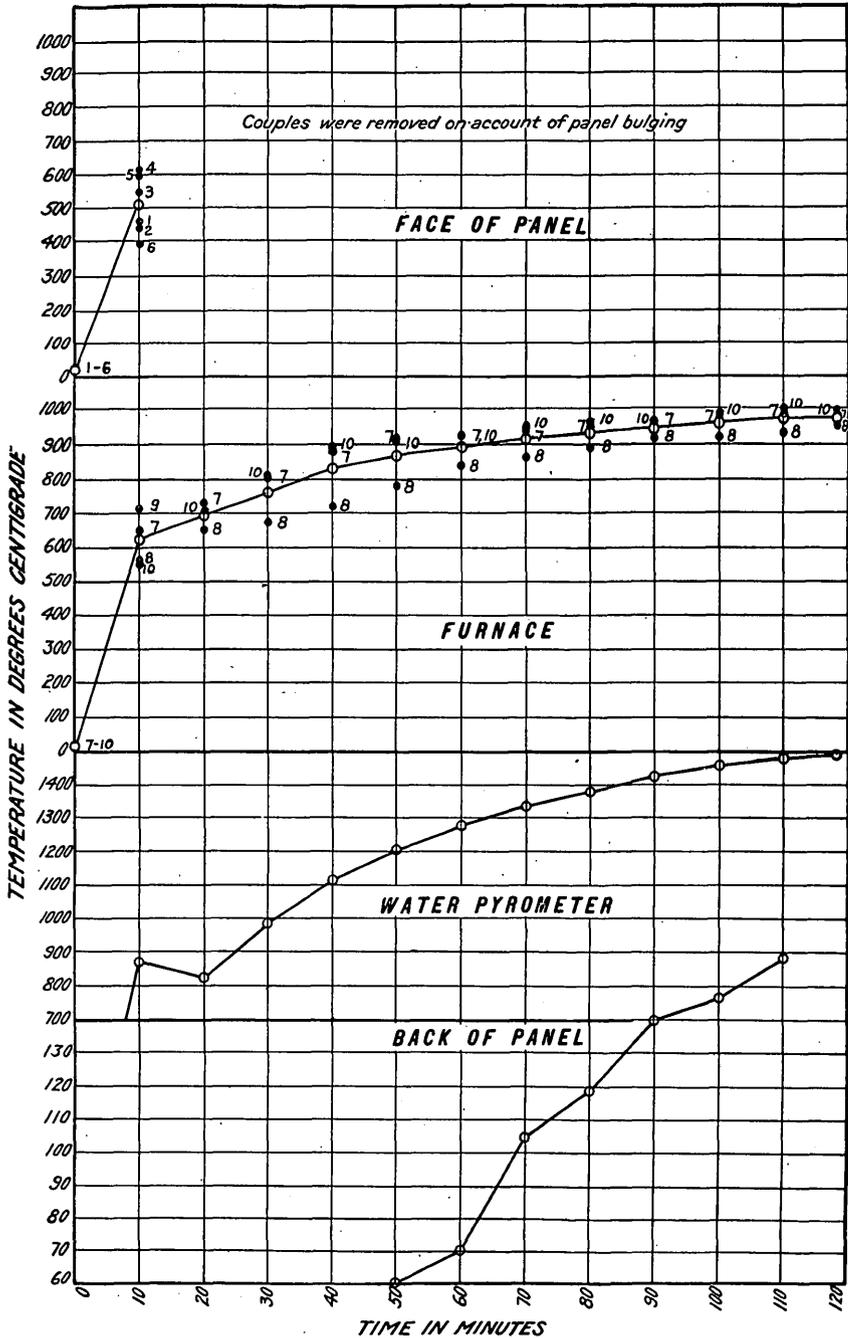
FIGURE 24.—Diagram showing temperature conditions in the furnace and on the back of panel 23. Temperature: Maximum, 69°; minimum, 59°; mean, 64°. Relative humidity: 7 a. m., 73; 7 p. m., 74. Direction of prevailing wind, northwest.

Curves showing the variations in temperature observed during the test are given in figure 24.

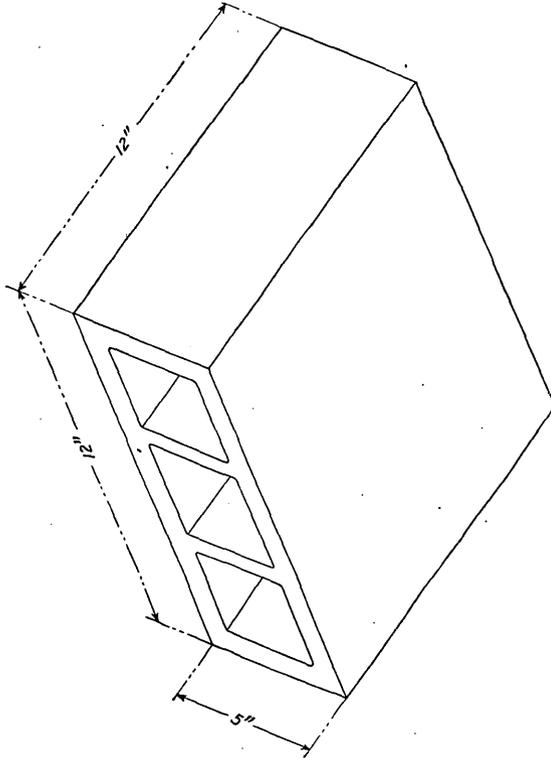
FIGURE 25.—Sketch of partition tile used in panel 24.

Material.—The material composing panel 24 was 5 by 12 by 12 inch partition tile, having three air spaces (fig. 25). The tiles were laid as a standard 5-inch partition wall with about $\frac{1}{2}$ -inch cement-mortar joints, having the core holes in a vertical position and broken joints. The face and back were plastered with a coat, about $\frac{1}{2}$ inch thick, of

Material.—The material composing panel 30 was 5 by 12 by 12 inch partition tile, having three air spaces (fig. 25). The tiles were laid in cement mortar, with about $\frac{1}{2}$ -inch joints, as a 5-inch partition. They were laid with the core holes vertical and the joints broken. The face of the panel was plastered with ordinary lime plaster containing a little plaster of paris and also some hair, the coating being about $\frac{1}{2}$ inch thick. No hardening coat was put on this panel, as it had been found seriously to interfere with the operation of the furnace by falling into the burners.

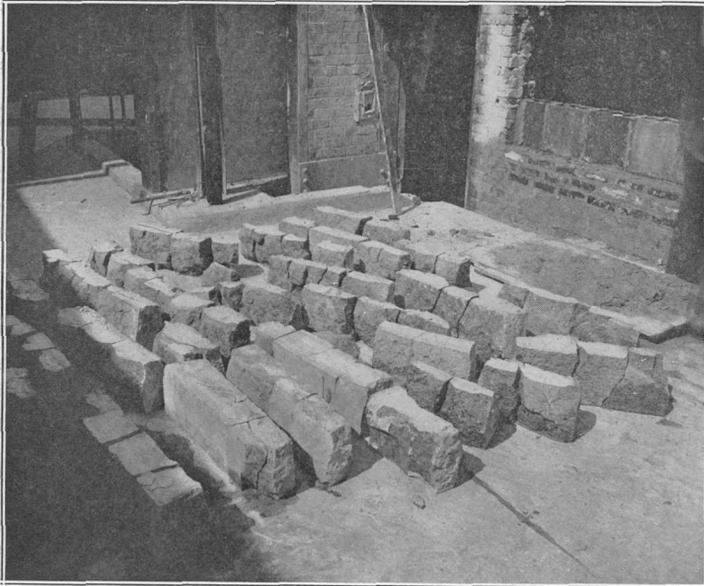
A. CONDITION OF DRESSED GRANITE ON REMOVAL FROM PANEL 23.

On taking down the panel it was found that all the pieces were very badly cracked, both across the stones and in a plane parallel to the face. The blocks were as a rule broken into pieces about 4 to 8 inches long. The back sides of the stones were found to be badly cracked in every direction, and by gentle tapping with the hammer could be broken into fragments.

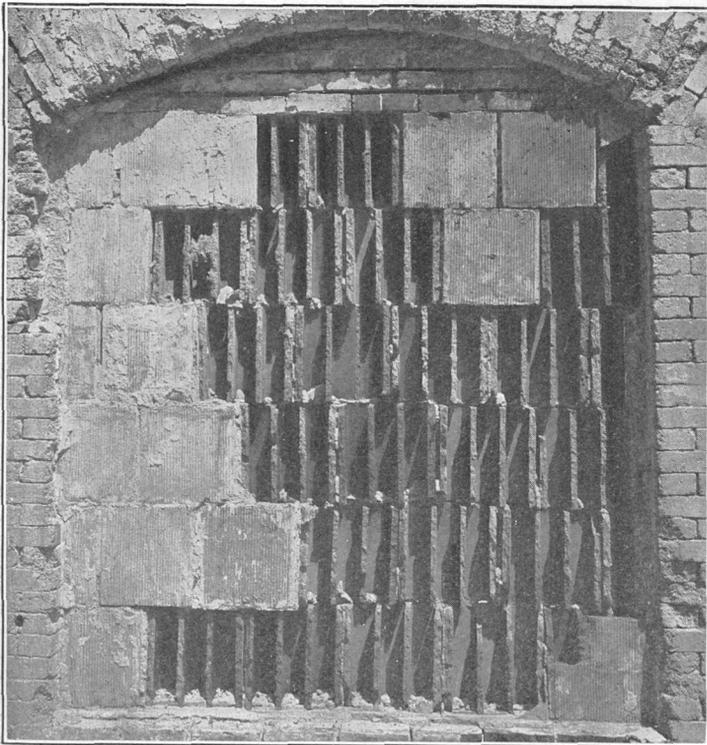
B. FACE OF PANEL 24, PARTITION TILE, AFTER FIRING AND QUENCHING.

After removing the door from the furnace it was found that about 75 per cent of the faces of the tiles of the entire panel had been washed away or would come off by gently tapping with the handle of a light screw-driver. The remaining 25 per cent were badly cracked, but were apparently rigidly attached to the back part of the tile. The faces remaining in place were very badly cracked, and could be easily broken in the hand.

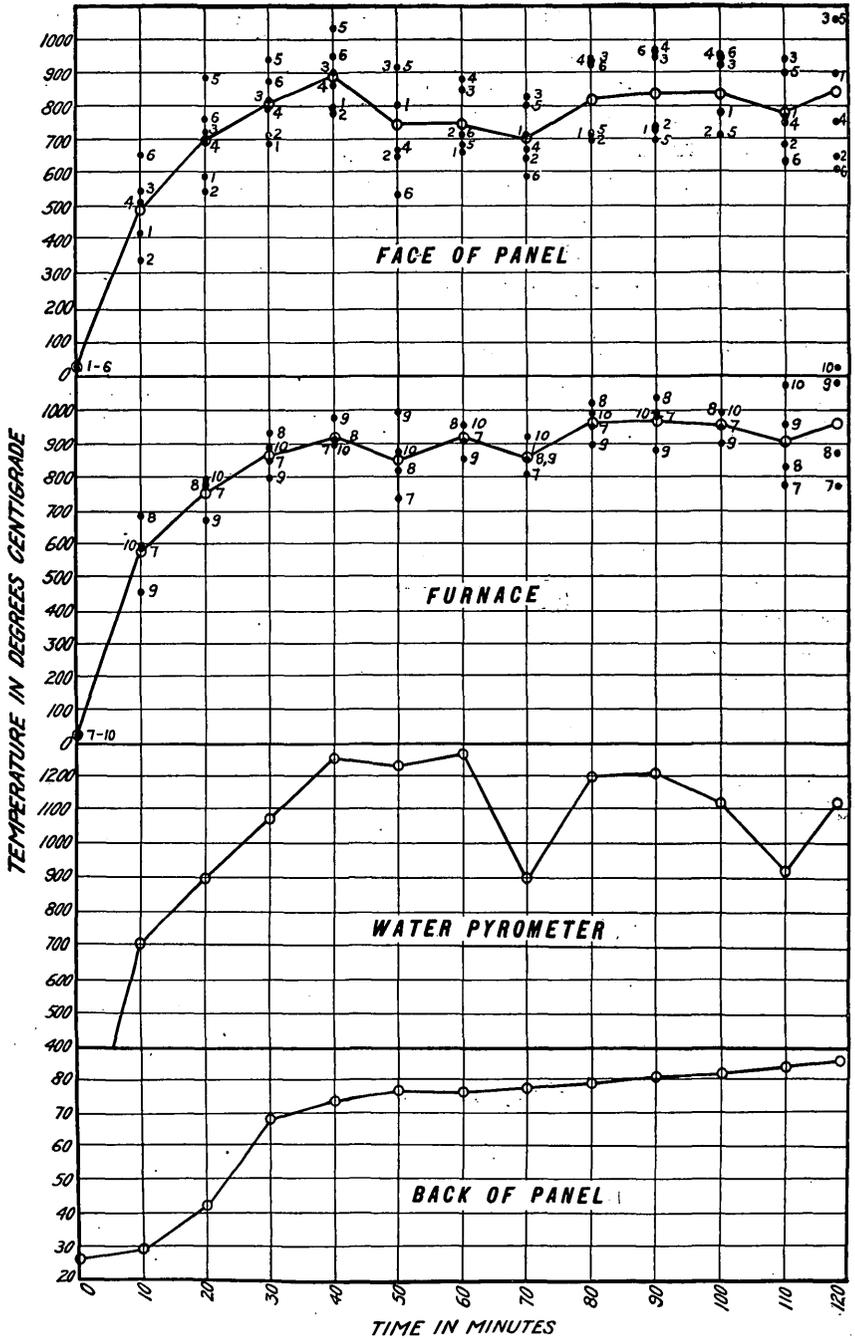
FIGURE 26.—Diagram showing temperature conditions in the furnace and on the back of panel 24. Temperature: Maximum, 83°; minimum, 61°; mean, 72°. Relative humidity: 7 a. m., 91; 7 p. m., 69. Direction of prevailing wind, northwest.

Curves showing the variations in temperature observed during the test are given in figure 26.

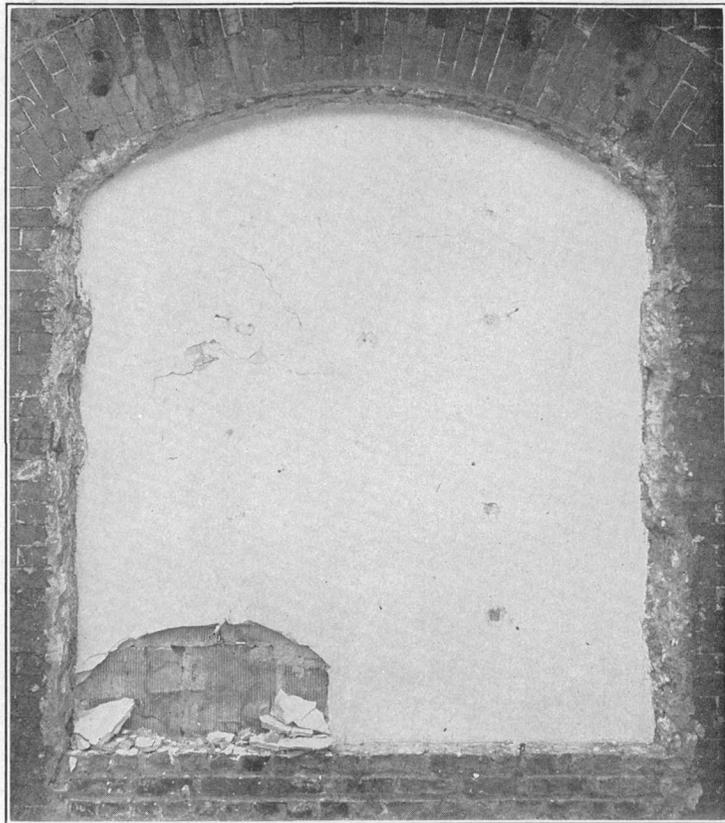
A. BACK OF PANEL 24, PARTITION TILE, AFTER FIRING AND QUENCHING.

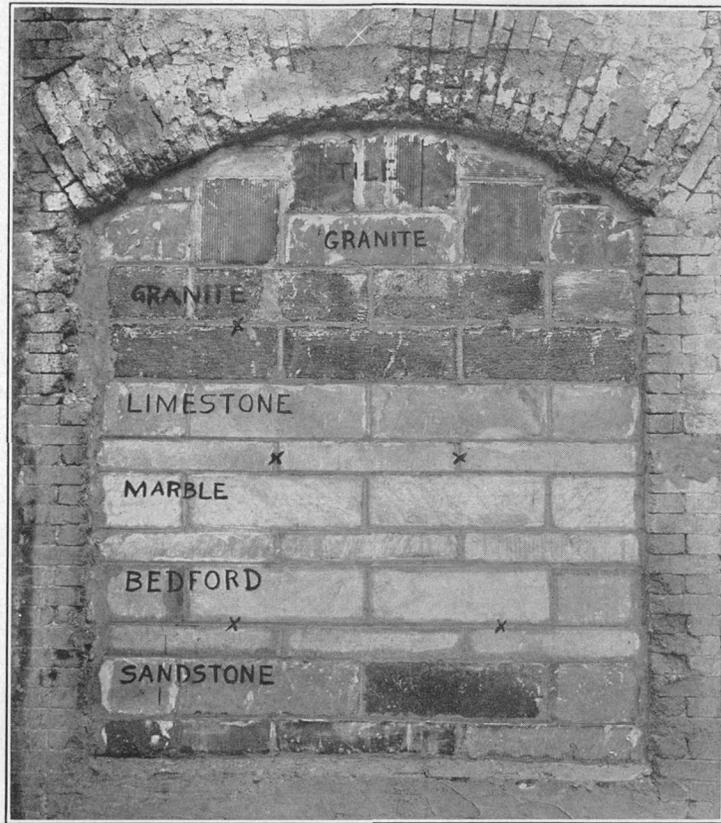
B. FACE OF PANEL 25, VARIOUS BUILDING STONES, BEFORE FIRING.

The top layers of the panel were filled in with hollow terra-cotta tile in order to make the panel as light as possible. There were two courses of each kind of stone, laid in cement mortar with broken joints. One course of the limestone and one of the sandstone was laid on the natural bed; the other had the plane of the natural bed exposed to the fire. In one course the exposed face of each block was $7\frac{3}{4}$ inches long and in the other $4\frac{1}{2}$ inches. The panel was backed up with common brick to make it less liable to collapse during the test.

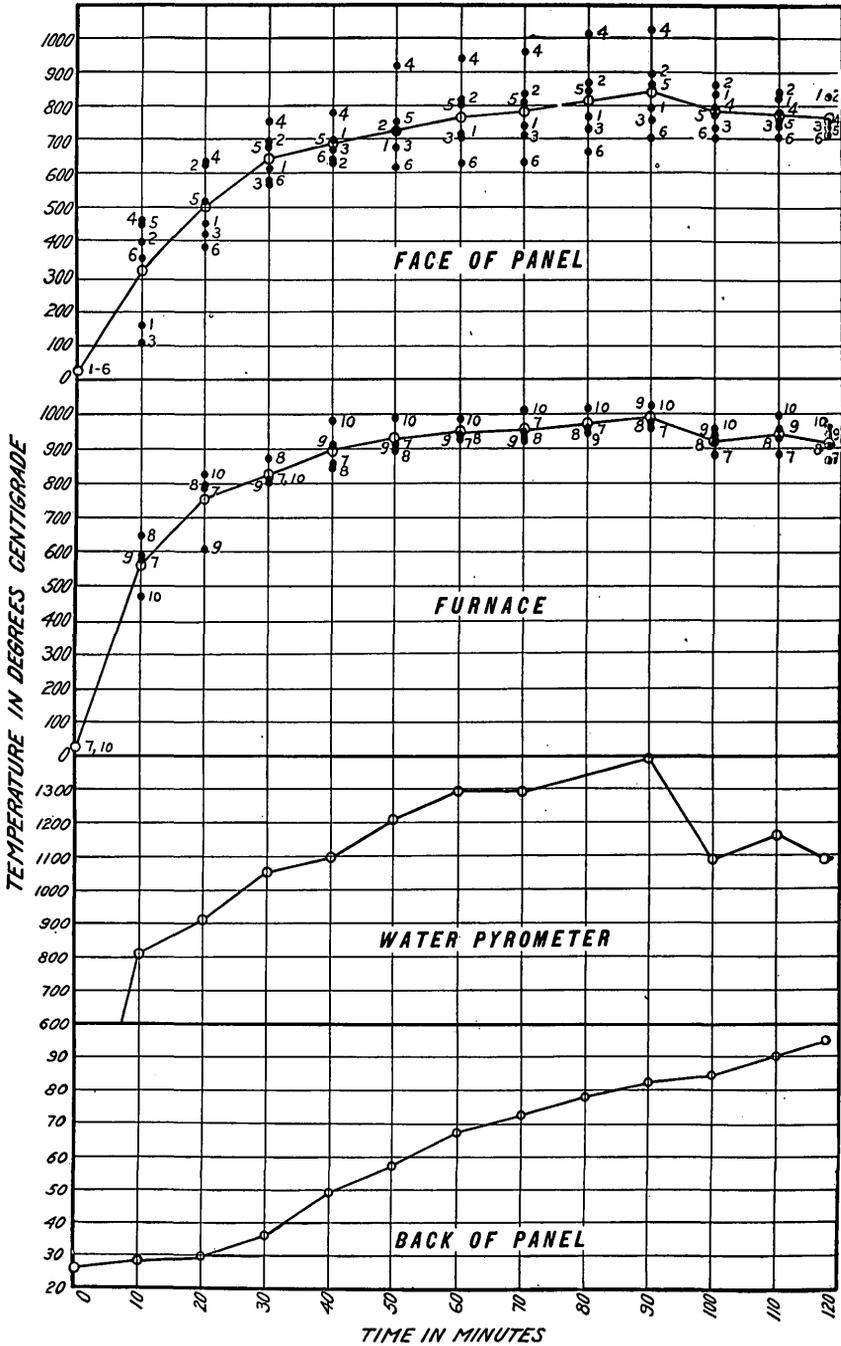
FIGURE 27.—Diagram showing temperature conditions in the furnace and on the back of panel 25. Temperature: Maximum, 83°; minimum, 61°; mean, 72°. Relative humidity: 7 a. m., 91; 7 p. m., 69. Direction of prevailing wind, northwest.

Curves showing the variations in temperature observed during the test are given in figure 27.

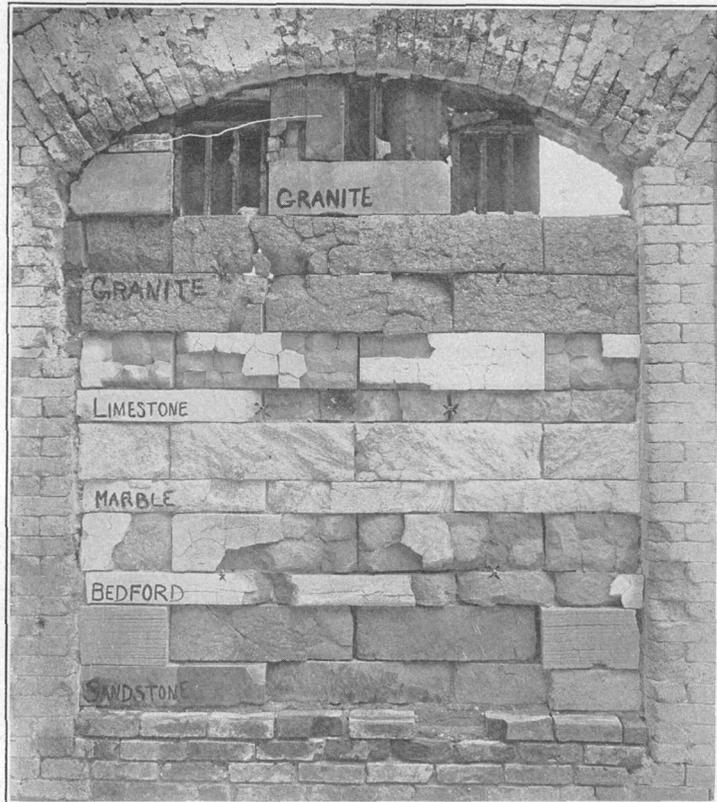
A. FACE OF PANEL 25, VARIOUS BUILDING STONES WITH BRICK BACKING, AFTER TESTING.

Results.—On removal of the panel it was found that the granite was badly spalled and cracked, but the face was still intact. The faces of the limestone were intact but very white, except the piece which fell out, before noted. The marble was very badly calcined and the face chalky white; no cracks were visible, and the entire face was intact. The Bedford limestone was badly cracked and the face considerably calcined. The sandstone showed deep seams in the pieces that were lying on their natural bed, and the other stones were more or less spalled.

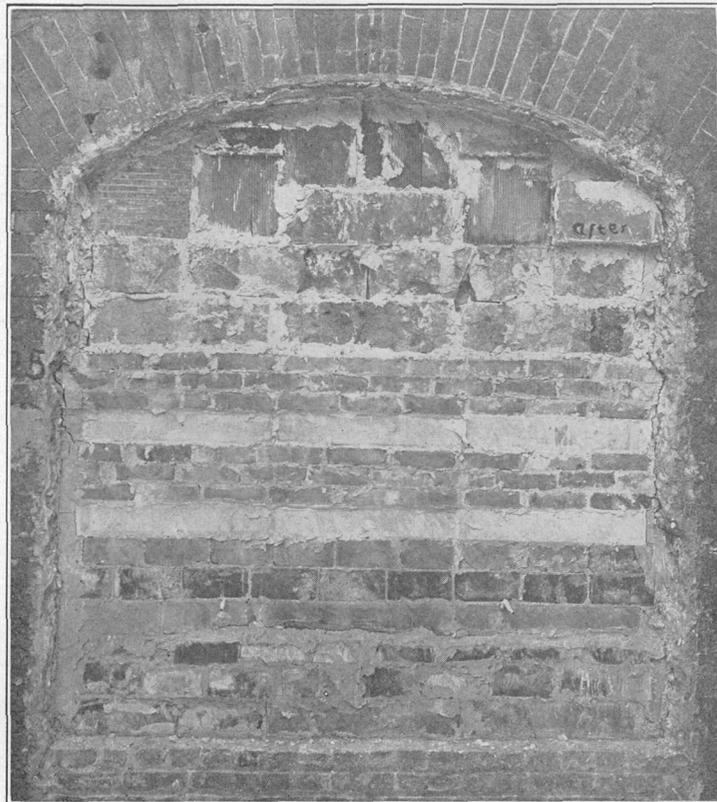
B. BACK OF PANEL 25, VARIOUS BUILDING STONES WITH BRICK BACKING, AFTER TESTING.

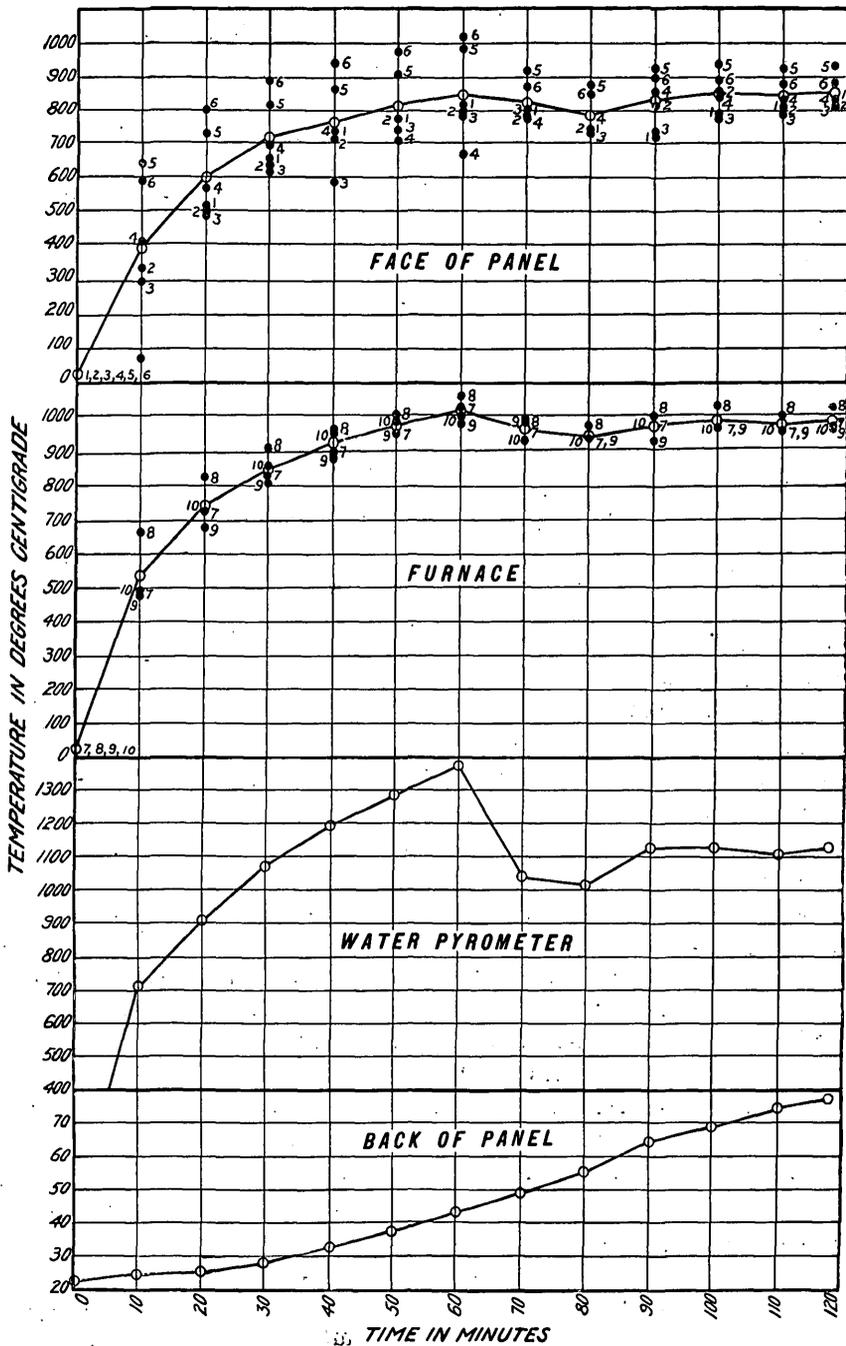
FIGURE 28.—Diagram showing temperature conditions in the furnace and on the back of panel 26. Temperature: Maximum, 79°; minimum, 65°; mean, 72°. Relative humidity; 7 a. m., 93; 7 p. m., 86. Direction of prevailing wind, north.

Curves showing the variations of temperature throughout the test are given in figure 28.

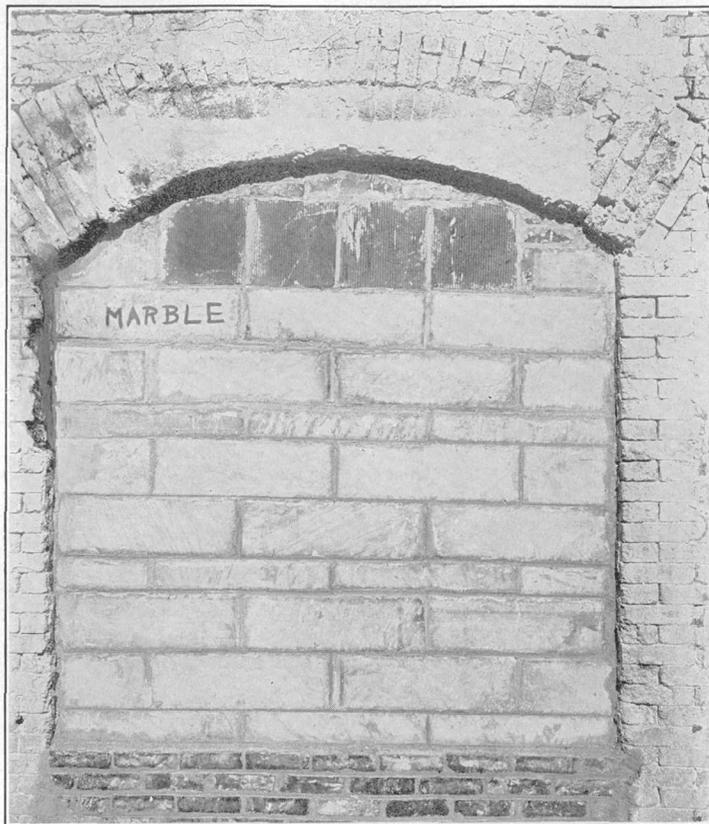
A. FACE OF PANEL 26, DRESSED MARBLE, BEFORE FIRING.

Material.—Panel 26 consisted of blocks of Georgia marble laid with broken joints in cement mortar with 4-inch and 7½-inch faces exposed, as shown in Plate XXXII, A. The lower part of the panel was backed with common brick, and the upper portion was laid up with partition tile in order to make the panel as light as possible.

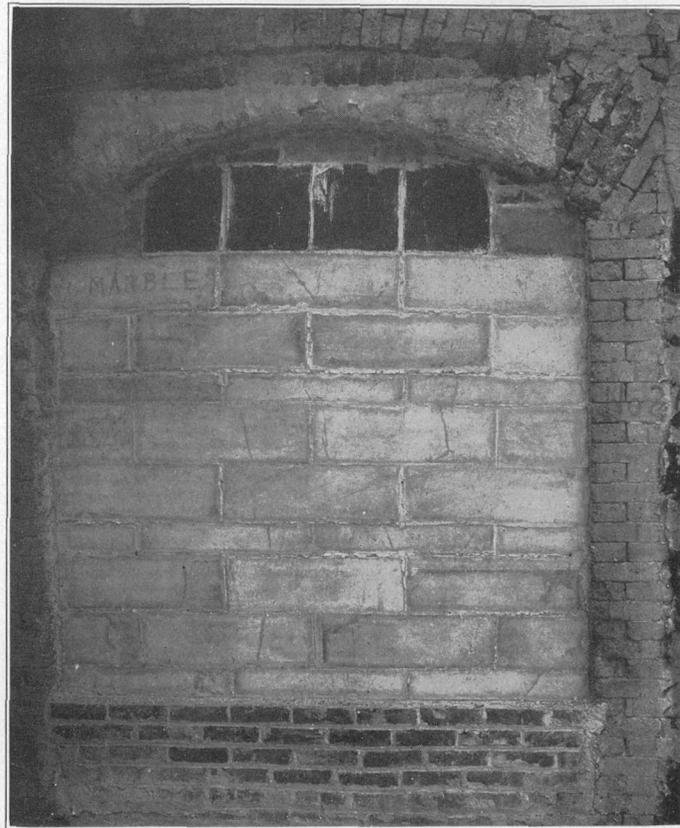
B. FACE OF PANEL 26, DRESSED MARBLE, AFTER FIRING AND BEFORE QUENCHING.

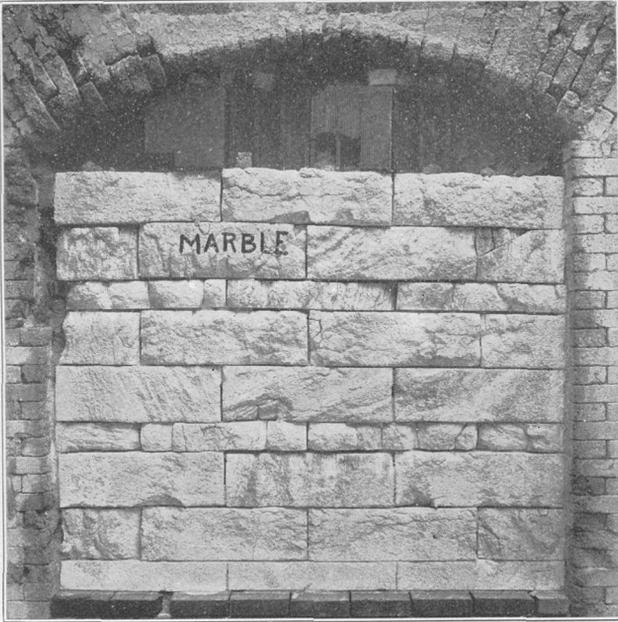
A. FACE OF PANEL 26, DRESSED MARBLE WITH BRICK BACKING, AFTER FIRING AND QUENCHING.

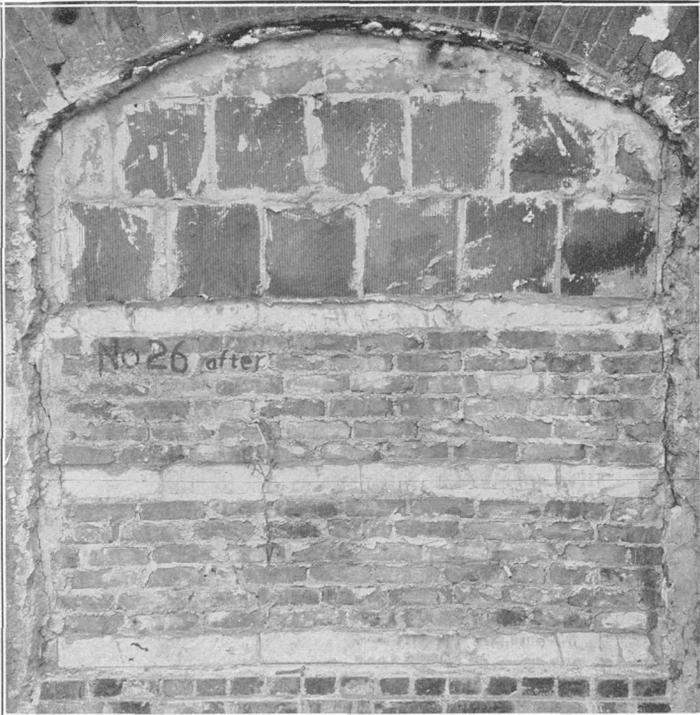
B. BACK OF PANEL 26, DRESSED MARBLE WITH BRICK BACKING, AFTER FIRING AND QUENCHING.

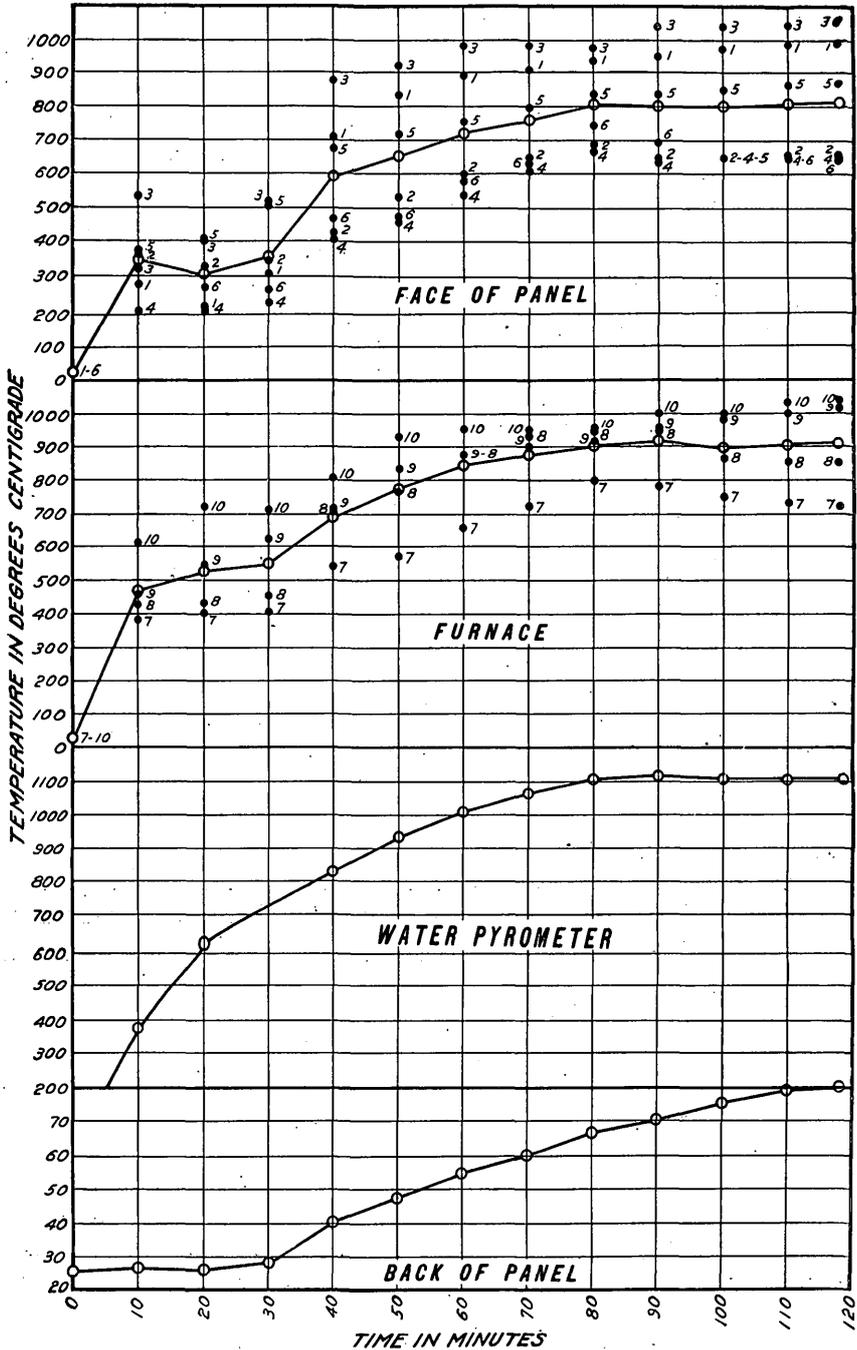
FIGURE 29.—Diagram showing temperature conditions in the furnace and on the back of panel 27. Temperature: Maximum, 85°; minimum, 72°; mean 78°. Relative humidity: 7 a. m., 67; 7 p. m., 58. Direction of prevailing wind, west.

Curves showing the variations of temperature throughout the test are given in figure 29.

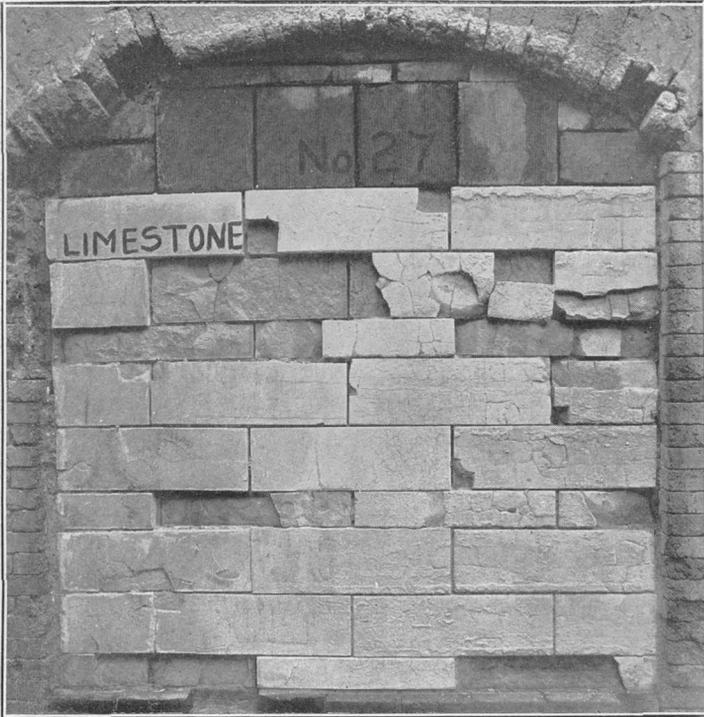
A. FACE OF PANEL 27, DRESSED LIMESTONE WITH BRICK BACKING, AFTER FIRING AND QUENCHING.

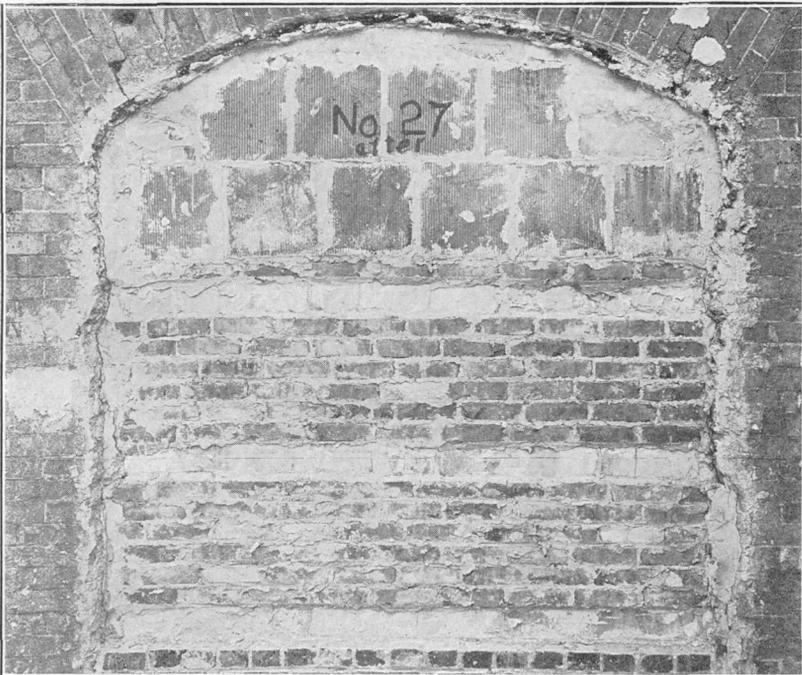
B. BACK OF PANEL 27, DRESSED LIMESTONE WITH BRICK BACKING, AFTER FIRING AND QUENCHING.

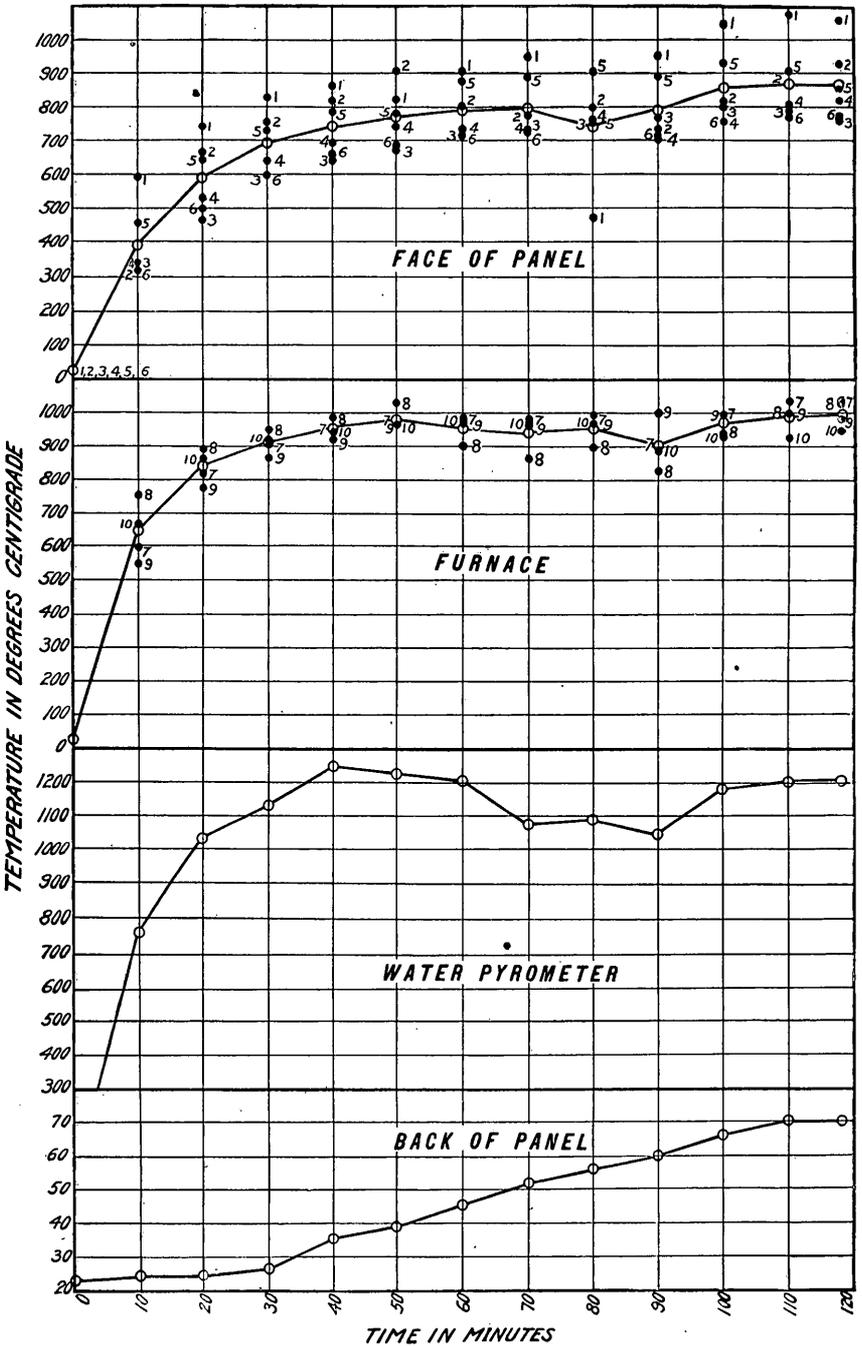
FIGURE 30.—Diagram showing temperature conditions in the furnace and on the back of panel 28. Temperature: Maximum, 77°; minimum, 69°; mean, 73°. Relative humidity: 7 a. m., 79; 7 p. m., 84. Direction of prevailing wind, east.

Curves showing the variations in temperature throughout the test are given in figure 30.

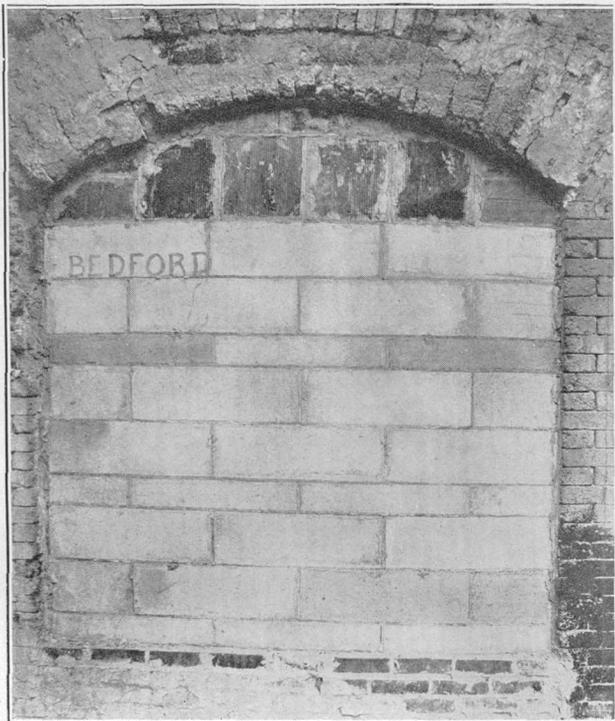
A. FACE OF PANEL 28, DRESSED LIMESTONE, AFTER FIRING AND BEFORE QUENCHING.

Plate XXXV, A, shows the face of the panel after firing, and Plate XXXVI, A, shows its appearance after applying water. Plate XXXVI, B, indicates the appearance of the blocks after removal from the furnace and gives an idea of the damage wrought.
