DEPARTMENT OF THE INTERIOR
UNITED STATES GEOLOGICAL SURVEY

BULLETIN 370

THE FIRE-RESISTIVE PROPERTIES OF
VARIOUS BUILDING MATERIALS

RICHARD L. HUMPHREY

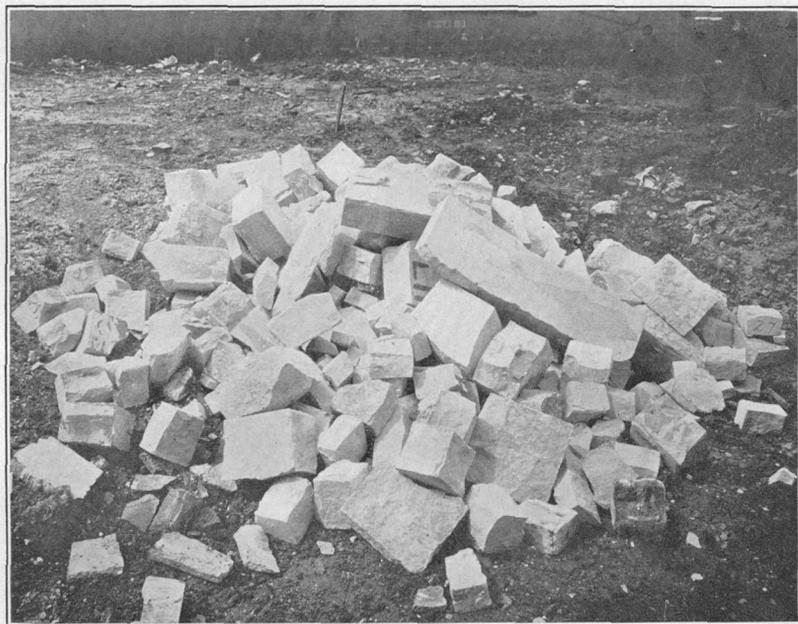
B. DRESSED LIMESTONE AFTER REMOVAL FROM PANEL 27.

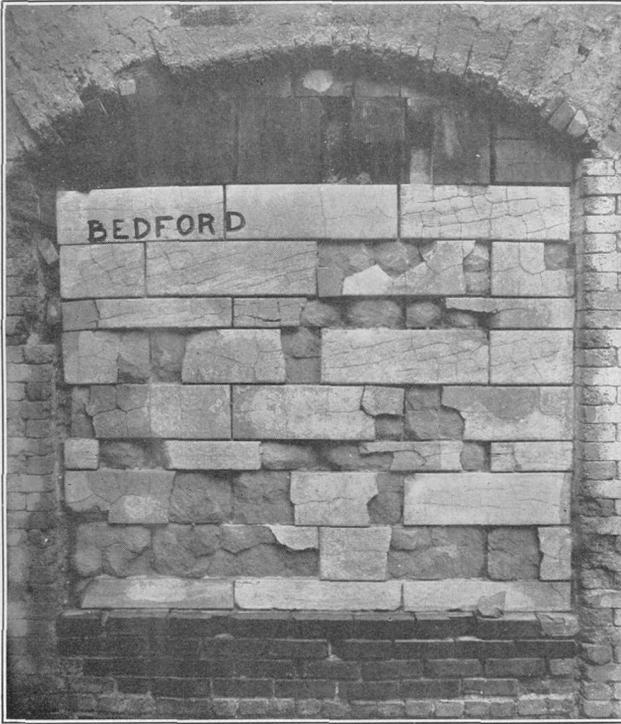
A. FACE OF PANEL 28, DRESSED LIMESTONE, AFTER FIRING AND QUENCHING.

Plate XXXV, A, shows the face of the panel after firing, and Plate XXXVI, A, shows its appearance after applying water. Plate XXXVI, B, indicates the appearance of the blocks after removal from the furnace and gives an idea of the damage wrought.

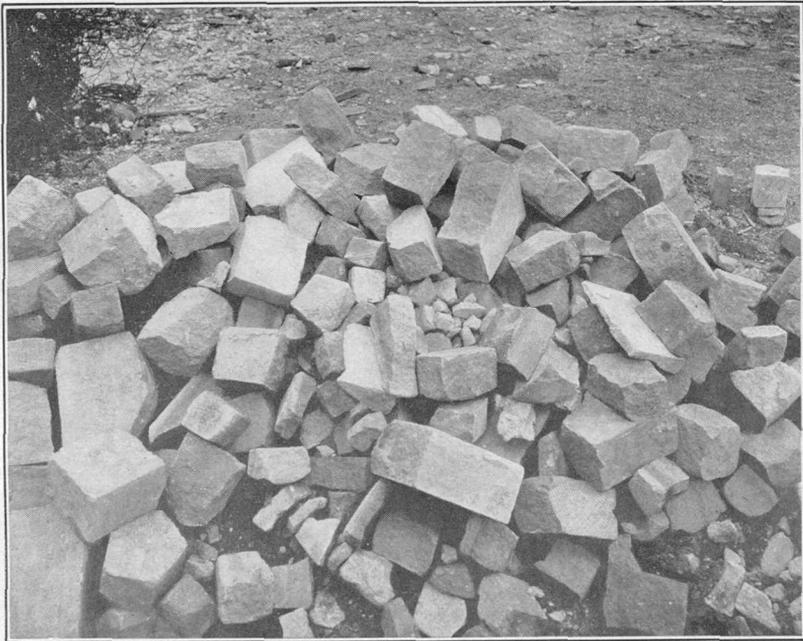
B. BLOCKS OF PANEL 28, DRESSED LIMESTONE, AFTER REMOVAL FROM FURNACE.

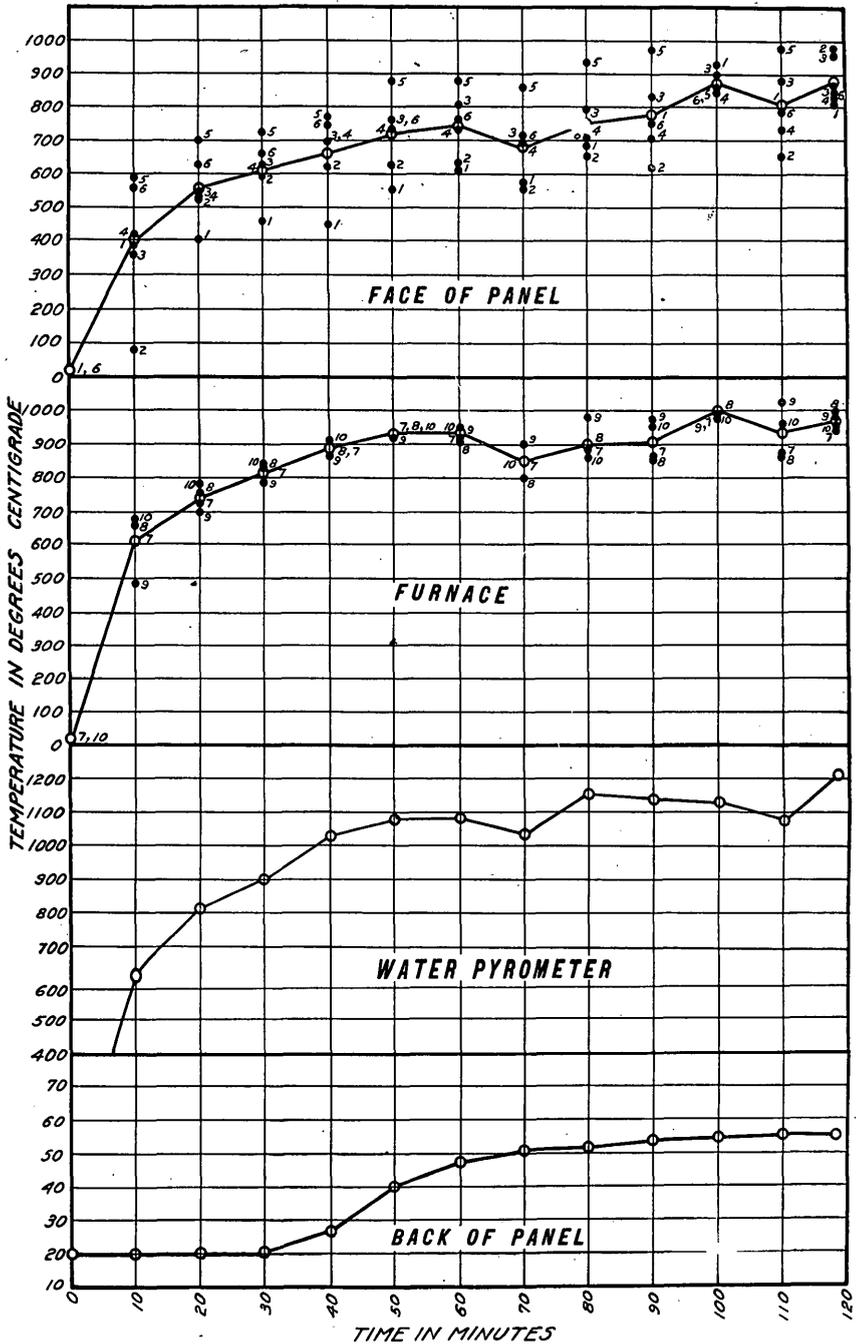
FIGURE 31.—Diagram showing temperature conditions in the furnace and on the back of panel 29. Temperature: Maximum, 71°; minimum, 63°; mean, 67°. Relative humidity: 7 a. m., 87; 7 p. m., 86. Direction of prevailing wind, north.

Curves showing the variations of temperature throughout the test are given in figure 31.

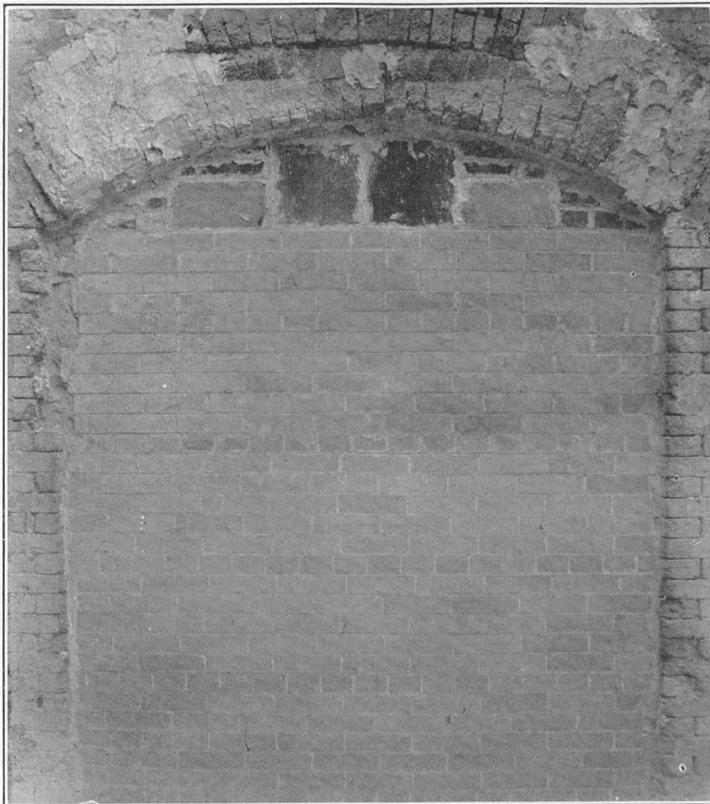
A. FACE OF PANEL 29, SAND-LIME BRICK, AFTER FIRING AND BEFORE QUENCHING.

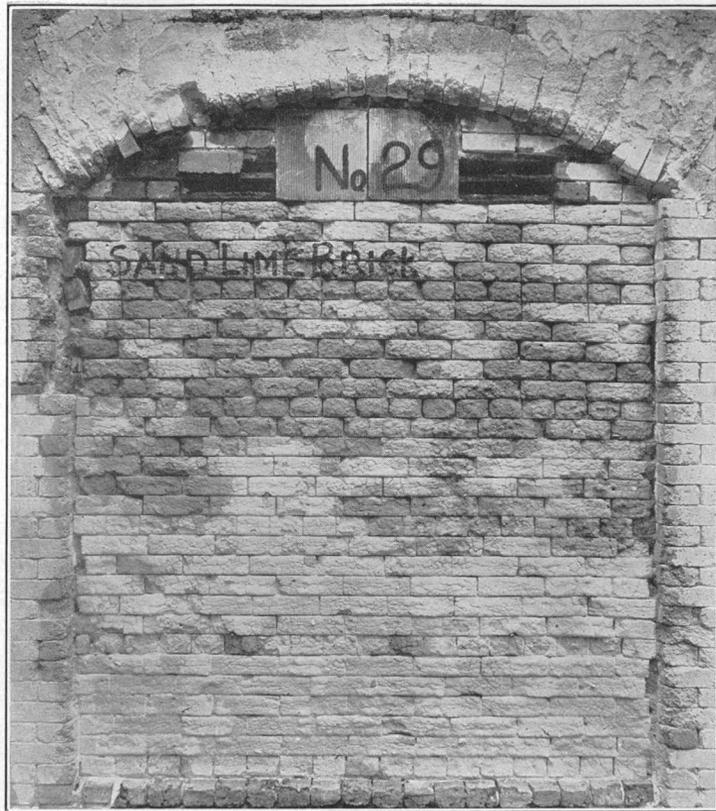
B. FACE OF PANEL 29, SAND-LIME BRICK, AFTER FIRING AND QUENCHING.

On taking down the panel it was found that the stretcher bricks composing the fired side were cracked back vertically from the fired face, usually in two or three pieces. The face was taken down with great care and about 20 per cent of the bricks were removed intact, but nearly all failed in handling, breaking into two or three pieces.

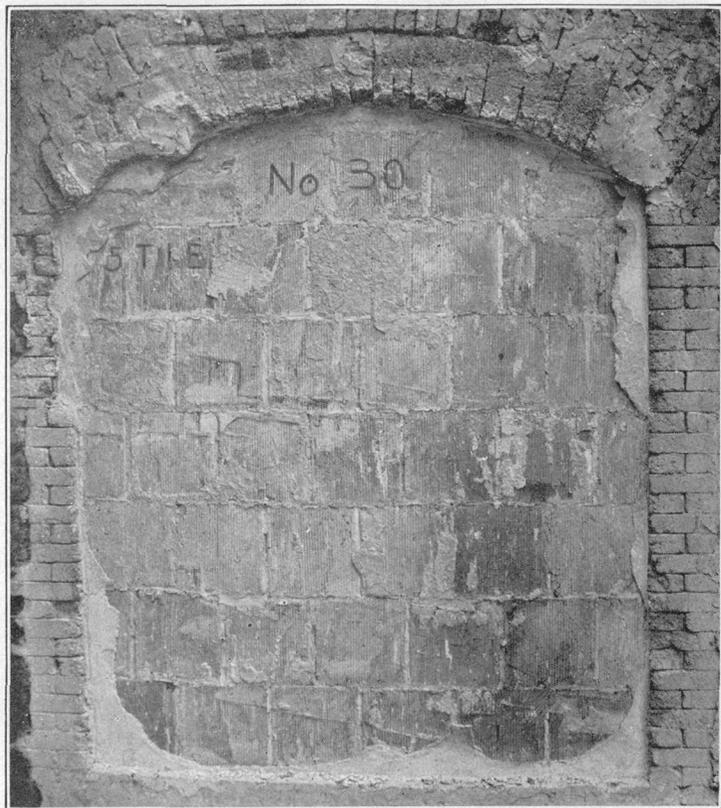
A. FACE OF PANEL 30, PARTITION TILE, AFTER FIRING AND BEFORE QUENCHING.

Results.—When the panel was removed from the furnace, the plaster was practically gone. Around the bottom edge and on the upper right-hand and left-hand corners there were small pieces, and a small patch on the second and third rows was still intact. The tiles were more or less cracked, especially the ones that were entirely free from mortar; that is, the second tile from the right-hand side in the third row and the tile nearest the right-hand side in the second row; also a small corner of the second tile on the right-hand side of the bottom row had cracked off. Cracks could not be observed in the other tiles, but they had a thin layer of plaster still sticking to them, which prevented examination.

Plate XXXVIII, *A*, shows the face of the panel after firing and before water was applied; Plate XXXVIII, *B*, the face of the panel after quenching; Plate XXXIX, *A*, the face of the panel after all loose pieces had been removed; and Plate XXXIX, *B*, the back of the panel after firing and quenching.

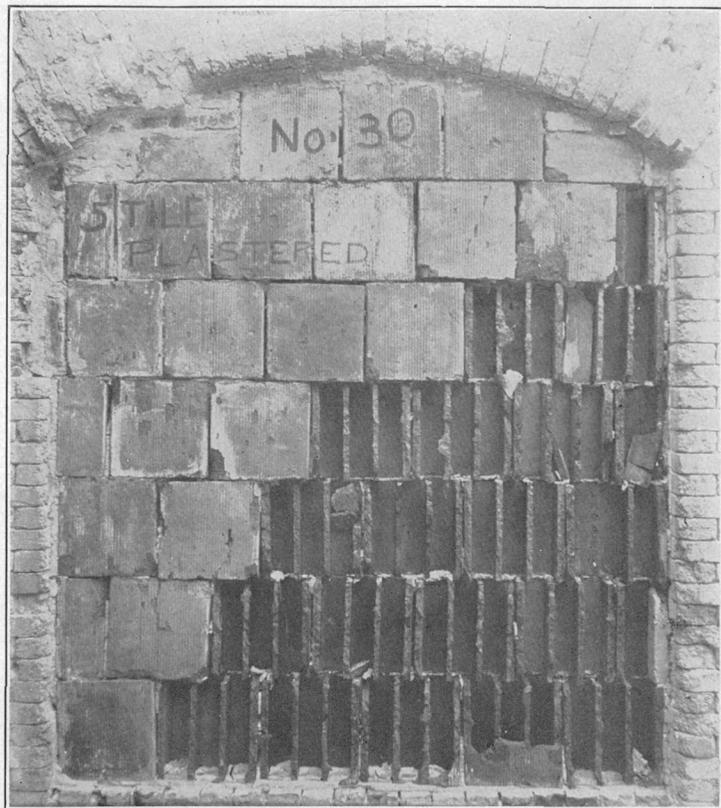
B. FACE OF PANEL 30, PARTITION TILE, AFTER FIRING AND QUENCHING.

On applying water the tiles cracked, and after the first minute the faces began to fall off. At the end of 5 minutes about 55 per cent of the faces of the tiles was washed away. This occurred on the lower and right-hand side of the panel. The tiles on the upper left-hand side still were in place. These tiles that were in place, however, were found to be cracked loose from the webs near the fired side, and the

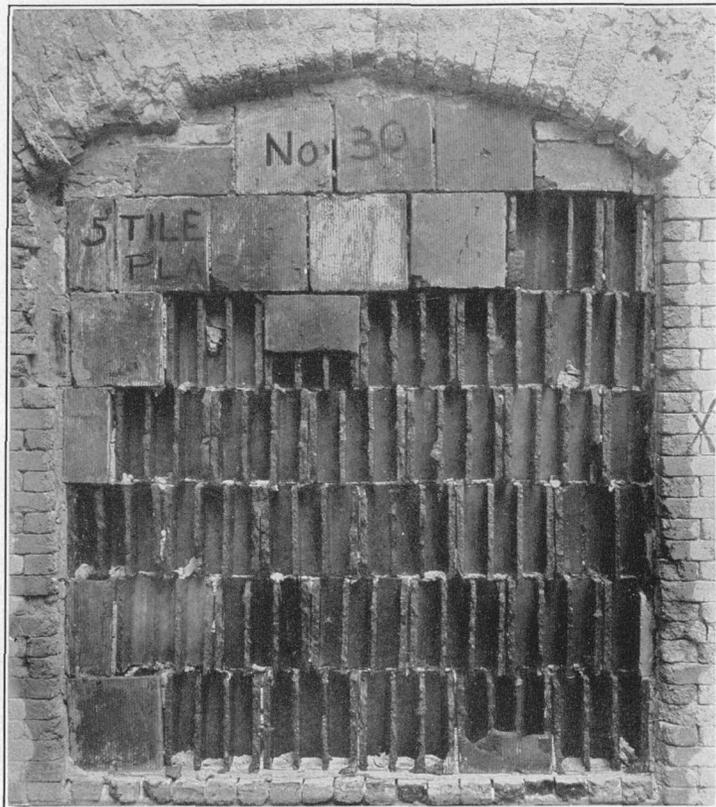
A. FACE OF PANEL 30, PARTITION TILE, AFTER FIRING AND QUENCHING, WITH ALL LOOSE PIECES REMOVED.

After the wall had cooled it was found that about 55 per cent of the tiles that remained in place could be lifted off. Those that did remain in place were cracked from the webs, and the faces were cracked but were apparently still rigidly attached. The portions of the web remaining attached to the backs and the backs themselves were apparently hard and free from cracks. The fired faces, however, crumbled easily in the hands. The plaster on the back wall was forced off, exposing about five tiles at the bottom of the wall; and although over the remainder of the wall the plaster remained intact it was badly bulged, and water had come through all the joints.

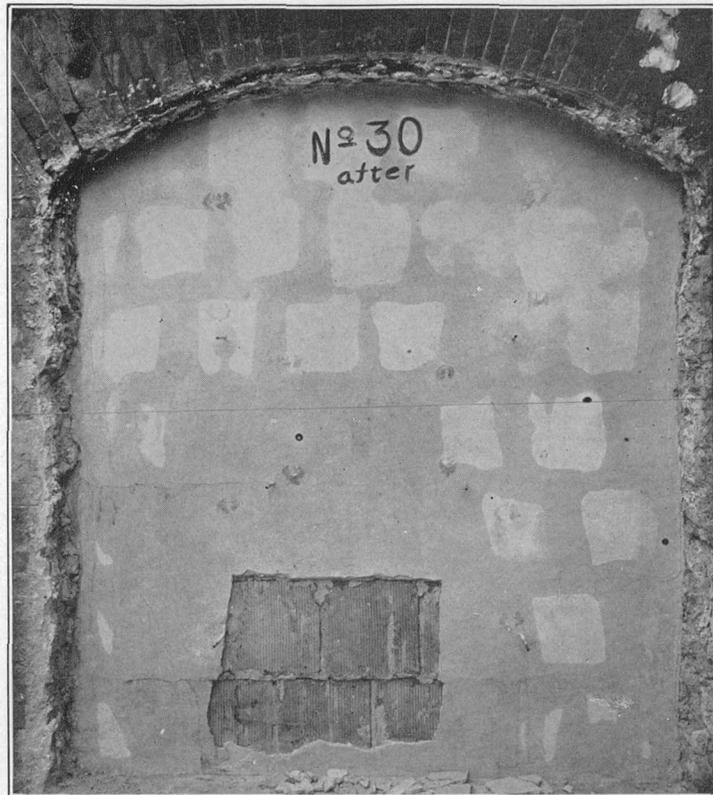
B. BACK OF PANEL 30, PARTITION TILE, AFTER FIRING AND QUENCHING.

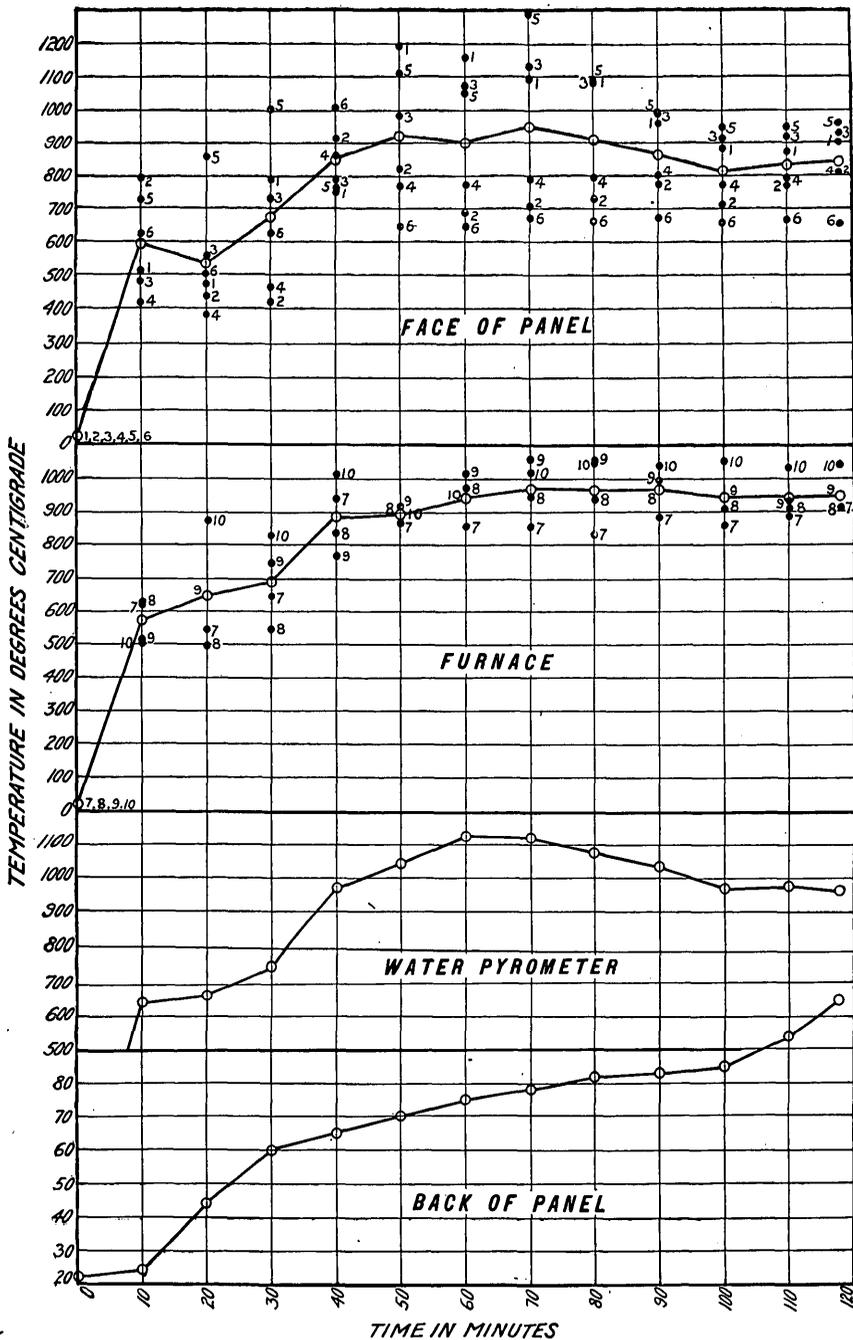
FIGURE 32.—Diagram showing temperature conditions in the furnace and on the back of panel 30,

Curves showing the variations in temperatures throughout the test are given in figure 32.
