Engagement of Metal Debris Into a Gear Mesh

*Robert F. Handschuh and Timothy L. Krantz
Glenn Research Center, Cleveland, Ohio*

Prepared for the
International Conference on Motion and Power Transmissions (MPT2009-Sendai)
sponsored by the Machine Design and Tribology Division of the Japan Society of Mechanical Engineers
Sendai, Japan, May 13–15, 2009

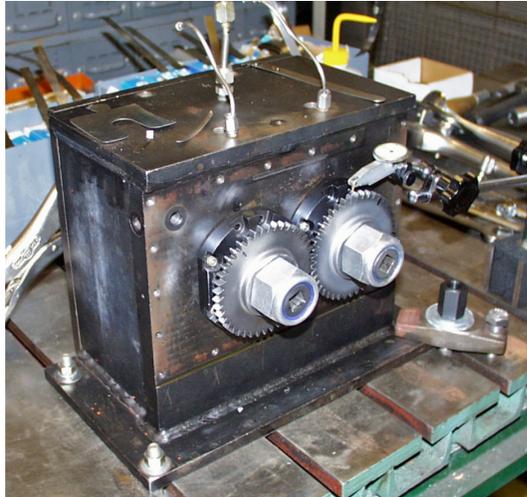
Figure 1.—Bench setup for gear chip engagement testing using the NASA Glenn Fatigue Rig.

The gear testing was done using a Glenn Research Center Spur Gear Fatigue test rig. This rig uses two identical spur gears engaged with one another. The shaft mounting is an overhung arrangement for the test gears, and the nearby bearings are roller bearings. The overhung distance from the bearing supports is approximately 32 mm (1.25 in.). Because the test machine was designed for experiments of gear fatigue, the shaft and bearing supports are relatively large and stiff. Figure 1 shows the test gearbox with a pair of test gears mounted.

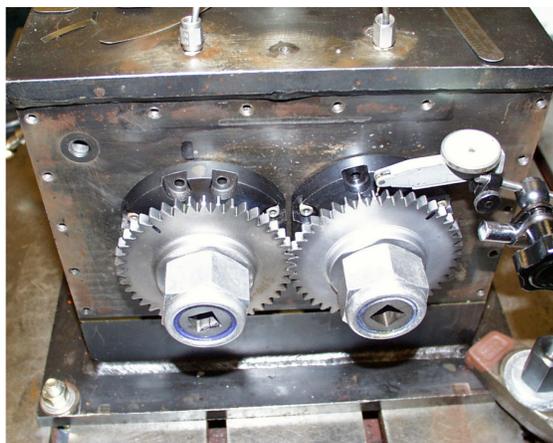
Figure 2.—Setup for backlash measurement using dial indicator.

The gear design specifications and the actual mounted center distance determine the root clearance and backlash of a pair of gears. The backlash and root clearances were determined for the first pair of test gear mounted on the test fixture. The backlash was measured as 0.15 mm (0.006 in.) using a standard measurement setup (Fig. 2). The root clearance was measured as 0.94 mm (0.037 in.). The root clearance was determined by running a piece of soft material (solder) through the mesh and measuring the deformed material with a caliper.

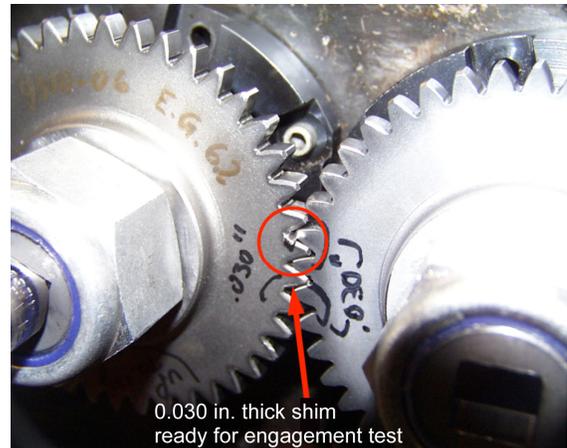
Figure 3.—Example of shim and placement used for engagement testing.

Three types of “debris” were placed into the meshing gear teeth for testing, namely steel shim stock, drill bit shanks, and pieces or “chips” from gear teeth. The shim stock materials used were steel and stainless steel. The shim thickness ranged from 0.13 to 1.88 mm (0.005 to 0.074 in.). The shims were cut to a length of approximately 2.5 to 3.8 mm (0.100 to 0.150 in.), representing approximately half of the tooth height. The shim lengths were wider than the faces of the gears and were placed to engage the full-face width of the gear teeth (Fig. 3). The drill bit shanks used for these experiments had shank diameters ranging from 1.07 to 1.96 mm (0.042 to 0.077 in.).

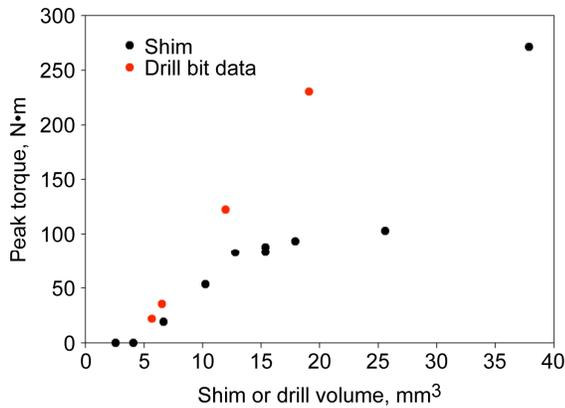
Figure 4.—Relationship of volume of engaged object to the peak torque required to rotate the gears for the NASA GRC spur gear rig using 12-pitch case-carburized steel gears.

The results for the shim stock and drill bit testing will be discussed first. To relate the peak torque required to roll the object through the gear mesh to the size of the object, the volume of the object was calculated assuming the full-face width of the gear was engaged and using a nominal height of 3.18 mm (0.125 in.) for the shim objects. The resulting relationship of peak torque to the object volume is provided in Figure 4. For the smallest shims tested, only a very small nominal drag torque of the rig setup was required to rotate the shim through mesh. The drill bit shanks required a significantly greater peak torque for an equivalent volume of

For the drill bit test data a straight line can be passed through the data. In the data for the much softer shim stock, there initially appears to be a linear relation up to a certain volume. Then a region of this data is nearly non-varying and only increasing torque slightly as the volume was increased. Finally for this data, a rather large increase in torque was recorded as the shim volume was in excess of 35 mm³.

A plausible explanation for this can be stated as follows. Initially the shim stock plastically compresses and an increase in volume causes a proportional change in torque. As the volume is increased, enough of the tooth tip—root clearance is still available to plastically compress the shim material resulting in little increase in the torque needed. Finally, as the volume of the tooth tip to root clearance is used up, the torque required to “extrude” the shim increase substantially.

Finally all the data generated is shown in Figure 19. The drill bit and shim stock mass data was found using the data from Figure 4. The drill bit data was very comparable to the tooth chip data following the same trend. The shim stock data had a lower torque level over all the data taken. This must be an artifact of the nominal material hardness. The scatter in the tooth chip data is possibly due to non-symmetric shapes in comparison to the symmetry of the drill bit data.

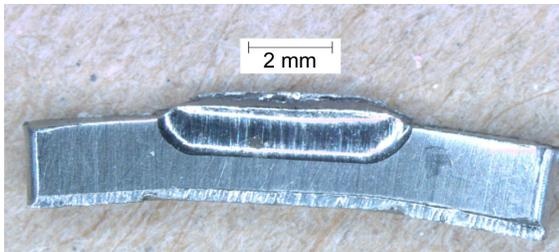
Figure 5.—Example of deformed shim stock after engagement of meshing gear teeth.

For the case of the shim stock material, the main effect was elastic deformation of the support structure (shaft and bearings) and plastic deformation of the shim stock. Essentially the shim stock was extruded. The shim stock took the shape of the root-fillet region of the driven gear with intrusion by the tip of the driving gear (Fig. 5). The peak torque was roughly a linear function of the engaged shim volume. By visual examination, it was judged that the gear

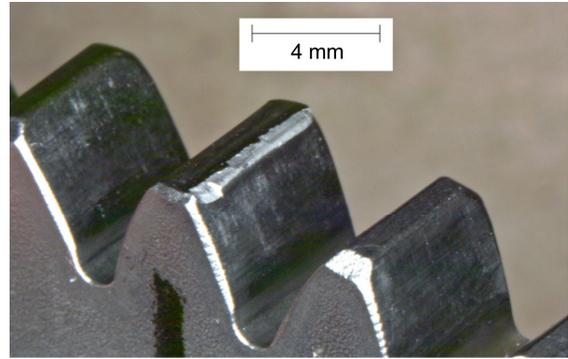
Figure 6.—Example of damaged tooth tip after engagement of 1.96 mm (0.077 in.) diameter drill bit shank.

teeth were not damaged by engagement of the shim stock. For the case of the drill bit, the main effect was elastic deformation of the supporting structure and some plastic deformation of the teeth. The drill bit shanks permanently deformed and damaged the tooth tip that made contact with the bit shank during the meshing process (Fig. 6).

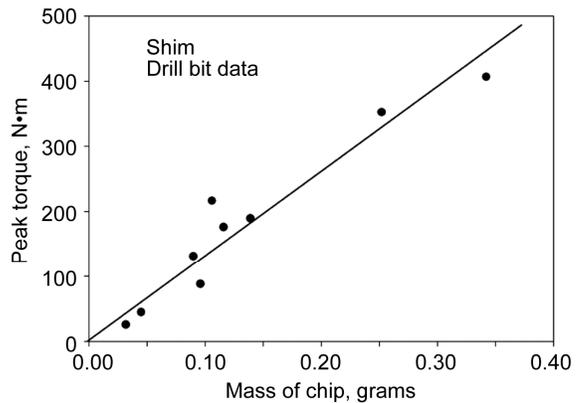
Figure 7.—Peak torque recorded during gear chip engagement testing on GRC bench test setup as a function of the mass of the engaged chip. The line is a linear regression of the data.

Next, the results of testing with the gear chips will be discussed. The peak torque required to rotate the gears was, to a good approximation, a linear function of the mass of the engaged chip (Fig. 7). For chip #2 of Table 2, the peak torque exceed the measuring capacity of the torque wrench, and since the peak torque was not know precisely the data point was not included in the plot of Figure 7. A larger capacity torque wrench was used for subsequent testing.

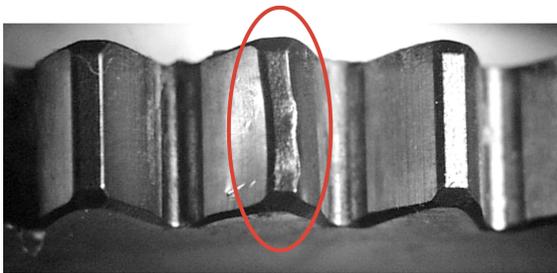
Figure 8.—Severely deformed gear tooth as result of engagement with largest chip tested, chip #7 having mass of 0.342 grams. The gears can no longer be rotated to engage and pass through this tooth using hand torque.

the tabletop. For the two largest chips (chips #6 and #7 of Table 2), the engaged gear teeth were deformed and damaged significantly enough that the gears could no longer be rotated with hand torque past the damaged tooth. An image of such damage is provided in Figure 8.

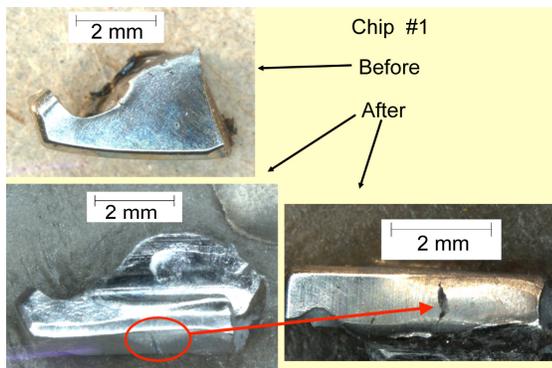
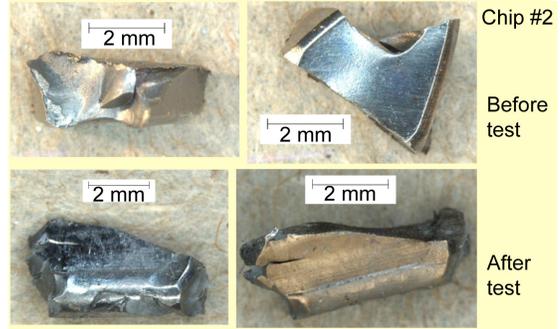
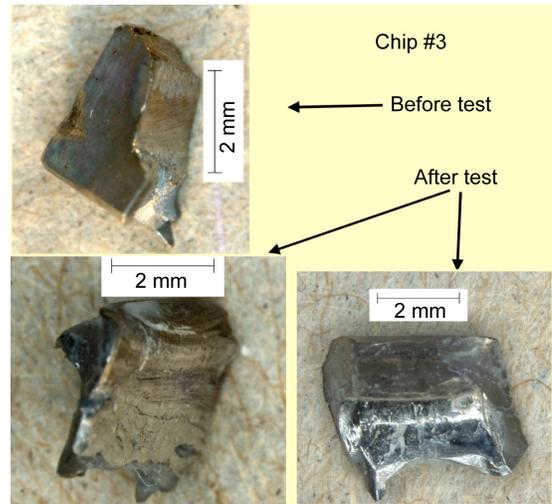
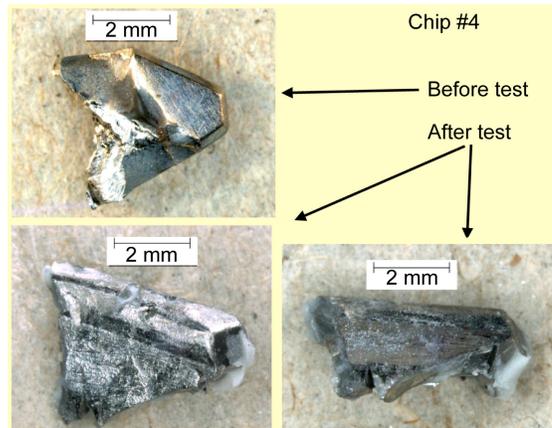
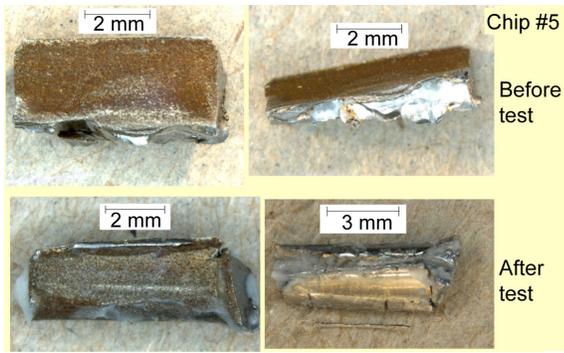
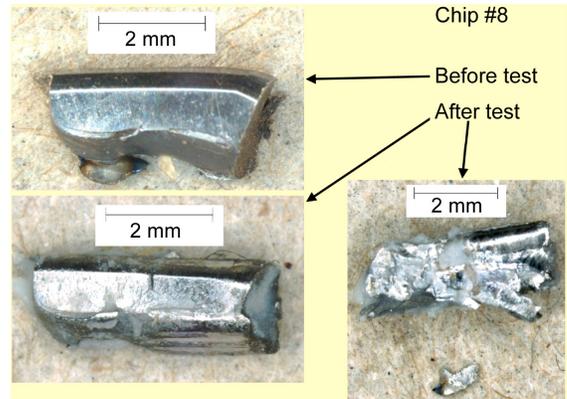
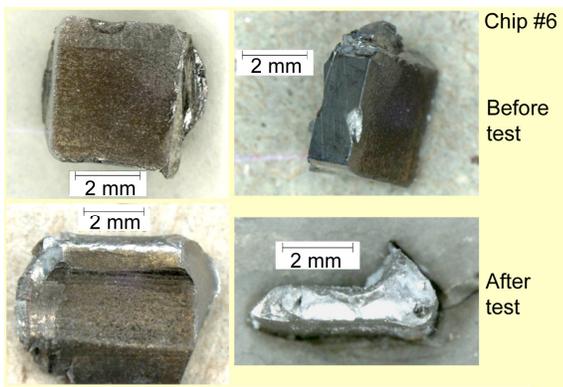
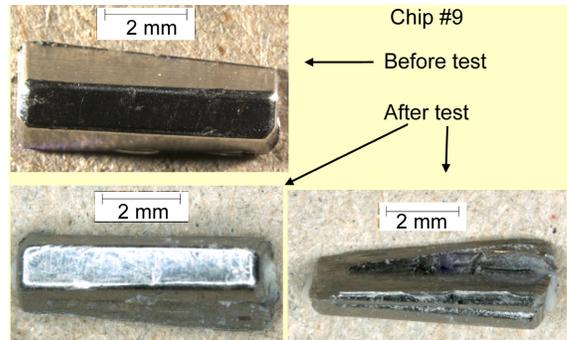
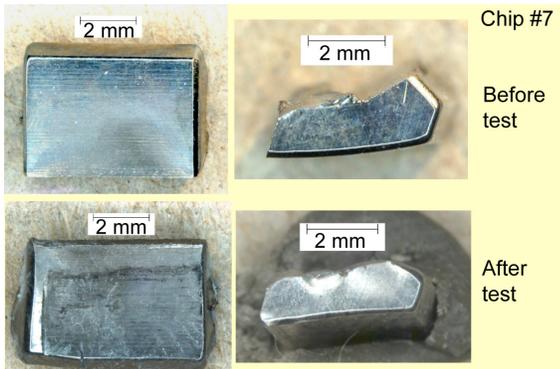
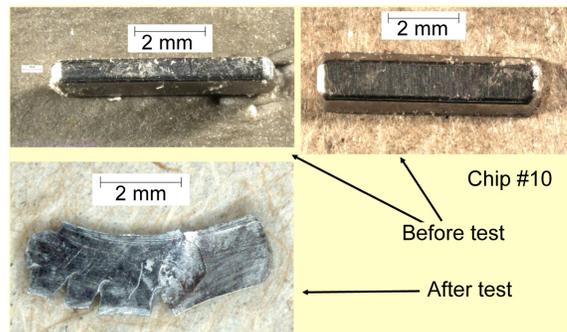
Figure 9.—Chip #1, mass of chip 0.090 grams.

Figure 10.—Chip #2, mass of chip 0.100 grams.

Figure 11.—Chip #3, mass of chip 0.106 grams.

Figure 12.—Chip #4, mass of chip 0.116 grams.

Figure 13.—Chip #5, mass of chip 0.139 grams.

Figure 16.—Chip #8, mass of chip 0.045 grams.

Figure 14.—Chip #6, mass of chip 0.252 grams.

Figure 17.—Chip #9, mass of chip 0.096 grams.

Figure 15.—Chip #7, mass of chip 0.342 grams.

Figure 18.—Chip #10, mass of chip 0.032 grams.

Images of the chips both before and after engagement testing are provided in Figures 9 to 18. The images show that the main effects on the chips were deformation of the chips to conform to the available tooth root spaces. In general, the chips remained intact. For the case of chips #5 and #8, small pieces were liberated from the main piece as can be seen in the figures. Chip #10 especially shows that the case-carburized material, even though generally described as brittle, can be significantly deformed and exhibit some toughness. Although the chip experienced some “tearing”, the chip did not “shatter” or otherwise exhibit extreme brittleness.

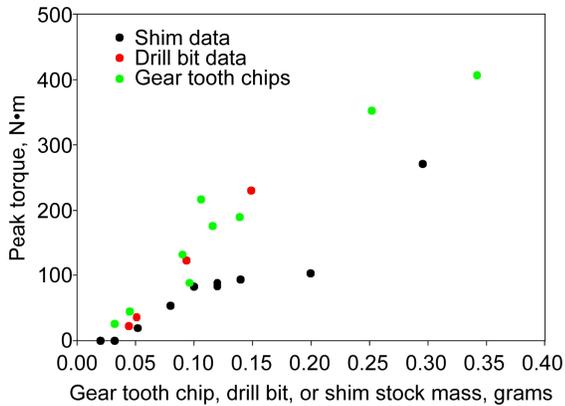
Figure 19.—Debris mass versus peak torque required to rotate the gear mesh.
