Galvanic Behavior Database for Titanium-Steel Alloy Couples

ARL-TR-2812

Ralph P. I. Adler, Christopher E. Miller, and Brian E. Placzankis
Weapons and Materials Research Directorate, ARL

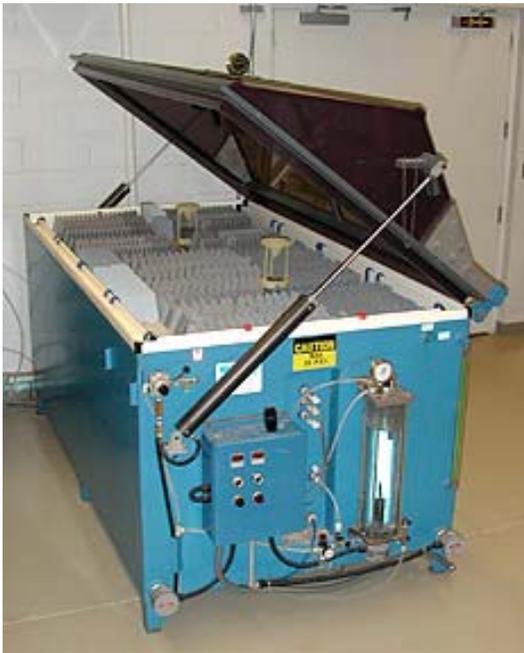
Figure 3. ASTM B117 SFT chamber.

ASTM B117-90 Test Chamber

- 95 F @ 100% RH
- 5% (by weight) NaCl Solution
- Compressed Air Atomized Fog

2.3.2.1 Salt Fog Testing (SFT). SFT of “TACOM Joint A Assembly” samples were performed according to ASTM B117 [2] protocol in two phases. Figure 3 shows the SFT chamber and lists the exposure parameters. The phase I exposure of 2500 hr was performed with an unbroken CARC seal. After unbolting and breaking the CARC seal, the interface was examined for any corrosion phenomena. Subsequently each couple, after one plate was rotated by 90° and rebolted to snug fit state, was given a second 2500-hr exposure (phase II) without the benefit of the original CARC seal. Sample interface characterization was then again documented.

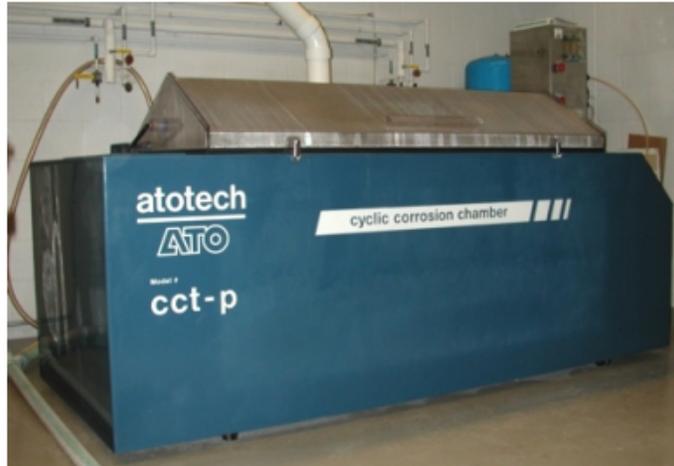
GM 9540P Cyclic Test Chamber

- 0.9% NaCl
- 0.25 NaHCO₃
- 0.1% CaCl₂

Figure 4. GM9540 P cyclic test chamber.

2.3.2.2 Cyclic Corrosion Testing (CCT). CCT of another series of “TACOM Joint A Assembly” samples were performed according to General Motors (GM) 9540P [3] protocol in two phases. Figure 4 shows the cyclic test chamber and lists the exposure parameters. The phase I exposure of 100 cycles was performed with an unbroken CARC seal. After unbolting and breaking the CARC seal, the interface was examined for any corrosion phenomena.

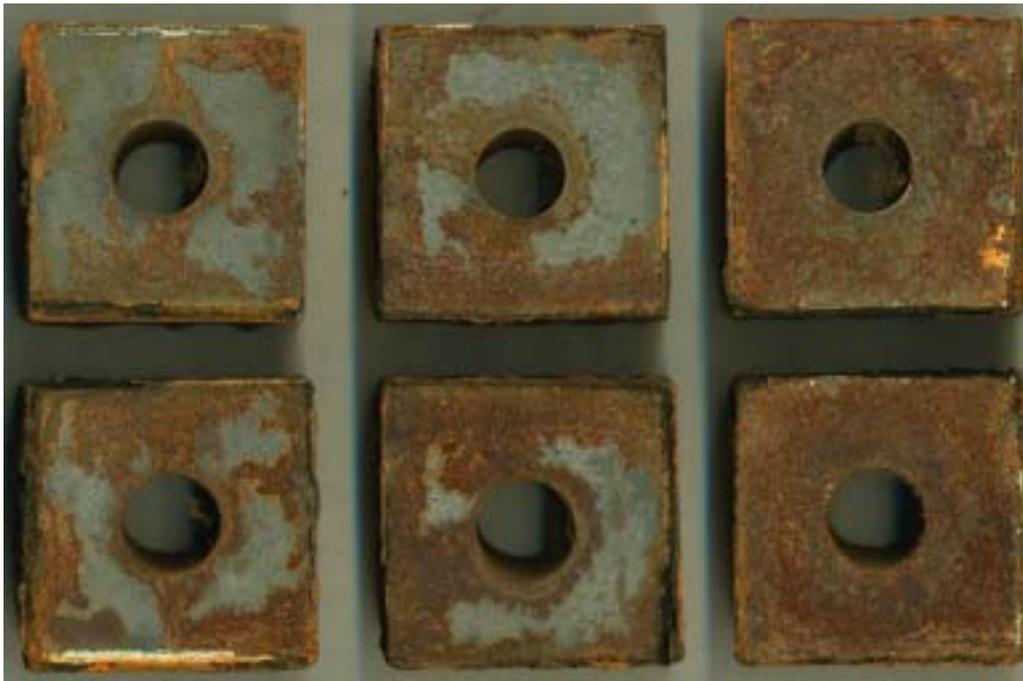
Figure 8. Macrophotos of Ti-steel interfaces after phase II salt fog exposure.

Table 7 provides the interface corrosion assessment after salt fog exposure. Illustrative macrophotos of these interfaces after salt fog exposures are provided for the Ti-steel interfaces for phase I (Figure 7) and phase II (Figure 8).

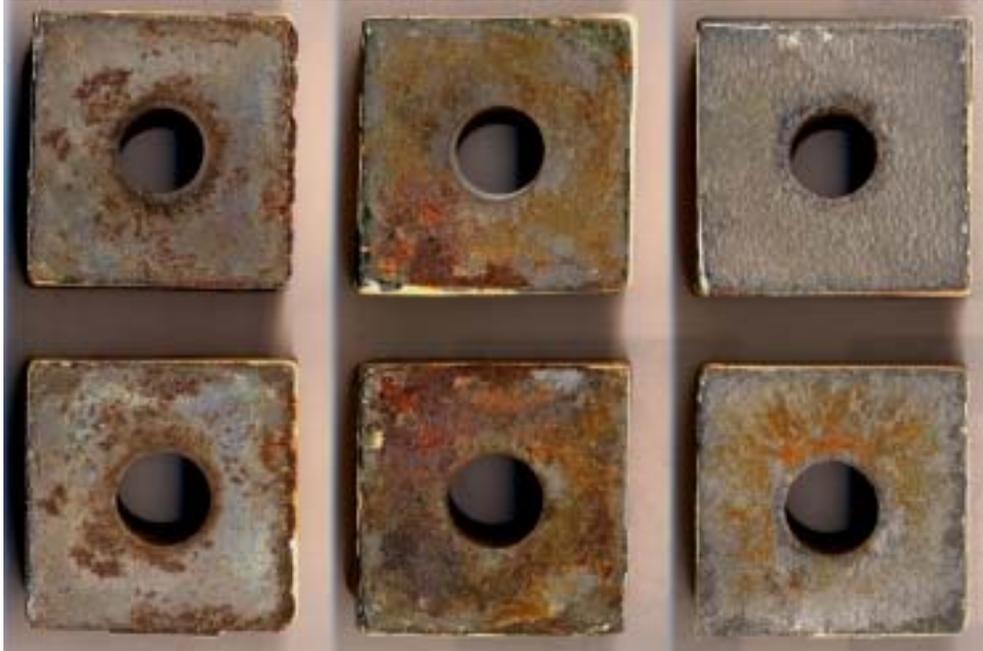
Figure 10. Macrophotos of Ti-steel interfaces after phase I cyclic corrosion exposure.

macrophotos of these interfaces after salt fog exposures are provided for the Ti-steel interfaces after phase I (Figure 10) and phase II (Figure 11). To be noted is that the buildup of interfacial corrosion products is even greater in the comparable Fe-Fe samples as listed in Tables 7 and 8 and illustrated in Figure 12 for salt fog and Figure 13 for cyclic corrosion phase II exposures. Clearly, the CCT protocol provides a more aggressive accelerated testing environment due to the programmed cyclic changes in thermal and chemical conditions compared to the constant exposure conditions within the SFT-accelerated testing chamber.

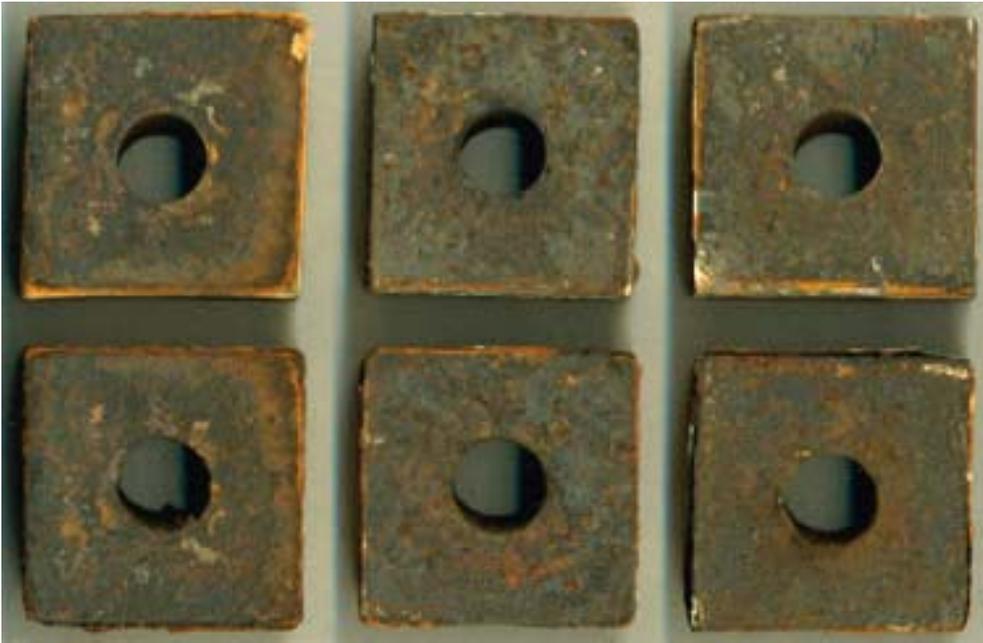
Figure 11. Macrophotos of Ti-steel interfaces after phase II cyclic corrosion exposure.

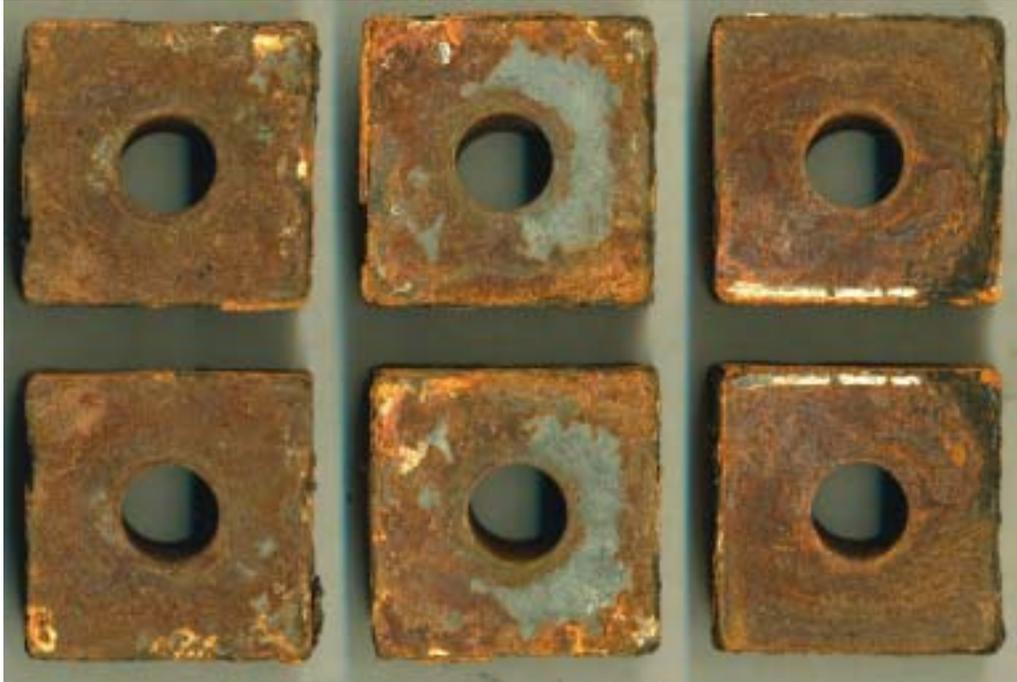
Figure 12. Macrophotos of Fe-Fe interfaces after phase II salt fog exposure.

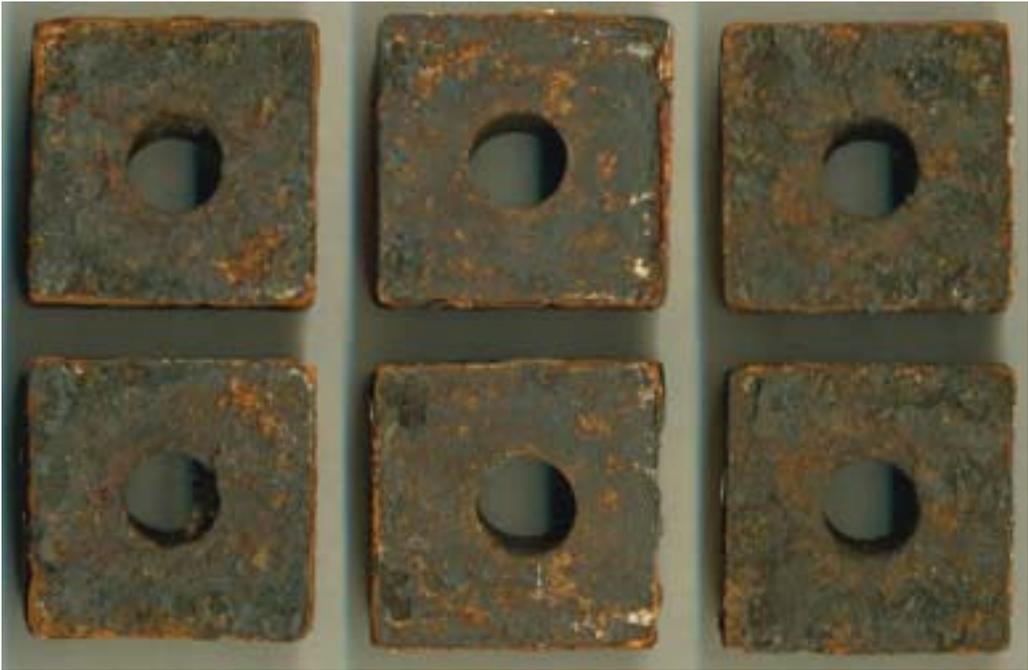
Figure 13. Macrophotos of Fe-Fe interfaces after phase II cyclic corrosion exposure.
