CULTURAL LANDSCAPE REPORT FOR GOVERNORS ISLAND NATIONAL MONUMENT

Volume 1:

By Lisa Nowak

Olmsted Center for Landscape Preservation
National Park Service, Boston, Massachusetts, 2010

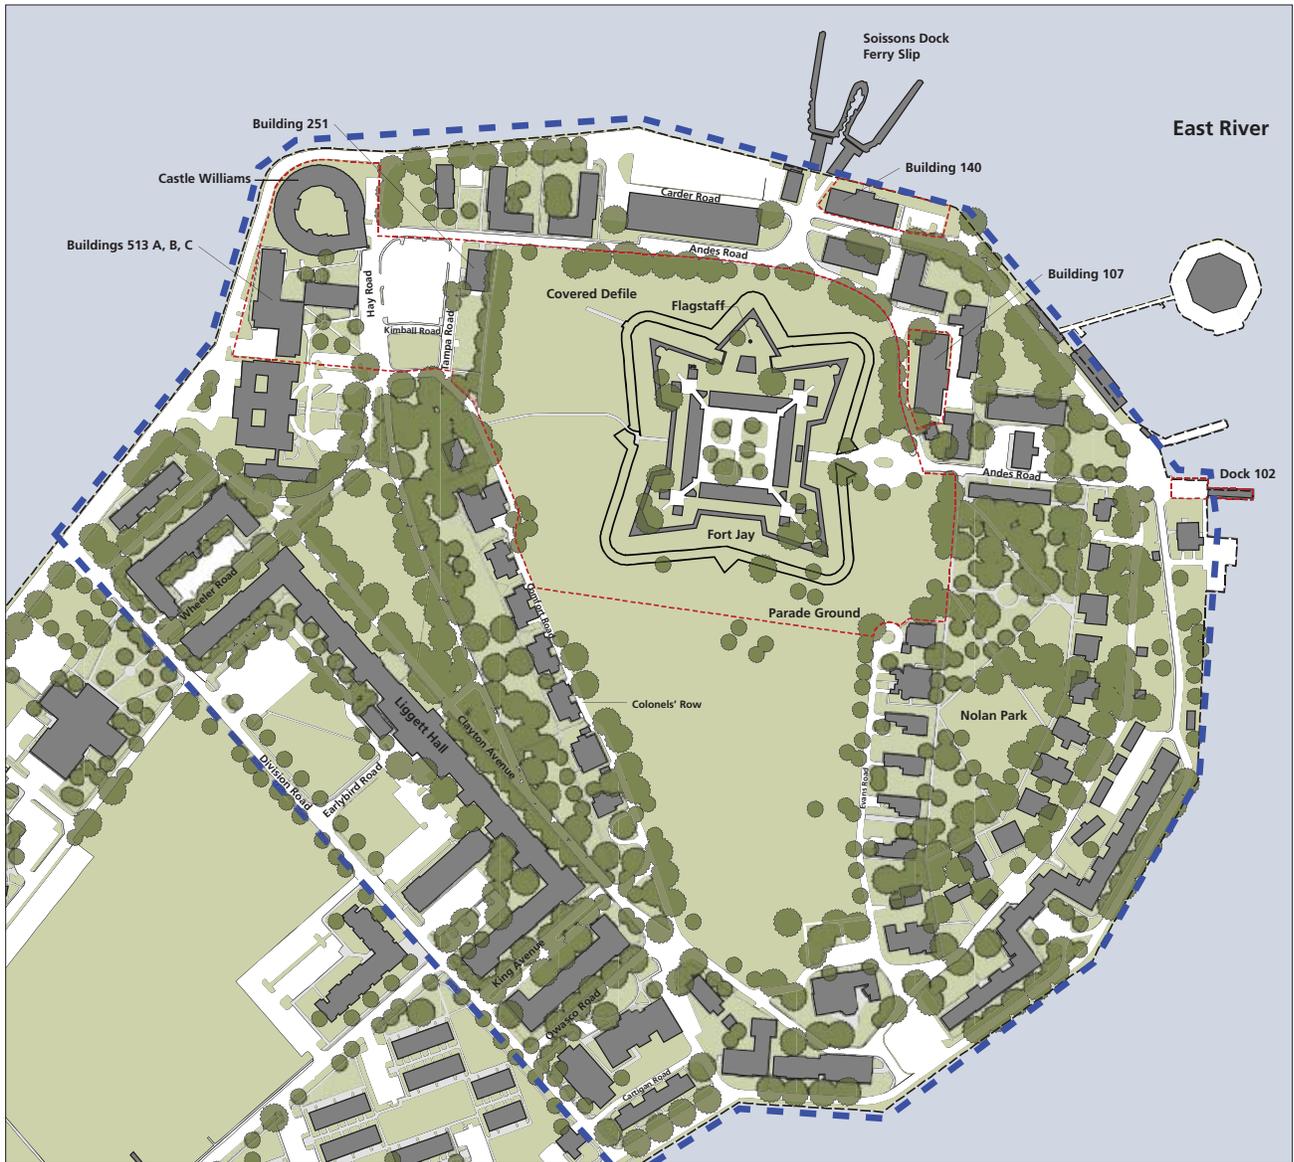
Figure 1.2. Governors Island National Historic Landmark District encompasses the northern portion of the island (outlined in blue). Governors Island National Monument is contained within the landmark district (outlined in red). Not to scale (OCLP, 2008).

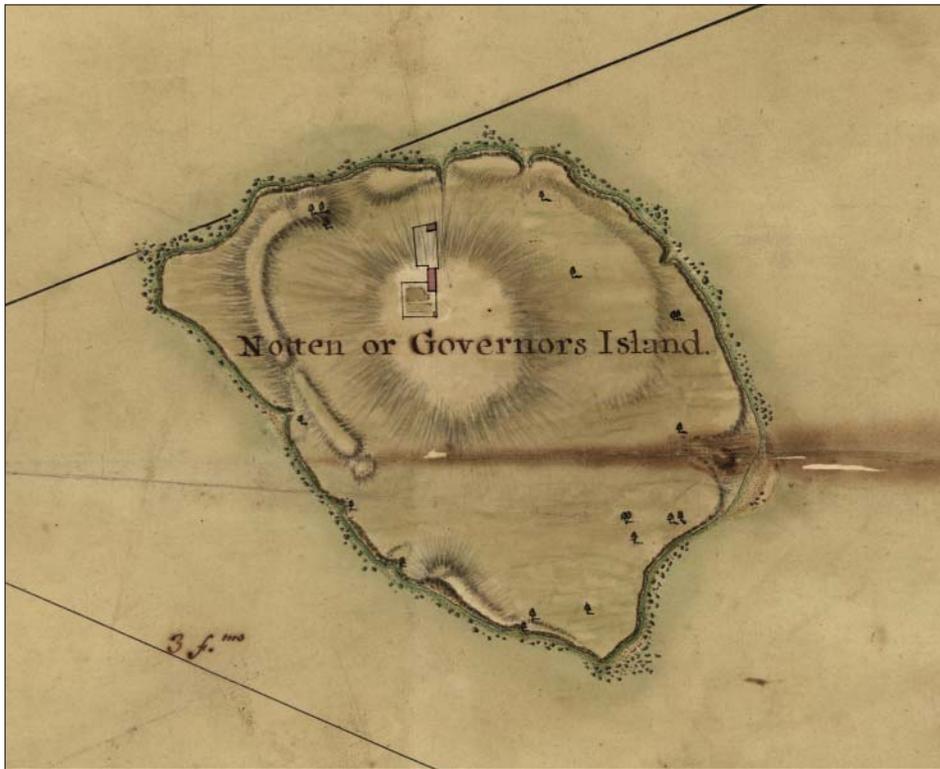
Figure 2.3. Enlargement of John Montresor's plan of Governors Island, 1766. A fort located on high ground is depicted in the center of the island, ringed on the west side by earthworks. The wharf area is also shown on this plan, located on the east side of the island (Library of Congress, "Plan of Governor's, Kennedy's, and Brown's Islands and Red Hook together with part of the Bay and Soundings, shewing the position they bear to each other and to New York," #G3804.N4P55 1766. M6 Faden 96).

The physical appearance of the island is better documented beginning in 1766. Several plans of the harbor were produced in that year showing development on Governors Island, some of which may date to the military encampment during the French and Indian War (Figures 2.3 and 2.4). Several built features are consistently depicted on period imagery, including the presence of a geometric fort or building near the center of the island, several earthworks surrounding the fort, especially to the north and west, and land manipulated for a wharf on the east side of the island, facing Buttermilk Channel. It appears that a channel was dug through the steep bluff near the wharf to create a level docking area and to create a navigable road up to the fort. This also may have been created to provide a depressed path where soldiers would be protected from enemy fire by the earthen sidewalls.

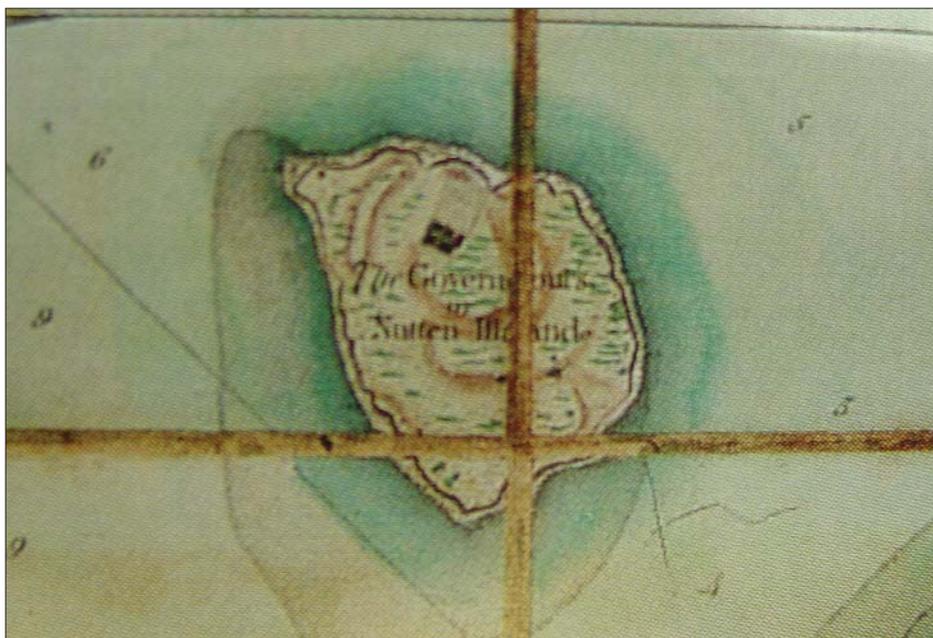
Figure 2.4. Governors Island, 1766-1767. The main fort in the center of the island is shown on this image, as well as raised earthworks northwest of the fort and what appear to be terraced earthworks leading down to the wharf area on the southeast side of the island (Library of Congress, Bernard Ratzer, Published by Faden and Jefferys, London, January 12, 1776, as in Yocum, Historic Structures Report for Fort Jay).

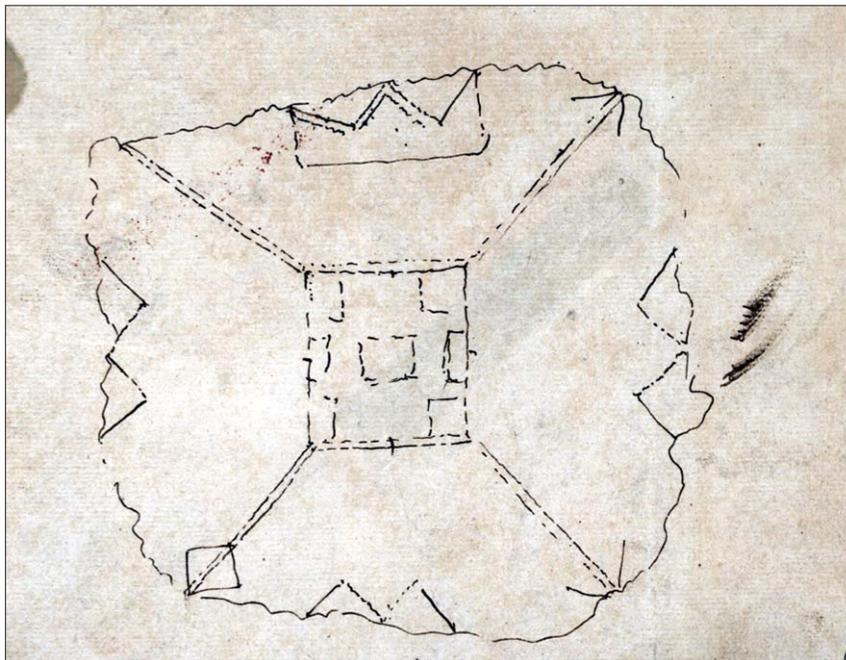
Figure 2.6. Design for Governors Island, 1766 (Library of Congress, John Montresor, #G3804.N4:2 G6 1766. M6 Vault).

In 1766, plans were drawn for proposed fortifications on Governors Island, likely to enhance the existing rudimentary fortification. One design by British engineer John Montresor called for a square fortress and moat at the center of the island (Figure 2.6). Montresor's plan used the same location as the existing geometric fort and may have been planned to encompass a portion of the extant infrastructure. He drew a detailed cross section of the dry moat, masonry fort walls, and sloped glacis designed to surround the main fortification (Figure 2.7). Smaller water batteries were planned for the four sides of the island. Montresor designed four roads radiating from the corners of the central fort to the outskirts of the island. These may have been intended to be covered defiles, or depressed walkways built to provide coverage from enemy artillery. Yet despite a plea made by the British colonial government in 1774 to appropriate funding for Montresor's plans, the fortifications were never built.¹⁵

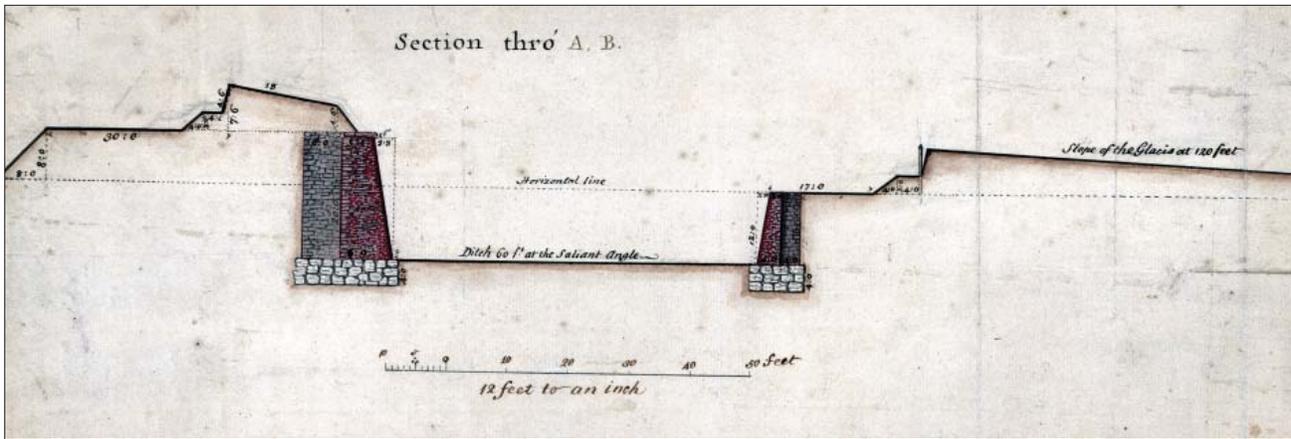
Figure 2.7. Cross section of proposed fortification walls on Governors Island, 1766 (Library of Congress, "Designs for fortifying Governors Island near New York," John Montresor, 1766, #G3804 N4:2G6 M61 Vault).

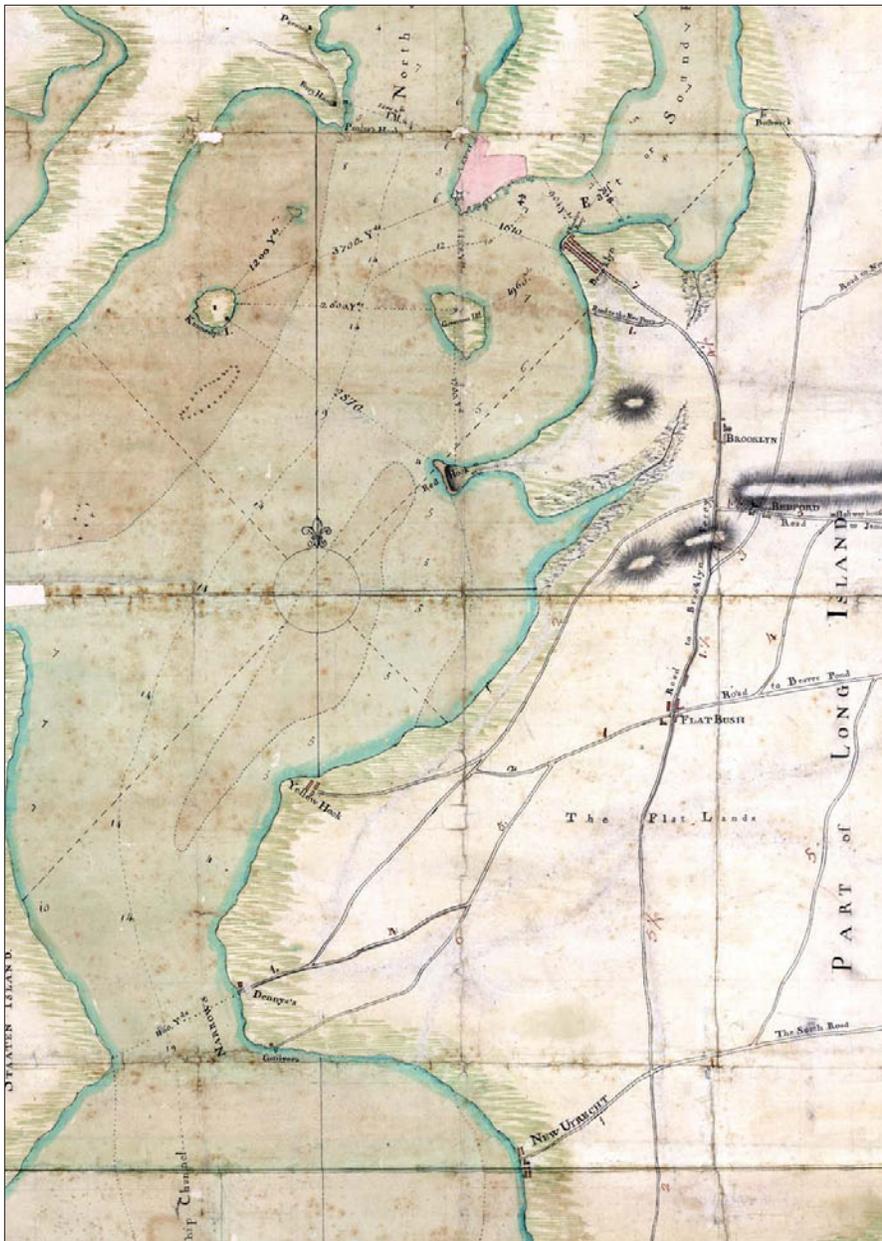
Figure 2.8. Map of New York Harbor, c 1776. Maps like these were produced to measure distances between landforms and fortifications, to aid battle planning (Library of Congress, "Sketch of New York, Narrows, and Part of Long Island with the Roads," 1776, #G3804.N4A1 1776. S5 Vault).

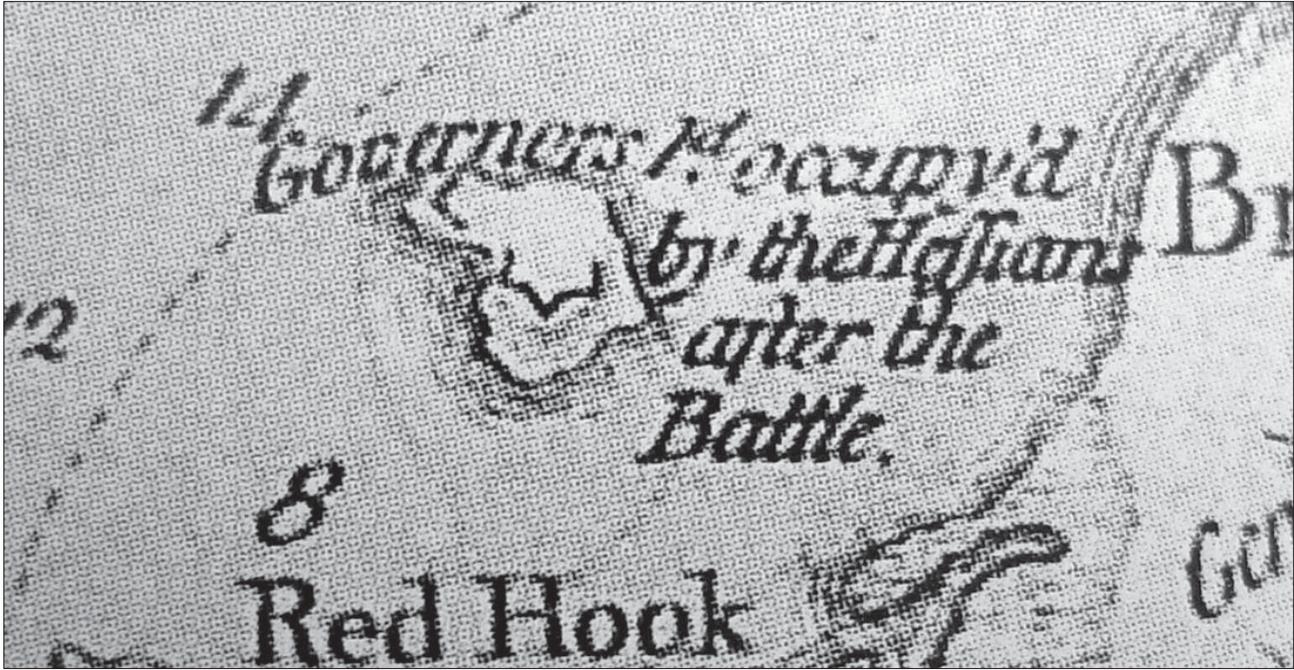
Figure 2.11. Governors Island after the battle of Long Island, 1776. Fortification walls are shown on the northwest and central areas of the island (Library of Congress, detail of "Plan of New York Island," William Faden, 1776, as in Yocum, "Historic Structures Report for Fort Jay, Governors Island National Monument").

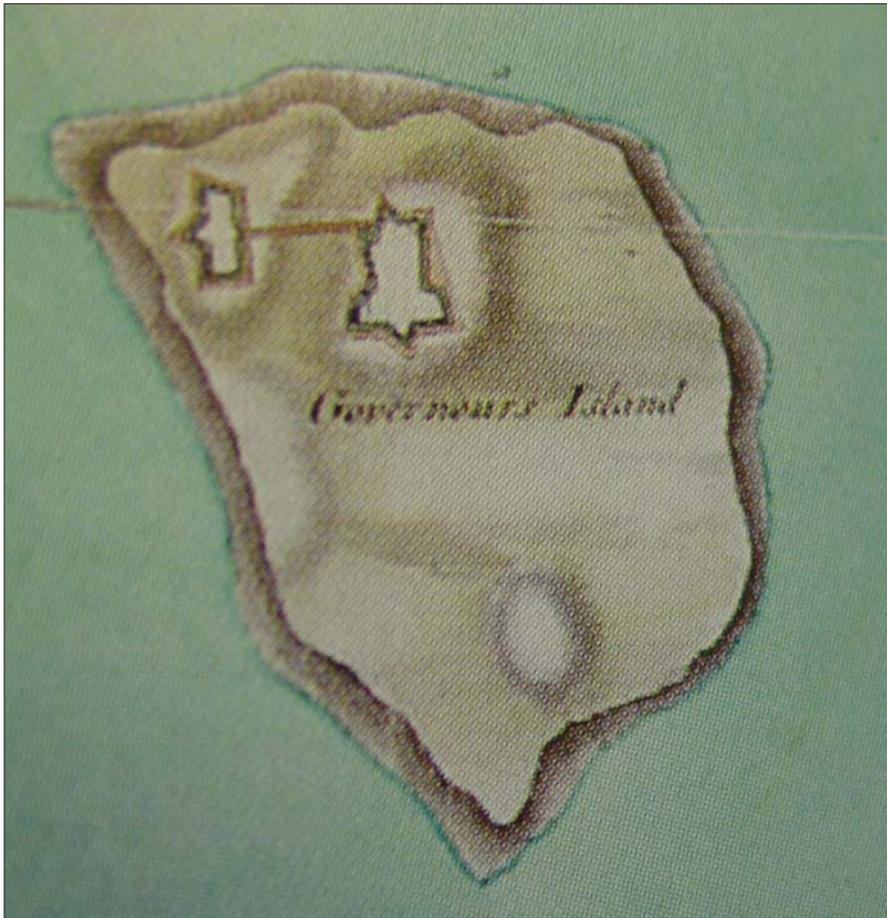
Figure 2.12. Fortifications of Governors Island, c. 1776 (New York State Library, Detail of a map drawn by Samuel Holland, as in Yocum, "Historic Structures Report for Fort Jay, Governors Island National Monument").

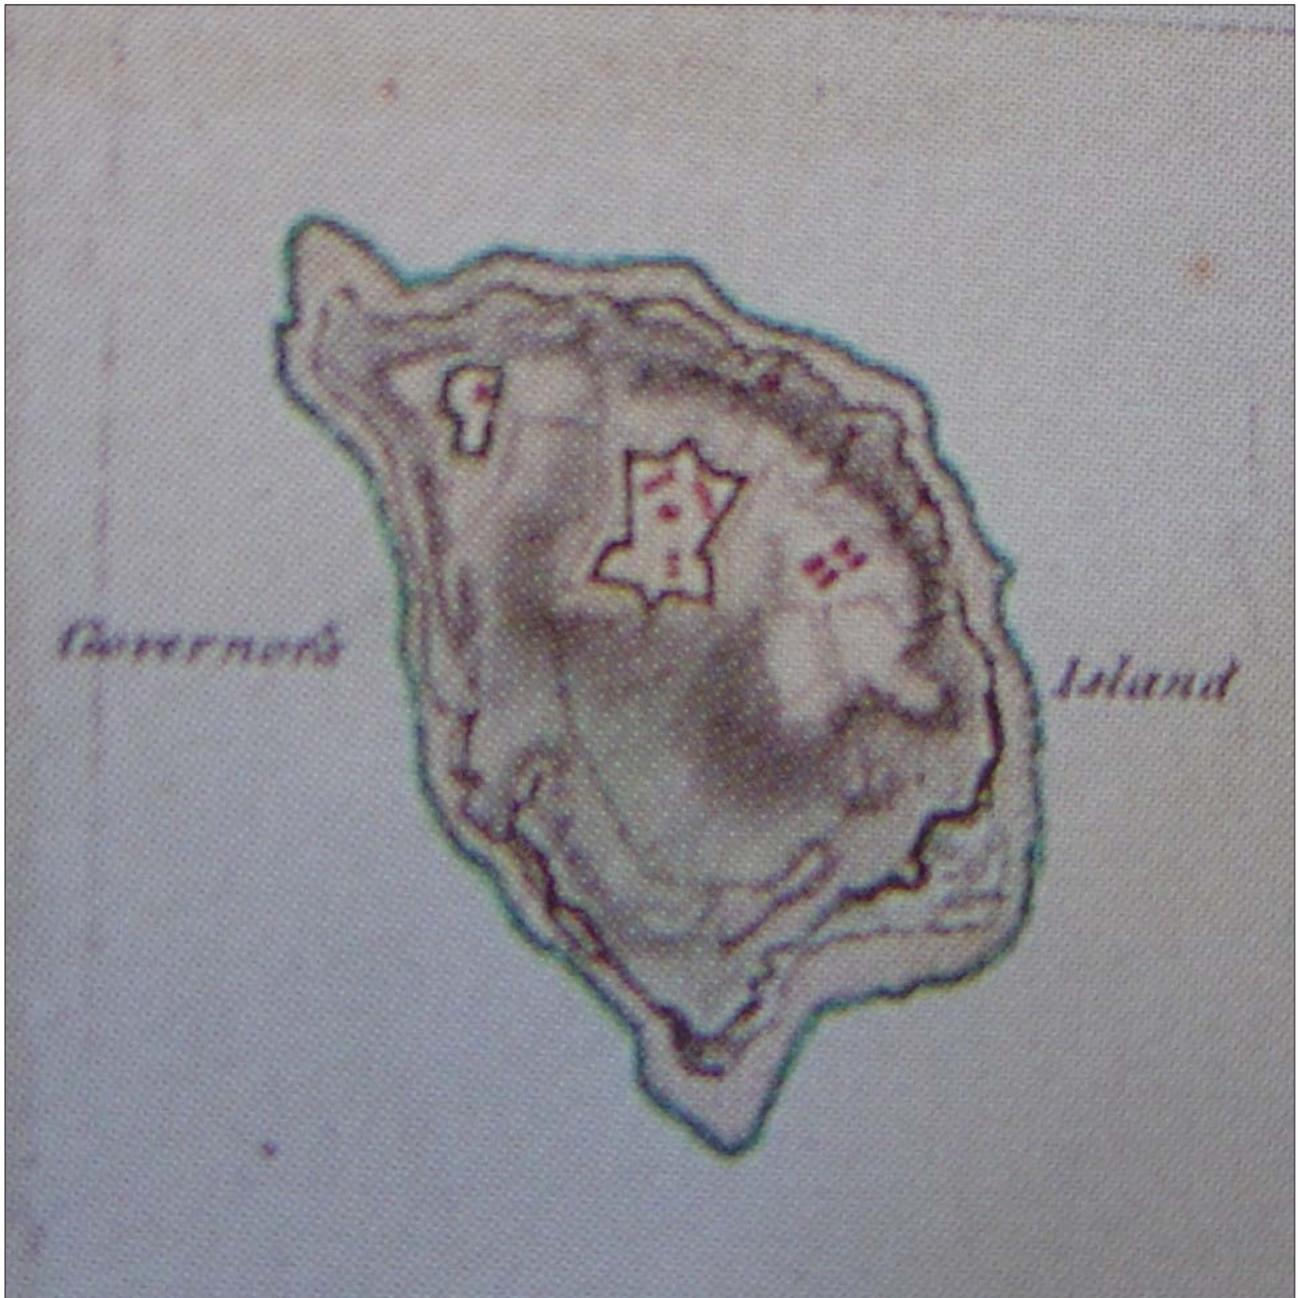
Figure 2.13. Untitled map, 1782. This map documents some of the features described by the British when they handed over control of the island to the Americans in 1783. The central fort, extensive water batteries near the water's edge, manipulated topography, and support structures are all visible (Governors Island, circa 1782, Public Records Office, London, as in Yocum, "Historic Structures Report, Fort Jay, Governors Island National Monument").

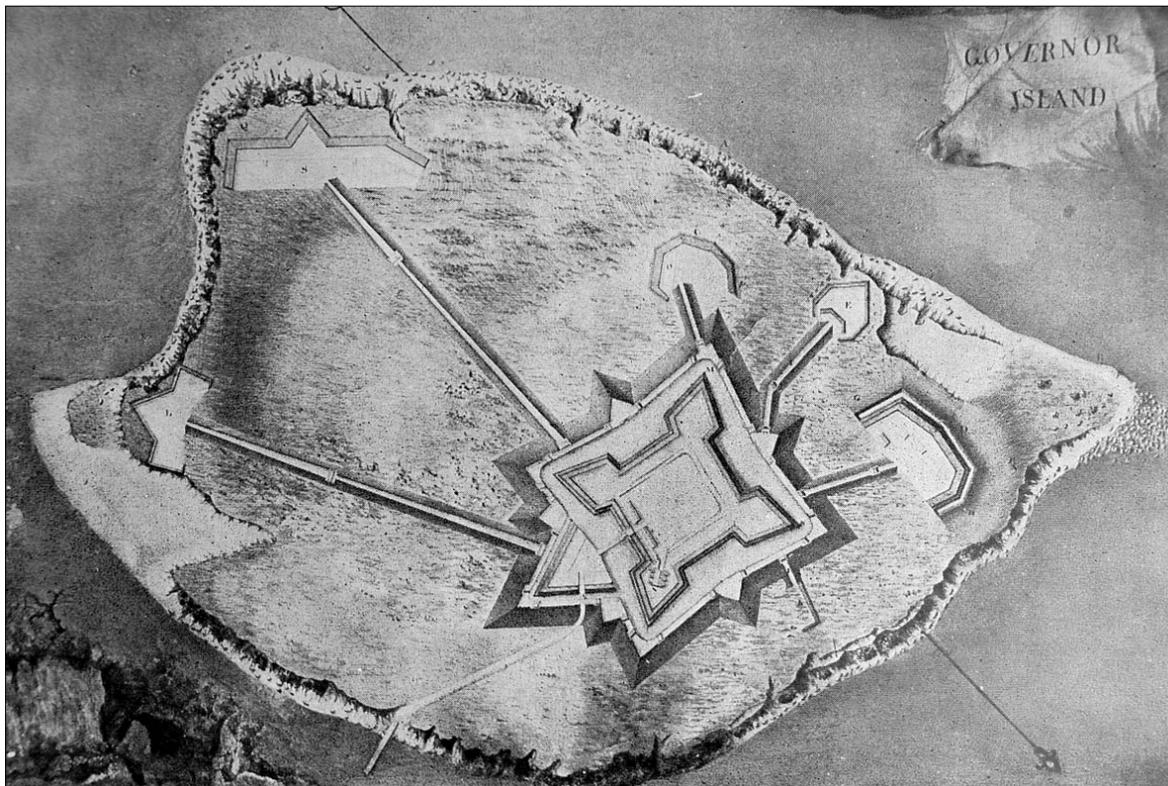
Figure 3.1. Plan of proposed fortifications on Governors Island, 1794 (as in *Governors Island, 1637-1937; Its History and Development*, 1937, original source not noted).

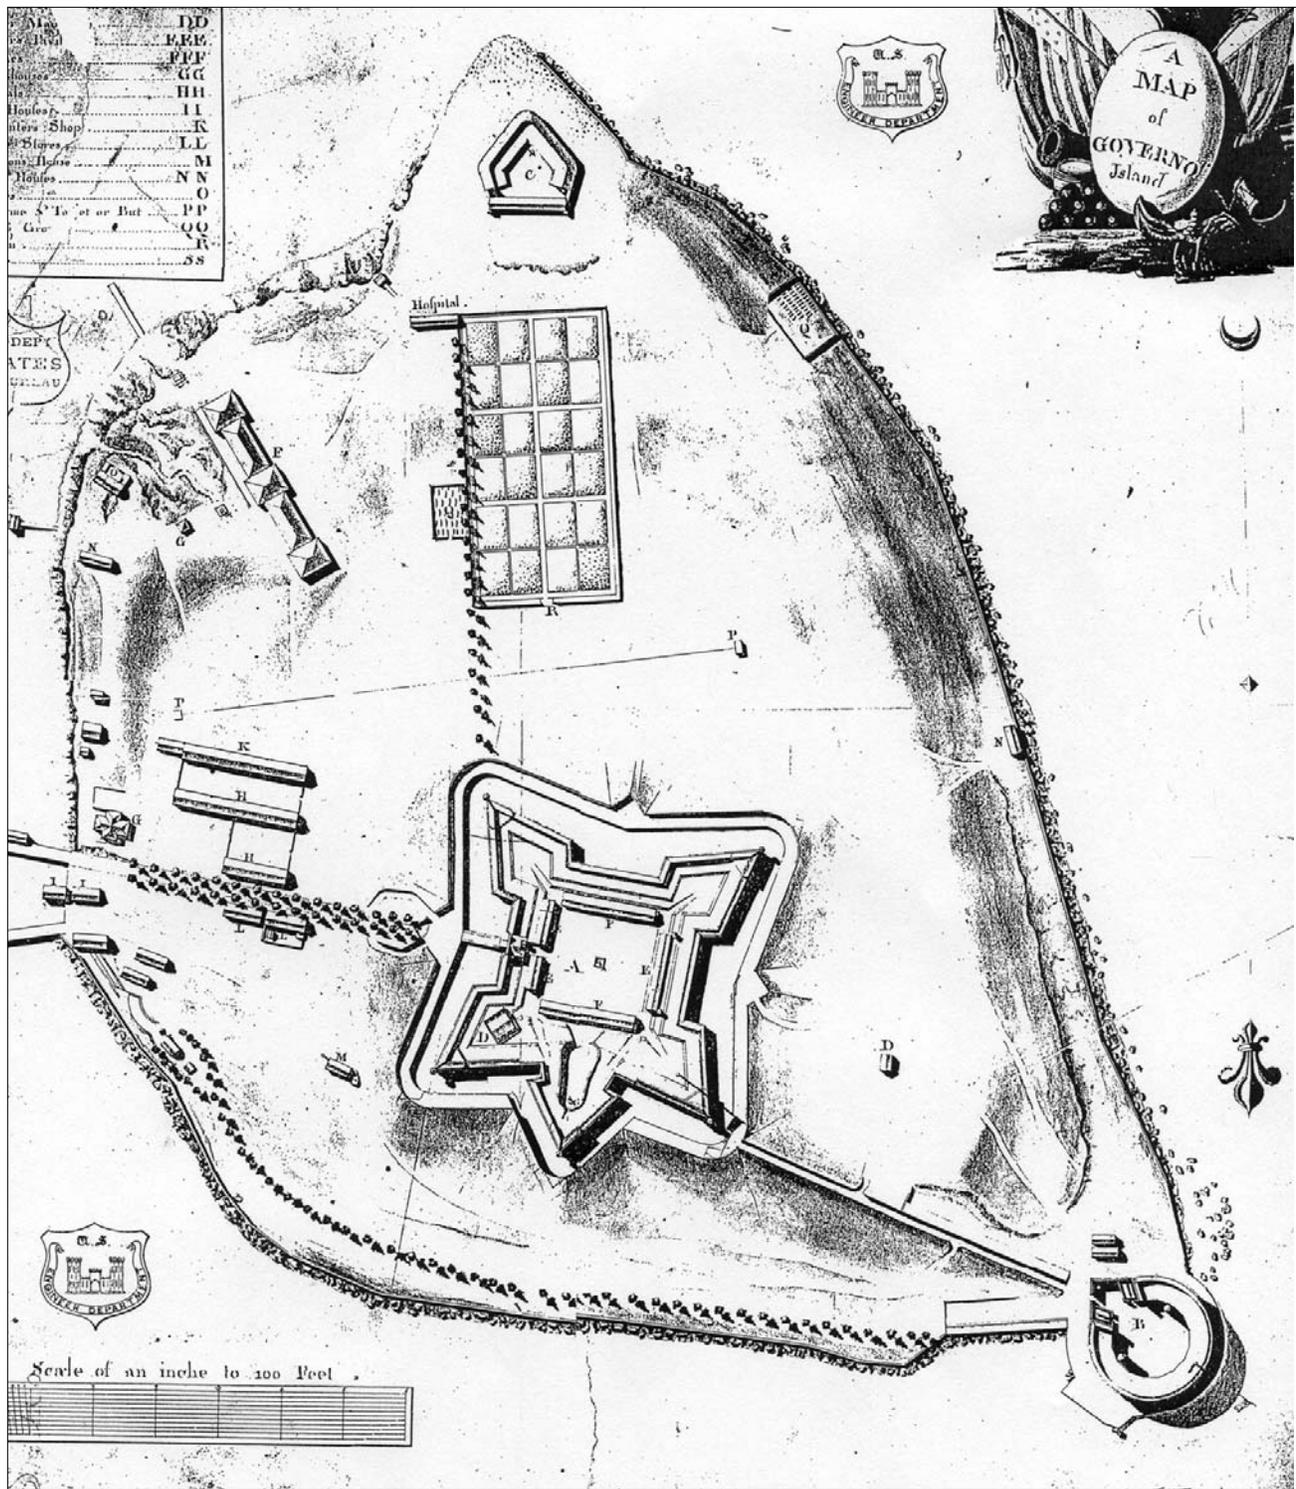
Figure 3.4. Governors Island Fortifications, circa 1813 (National Archives II, Architecture and Cartographic Branch, Fortifications files, Record Group 77, Drawer 37, Sheet 1.

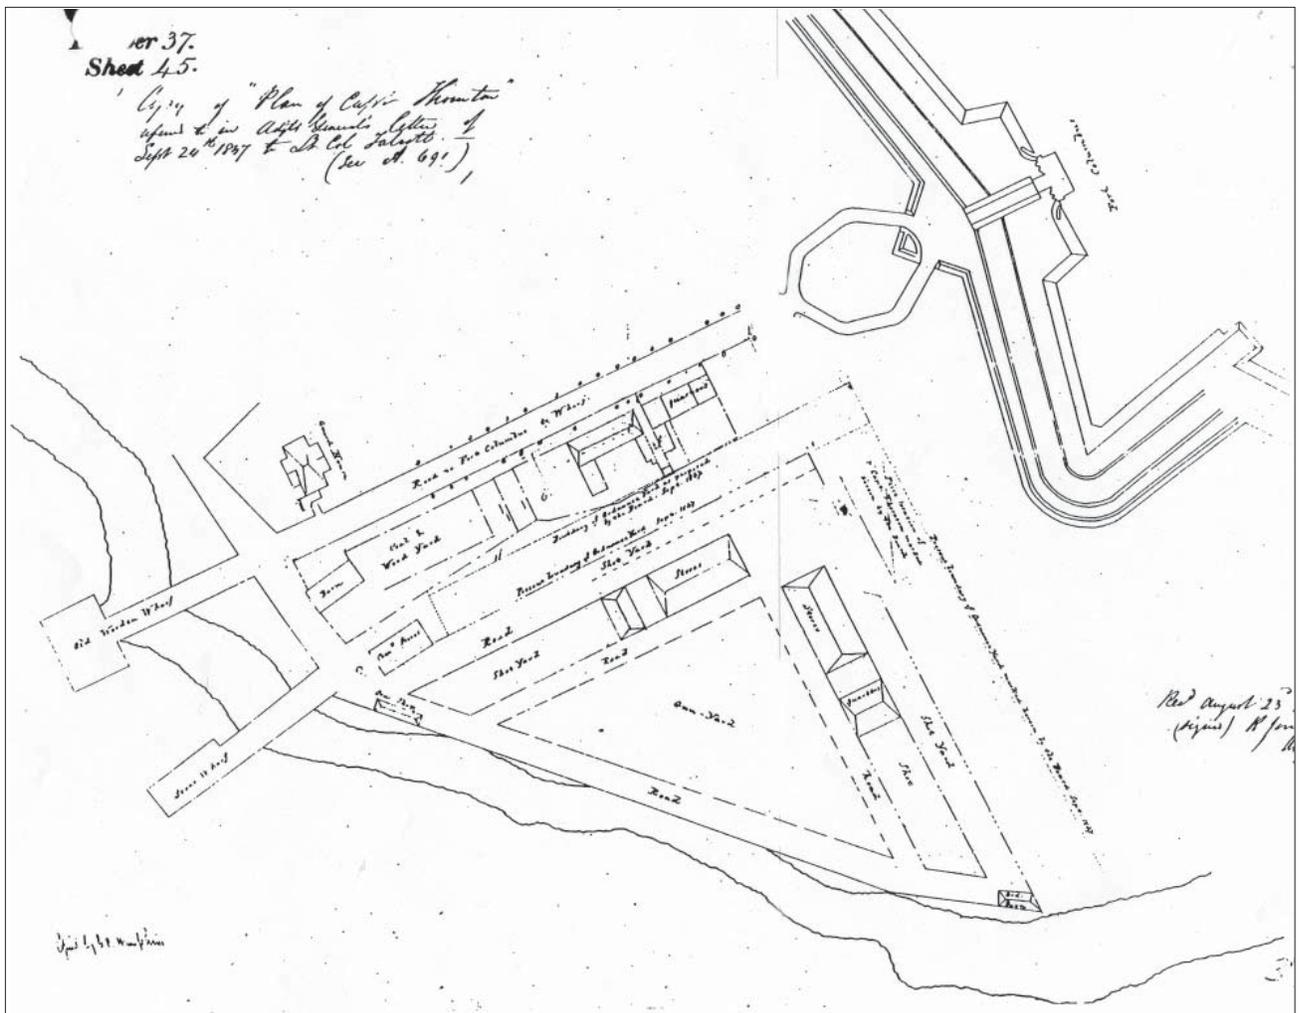
Figure 4.2. "Plan of Captain Thorton" for the New York Arsenal, 1847. Generated after development of the district had already begun, this plan articulated the spatial organization, roads, and open spaces of the Arsenal (National Archives II, Record Group 77, Fortifications File, Drawer 37, Sheet 45).

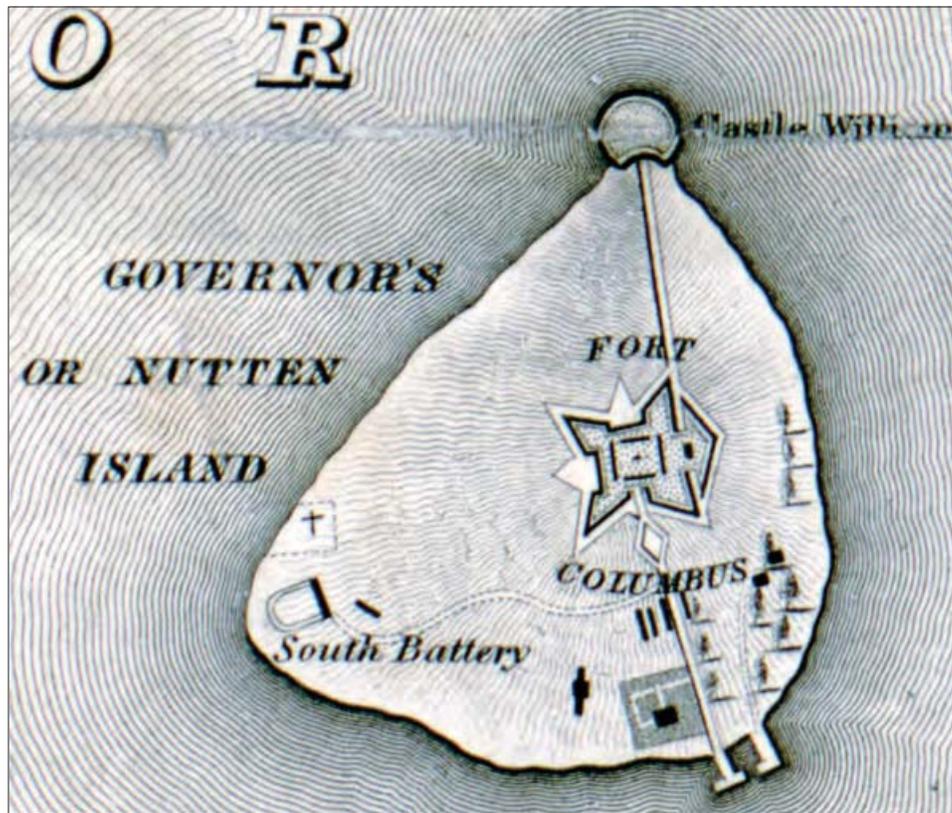
Figure 4.3. Governors Island, 1836. The newly completed Fort Columbus barracks created an inner courtyard. Arsenal developments, the Commanding Officer's quarters, and cemetery are all depicted on this plan (Library of Congress, enlargement of "Topographical map of the city and county of New York and the adjacent country," J.H. Colton and Co., #G3804.N 1836.J2).

New physical improvements for the Army facilities began in the 1830s. Initial development addressed the need for housing on the island. Inside Fort Columbus, where barracks had been located since the Revolutionary War, four new buildings replaced older structures in 1834 to provide improved conditions and make better use of the open space inside the fort. The new barracks, used as officers' quarters, were arranged in a square, backing onto the ramparts to create a geometric inner courtyard (Figure 4.3).

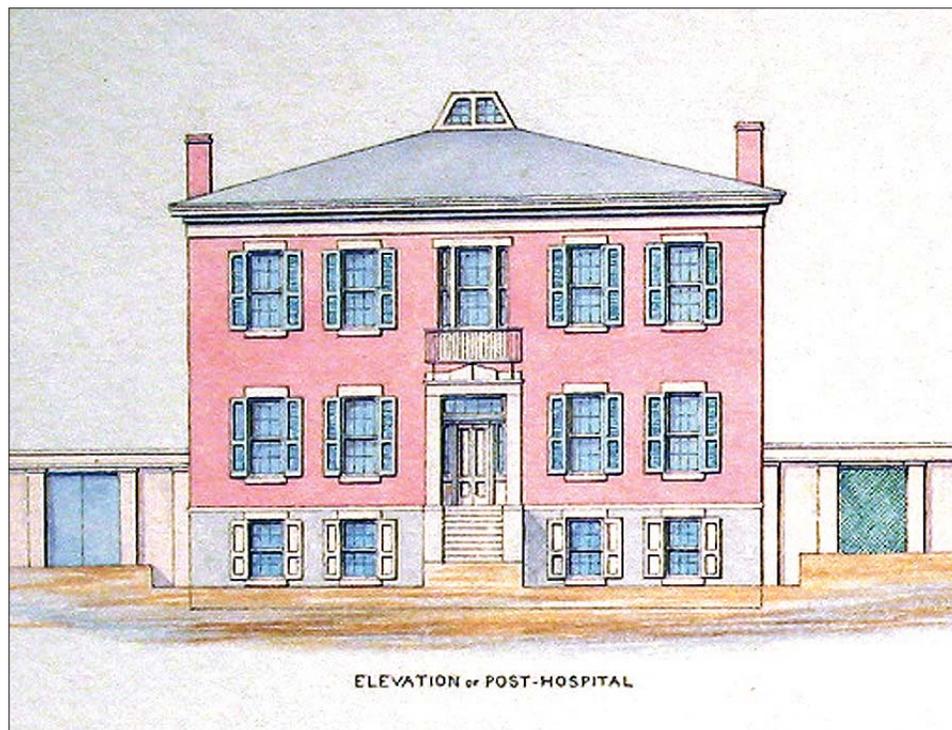
Figure 4.4. Post Hospital, 1863 (National Archives II, Record Group 77, Miscellaneous Fortification File, Records of the Office of the Chief of Engineers, #12).

Several new structures provided support services to the growing military community by the 1840s. A new hospital was built in 1839 southeast of Fort Columbus, near the location of earlier hospitals (Figure 4.4).¹¹ It was separated from the growing cluster of buildings near the wharf, likely on purpose, to separate the sick from the well and inhibit the spread of disease. The Army built a wood frame chapel southeast of the hospital, adjacent to South Battery in the 1840s.¹² Also located near South Battery was the cemetery on the southwest shore and a garden to the east of the cemetery. The Army relocated the garden from its previous location further north on the Parade Ground.

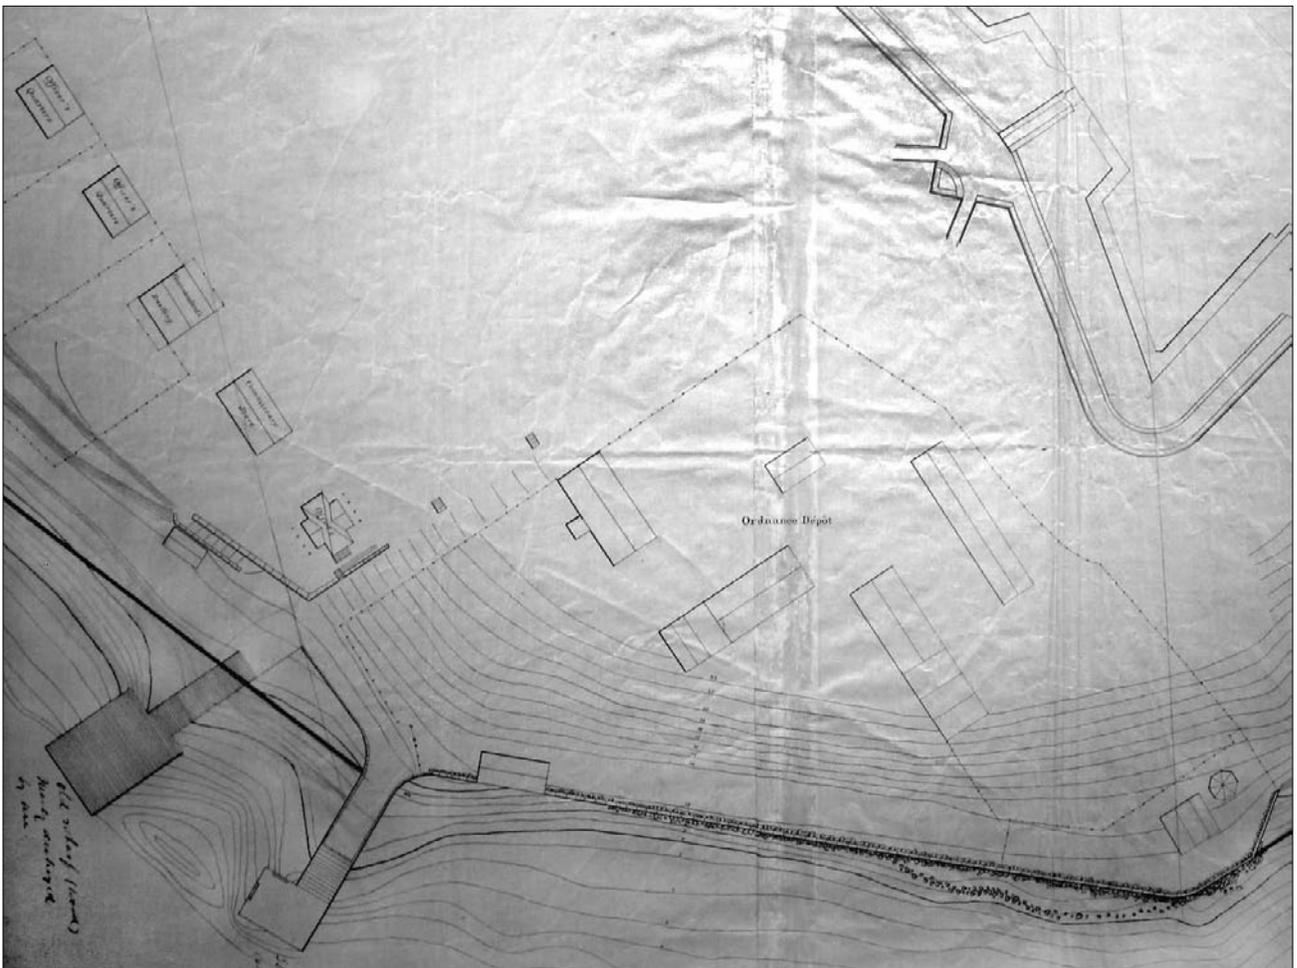
Figure 4.6. Wharf area of Governors Island, 1857 (National Archives II, "Map of a survey of the shore of Governors Island made under the direction of Major John G. Barnard, by A.R. Van Nostrand C.E., Record Group 77, drawer 37, sheet 42).

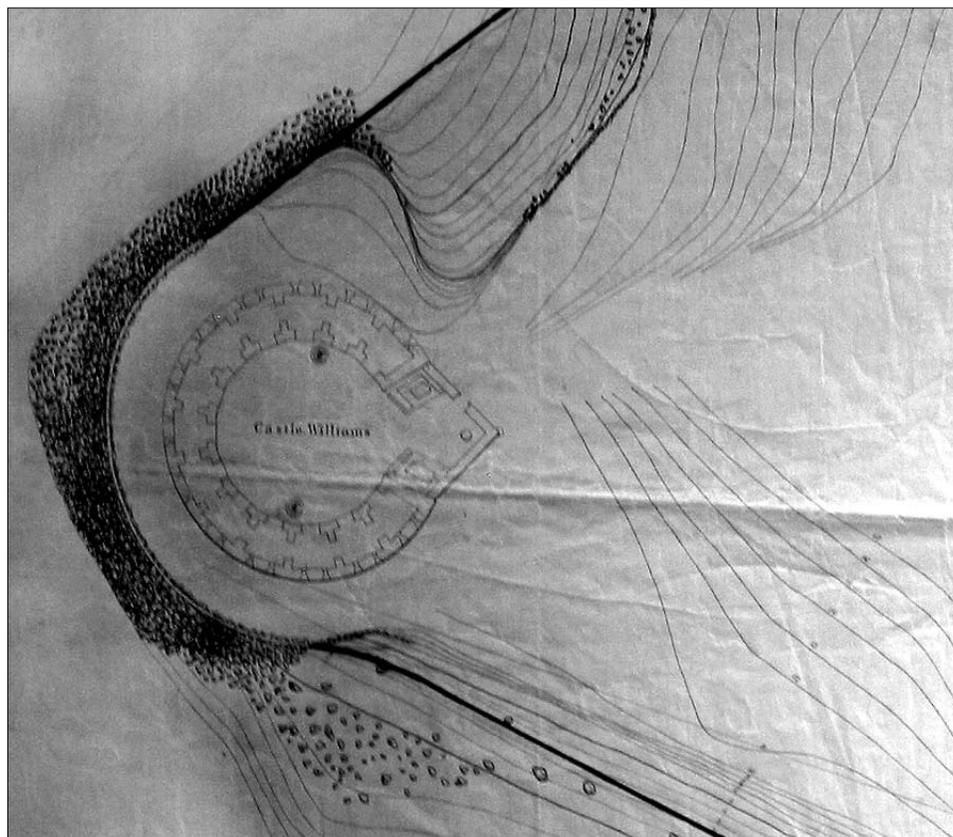
Figure 4.8. Castle Williams, 1857 (National Archives II, "Map of a survey of the shore of Governors Island made under the direction of Major John G. Barnard, by A.R. Van Nostrand C.E., Record Group 77, drawer 37, sheet 42).

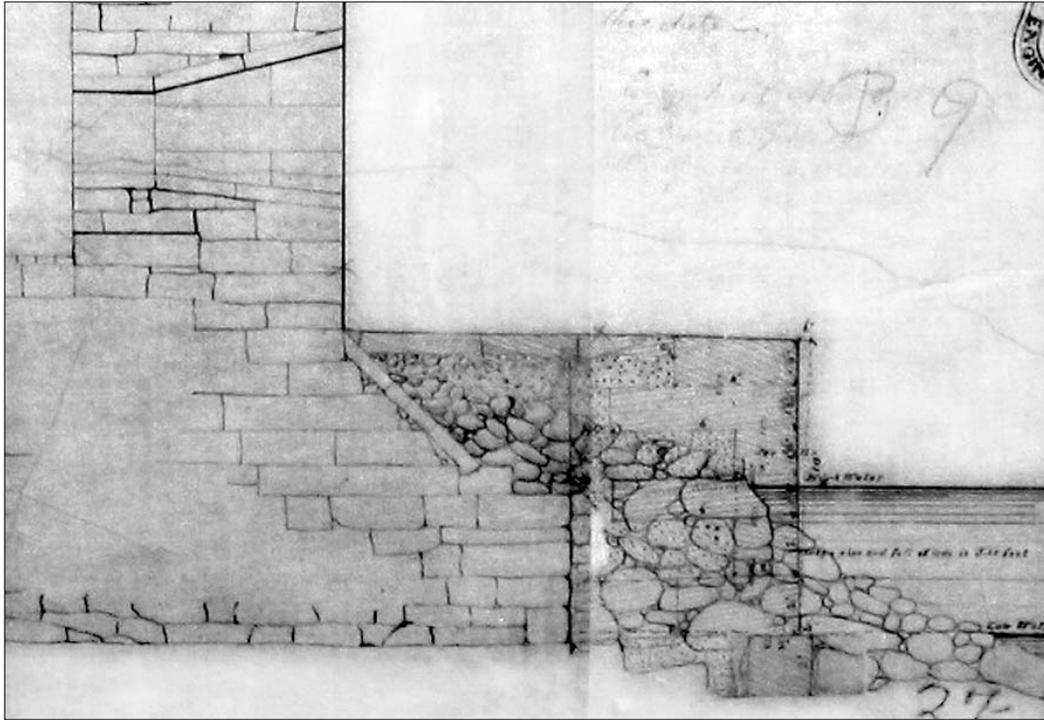
Figure 4.9. Castle Williams, 1841. This image shows the old rubble wall that abutted the fort and the proposed new seawall (National Archives II, "Section of Castle Williams, New York Harbor," Record Group 77, Drawer 37, Sheet 25).

The Army began a program of strengthening the island's shoreline in the mid-1800s, replacing the natural sand and rock beaches and bluffs with masonry walls. Encircling the entire island with engineered walls was probably not completed until the early 1900s due to repeated storm damage that obliterated segments of the Army's seawalls over several decades.¹³ However, one of the early phases can be seen in images of Castle Williams from the middle of the nineteenth century (Figures 4.8 and 4.9). Army engineers built a raised masonry platform at the base of the fortification to protect the structure from the direct impact of the ocean.

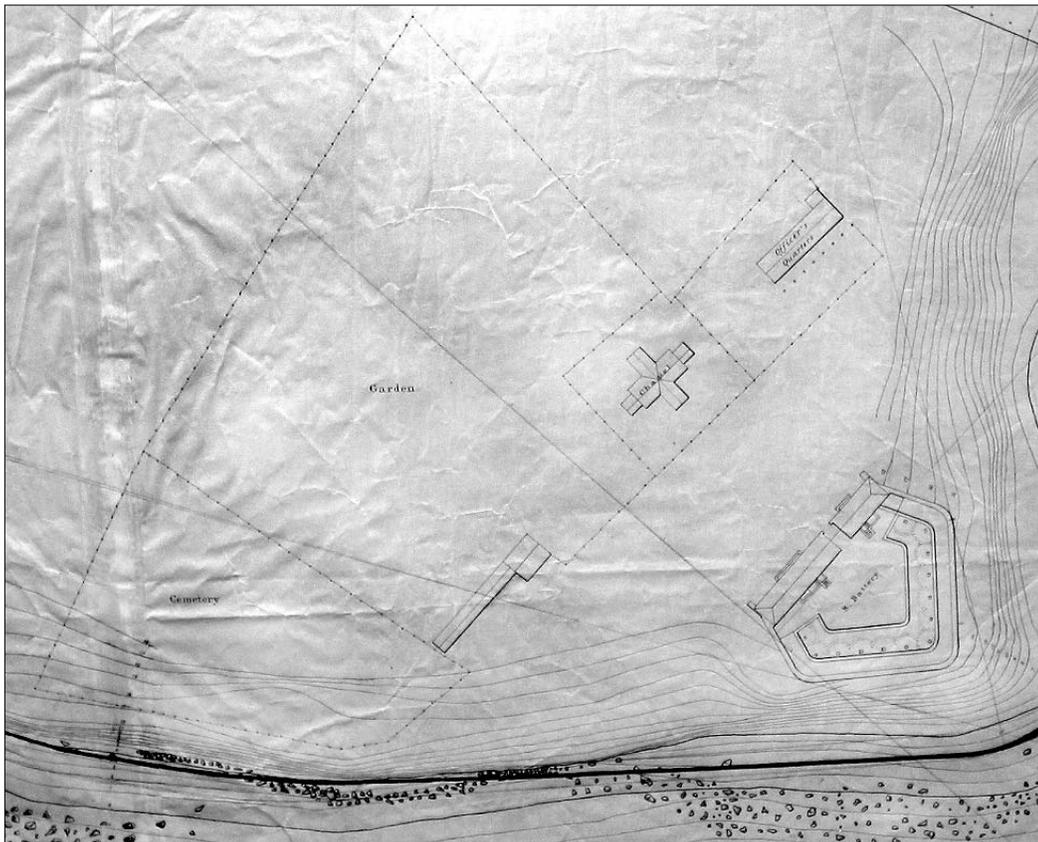
Figure 4.10. South side of Governors Island, showing the cemetery, garden and South Battery, 1857 (National Archives II, "Map of a survey of the shore of Governors Island made under the direction of Major John G. Barnard, by A.R. Van Nostrand C.E., Record Group 77, drawer 37, sheet 42).

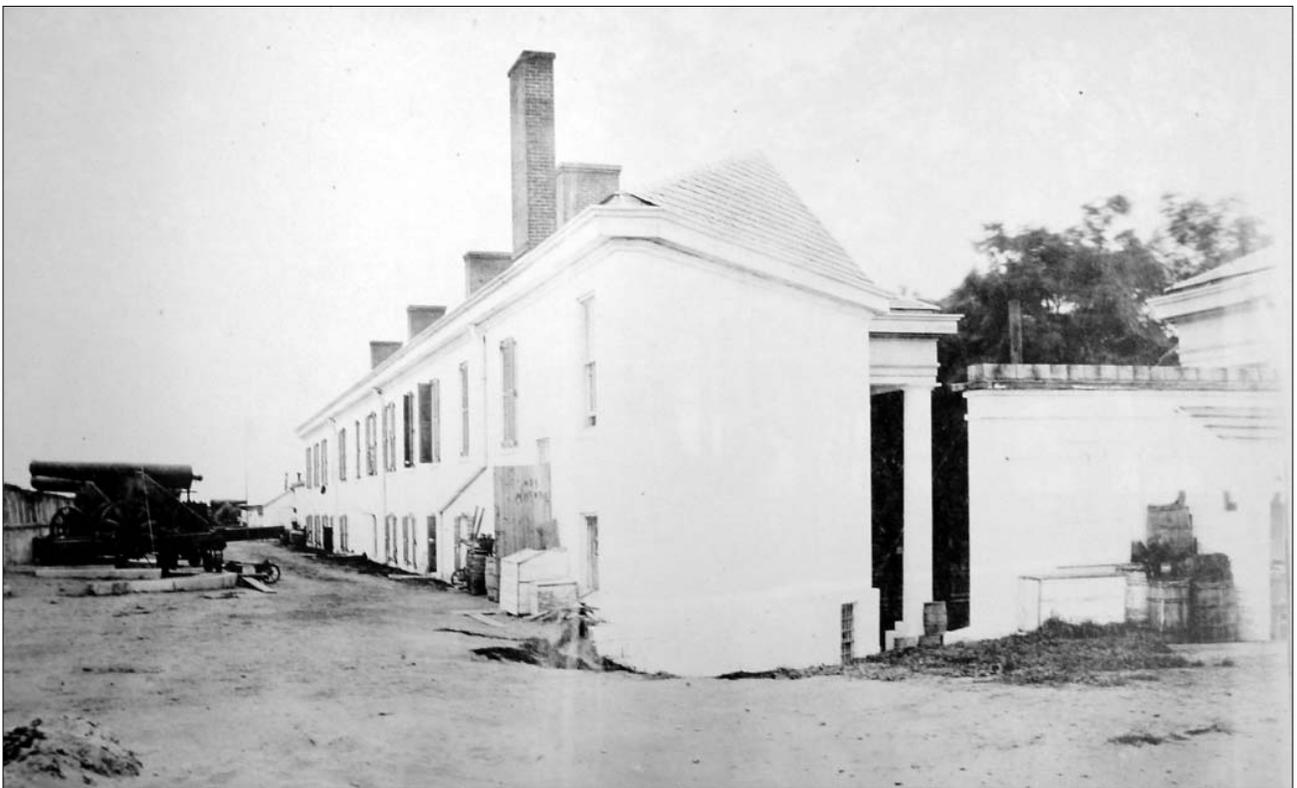
Figure 4.14. Ramparts and rear elevation of Fort Columbus barracks, 1864 (National Archives II, U.S. Quartermaster's Department, #165-C-1089; SPB/NACP).

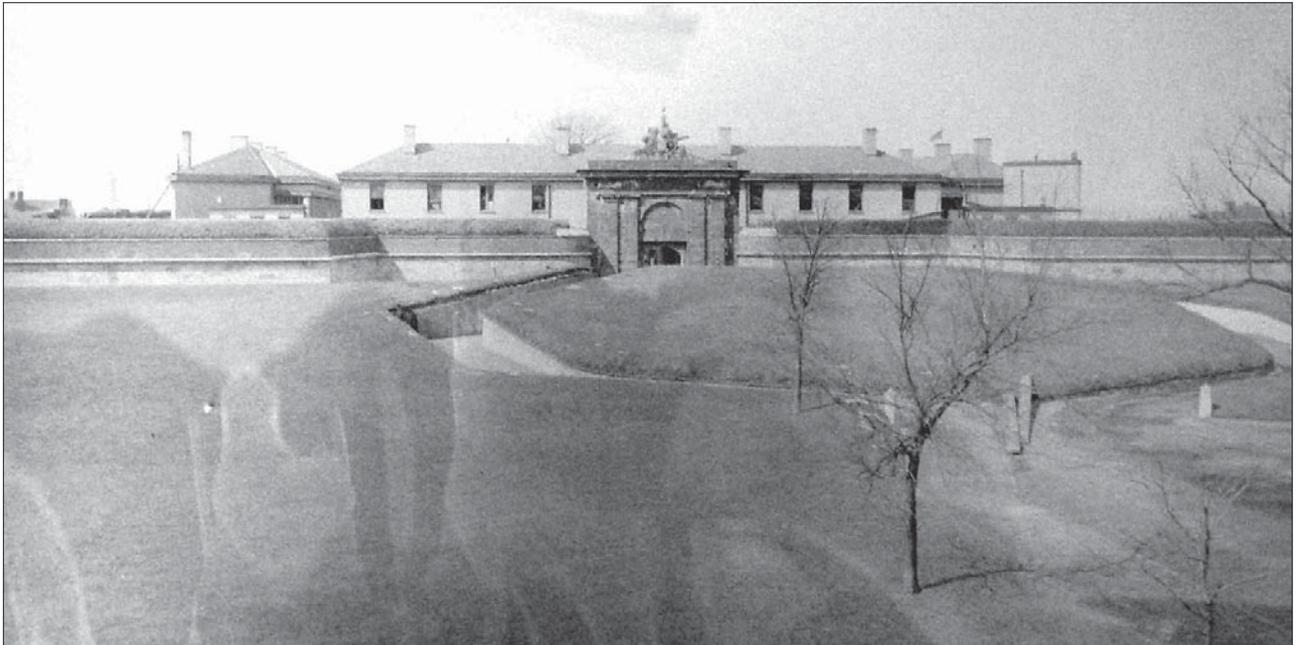
Figure 5.2. Looking west to Fort Columbus's entrance, 1898. This image illustrates the layout of the barbican blocking direct views to the Fort's gate. The street trees that lined the road between the fort and the main wharf are visible at image right (National Archives II, "Entrance to Regular Fort" at Fort Columbus circa 1898. "U.S. Military Posts of the Late 19th Century, Fort Columbus, NY," Records of the Quartermaster General, Catalogue #92-F-15-6, SPB/NACP).

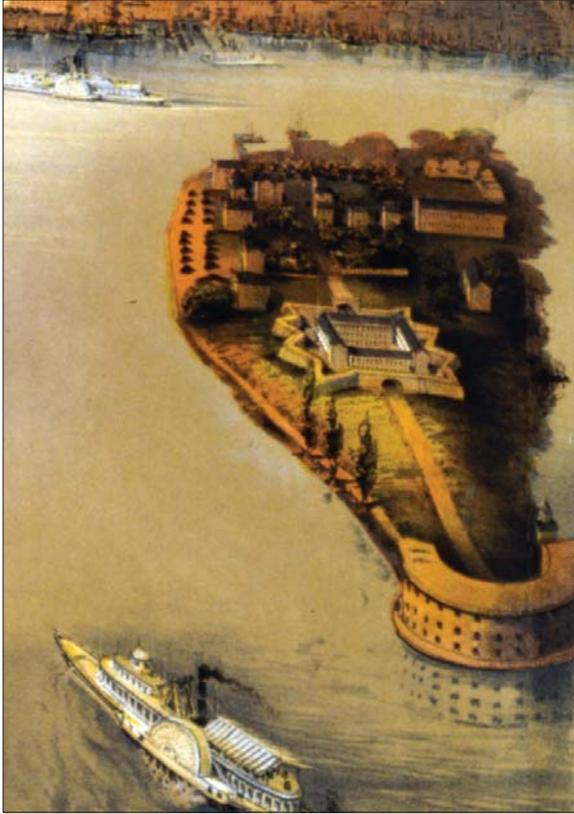
Figure 5.3. View of Governors Island, looking east, 1874. This engraving depicts the tall Lombardy poplars along the north shore of the island near Castle Williams that were also captured in the Civil War-era Matthew Brady photographs (see Figures 4.16 and 4.17) (Library of Congress, New York/ Print by G. Shlegel, Published by Tamsen and Dethlefs, c. 1874, #PGA-Schlegel-New York, 3G07337u)
