CULTURAL LANDSCAPE REPORT FOR GOVERNORS ISLAND NATIONAL MONUMENT

Volume 1:

By Lisa Nowak

Olmsted Center for Landscape Preservation
National Park Service, Boston, Massachusetts, 2010

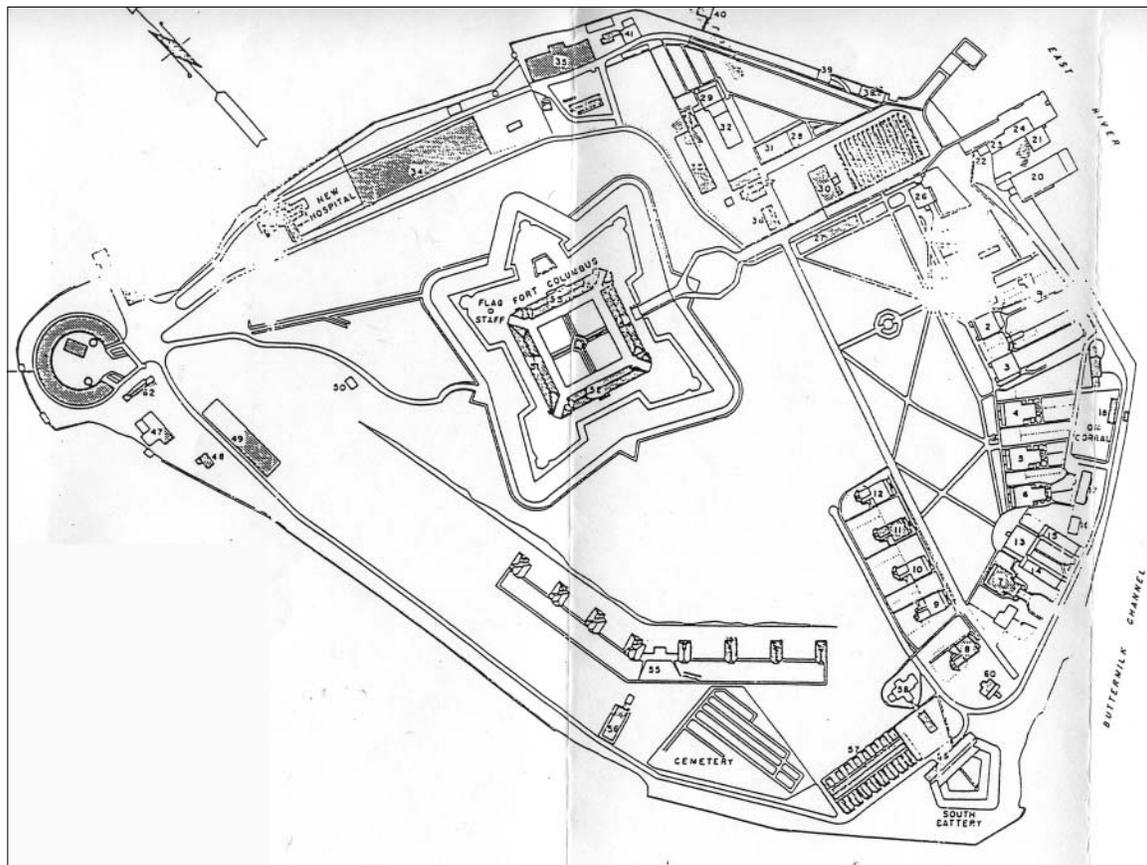
Figure 5.6. Plan of Governors Island, 1879. The deficient housing called "rotten row" was replaced with new wood frame cottages, depicted on the map between South Battery and the cemetery ("First U.S. Army Engineers Map of Governors Island - 1878, from a survey by 1st Lt. E. Griffin, CE and F. N. Owen, Asst. Engr." Redrawn in January 1962, Appearing in "Ordnance and Explosives Archives Search Report, Findings," U.S. Coast Guard Support Center, Governors Island, 1997, Governors Island National Monument collection).

The Army built a row of new wood-frame barracks, observed as “pretty frame cottages,” near South Battery, adjacent to the post cemetery and vegetable garden in 1872 (Figure 5.6).⁸ These structures reportedly replaced older barracks buildings that had earned the unflattering nickname “rotten row.”⁹

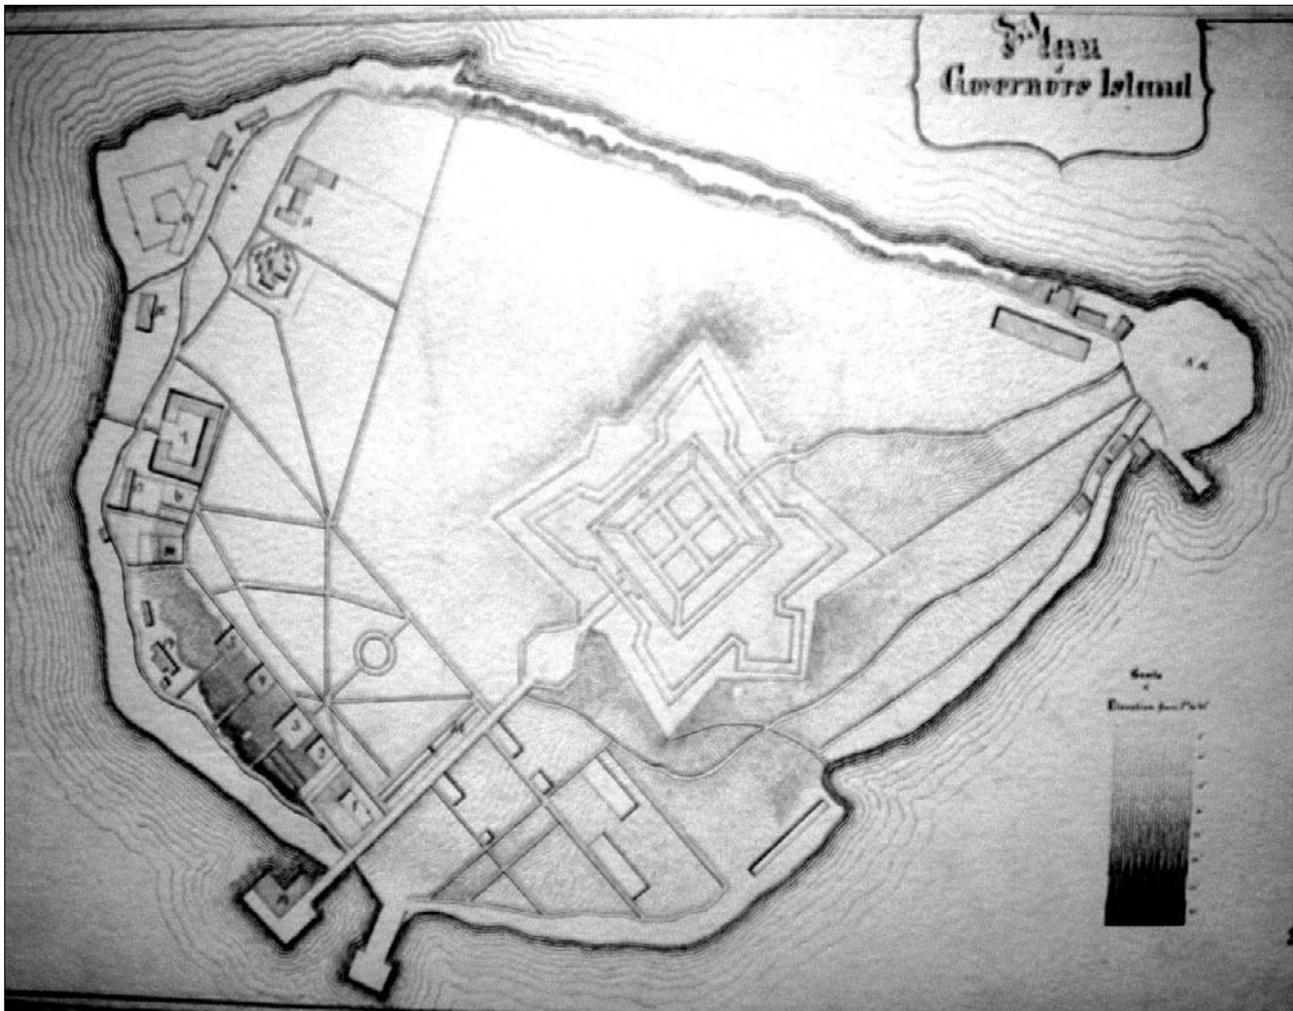
Figure 5.7. Plan of Governors Island, 1871. This plan clearly depicts the buildings and circulation systems of Governors Island. Nolan Park, the new park-like district of officers' quarters, is pictured at image left. As of 1871, only a few of the Nolan Park residences were completed and the district, characterized by the complex system of pedestrian paths, opened onto the Parade Ground (National Archives II, RG 77 Miscellaneous Fortification File, #33, Records of the Office of the Chief of Engineers).

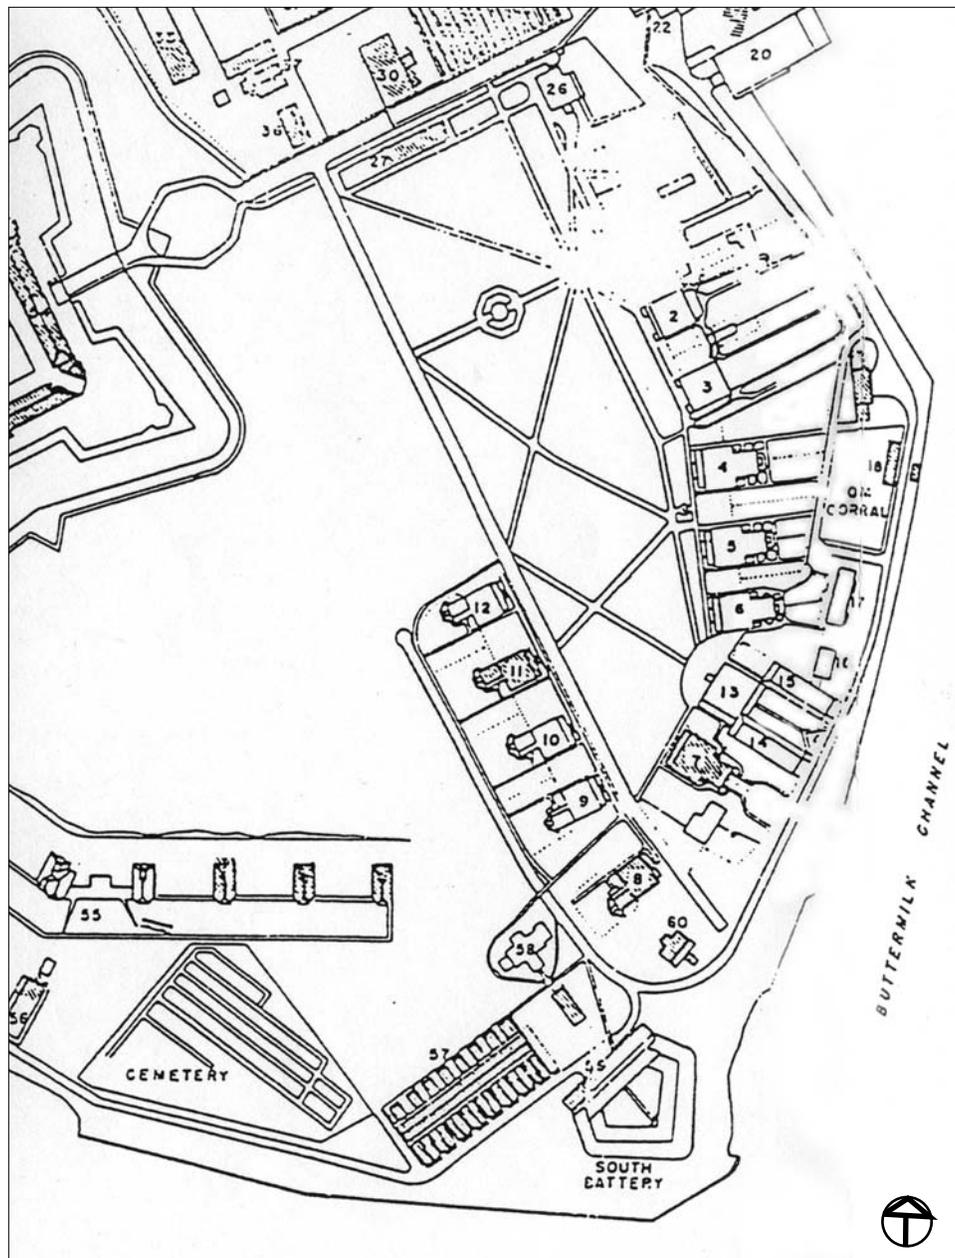
Figure 5.8. Governors Island, 1879. This enlargement highlights the new dwellings (buildings 8-12 on the plan) built on the southeast side Nolan Park, partially enclosing the park that formerly overlooked the open parade ground ("Map of Governors Island, 1879, First Army Engineers, redrawn in January 1962, appearing in "Ordnance and Explosive Archive Search Report," U.S. Coast Guard, Governors Island National Monument files).

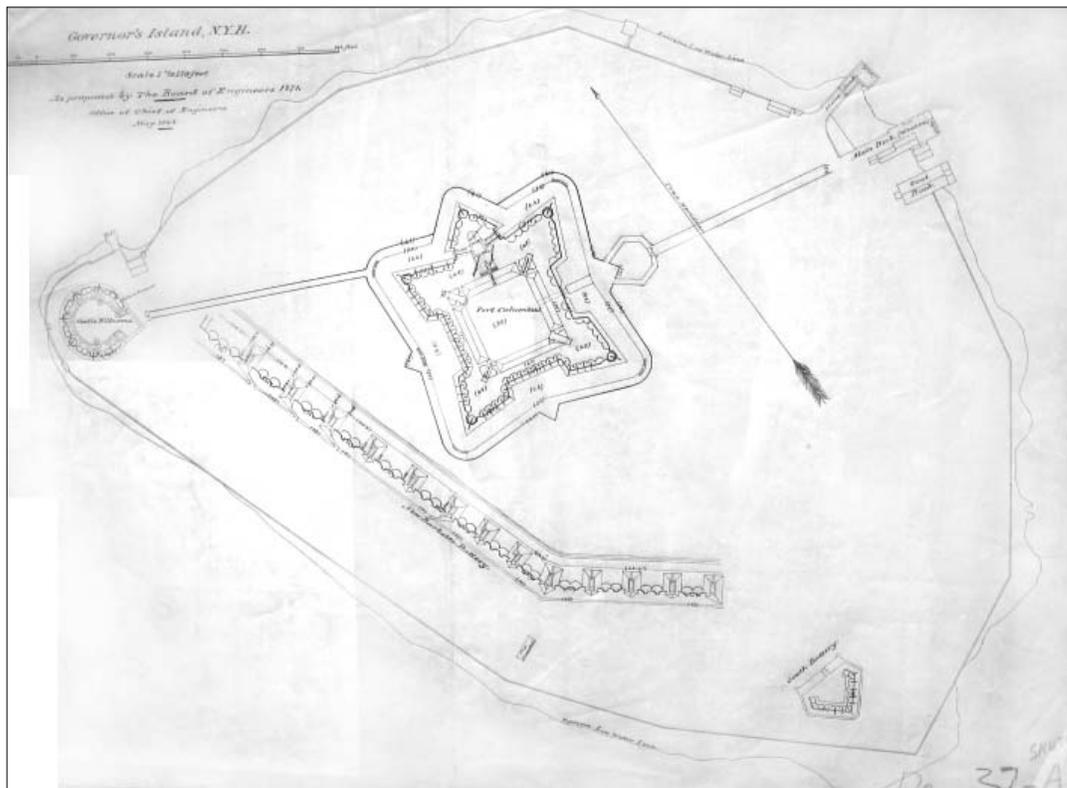
Figure 5.9. Sketch of proposed barbette battery at Governors Island, 1871. Military engineers designed a long open platform battery spanning the south side of the island to provide coverage of the harbor (National Archives II, RG 77, Drawer 37, Sketch A “Governors Island, NY, as proposed by the board of engineers, 1871,” NARA cartographic).

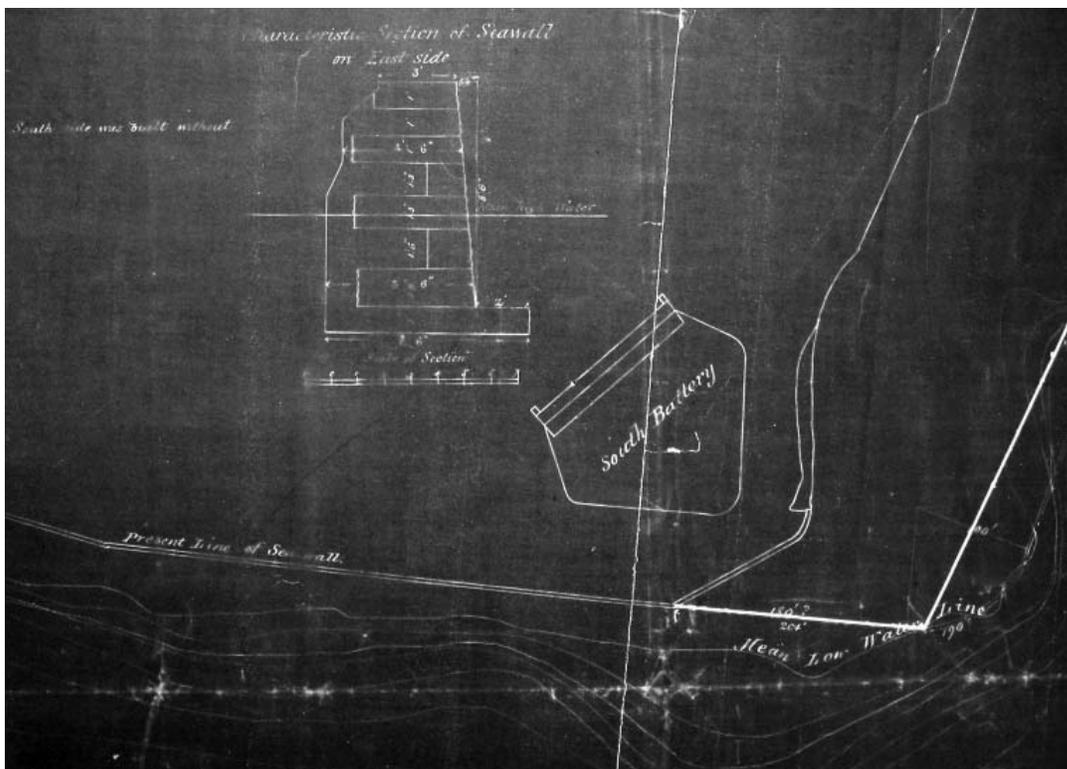
Figure 5.10. Plan of Governors Island showing the seawall (dark white line) built around South Battery, 1880. The seawall was extended along the east side of the island (on the right side of the image) to strengthen the shoreline and add usable land (National Archives II, RG 77 Drawer 37, Sheet 71, “Map of Governors Island with Water Contours to the Twelve Foot Curve,” NARA cartographic).

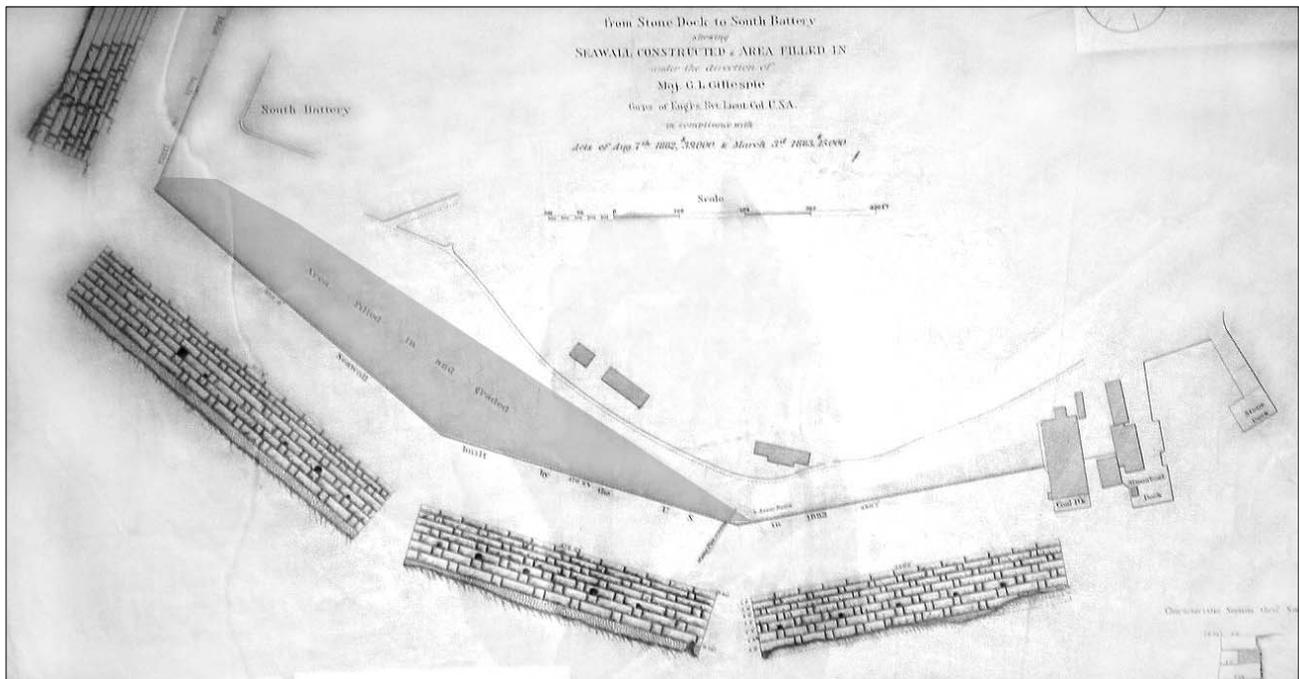
Figure 5.11. Plan of the extended seawall on the east side of the island, 1884. Note South Battery on image left. This plan highlights the amount of fill used to complete the eastern seawall (National Archives II, RG 77, Drawer 37, Sheet 63, "Chart of the East Shore of Governors Island, 1884," NARA cartographic).

¹³ As noted on “Chart of the East Shore of Governors Island, 1884,” National Archives II, RG 77, Drawer 37, Sheet 63, NARA cartographic.

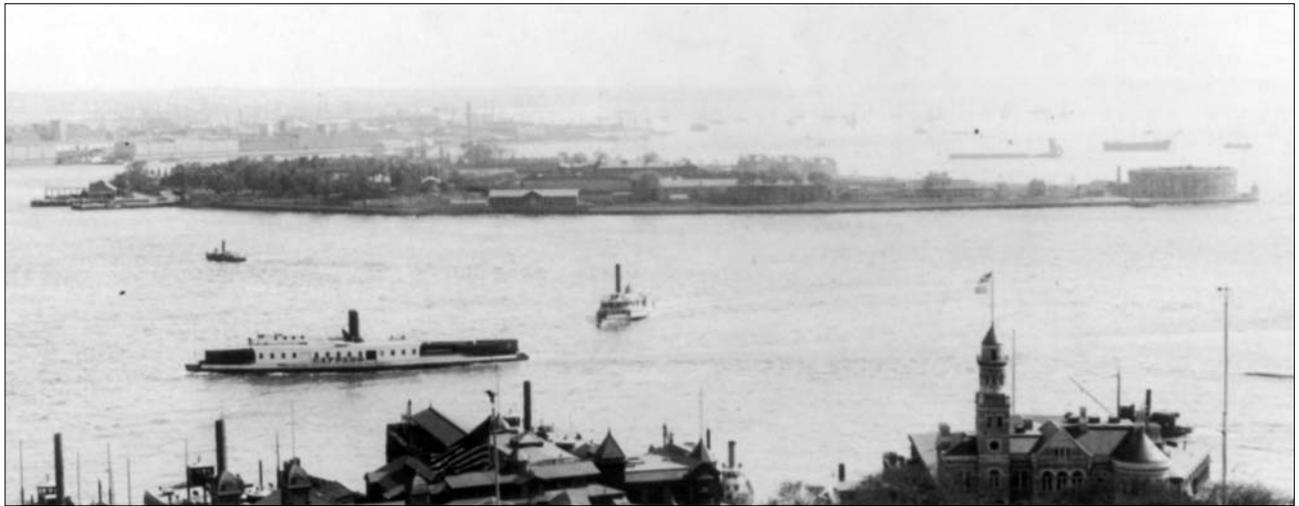
Figure 5.12. Governors Island as seen from Manhattan, 1894. Near the turn-of-the-century, the northern shoreline of Governors Island had been engineered through the construction of perimeter seawalls (Library of Congress, image # 3614809).

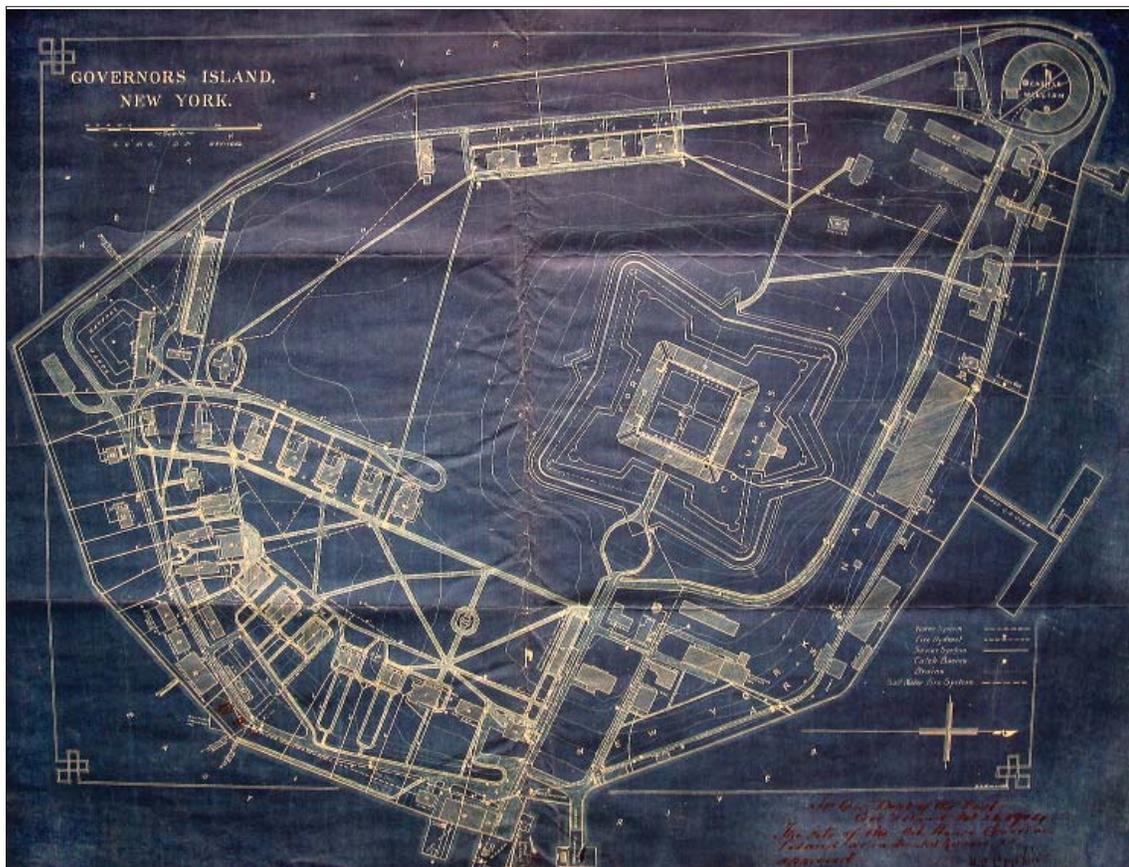
Figure 5.16. Governors Island plan, 1902. This blueprint depicts conditions of the island at the turn-of-the-century, illustrating the existing buildings, wharves, and circulation systems (National Archives II, RG 92, Blueprint File, Governors Island, NY, #5).

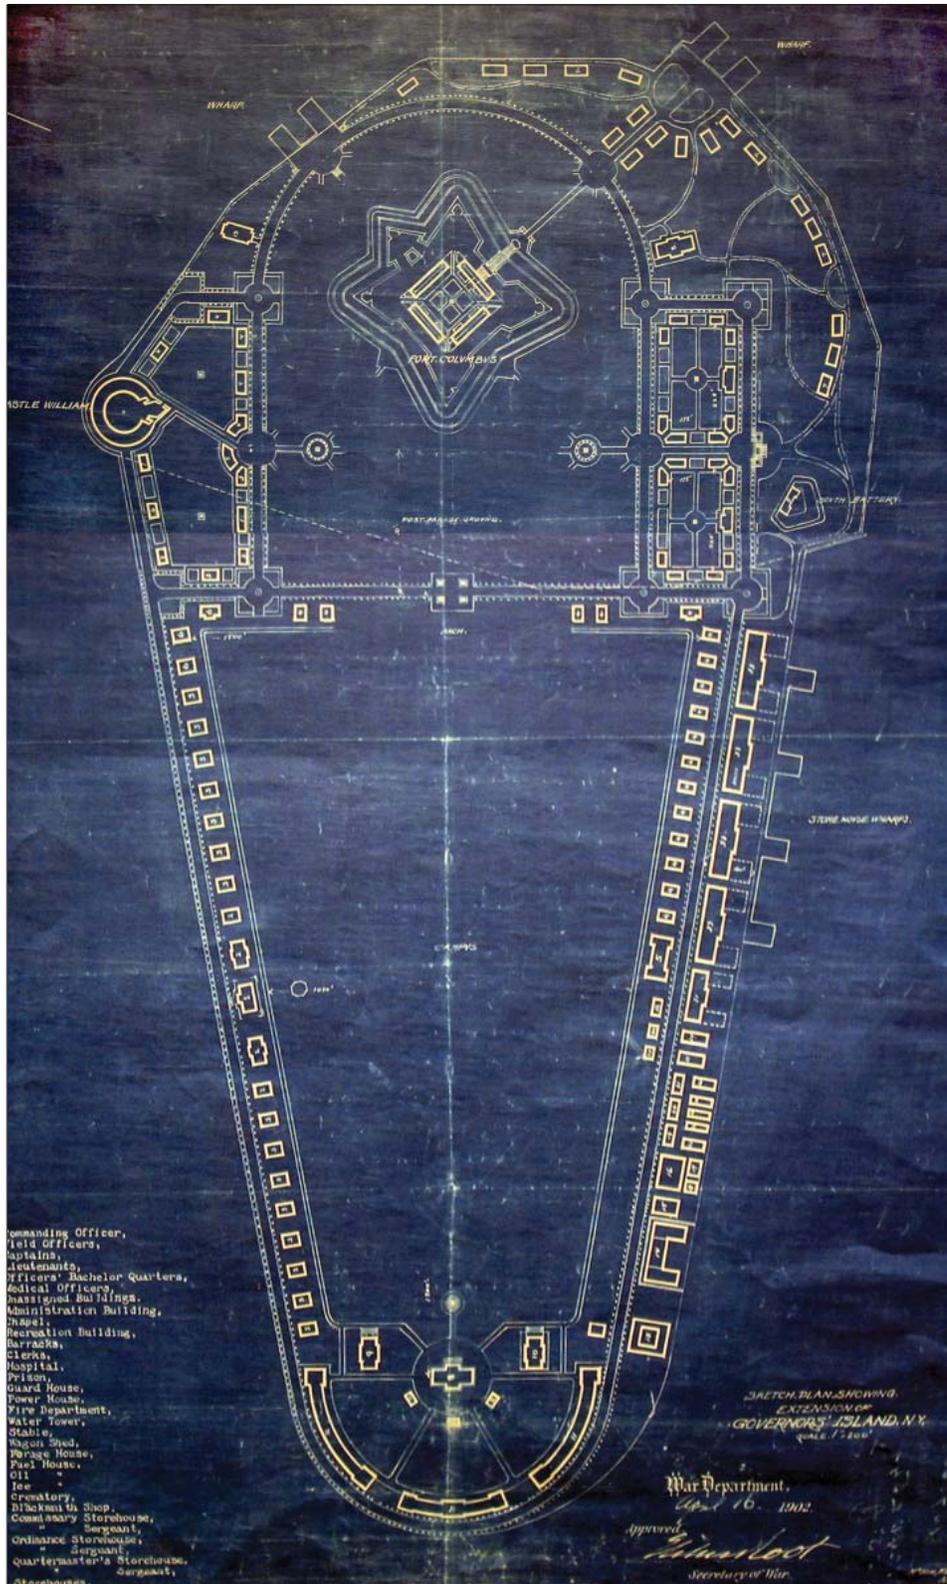
Figure 5.17: Proposed plan of the redesign of Governors Island, prepared by McKim, Mead, and White, 1902. Anticipating the expansion of the island, the War Department contracted with architects to generate a new vision for Governors Island. This plan called for the removal of all of the island's existing infrastructure, with the exception of Fort Columbus, Castle Williams, and South Battery (National Archives II, RG 92, Blueprint file, Governors Island, NY, #2, "Sketch Plan Showing Extension of Governors Island," April 16, 1902, NARA cartographic).

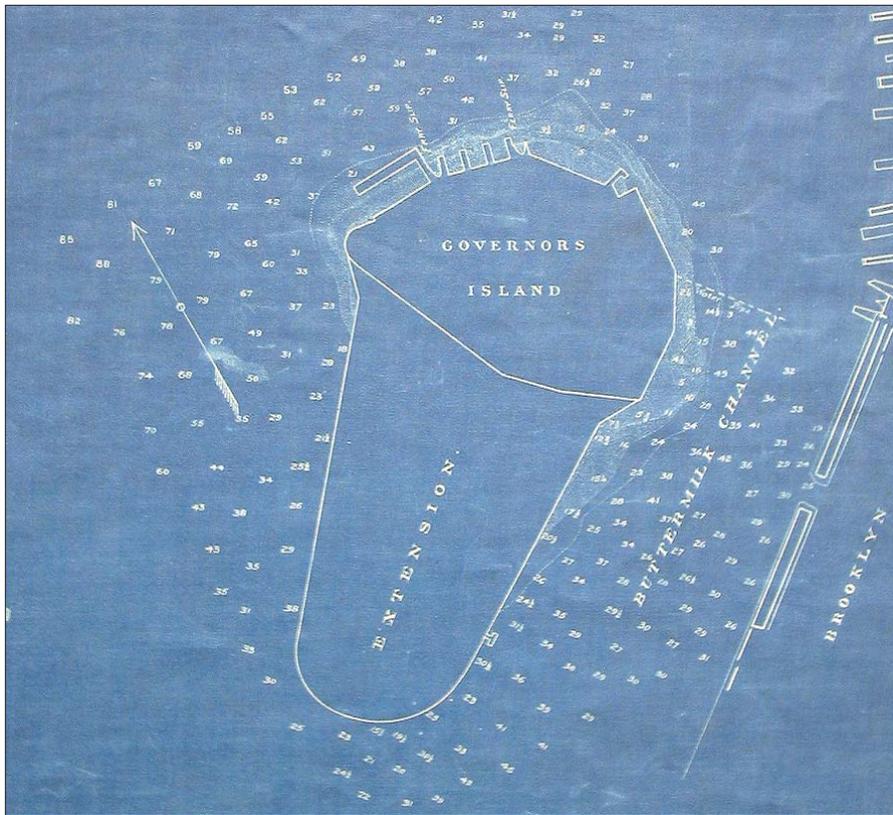
Figure 5.18: Plan showing the extension of Governors Island, proposed piers, ferry slips, and depth chart, 1907 (National Archives II, RG 92, Blueprint file, Governors Island, NY, #9, "Governors Island, Plan Showing Proposed Piers and Ferry Slips," May 1907, NARA cartographic).

Despite the time and money spent redesigning Governors Island, none of McKim's plans came to fruition. Work did progress on the island expansion, first by building seawalls around the shoals, then by pumping the water out and lastly by filling the void (Figure 5.18). The project was largely complete by 1909 (Figure 5.19).

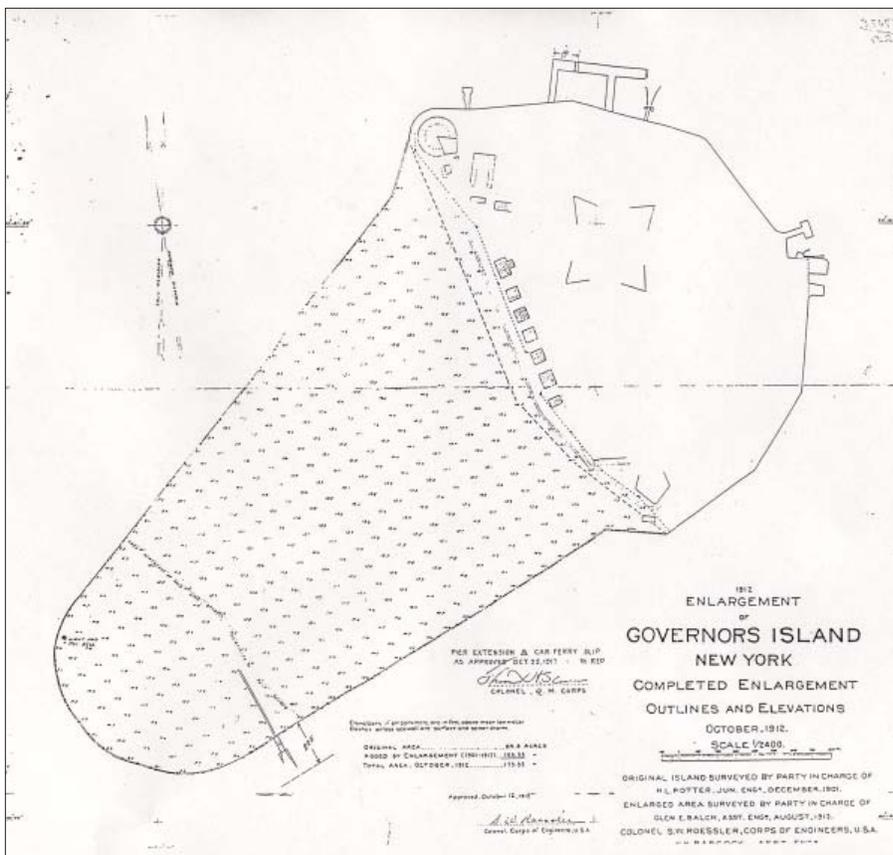
Figure 5.19. As-built drawing of the enlargement of Governors Island, 1912. The new land mass was surveyed. The only feature recorded was a light and fog tower on the southwest side of the island ("1912 Enlargement of Governors Island, New York, Completed Enlargement, Outlines and Elevations, October 1912," National Archives-Northeast Region, New York, NY, RG 77, entry 802, Box 25: New York City, Governors Island; File: 5 Docks).

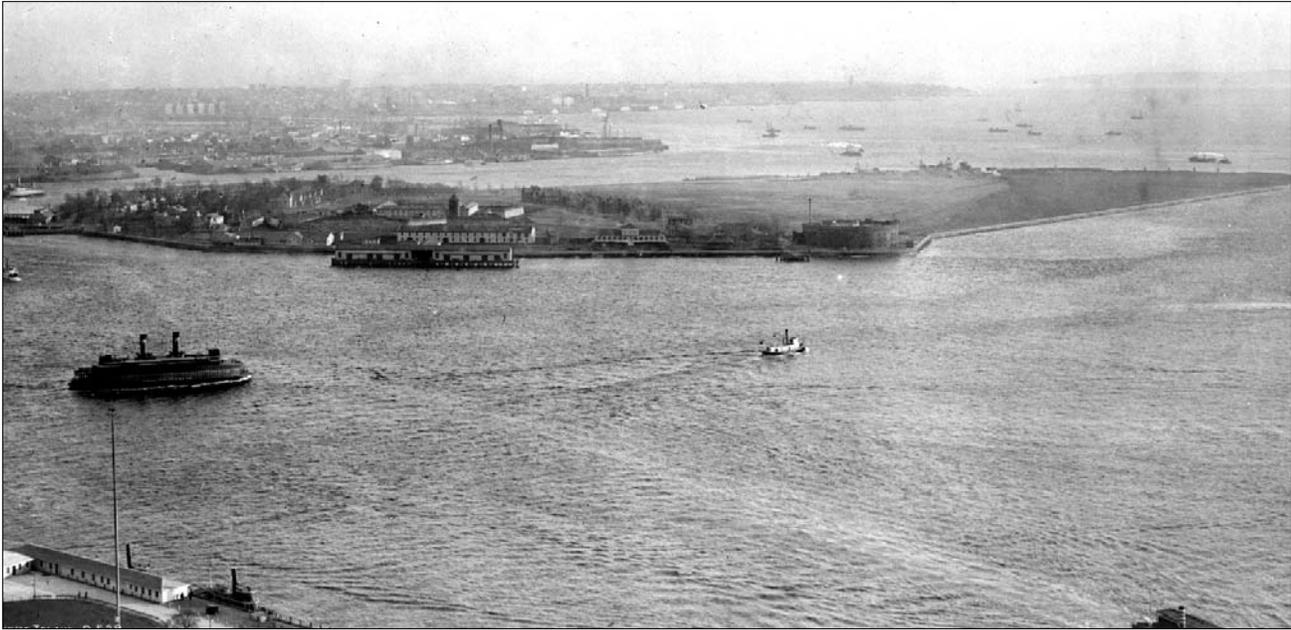
Figure 5.20. Governors Island, 1911. This photograph was taken shortly after the island's expansion. With the exception of a few small structures on the far tip of the newly filled land, the south portion of the island was devoid of development (Library of Congress, LOT 12482 [P&P]).

Little development occurred on the island's new land following the completion of the expansion project. As seen in a 1911 photograph of the island, a small cluster of unidentified structures stood on the far end but the rest of the terrain remained devoid of defining features (Figure 5.20). This stood in stark contrast to the original portion of the island, with its well established street trees, green lawns, work yards, and domestic and utilitarian buildings (Figures 5.21 and 5.22).

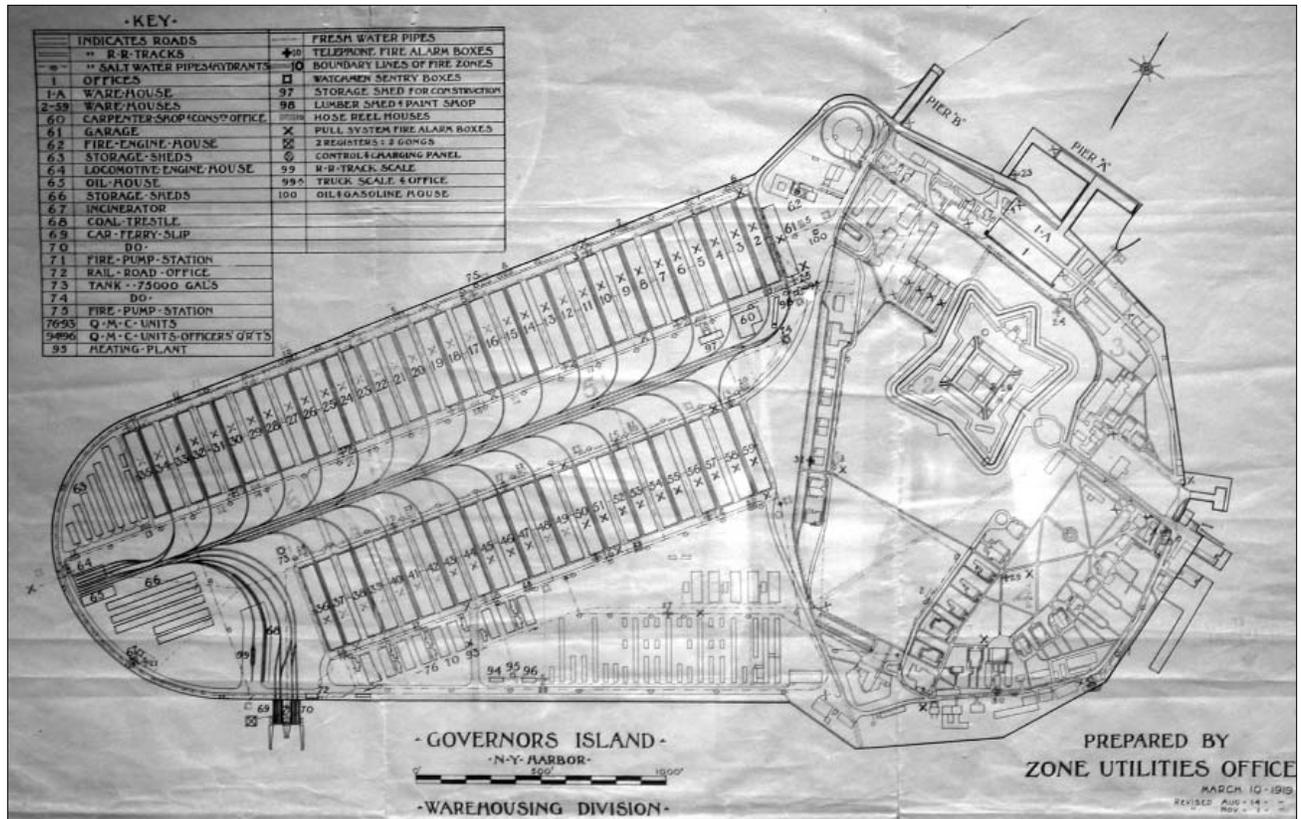
Figure 5.24. Plan of Governors Island, 1919. This image, prepared by the warehousing division, depicts the conditions of the island after World War I. The south side of the island, image left, is covered by temporary warehouses and support structures, and the Governors Island railroad. The map also depicts several temporary structures located around Fort Jay and Castle Williams (National Archives II, RG 92, Railroad Blueprint folder, #10-5 "Governors Island").

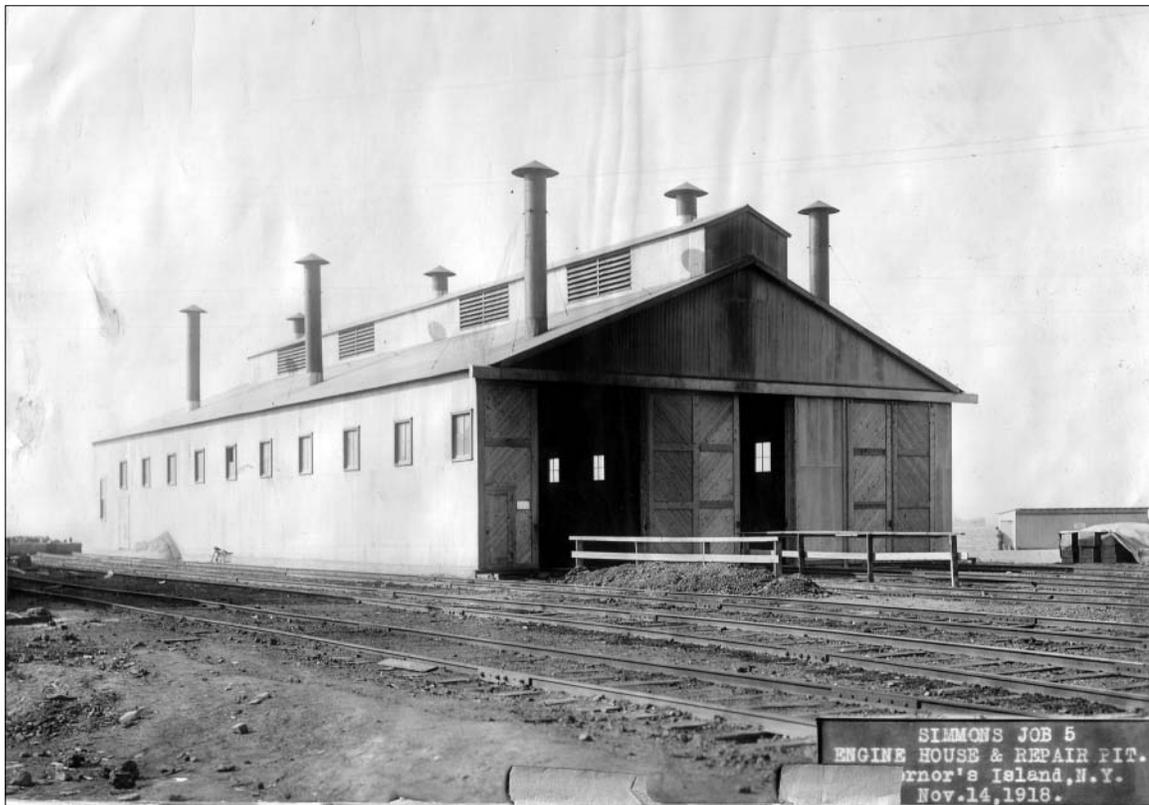
Figure 5.25. Railroad Repair Shop, 1918. This building was located on the southern tip of the island, part of the support system that transported freight between the World War I warehouses and the docks at the southern extents of the island (National Archives II, RG 77, Entry 393, Box 140).

Governors Island, strategically located at the mouth of the Atlantic Ocean and near a major shipping and population center, was positioned to serve as a supply depot for materials and soldiers heading to the war in Europe. Indecision about how to develop the new acreage was set aside and dozens of identical, massive storehouses were constructed on the southeast side of the island (Figure 5.23). The Army moved material between buildings and a dock at the southeast corner of the island using a railroad (Figure 5.24). The southeast side of the island also hosted numerous other support structures, including machine shops, railroad repair shops, fuel storage facilities, barracks, and mess halls (Figure 5.25).

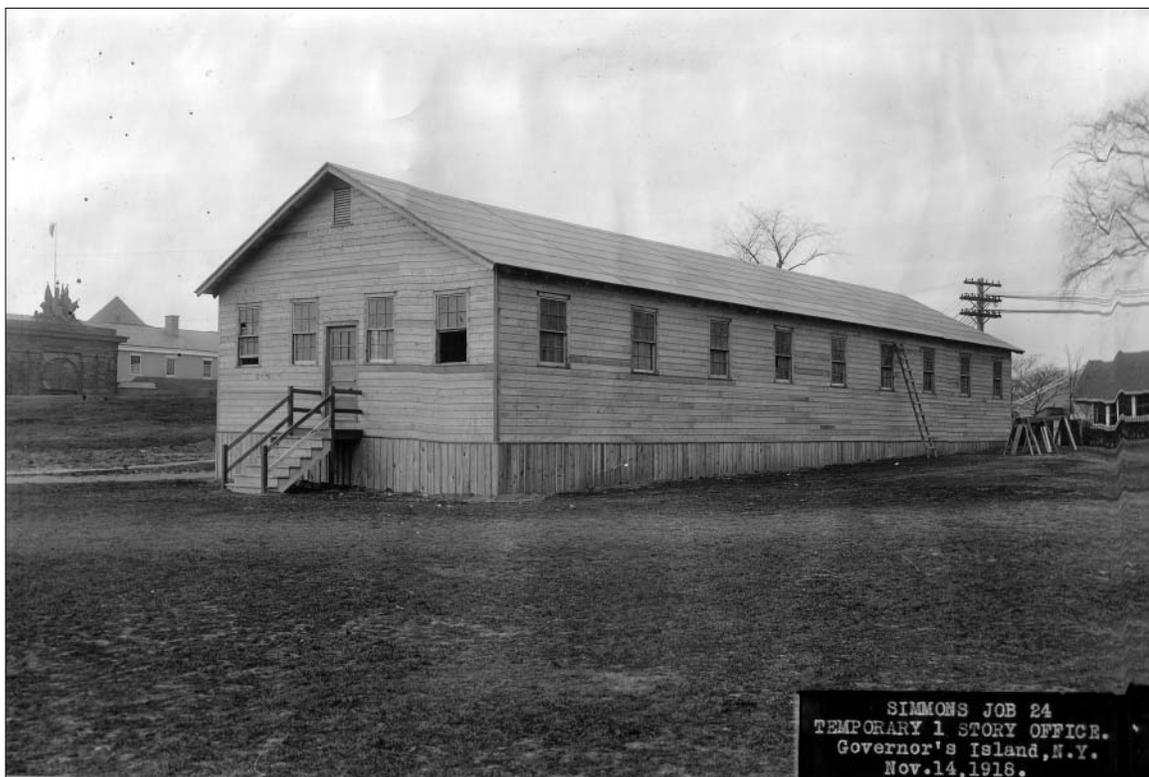
Figure 5.26. Temporary office building, 1918. This one-story, wood frame building was typical of the design of many World War I temporary buildings on the island. It was located east of the Fort Jay main gate (visible at image left), along the approach road to the historic wharf district (National Archives II, RG 77, Entry 393, Box 140).

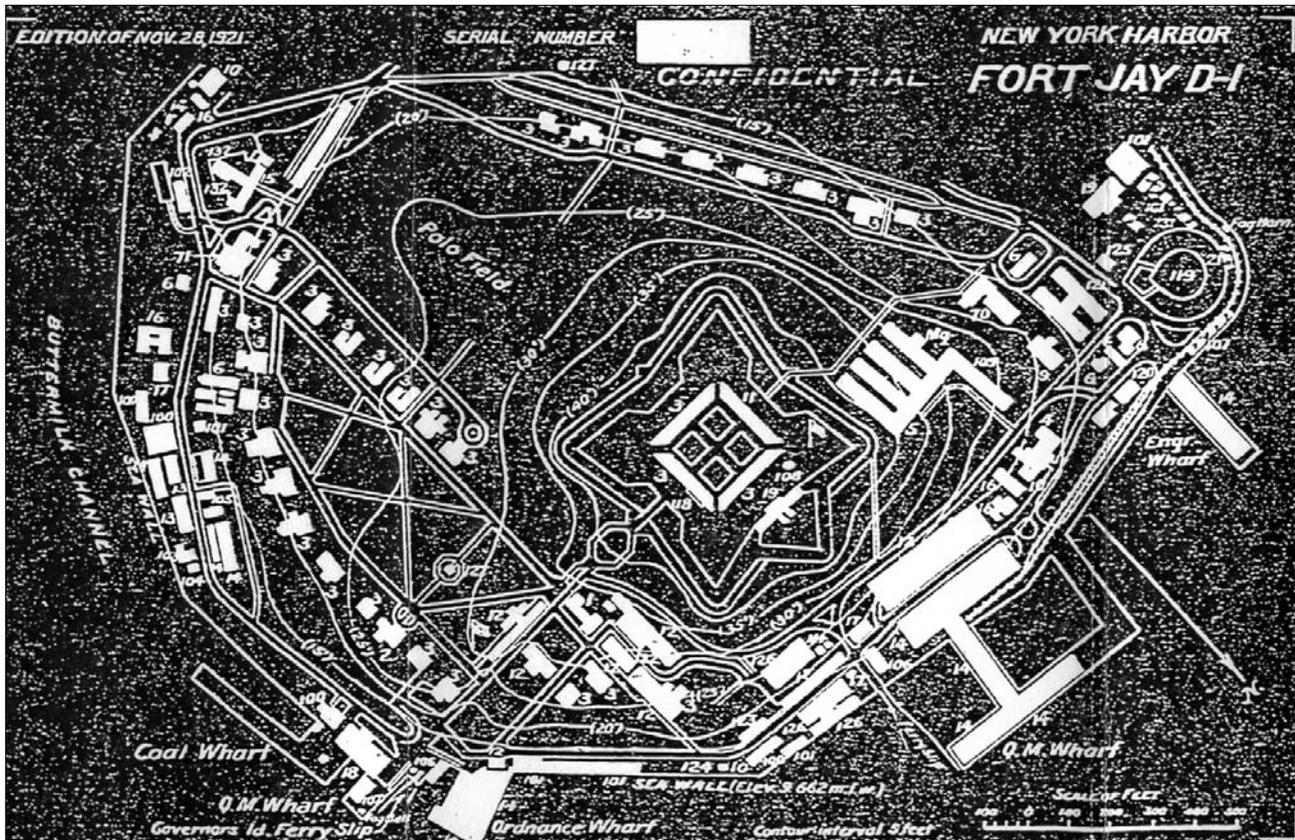
Figure 6.1. 1921 Map of Governors Island. The World War I temporary building near Fort Jay's main gate had been removed by 1921 but the cluster of buildings northwest of the fort's outer walls remained. Notice the annotation of the polo field on the parade ground (National Archives I, Washington DC, GR 77, Entry 1007, box 84, file 660 (NY Harbor, Defenses of)).

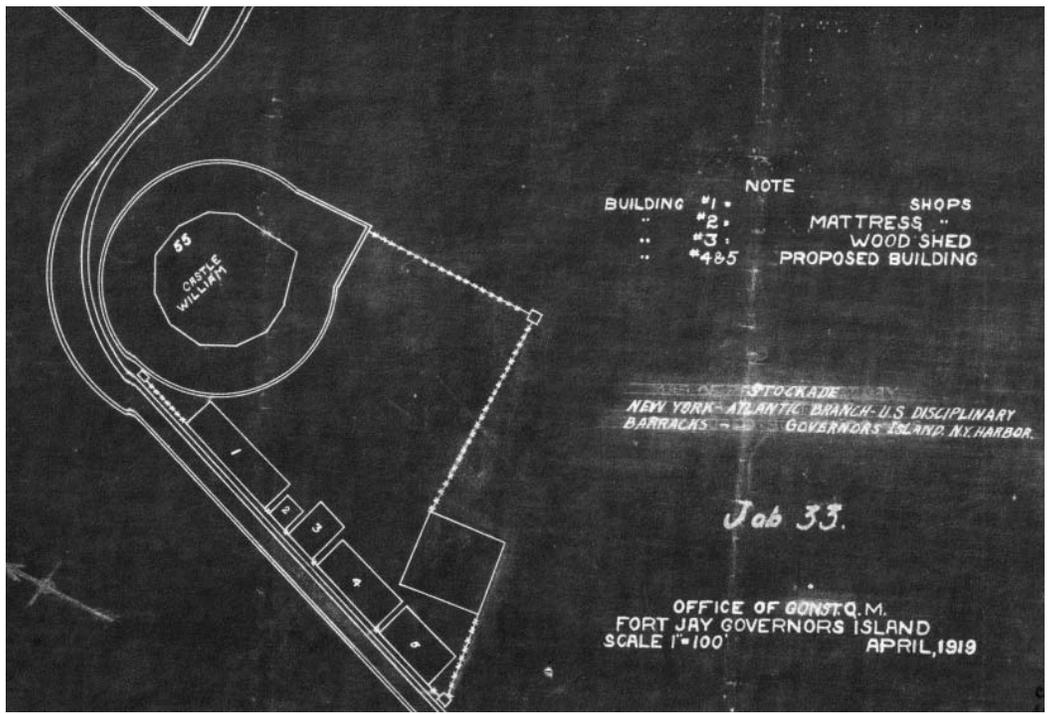
Figure 6.2. Castle Williams prison yard, 1919. Several buildings south of Castle Williams were converted into prison barracks and enclosed with barbed wire to increase the capacity of the military prison after World War I (National Archives II, RG 77, Entry 393, Box 140, Construction Completion Report, 1918, "Fort Jay 1").

The intense activity associated with World War I subsided after 1918 with the exception of the island's role as a military prison. To accommodate the increase in prisoners after the war, the Army housed some of them in "buildings not heretofore used as prisoners' barracks, which in order make suitable for the purpose, had to be enclosed by a stockade."¹ Several structures southwest of Castle Williams, including a wood shed, and two shop buildings, were incorporated into the prison complex and enclosed inside a guarded yard by eight foot tall wooden fencing topped with barbed wire (Figure 6.2).² Raised guardhouses provided sentries with a view of the prison yard. Just prior to these modifications, photographic documentation depicts the area as a utilitarian, unkempt, work yard (Figure 6.3). The number of inmates must have soon decreased, as photographs from the mid-and late-1920s show the area south of Castle Williams transformed into a manicured grass lawn, with orderly displays of militaria, curbed streets, and uniform street lighting surrounding the Castle's main gate (Figures 6.4, 6.5, and 6.6).

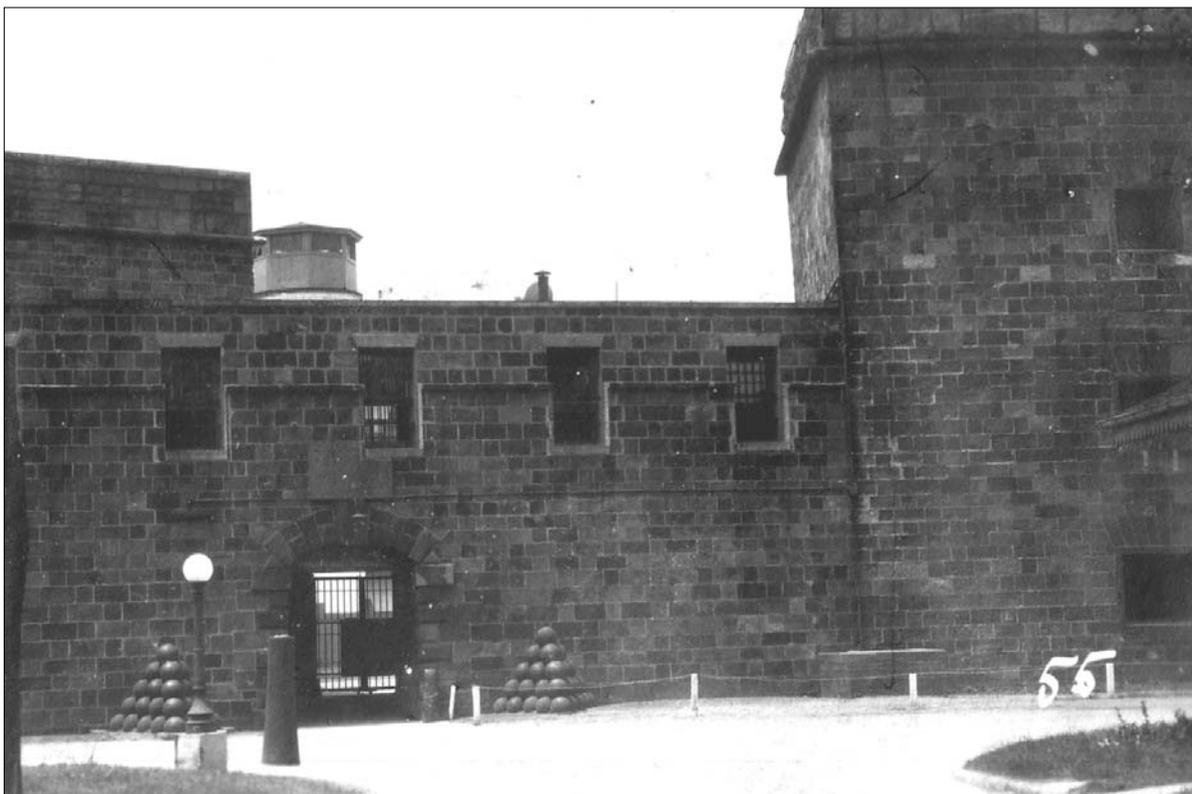
Figure 6.4. Castle Williams, 1924. By the early 1920s, the appearance of the Castle's entry had been cleaned up with the addition of street lighting, curbing, and ornamental stacks of cannon balls (NARA, RG 77, Entry 393, Box 102).

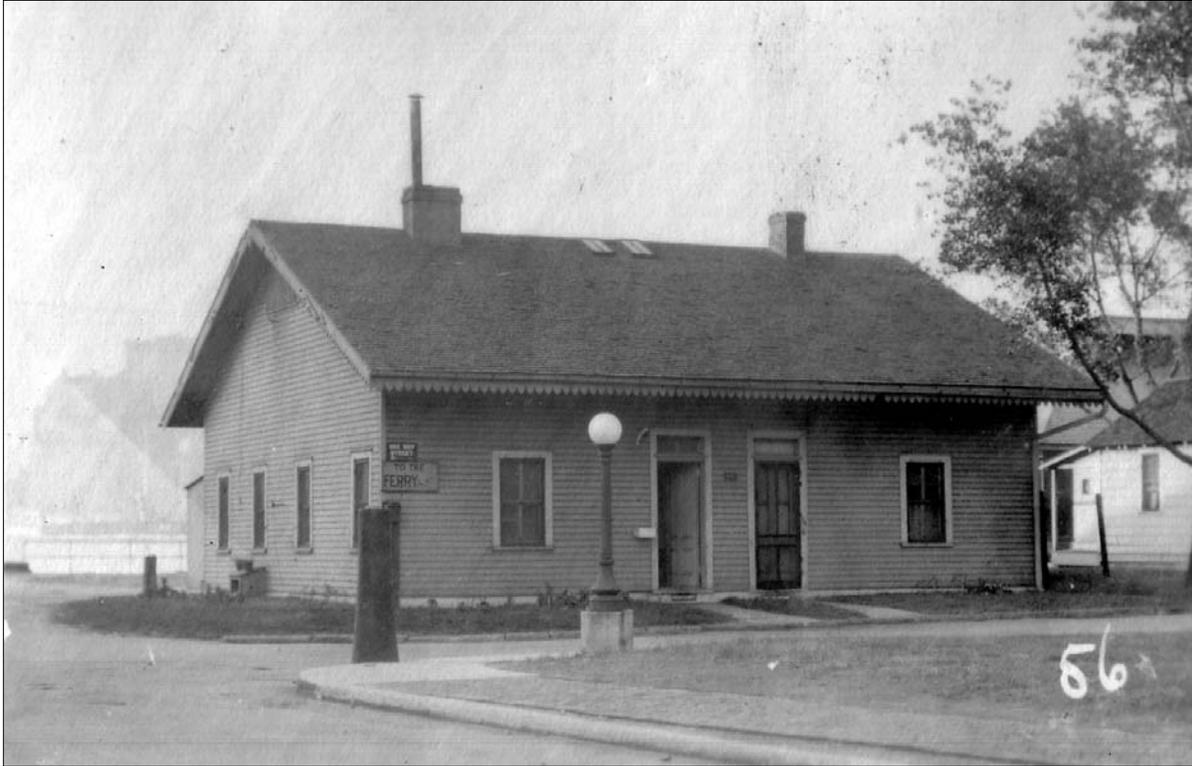
Figure 6.5. Non-Commissioned Officers' Quarters, Governors Island, 1924. This wood frame structure stood east of Castle Williams and illustrates the improved streetscape that included sidewalks, street lighting, and curbed streets (National Archives II, RG 77, Entry 393, Box 102).

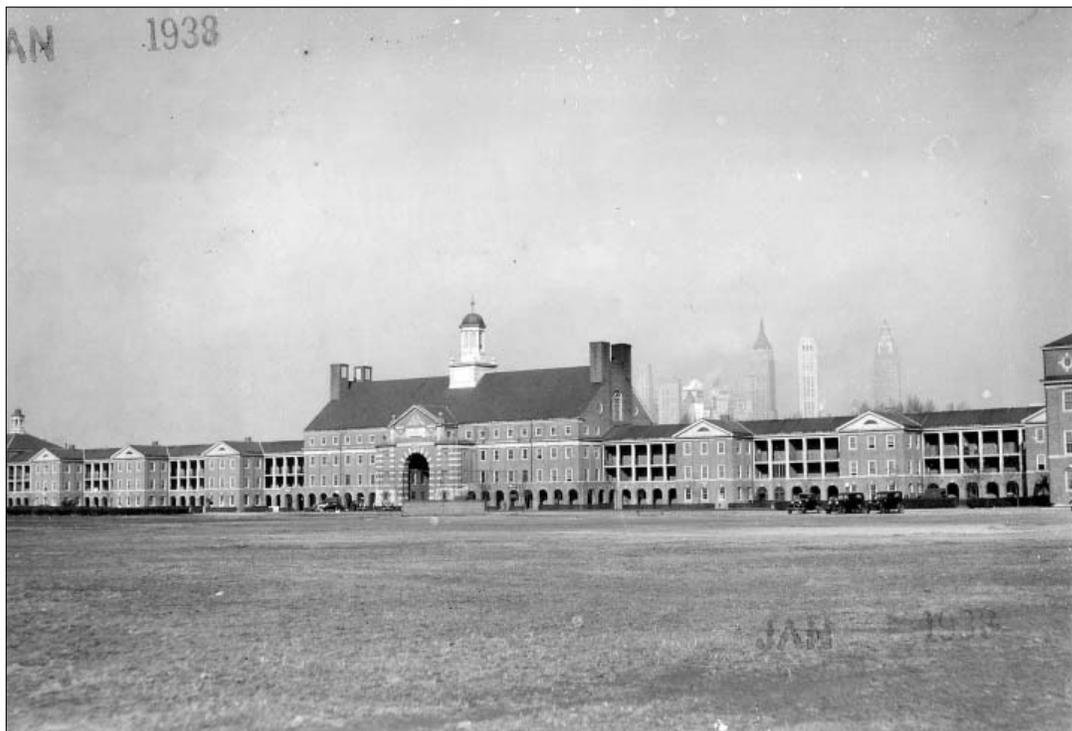
Figure 6.10. Liggett Hall, 1938. Liggett Hall became the largest building on the island, marking the boundary of the new and original landmass (National Archives II, RG 77, Entry 393, Box 102).

Congressman Kreiss's plea for improved housing on Governors Island supported the Army's desire to move forward with the McKim, Mead, and White master plans for the island generated years earlier. In 1928, funding materialized to undertake the first large scale facility development since World War I, and construction of a large barracks building named Liggett Hall (now commonly known as Building 400) began. Staff from McKim, Mead, and White designed and oversaw construction of the building. The neo-Georgian brick structure, built on the new fill, spanned almost the entire width of the island south of Colonels' Row and was by far, the largest building on Governors Island (Figure 6.10). The linear brick building featured two wings that projected south. A grand portal cut through the building near its midpoint, framing views between the old and new parts of the island.
