CULTURAL LANDSCAPE REPORT FOR GOVERNORS ISLAND NATIONAL MONUMENT

Volume 1:

By Lisa Nowak

Olmsted Center for Landscape Preservation
National Park Service, Boston, Massachusetts, 2010

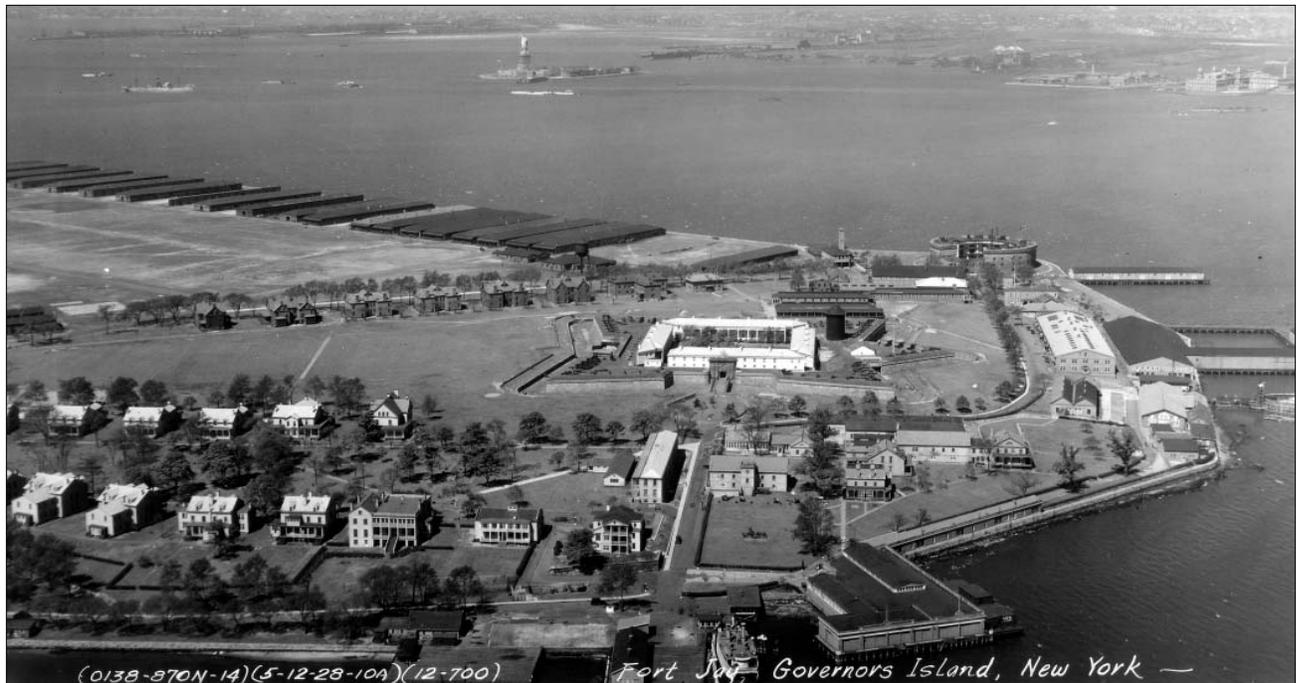
Figure 6.11. 1928 oblique aerial photograph of Governors Island. This view shows the progress of demolition of World War I structures. The line of buildings on the southwest side (center left of image) of the island remained in 1928, as did those northwest of Fort Jay. Many World War I warehouses east of the ones pictured at the center left of the image had been removed by 1928 (National Archives II, RG 77, entry 393, Box 102).

To prepare for construction of Liggett Hall, several World War I-era buildings flanking the proposed building site were removed (Figures 6.11 and 6.12). These temporary work buildings were the only obstructions on the otherwise barren ground plane, as some of the World War I warehouses on the south side of the island had already been removed by this date. The line of World War I warehouses on the east side of the rail tracks were the first to be demolished and were followed by the piecemeal removal of selected buildings west of the track (Figure 6.13). Portions of the railroad were removed by this time as well, although some segments remained for the delivery of coal.⁴ Photographic evidence shows that the remaining portions were removed by the early 1930s (Figure 6.14).

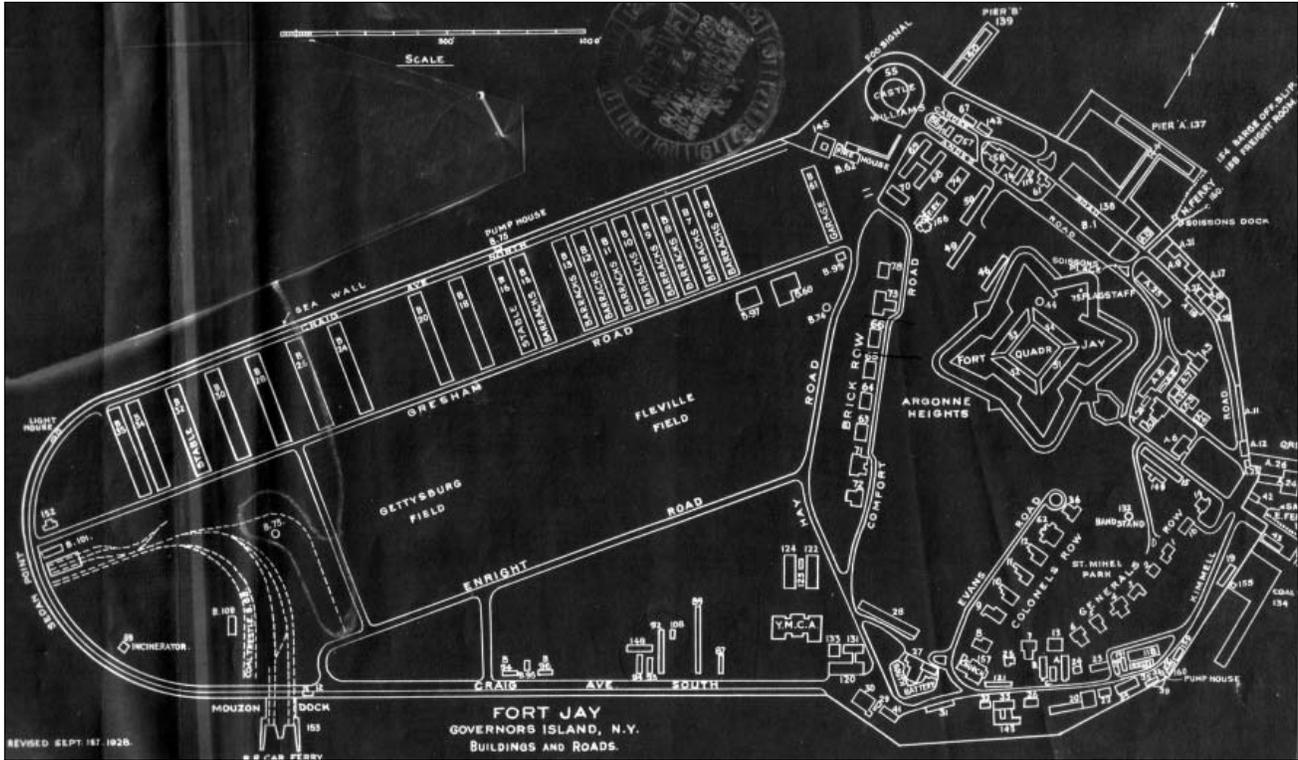
Figure 6.13. Plan of Governors Island, 1928. This plan shows clearly the island's infrastructure after World War I. This plan depicts condition prior to the construction of Liggett Hall but after many of the temporary buildings on the south side of the island had already been demolished (National Archives II, RG 77, Entry 393, Box 102).

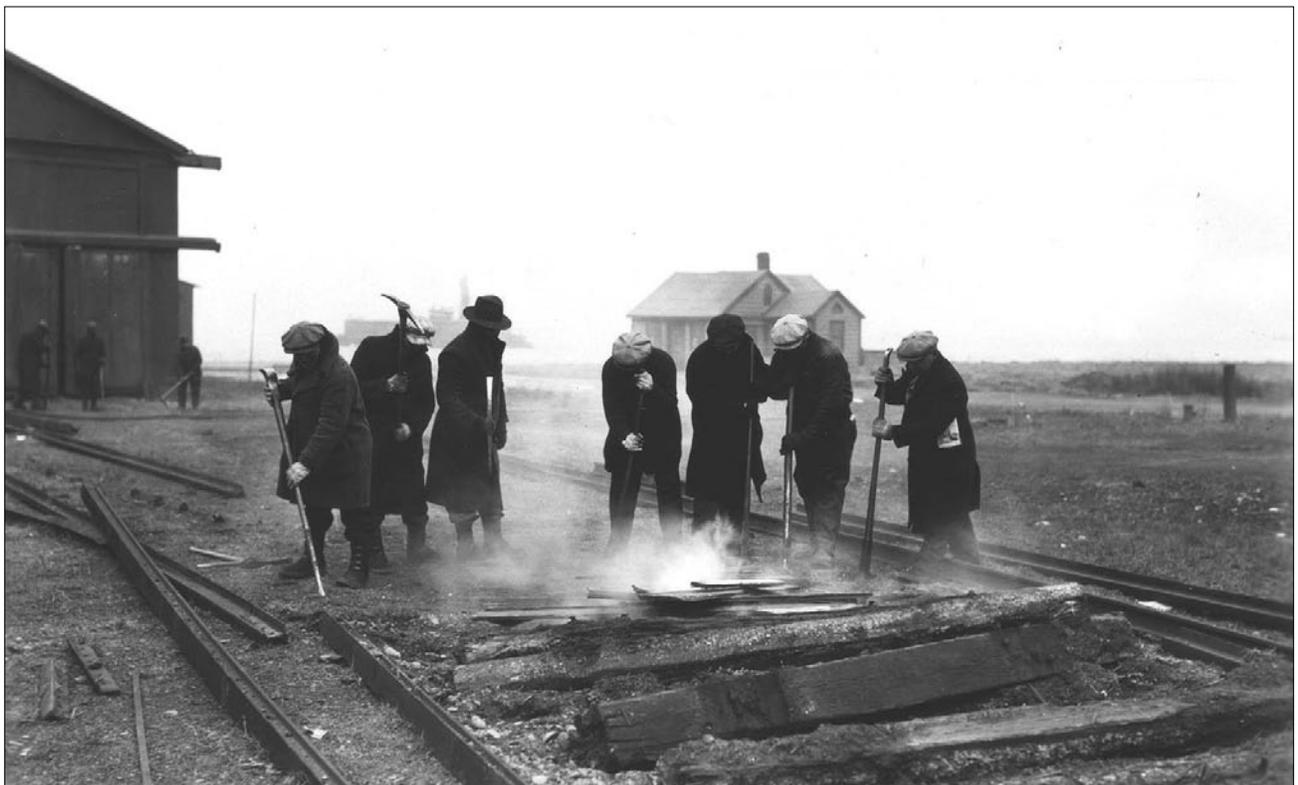
Figure 6.14. Railroad wrecking gang, 1931. Workmen dismantle the railroad tracks on the south side of the island (New York Public Library, 732039F, US Army, Signal Corps Photo).

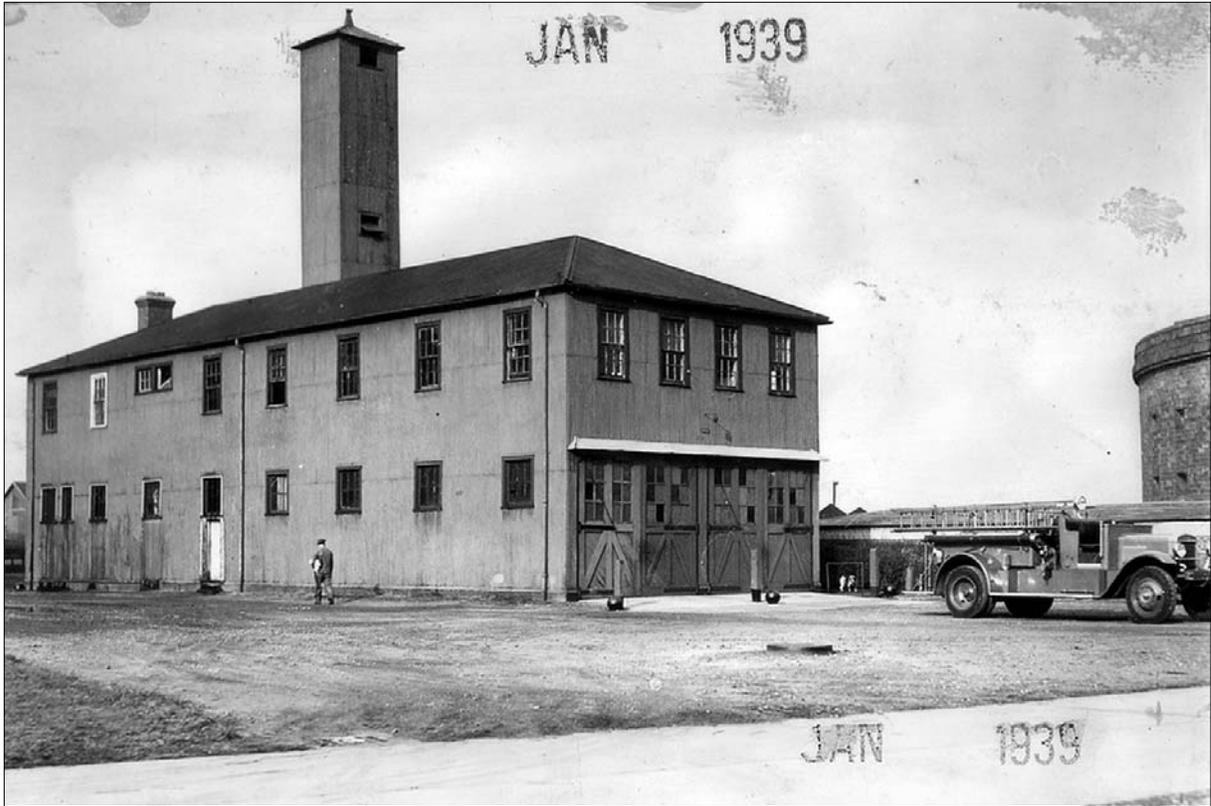
Figure 6.19. The post fire station, 1939. The fire station stood adjacent to the new hospital (out of frame at image left) and near Castle Williams (at image right) (National Archives II, RG 77, Entry 393, Box 102).

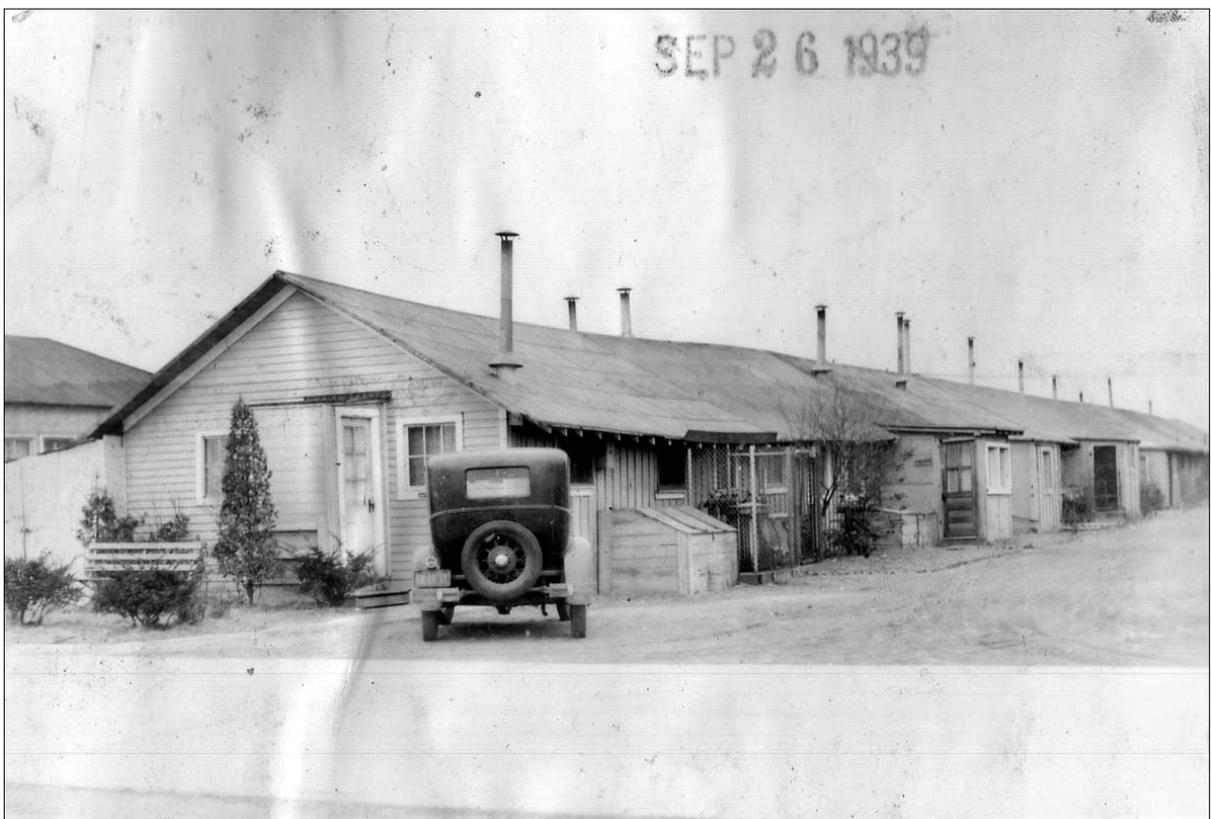
Figure 6.20. Non-commissioned officers' quarters, 1939. Old wood frame quarters like these were renovated by the Works Progress Administration (National Archives II, RG 77, Entry 393, Box 102).

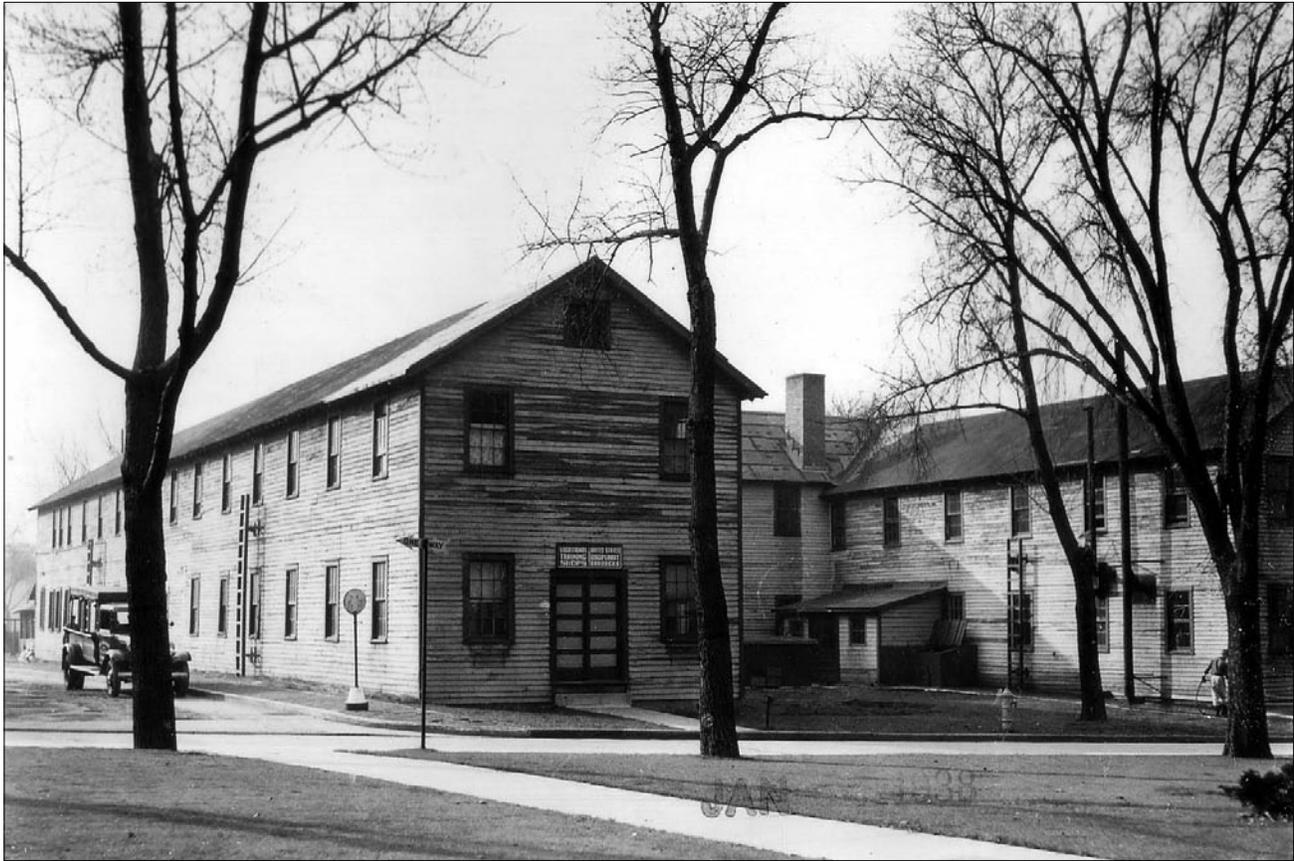
Figure 6.21. Barracks buildings, 1938. Some soldiers were still being housed in World War I-era wooden barracks despite the substantial building campaign of the early 1930s (National Archives II, RG77, Entry 393, Box 102).

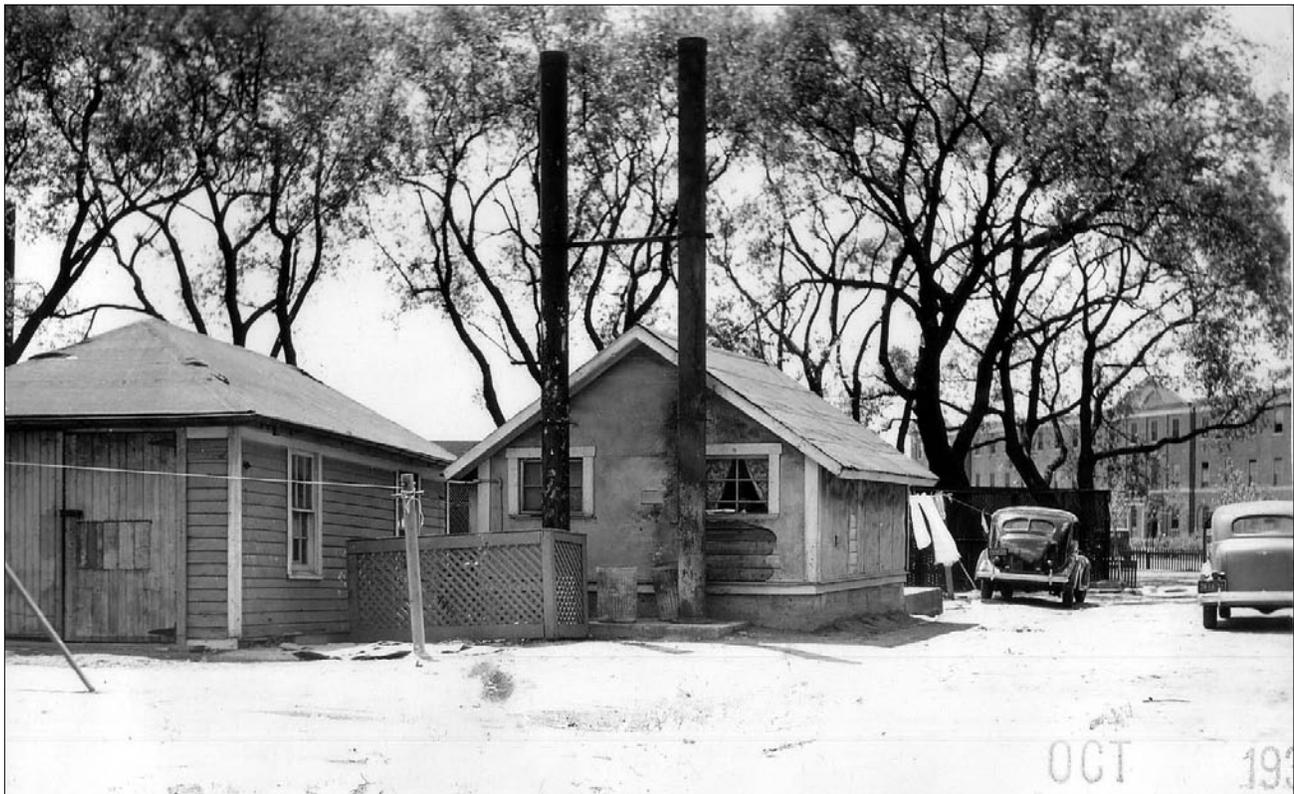
Figure 6.22. Boiler room, 1938. These small buildings served as a boiler room and living quarters (National Archives II, RG 77, Entry 393, Box 102).

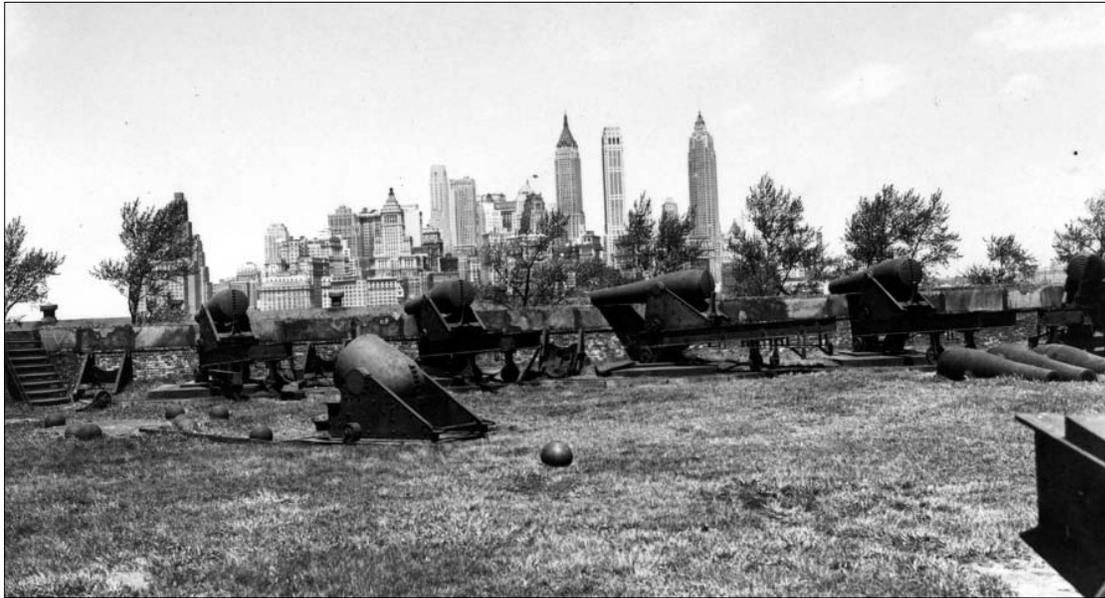
Figure 6.25. Terreplein of Fort Jay looking north toward Manhattan, 1935. Armament remained on the terreplein of Fort Jay through the 1930s. The Army maintained the surface as roughly cut grass (New York Public Library 732061F, Photo by Sperr, Percy Loomis).

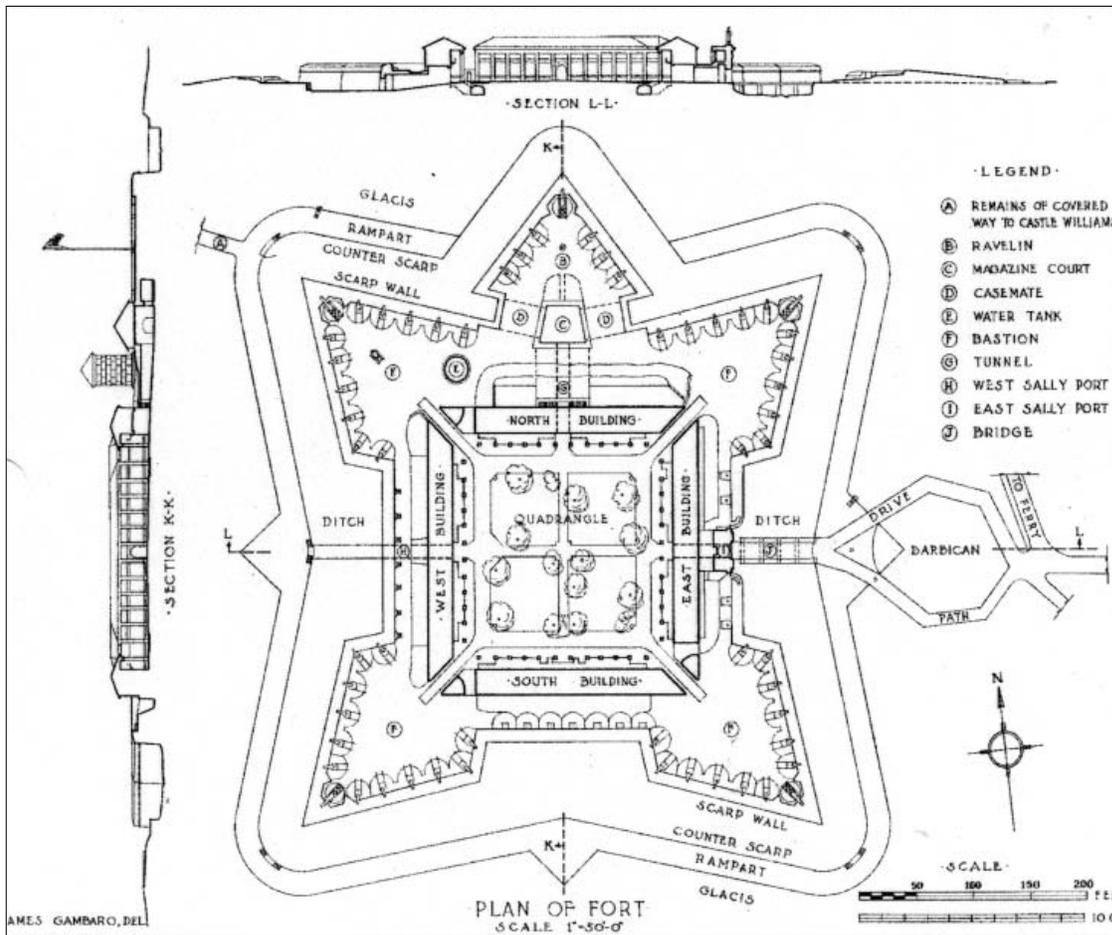
Figure 6.26. 1934 Historic American Building Survey drawing of Fort Jay, Governors Island. This drawing depicts the scores of cannon still arrayed around the scarp wall of the fort. Also notable about this drawing is the vegetation in the quadrangle. Numerous mid-sized trees are located in a random pattern (Library of Congress, Historic American Building Survey, Governors Island, New York Harbor, New York, 1934).

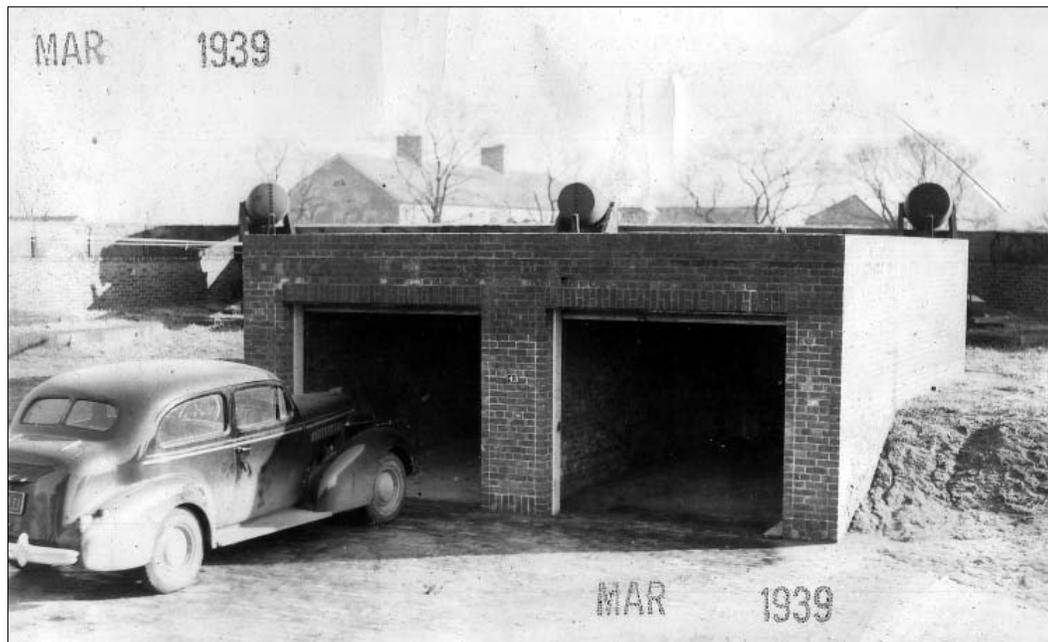
Figure 6.28. Fort Jay garages, 1939. The Army built automobile garages in the corners of the terreplein, behind the Fort Jay barracks, in the 1930s (National Archives II, RG 77, Entry 393, Box 102).

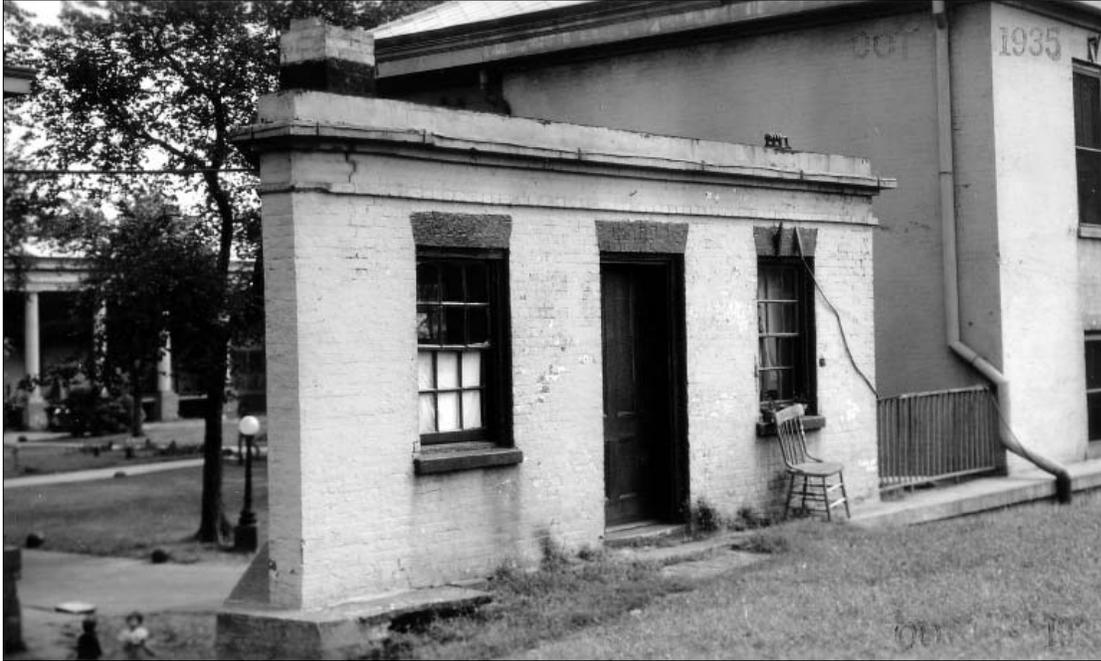
Figure 6.29. Fort Jay, 1935. This image of the back side of one of the Fort Jay barracks shows the landscape treatment of the terreplein, with its rough cut grass and no woody growth. On image left, a view of the courtyard is available, showing children at play, the decorative cannon ball edging, shade trees, and street lights (National Archives II, RG 77, Entry 393, Box 102).

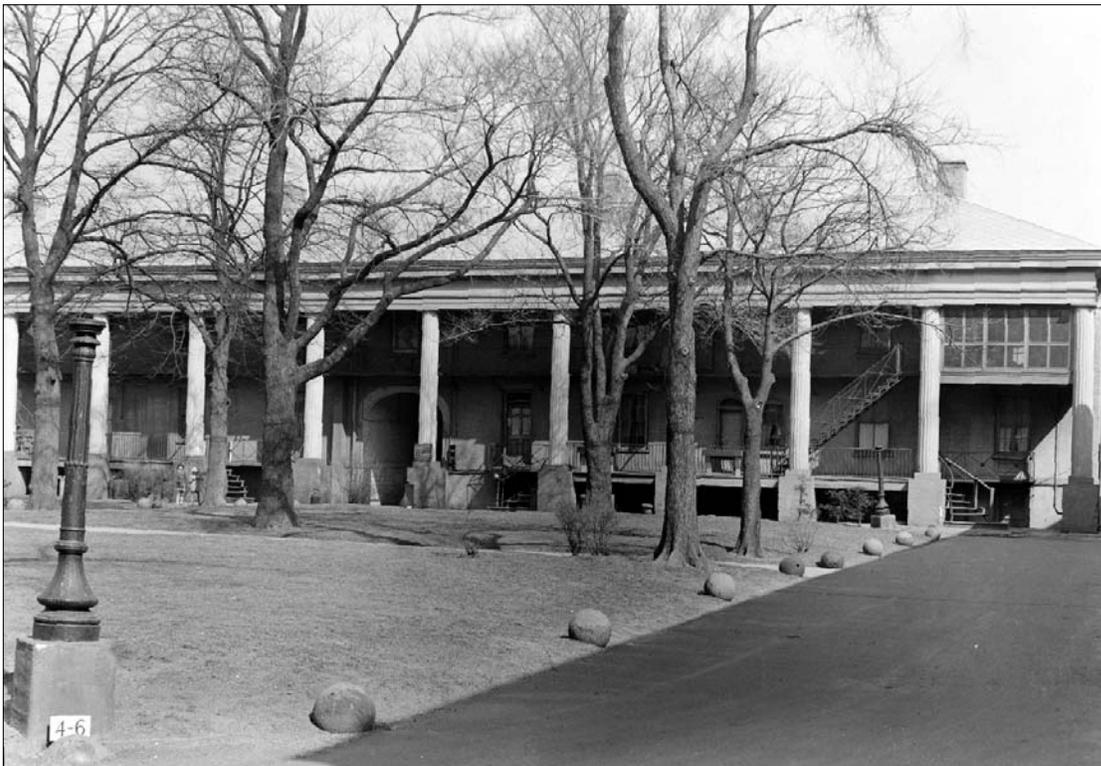
Figure 6.30. Fort Jay courtyard, 1934. This Historic American Building Survey photograph documents the site conditions of the courtyard in the 1930s. Cannon balls marked the edge between the asphalt perimeter driveway and the grass inner courtyard space. Randomly spaced shade trees and shrubs are located on the interior of the space. Notice the street light on image left with the missing globe (Library of Congress, Historic American Building Survey, photograph by E.P. McFarland, March 15, 1934, East Building (west elevation), HABS NY, 31-GOVI, 1-7).

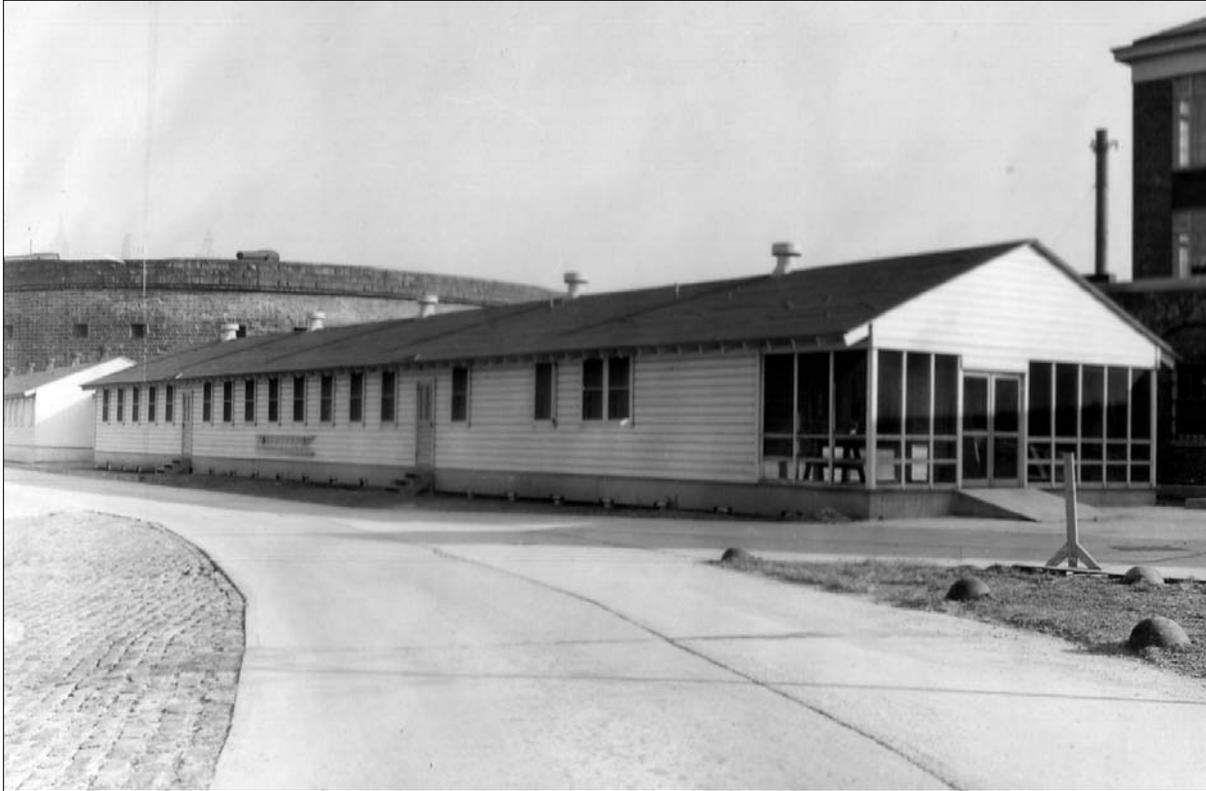
Figure 6.37. Hospital Mess, 1942. This World War II-era structure was built on the rear side (west) of the post hospital (image right) and south of Castle Williams (image left). This building added to the haphazard collection of temporary structures associated with the hospital. Cannon balls lined the grass area at image left. These were collected for scrap shortly after the photograph was taken (National Archives II, RG 77, Entry 393, Box 102).

during World War I. The Army built additional nurses' quarters, a cafeteria, and hospital annex buildings (Figures 6.36, 6.37, and 6.38).

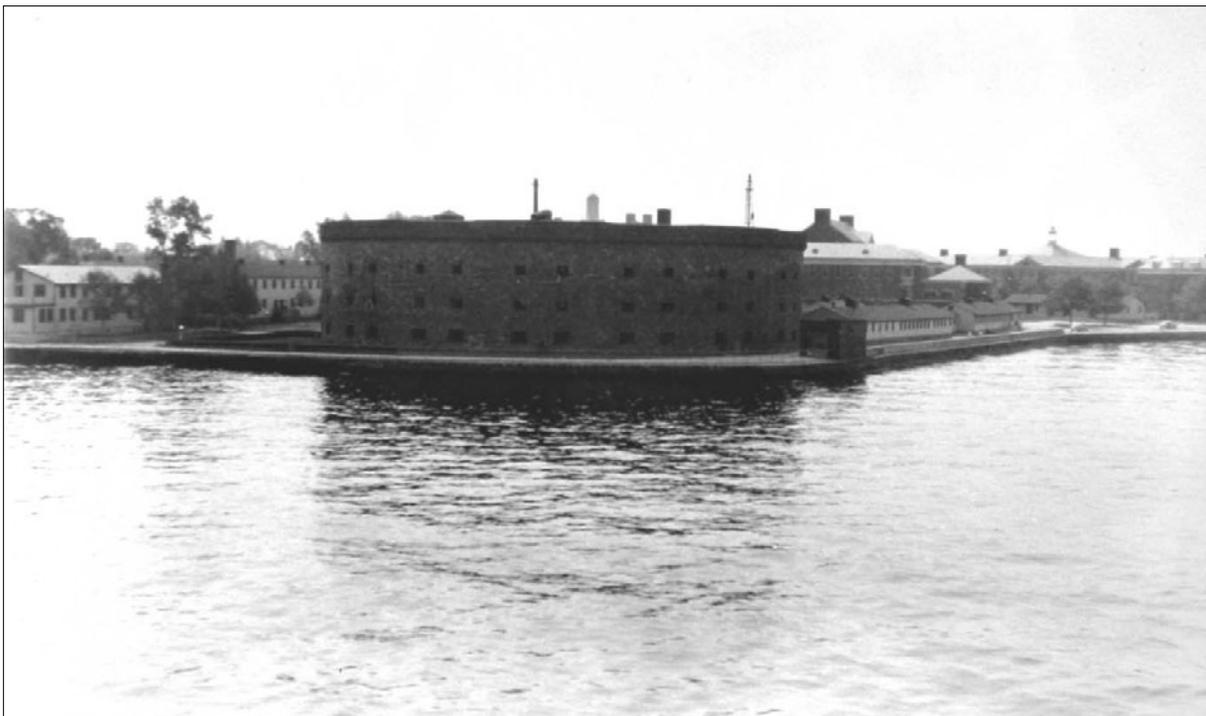
Figure 6.38. Castle Williams, as seen from the north, circa 1942. This image displays the numerous temporary buildings erected near the castle. Notice the nurses' quarters to the left of the castle and the hospital mess hall to the right (Center for Military History, RG 762 S, Richard S. Allen Collection, Box 1).

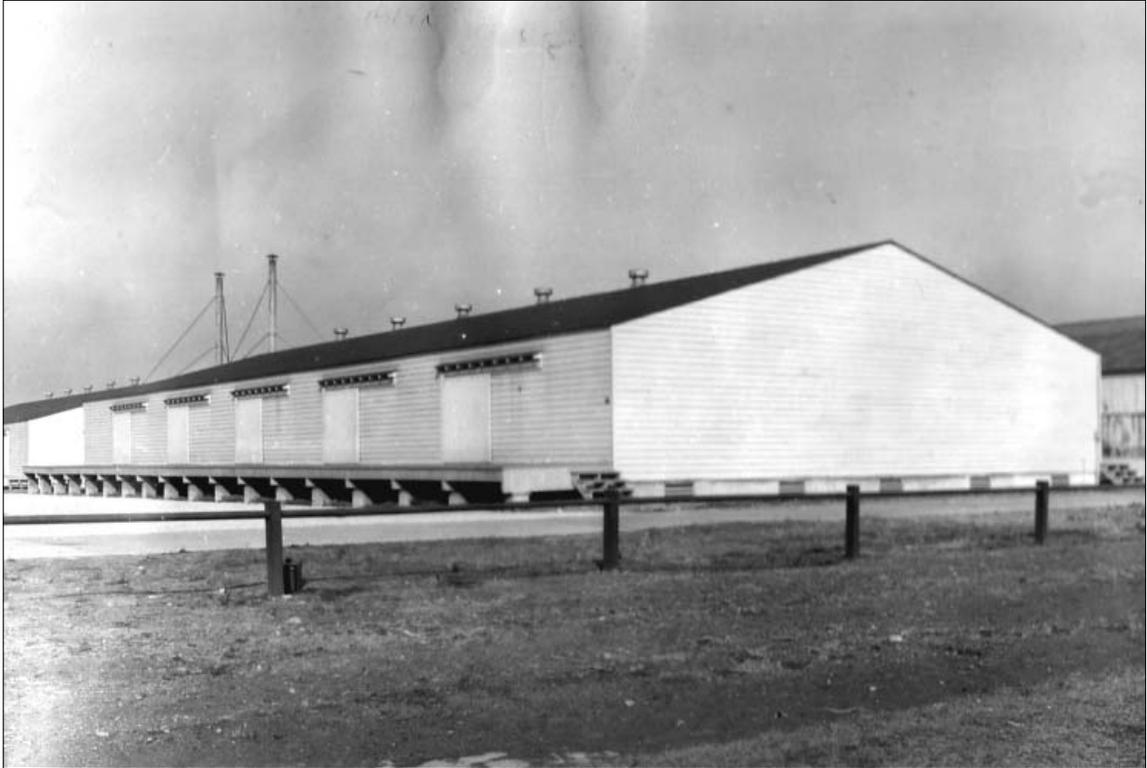
Figure 6.39. Warehouse, Governors Island, 1942. Several World War II-era warehouses were built on the south side of the island, although far fewer than during World War I (National Archives II, RG 77, Entry 393, Box 102).

The Army made use of the south side of the island for temporary war-time structures, as they had during World War I, and built several warehouses and barracks (Figure 6.39). As lamented by the *New York Times* in 1941, . . . "new barracks have usurped the polo field."²² The compromised polo field also served as the stage for large-scale training exercises and ceremonies (Figure 6.40).

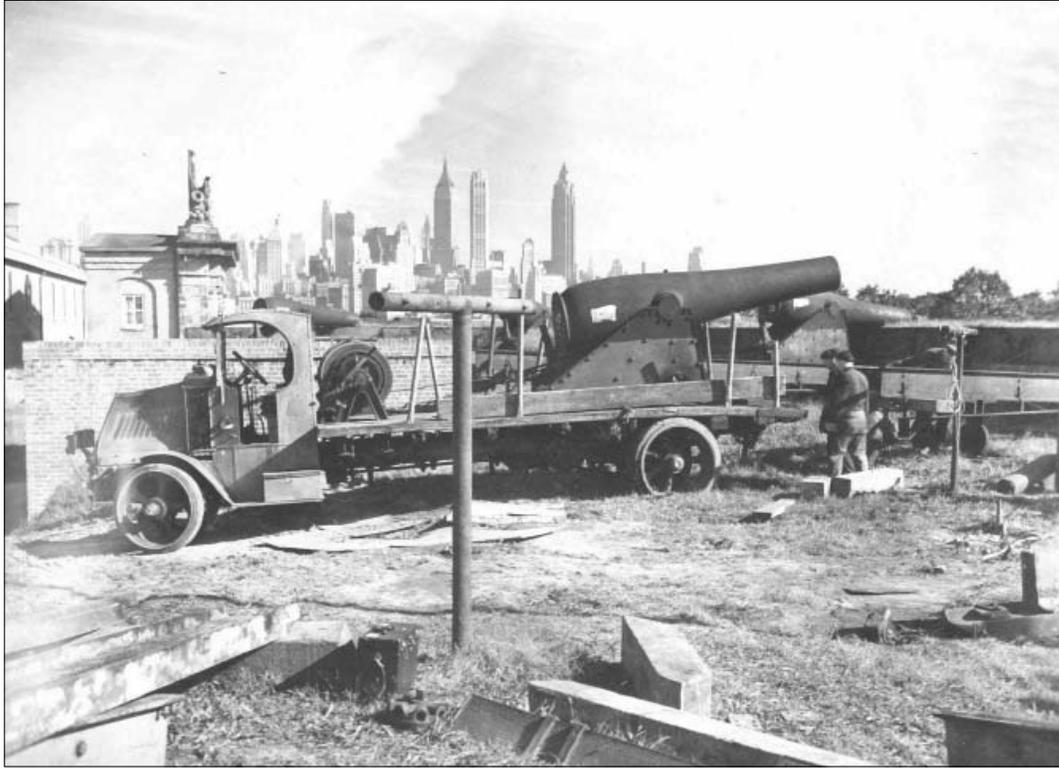
Figure 6.41. Cannon being removed from Fort Jay, 1942. This photograph, looking north, shows workmen removing cannons from their mounts along the scarp wall of Fort Jay (Center for Military History, RG 239 S, Grunert Collection, P. 43 (1)).

To meet the enormous need for raw materials for military equipment manufacturing, the war department acquisitioned scrap metal from across the country, including historic armament from historic sites and military bases. Governors Island retained scores of obsolete cannon and cannon balls at Fort Jay and Castle Williams that were deemed necessary for the war effort. In 1942, the Army dismantled a majority of the island's guns and sent them to be melted down (Figures 6.41 and 6.42).

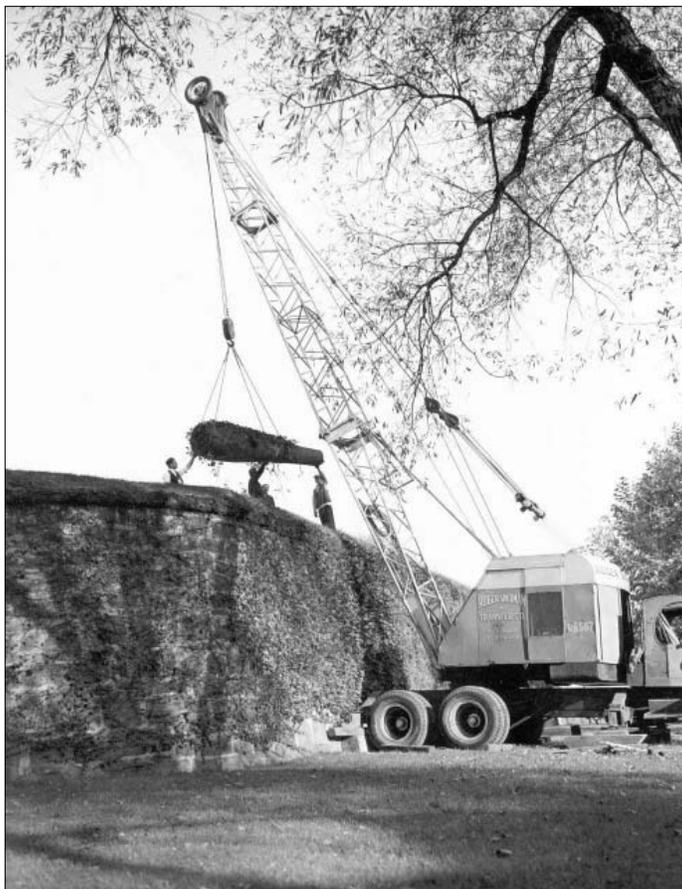
Figure 6.42. Cannon being removed from South Battery, 1942. A crane was used to lift the heavy cannon from the walls of Fort Jay. Notice the vines still clinging to the surface of the historic gun (Center for Military History, RG 239 S, Grunert Collection, P. 43 (2)).

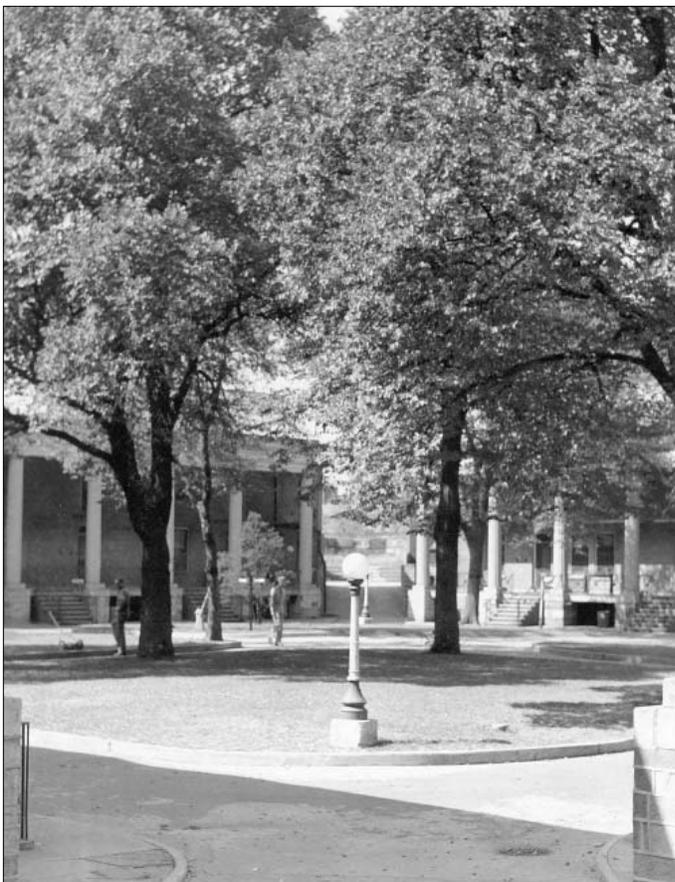
Figure 6.44. Fort Jay courtyard, 1944. Some changes since the 1930s are visible in this image. The decorative cannon balls had been removed, likely collected for scrap, curbing was added, and the understory shrubs had been removed (Center for Military History, RG 239 S, Grunert Collection, P. 37 (2)).

War-time use of Fort Jay continued to be predominantly residential, although the Army continued to use the protected area inside the dry moat for target practice (Figure 6.43). Period photographs show that subtle changes had occurred in Fort Jay's inner courtyard since the 1930s. The Army removed the cannon balls lining the perimeter of the grass area and replaced this edge treatment with curbing.

Shrubs had been removed from the interior green space, leaving only scattered shade trees and lawn inside the courtyard (Figure 6.44).

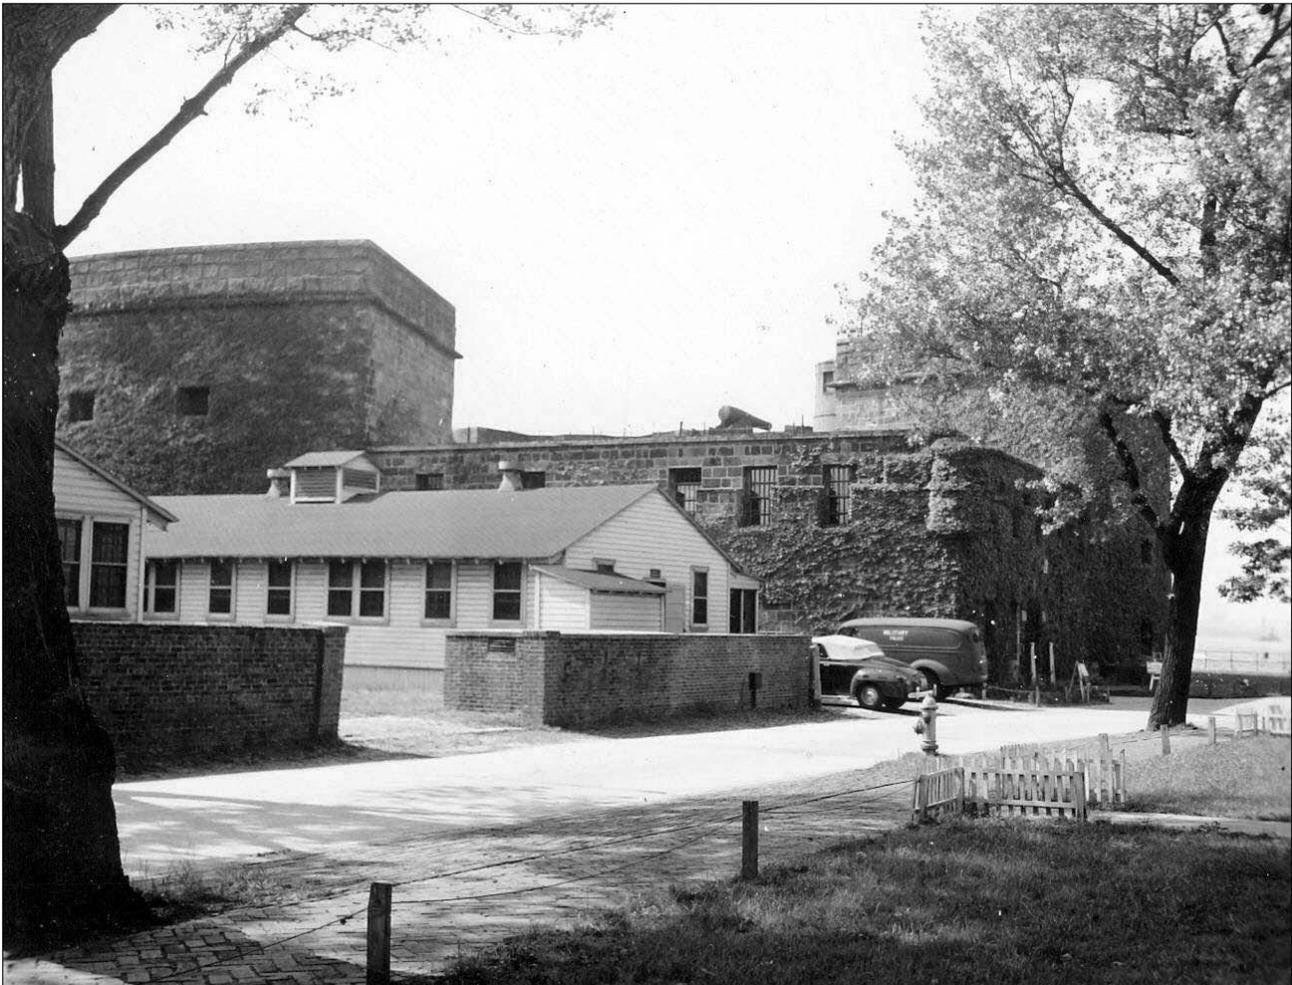
Figure 6.46. Below. Castle Williams from the south, 1944. This war-time photograph documents the temporary hospital annex buildings adjacent to Castle Williams. Also, streetscape elements like street trees, brick sidewalks, and low fencing along grass areas are visible (Center for Military History, RG 239 S, Grunert Collection, P. 34 (3)).

Castle Williams continued to serve as a military prison throughout World War II. As it was historically, the only door faced east, looking down Andes Road (Figure 6.45). The ivy-covered building was surrounded on the east, south, and west by wood frame temporary buildings. The streetscape outside the fort had been altered by the new buildings but familiar elements like mature street trees and brick and concrete sidewalks remained from earlier decades. The Army used several fencing styles to keep pedestrians off grass areas, including low, post and wire fencing and low, pipe-rail fencing (Figure 6.46 and see Figure 6.36). See Figures 6.47 and 6.48 for period mapping of Governors Island during World War II.

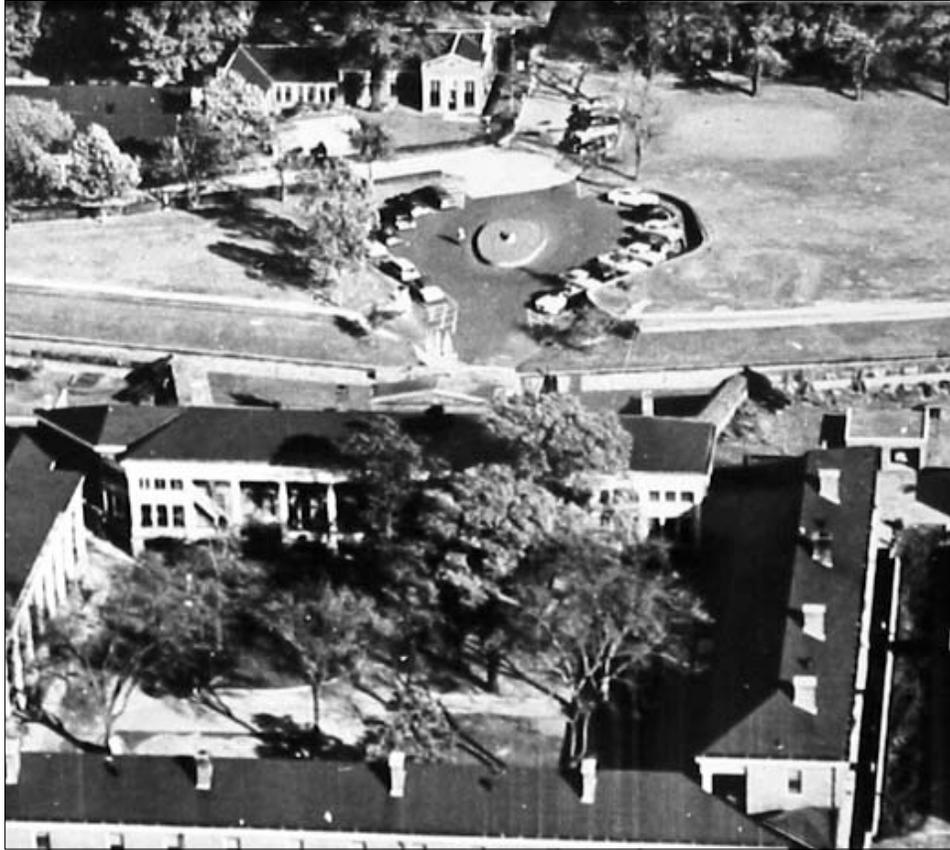
Figure 6.51. Fort Jay, 1966. The Army redesigned the interior of the barbican at Fort Jay's main gate. The large center island was replaced with a small raised planter and the amount of asphalt was increased to provide vehicular parking (Center for Military History, RG 97 S, Forts Misc Collection, Fort Jay).

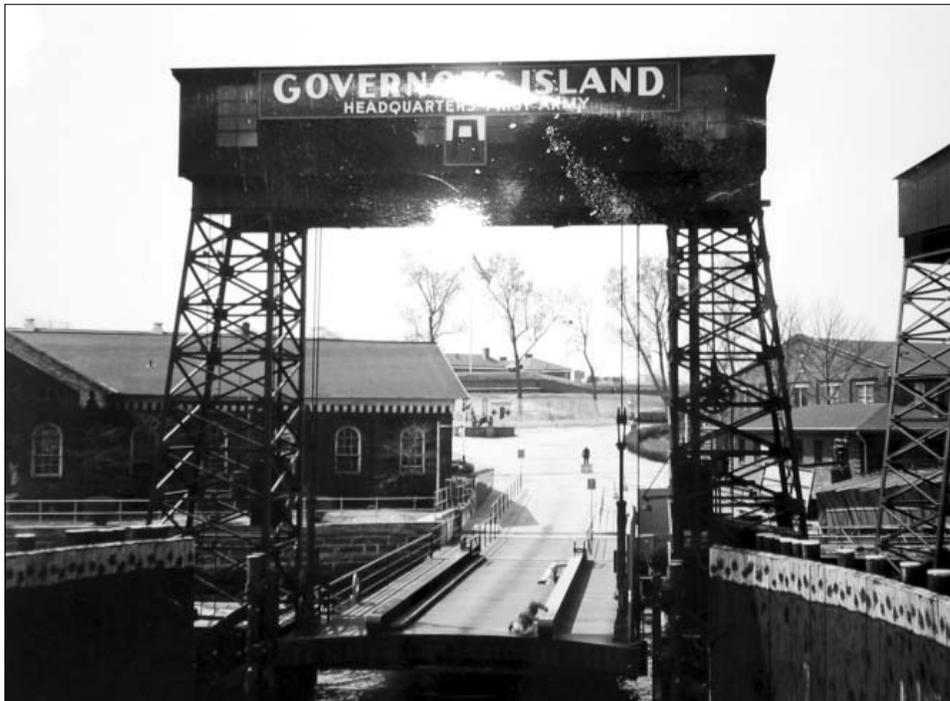
Figure 6.52. Soissons Dock, 1966. Fort Jay is visible in the background, as is the tall chain link fence erected to keep golf balls in the golf course (Center for Military History, RG 97 S, Forts Misc Collection, Fort Jay).

Changes to the landscape occurred to address the need for increased parking, including the removal of a large administration building north of Building 110. Likewise, the barbican east of Fort's Jay's main gate was modified in the 1960s to accommodate parking. The outline of the feature remained the same but the large raised-earth inner circle that once blocked clear views into the sallyport was removed and replaced by a small brick-edged raised planter. The reduction of the size of the center circle to allowed room for cars to park along the perimeter of the space (Figure 6.51). It was also during this period that the Army placed a tall chain link fence along the edge of Andes Road, between the privet hedge and the street trees, to protect pedestrians from errant golf balls (Figure 6.52).

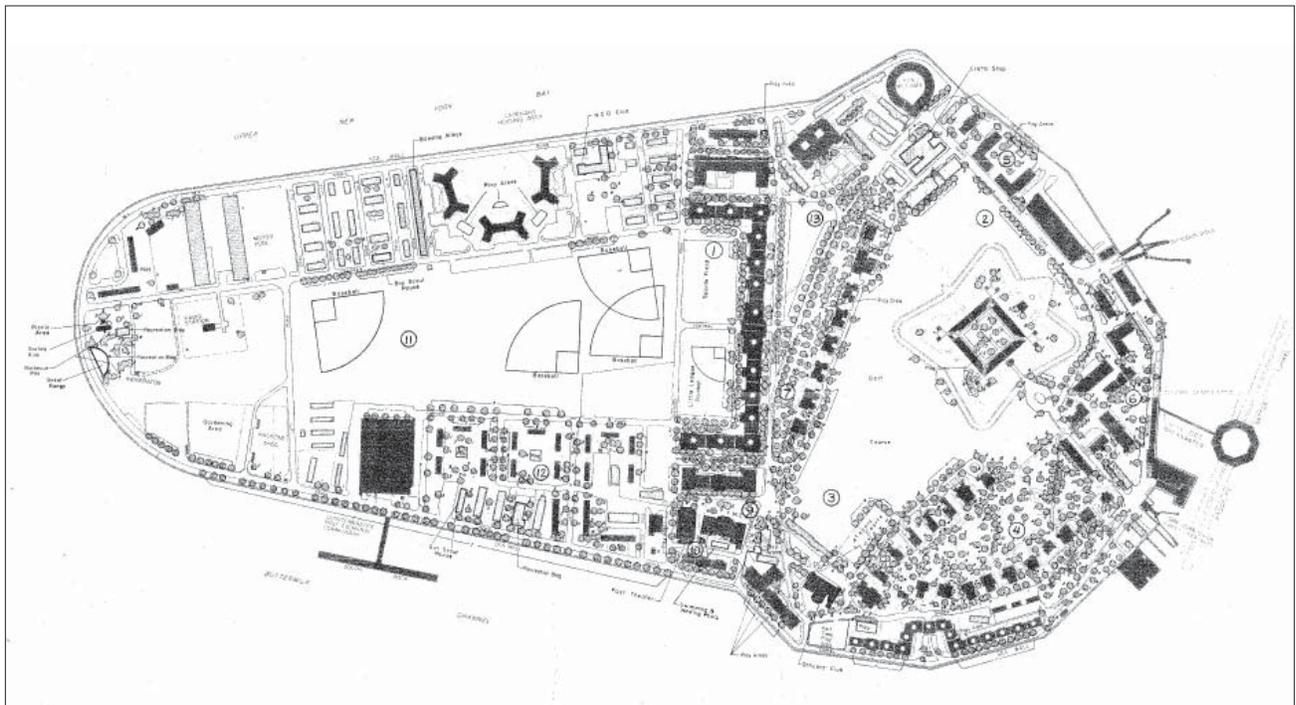
Figure 7.2. "General Tree-Cover and Recreation Map, Fort Jay, 1962." This plan illustrates changes made to the island near the end of the Army's tenure on the island. It depicts extensive tree planting north of Liggett Hall and the numerous recreational facilities throughout the island (Governors Island National Monument image collection).

Prepared four years before the transfer to the Coast Guard, a 1962 map of the island displays the vegetative cover, layout of buildings and roads, and location of recreational facilities (Figure 7.2). At Fort Jay, several trees had been allowed to grow along the terreplein, where for over one hundred years the area had been cleared of woody growth and maintained as cut grass. The same irregular spacing of shade trees persisted inside the courtyard. An imperfectly spaced ring of trees was located along the exterior of the recently redesigned barbican at the fort's main gate. Street trees lined the south and west side of Andes Road as it wrapped around the north side of the golf course, passing the main dock, Soissons Dock. Temporary buildings remained around Castle Williams, evoking World War II-conditions. Two structures lined the northwest border of the parade ground next to a line of London plane trees. The 'H' shaped former hospital, two-story nurses' quarters, and numerous hospital annex buildings remained to the south and east of the castle. The Army had created numerous recreational opportunities throughout the island including the golf course, tennis courts, baseball diamonds, a swimming pool, and children's play areas.
