CULTURAL LANDSCAPE REPORT FOR GOVERNORS ISLAND NATIONAL MONUMENT

Volume 1:

By Lisa Nowak

Olmsted Center for Landscape Preservation
National Park Service, Boston, Massachusetts, 2010

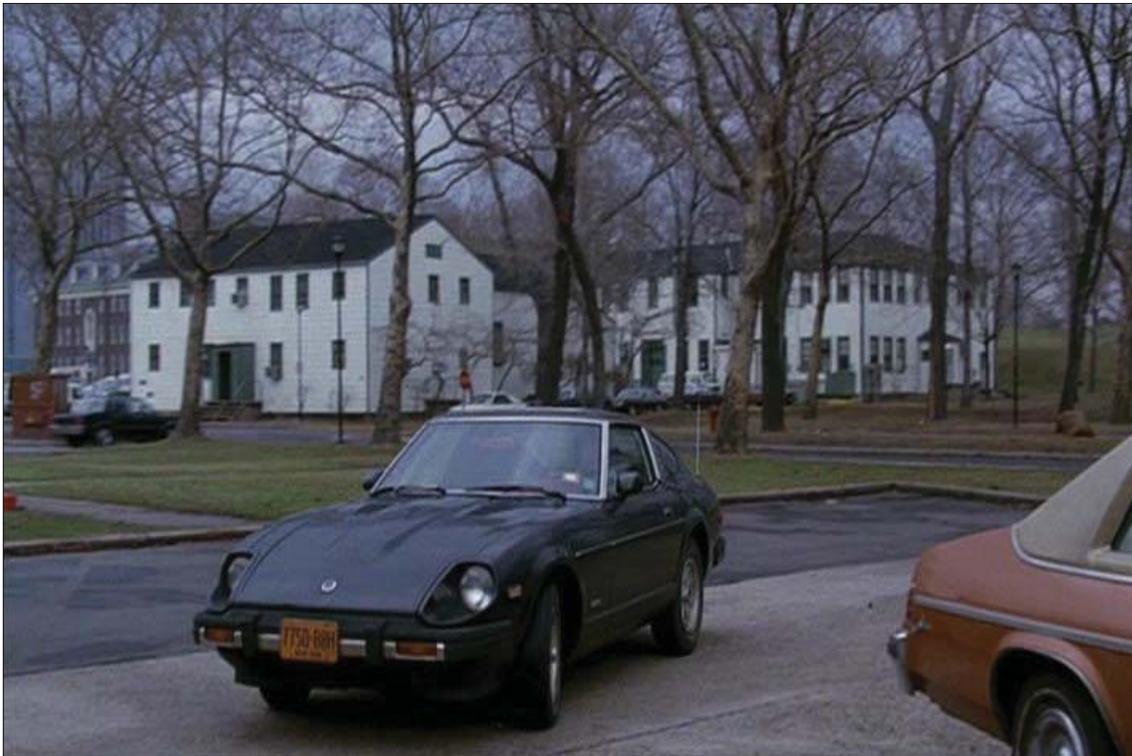
Figure 7.3. Barracks, Governors Island, c. 1975. The Coast Guard removed most of the World War II-era buildings left by the Army, including the ones pictured above (Steve Decarteret photograph, Governors Island National Monument image collection).

Photographs document changes made by the Coast Guard to meet their mission requirements and the needs of their personnel. By the late 1970s they had removed most of the World War II-era temporary buildings, with a few notable exceptions (Figure 7.3). As seen in a 1977 image, a parking lot replaced the 'H'

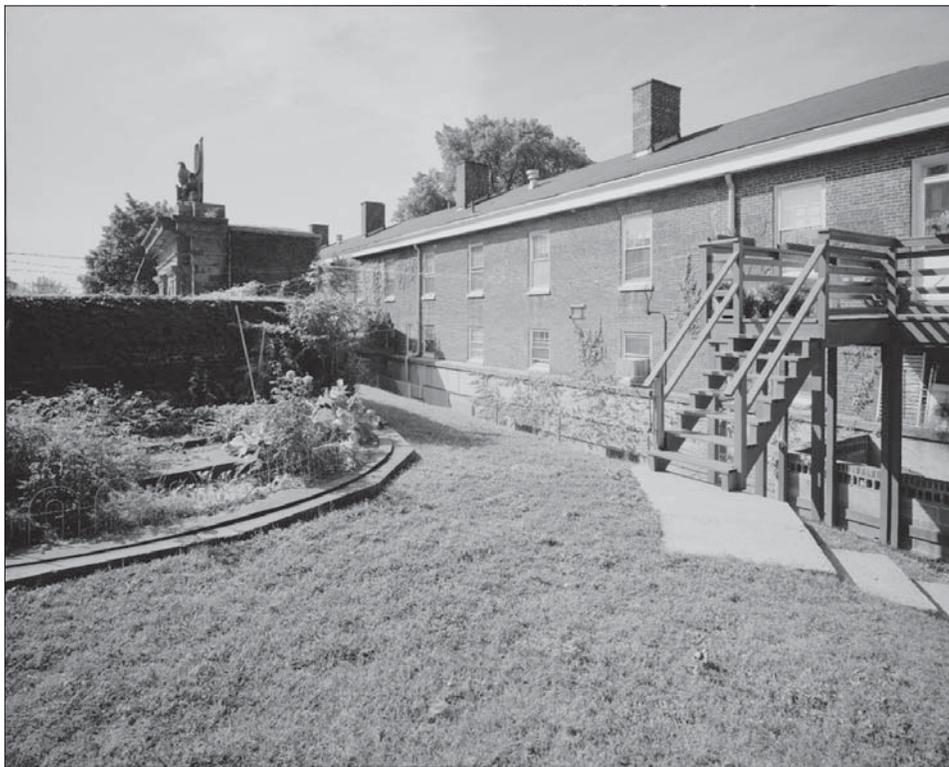
Figure 7.4. "Fort Columbus Building No 202, east side, looking southwest, 1983." This Historic American Building Survey photograph captured the alterations people made to the fort landscape to make it comfortable domestic space. Notice the wooden deck and planter boxes, and the small garden in the gun mount that is enclosed with a hairpin-style wire border (Library of Congress, Historic American Building Survey, NY, 31-GOVI, 1A-4).

At Fort Jay, the Coast Guard allowed existing trees to grow on the terreplein and families used the grass areas under the scarp walls for gardening, hanging laundry, and entertaining, evidenced by the presence of clothes lines, domestic plantings, and a stone barbeque (Figure 7.4). Play equipment was added to the interior courtyard green space to accommodate service members' children (Figure 7.5). The Governors Island golf course remained a popular feature and was supplemented with the planting of several tree lines to direct play and shield structures from errant golf balls. Three lines of trees are visible in birds-eye photographs from the late 1970s and early 1980s, one along the north side of Colonels' Row, another in the northwest corner of the golf course near the library, and the last along the northern edge of the golf course, facing Soissons Dock (Figures 7.6 and 7.7).

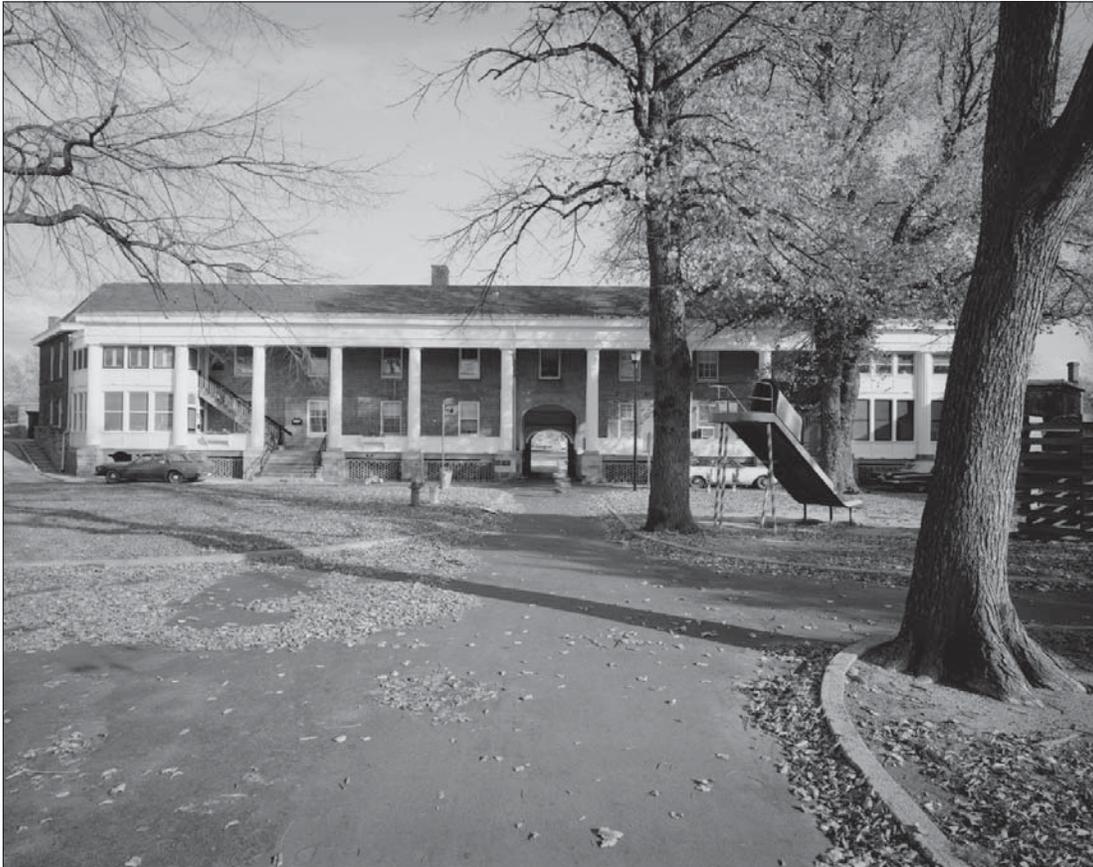
Figure 7.5. "Governors Island, Fort Columbus, Building 202, west front, 1983." This Historic American Building Survey photograph shows the Fort Jay courtyard in the 1980s, capturing the curbed green space, shade trees, and children's play equipment (Library of Congress, Historic American Building Survey, NY, 31-GOVI, 1A-3,).

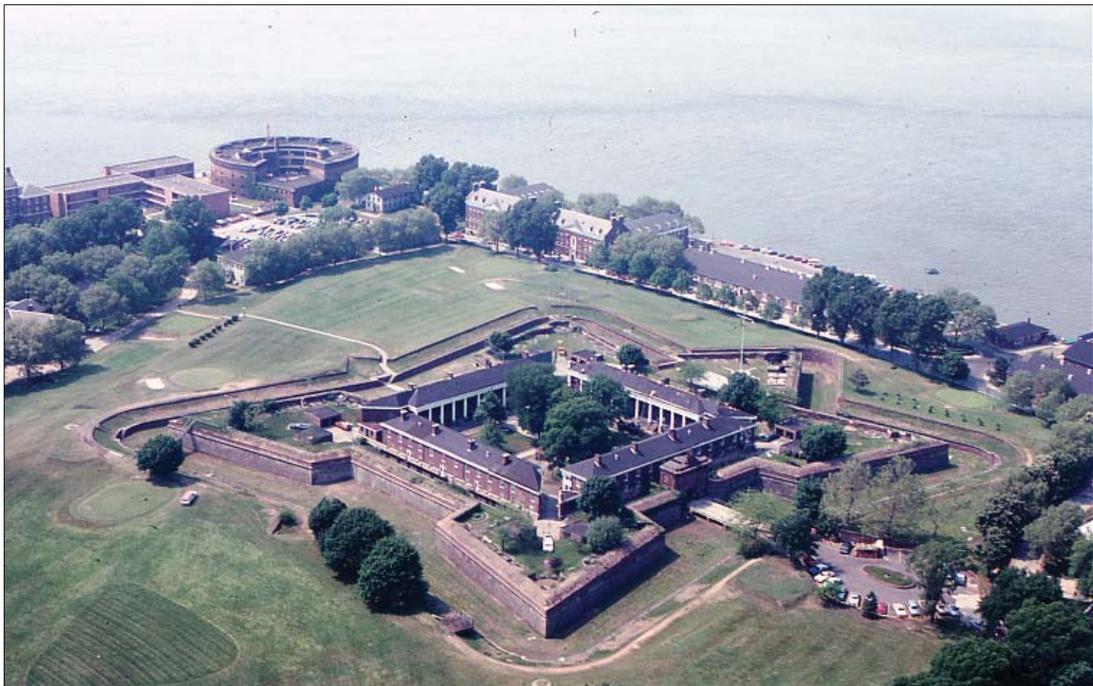
Figure 7.6. Fort Jay oblique aerial, looking north, 1977. This image captures golf course elements on the parade ground. Greens, bunkers, and tree lines are located throughout the space. Notice the scattered tree growth on the walls of Fort Jay. The new barracks built on the south side of Castle Williams can be seen at image left (Frank Bennett photograph, Governors Island National Monument image collection).

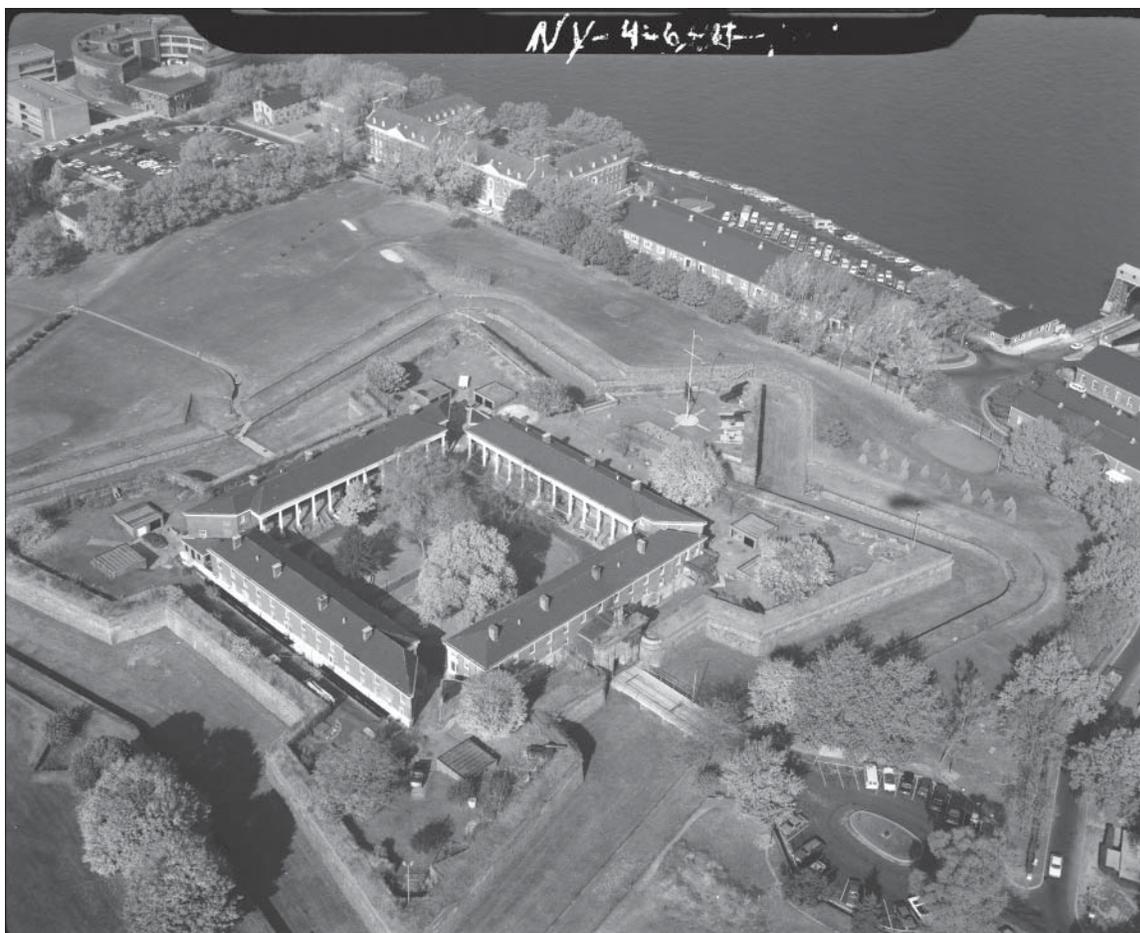
Figure 7.7. "Governors Island, Fort Columbus, aerial views, looking northwest, 1983." Tree lines added to the golf course in the late-1970s and early 1980s are visible at image left, image right, and above Fort Jay (Library of Congress, Historic American Building Survey, NY, 31-GOVI, 1-11).

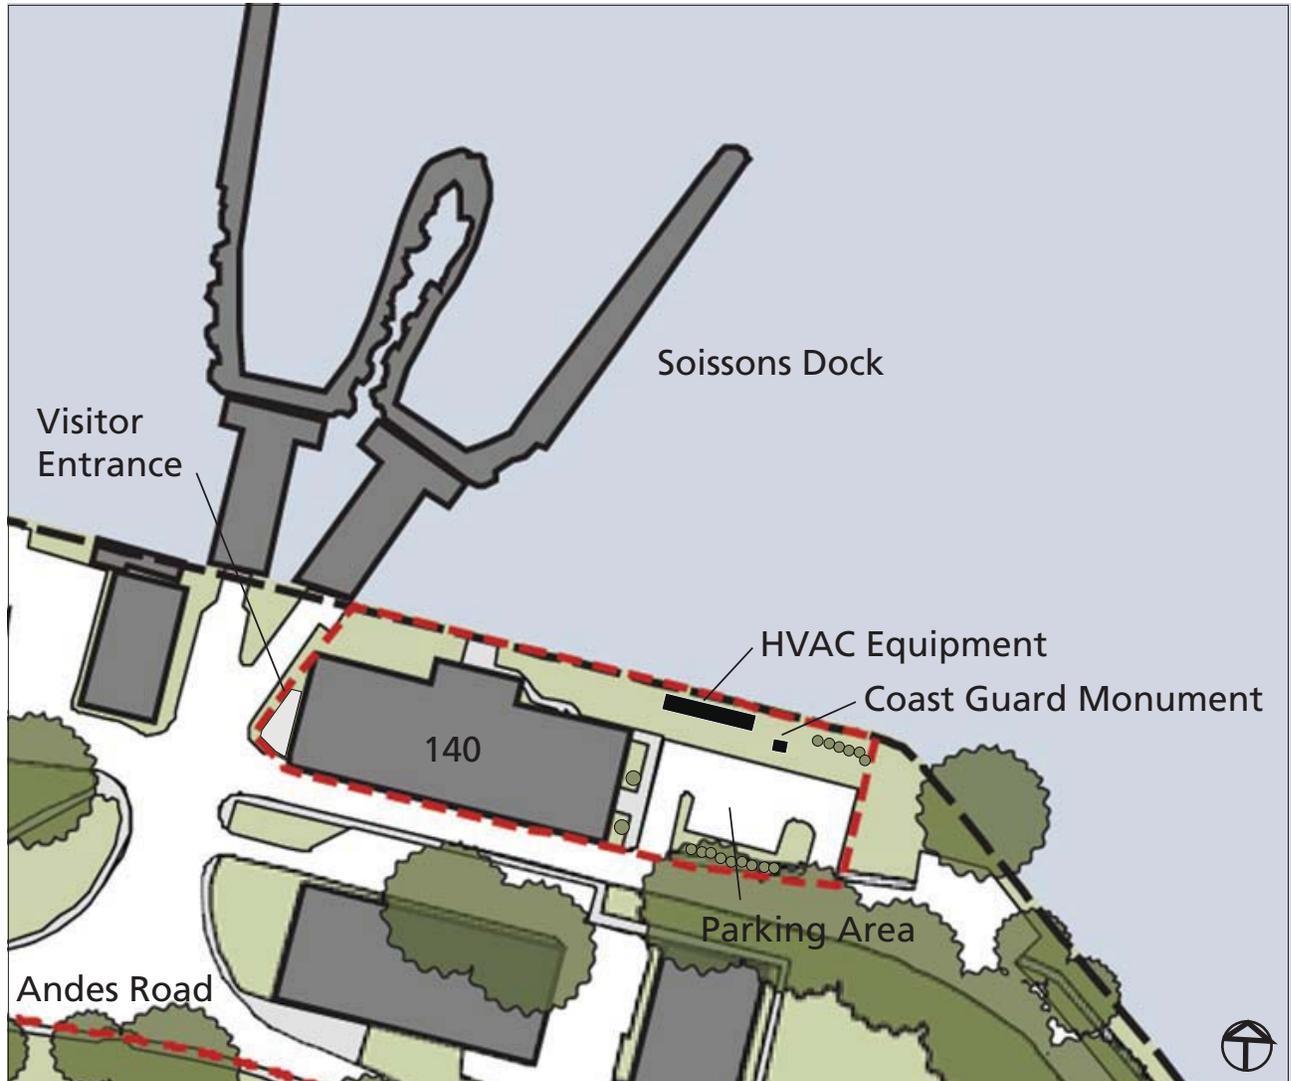
Figure 8.1. Building 140 and environs. The building falls within the boundary of the National Monument but the National Monument does not own the building. However, they do own a 1,000 square foot easement in the building. Visitors exit the ferry at Soissons Dock and receive orientation information at Building 140. The National Monument boundary is outlined in a dashed red line. Not to scale (OCLP, 2009).

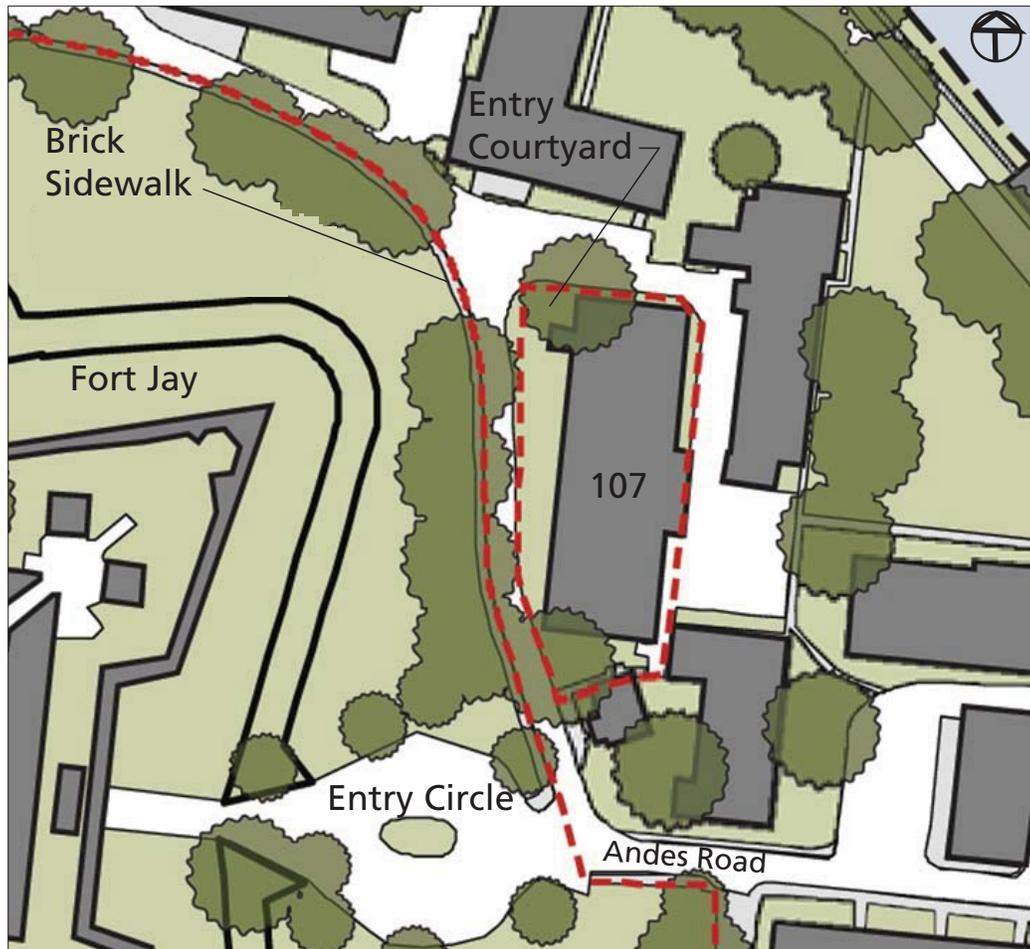
Figure 8.6. Above. Building 107 houses the National Monument's administrative functions. The Parade Ground is just out of the image frame to the right (OCLP, 2008).

Building 107 is located northwest of Dock 102, uphill from the dock along Andes Road (Figures 8.5 and 8.6). The one-story brick building was constructed in the 1850s as an Arsenal storehouse and today serves as the park headquarters. It shares design similarities with Building 140, including red brick, one-story construction with elements associated with the Romanesque Revival style. The rectangular brick building stretches north-south on a .44-acre site and is surrounded with a narrow grass lawn that hosts a few ornamental trees and shrubs. Two street lights are located in this green strip as well. These black metal, post-mounted light fixtures are cylindrical with four clear glass panels and a rounded, solid black cap. Unless otherwise noted, this is the lamp post style of most street lights on the National Monument property.

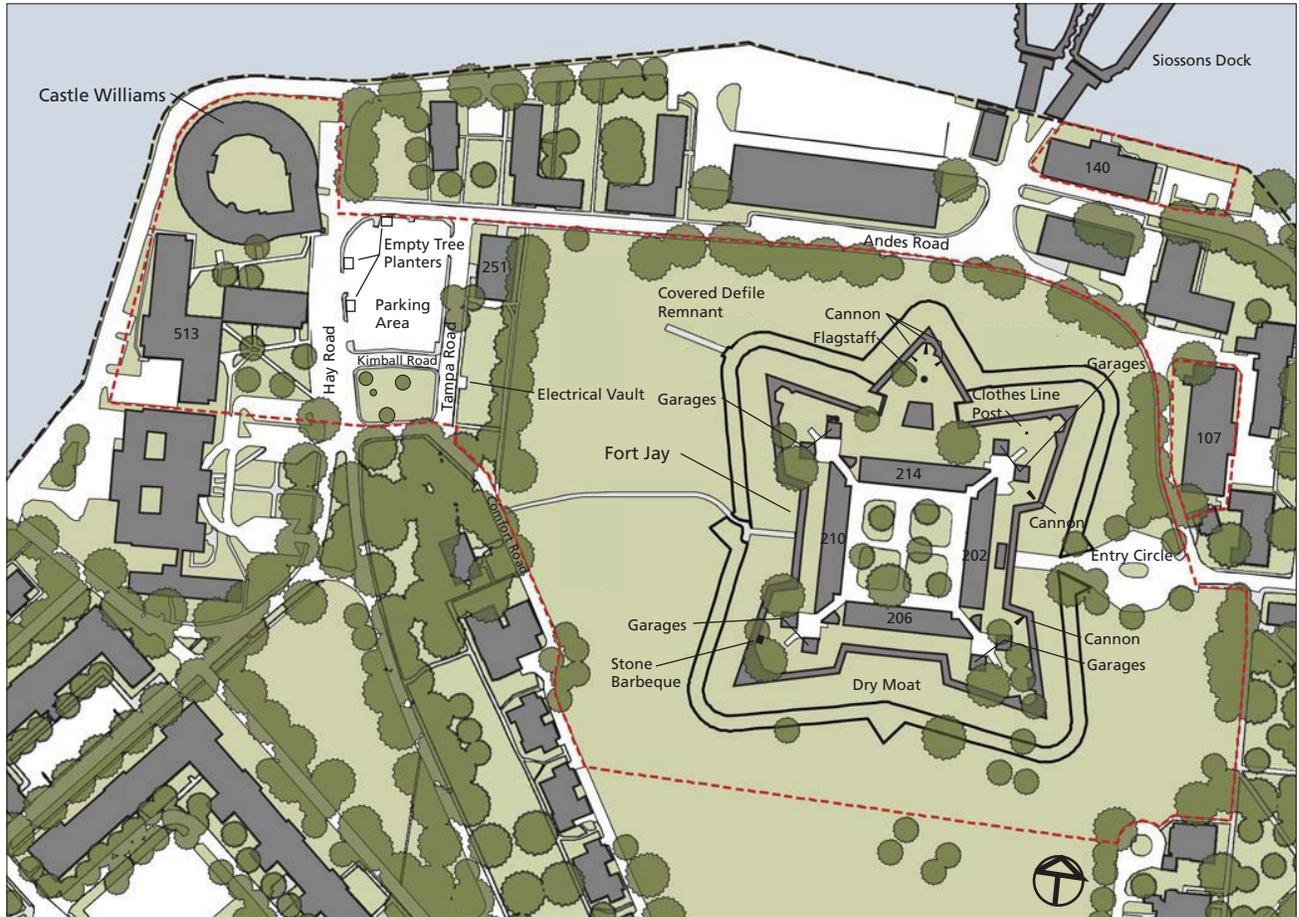
Figure 8.8. The Fort Jay and Castle Williams areas of the National Monument. The National Monument boundary is outlined in a dashed red line. Not to scale (OCLP, 2009).

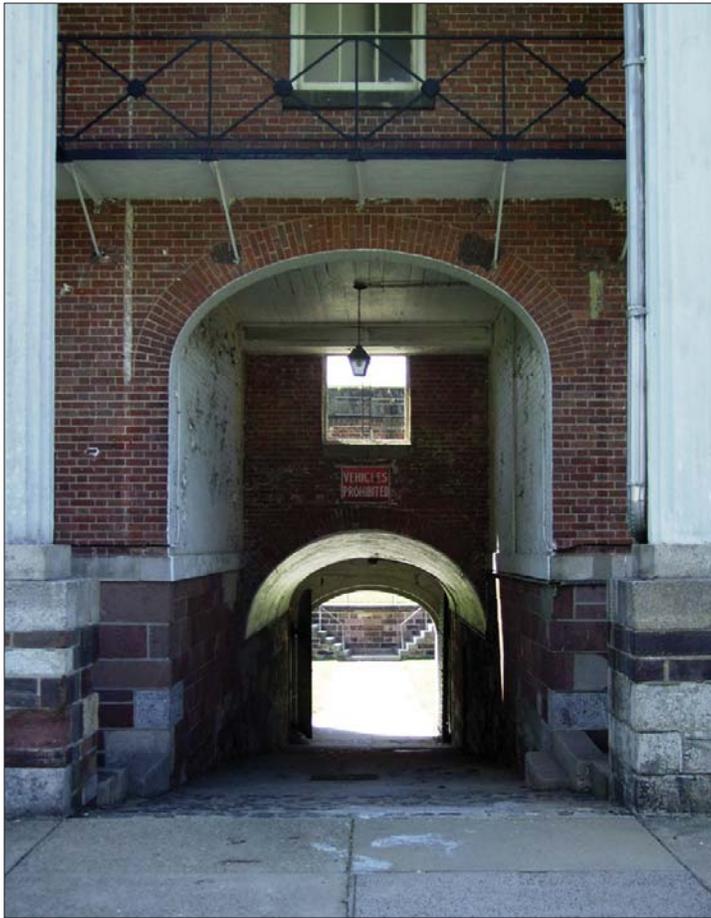
Figure 8.14. Stone-paved alleys lead to the terreplein behind the barracks at each corner of the Fort Jay inner courtyard (OCLP, 2008).

Tunnels extend from the courtyard under three of the four barracks (Building 210, 214, and 202, but not Building 206). Sallyports are only located at the tunnels for Buildings 202 and 210 (Figure 8.13). Cobblestone alleys connect the courtyard to the terreplein level behind the barracks at the four corners of the space (Figure 8.14).

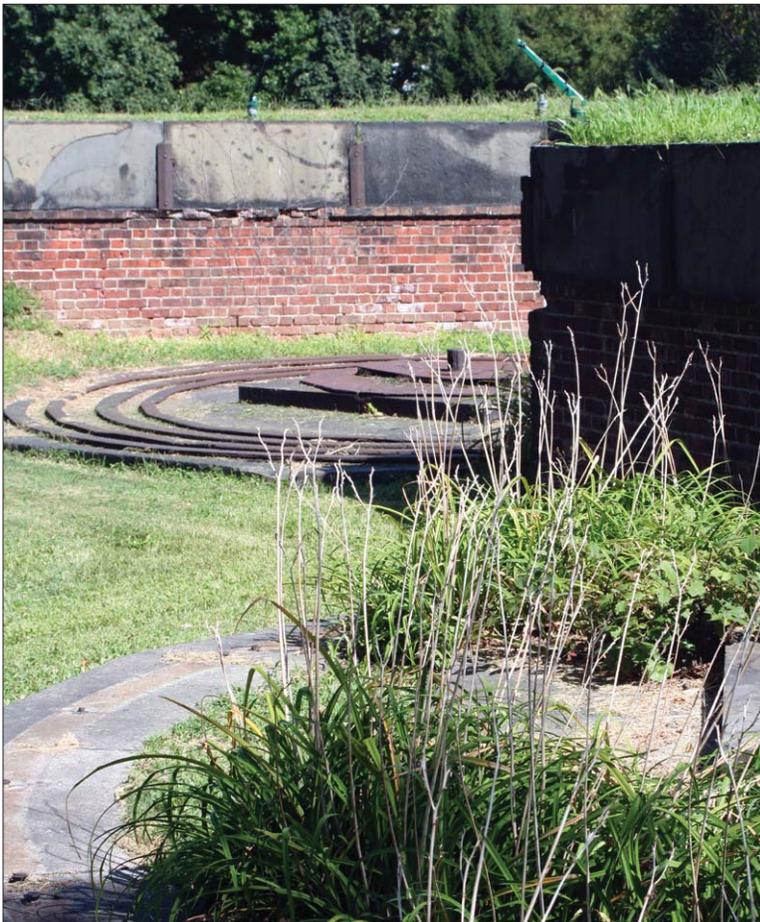
Figure 8.17. Stone barbeque built amidst the gun mounts on the terreplein of Fort Jay (OCLP, 2008).

Barbed wire brackets remain atop the scarp wall surrounding the eleven gun mounts on the southwest bastion. A maple tree, a juniper and an American elm are located in the space along with a stone barbeque grill at the west wall (Figure 8.17). Two, one-story brick garages flank opposite sides of the cobblestone open space that connects to the alley. Because of the topography, one garage has steps

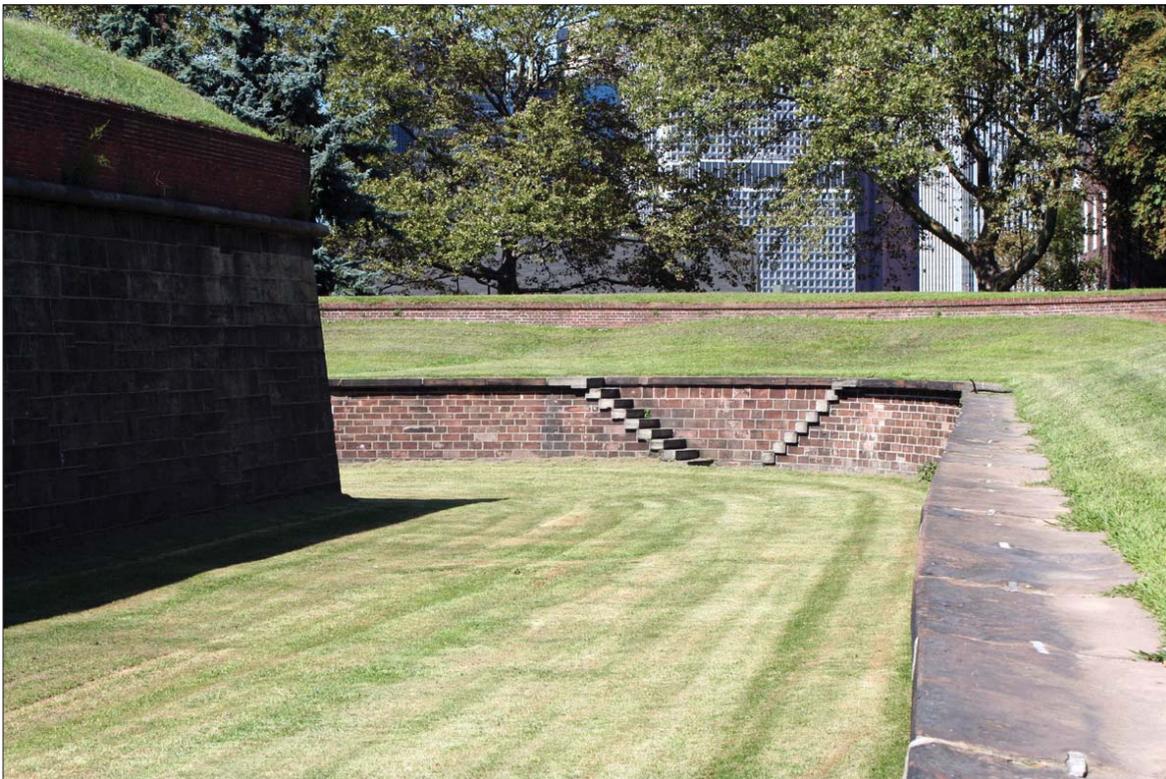
Figure 8.20. Below. Fort Jay's dry moat rests between the scarp walls (left) and counterscarp walls (center and right). The moat is maintained as mowed turf (OCLP, 2008).

The exterior of Fort Jay is comprised of a series of masonry walls and grass spaces. The outer wall system creates concentric rings of identically shaped defensive walls around the main fort. Viewing the fort from the outside, the tall fortification walls on which the cannon are mounted are called scarp walls. These walls are offset approximately forty feet by another ring of masonry walls, called counterscarp walls (Figure 8.20). Between the two features is a dry moat that sits approximately fifteen feet below the grade of the Parade Ground. Four sets of masonry stairs are built into the counterscarp walls, providing access between the dry moat and the intermediate level of the outer walls (Figure 8.21). Two sets of wooden stairs are also located in the outer wall system to provide additional access between the multi-leveled landscape. The outer walls of the dry moat, or counterscarp walls, are ringed by an additional almost continuous masonry wall, approximately four feet tall, on top of which lies the Parade Ground. Between

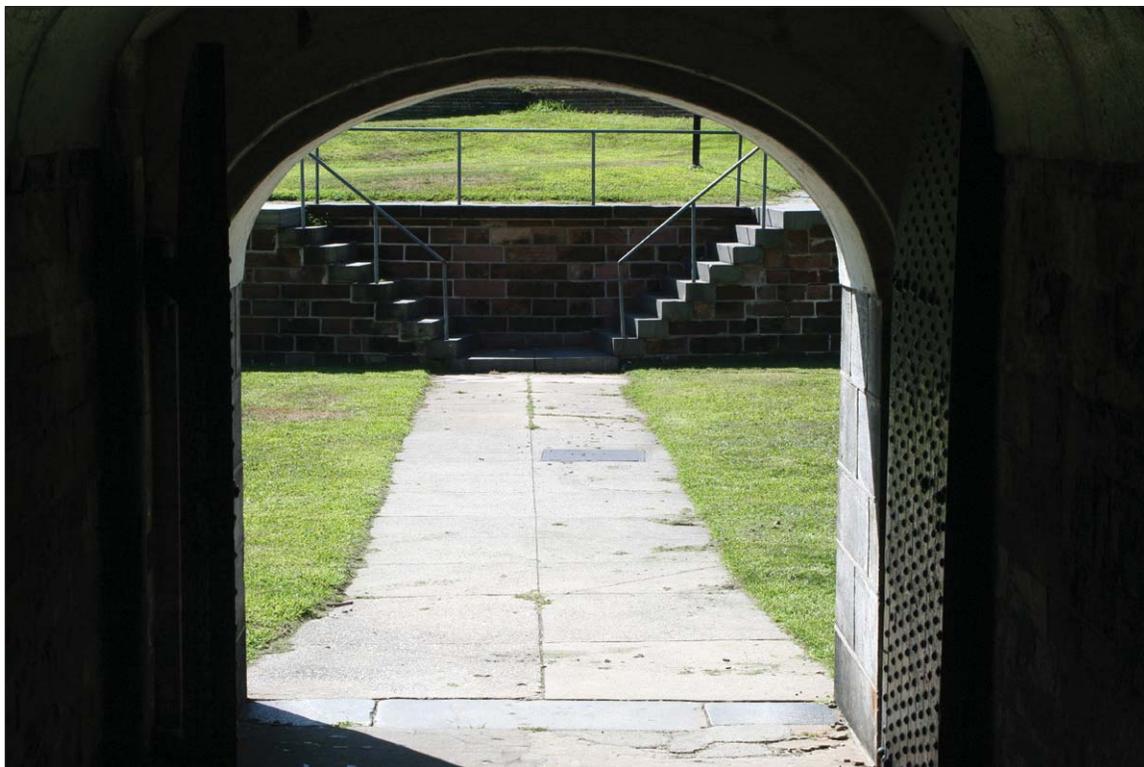
Figure 8.21. The west sallyport of Fort Jay, looking toward the stairs that lead to the covered defile and Parade Ground (OCLP, 2008).

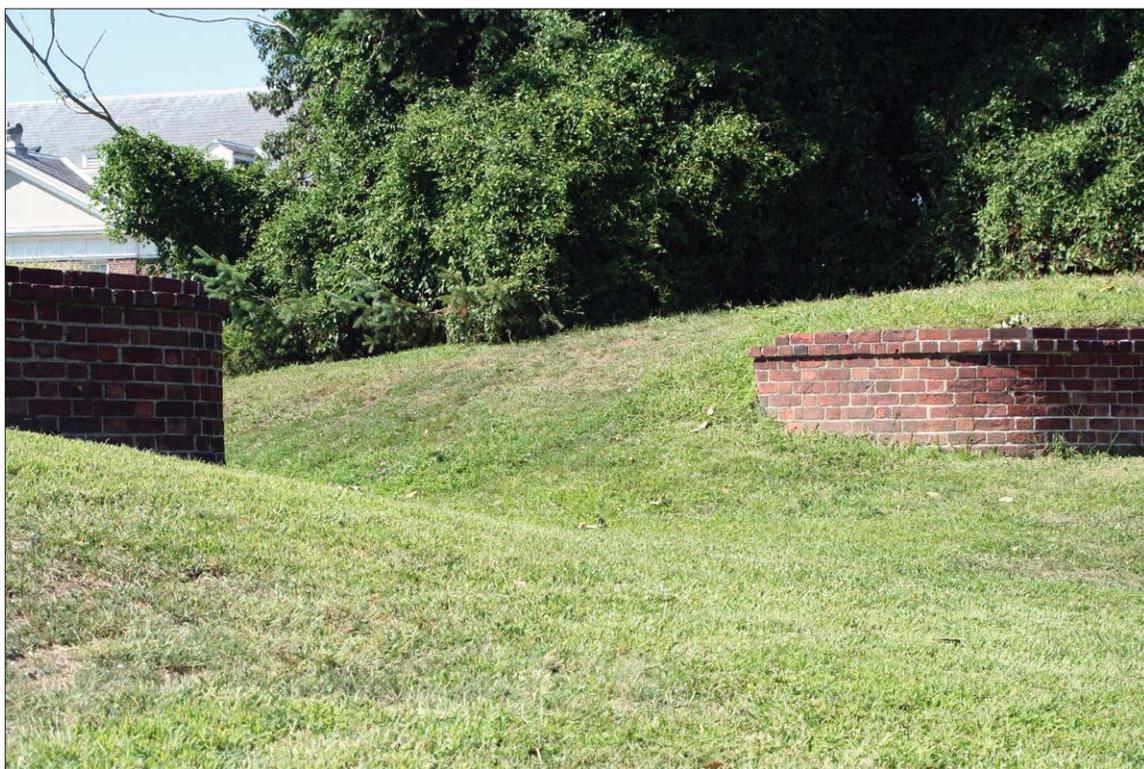
Figure 8.22. Remains of the covered defile exist at the northwest corner of Fort Jay's outer walls. The feature once connected Fort Jay and Castle Williams but now meets existing grade a few yards northwest of Fort Jay (OCLP, 2008).

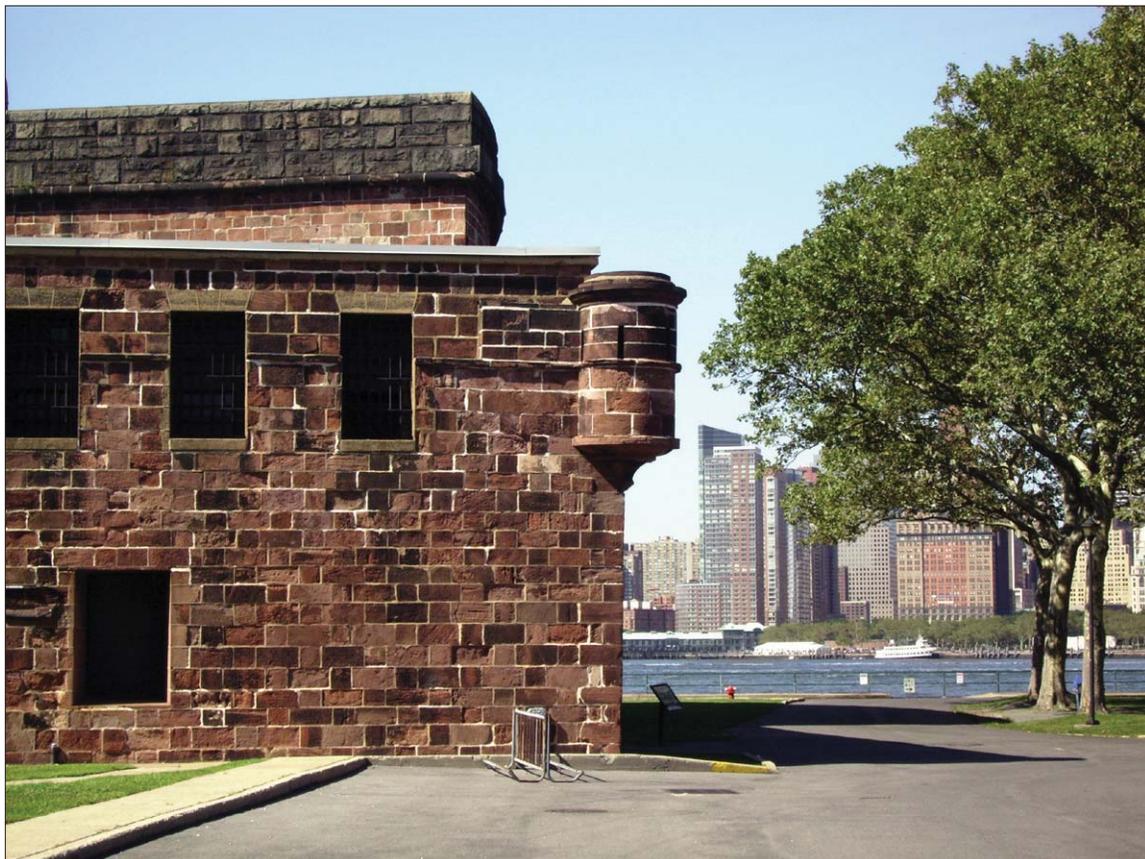
Figure 8.34. Below. The east side of Castle Williams, looking north. The fort's main gate faces image right (OCLP, 2008).
