NASA CASE NO. LAR 14581-1-SB

METHOD AND APPARATUS FOR EVALUATING MULTILAYER OBJECTS
FOR IMPERFECTIONS

PATENT APPLICATION

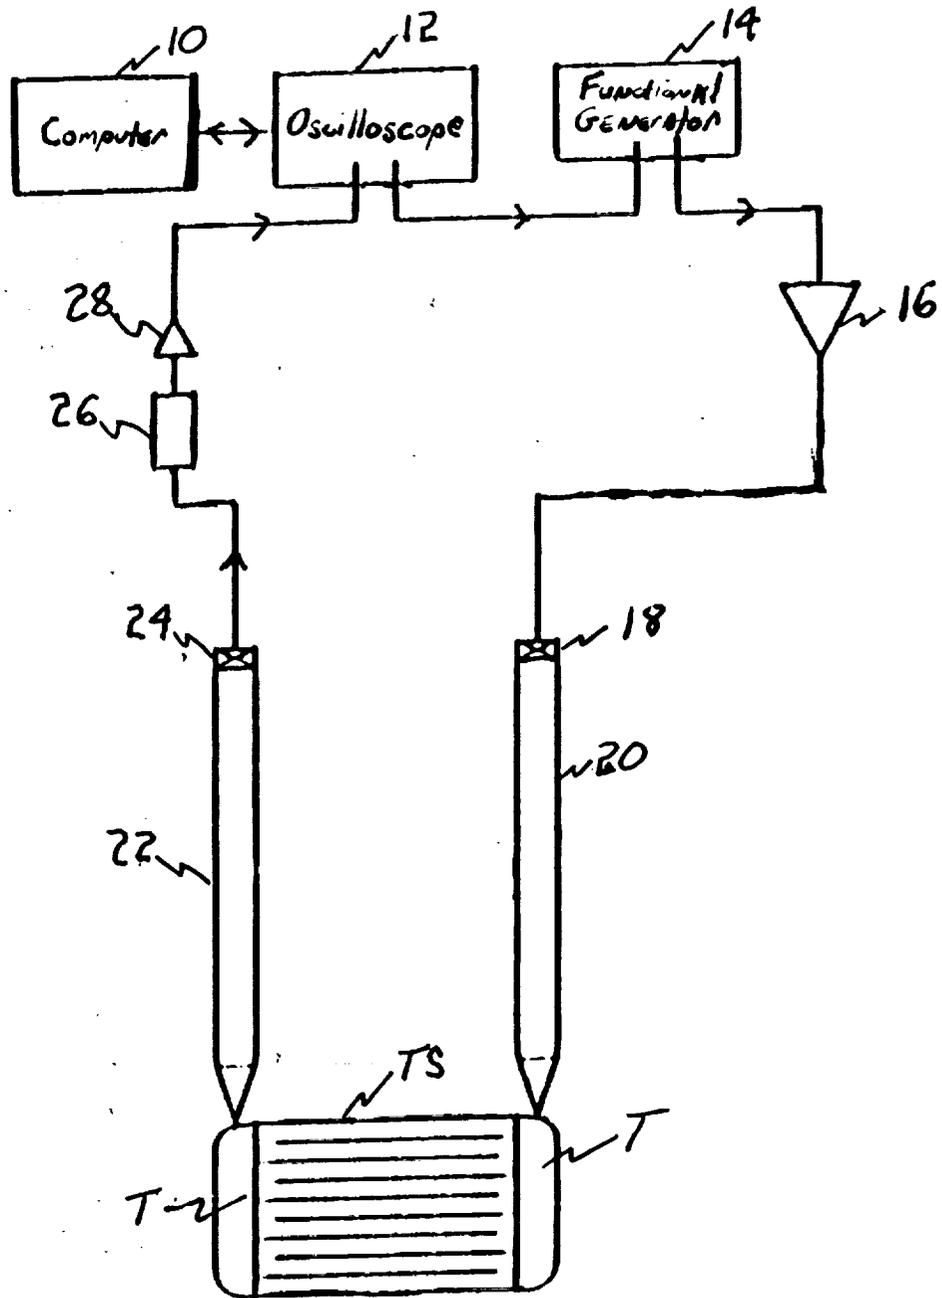
Fig. 1

FIG. 1 is a schematic of an apparatus for evaluating a multilayer object for imperfections according to the present invention;

Referring to FIG. 1, a schematic diagram is shown of the apparatus used in the present invention. A computer 10 is provided which is connected to and controls an oscilloscope 12, preferably a digital oscilloscope such as the LeCroy
25 9400A which is commercially available from LeCroy Corporation. A line out from the oscilloscope is connected to a function generator 14 for generating a radio frequency (RF) pulse which is amplified by RF power amplifier 16. For example, the computer can command that a RF pulse with a center frequency of 1 MHz be generated. The frequency chosen is dependent upon the material
30 properties and structural dimensions of the test specimen TS.

The amplified RF pulse is applied to the multilayer test specimen TS, which may be a multilayer ceramic chip capacitor (MLCC). The pulse is applied by a transmitting transducer 18 which is acoustically coupled to the TS via a first tapered buffer rod 20. Buffer rod 20 is uniformly cylindrical from a first end
5 coupled to the transducer 18 throughout its body. The opposite end is tapered to a fine point in order to produce a sharp acoustic contact by reducing the interface area between this pointed end and the TS. The resulting acoustic wave propagates across the TS and is picked up by a second tapered buffer rod 22. Second tapered buffer rod 22 is similar in shape to first rod 20. By
10 way of example, both rods may be copper and have an untapered diameter of approximately 700 μ m.

A receiving transducer 24 is coupled to the untapered end of second buffer rod 22, detects the propagated acoustic wave, and converts it into an electrical signal which is transmitted to a low pass filter 26 and then amplified
15 by amplifier 28. The amplified electrical signal is then supplied to the oscilloscope 12. Oscilloscope 12 permits a visual display of the received acoustic signal and transmits this data along with temporal data to the computer 10 as discussed in greater detail below with reference to FIGS. 2-5. This permits the evaluation of the MLCC, as discussed below.

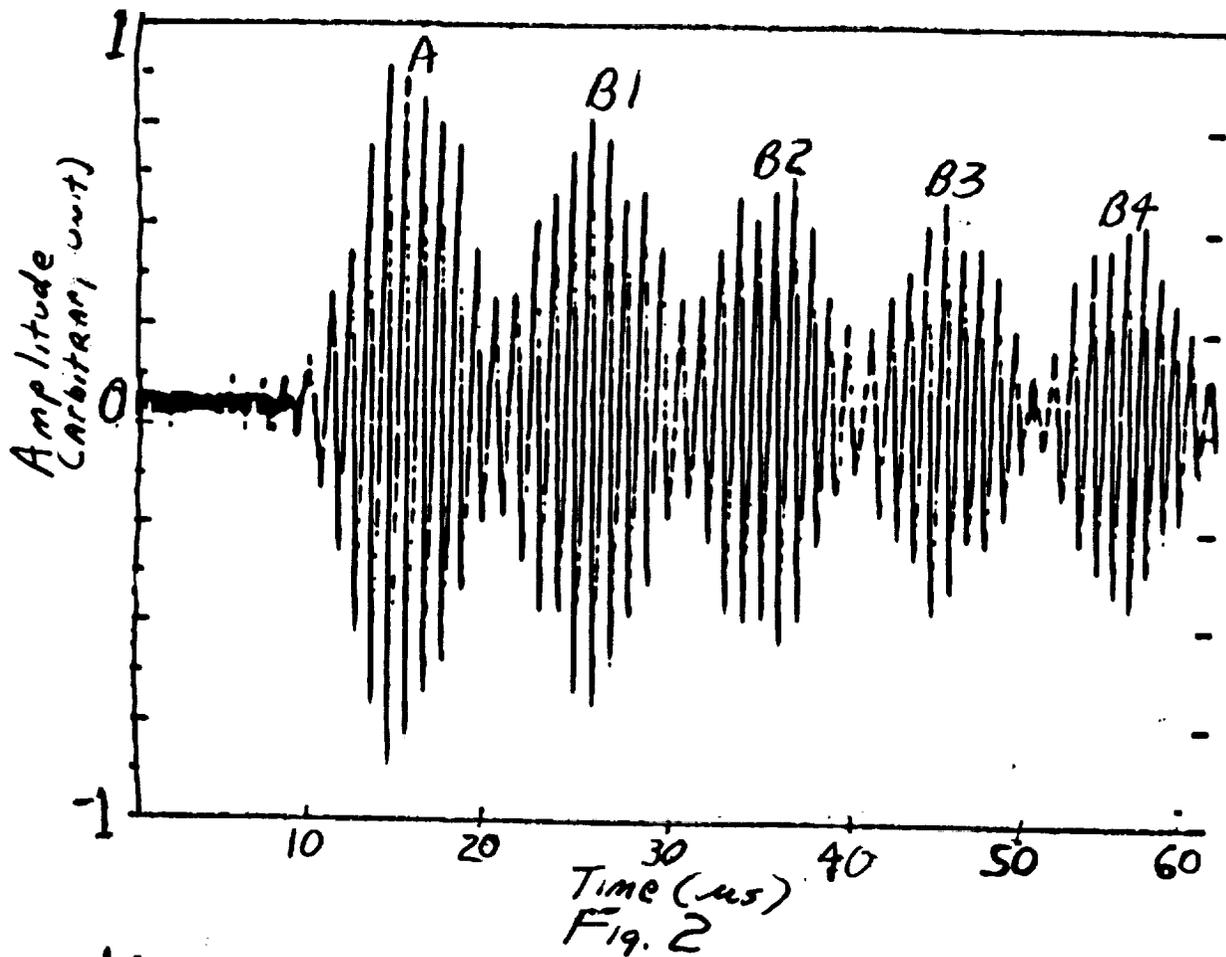
5 FIG. 2 is a graph of pulse echo signal groups taken over time for an undamaged multilayer chip capacitor;

The MLCC was determined to be relatively defect free prior to testing based on known manufacturing quality and microscopic inspection. FIG. 2 depicts pulse echo signals versus time for the same type of "good", i.e., relatively defect free, capacitor. The C-3216-CH-1H102K MLCC has typical dimensions of 3.2 mm x 1.6 mm x 0.85 mm. The buffer rod points were placed at the length ends so that the pulse traveled a typical length of 3.2 mm.

Both Table 1 and FIG. 2 clearly show a waveform consisting of an initial transmitted pulse (A in FIG. 2) followed by a series of undistorted echoes spaced at equal intervals (B_i in FIG. 2) for a "good" MLCC. This information is digitally transmitted to the computer 10, where it is stored for subsequent analysis. Based on the time between subsequent echoes (approximately 10 μ s) and the known path length (6.4 mm), the velocity of sound in the capacitor is determined by the computer or manually to be 640 m/sec.

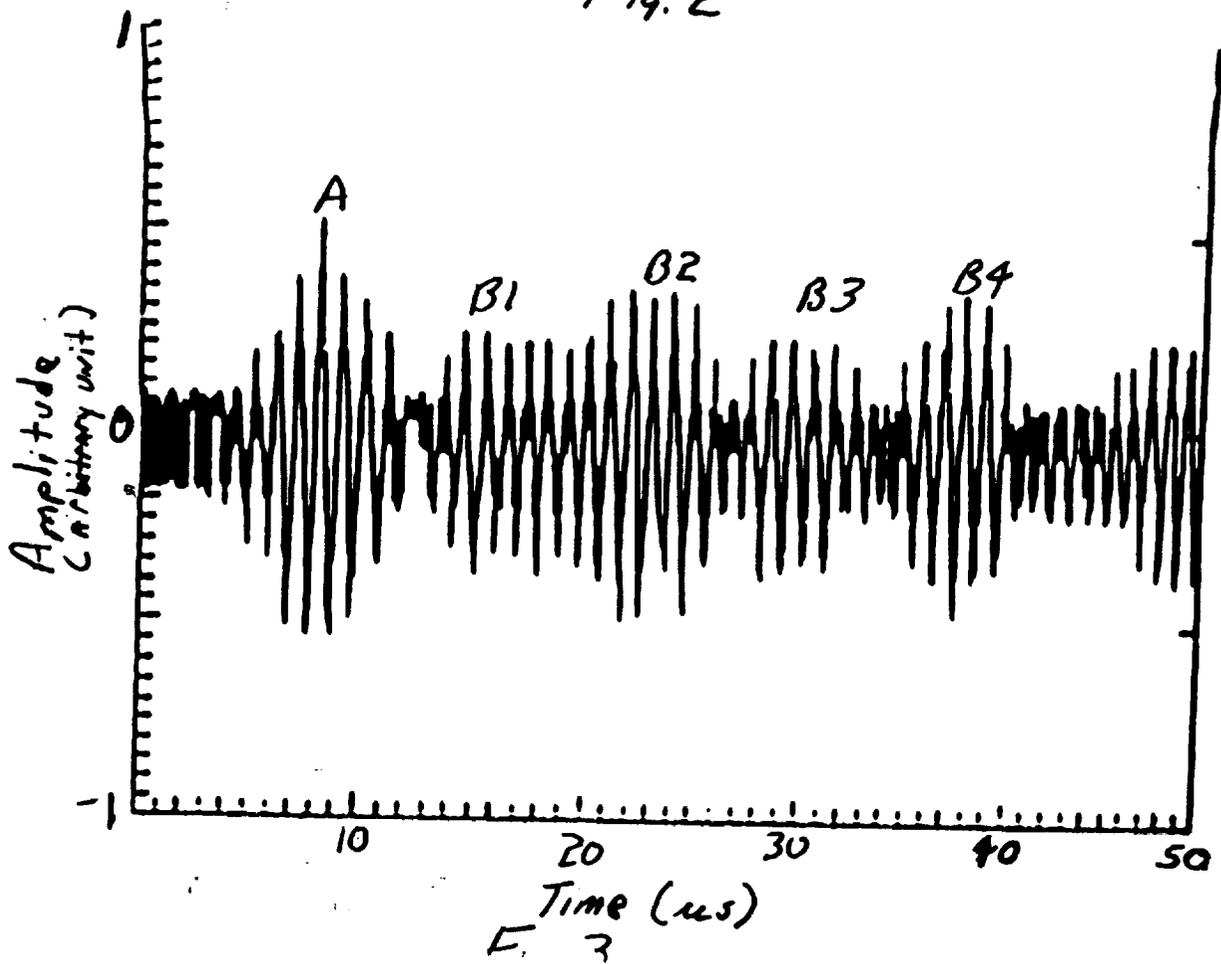
FIG. 3 is a graph of pulse signal groups taken over time for a damaged multilayer chip capacitor;

applying 1.7 kV of RF power across the terminal T in the acoustic propagation direction resulting in microcracks indicative of parametric or catastrophic failure. The microcracks were observed with a microscope. The damaged capacitor was then evaluated according to the method described above. FIG. 3 depicts the acoustic pulse echoes versus time for the damaged capacitor. Unlike the results of FIG. 2, FIG. 3 shows distorted echo trains which are unevenly spaced. Accordingly, the acoustic profile of a MLCC indicates the presence of damaging imperfections such as delaminations, voids, and microcracks. This acoustic profile can be evaluated as a function of time, i.e., computer sampled pulse groups or computer sampled peak amplitudes of each group which occur approximately periodically (equal intervals of time) indicates an acceptably undamaged MLCC whereas unequal intervals indicate an unacceptably damaged MLCC. Alternatively, the acoustic profile can be evaluated as discussed below in reference to FIGS. 4 and 5.

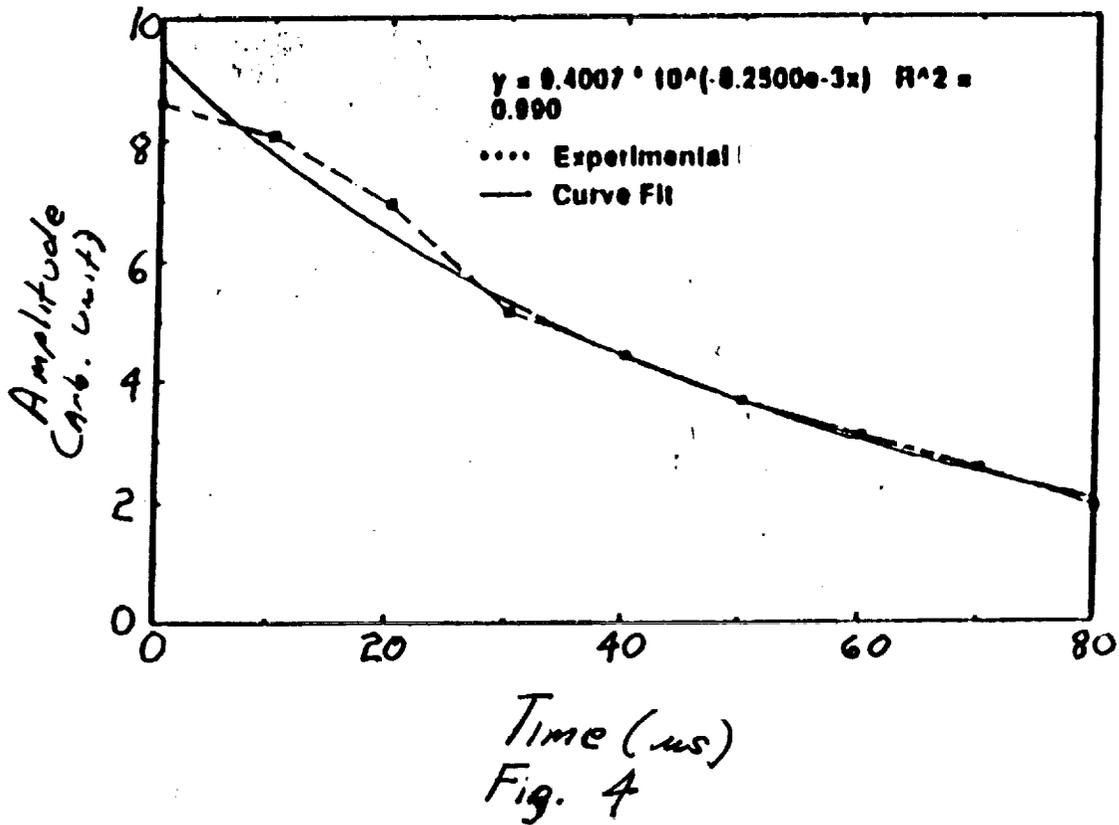
10 FIG. 4 is a graph of experimentally obtained peak amplitudes for each signal group in FIG. 2 and a model exponential curve;

FIG. 4 shows the amplitude of the acoustic signal versus time for the undamaged "good" MLCC. Specifically, the peak amplitudes of each distinct wave envelope or group of FIG. 2 is sampled by the computer, plotted as a data point and connected to other data points via a dashed line. A model exponential curve fit, represented by a solid line, is applied to the experimental data curve via the computer executing a conventional curve fitting program. The data in this case closely follows the exponential curve fit. Thus, it is seen that the amplitude of the acoustic signal for the "good" MLCC decreases over time. Similarly, FIG. 5 depicts the experimental amplitude peaks versus time for the MLCC test results of FIG. 3 connected via a dashed line. Once again, a model exponential curve fit is applied to the data points. The experimental data clearly does not follow the exponential due to damage caused by the applied RF power. Accordingly, the presence of distorted wave trains and deviation of peak amplitude from an exponential curve fit indicates a damaged MLCC.

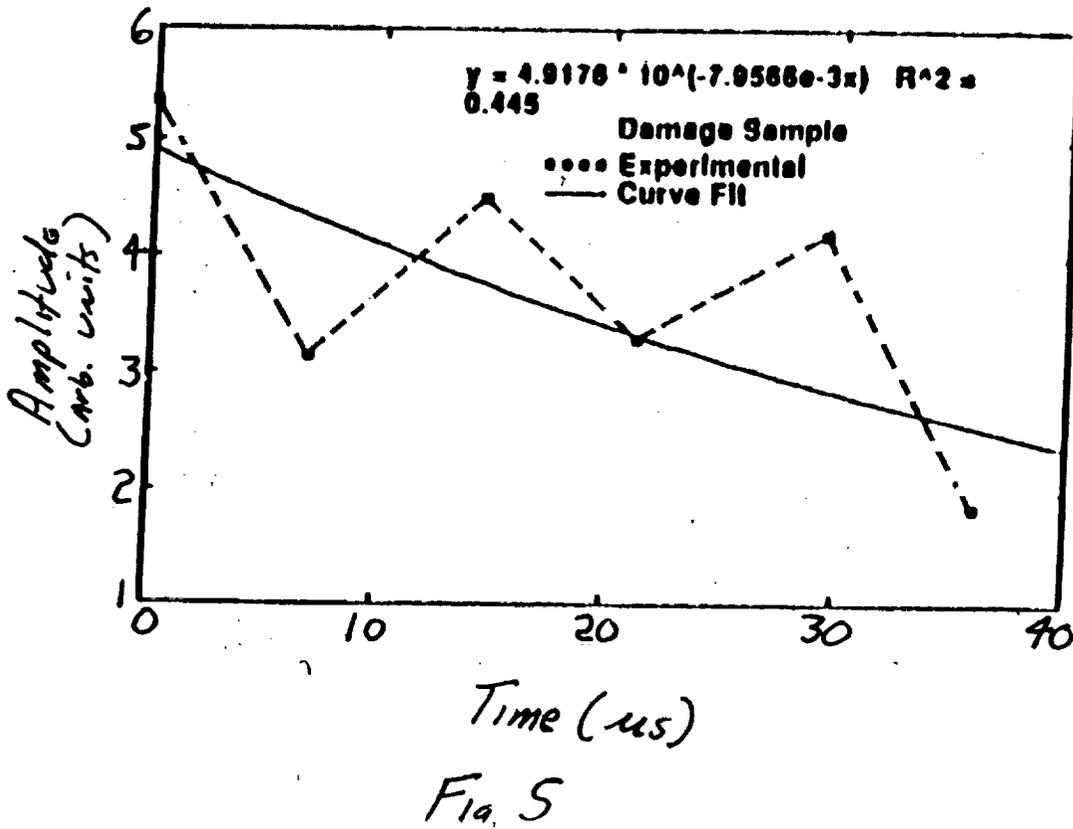
FIG. 5 is a graph of experimentally derived peak amplitudes for each signal group in FIG. 3 and a model exponential curve;

exponential indicates a relatively undamaged MLCC and a deviation from the curve fit indicates the converse. The percentage of fit indicative of a relatively undamaged state is of course application specific. A fit of approximately 80-90% has been found to be a good indication of an acceptable undamaged state and a deviation of 10-20% to indicate an unacceptable damaged state.

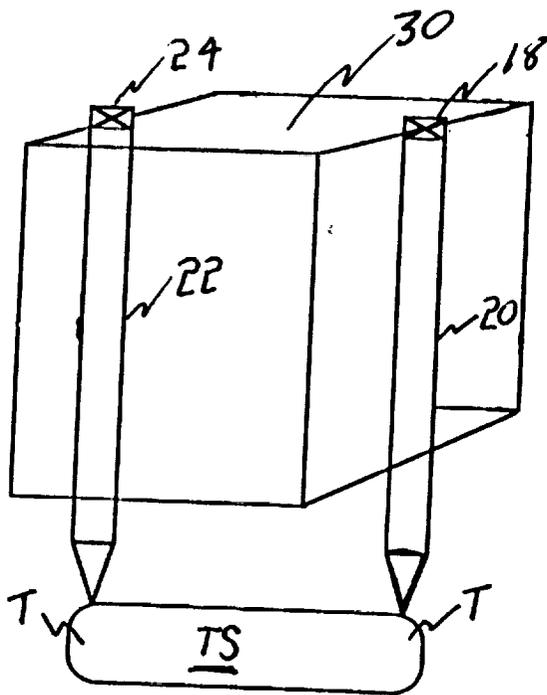
Fig. 6

FIG. 6 is a perspective of an embodiment of a transducer/waveguide combination used in the present invention;

FIG. 6 shows the use of a spacing device 30 which maintains the physical, electrical, and acoustic separation of the tapered ends of the buffer rods 20 and 22 respectively coupled to transmitting and receiving transducers 18 and 24. Spacing device 30 is depicted as a box-like structure wherein the buffer rods are attached to perpendicular faces of the structure. The buffer rods should be spaced so as to contact the terminal ends T of the MLCC test specimen TS. Of course, various alternative holding devices could be employed, e.g., an adjustable spacer located between the buffer rods.

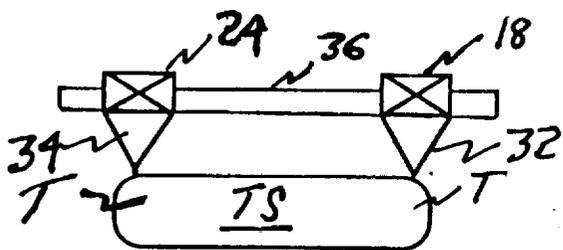
Fig. 7

15 FIG. 7 is a side view of another embodiment of a transducer/waveguide combination; and

FIG. 7 depicts an embodiment wherein the buffer rods are replaced with buffer cones 32 and 34. The transmitting and receiving transducers 18 and 24 are respectively coupled to the bases of cones 32 and 34.
