This Is **Not** the Kind of Tip You Want to Leave

By Ens. Kevin Shmihluk,
USCGC Hamilton (WHEC 715)

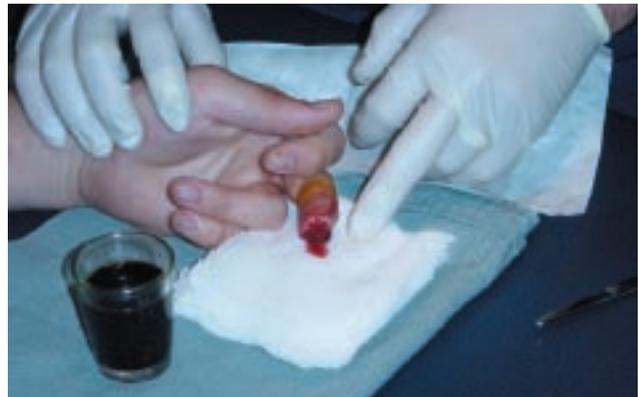
Hamilton's petty officer was loading trash onto the loading bucket when he suddenly felt a sharp pain in his left hand. Looking at it, he saw his middle finger had been mashed between the seating plate and the bucket arm, which was in the position shown in the photo.

The injury did not reach his knuckle, but the fingertip was damaged. Within minutes, the PO3 was stabilized and being treated by a ship's health services technician. The injury to his fingertip was severe enough to require amputation. Meanwhile, *Hamilton* had to suspend operations and change course so the petty officer could be taken by medevac to a hospital ashore.

Because a Coast Guard petty officer had his hand in the wrong place, he lost the tip of a finger (above) to an incinerator like the one below. This incinerator is found aboard all 12 Coast Guard *Hamilton*-Class, high endurance cutters.

Operators have been reminded to be more vigilant—and to stay focused—while operating the incinerator. ☹

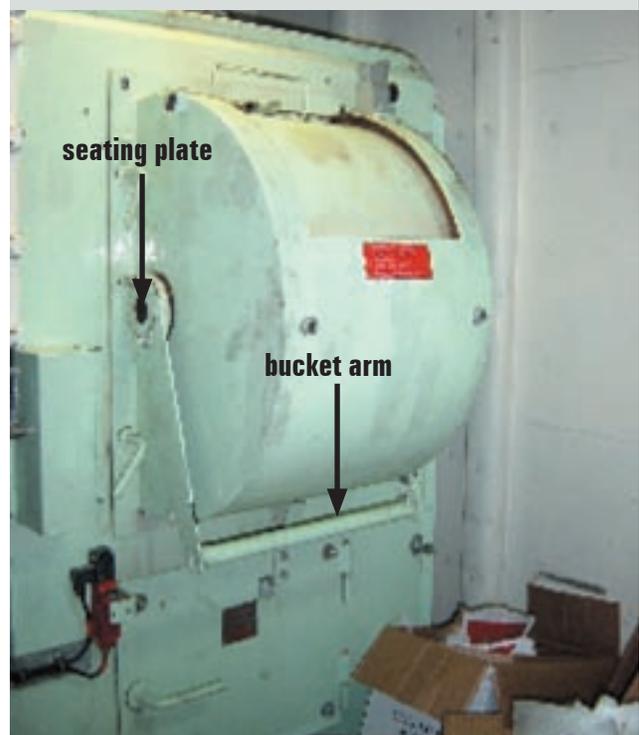
Some background: *Hamilton's* shipboard incinerator operates at high temperatures, so when a plastic bag of trash is placed on the loading bucket, the loading arm must be pushed up with enough force to make sure all trash falls into the burner and no bags stick to the bucket. The loading arm then must be pushed down hard again to its original closed position so the incinerator operator isn't looking directly into the burner fire.

How and why did this injury occur? The petty officer's left hand was not in the proper position to operate the incinerator. Instead of holding the bar that goes across the bucket, the PO3 had his left hand on the loading-bucket arm, up far enough to where the arm touches the seating plate. During the investigation, the operator attributed his hand being out of position to a loss of situational awareness. He also expressed fear his hands would hit the safety shield's bar when he raised the loading arm (see the picture).
