A FLIR-Pod Fumble

By A member of the VMFA-212 Maintenance Department

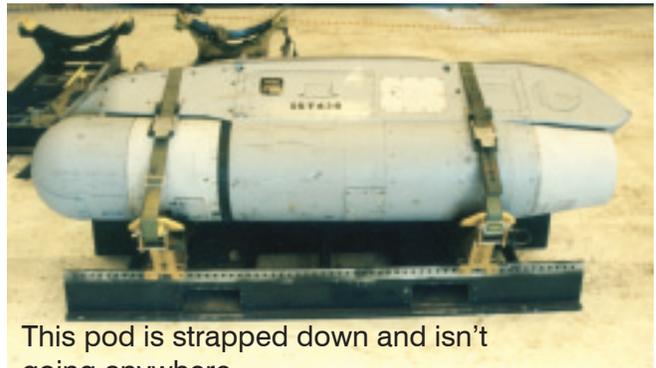
This pod is strapped down and isn't going anywhere.

Since the incident, we have changed the way we move FLIR pods. We now use a skid platform and soft-belt adapter to hold the FLIR pod on the skid platform. We also must use a SATS weapon loader to move the FLIR pods to the aircraft.

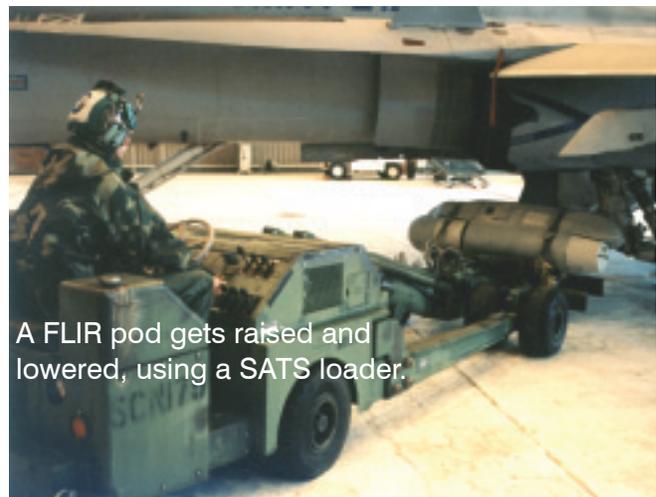
A FLIR pod gets raised and lowered, using a SATS loader.
