Electrical Cable Test Results and Analysis During Fire Exposure (ELECTRA-FIRE)

**A Consolidation of Three Major
Fire-Induced Circuit and Cable
Failure Experiments Performed
Between 2001 and 2011**

Draft Report for Comment

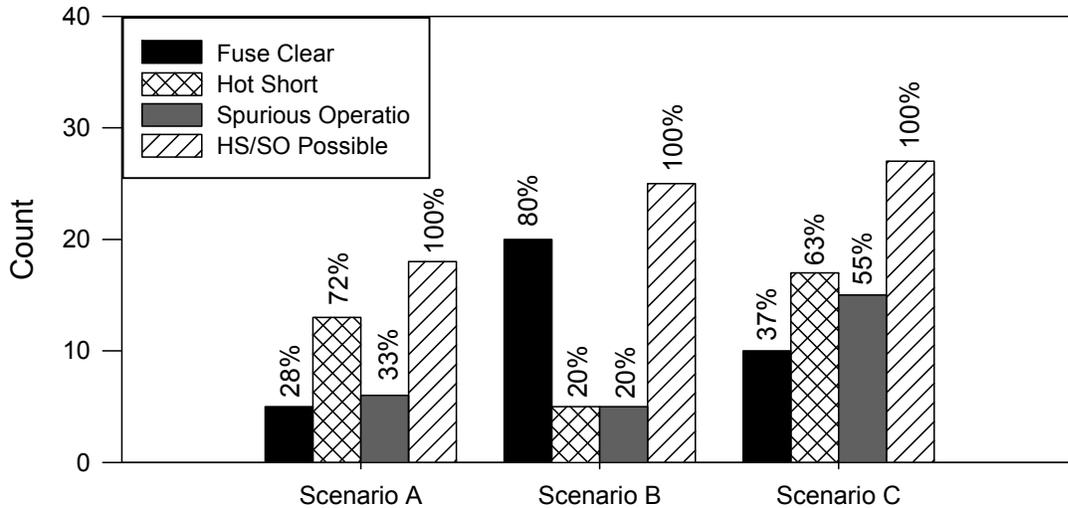
Figure 1-1. Examples global approach failure mode column plot

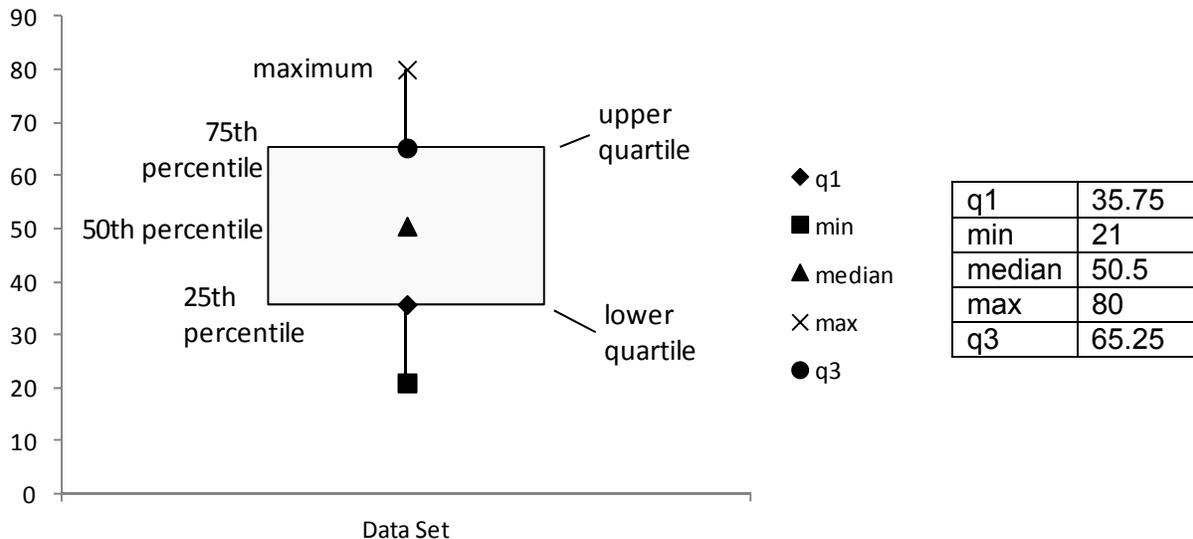
To provide a realistic and simple graphical representation of the duration data set, this report provides hot short and spurious operation duration box plots, also known as box and whisker plots. An example of a box and whisker plot is provided in Figure 1-2. The example data set used to prepare this example plot is a continuous set of integers ranging from 21 to 80.

Figure 1-2. Box and whisker plot example

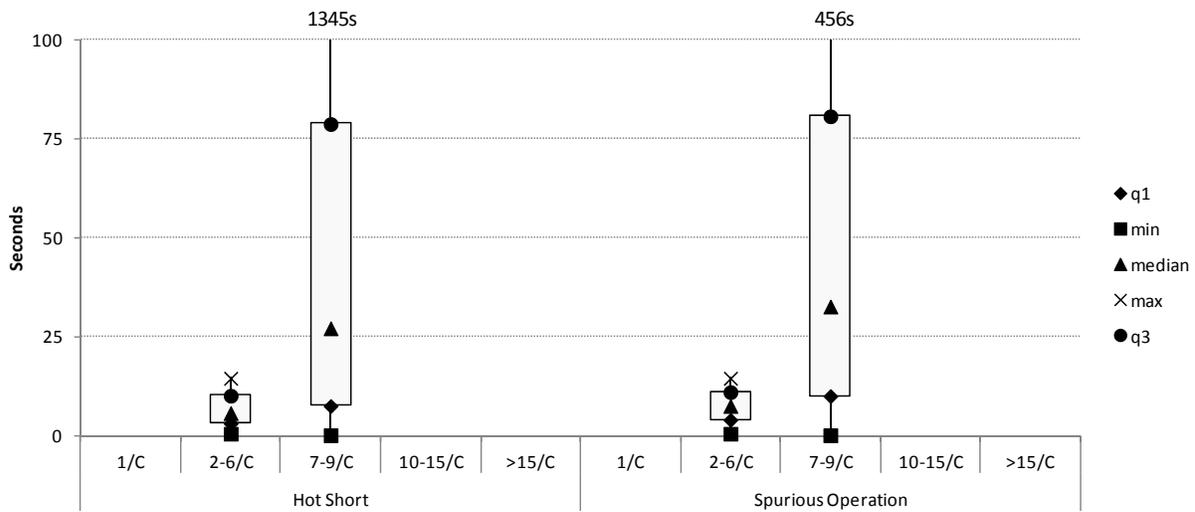
Hot Short					Spurious Operation				
	1/C	2-6/C	7-9/C	10-15/C	>15/C	1/C	2-6/C	7-9/C	10-15/C	>15/C
q1	-	3	8	-	-	-	4	10	-	-
min	-	1	1	-	-	-	1	1	-	-
median	-	6	27	-	-	-	8	33	-	-
max	-	15	1345	-	-	-	15	456	-	-
q3	-	10	79	-	-	-	11	81	-	-
mean	-	7	69	-	-	-	8	61	-	-

Figure 2-3. Conductor count box plot, duration, ac tests

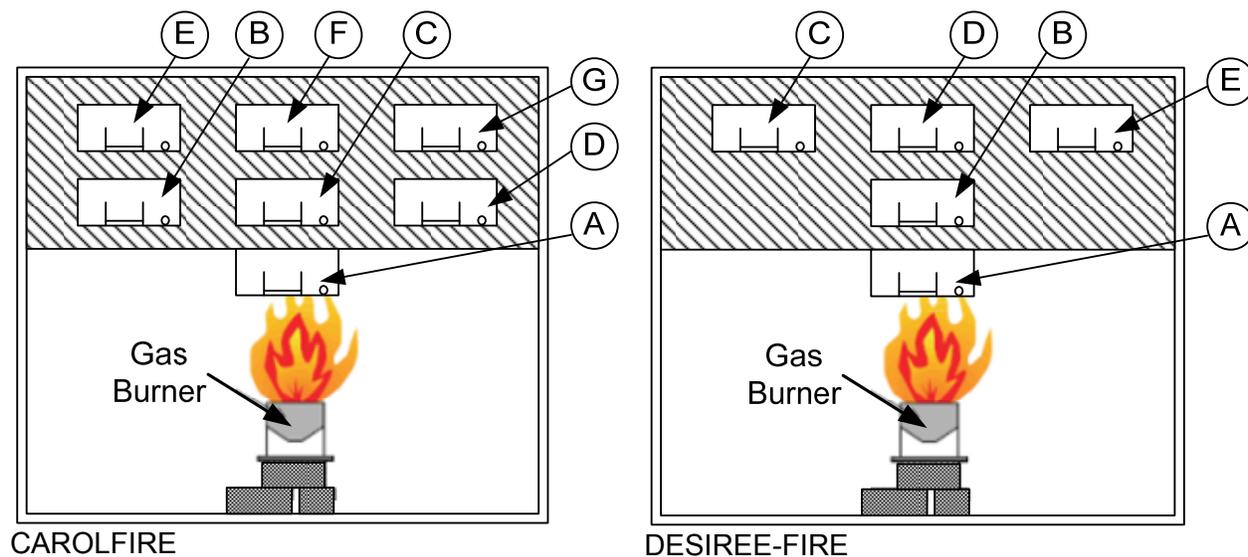
Figure 2-4. Intermediate-scale cable raceway location

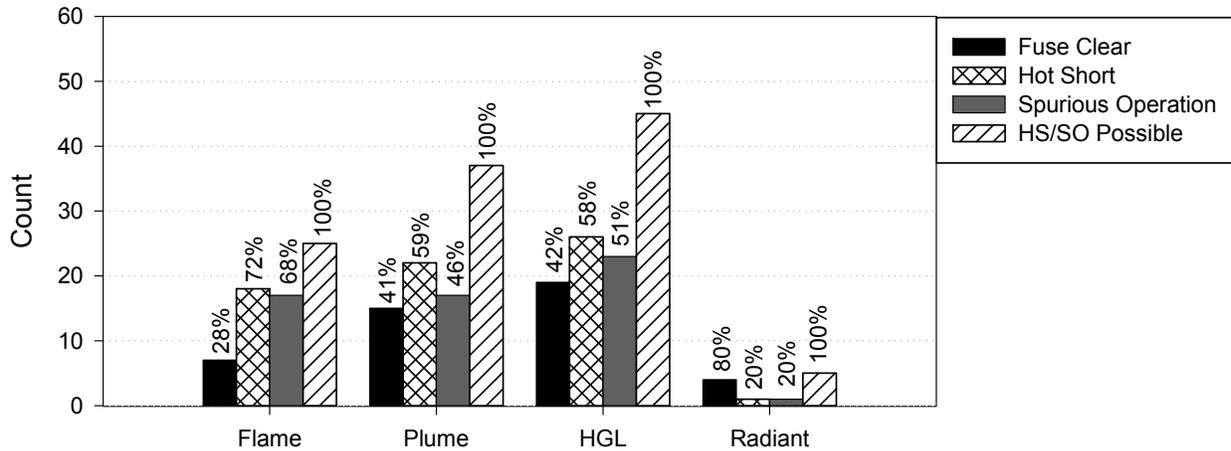
Global Approach	Flame	Plume	HGL	Radiant
Fuse Clear	7	15	19	4
Hot Short	18	22	26	1
Spurious Operation	17	17	23	1
HS/SA Possible	25	37	45	5

Figure 2-5. Thermal exposure conditions, global approach, ac tests

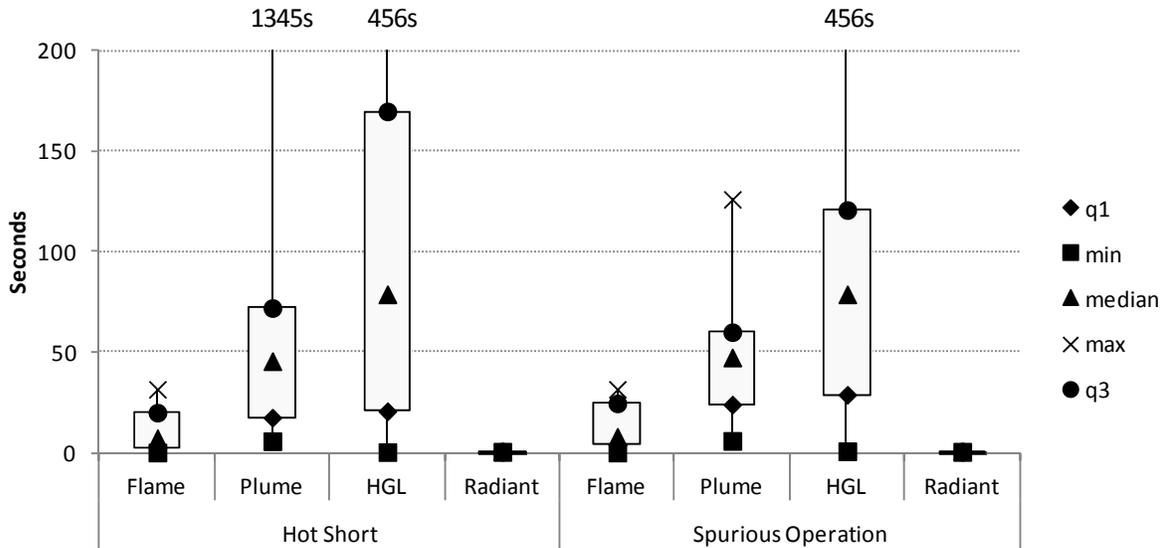
³ Note that one duration for the hot short plume data set was 1345 seconds. This data point has been removed from the generalized discussion, but is important when considering maximum test data durations.

Figure 2-6. Thermal exposure conditions box plot, duration, ac tests

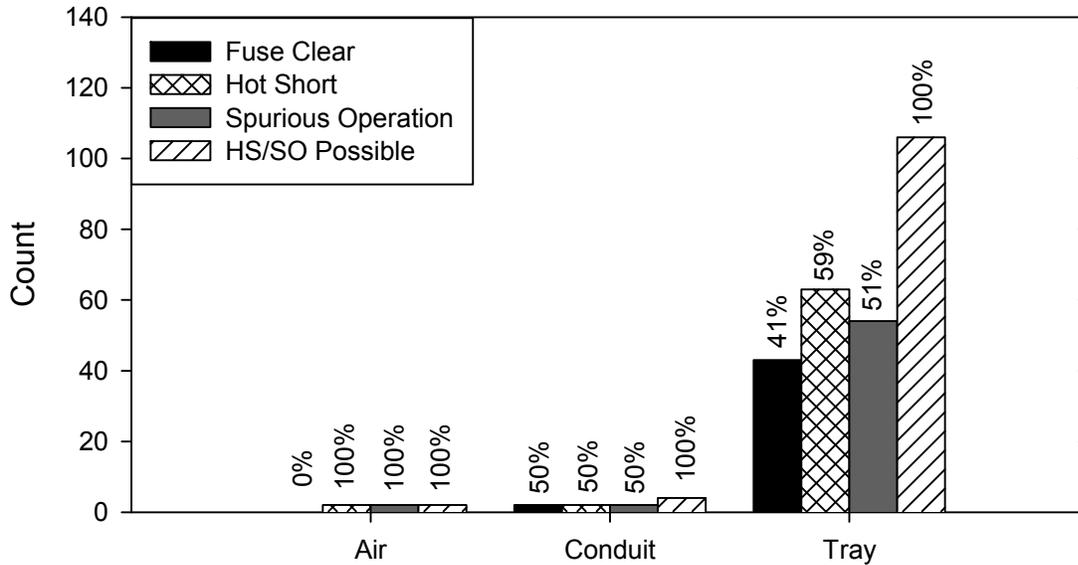
Global Approach	Air	Conduit	Tray
Fuse Clear	0	2	43
Hot Short	2	2	63
Spurious Operation	2	2	54
HS/SA Possible	2	4	106

Figure 2-9. Raceway routing column plot, global approach, ac tests

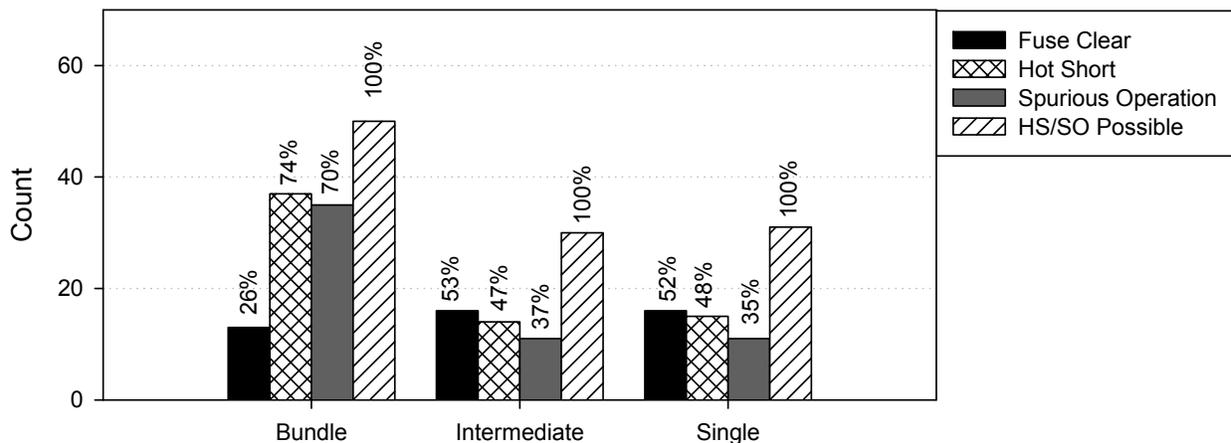
Global Approach	Bundle	Intermediate	Single
Fuse Clear	13	16	16
Hot Short	37	14	15
Spurious Operation	35	11	11
HS/SA Possible	50	30	31

Figure 2-14. Raceway fill column plot, global approach, ac tests

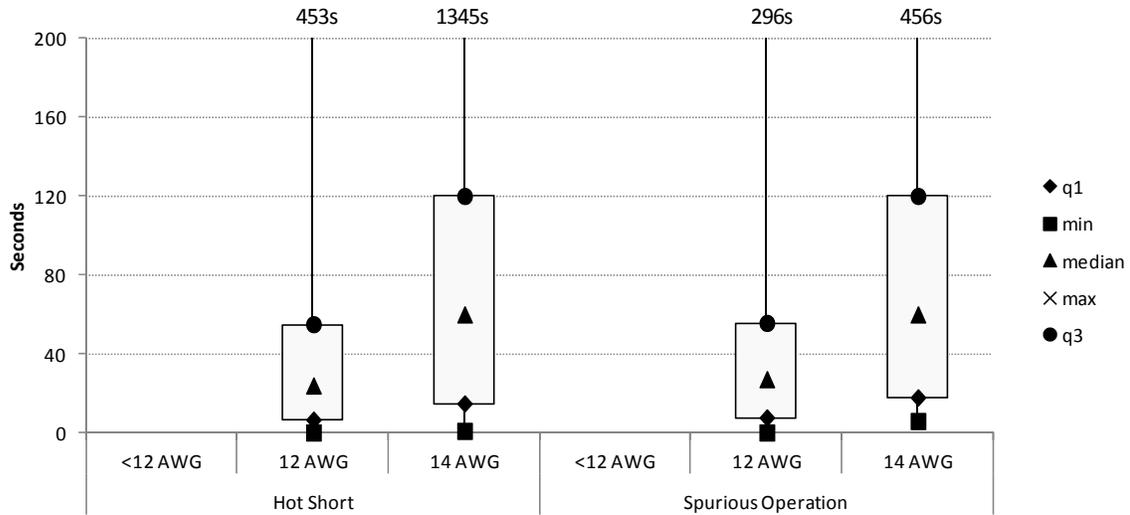
Hot Short			Spurious Operation		
	<12 AWG	12 AWG	14 AWG	<12 AWG	12 AWG	14 AWG
q1	-	7	15	-	8	18
min	-	1	1	-	1	6
median	-	24	60	-	27	60
max	-	453	1345	-	296	456
q3	-	55	120	-	56	120
mean	-	52	115	-	49	94

Figure 2-29. Conductor size box plot, duration, ac tests

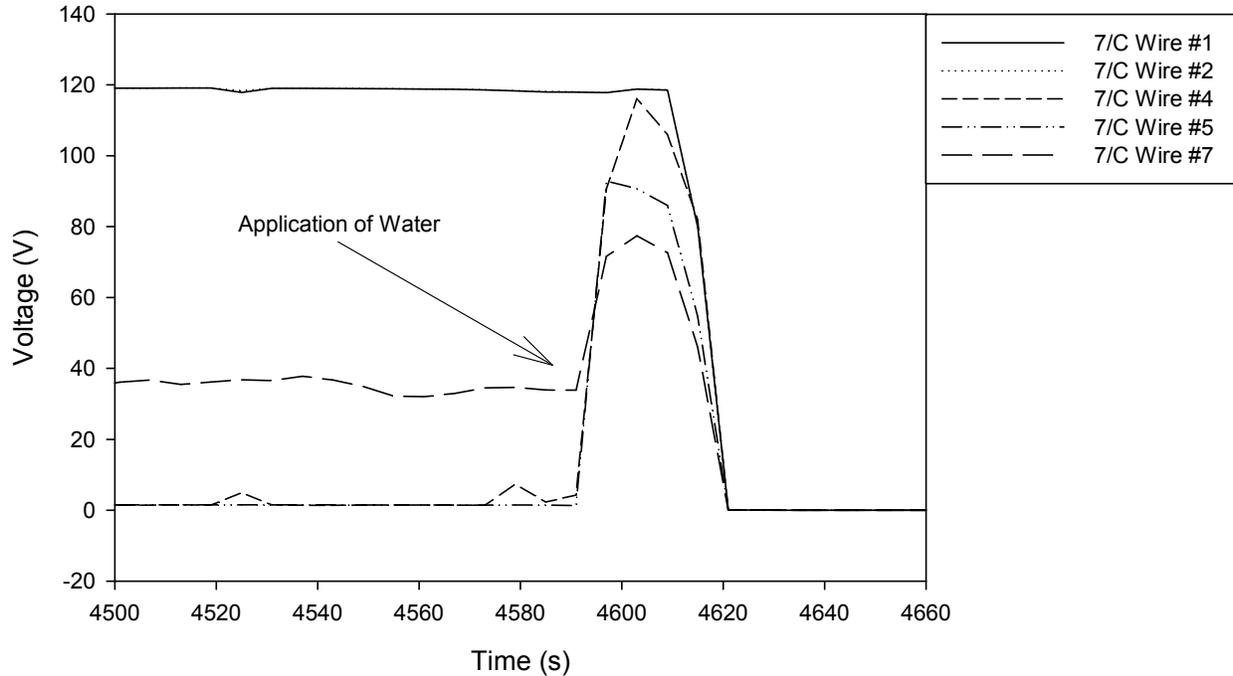
Water spray was observed to cause spurious operations in only one EPRI/NEI test, Test 3. In this case, a spurious operation did coincide with water spray, and persisted for approximately 24 seconds before a fuse clear occurred. This test cable was located at the center of the top layer of a two-layer cable fill test. Figure 2-30 provides a voltage plot of test circuit 3 for EPRI/NEI Test #3, showing the spurious operation on the target conductor, Wire #4 but only hot shorts on non-spurious operation target Wire #5 and Wire #7.

Figure 2-30. EPRI/NEI Test 3 voltage plot - water spray

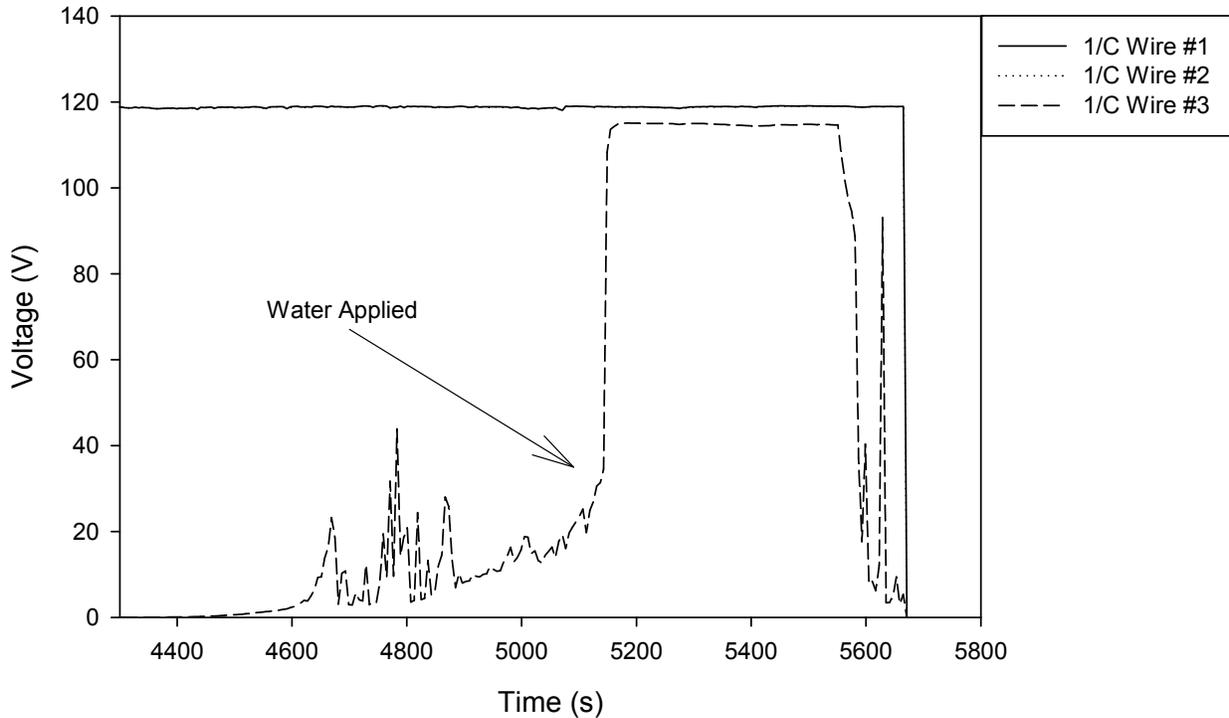
In Test 10 of the EPRI program, water spray was applied during an ongoing spurious operation. The application of water terminated the spurious operation (cleared for 42 seconds), followed by a brief operation of a target conductor (6 seconds), followed by a fuse clear failure. These electrical interactions are shown in Figure 2-31. In two other tests, water spray showed marginal effects on the cable electrical response. In one case, an induced voltage had built upon the spare conductor. When water spray was initiated, the induced voltage was rapidly lost. In the other case, very minimal current spikes (~0.05 amps) were observed in the 1/C cables, coincident with water application. The reader is encouraged to refer to the EPRI test report for more information.

Figure 2-31. EPRI/NEI Test 10 voltage response following water spray

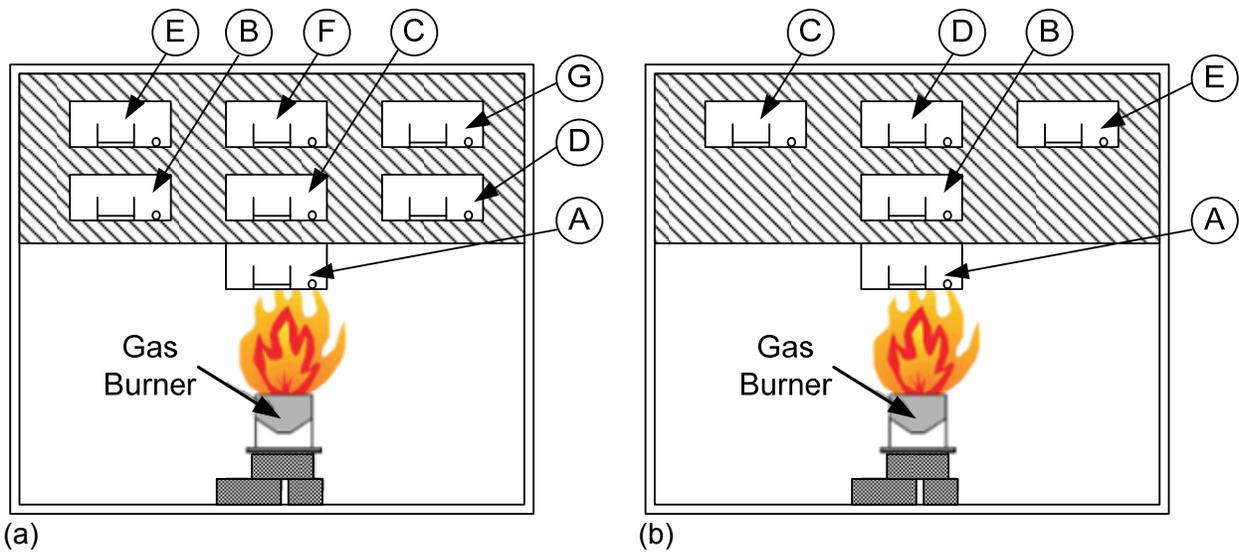
To complete this comparison, the intermediate-scale test data from CAROLFIRE and the intermediate-scale ac test data from DESIREE-FIRE were combined and separated by location. As shown in Figure 2-32, the locations were labeled differently between projects, so care was taken to ensure that labeling differences did not lead to binning errors. Symmetrical cable locations were grouped together as one location because of identical exposure conditions. For example, in the CAROLFIRE configuration in Figure 2-32(a), locations E and G were grouped together, as well as locations C and E of the DESIREE-FIRE configuration in Figure 2-32(b). However, locations C and F of CAROLFIRE and locations B and D of DESIREE-FIRE were not grouped together because the plume transition zone near the top location (F in CAROLFIRE, D in DESIREE-FIRE) likely has different exposure conditions than the location directly below. Trays grouped by location would be exposed to the same fire conditions, heat release rate, and location relative to the wall. The data was then analyzed to find times when hot shorts occurred in the same location at the same times (i.e., concurrence).

Figure 2-32. (a) CAROLFIRE and (b) DESIREE-FIRE intermediate-scale exposure location designation

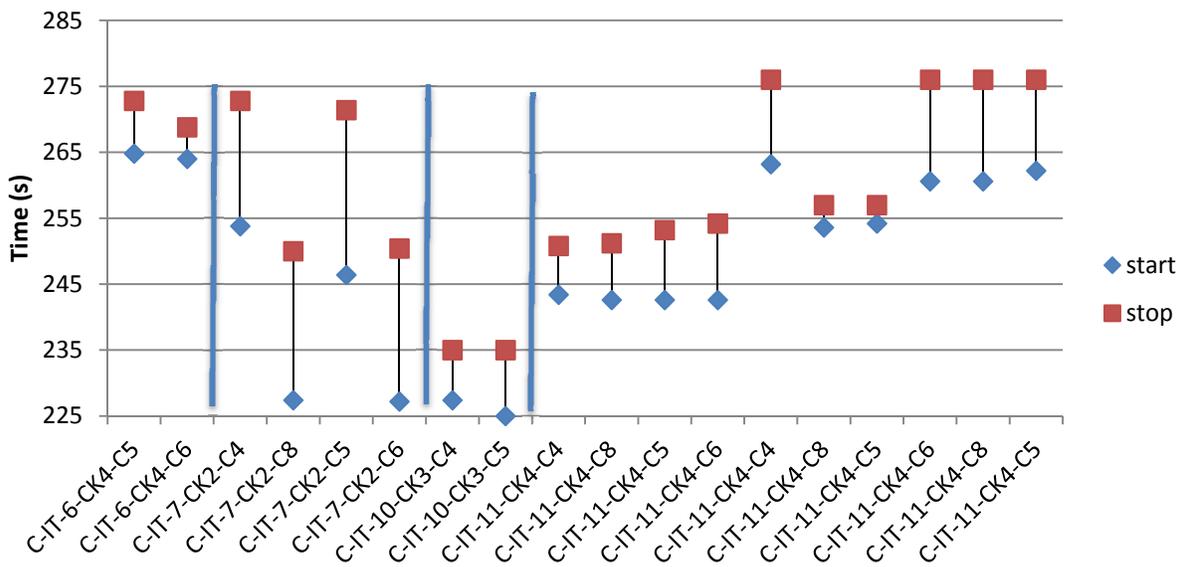
Figure 2-33. Concurrent hot shorts - location a - 4 cables

Analyzing the data in this way shows that concurrent hot shorts were observed in CAROLFIRE/DESIREE-FIRE location A and CAROLFIRE location G/E (DESIREE-FIRE location C/E), “upper hot gas layer,” when the individual test data was grouped together. At location A, two sets of concurrence were identified, as shown in Figure 2-33 and Figure 2-34.

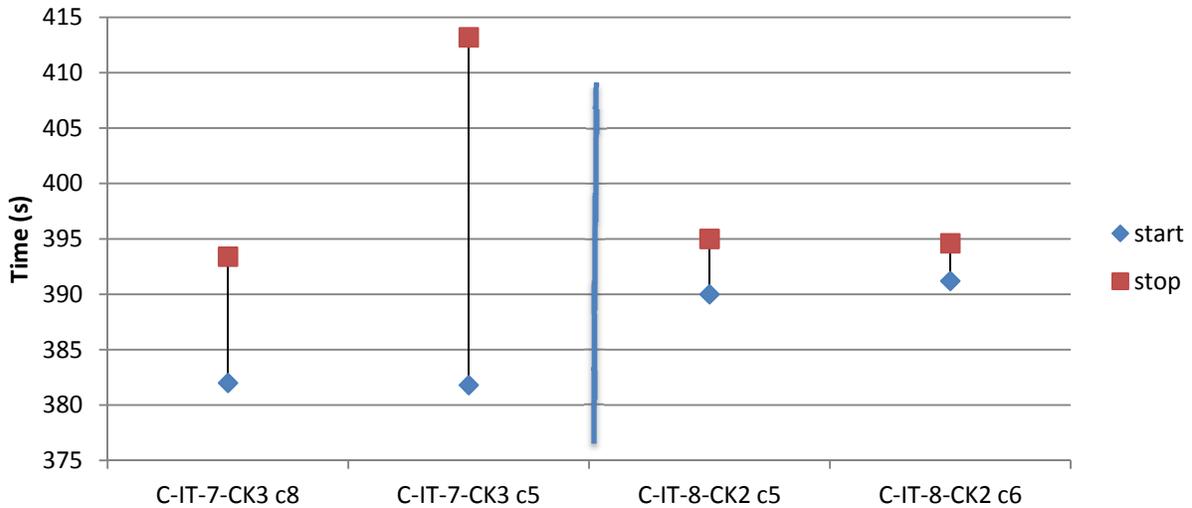
Figure 2-34. Concurrent hot shorts - location A - 2 cables

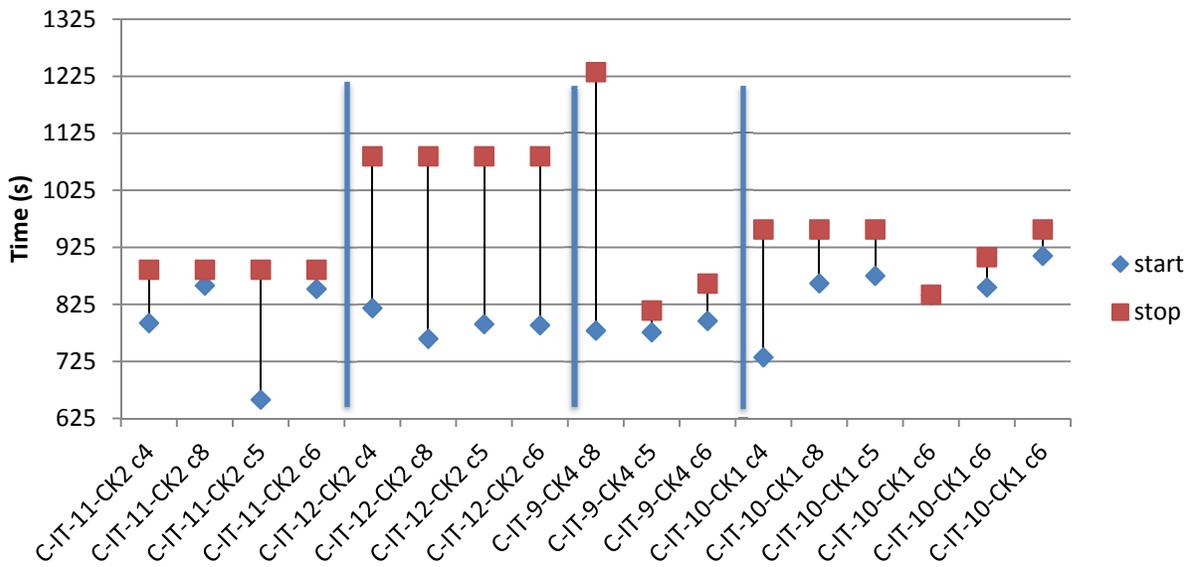
The other instance in which concurrent hot shorting was identified in this analysis was in the upper hot gas layer exposure locations (CAROLFIRE location G/E, DESIREE-FIRE location C/E). Again, two sets of concurrence were observed. The first occurrence included four cables, of which three were of the same construction (PE/PVC) and the other was PVC/PVC. All were of the thermoplastic polymer variety. The second instance of concurrence included two cables; one was EPR/CPE, and the other was PVC/PVC. Figure 2-35 and Figure 2-36 present plots of the hot short durations, and Table 2-32 provides a listing of the circuits involved in spurious operation concurrences and associated durations. The durations of these concurrences are longer than those in location A, likely due to the difference in thermal exposure conditions.

Figure 2-35. Concurrent hot shorts - upper hot gas layer - 4 cables

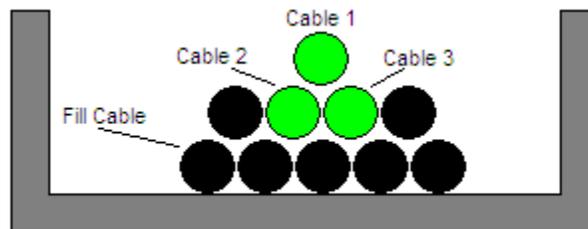
Figure 3-1 provides an illustration of how the cables were oriented within a cable tray for the inter-cable tests during the EPRI/NEI program. Cables 1-3 were monitored for electrical response, with cables 1 and 3 containing both energized source conductors and target conductors, while cable 2 only contained target conductors. The target conductors were connected to burden resistors to simulate a load. The black cables in Figure 3-1 represent fill cables that were not monitored for electrical response, but were used as a buffer between the electrically monitored cables and the metallic cable tray. These fill cables likely reduced the likelihood of an energized source coming in contact with the ground plane and causing a fuse clear failure.

Figure 3-1. EPRI/NEI inter-cable test tray fill

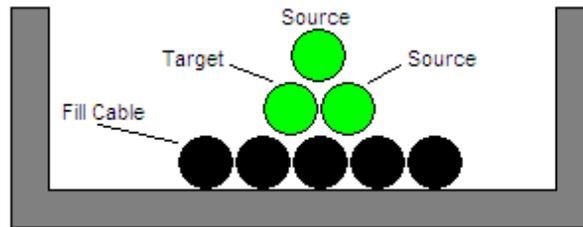
The CAROLFIRE inter-cable test set-up was slightly different in that all of the conductors in two multi-conductor cables were energized as sources and a third multi-conductor cable had all of its conductors connected to a motor starter contactor, a target. Thus, the CAROLFIRE circuit could detect inter-cable interactions, but was unable to recognize when conductors internal to the multi-conductor cables had failed. The CAROLFIRE inter-cable test set-up is shown in Figure 3-2.

Figure 3-2. CAROLFIRE inter-cable test tray fill

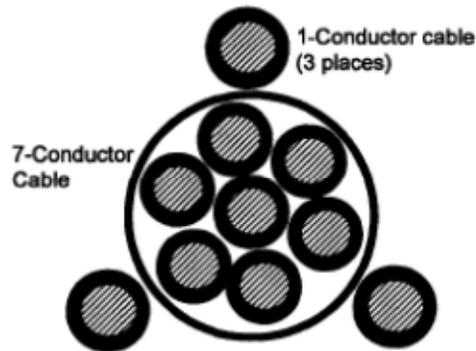
Figure 3-3. EPRI/NEI cable configuration

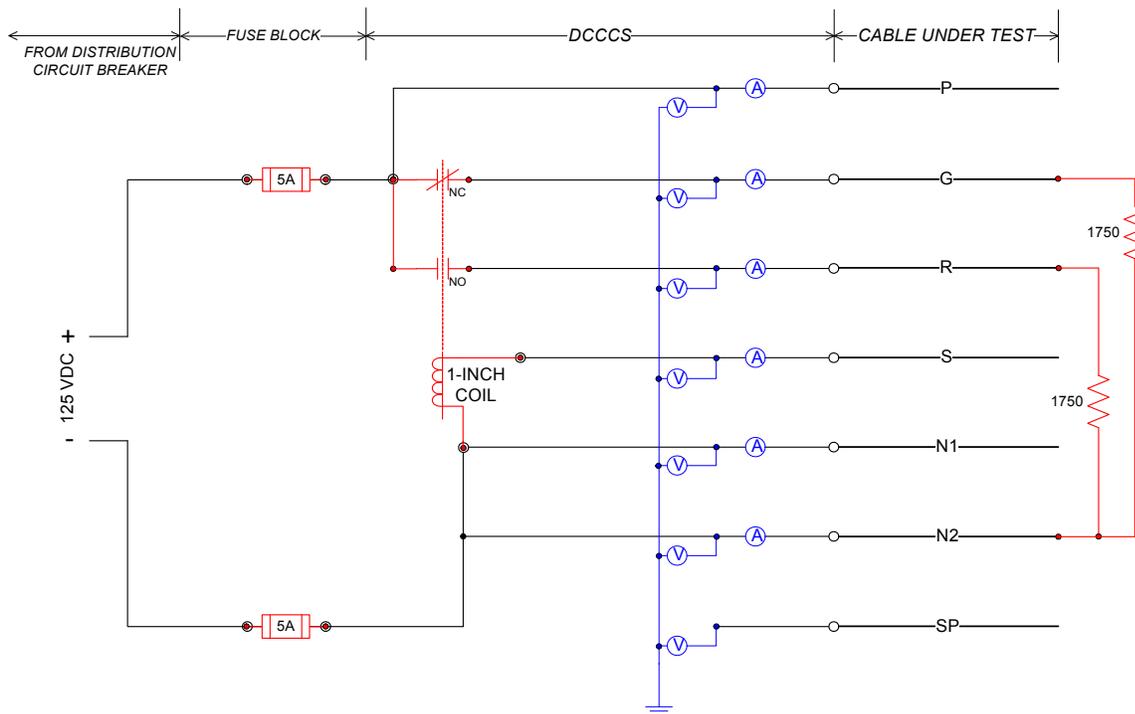
For the 1-inch valve circuit, conductor S was the hot short (HS)/spurious operation (SA) target, and conductors G and R were the HS targets for the penlight tests. For intermediate-scale tests, conductor S was the HS/SA target, and conductors G and R were not used for fuse status. The SP conductor was a non-energized target that could either short to the positive or negative sides of the circuit for all tests. The other conductors were used to determine whether a fuse had blown. Once the positive or negative fuse had blown, the durations for the HS and/or HS/SA were assumed to be complete.

Figure 4-1. Line drawing of the dc-SIM panel layout for a 1-inch coil circuit

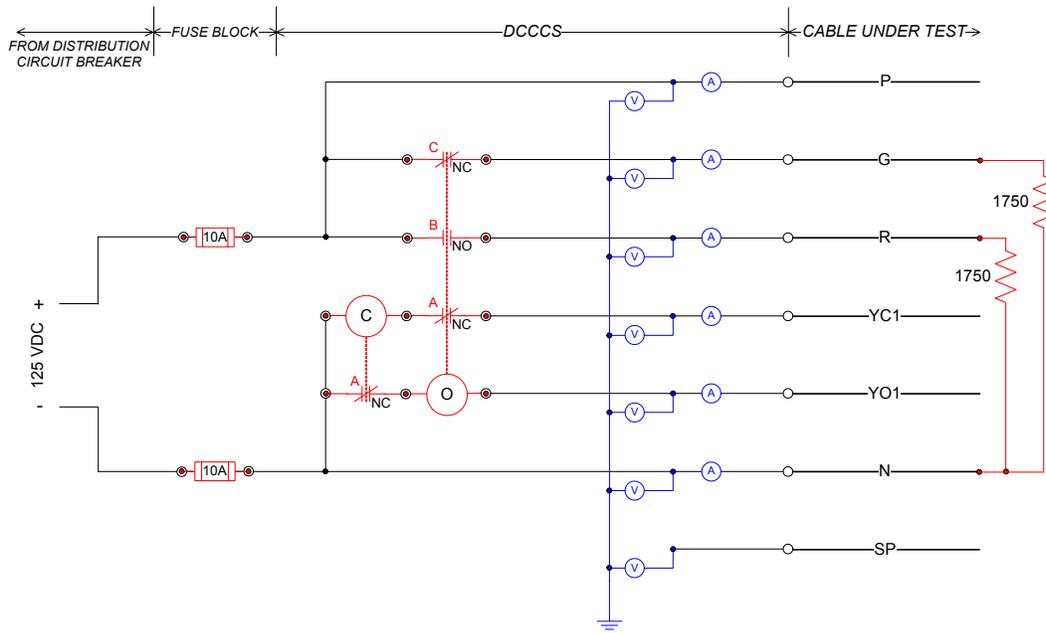
The MOV circuit that was tested is shown below in Figure 4-3. As seen in the figure, there are seven conductors that were monitored during the test. Those seven conductors' electrical measurement data was analyzed based on the information displayed in Table 4-4 for all tests. Each test had two MOV circuits designated as MOV1 and MOV2. Conductors YO1 and YC1 for MOV1 were HS/SA and HS targets. With MOV1, there were mechanical interlocks that caused YC1 to lock out if YO1 was engaged; thus, if YO1 had an HS/SA while YC1 got an HS, YC1 would not engage. Conductors G and R were HS targets. The SP conductor was a non-energized target that could short to either the positive or the negative side of the circuit for all tests. The other conductors were used to determine whether a fuse had blown. Once the positive or negative fuse had blown, the durations for the HS and/or HS/SA were assumed to be complete.

Figure 4-3. Line drawing for dc MOV circuit

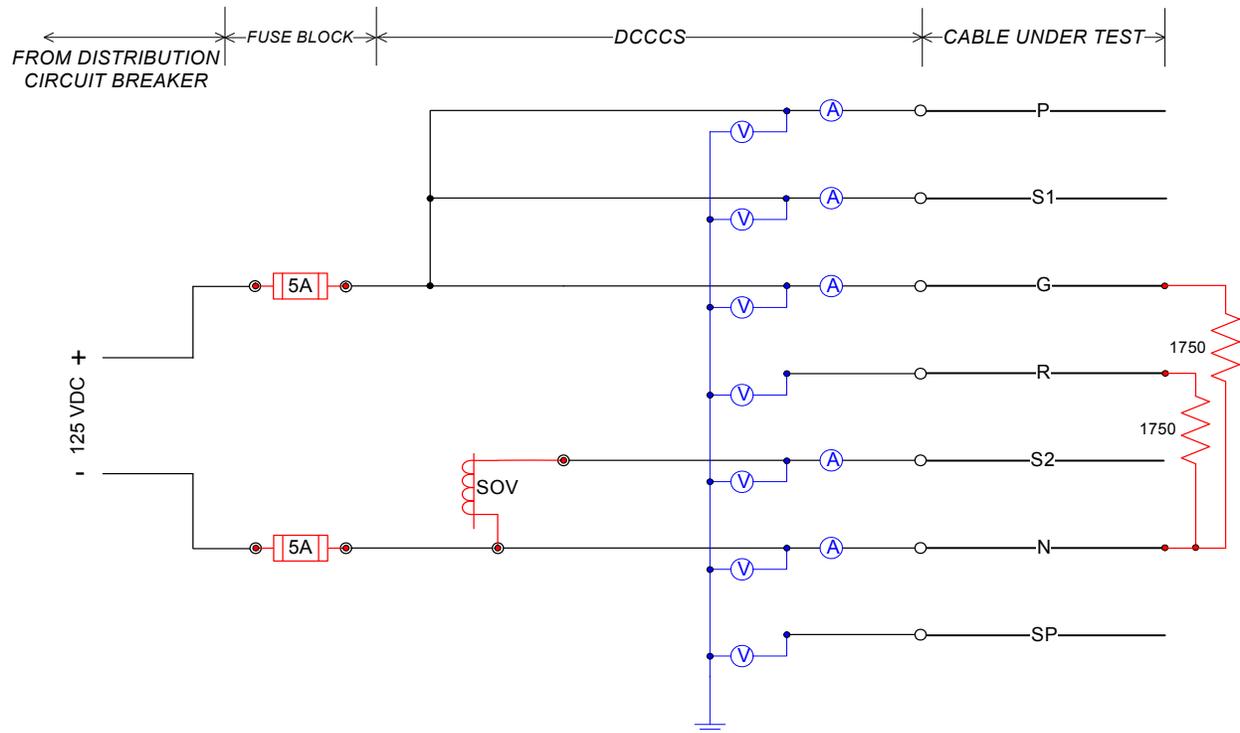
The SOV circuit that was tested is shown below in Figure 4-4. As seen in the figure, there are seven conductors that were monitored during the test. Those seven conductors' electrical measurement data was analyzed based on the information displayed in Table 4-5 for all tests. For this circuit conductor, S2 was the HS/SA target, and conductor R was an HS target for all tests. The SP conductor was a non-energized target that could short to either the positive or the negative side of the circuit for all tests. The other conductors were used to determine whether a fuse had blown. Once the positive or negative fuse had blown, the durations for the HS and/or HS/SA were assumed to be complete.

Figure 4-4. Line drawing for dc SOV circuit

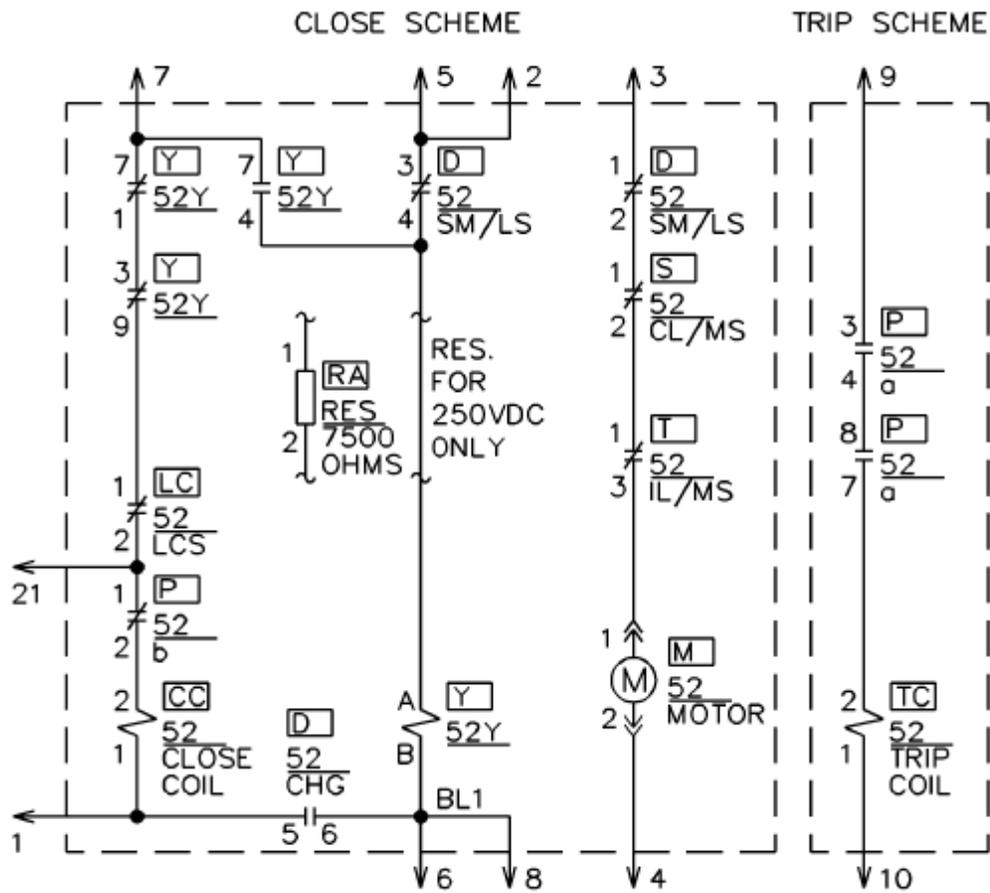
There were two different medium-voltage circuit breakers (SWGR) circuits used during DESIREE testing. As mentioned in the report, there was a problem with the first breaker during intermediate-scale Test #8. The first SWGR circuit is displayed in Figure 4-5, with the instrumentation's data analysis displayed in Table 4-6. The internal manufacturer wired this SWGR in reverse, which is depicted in Figure 4-5. The wiring did not affect the functionality of the SWGR, the only difference being that the red light was not energized. Table 4-6 has a different set-up than the tables for the previous circuits analyzed. The SWGR circuits were more complex to analyze, resulting in the different format. Conductors G, T, and C1 were hot short targets, while T and C1 were used to determine whether the breaker had tripped or closed (HS/SA target). The duration for the HS/SA was never more than one time step. Conductor R was treated as a energized spare. The two SP conductors were non-energized targets that could short to either the positive or the negative side of the circuit for all tests. The other conductors were used to determine whether a fuse had blown. Once the positive or negative fuse had blown, the durations for the HS and/or HS/SA were assumed to be complete. The second SWGR circuit is displayed in Figure 4-6, with the instrumentation's data analysis displayed in Table 4-7. The only difference with this SWGR in terms of the data analysis logic was that R was an HS target and not an energized spare. It is also noted in Table 4-6 and Table 4-7 that there were two cables tested for each SWGR test. One cable was connected to the close circuit, and the other was connected to the trip circuit. The conductors associated with each are identified in the tables.

Figure 4-6. Line drawing for dc SWGR 2 circuit

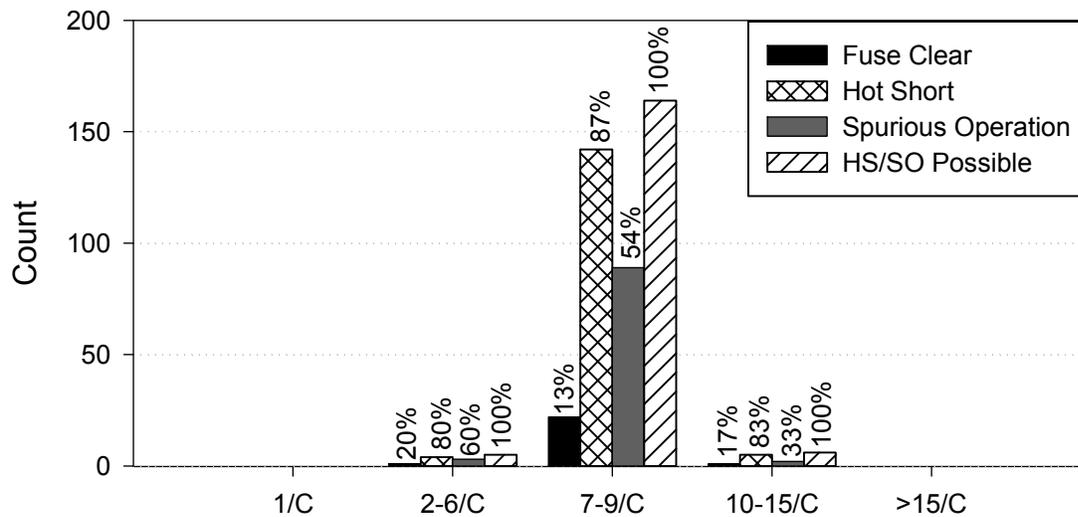
Global Approach	1/C	2-6/C	7-9/C	10-15/C	>15/C
Fuse Clear	-	1	22	1	-
Hot Short	-	4	142	5	-
Spurious Operation	-	3	89	2	-
HS/SA Possible	-	5	164	6	-

Figure 4-7. Conductor count column plot, global approach, dc tests

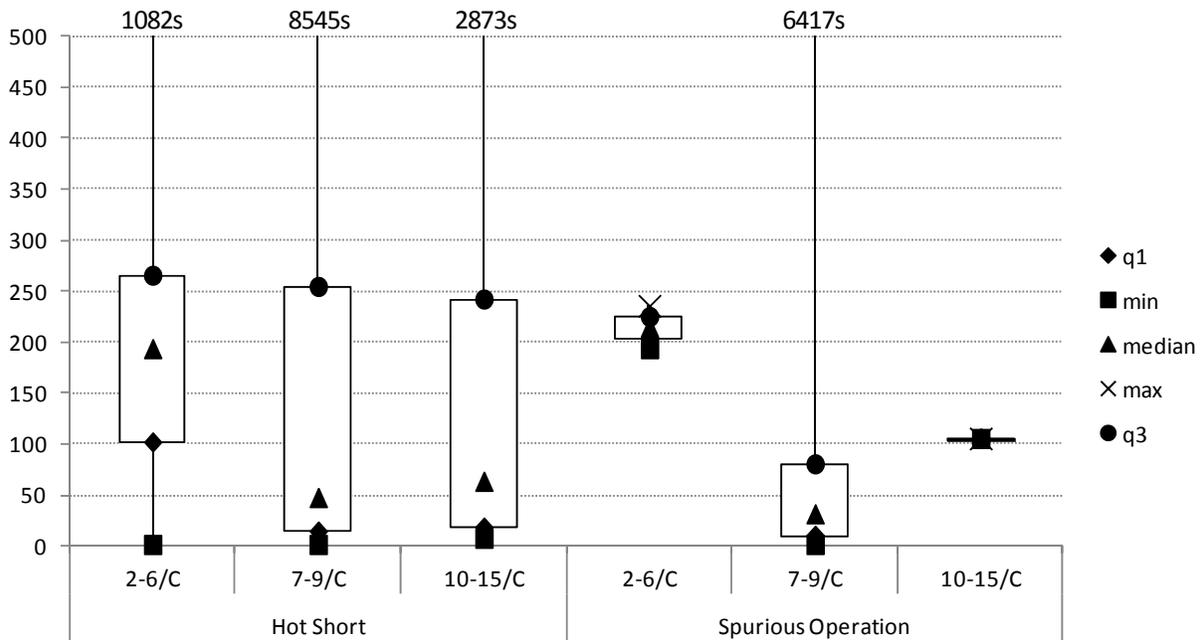
Hot Short					Spurious Operation				
	1/C	2-6/C	7-9/C	10-15/C	>15/C	1/C	2-6/C	7-9/C	10-15/C	>15/C
q1	-	101.5	14	18	-	-	203.5	10	105	-
min	-	1	1	7	-	-	193	1	105	-
median	-	193	47	63	-	-	214	31	105	-
max	-	1082	8545	2873	-	-	235	6417	105	-
q3	-	265	254	242	-	-	224	80	105	-
mean	-	302	409	471	-	-	214	195	105	-

Figure 4-8. Conductor count box plot, duration, dc tests

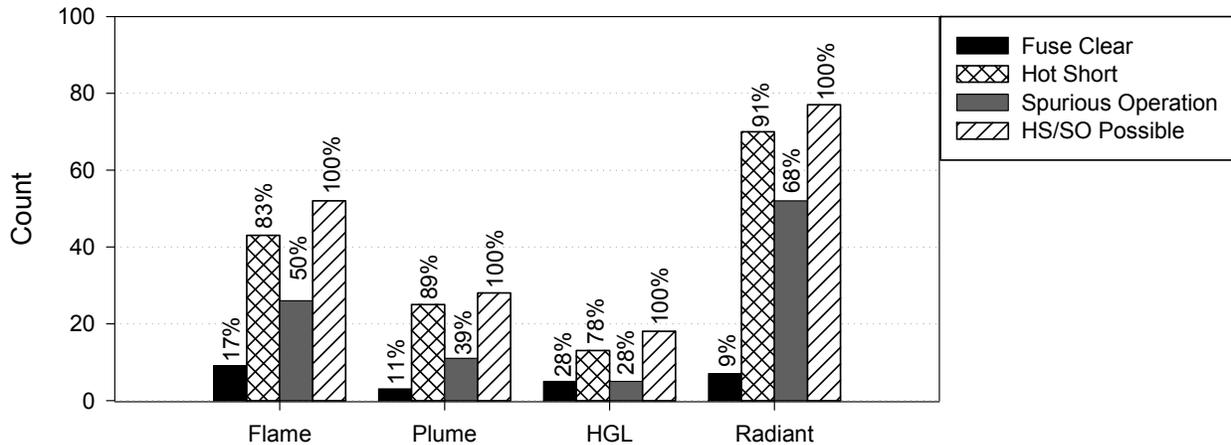
Global Approach	Flame	Plume	HGL	Radiant
Fuse Clear	9	3	5	7
Hot Short	43	25	13	70
Spurious Operation	26	11	5	52
HS/SA Possible	52	28	18	77

Figure 4-9. Thermal exposure conditions column plot, global approach, dc tests

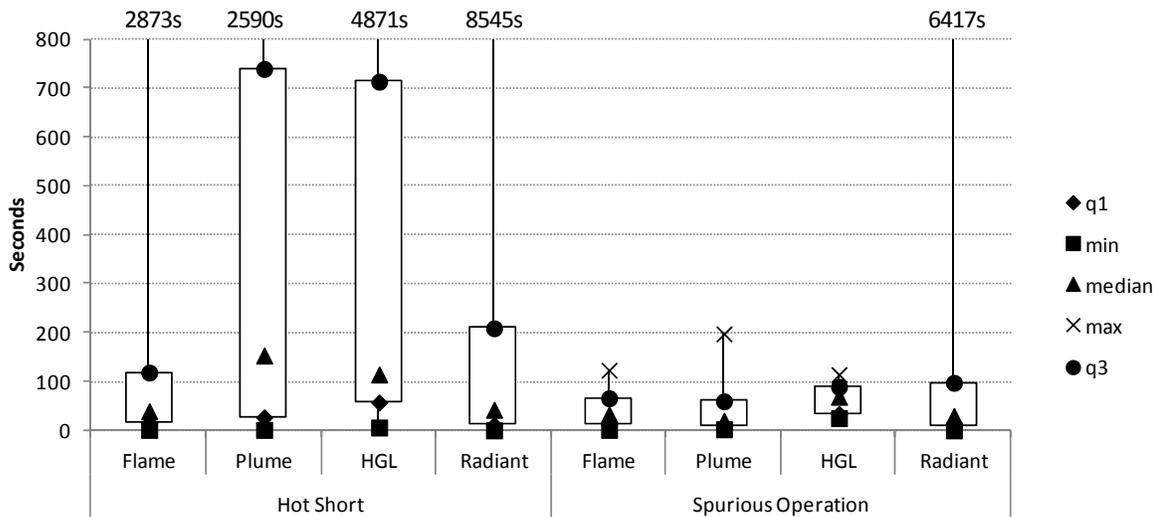
Hot Short				Spurious Operation			
	Flame	Plume	HGL	Radiant	Flame	Plume	HGL	Radiant
q1	16.4	27.5	57.95	12	13	10.7	34.8	10
min	2	2	7	1	3	3.4	26	1
median	40	154	115	43	34	20.6	70	31
max	2873	2590	4871	8545	124	198.4	115	6417
q3	119.2	740	714	210	66.7	60.5	90.0	98.3
mean	61.6	468.7	587.8	428.4	45.1	146.6	111.9	301.0

Figure 4-10. Thermal exposure conditions box plot, duration, dc tests

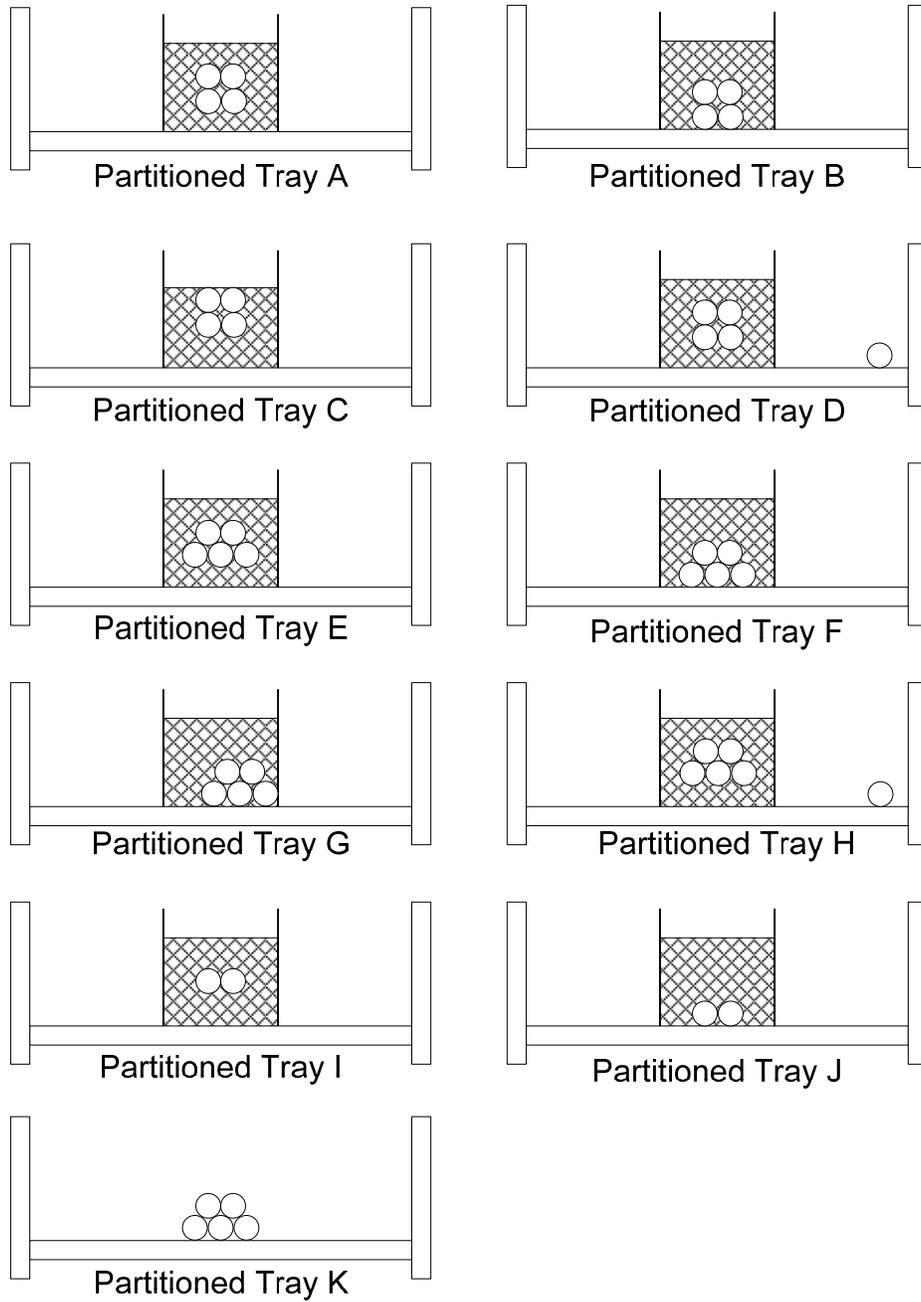
Figure 4-15. Circuit cable orientation for partitioned trays

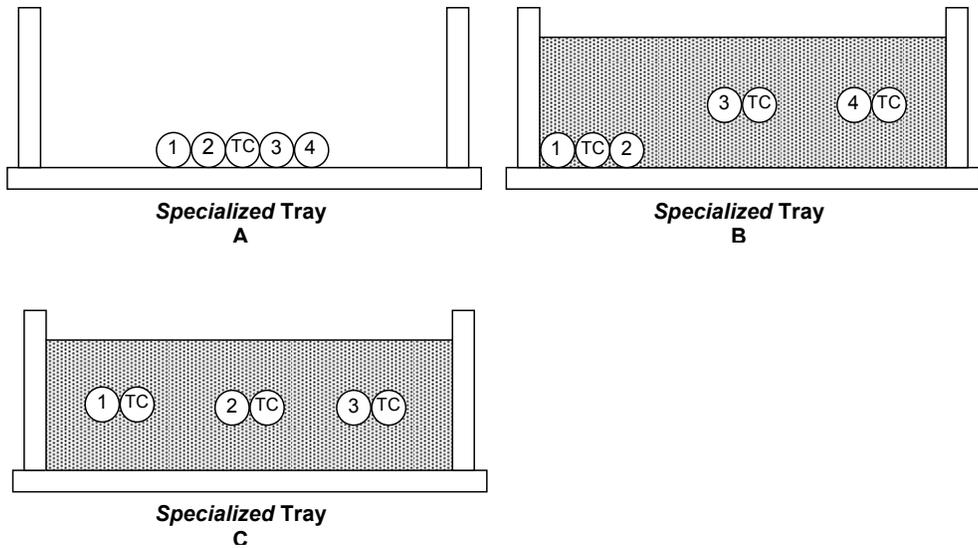
Figure 4-16. Circuit cable orientation for specialized trays

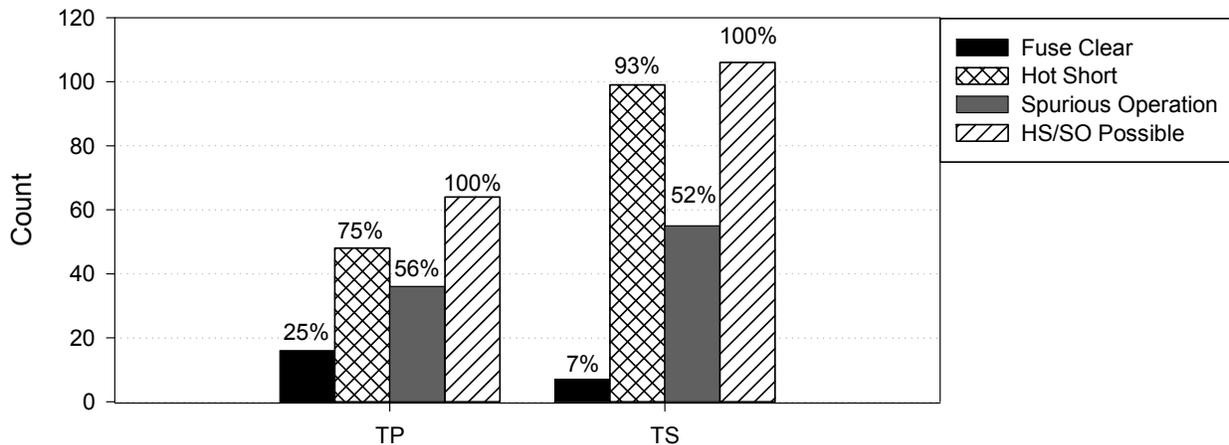
Global Approach	TP	TS
Fuse Clear	16	7
Hot Short	48	99
Spurious Operation	36	55
HS/SA Possible	64	106

Figure 4-19. Insulation type column plot, global approach, dc tests

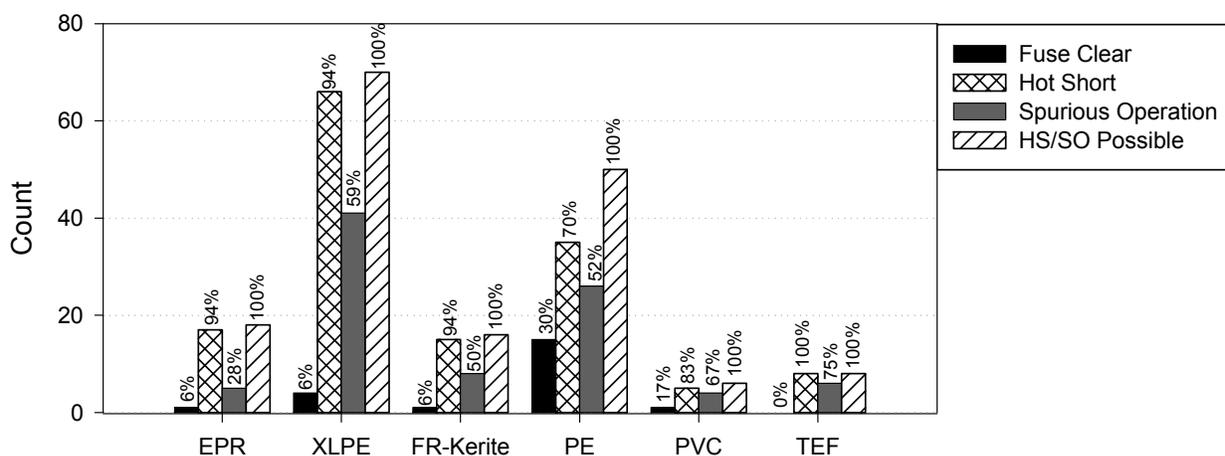
Global Approach	TS			TP		
	EPR	XLPE	Kerite-FR	PE	PVC	TEF
Fuse Clear	1	4	1	15	1	0
Hot Short	17	66	15	35	5	8
Spurious Operation	5	41	8	26	4	6
HS/SO Possible	18	70	16	50	6	8

Figure 4-21. Insulation material column plot, global approach, dc tests
