Electrical Cable Test Results and Analysis During Fire Exposure (ELECTRA-FIRE)

**A Consolidation of Three Major
Fire-Induced Circuit and Cable
Failure Experiments Performed
Between 2001 and 2011**

Draft Report for Comment

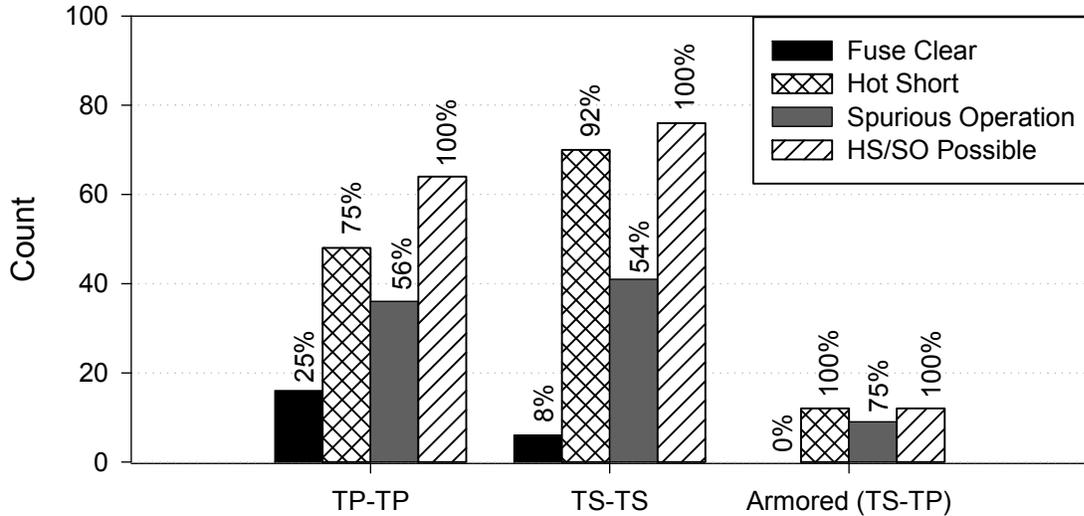
Global Approach	TP-TP	TS-TS	Armored (TS-TP)
Fuse Clear	16	6	0
Hot Short	48	70	12
Spurious Operation	36	41	9
HS/SA Possible	64	76	12

Figure 4-23. Insulation-jacket type column plot, global approach, dc tests

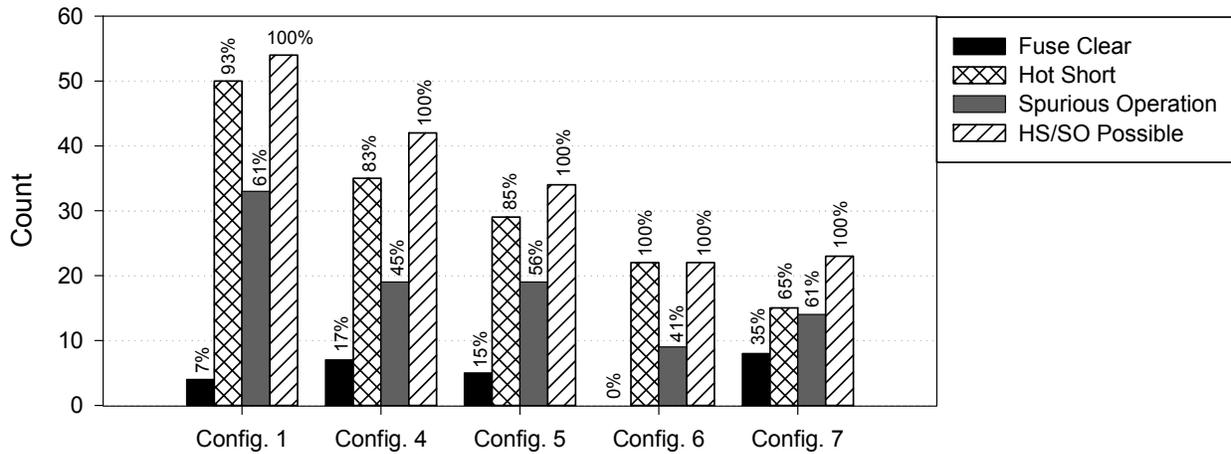
Global Approach	Config. 1	Config. 4	Config. 5	Config. 6	Config. 7
Fuse Clear	4	7	5	0	8
Hot Short	50	35	29	22	15
Spurious Operation	33	19	19	9	14
HS/SA Possible	54	42	34	22	23

Figure 4-25. Wiring configuration column plot, global approach, dc tests

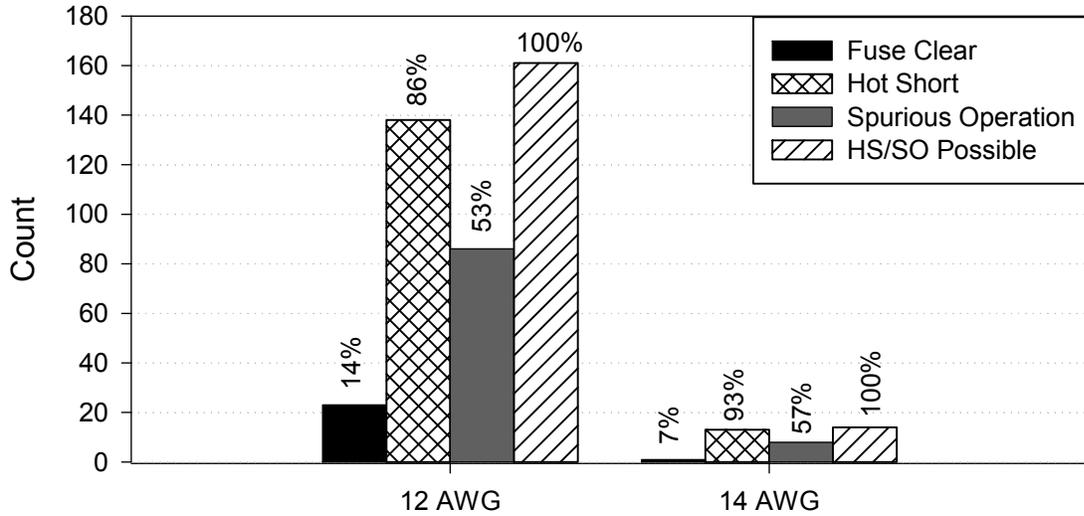
Global Approach	12 AWG	14 AWG
Fuse Clear	23	1
Hot Short	138	13
Spurious Operation	86	8
HS/SA Possible	161	14

Figure 4-27. Conductor size column plot, global approach, dc tests

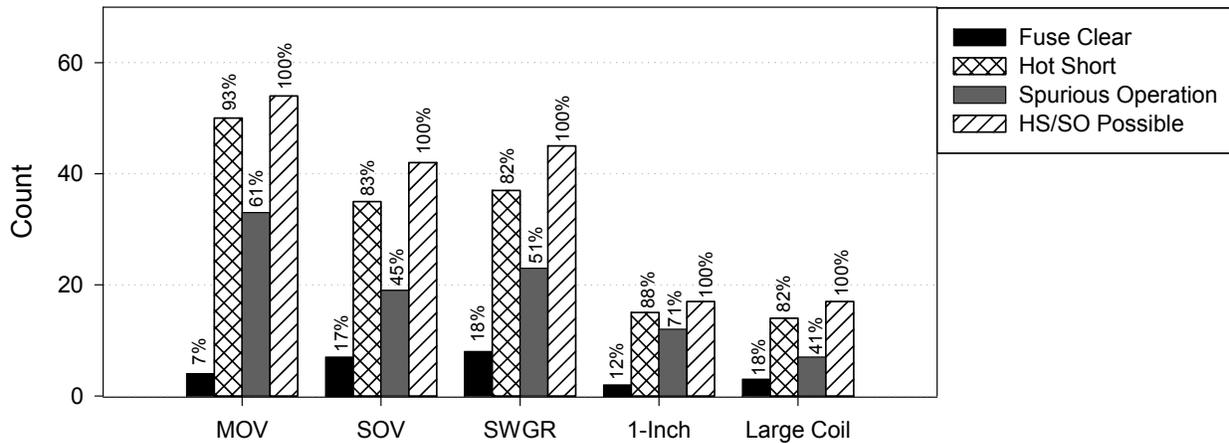
Figure 4-29. Circuit type column plot, global approach, dc tests

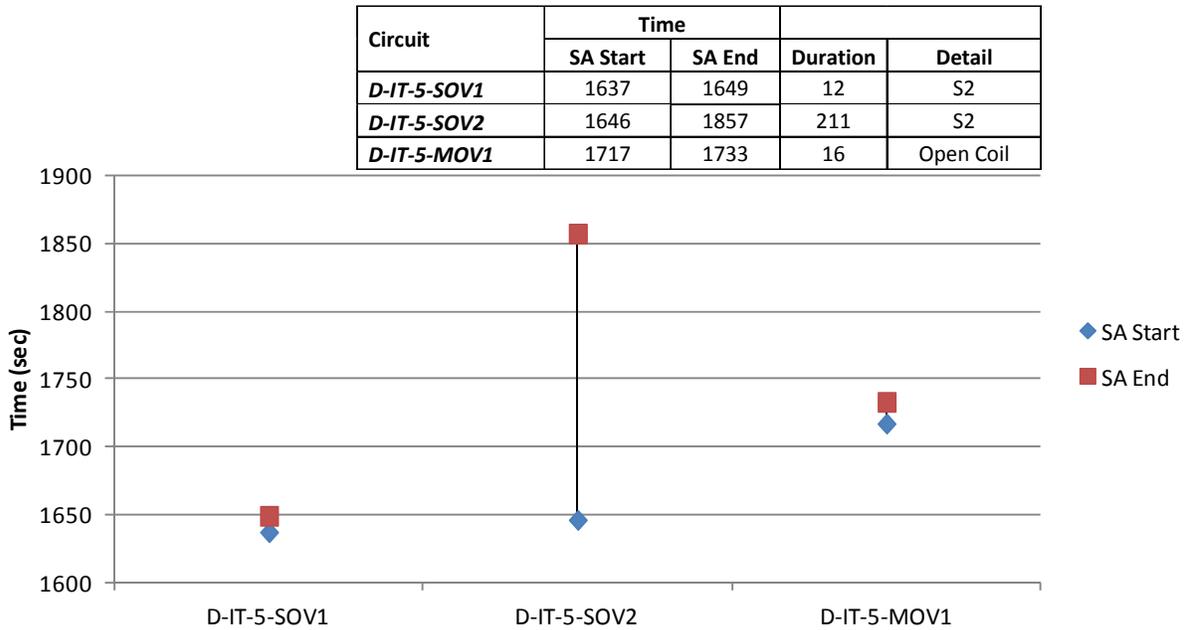
Figure 4-35. Time plot of concurrent hot shorts for DESIREE-FIRE intermediate-scale test 5

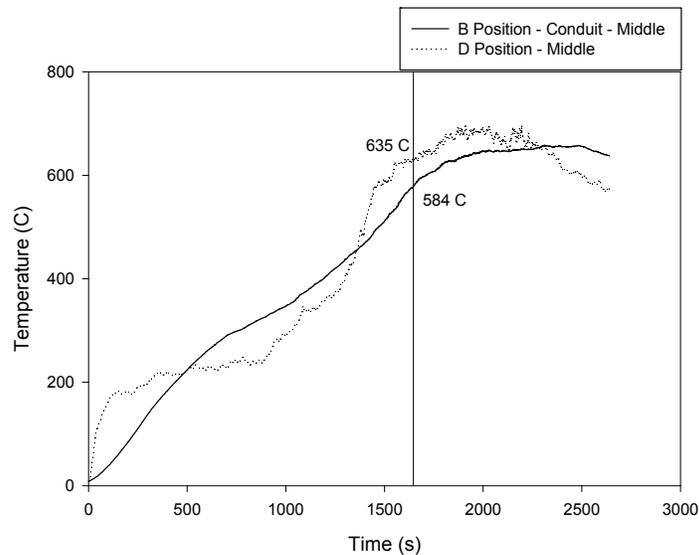
Figure 4-36. Plot of intermediate-scale test 5 for MOV and SOV cable locations

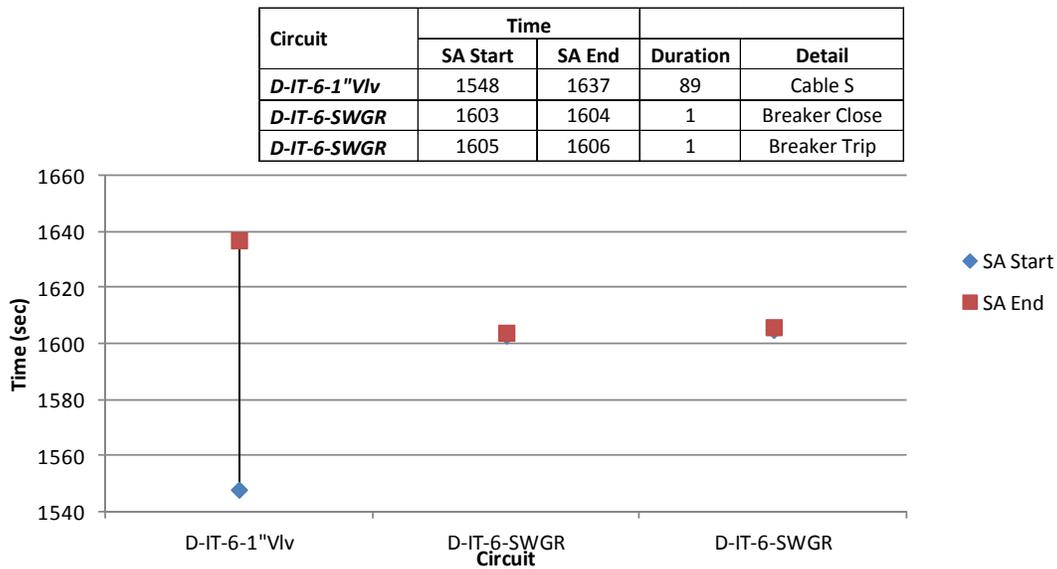
Figure 4-37. Concurrent hot shorts - test 6

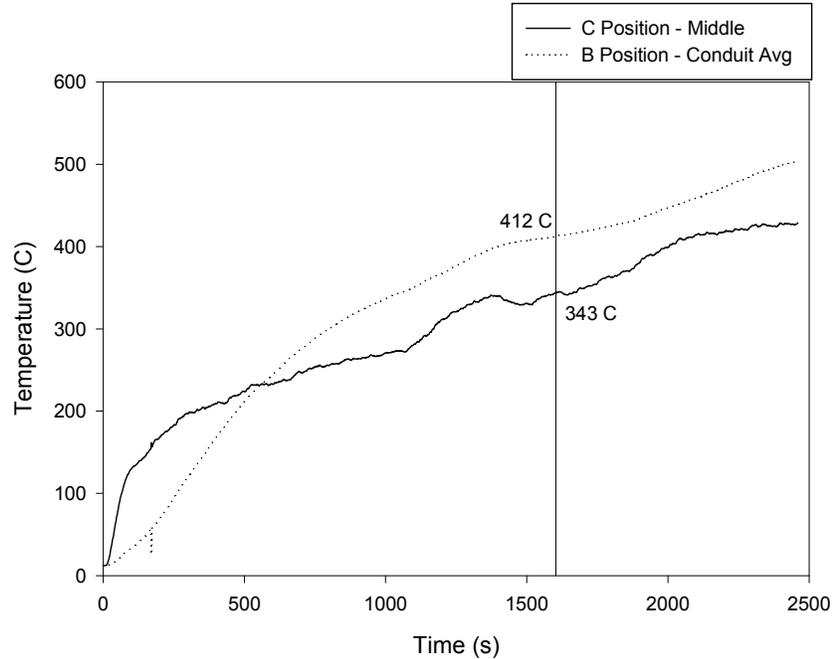
Figure 4-38. Plot of intermediate-scale test 6 for 1-inch valve and switchgear cable locations

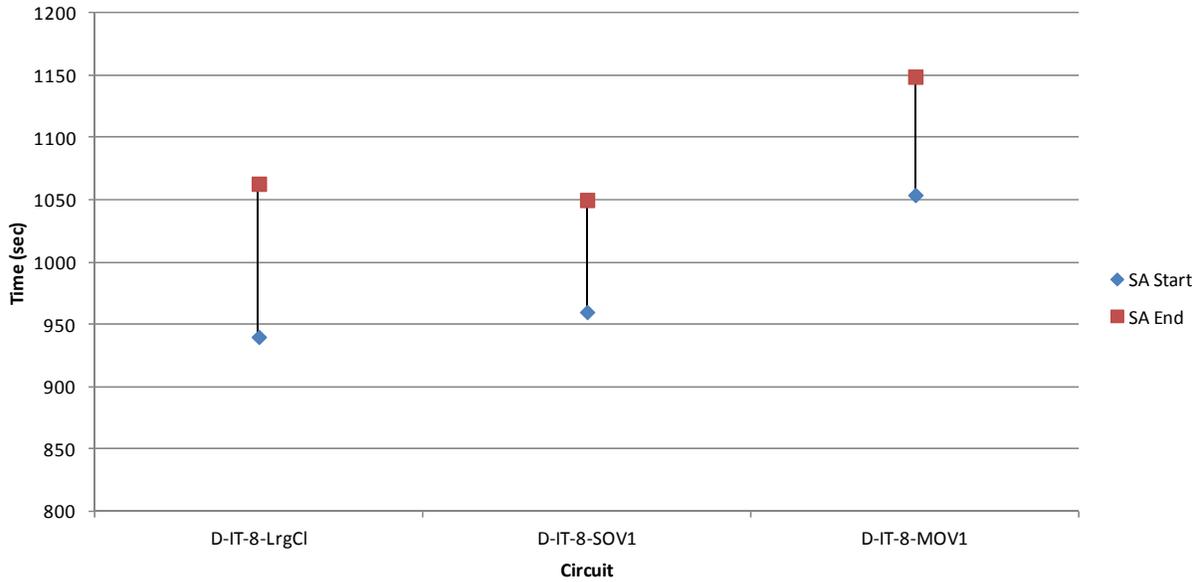
Figure 4-39. Concurrent hot shorts - test 8

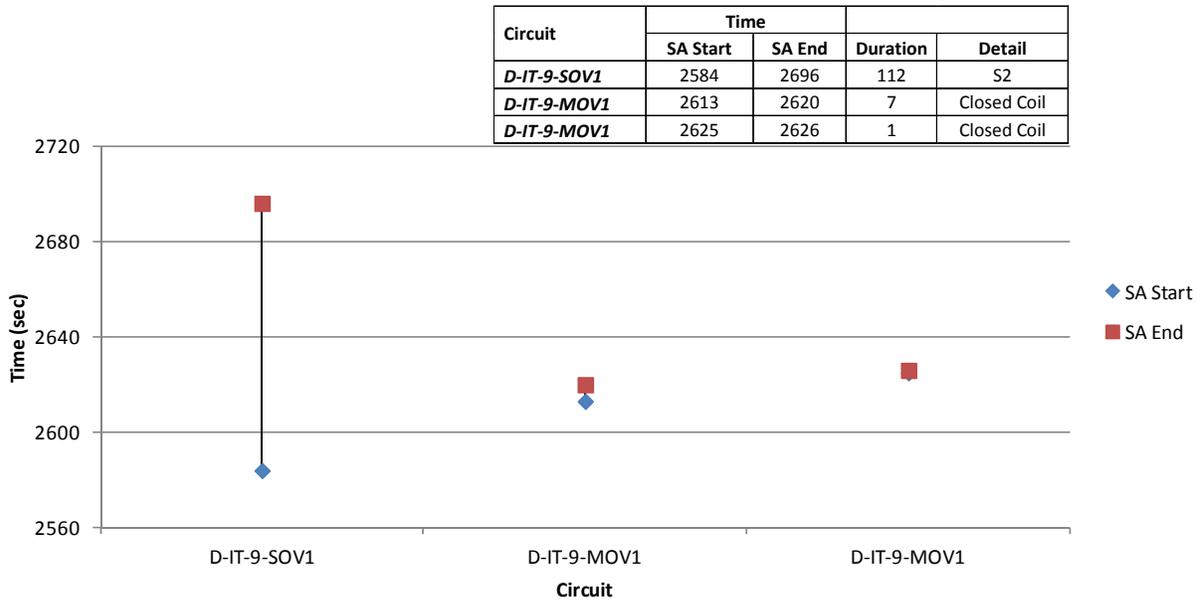
Figure 4-40. Concurrent hot shorts - test 9

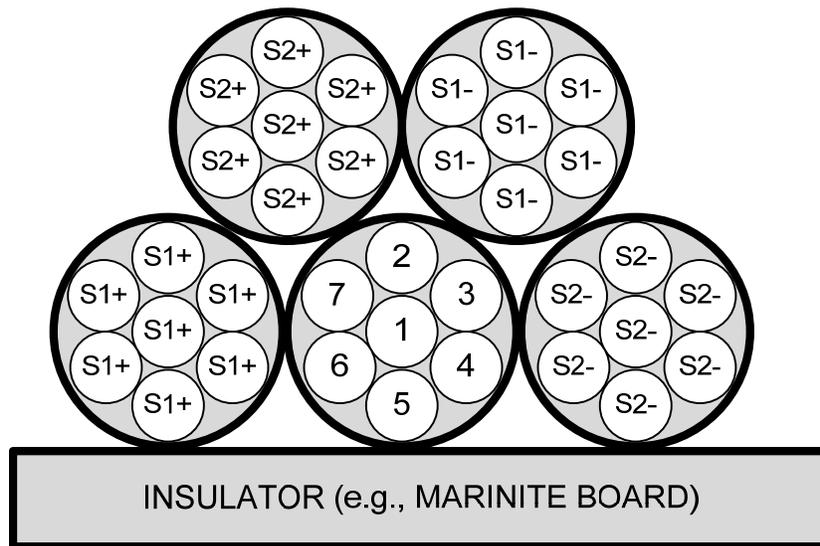
Figure 5-1. DESIREE-FIRE inter-cable configuration

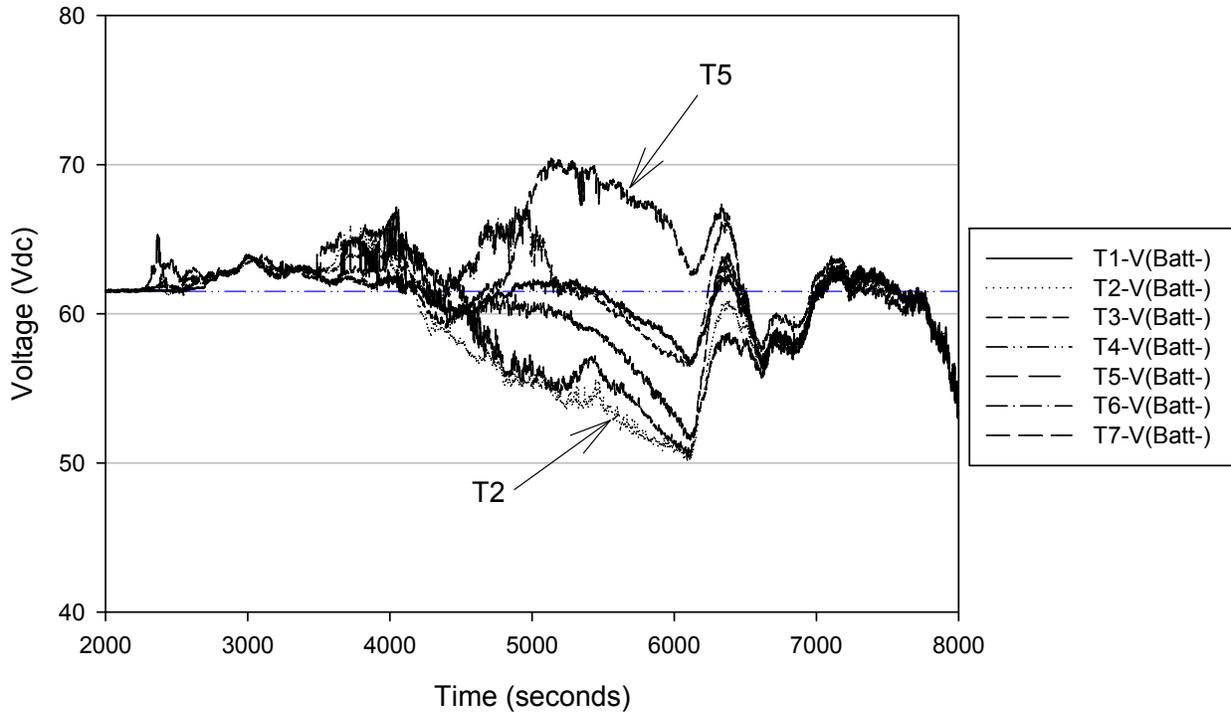
Figure 5-2. DESIREE-FIRE inter-cable test results penlight #47

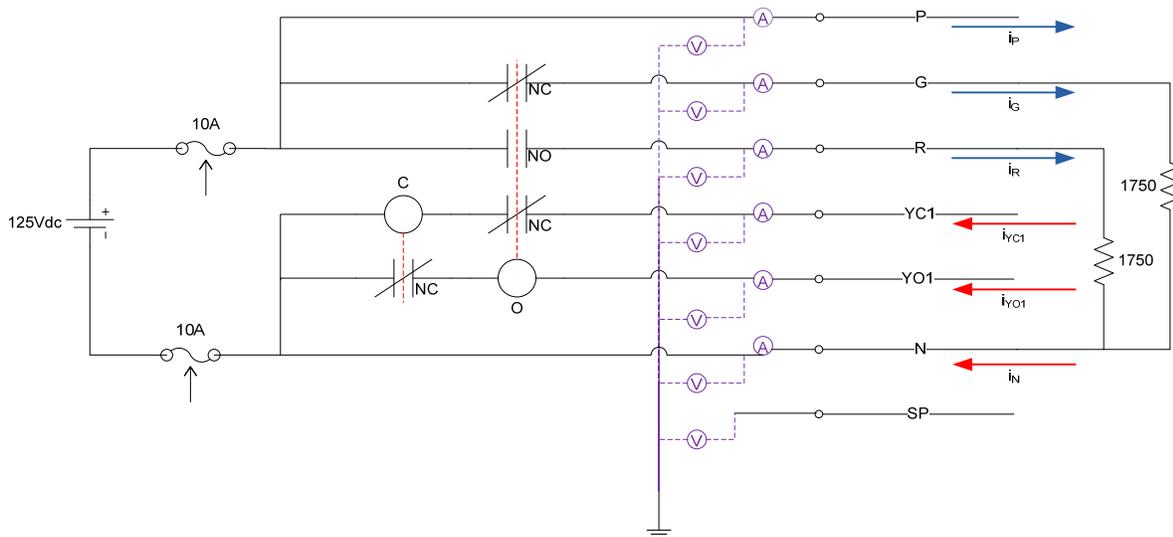
Figure 5-3. dcMOV schematic showing current summation used in identifying inter-cable shorting behavior

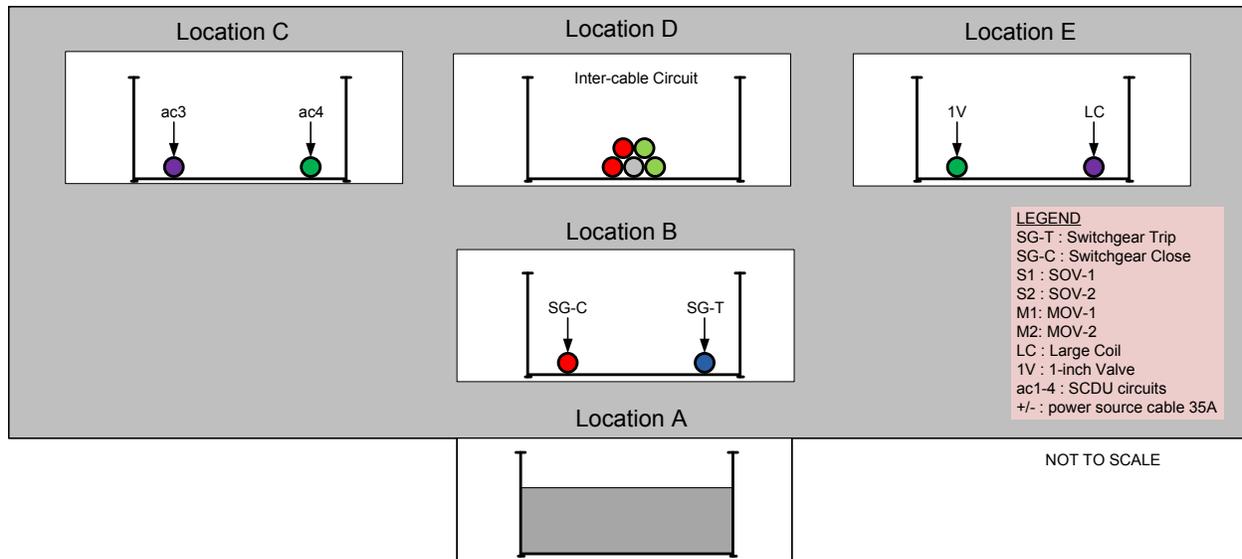
Figure 5-5. Intermediate-scale test preliminary 1 cable loading configuration

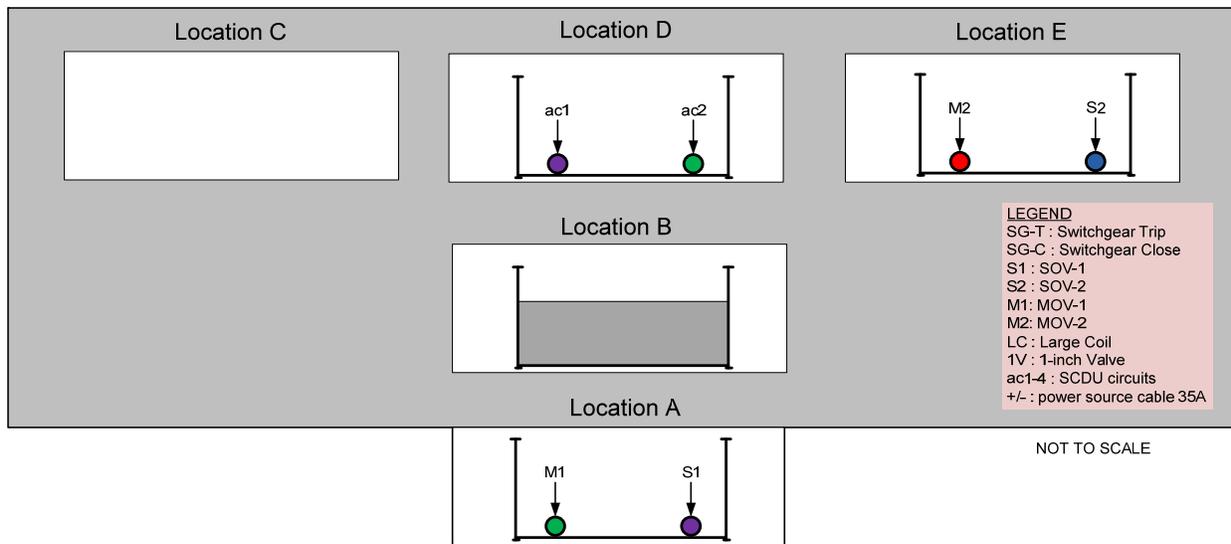
Figure 5-6. Intermediate-scale test preliminary 2 cable loading configuration

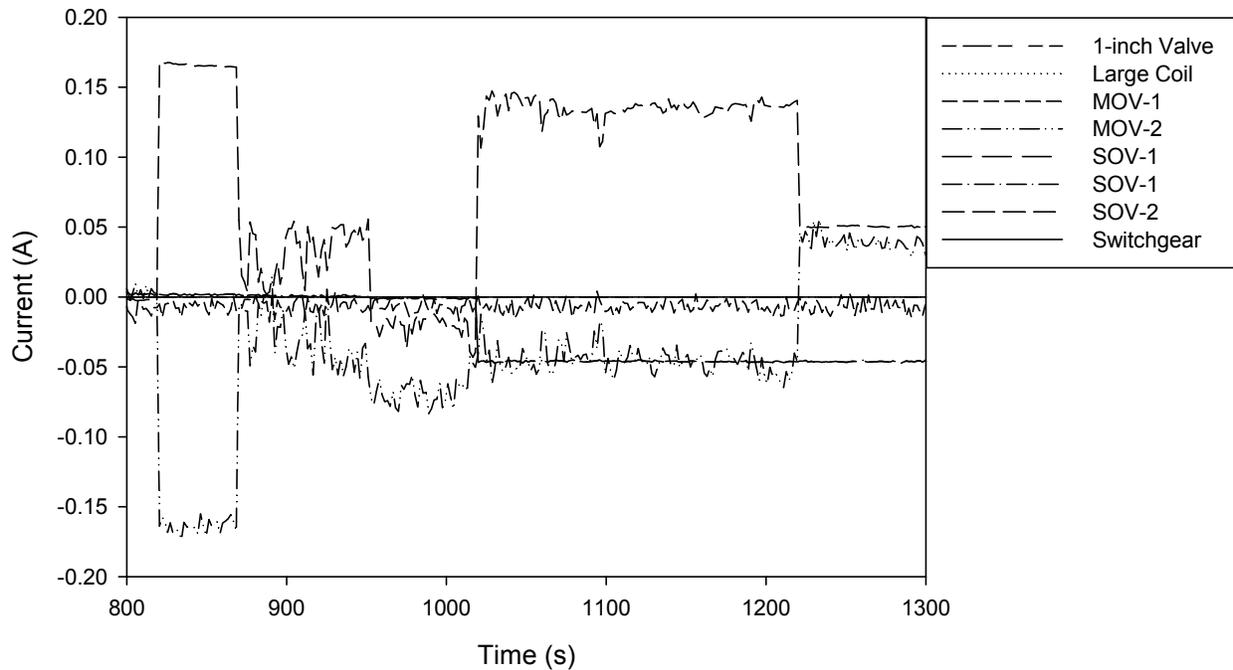
Figure 5-7. Intermediate-Scale Test Preliminary 2 – Inter-cable shorting between SOV-2 and MOV-2

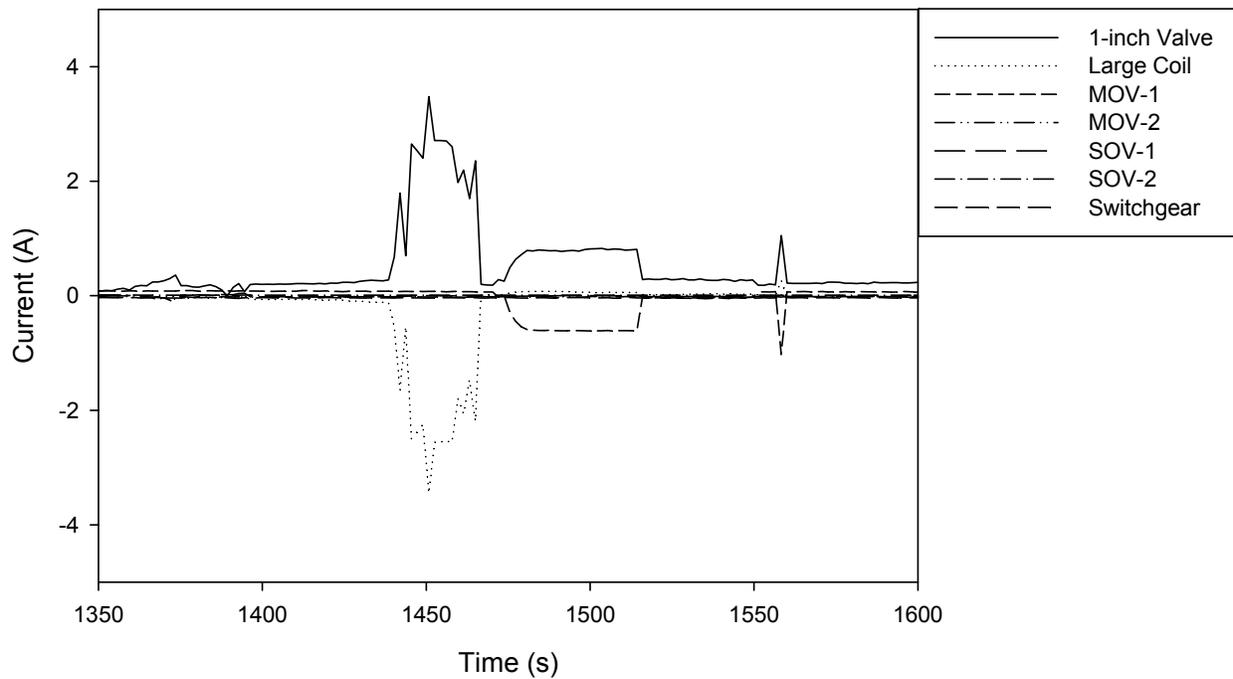
Figure 5-9. Outstanding current hot shorting for Intermediate-Scale Test #1 between 1-inch valve, large coil, and MOV-1 circuits

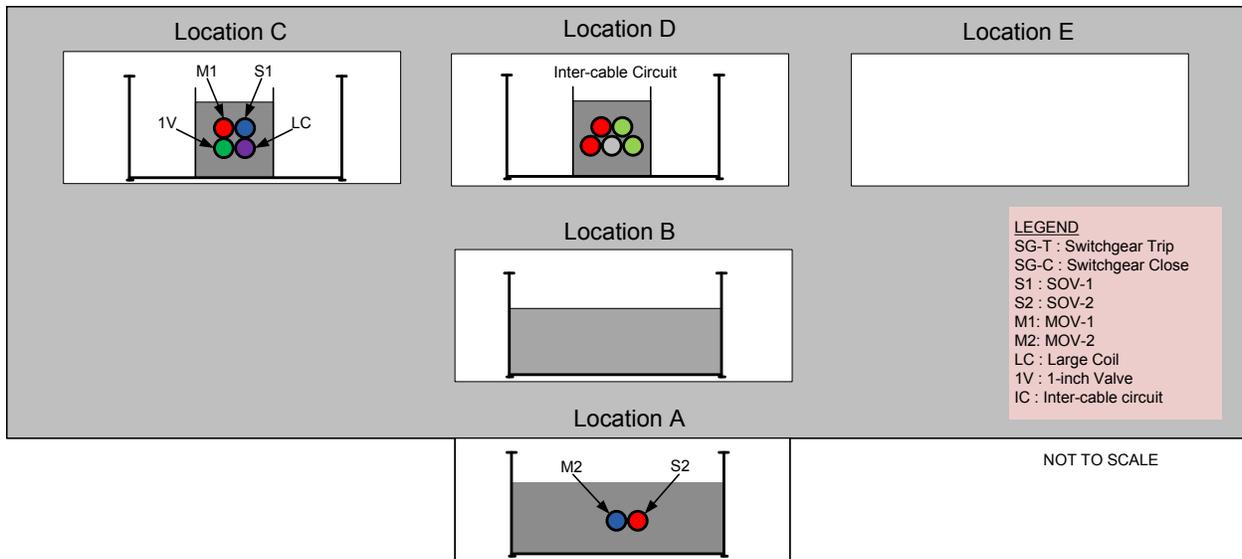
Figure 5-10. Intermediate-scale test 2 cable loading

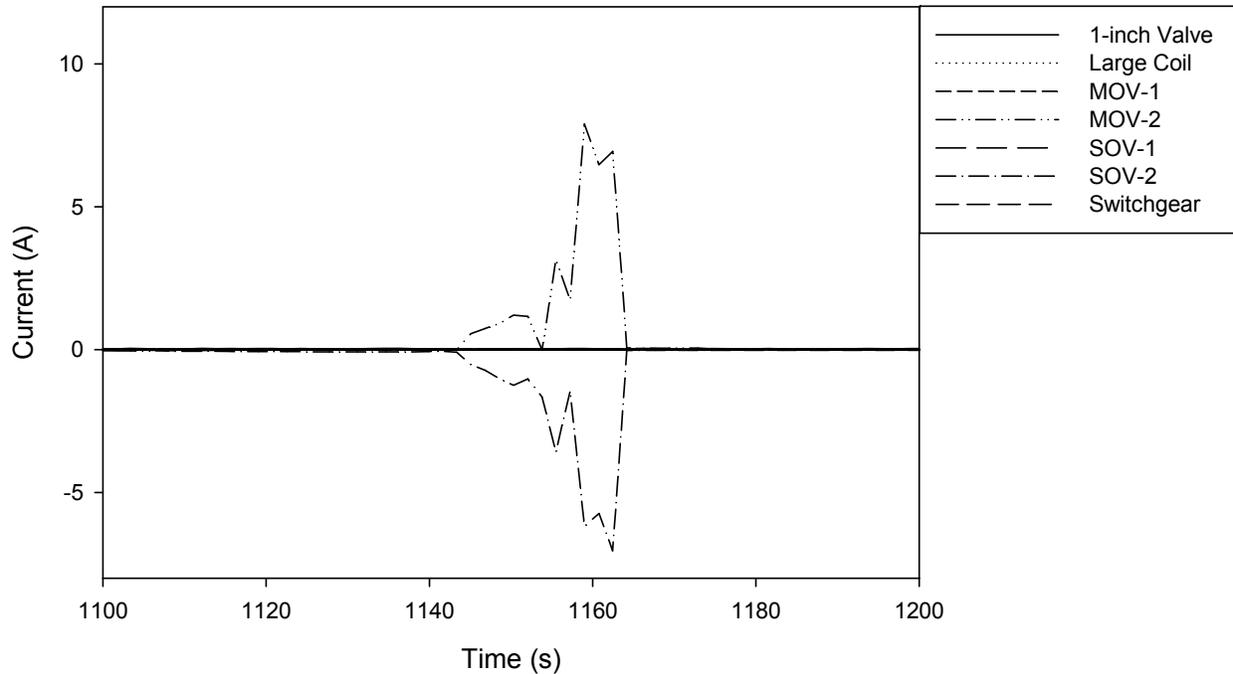
Figure 5-11. Outstanding current shorting in Intermediate-Scale Test #2, between SOV-2 and MOV-2

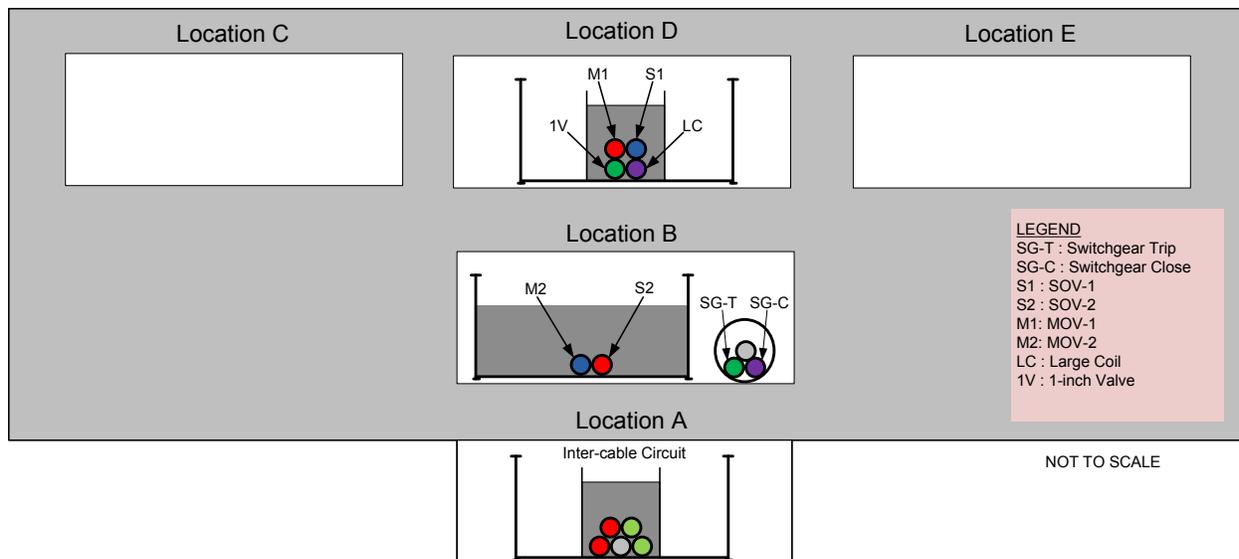
Figure 5-12. Intermediate-scale test 3 cable loading

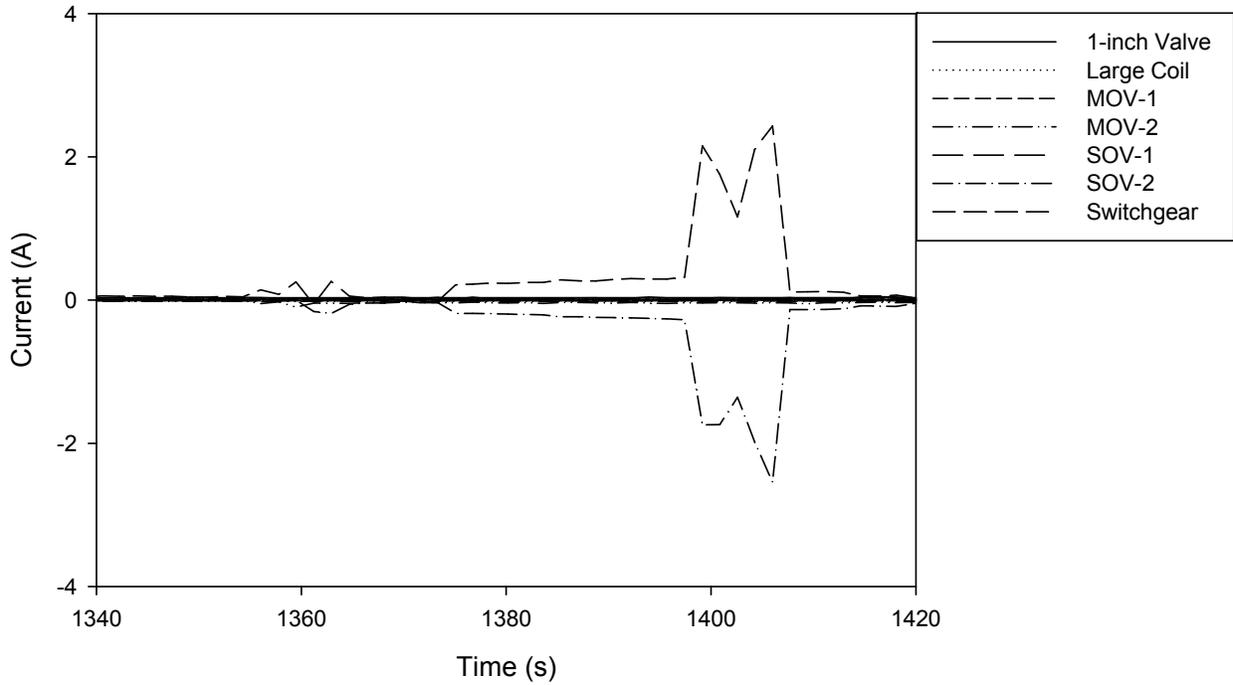
Figure 5-13. Outstanding current shorting in Intermediate-Scale Test #3, between SOV-2 and SWGR-T

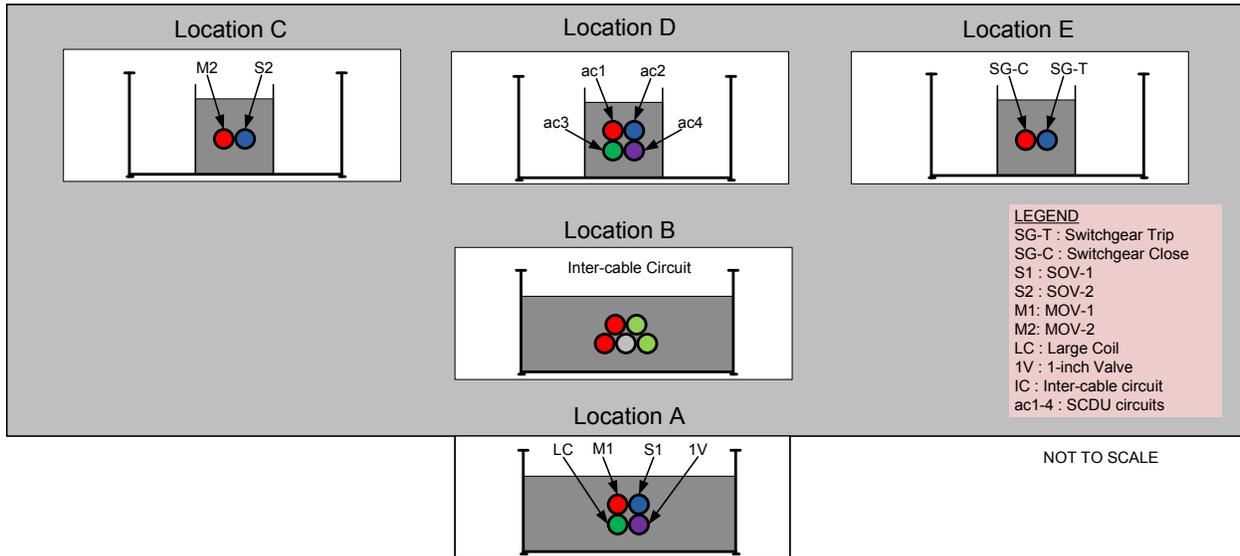
Figure 5-15. Intermediate-scale test 4 cable loading

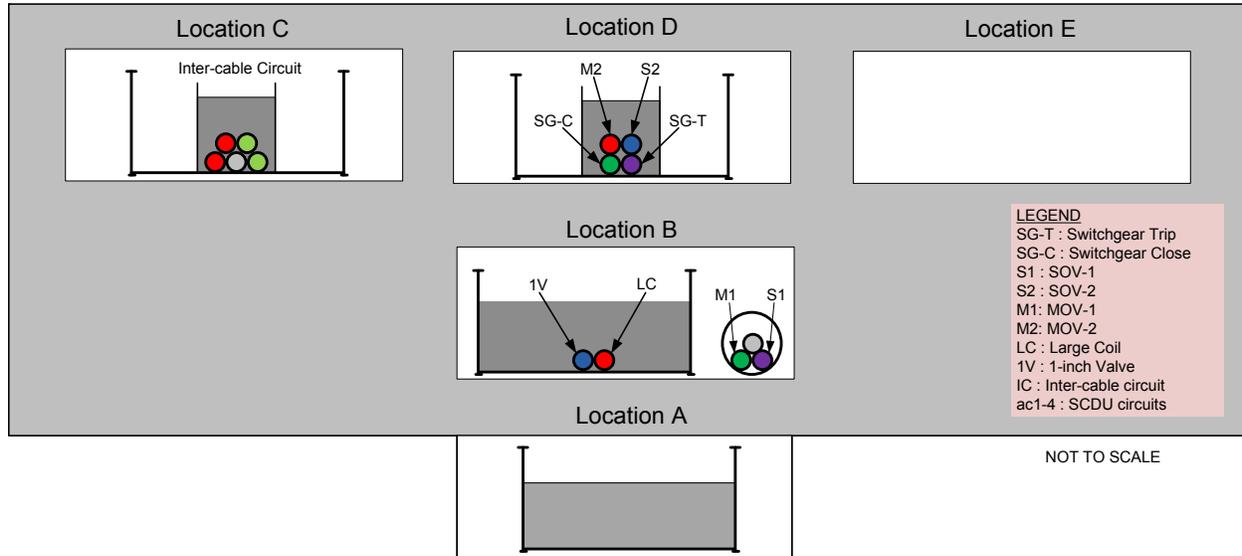
Figure 5-16. Intermediate-scale test 5 cable arrangement

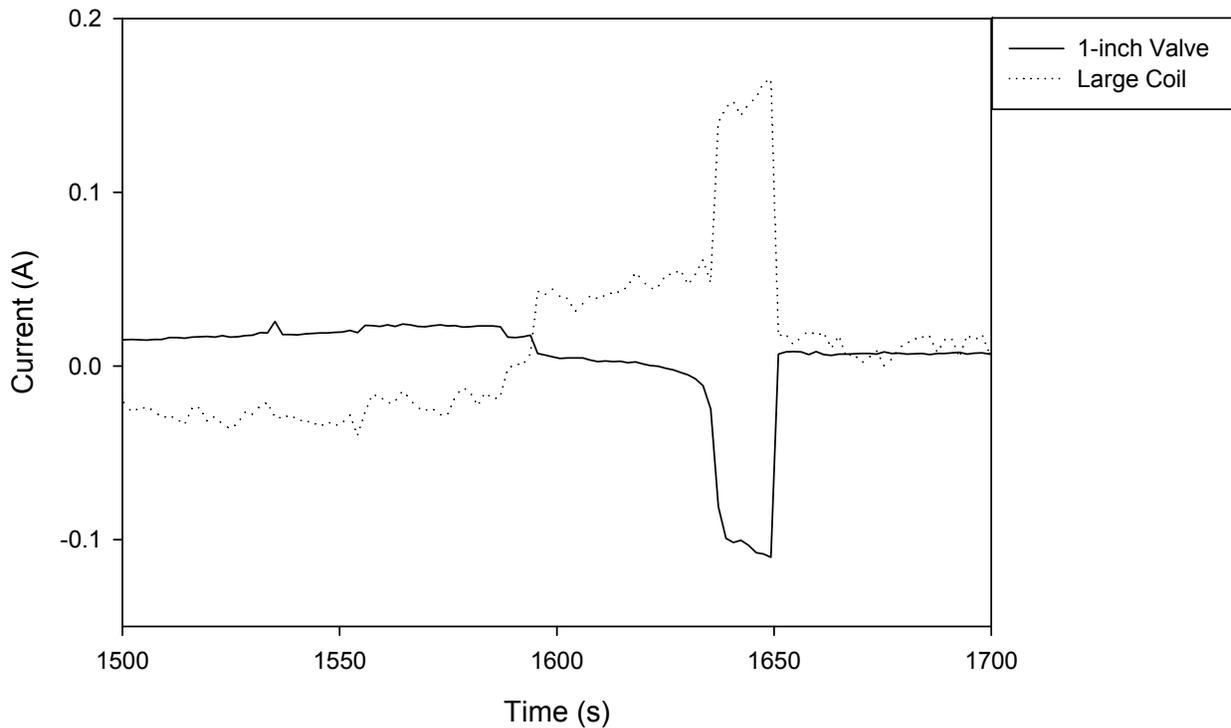
Figure 5-17. Outstanding current shorting in Intermediate-Scale Test #5, between SOV-1 and SWGR-T

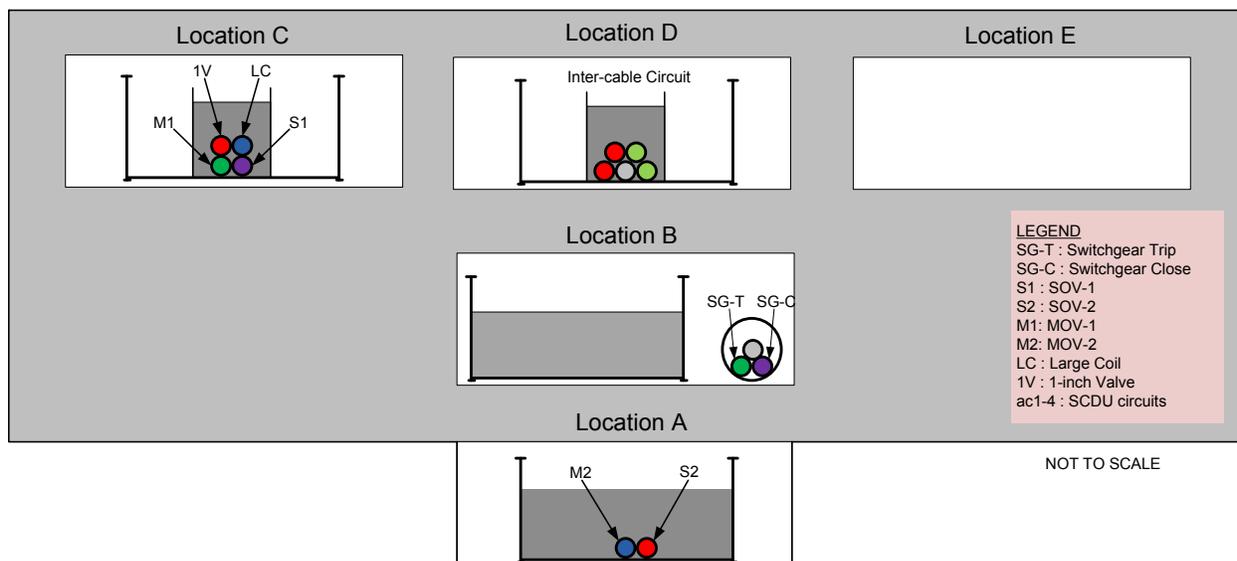
Figure 5-18. Intermediate-scale test 6 cable arrangement

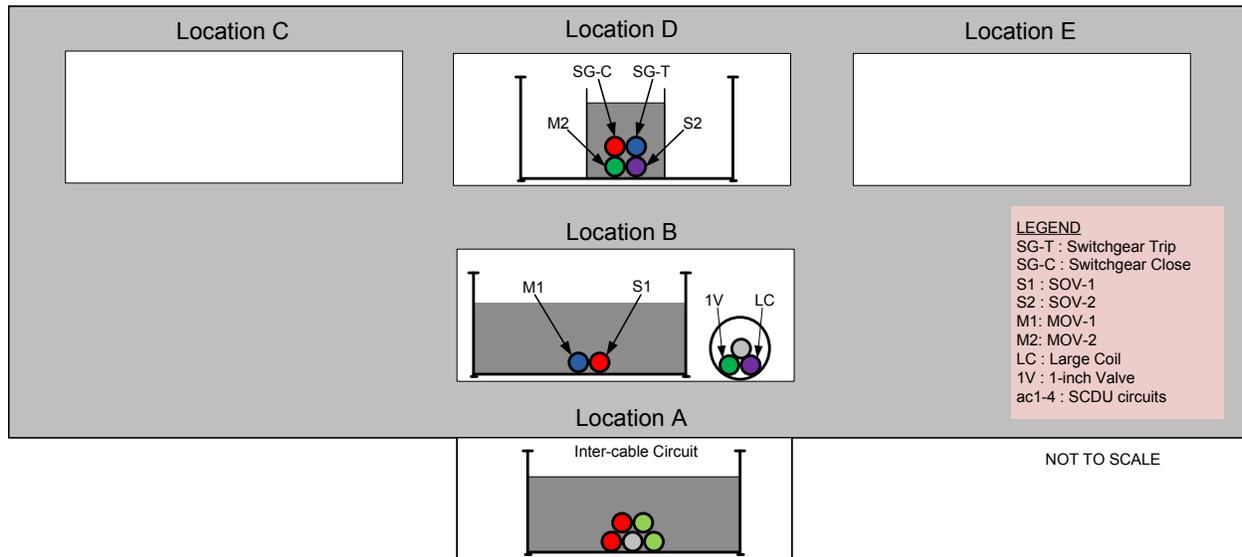
Figure 5-19. Intermediate-scale test 7 cable arrangement

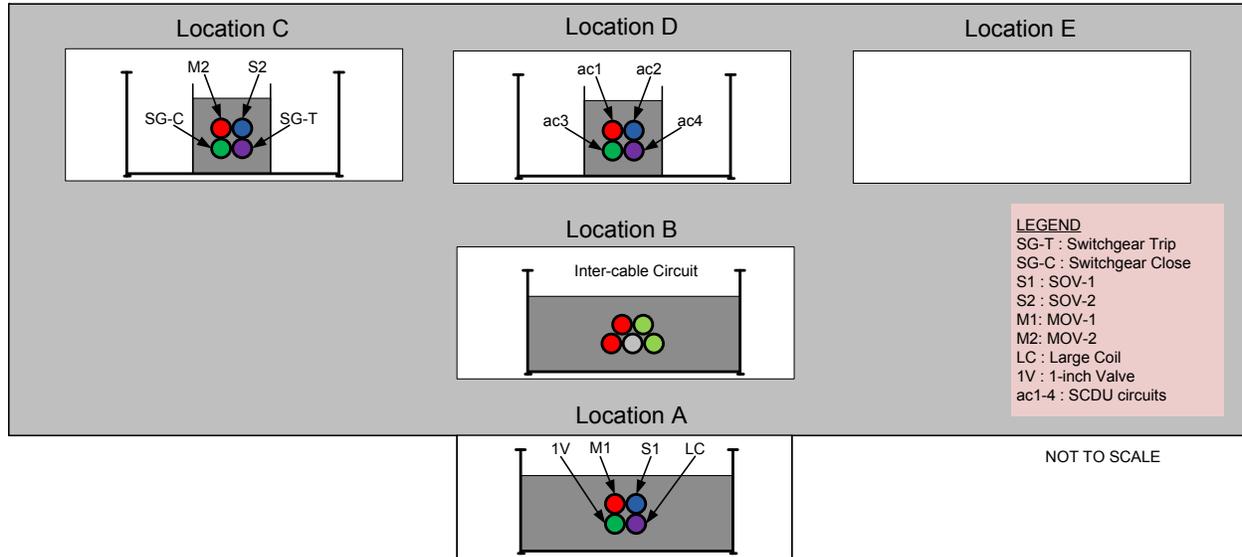
Figure 5-20. Intermediate-scale test 8 cable arrangement

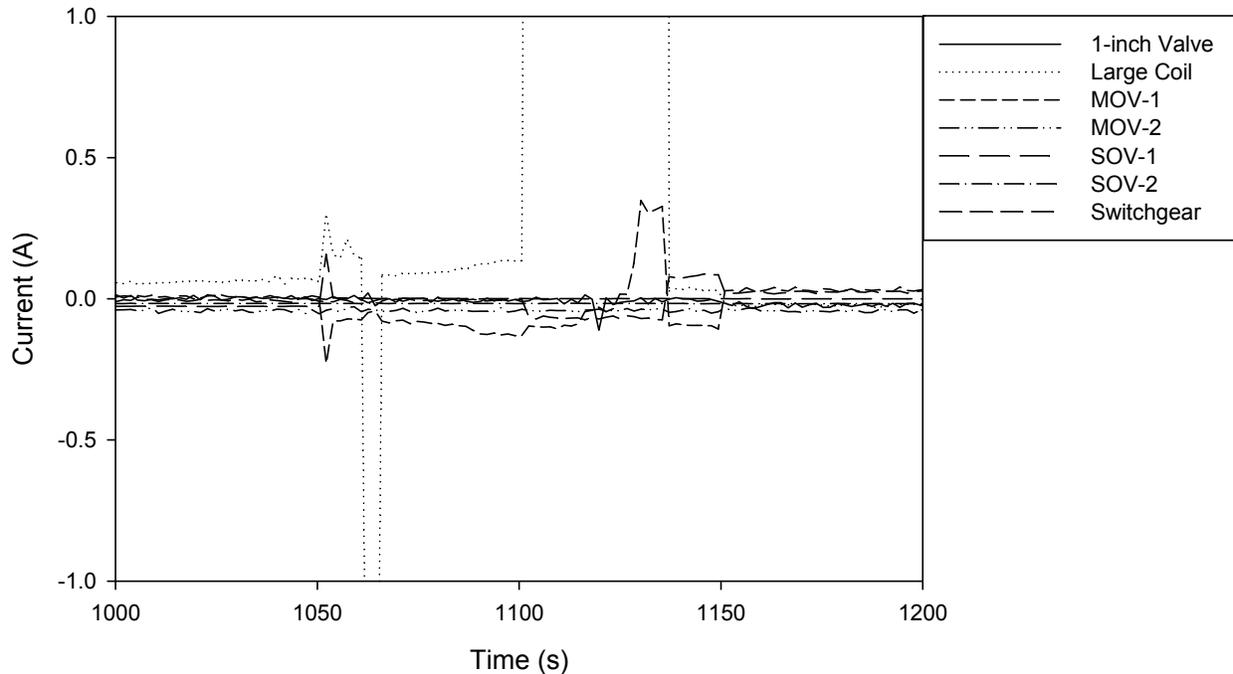
Figure 5-21. Outstanding current shorting in Intermediate-Scale Test #8, between MOV-1 and Lg Coil

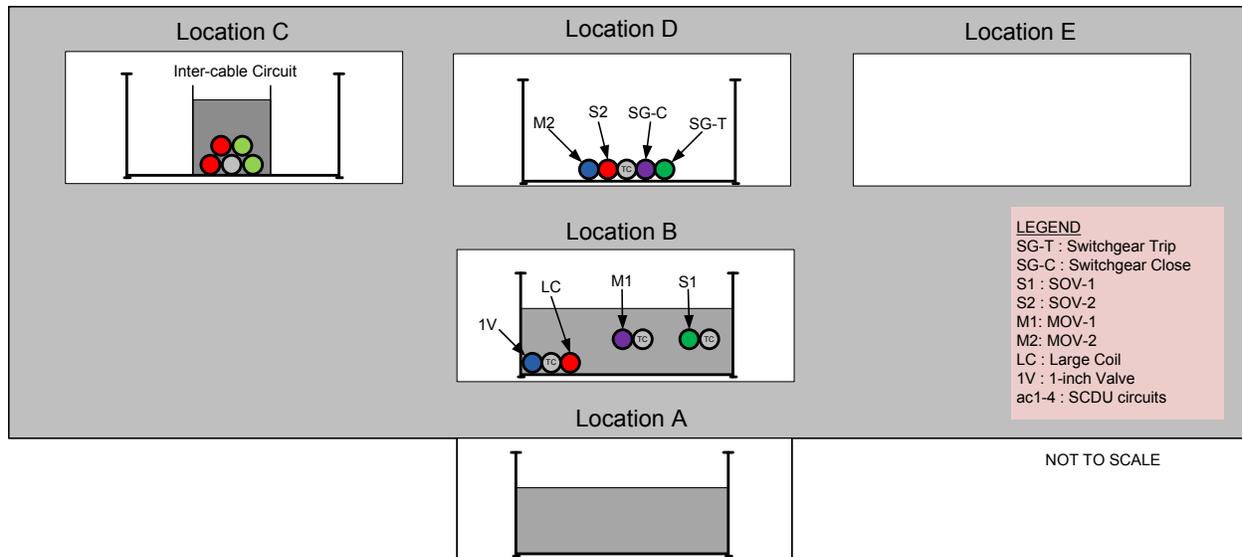
Figure 5-22. Intermediate-scale test 9 cable arrangement

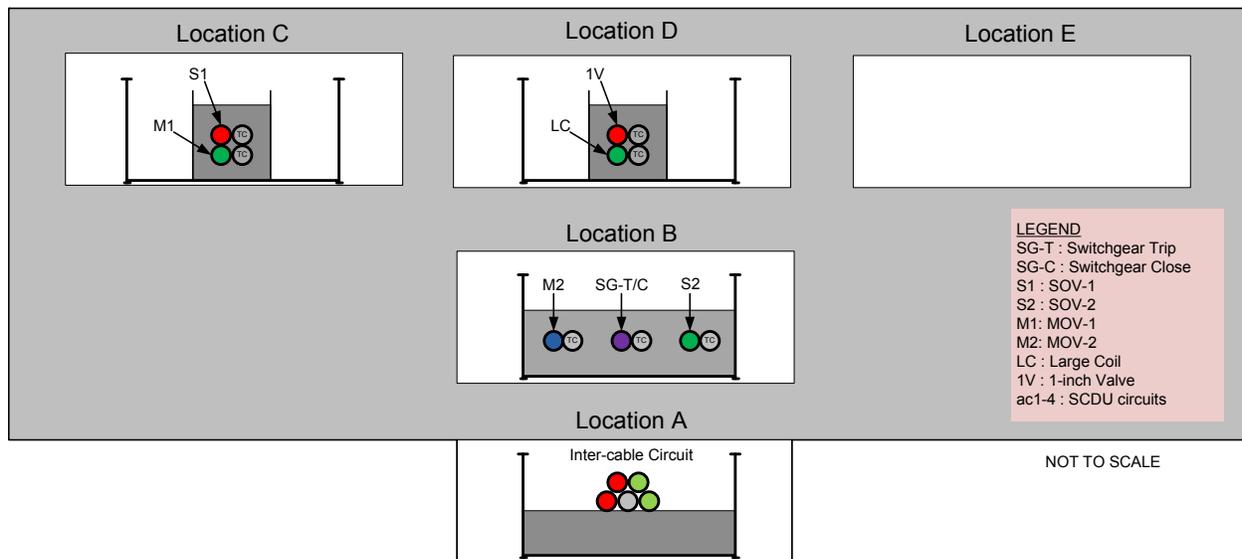
Figure 5-23. Intermediate-scale test 10 cable loading

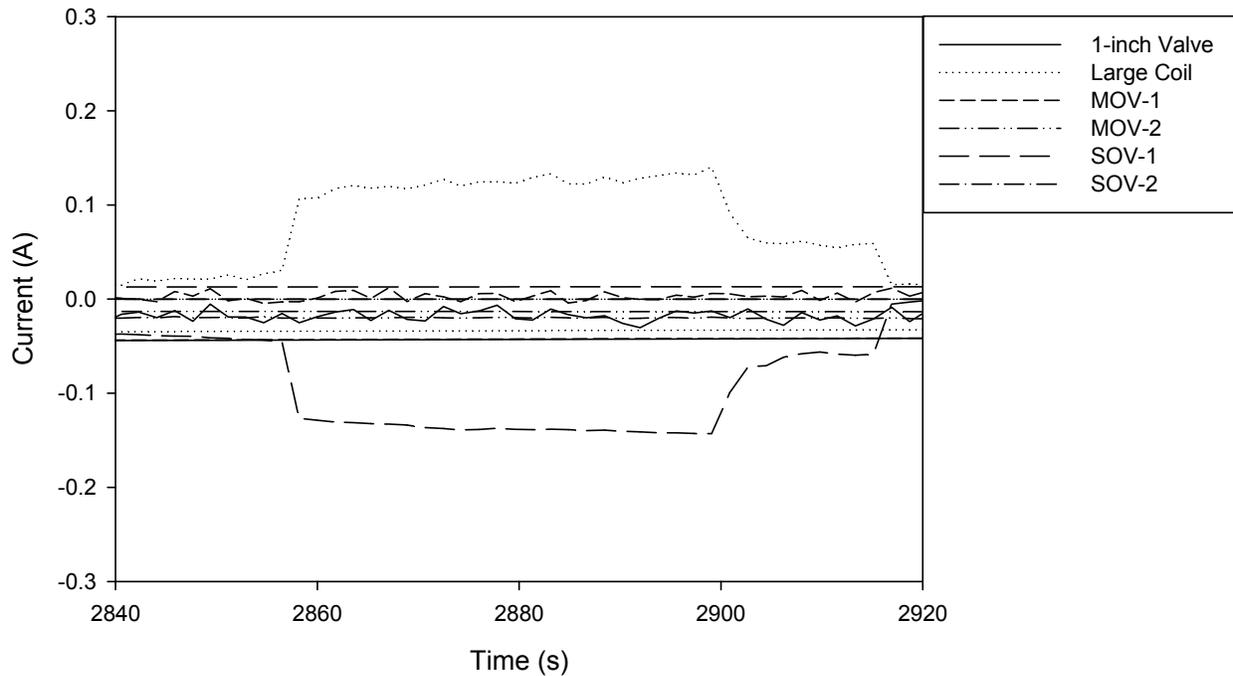
Figure 5-25. Intermediate-Scale Test #11 Current Summation
