Electrical Cable Test Results and Analysis During Fire Exposure (ELECTRA-FIRE)

**A Consolidation of Three Major
Fire-Induced Circuit and Cable
Failure Experiments Performed
Between 2001 and 2011**

Draft Report for Comment

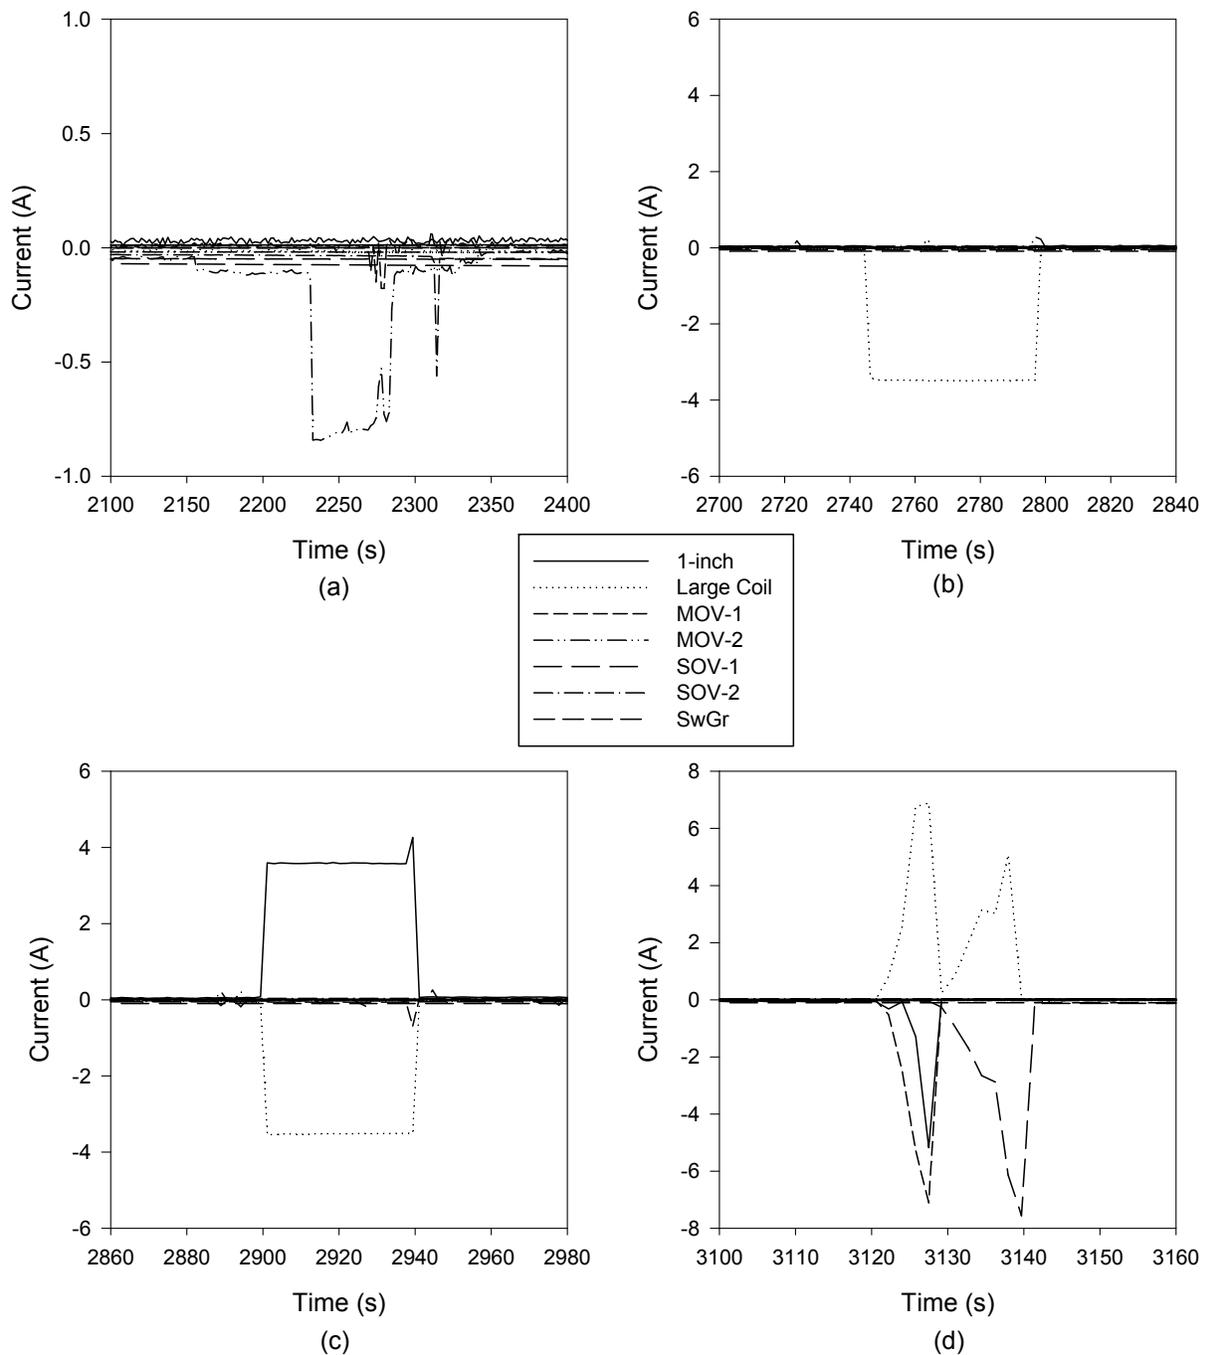
Figure 5-27. Intermediate-Scale Test 12 Current Summation Plot

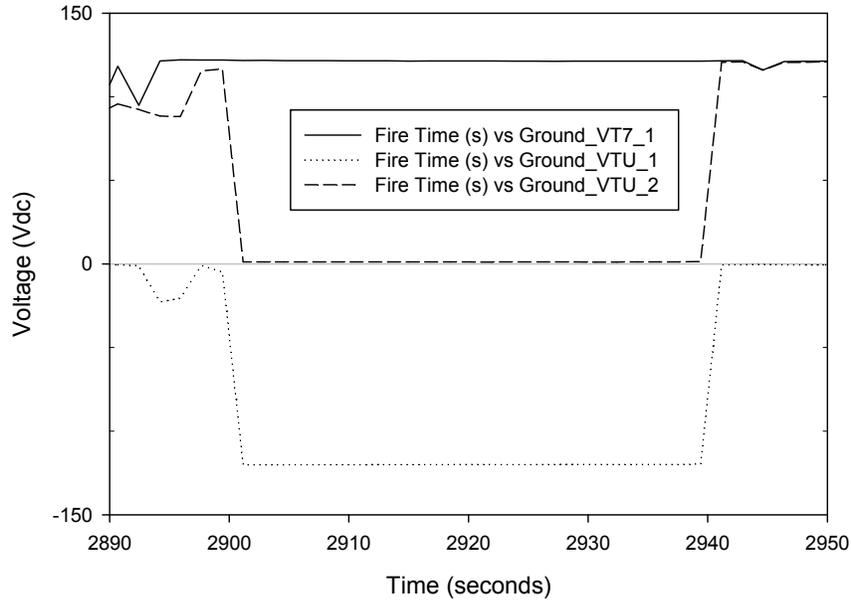
Figure 5-28. Ground Fault Detection Voltage Response for Second Lg Coil SA

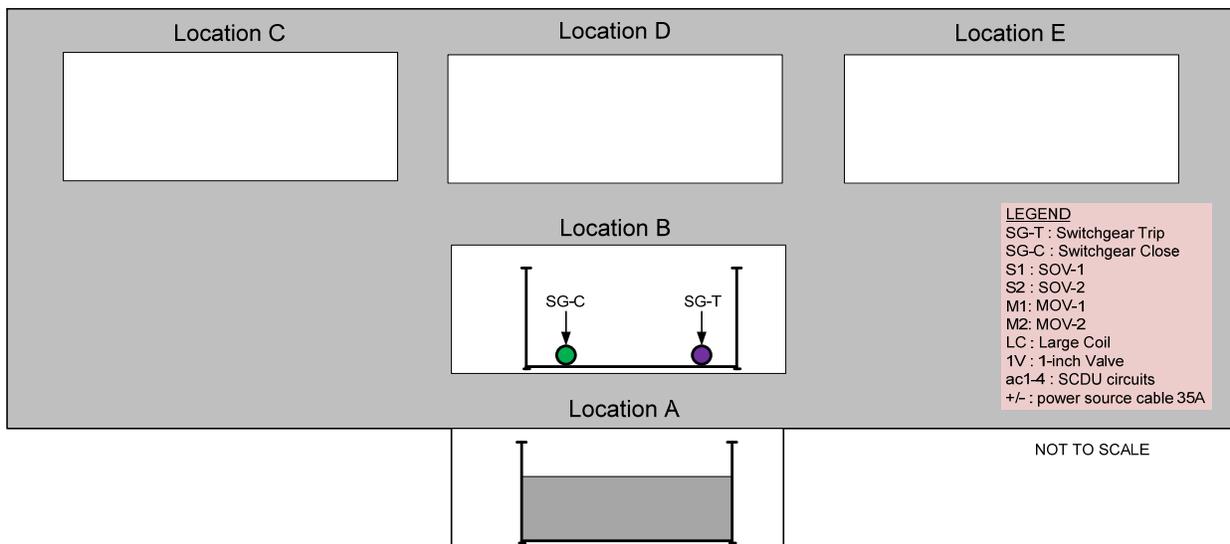
Figure 5-29. Intermediate-scale test contingency A cable loading configuration

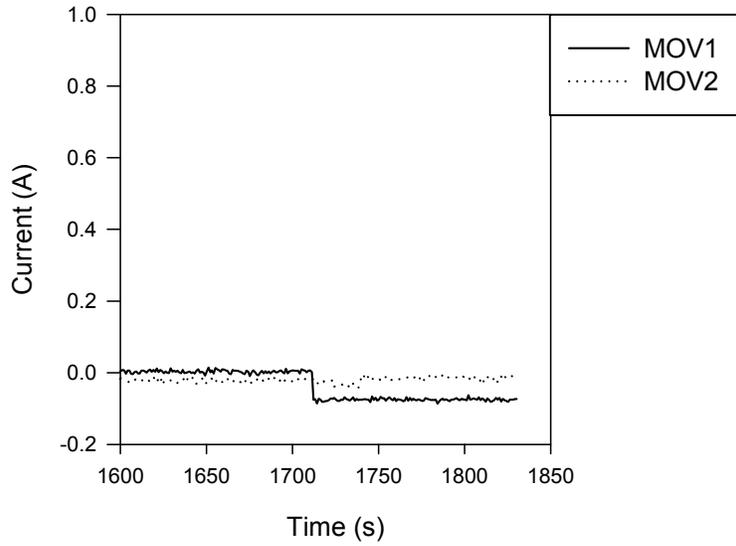
Figure A-13. Outstanding current shorting in Penlight MOV Test #37

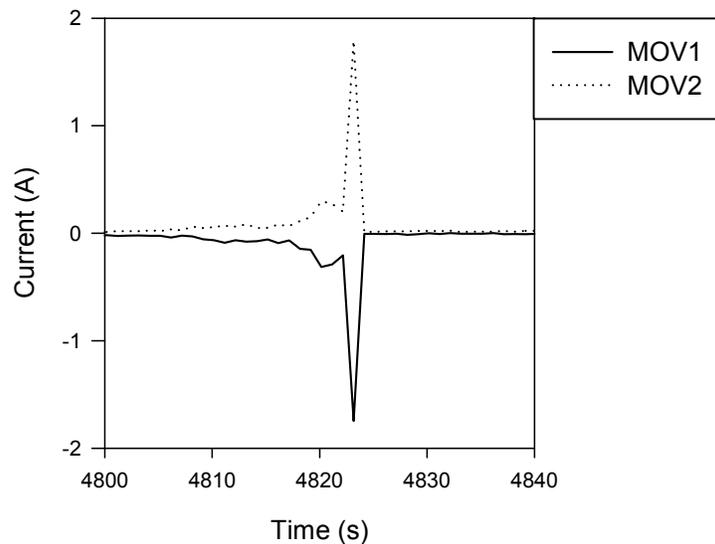
Figure A-19. Outstanding current shorting in Penlight MOV Test #49

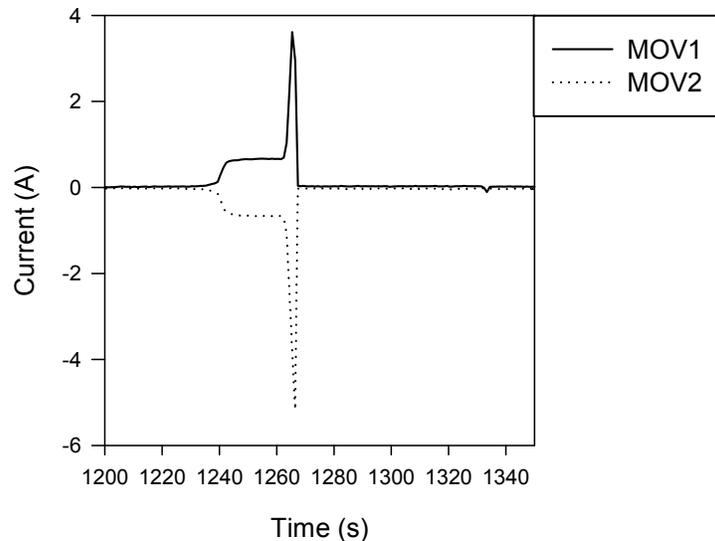
Figure A-22. Outstanding current shorting in Penlight MOV Test #50

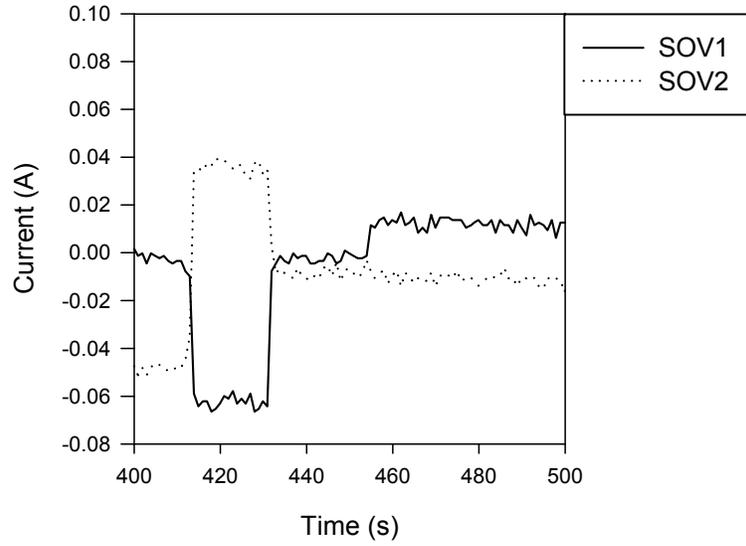
Figure A-34. Outstanding current shorting in Penlight SOV Test #31

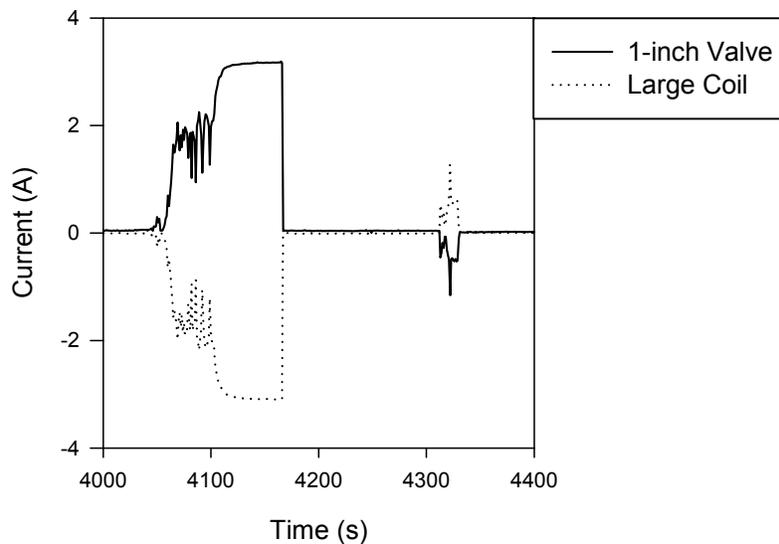
Figure A-40. Outstanding current shorting in Penlight 1-inch valve and large Coil Test #40
