NASA/TM-2013-218049

# Evaluation of the Behavior of Technova Corporation Rod-Stiffened Stitched Compression Specimens

*Dawn C. Jegley  
Langley Research Center, Hampton, Virginia*

October 2013

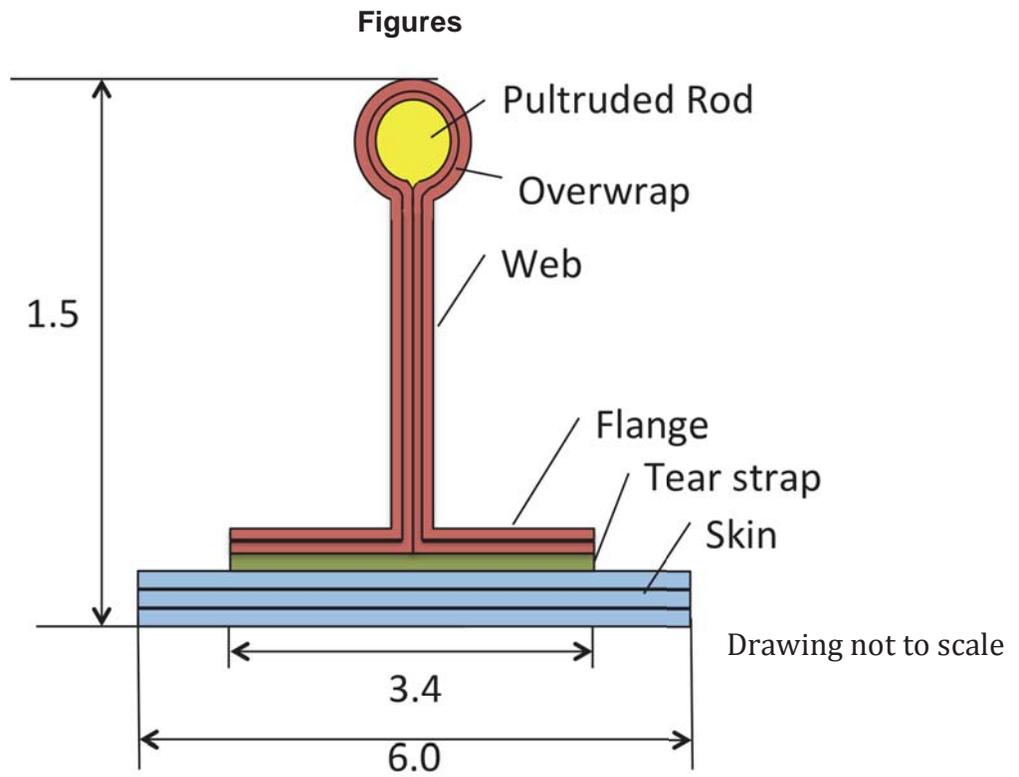
Fig. 1. Cross section geometry. Dimensions are in inches.

The cross section geometry of a pultruded rod stitched crippling specimen is shown in figure 1. The two specimens had nominally the same geometry. Photographs of the Technova specimens are shown in figures 2 and 3. Specimens were approximately 17 inches long and 6 inches wide. Stiffeners were approximately 1.5 inches tall and the skin was approximately 0.12 inches thick. Specimen dimensions are described in Table 1.

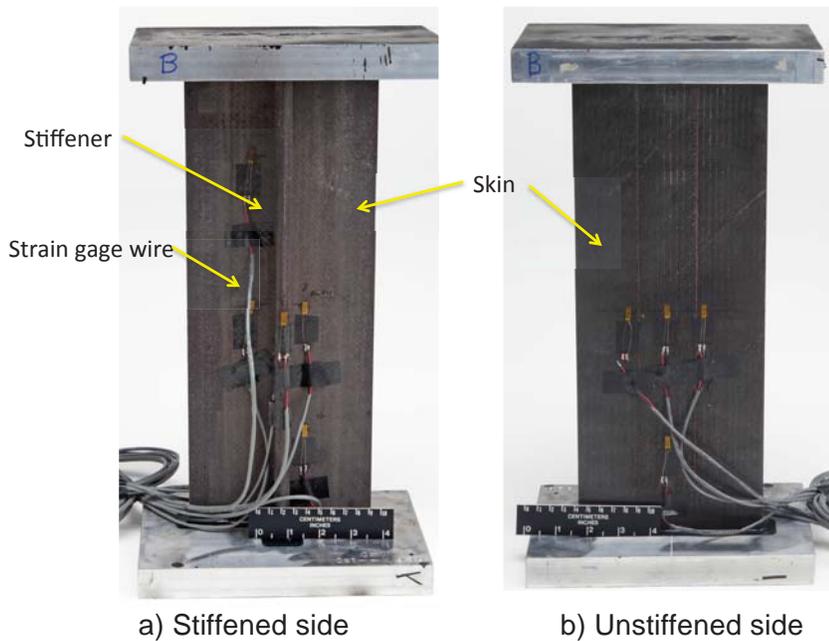
Fig. 2. Technova non-prestressed specimen.

Both Technova specimens were delivered to NASA with strain gages attached and the ends potted in one inch of an epoxy compound on each loaded end. Ten strain gages were applied to each specimen. All strain gages were axial, with gages on the skin, flanges, stiffener web, and stiffener rod overwrap as shown in the figures 2 and 3.

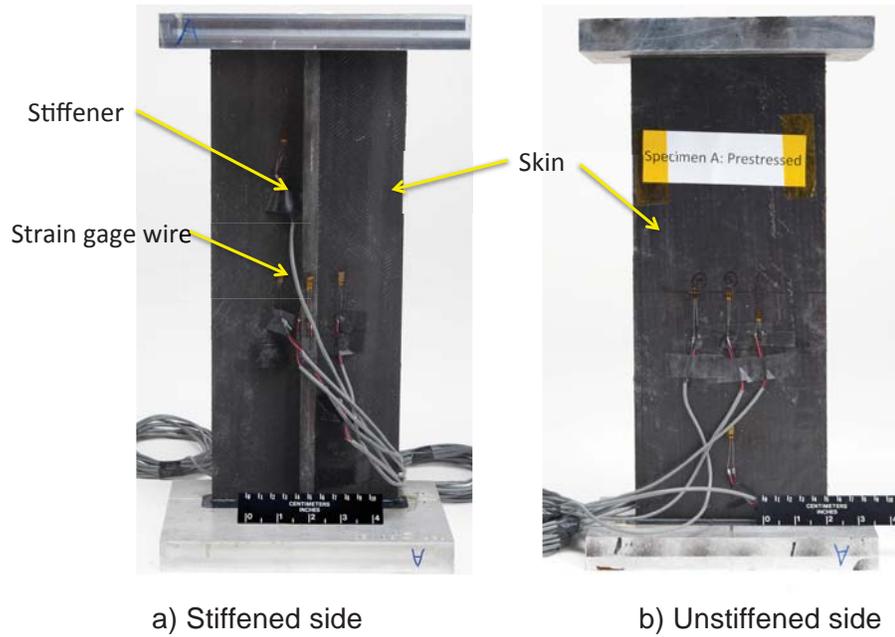
Fig. 3. Technova prestressed specimen.

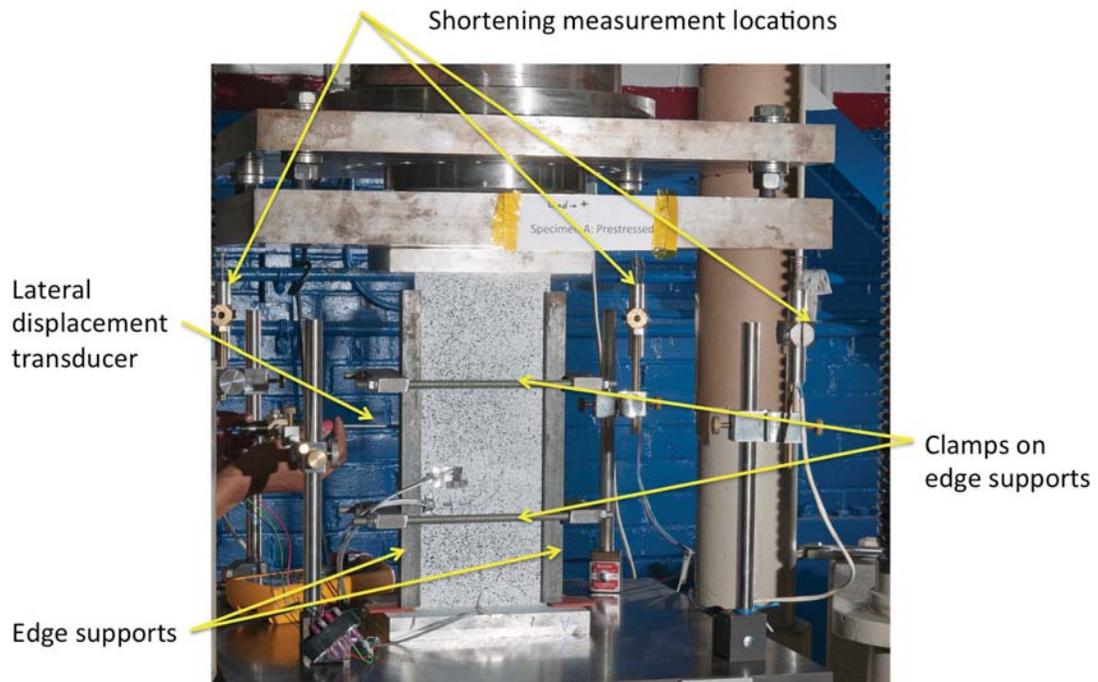
Fig. 4. Specimen in test machine and displacement measurement locations.

Prior to testing, the unstiffened side of each specimen was painted with a black and white speckle pattern to allow the use of a digital image correlation (DIC) system during loading to obtain full field displacements and strains of the unstiffened surface. A photograph of the prestressed specimen in the test machine is shown in figure 4, where the speckle pattern is visible. Four displacement transducers were used with each specimen. Three displacement transducers were positioned on the crosshead, as shown in figure 4, to monitor the motion of the crosshead so that the uniformity of the shortening could be determined and any rotation of the crosshead could be evaluated. These transducers were located 1 inch in each direction from the corners of the platen, or 11 inches in front of and behind the centerline of the platen and 10.5 inches from the centerline of the stiffener web. The fourth displacement transducer was positioned perpendicular to the stiffener at the midlength position, parallel to the plane of the crosshead. This transducer was used to measure the rolling of the stiffener.

Side supports used to restrict the motion of the unloaded edges were positioned on each unloaded edge 2.5 inches above and below the axial centerline of the specimen, as shown in figure 4. A sketch of these side supports is shown in figure 5, where the slot for the specimen skin is shown. Supports were clamped to the specimen restricting both lateral in-plane motion and out-of-plane motion. Shortening should not have been restricted by the side supports. The nuts on the supports were tightened “finger tight.” The specimen skin thickness was within 0.03 inches of the slot thickness, so only a very small amount of local deformation out-of-plane could occur. Because of the contact between the supports and the specimen skin included approximately 0.2 inches from the edge of the specimen, this condition resembled a clamped edge. In the vertical direction gaps were allowed between the support and the potting at each end of the specimen to allow the specimen to shorten without loading the supports.

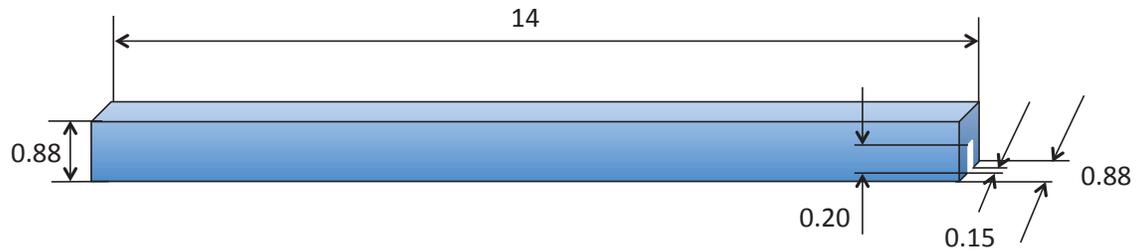
Fig. 5. Edge supports. Dimensions are in inches. Drawing not to scale

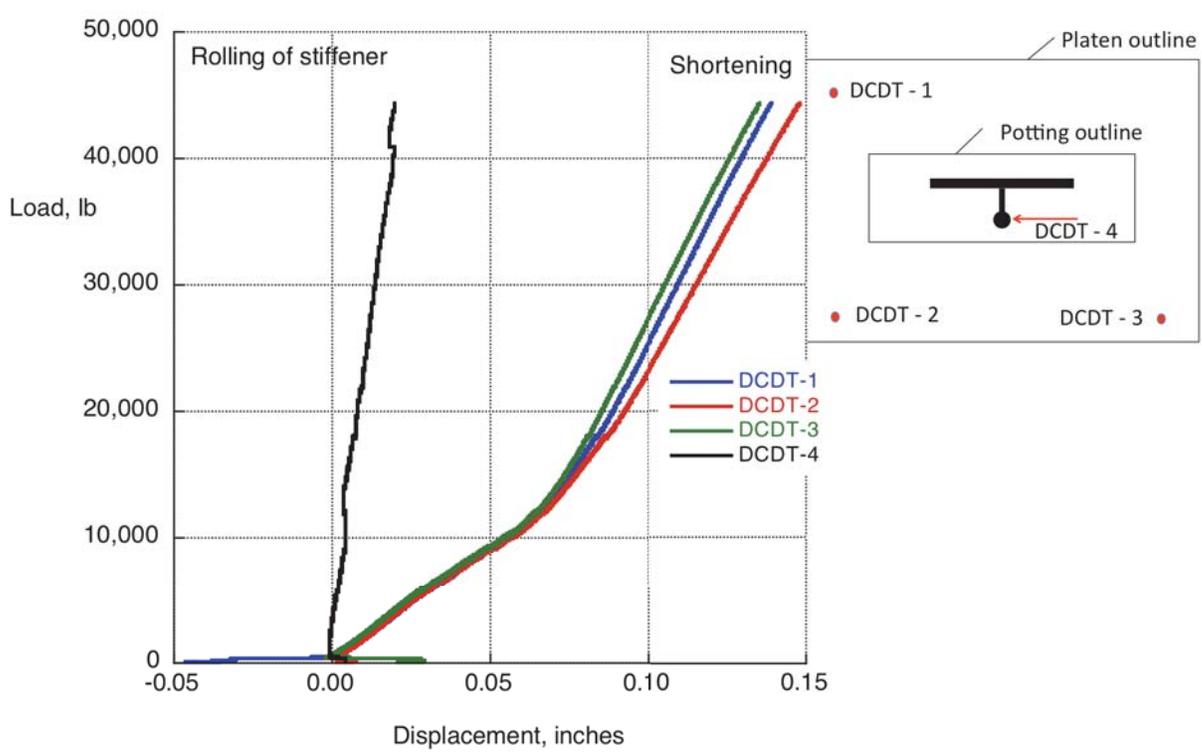
Fig. 6. Displacement transducer measurements for Technova non-prestressed specimen.

The displacements measured by all four transducers are shown in figures 6 and 7, respectively, for the non-prestressed and prestressed specimens. The shortening results are shown as the red, blue and green curves and the lateral motion is shown as the black curve.

For both specimens, the displacement transducers measuring shortening showed significant nonlinearity in the load-shortening curves for loading less than approximately 15,000 lb. However, for loading greater than 15,000 lb, the load-shortening relationship is linear. This initial nonlinearity is believed to be caused by irregularities in the potting and load introduction. The three shortening measurements were initially almost identical and remained within approximately 10% of each other throughout the test. For both specimens, some motion of the stiffener occurred but that motion does not appear to indicate stiffener rolling since it remained very gradual motion and never exceeded 0.02 inches for the non-prestressed specimen and 0.01 inches for the prestressed specimen.

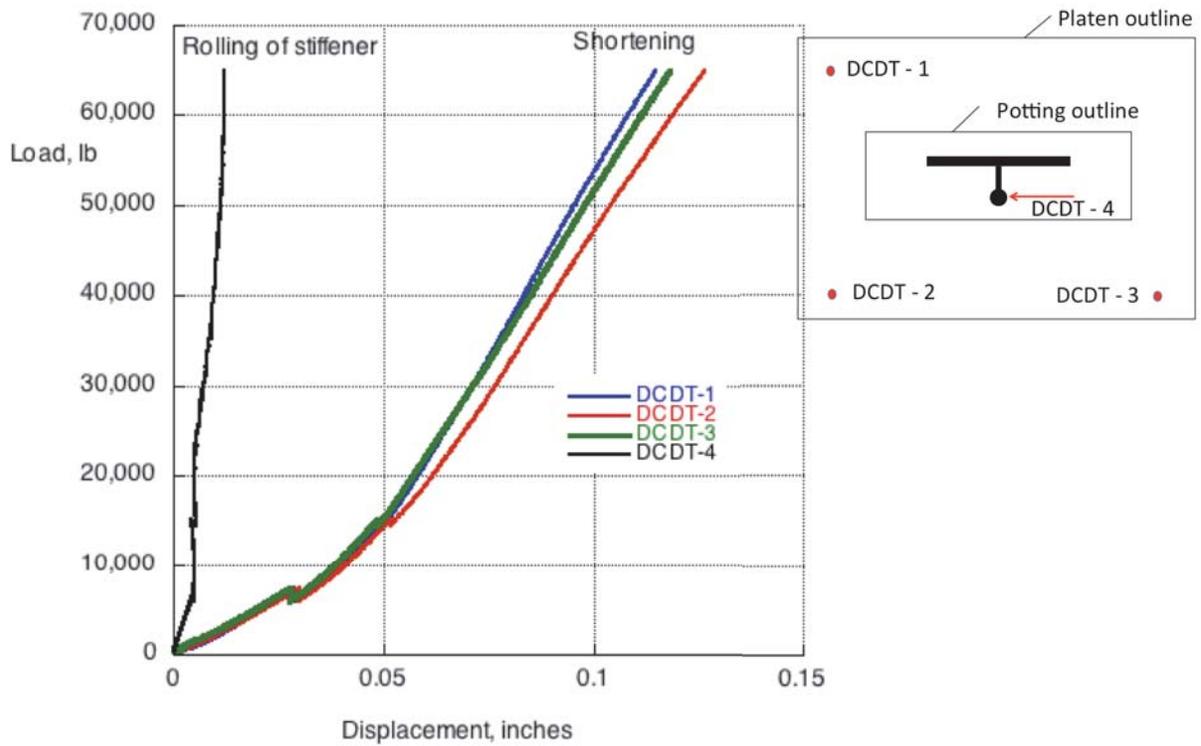
Fig. 7. Displacement transducer measurements for Technova prestressed specimen.

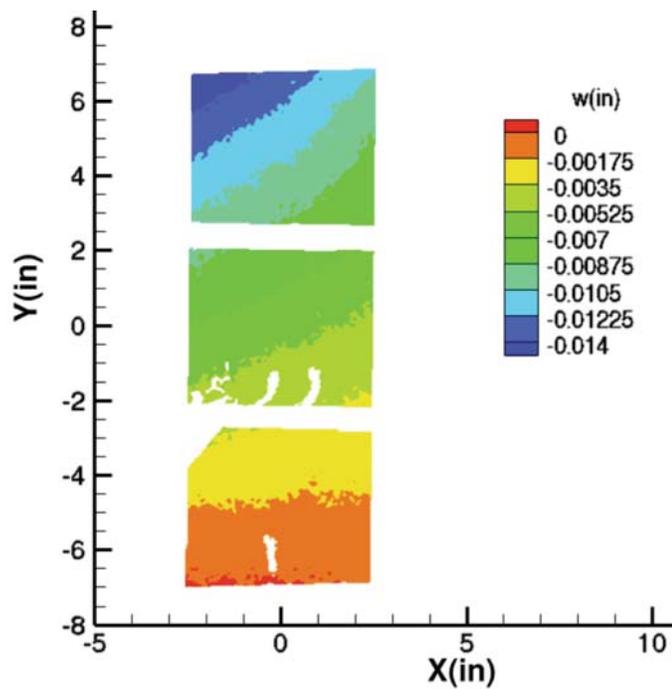
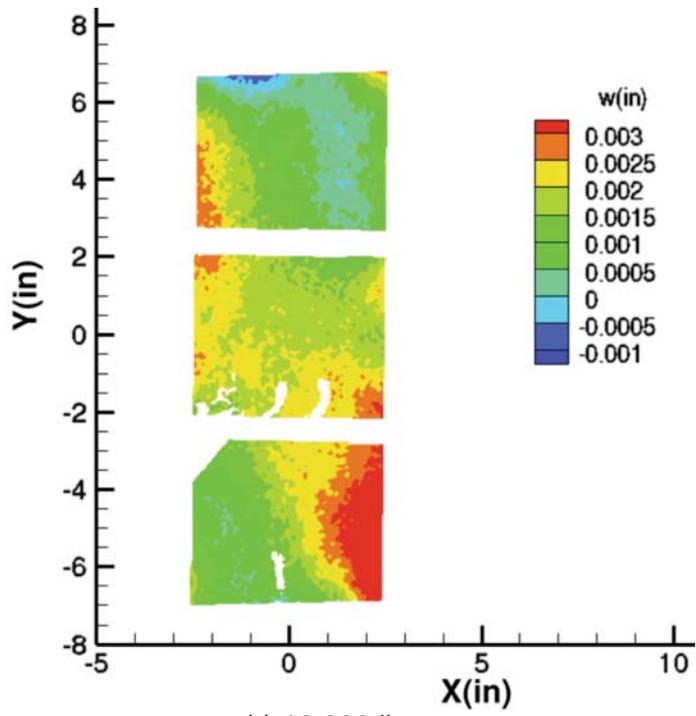
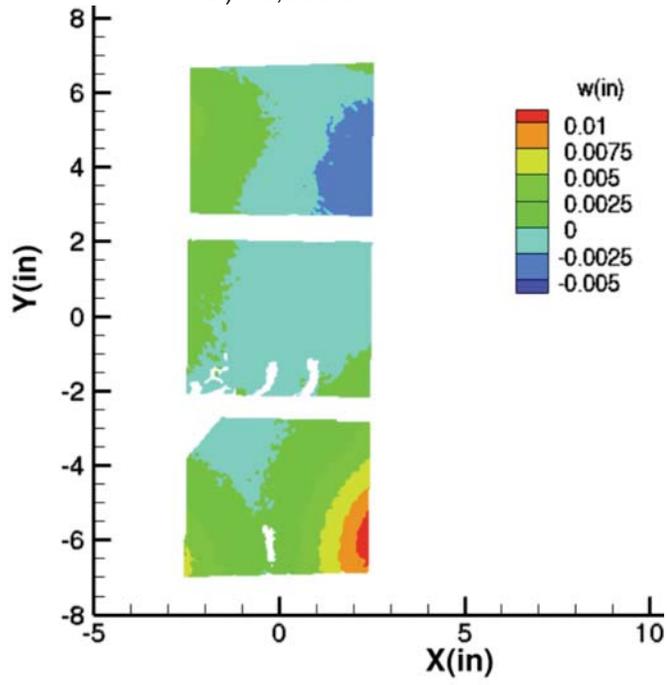
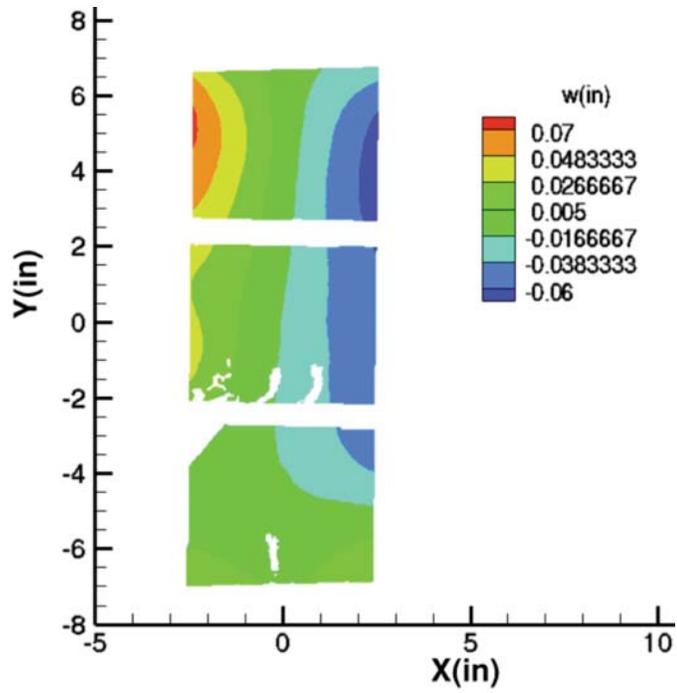
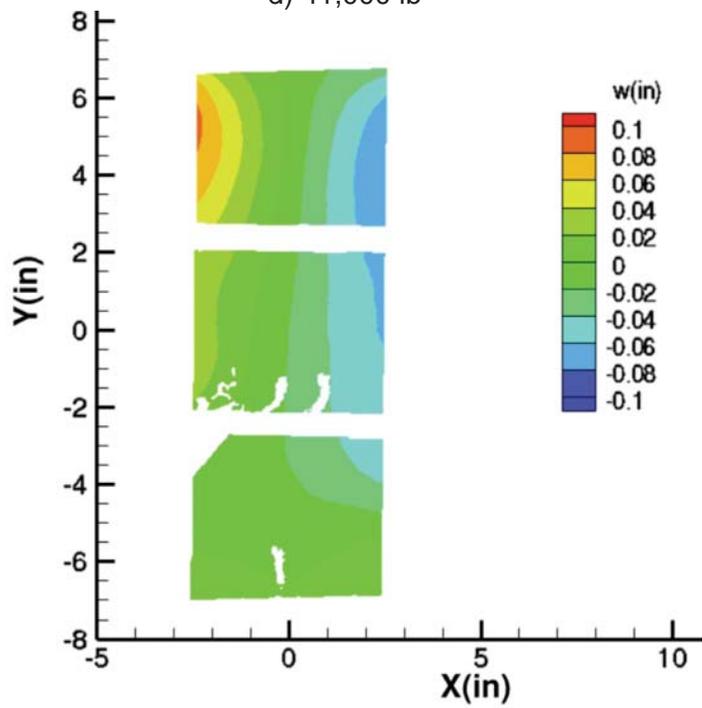
Fig. 8. Full-field displacements for Technova non-prestressed specimen.

Digital image correlation full-field out-of-plane displacement results are shown in figures 8 and 9, respectively, for the non-prestressed and prestressed specimens. White regions within the images are locations where data could not be obtained because of hardware between the camera and the specimen surface such as restraints, clamps, and strain gage wires. Anything attached to the surface or in the field of view of either camera, or casting a shadow on the test article, can limit the area for which DIC data can be reliably collected. Load levels of approximately 500, 10,000, 12,100, 41,000, and 44,000 lb for the non-prestressed specimen are shown. Load levels of approximately 500, 5,000, 15,000, 61,000, and 65,000 lb are shown for the prestressed specimen.

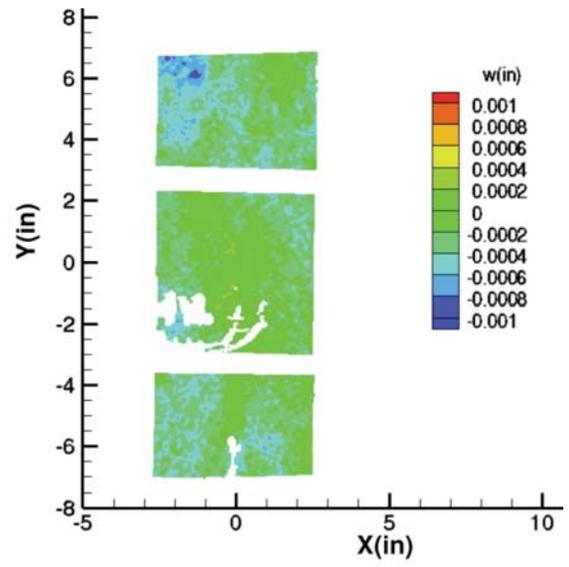
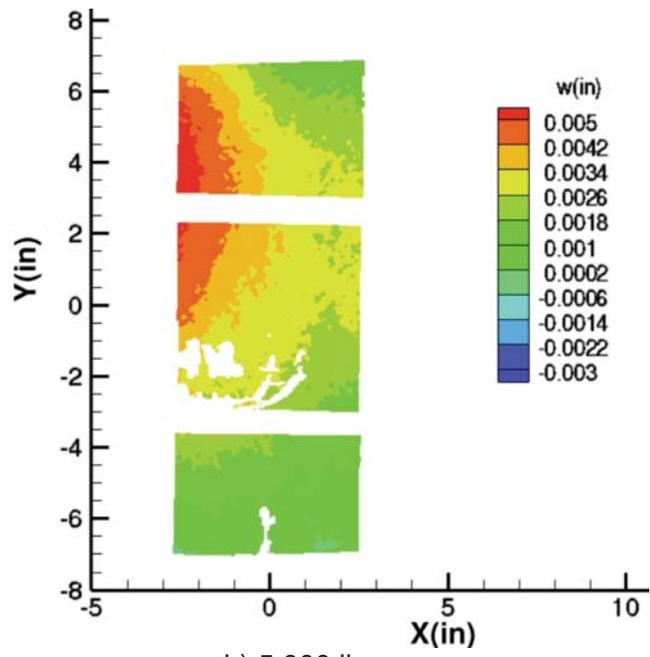
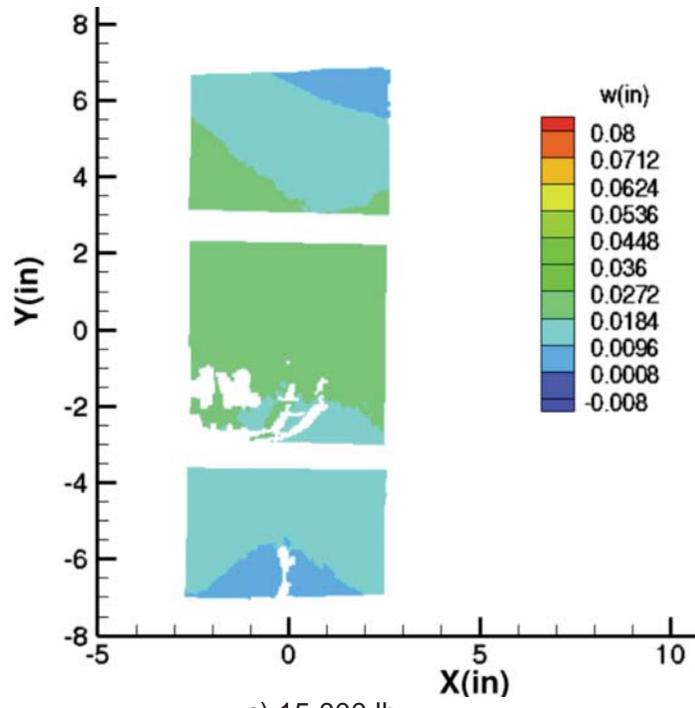
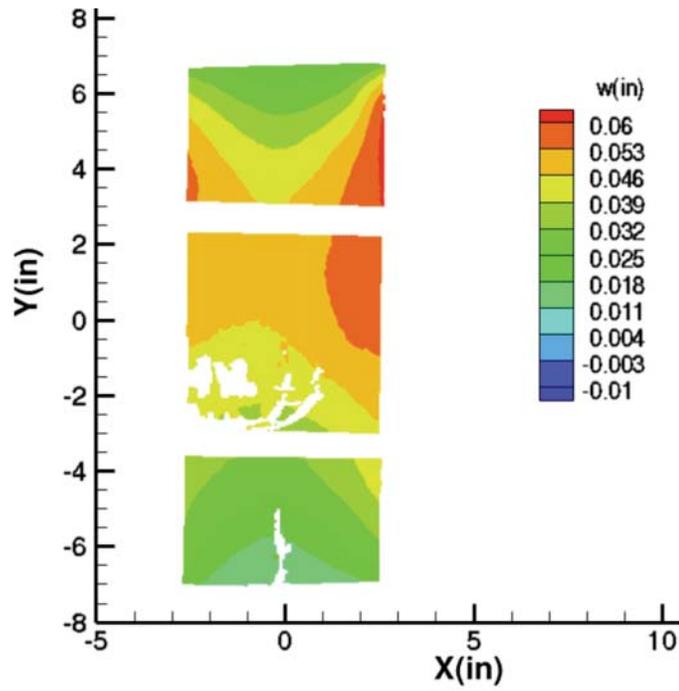
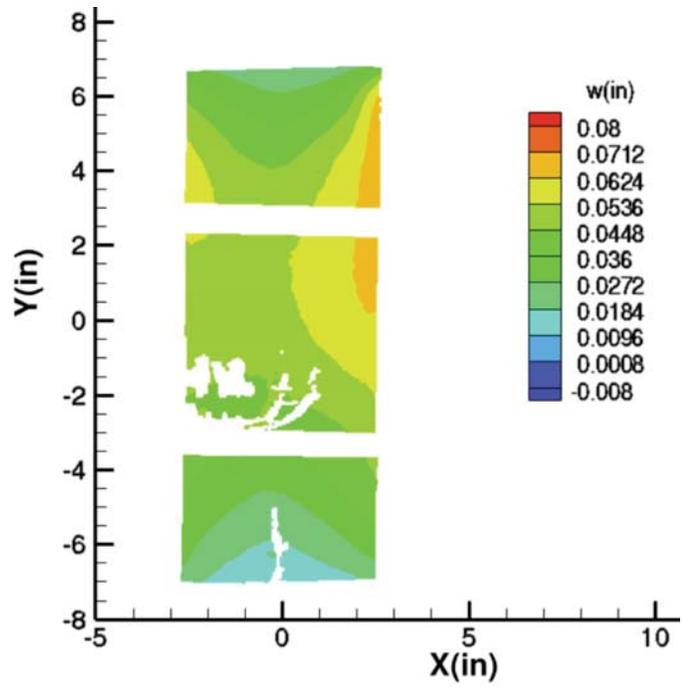
Fig. 9. Full-field displacements for Technova prestressed specimen.

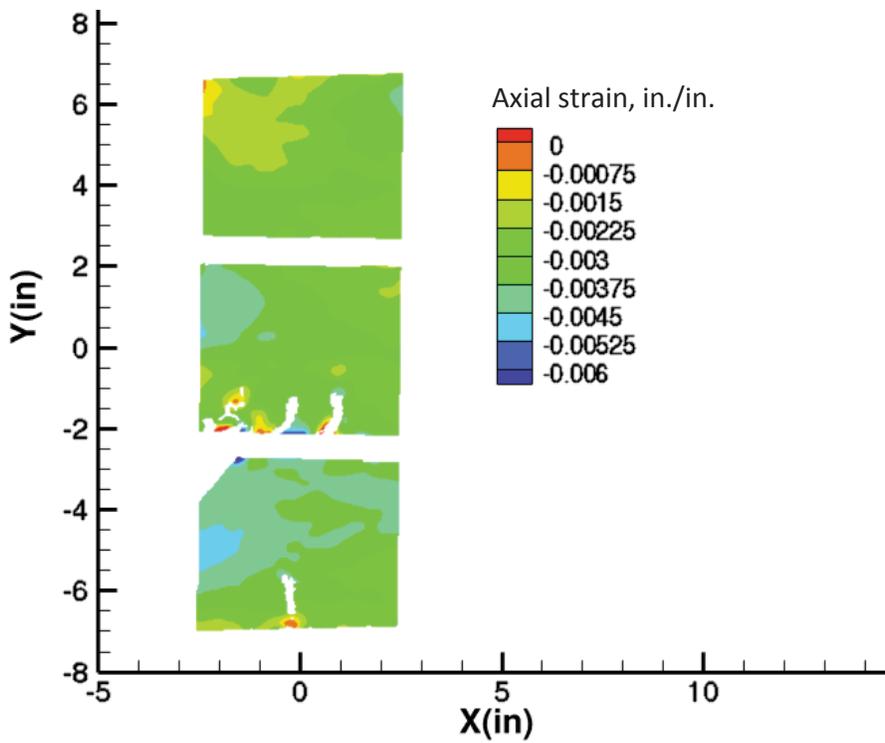
Fig. 10. Full-field strains for non-prestressed specimen at 44,300 lb.

Full-field axial strain results are shown in figures 10 and 11, respectively, for the non-prestressed and prestressed specimen for load levels immediately prior to failure. Specifically, load levels of approximately 44,300 lb for the non-prestressed specimen and approximately 65,000 lb for the prestressed specimen are shown. Again, white regions within the images are locations where data could not be obtained because of hardware between the camera and the specimen surface such as restraints, clamps, and strain gage wires. Isolated peaks in the strains immediately adjacent to the white areas are also inaccuracies based on the obstructed areas. Surface strains in the skin on the unstiffened side did not exceed a compressive strain of 0.006 in./in., indicating that failure did not initiate due to excessive strain in the skin.

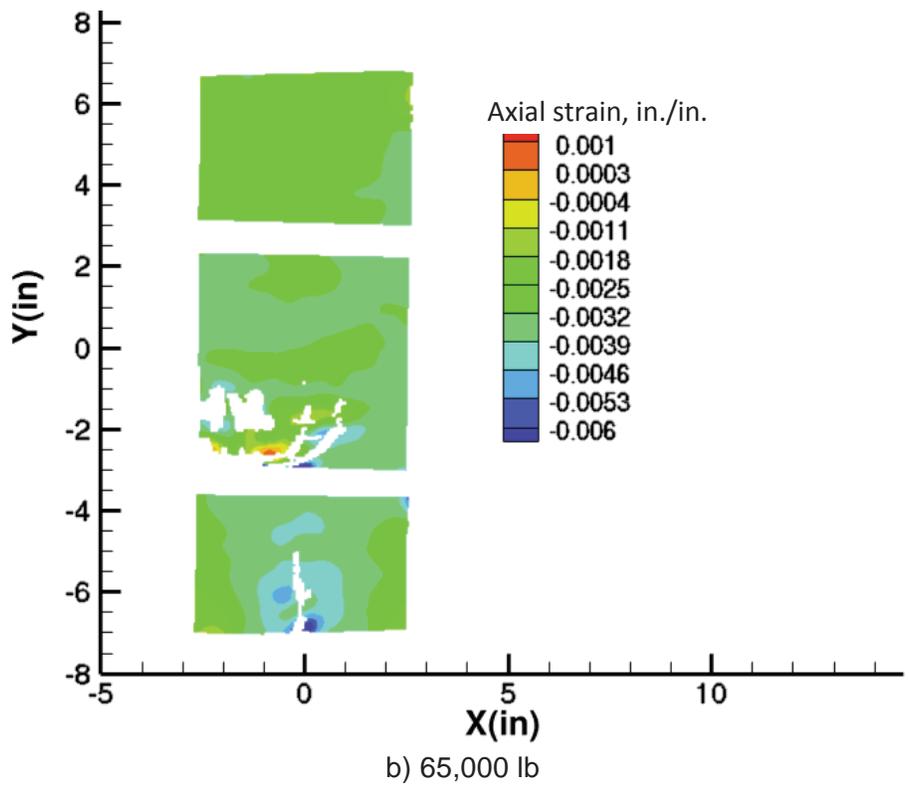
Fig. 11. Full-field strains for Technova prestressed specimen.

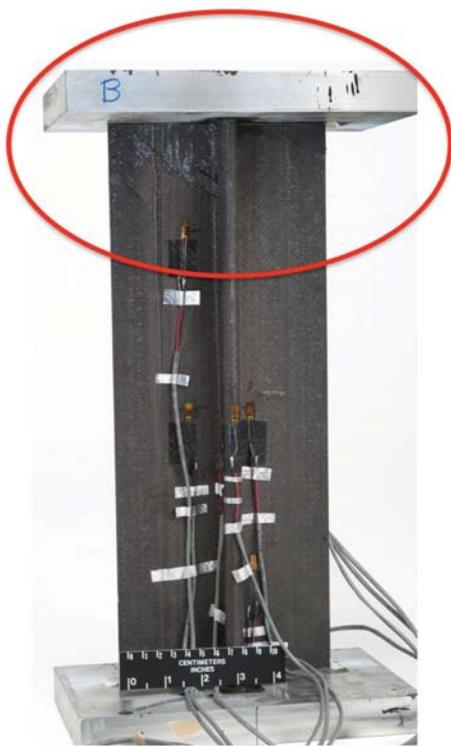
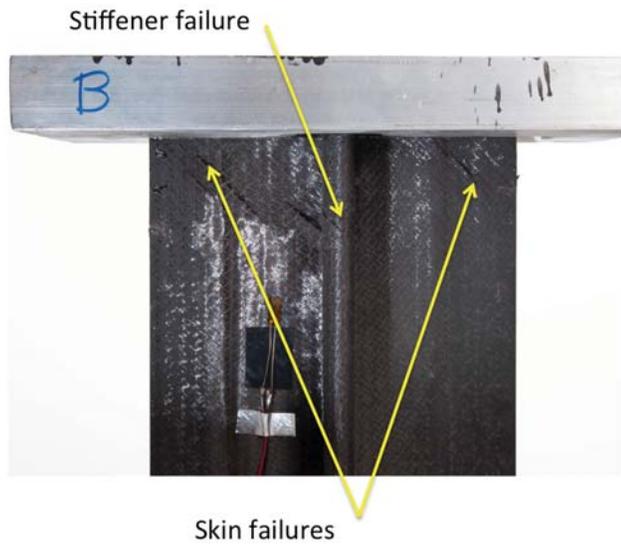
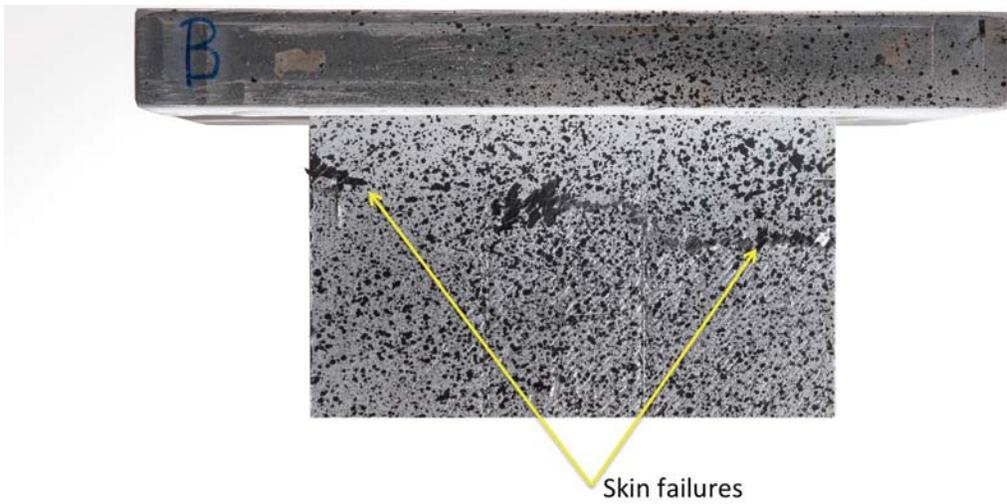
Fig. 12. Post-test photographs of Technova non-prestressed specimen.

The maximum load for the non-prestressed specimen was 44,339 lb. Failure occurred through the skin and stiffener near the potting, as shown in figure 12. The maximum recorded load for the prestressed specimen was 64,955 lb. Failure occurred through the skin near the potting and through the rod overwrap both near the potting and approximately 3.5 inches away from the top failure, as shown in figure 13.

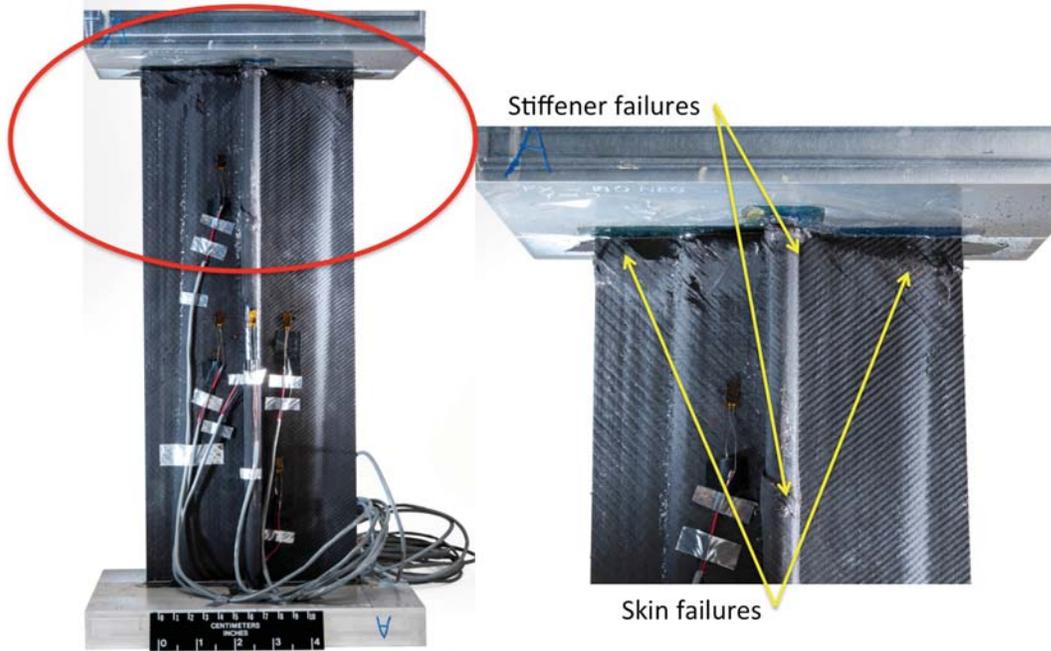
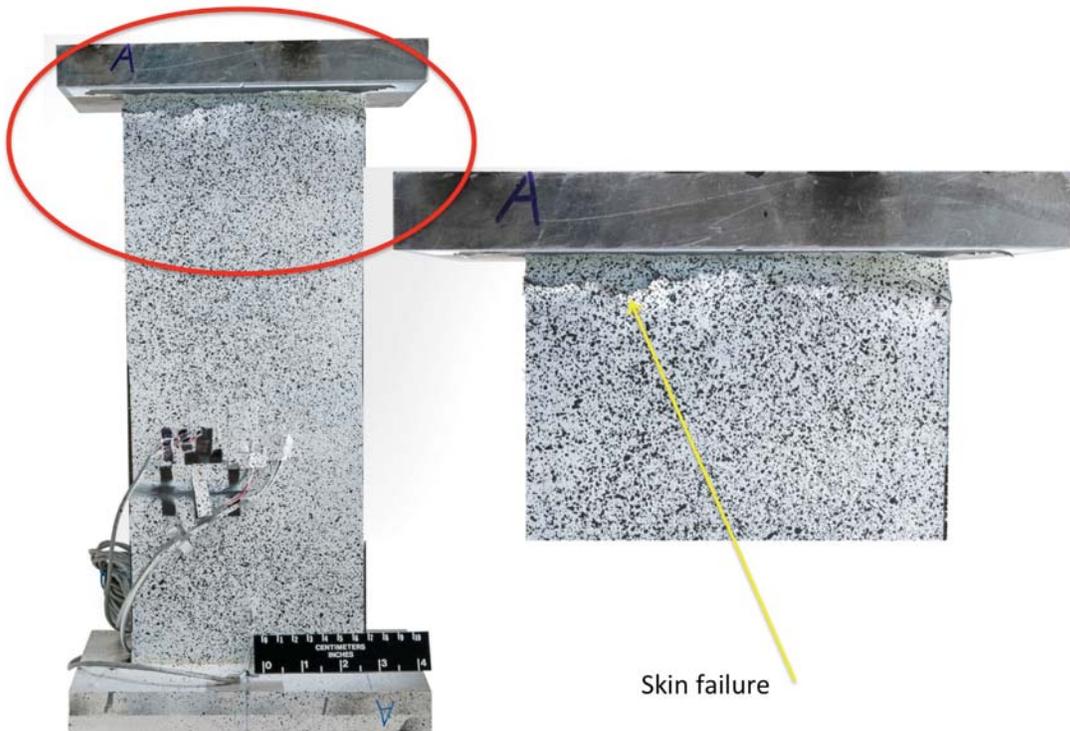
Fig. 13. Post-test photographs of Technova prestressed specimen.

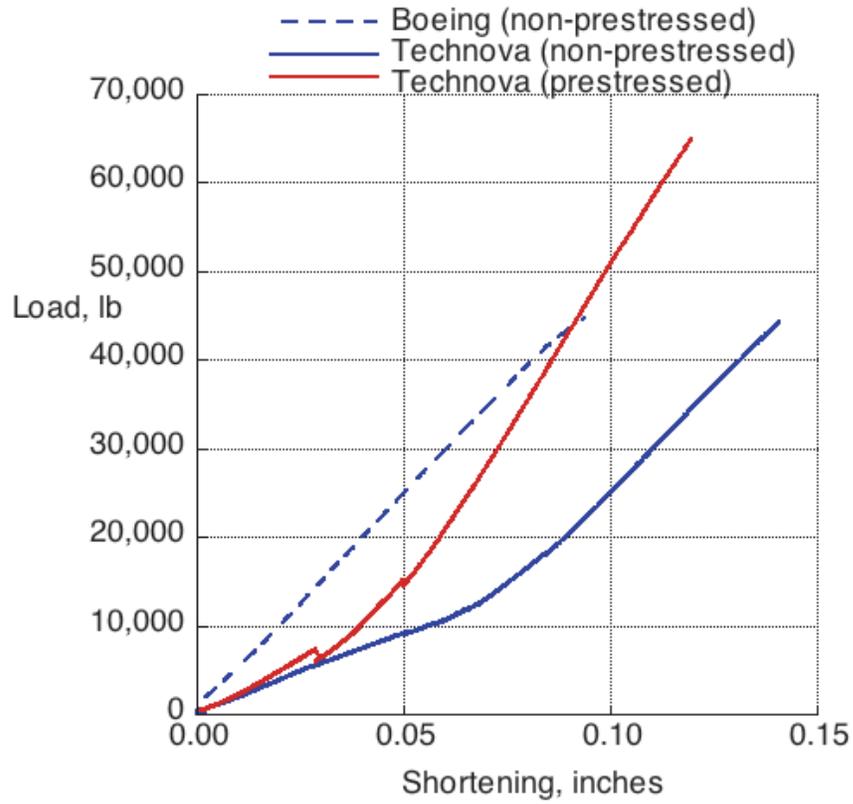
Fig. 14. Load-shortening comparison with Boeing specimen.

The average of the measured shortening results are shown in figure 14 for a typical Boeing rod-stiffened crippling specimen and both Technova specimens. The Boeing specimen was geometrically similar to the Technova specimen with a width of 6.0 inches, a stiffener diameter of 0.48 inches and a length of 18 inches. The Boeing specimens were assumed to be nominally the same as non-prestressed Technova specimen. The skin of the Boeing specimens was 0.055 inches thick so the Technova specimens were approximately twice the thickness of the skin of the Boeing specimens.

The Boeing specimen displayed a more linear load-shortening behavior than the equivalent Technova specimen, but the maximum load values were similar. Two pristine Boeing crippling specimens and two fatigued Boeing crippling specimens (ref. 3) have been tested with the failure loads shown in Table 2, resulting in an average failure load of 45,638 lb. The Technova non-prestressed specimen failed at a load level typical of the Boeing specimens.

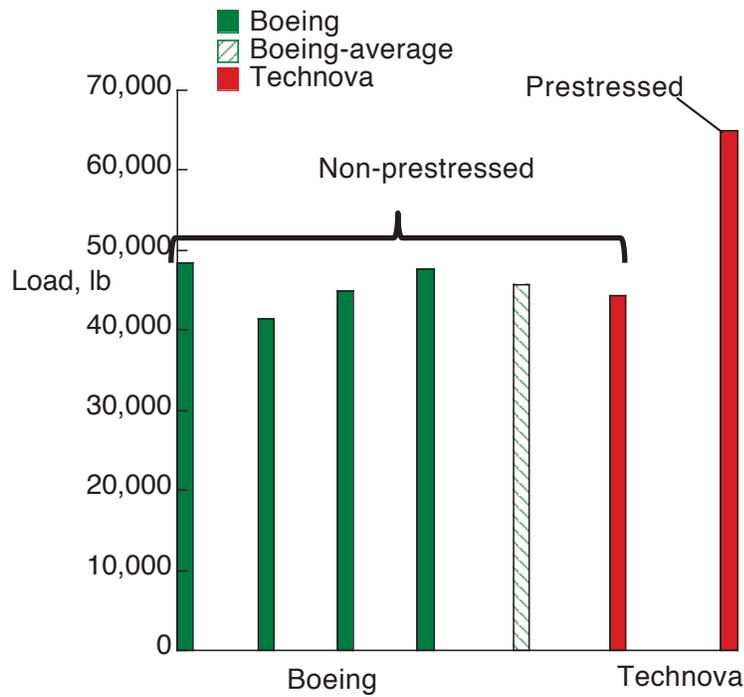
Fig. 15. Failure load comparison with Boeing specimens.

The failure load of the prestressed Technova specimen was significantly greater than that of the non-prestressed specimens. Comparing the prestressed specimen to the average of the Boeing specimens or to the Technova non-prestressed specimen, the prestressed specimen supported over 40 percent more load than specimens without prestressing, as shown in figure 15. Boeing specimens are represented in the figures as solid green bars and their average is the green hatched bar. Technova specimens are represented by the solid red bars. With only one prestressed specimen, definitive conclusions cannot be drawn, however, the prestressing appears to have a significant impact on the load-carrying ability of the specimen.
