NUREG/CR-7187
PNNL-23659

Managing PWSCC in Butt Welds by Mitigation and Inspection

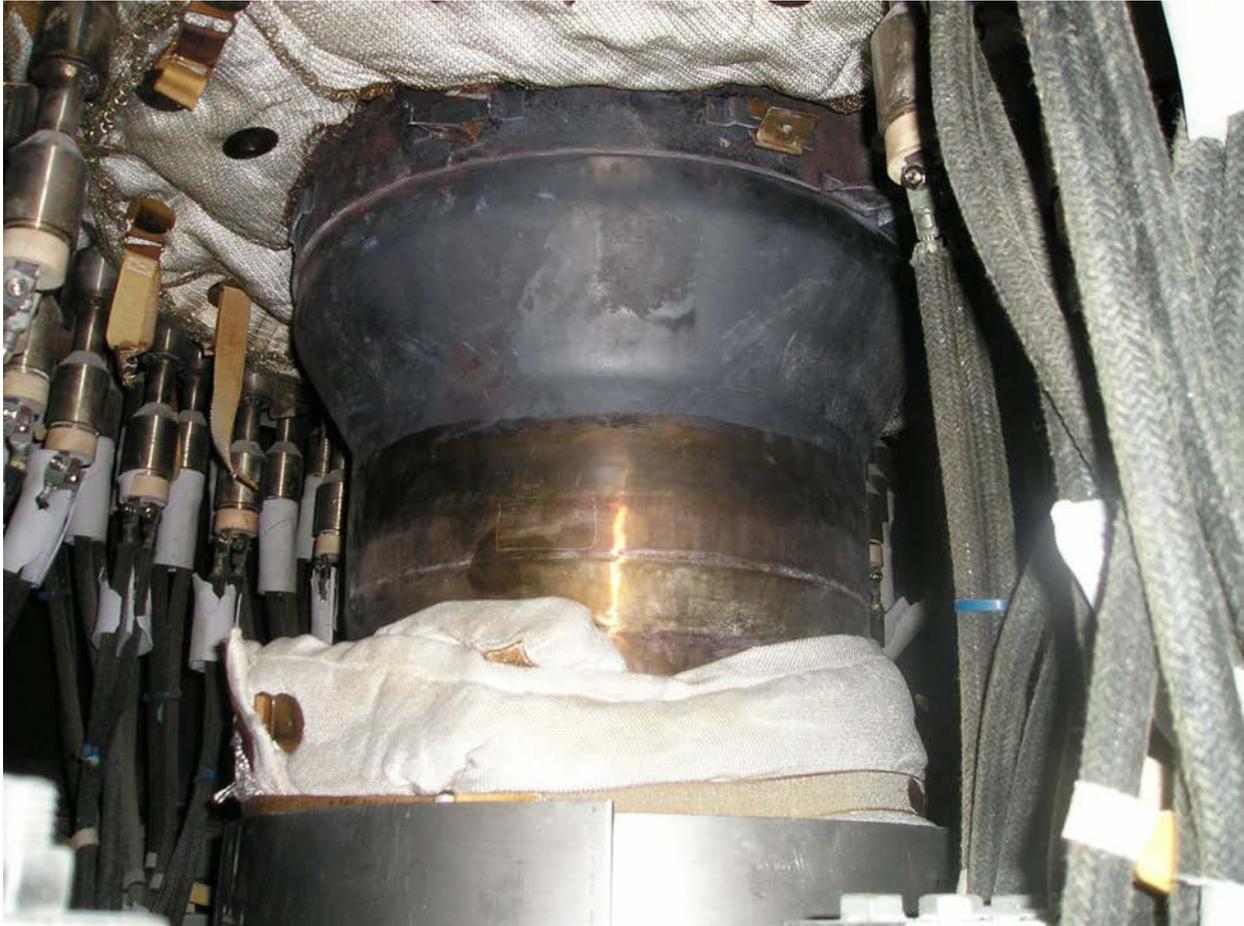
Figure C.2 Photograph of Pressurizer Surge Nozzle, Nozzle Weld, and Safe End

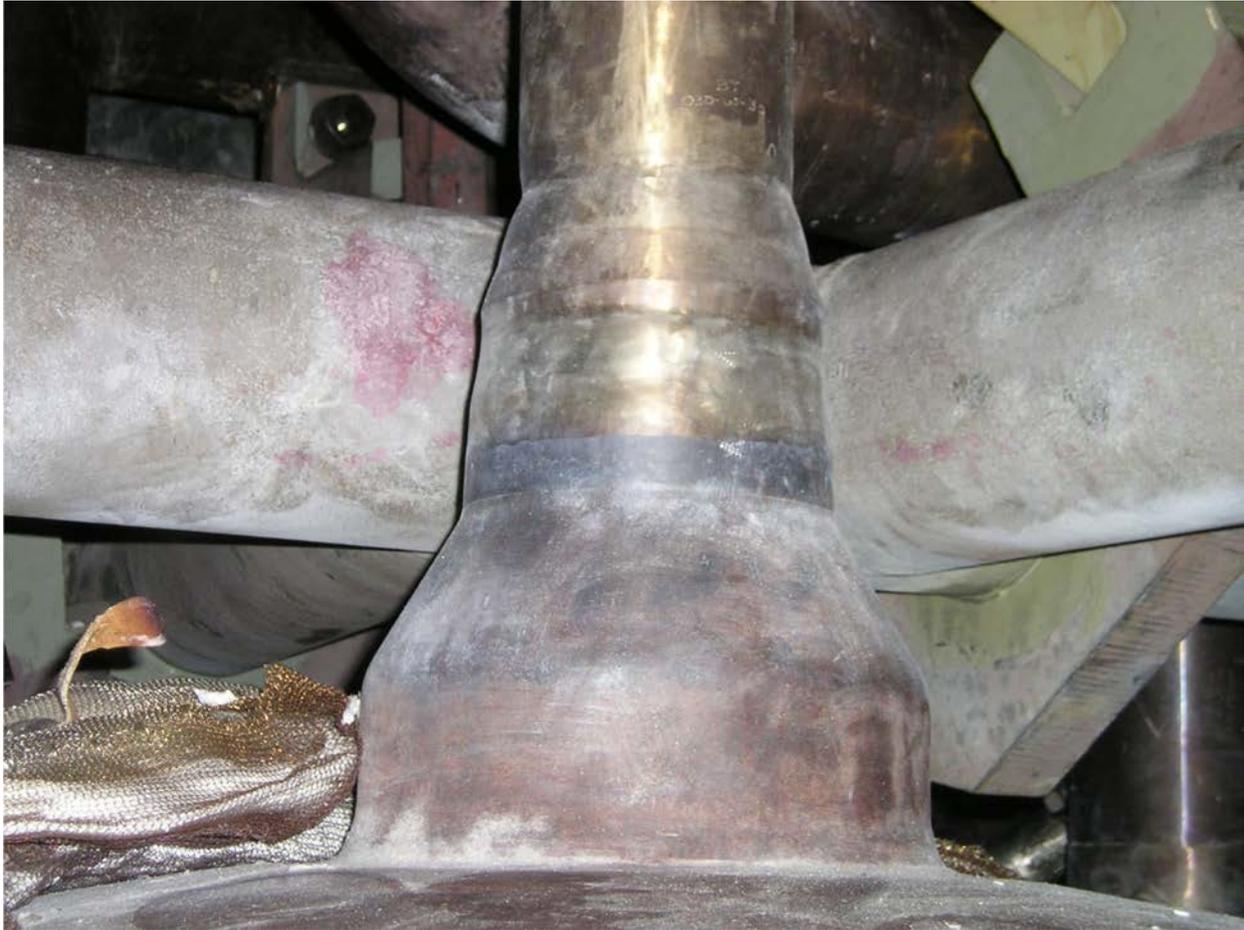
Figure C.5 Photograph of Pressurizer Spray Nozzle, Nozzle Weld, and Safe End

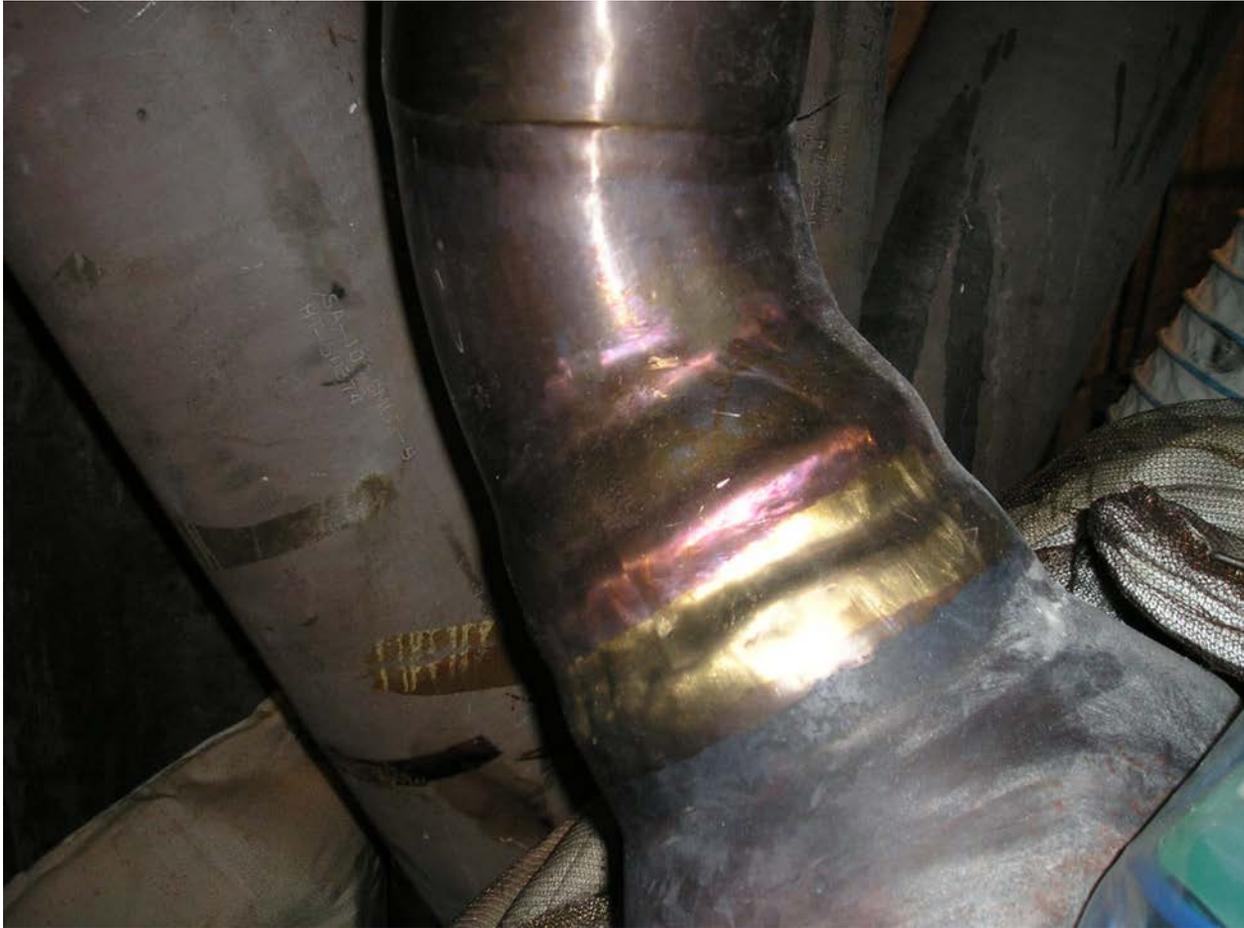
Figure C.8 Photograph of Pressurizer Safety and Relief Nozzle, Nozzle Weld, and Safe End

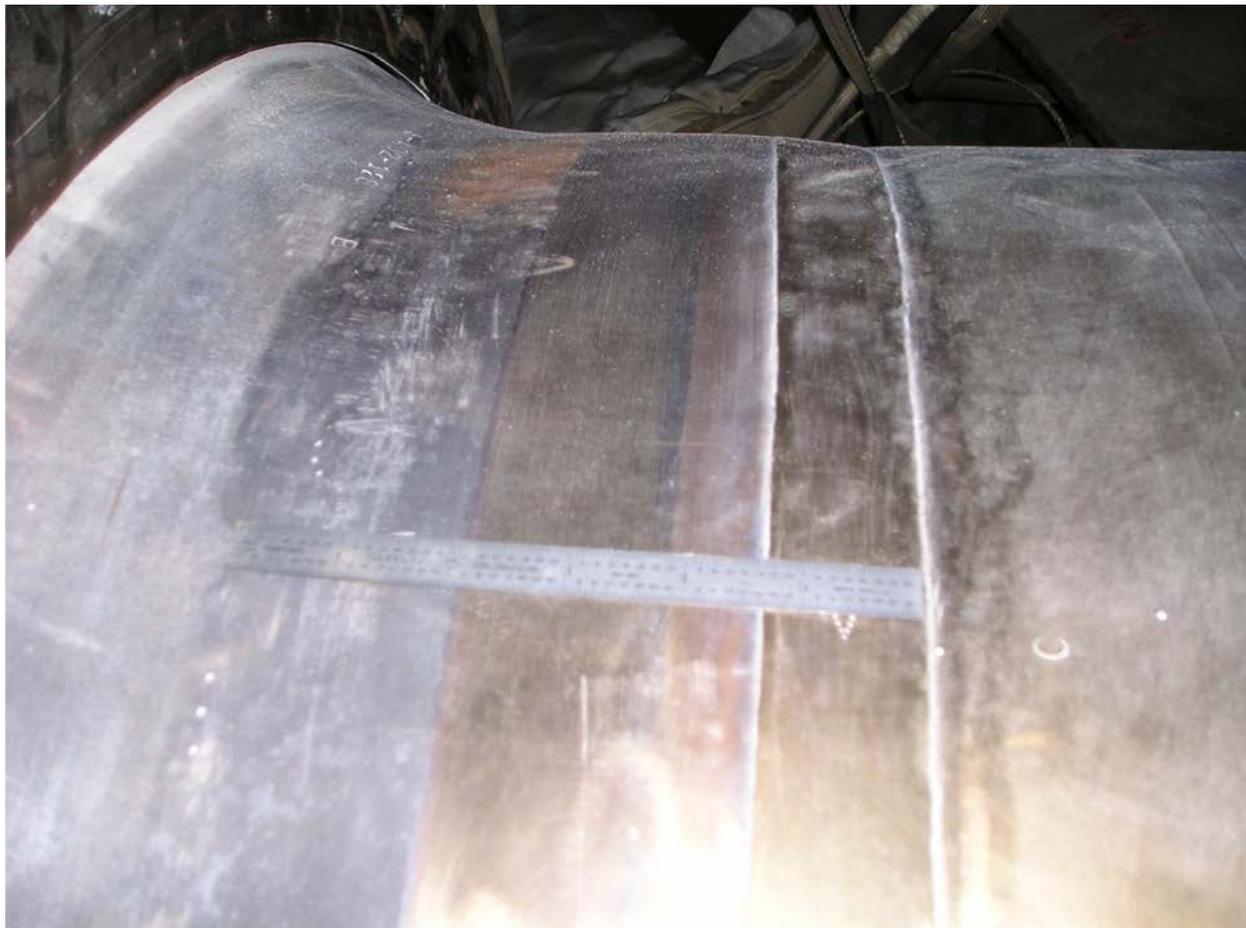
Figure C.10 RPV Hot Leg Nozzle, Nozzle Weld, and Safe End

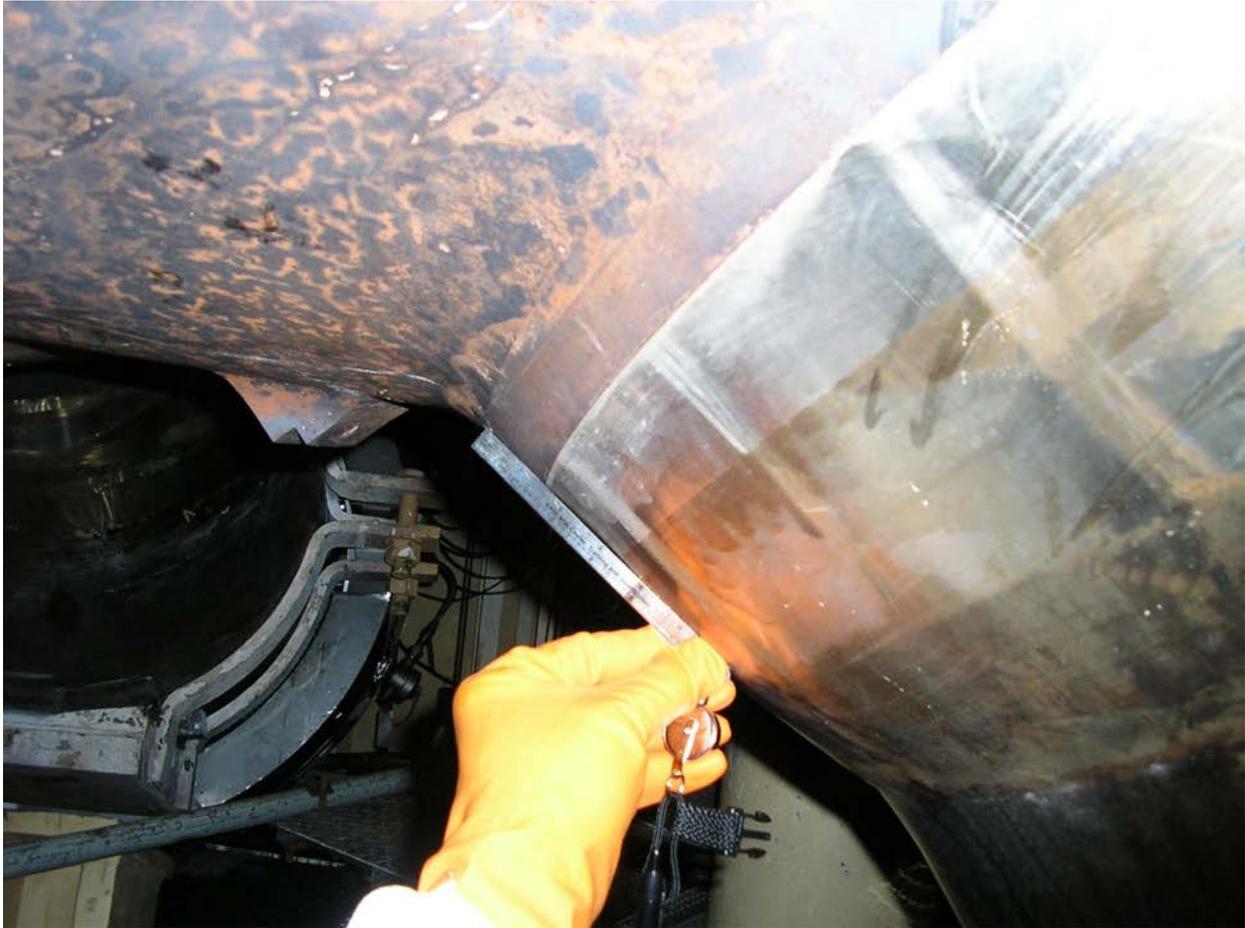
Figure C.13 Photograph of Steam Generator Hot Leg Nozzle, Nozzle Weld, and Safe End

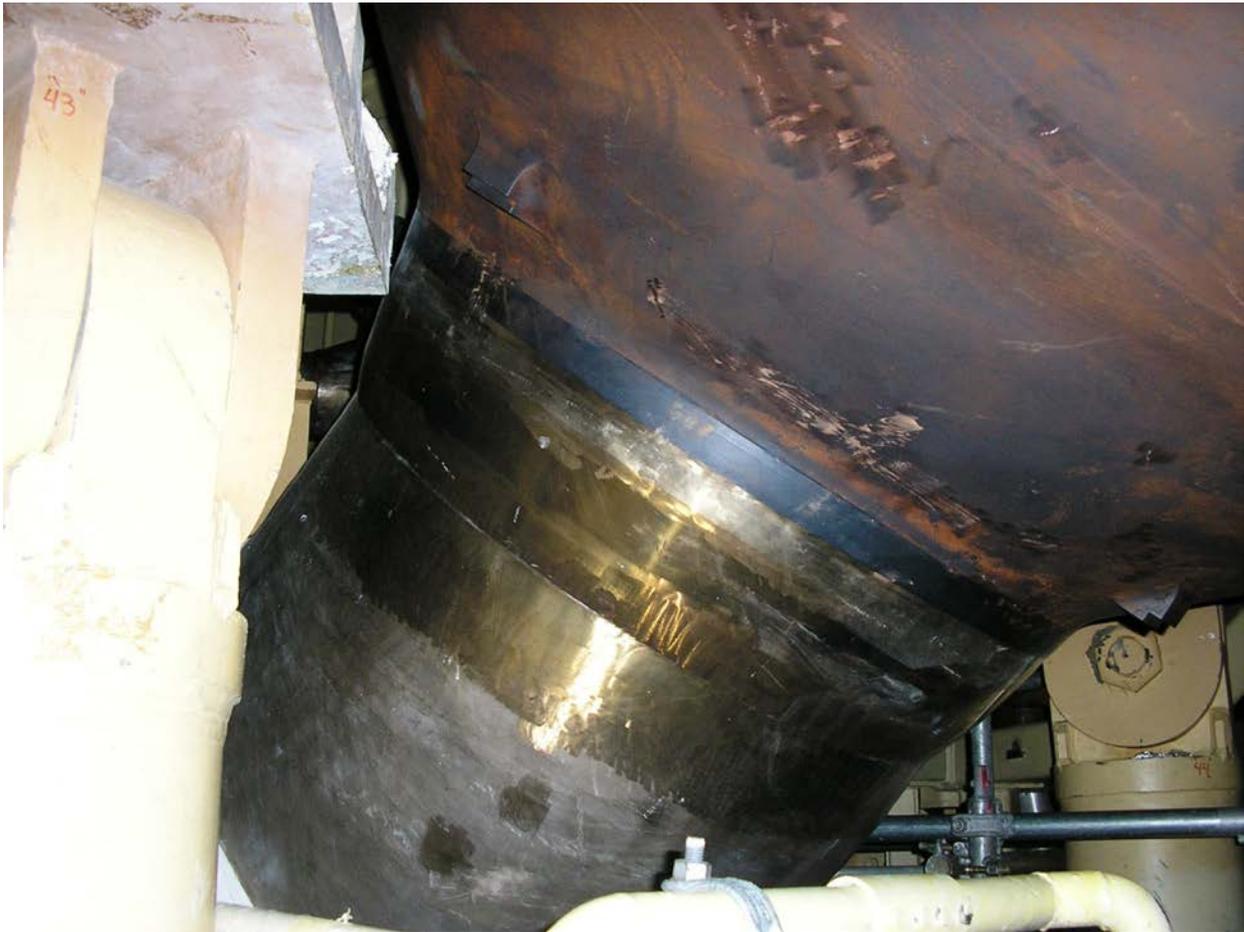
Figure C.16 Photograph of Steam Generator Cold Leg Nozzle, Nozzle Weld, and Safe End

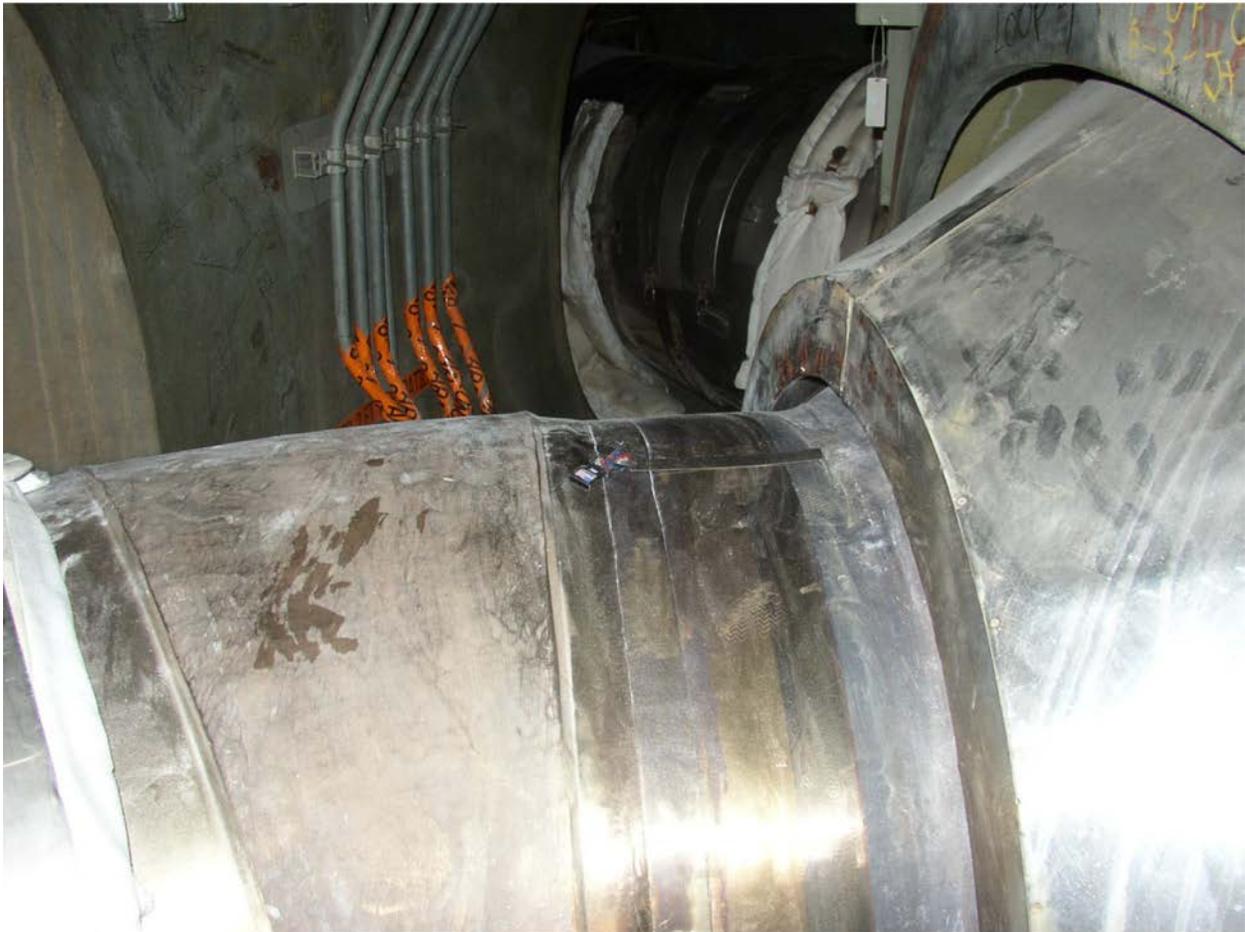
Figure C.19 Photograph of RPV Cold Leg Nozzle

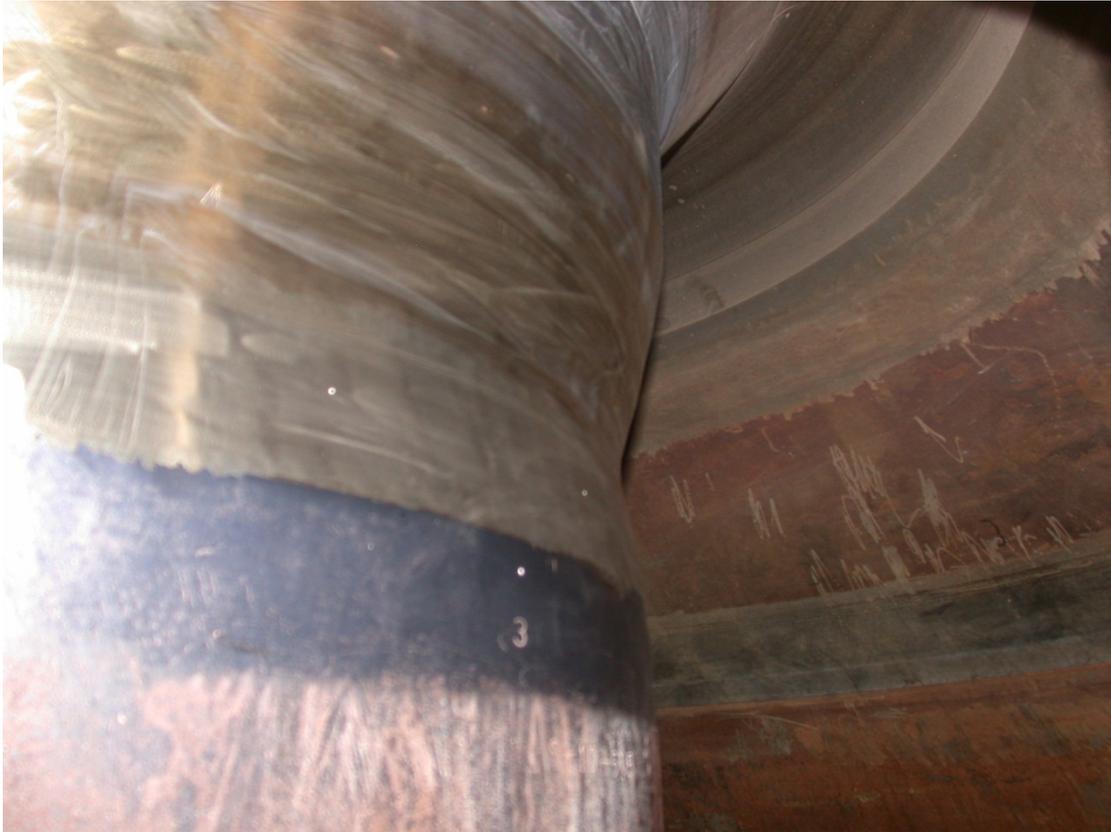
Figure D.2 Photograph of RCP Suction Nozzle, Nozzle Weld, and Safe End

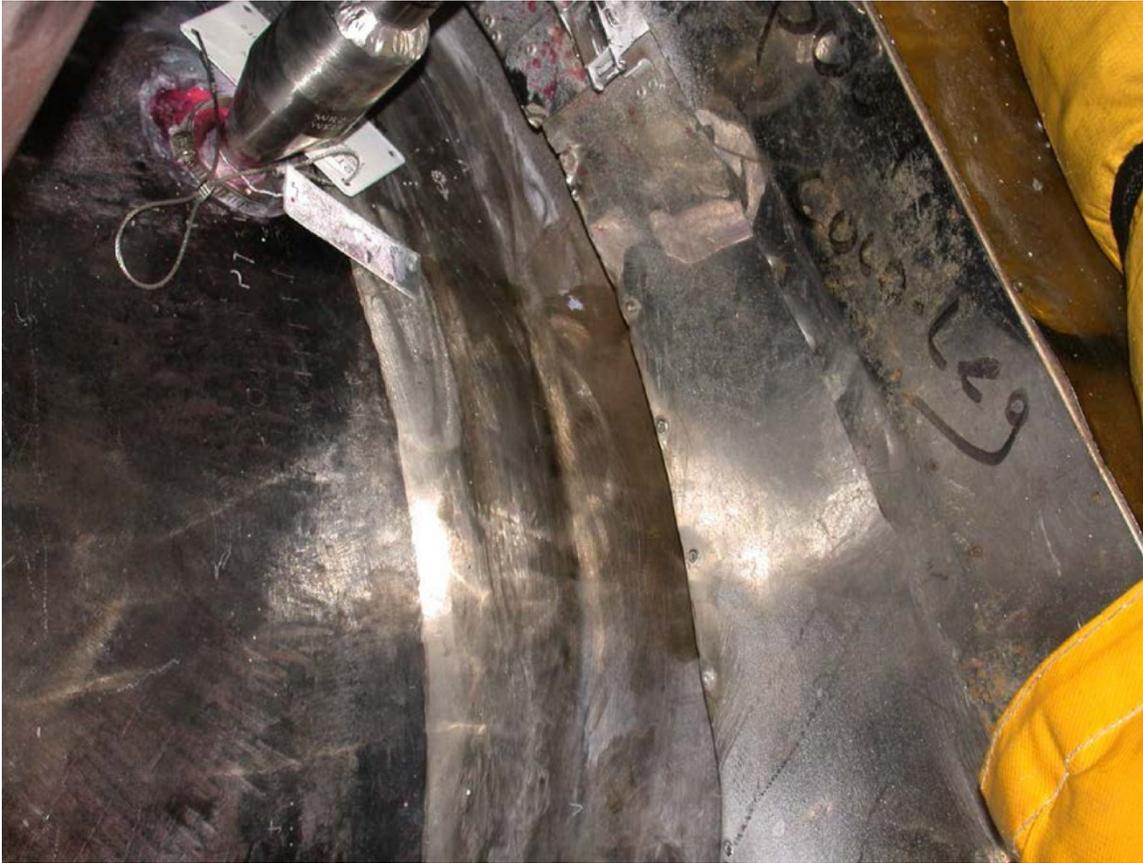
Figure D.5 Photograph of RCP Discharge Nozzle, Nozzle Weld, and Safe End

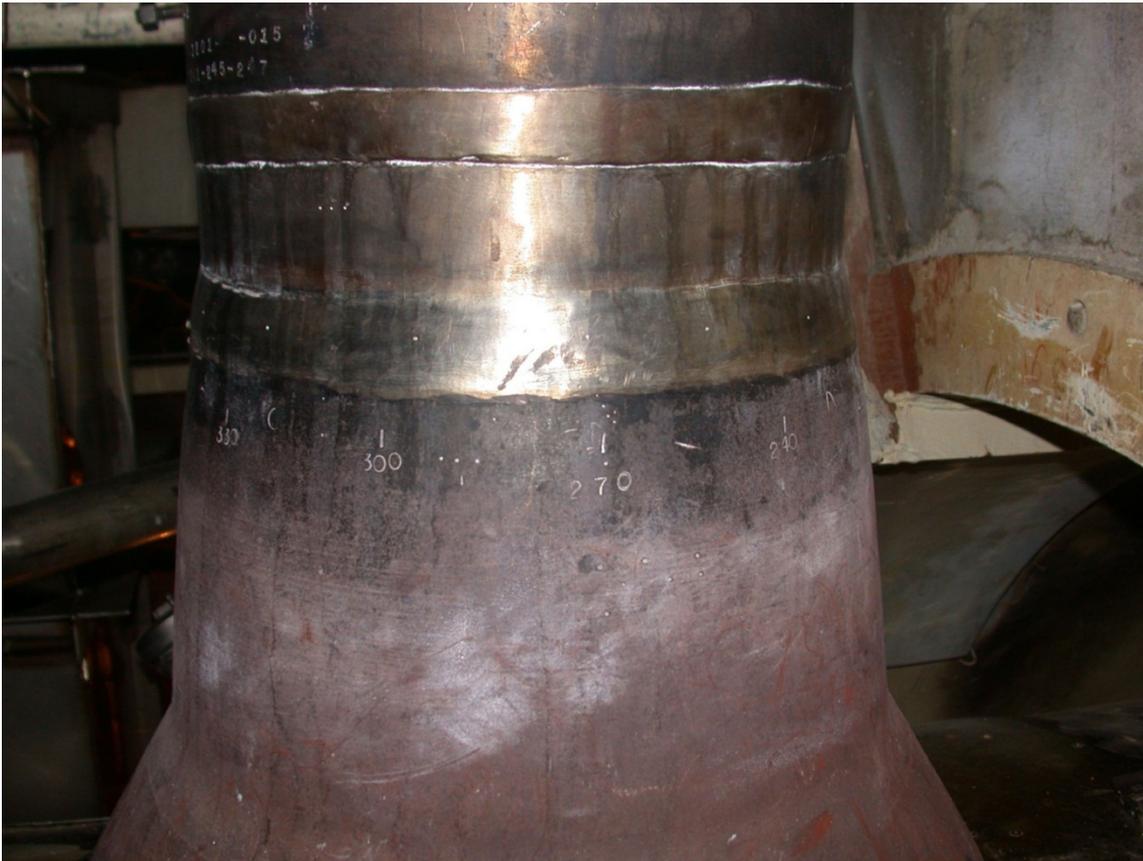
Figure D.8 Photograph of Surge Nozzle, Nozzle Weld, and Safe End

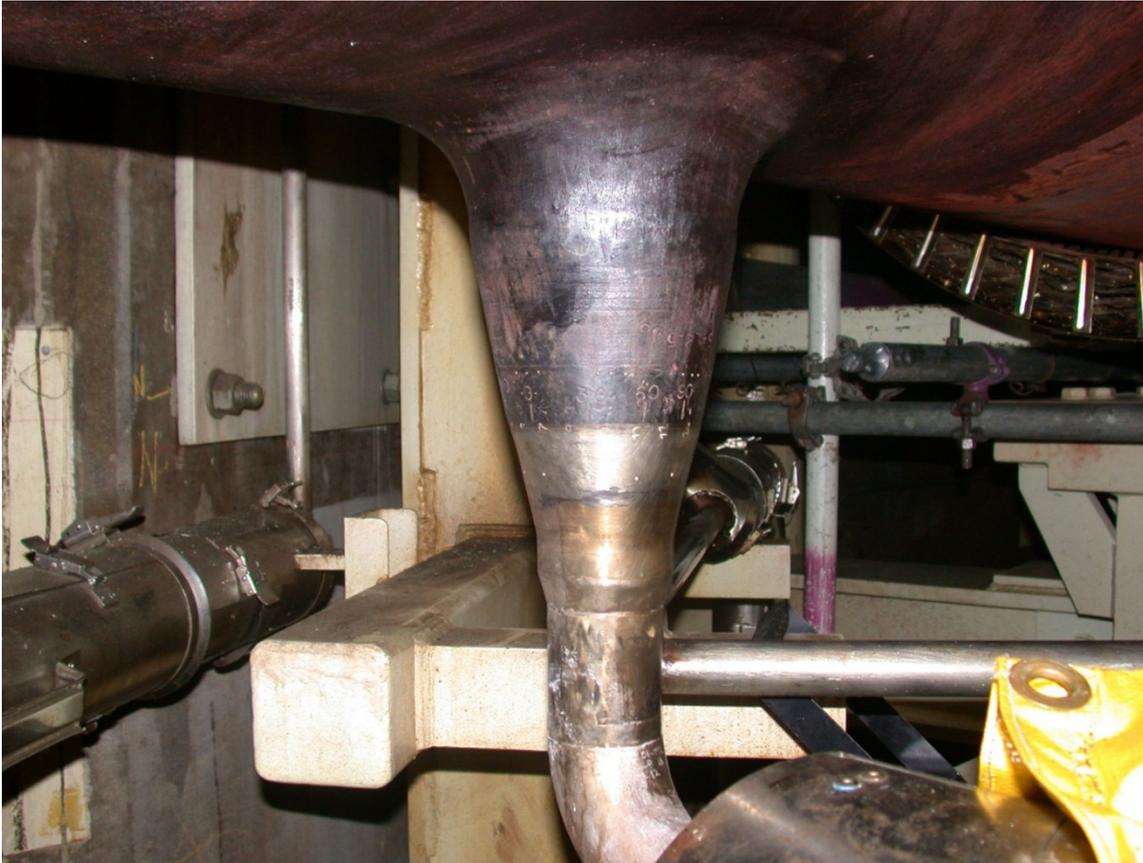
Figure D.11 Photograph of Letdown and Drain Nozzle, Nozzle Weld, and Safe End

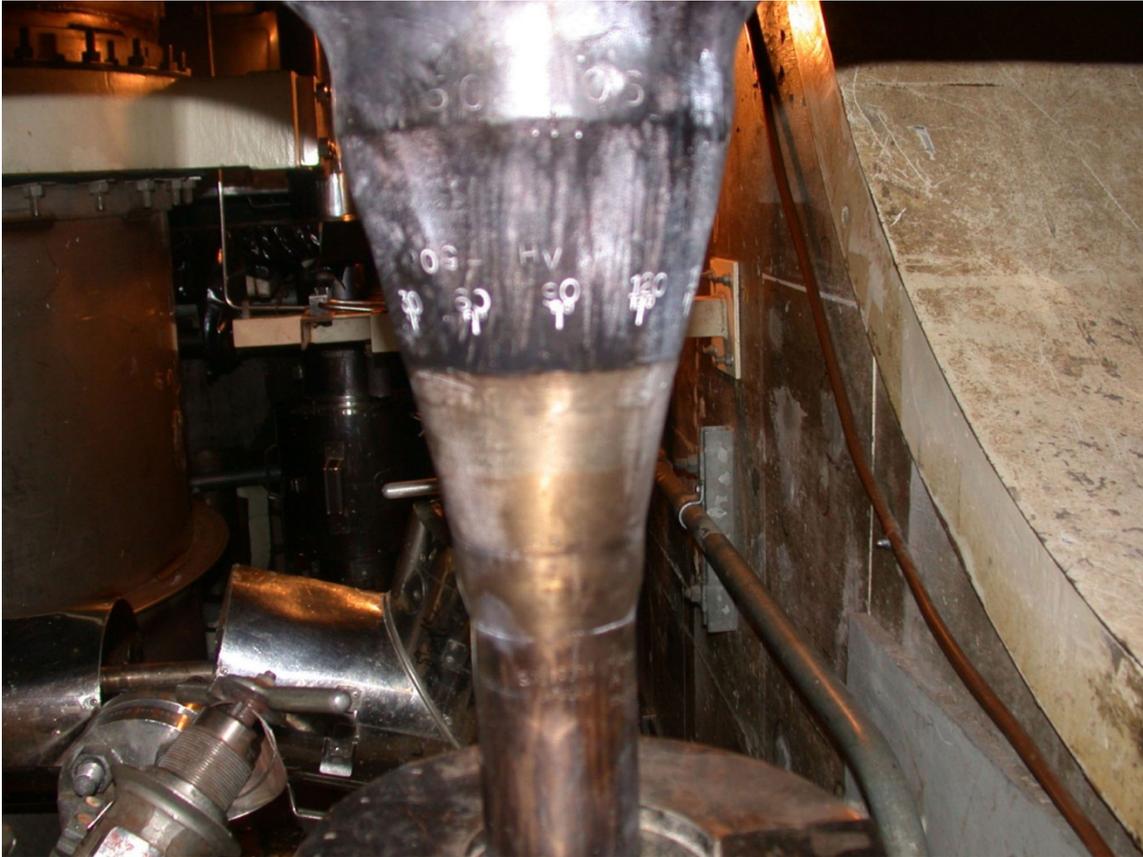
Figure D.14 Photograph of Hot Leg Drain Nozzle, Nozzle Weld, and Safe End

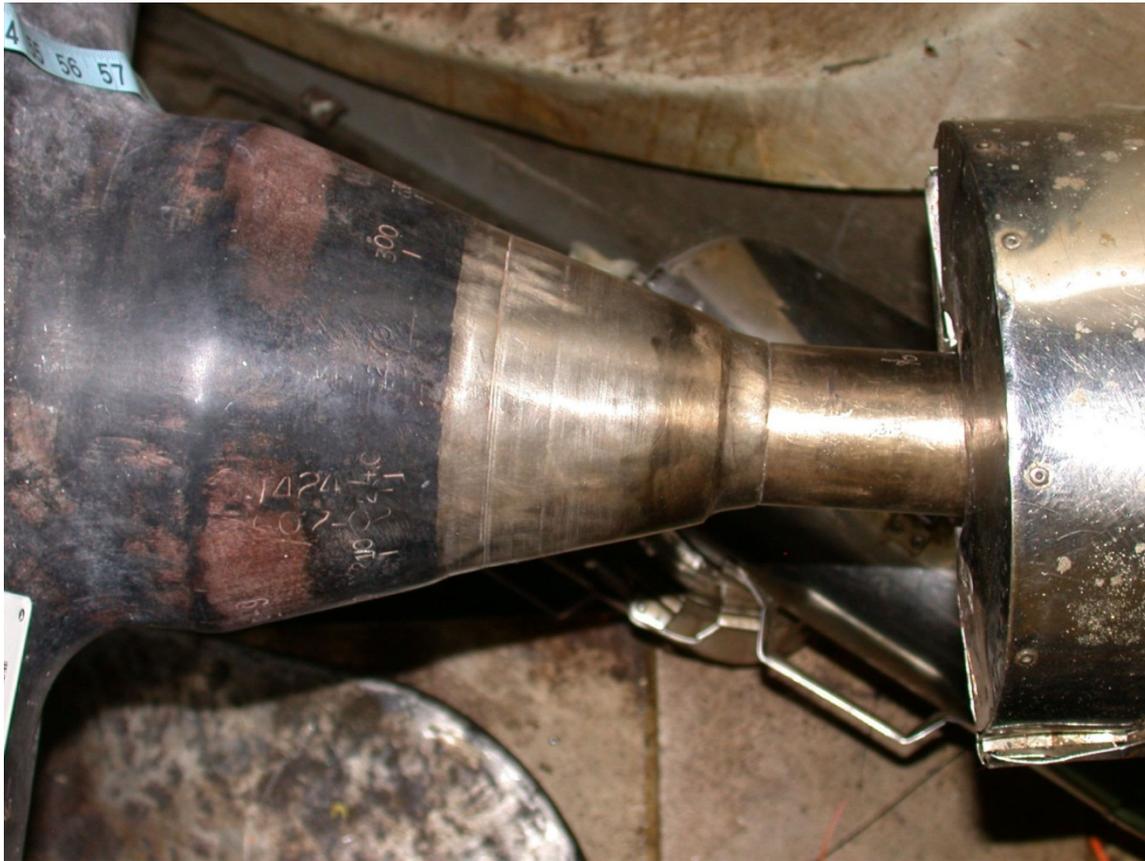
Figure D.17 Photograph of Charging Inlet Nozzle, Nozzle Weld, and Safe End

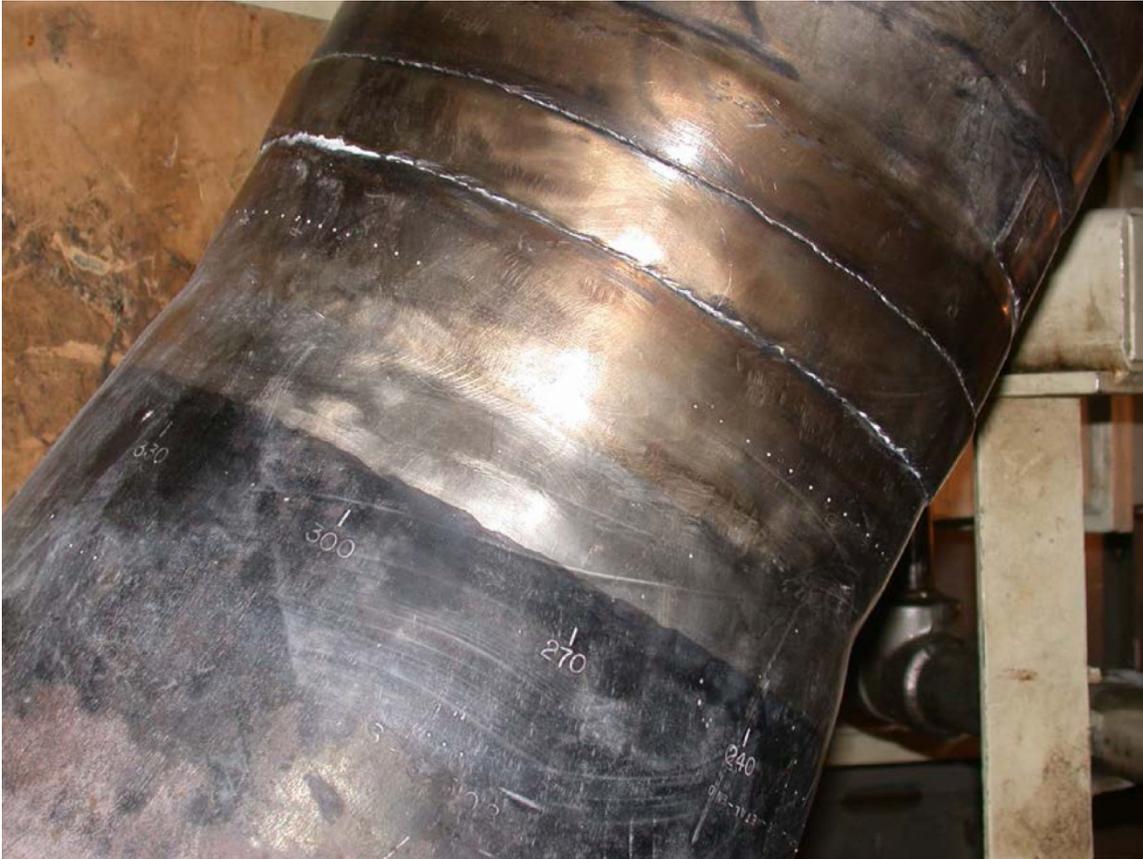
Figure D.20 Photograph of Safety Injection Nozzle, Nozzle Weld, and Safe End

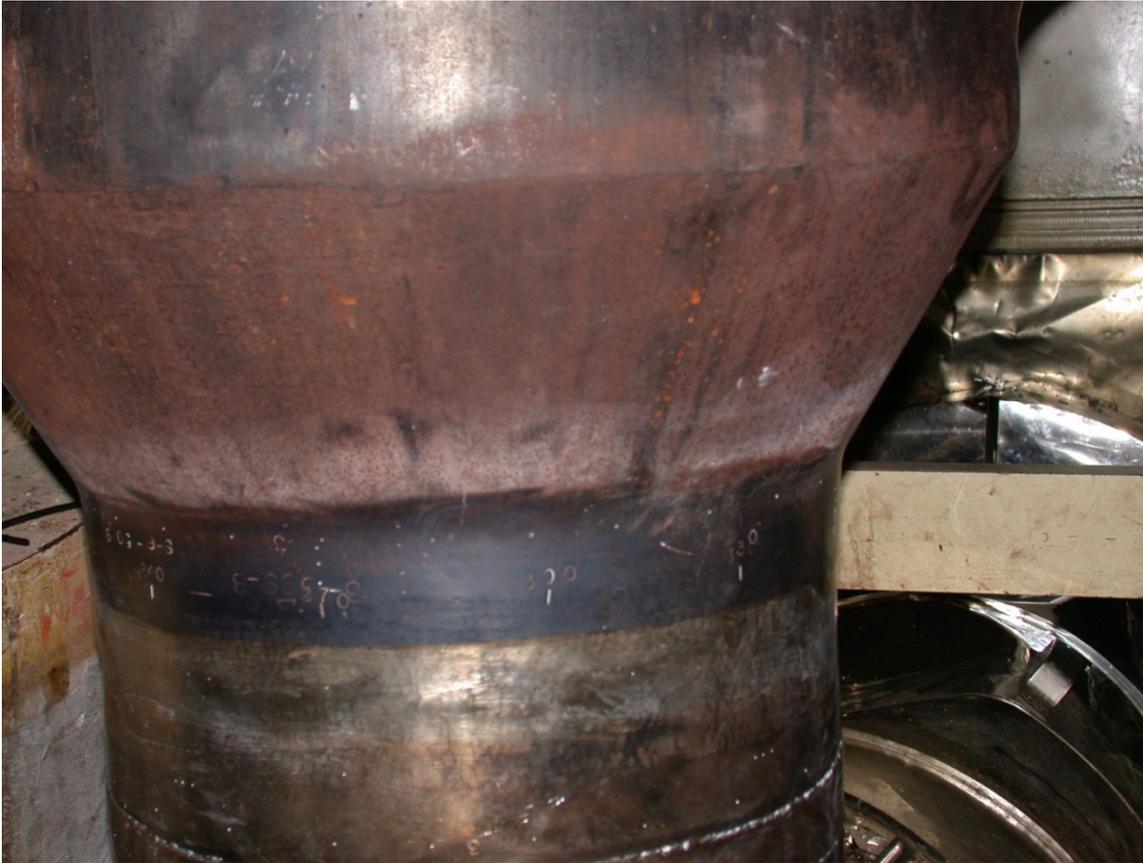
Figure D.23 Photograph of Shutdown Cooling Nozzle, Nozzle Weld, and Safe End

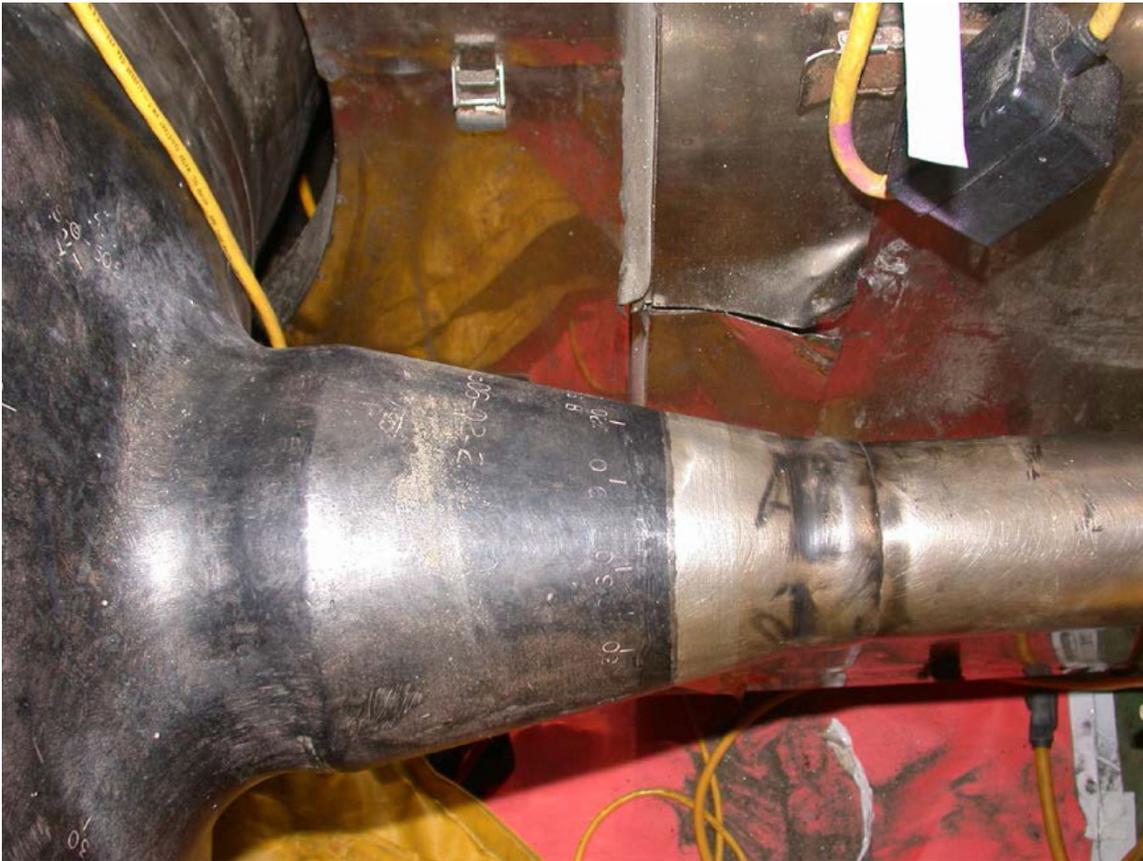
Figure D.26 Photograph of Spray Nozzle, Nozzle Weld, and Safe End

There were no examination limitations for the spray nozzle Alloy 82/182 butt.

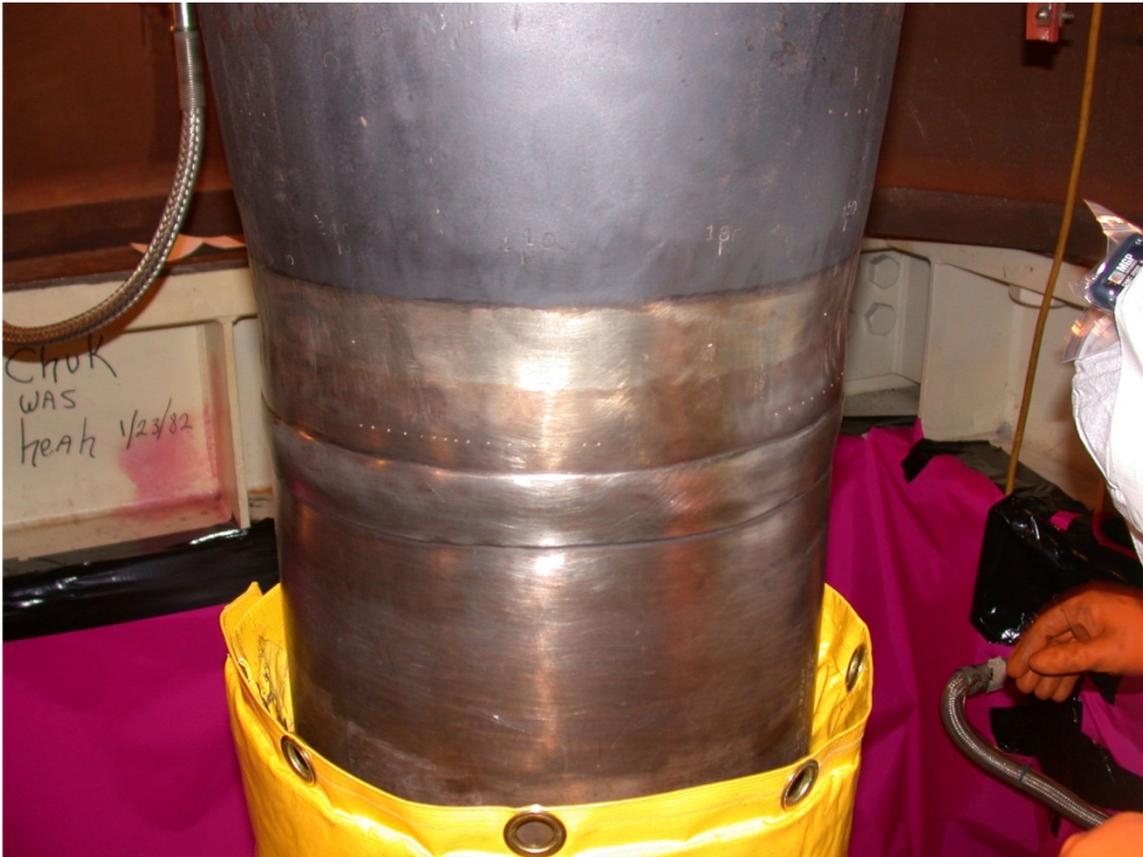
Figure D.29 Photograph of Pressurizer Surge Nozzle, Nozzle Weld, and Safe End

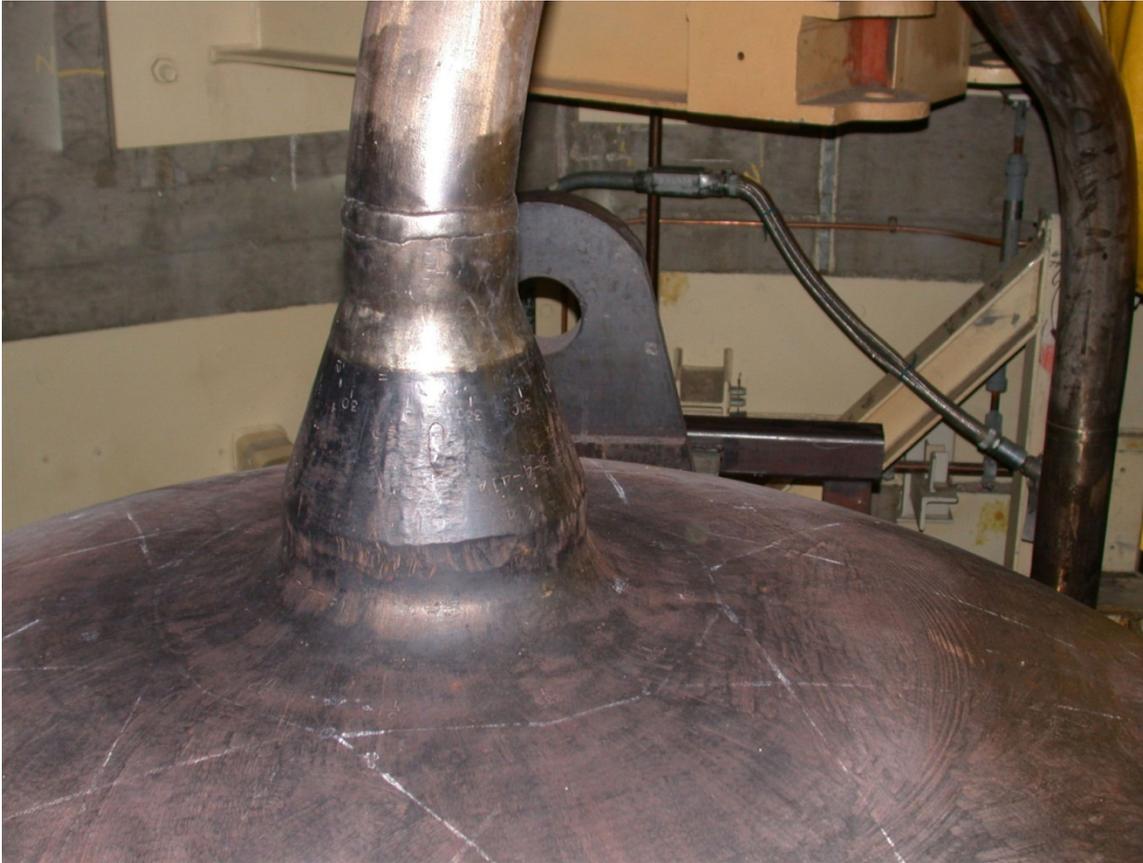
Figure D.32 Photograph of Pressurizer Spray Nozzle, Nozzle Weld, and Safe End

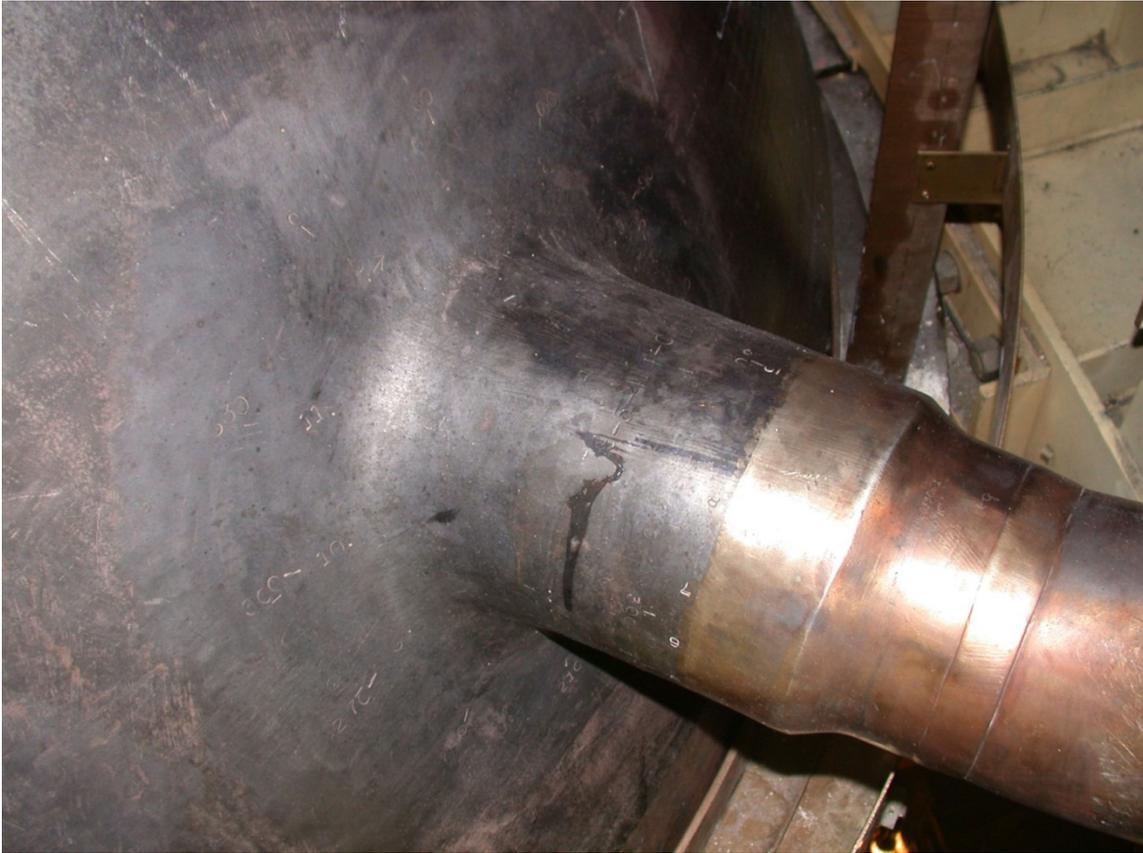
Figure D.35 Photograph of Pressurizer Safety & Relief Nozzle, Nozzle Weld, and Safe End
