NASA/TM-2014-218169

Impact Testing and Simulation of Composite Airframe Structures

*Karen E. Jackson, Justin D. Littell, Lucas G. Horta, and Martin S. Annett
Langley Research Center, Hampton, Virginia*

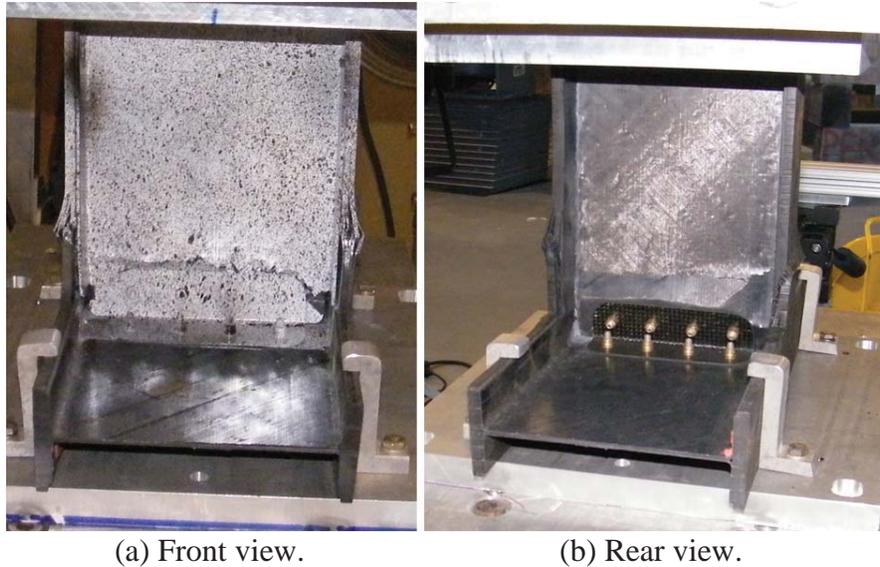
Figure 24. Post-test photographs of the 2-ft T-section test specimen.

The post-test photographs shown in Figure 24 confirm photogrammetric data for failure. Both the front and back views show a distinct failure line running horizontally right above the doubler on the web. Furthermore, these photographs show composite layer delamination and localized bending of the vertical flanges, near the transition region between vertical and horizontal. This evidence supports the conclusion that the specimen failed through crushing near the boundary edges and delamination of the vertical flanges.

the doubler region and delamination of the vertical flanges. This finding is confirmed by examining the videos and pictures post-test. Photographs of the post-test specimen are shown in Figure 24.
