# Modeling the Deterioration of Engine and Low Pressure Compressor Performance During a Roll Back Event Due to Ice Accretion

*Joseph P. Veres, Philip C.E. Jorgenson, and Scott M. Jones  
Glenn Research Center, Cleveland, Ohio*

Prepared for the  
50th Joint Propulsion Conference  
cosponsored by AIAA, ASME, SAE, and ASEE  
Cleveland, Ohio, July 28–30, 2014

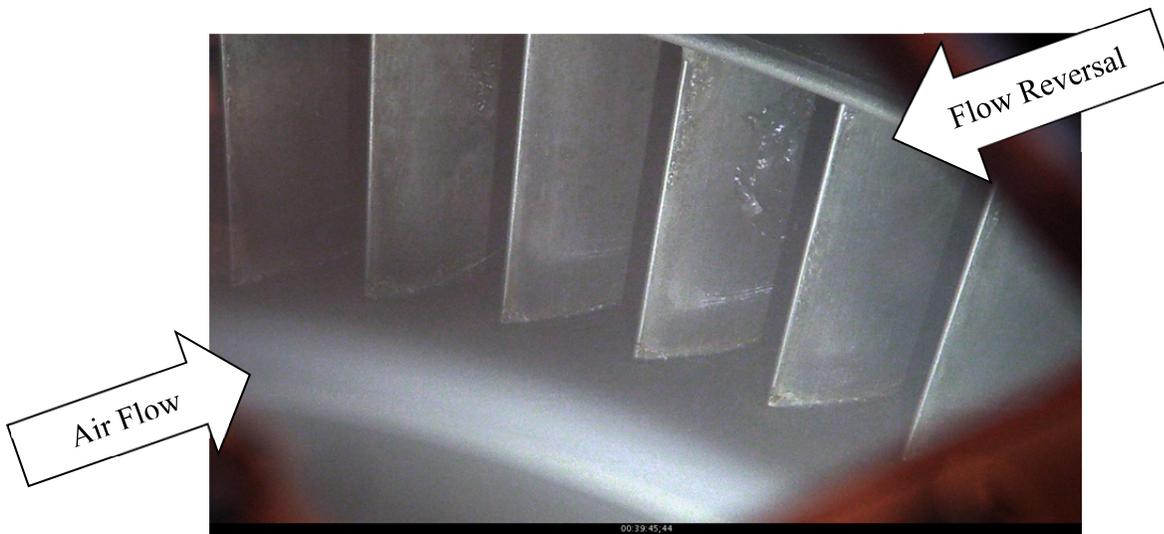
Figure 16.—Image capture from video taken during the PSL engine testing of the IGV showing water flowing upstream on the IGV surface beyond Escort scan 180. This is evidence of air flow reversal and corroborates the results of the computational flow analysis, indicating a stalled LPC.

Confirmation of compressor stall in the region of Escort scan 180 and beyond was verified by a video recording taken during the PSL engine icing test, where it was noted that there was evidence of flow reversals, e.g., water flowing upstream on the surface of the IGV vane, as shown in Figure 16.

The video of the IGV during the PSL engine test showed the water on the IGV actually flowed upstream out of the engine, indicating that the fan-core rotor is in stall, which is characterized by flow reversal. The blockage caused by ice accretion in the EGV stators is reducing the available flow area, thereby reducing the core flow to a mere fraction of the nominal core flow without ice blockage, while the EGV is nearly choked due to the reduced flow area. The low air flow into the core is the reason the fan-core rotor and stators are in stall, while the EGV is nearly choked even though the core flow rate is severely reduced.
