# Cultural Landscape Report

## West Potomac Park Lincoln Memorial Grounds National Capital Parks Central August 1999

Part 1: Site History,  
Analysis and Evaluation  
and Design Guidelines

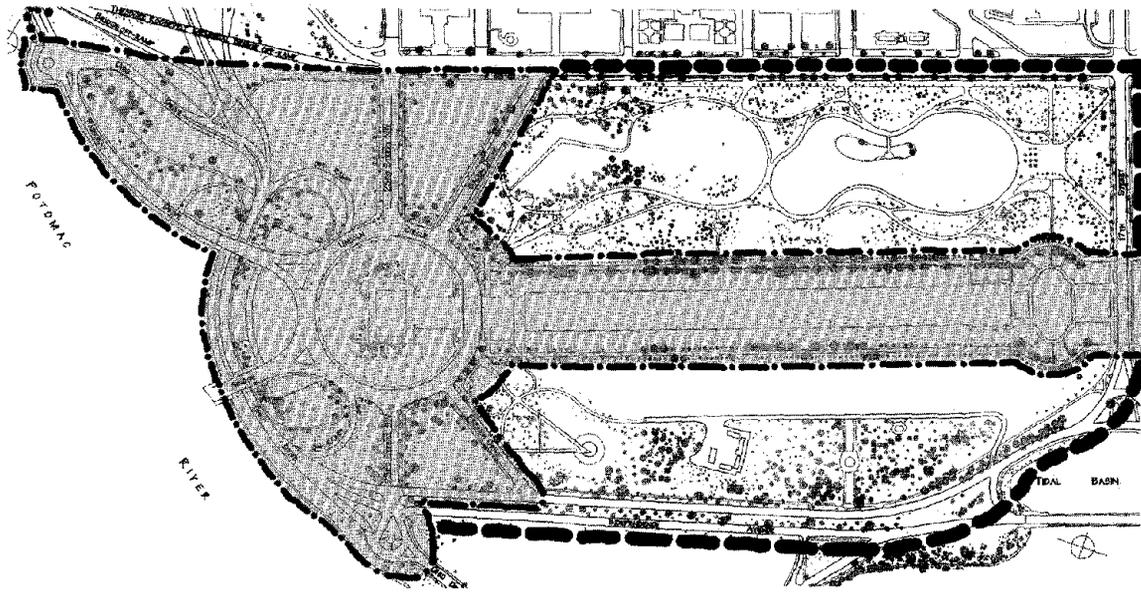
The study area encompasses 94 acres of West Potomac Park and includes the Lincoln Memorial, Reflecting Pool, Rainbow Pool, Watergate area and bridge, and parkway approaches. There are two separate study boundaries: the *contextual boundary* is marked by Constitution Avenue on the north, 17<sup>th</sup> Street on the east, Independence Avenue on the south, and the Potomac River on the west. Investigating the historical development of this greater area will provide an overall context for the Lincoln Memorial. The investigation goes further by examining in greater detail those areas with the *landscape feature boundary* where physical features and relationships around the memorial will be documented. In this core area the circular drive and a portion of the radial roads leading from the memorial are included. Views and vistas extending beyond the physical boundaries of the study area are examined as are those views that fall within. All significant viewpoints, both internal and external, will be documented and analyzed (see Map 1 *Study Boundaries*).

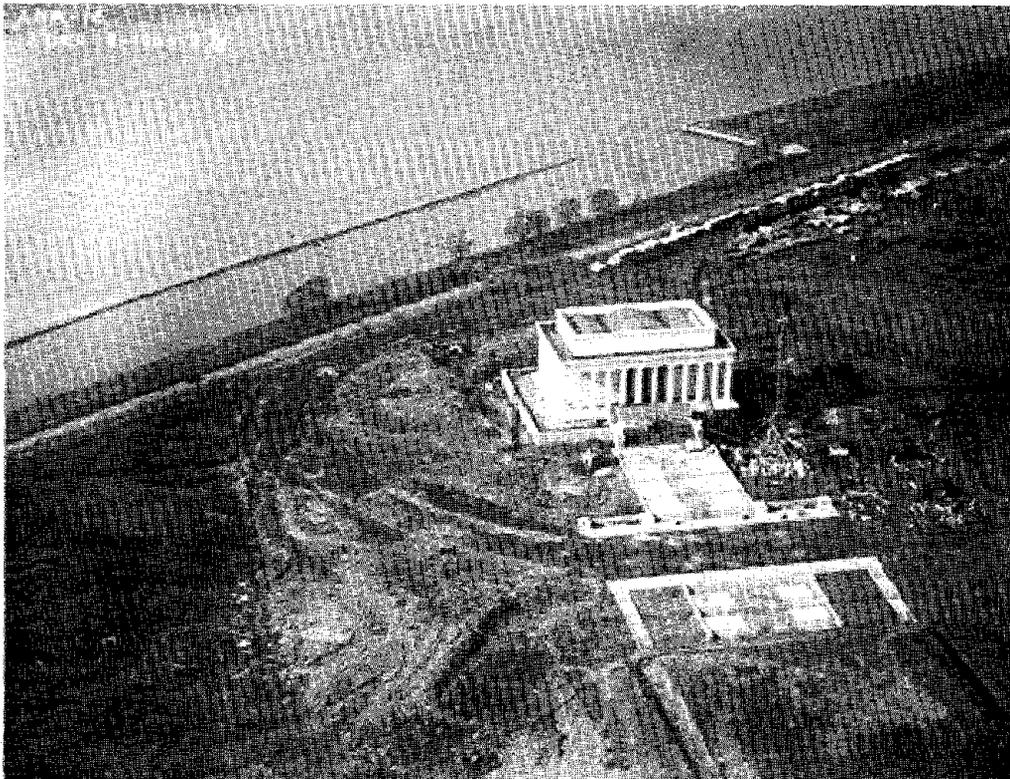
Figure 3 - Construction of approachway, Dec. 12, 1918. U.S. Navy photo. MRC 1-58.

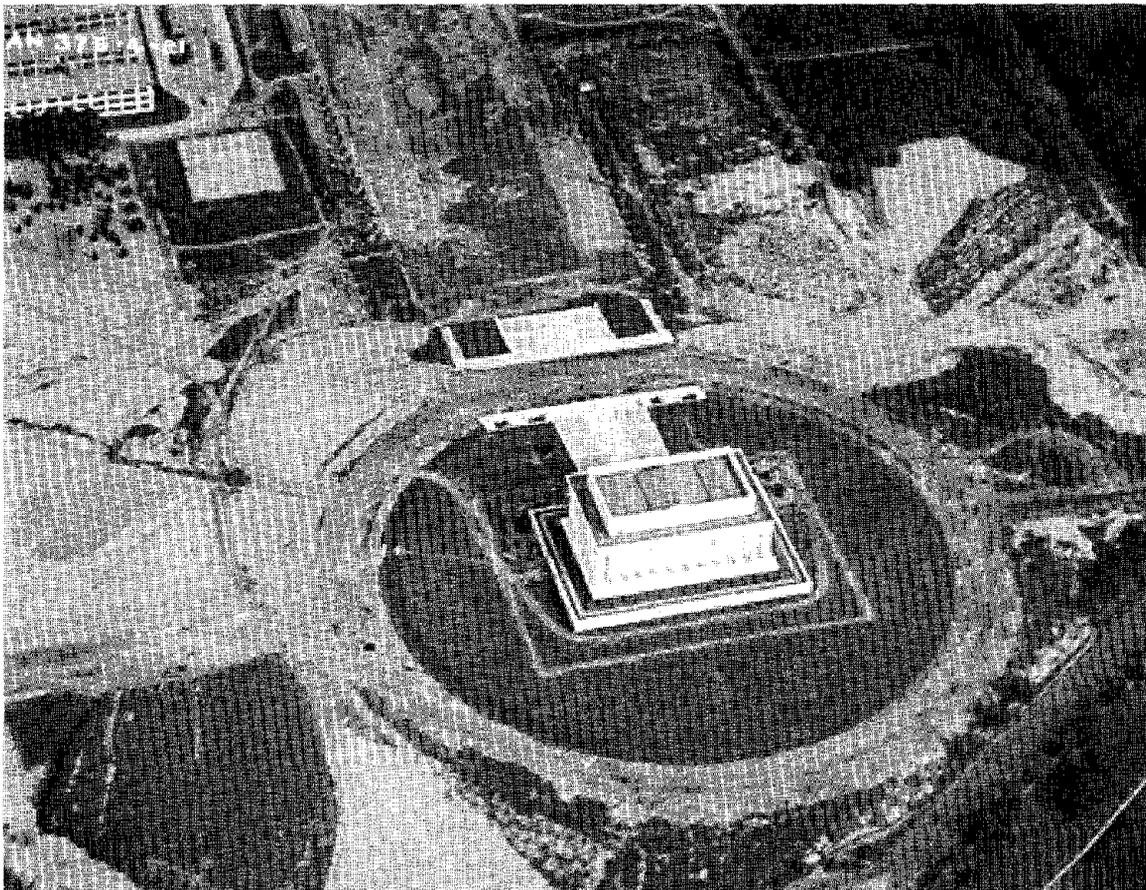
Figure 4 – Grading operations around the memorial, April 17, 1921. MRC 1-60.

When the superstructure of the memorial was completed in 1917, efforts were underway to complete the overall landscape setting for the Lincoln Memorial. A new bulkhead, or seawall, which followed the shoreline for approximately 3,000 feet, was constructed along the river between the Lincoln Memorial and the Highway Bridge at 14th Street. The design called for filling in the shallow shoreline of the Potomac behind the seawall to extend the shoreline west of the Lincoln Memorial. The proposed extension would create more room for the full effect of the “rond point,” or end point of the east/west axis, which consisted of the Lincoln Memorial, its base, the circular terrace and roadway. Grading of the radial roadway northeast of the Lincoln and of the circular road around the memorial was also initiated, as was the preparation of the soil for the lawn on the circular terrace. Much of this work was completed in 1919. However, the concrete gutters, sidewalks and curb were not completed until 1922.

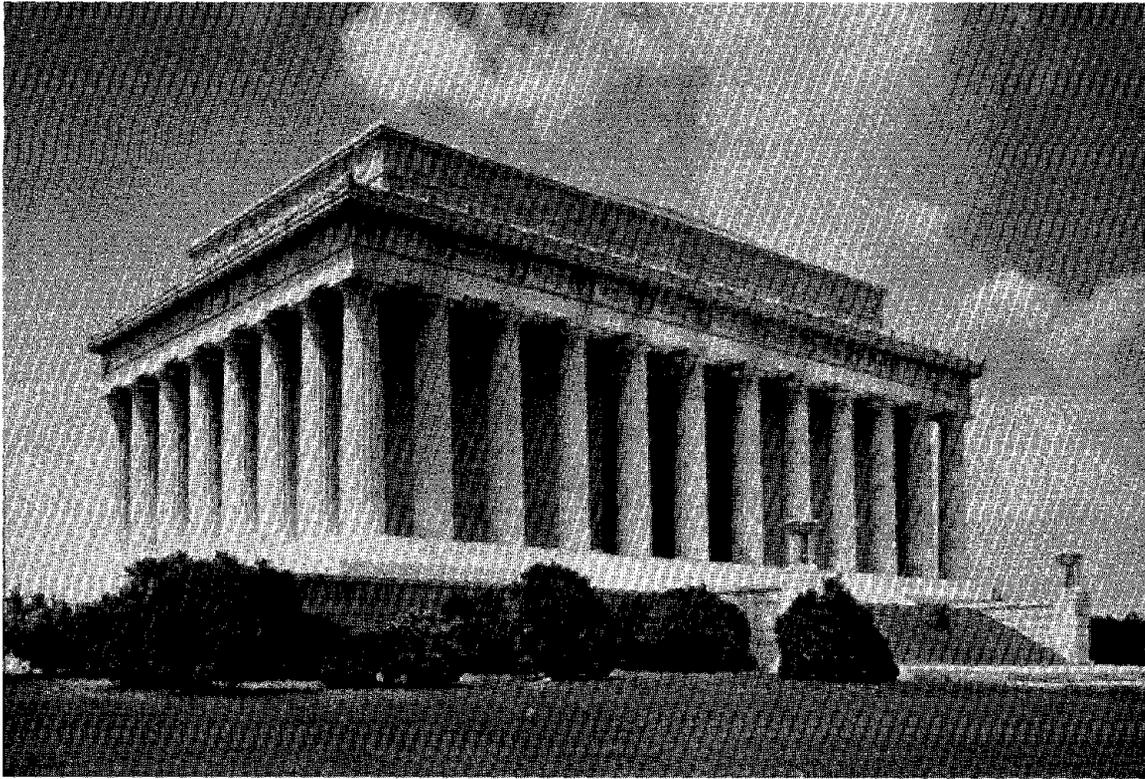
*Figure 6 – Mature boxwood and yew shrubs on southeast side of Lincoln Memorial, August 1922. MRC 2-16.*

Greenleaf noted that yews (*Taxus* sp.) can reach a width of 25 feet and a height of nearly 15 feet.

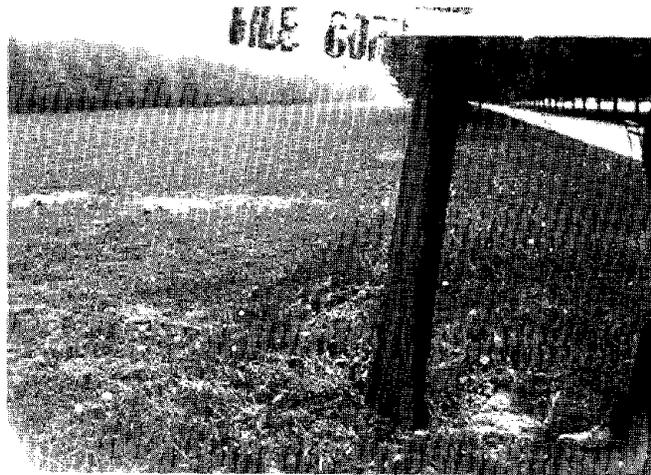
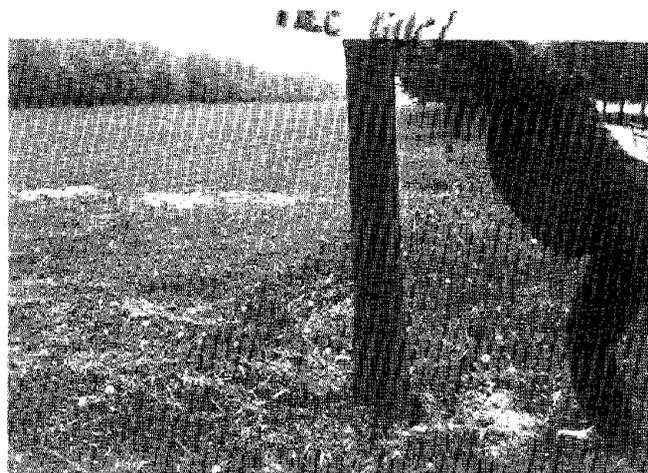
**Figure 14 & Figure 15 – Series of images document the condition of “English” elms along the Reflecting Pool north and south walk, 1928-1929. MRC 2-37 & 2-38.**

View taken on the south side of the Reflecting Pool.  
 4. Tree #2. A 10" tree being pulled 8" by single man from its normal vertical position. All of the swaying is from around. File No. 19.4-40B

View taken on the south side of the Reflecting Pool.  
 5. Tree #2. Same as picture no. 4, half tree is being pushed from its vertical position. File No. 19.4-40B

In the Reflecting Pool area, the double rows of elms had developed such full crowns that they appeared to require pruning and reshaping. Further investigation revealed that while the canopy was full, the root development of the individual trees was very poor. The roots were so underdeveloped that the trees were not secure in the ground. Several years passed before the elms' condition stabilized. Of the 250 elms planted in 1916, prior to the excavation of the reflecting basins, most exhibited such poor root development by 1929 that they were top-heavy and prone to falling over in high winds. Because the elms had been planted in moist, soggy conditions with inadequate drainage, replacement of these specimens would eventually be required. With the subsequent improvement of the groundwater level, the replacements evidently survived.<sup>51</sup>

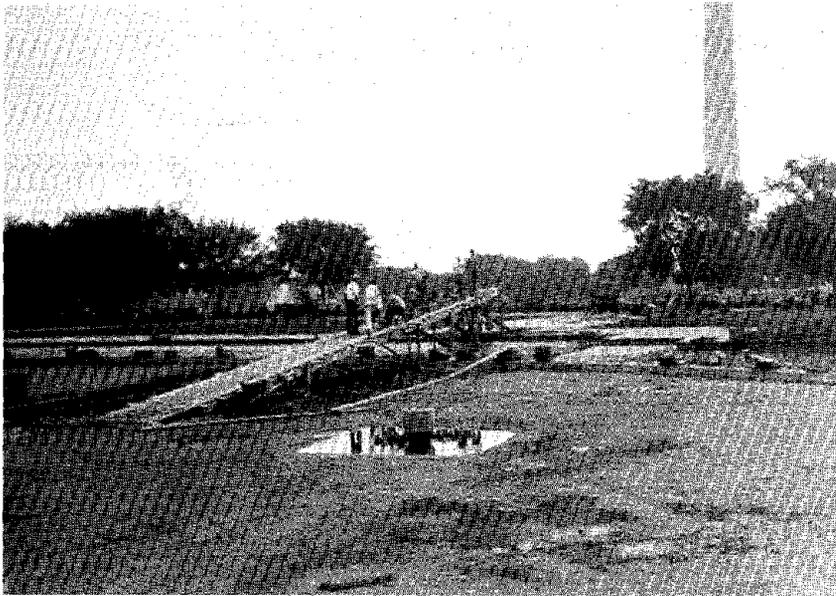
*Figure 18 – Repair work to the Rainbow Pool, July 15, 1929. MRC 3-17.*

In 1929 both reflecting basins required repair. Because they had been constructed on “hydraulic fill” and had settled unequally, the smaller pool needed a new reinforced concrete bottom. The larger pool needed routine sealing maintenance. Rose Brothers completed these repairs in the fall of 1929. There may have also been problems with vegetation growing in the pools.<sup>53</sup>

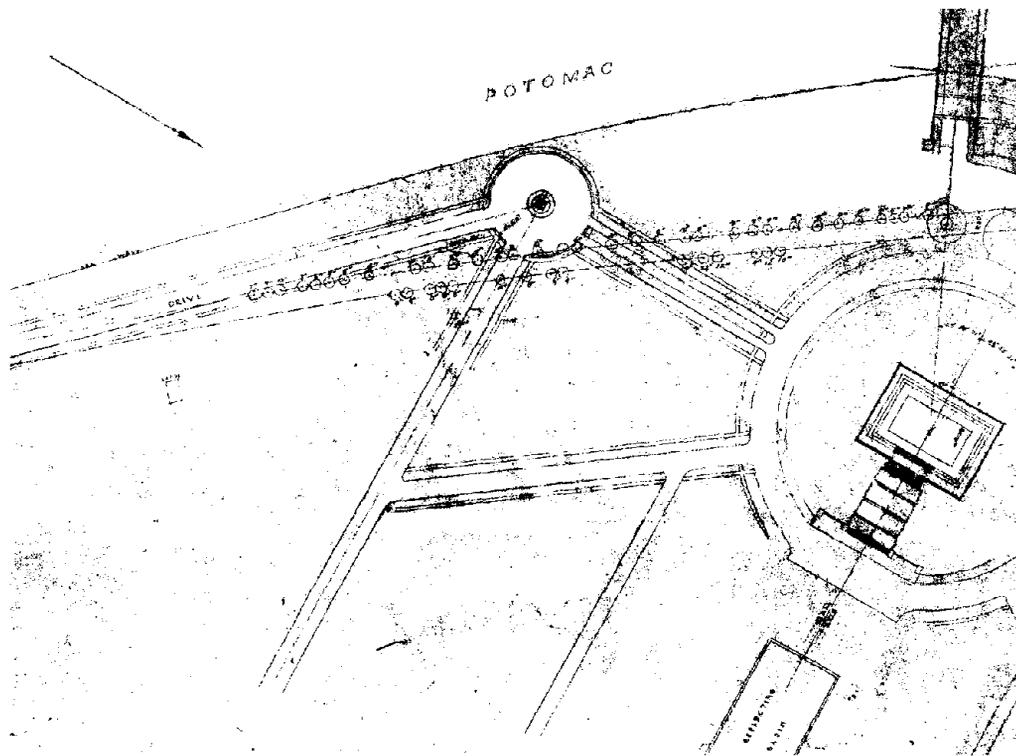
*Map 6 - Plan to relocate elms located along abandoned section of Riverside Drive, rev. 1929. NPS Map 801/80129.*

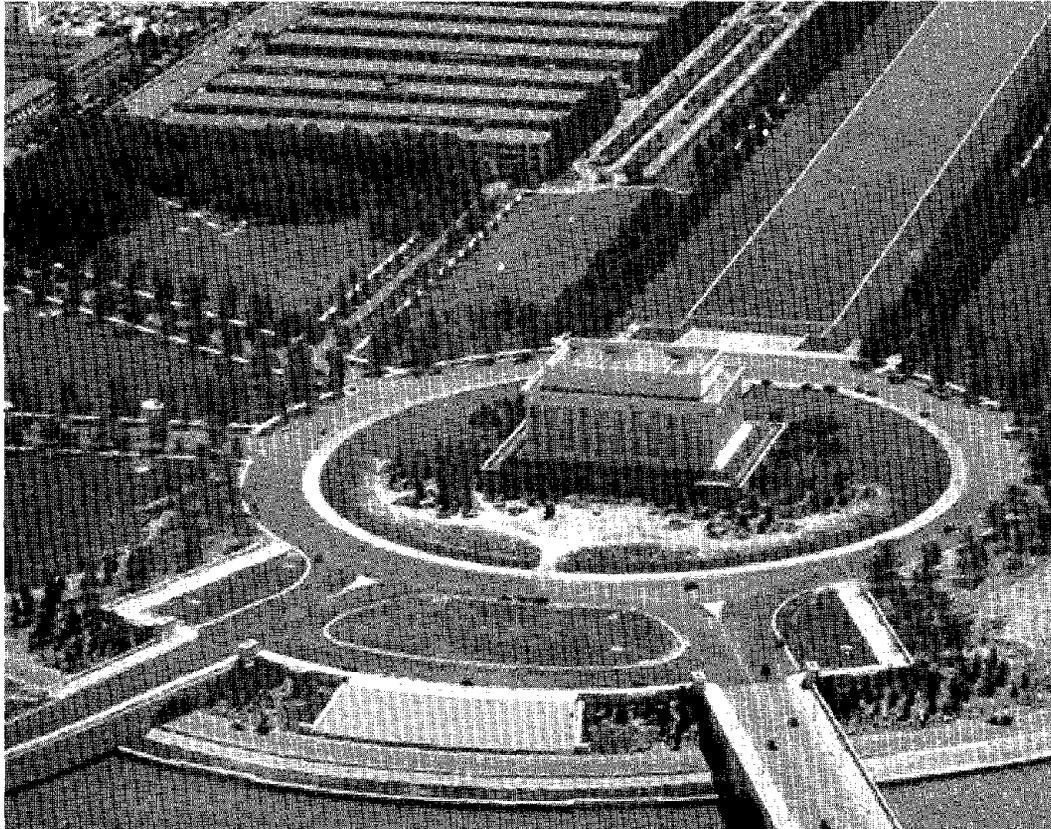
*Figure 19 - Aerial view of installation of trees and shrubs on west side of Lincoln Memorial and beds flanking the Watergate steps, 1932. MRC 1-66.*

In the end, the plant material used for the west side of the Lincoln Memorial, Watergate, and wing walls included several different types of glossy-leaved and coniferous evergreen trees and shrubs. Selected for the Lincoln Memorial were large specimens of southern magnolia, American holly, "treebox," dwarf boxwood, common boxwood, Japanese yew (*Taxus cuspidata*) and mugo pines. Similar plants were used at the Watergate and wing walls, with the exception of the southern magnolia, which were replaced by white pines (*Pinus strobus*).

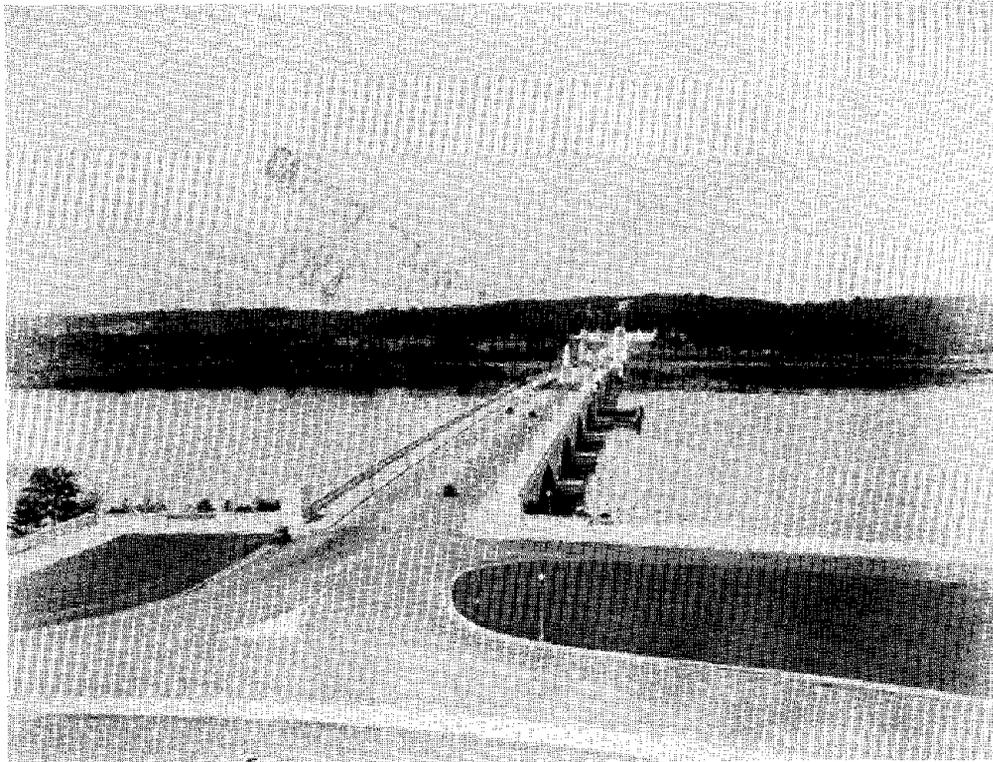
*Figure 20 – Completion of Watergate plaza, sidewalks and bridge trail, June 9, 1933. MRC I-75.*

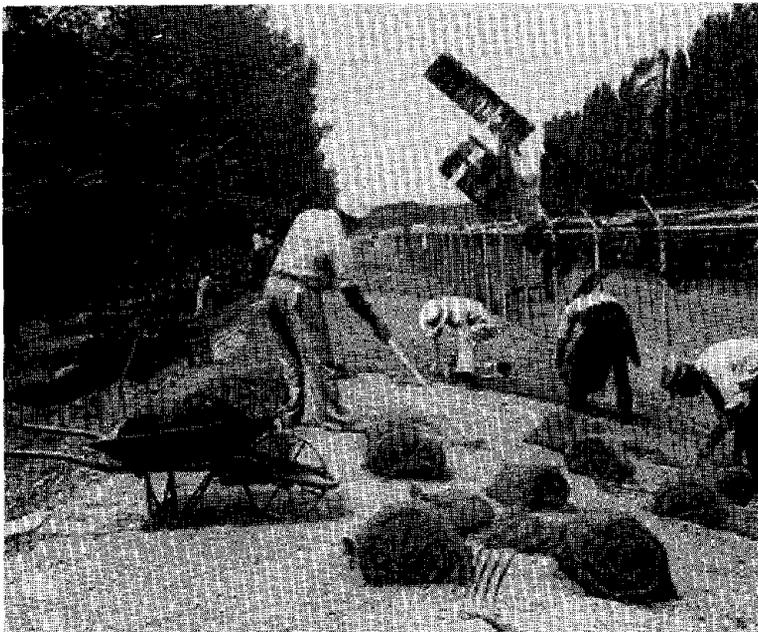
*Figure 23 - Laying sod on flood levee to stabilize the earthen berm, August 4, 1936. MRC 2-127.*

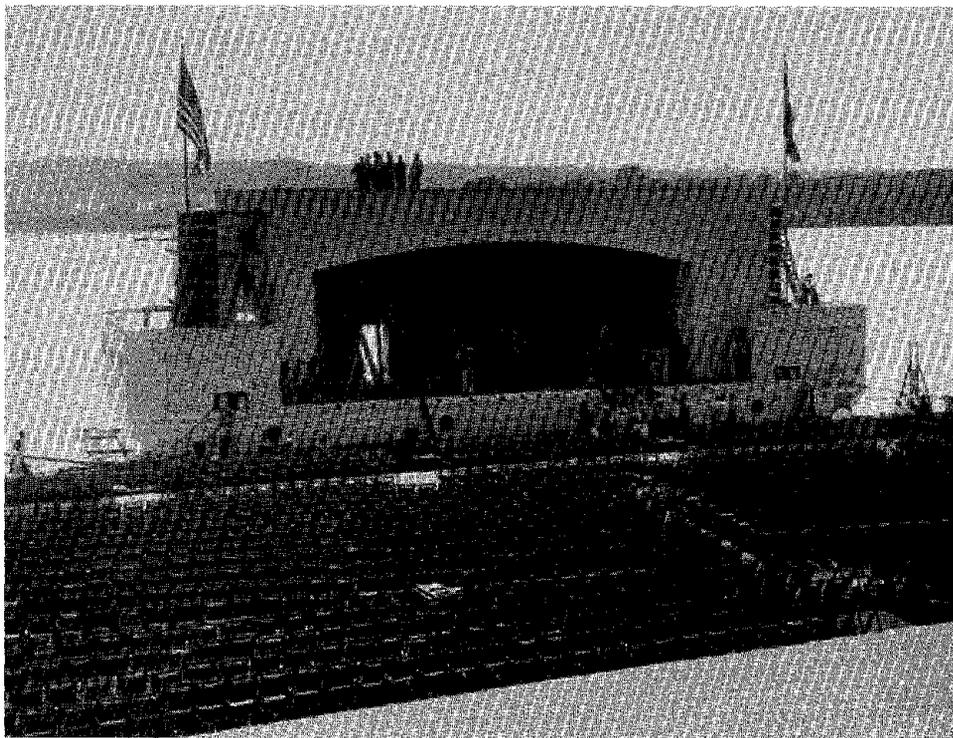
*Figure 24 - Concert barge tethered at the base of the Watergate steps, in preparation for a concert, July 12, 1939. MRC 1-3.*

documentation suggests that a formal orchestral barge was not in place before 1937. A more stylized architectural shell was created in 1939, and the third, an elaborate covered stage set off by flagpoles and planter boxes, was developed during 1947-1948. The steps provided most of the seating, with additional chairs arranged for the audience on the strip of lawn along the river, on platforms that spanned the road surface of the drive located between the steps and the lawn, and at the top of the steps. During concerts the underpass was closed to traffic, which was probably directed away from the river road to the Lincoln Circle. The summer series of concerts included performances by military bands, opera companies, and by the Watergate Symphony Orchestra “and the world’s great

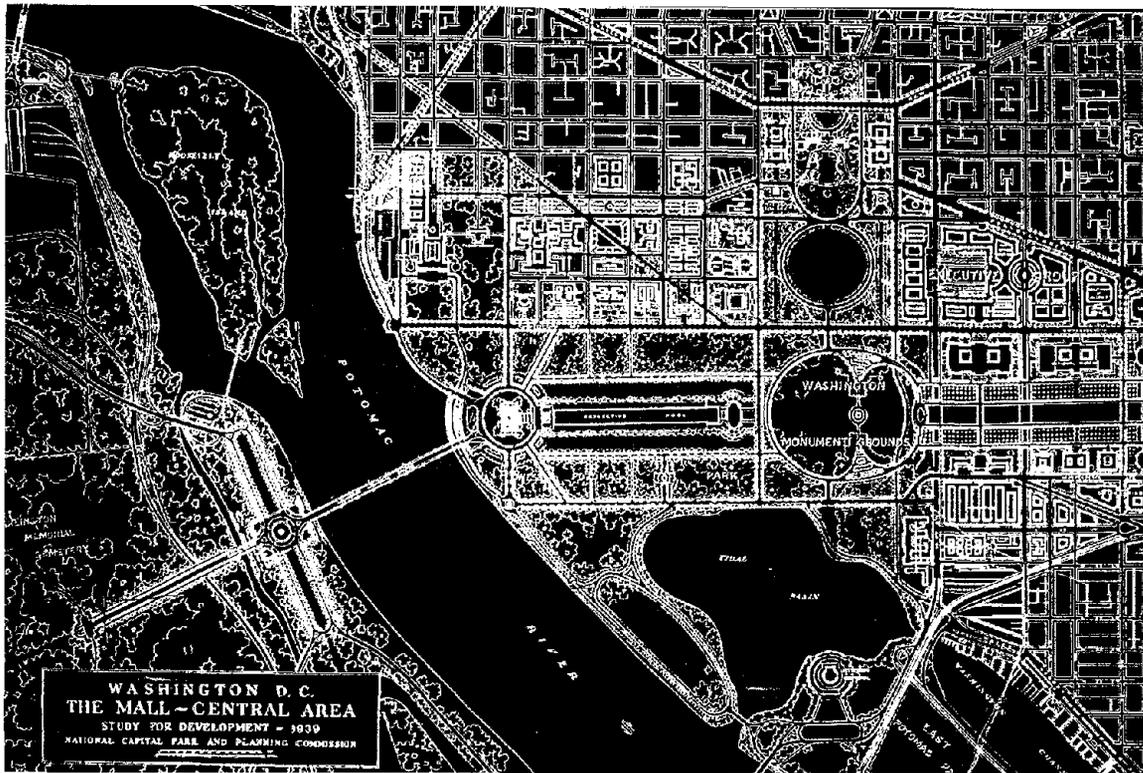
*Map 7 -Development plans for the later part of the 1930s no longer depicted the Reflecting Pool "cross arms," 1939. NPS Map microfilm 35-52F/1.*

effect of the new flood control berm on the double rows of elms and the design for the planned open space next to the north side of the Reflecting Pool are not depicted, probably because a parking lot for the World War I temporary buildings still occupied this area, even though it was not marked on the NCPPC plans. While the berm served to help screen the parking from the pool area at this time, it eventually would become a topographical barrier, separating spaces that were designed to be together.

Elements of these plans that remain consistent with earlier NCPPC plans and the McMillan Plan for the Lincoln Memorial are the overall spatial organization, the vehicular and pedestrian circulation, and the longstanding arrangement of vegetation around the memorial structure along the outer edge of the circular roadway and along the pool. The three plans, however, outline new treatment for the Washington Monument grounds and the Tidal Basin that had a long-term impact on the Lincoln Memorial landscape. The 1939 and the 1941 plans, conceived by Gilmore Clarke, indicate the site of the Jefferson Memorial, which was then under construction. All three delineate proposals for the extension of Independence Avenue west from 14th Street along the route of B Street, S.W. Only the 1941 plan includes the design of an access ramp near the Watergate to connect the Independence Avenue extension with Arlington Memorial Bridge and Rock Creek and Potomac Parkway.<sup>63</sup>

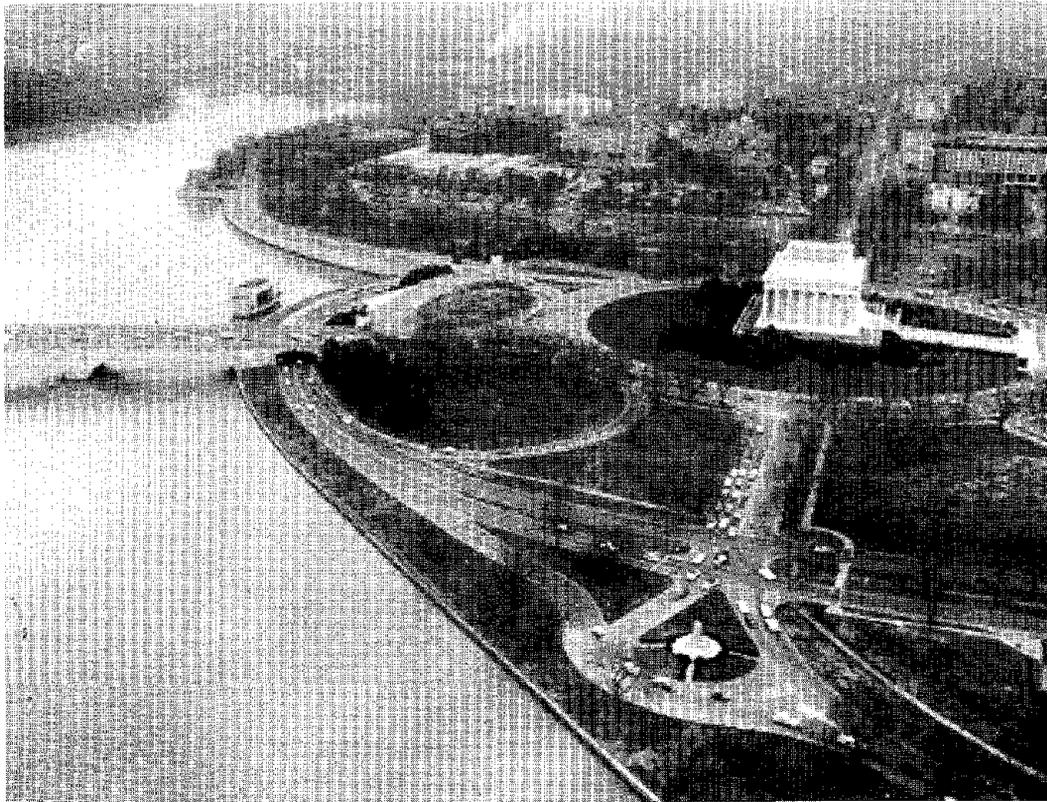
*Figure 25 - New configuration of road system, with the addition of Independence Avenue and the on and off ramps from Lincoln Circle, January 27, 1960. MRC 1-108.*

The proposal for the extension of Independence Avenue from 14th Street to 23<sup>rd</sup> Street, S.W. was presented to the Commission of Fine Arts in November 1941. Concerns over the effect that a through route, designed primarily for connecting the new War Department Building (the Pentagon) in Virginia with the two major river crossings, at 14th Street and at Memorial Bridge, would have on the adjacent park land was a key issue in efforts to win approval for the change. The approved route, developed by mid-1942, created a system of one-way routes, rather than a single, two-way road that would make “. . . driving safer and pleasanter.” This design also incorporated sections of existing park roads and portions of a circumferential road system designed by Frederick Law Olmsted Jr. in 1931 for the Washington Monument grounds. (The Olmsted design was never fully implemented.)<sup>64</sup> Automobiles using the old riverside drive still had to negotiate the small traffic circle at the Ericsson Memorial. However, sometime in 1943 the route was altered around this smaller monument to accommodate higher volumes of cars that developed when a separate eastbound lane was completed. This lane passed over the Tidal Basin on a newly constructed bridge, which was subsequently named Kutz Bridge in 1954 to honor D.C. Commissioner Engineer Charles Kutz. As part of the extension project, which was completed in August 1943, the entrances and exits to the Rock Creek and Potomac Parkway and Arlington Memorial Bridge were realigned to a partial cloverleaf pattern.

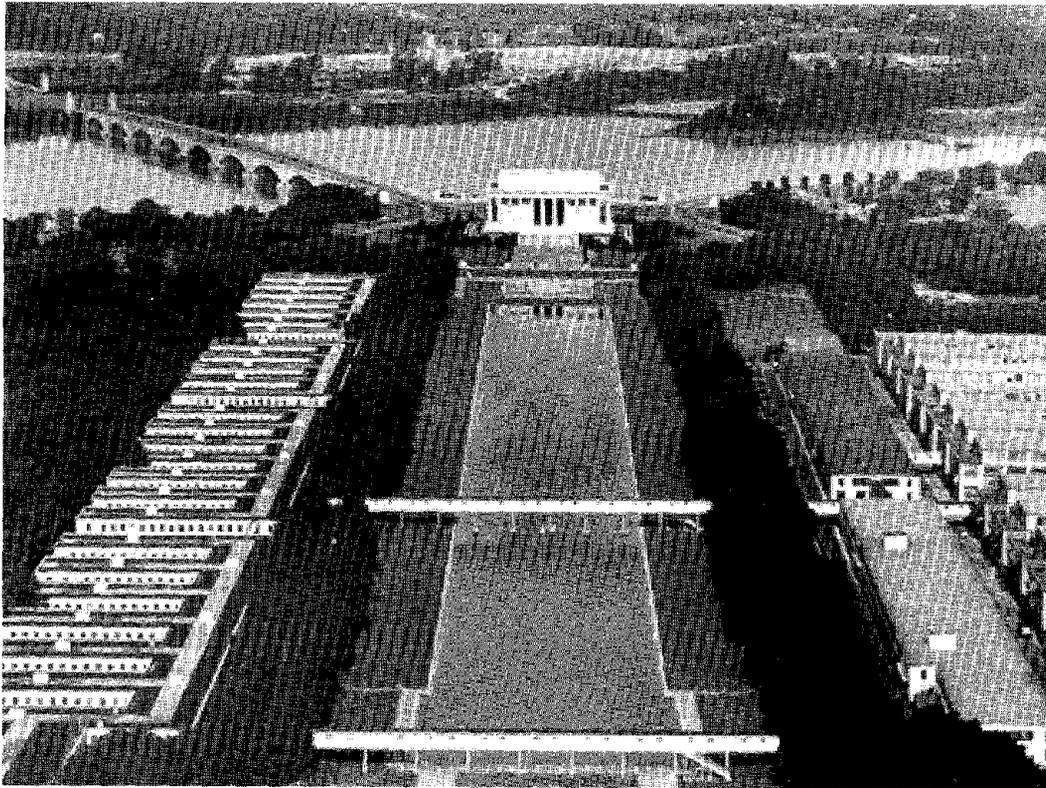
*Figure 26 - Temporary elevated pedestrian bridges over the Reflecting Pool, June 1944. MRC 3-29.*

The area around the Reflecting Pool was adapted in other ways to meet the expansion of the federal government during World War II. During 1942 temporary office and dormitory buildings were constructed for the use of government employees brought to the city to work on the war effort. Some of these quickly-built “tempos” were located on the western side of the Washington Monument grounds, on the main axis between 17<sup>th</sup> Street and the monument. Others were constructed in the area south of the reflecting pools. A chain-link fence, running along the most southern line of elm trees, separated these structures from the Reflecting Pool area. Two additional structures were constructed perpendicular to the older cluster of World I temporary buildings in the space formerly occupied by the parking lot on the north side of the flood control embankment. Finally two covered, elevated pedestrian bridges were erected in 1942 across the east/west axis to link the WWI structures with the newer WWII temporary buildings to the south. One spanned the Reflecting Pool close to the 19th street alignment, and the second crossed over the small plaza between the Reflecting Pool and the Rainbow Pool. A third bridge crossing 17<sup>th</sup> Street, just south of Constitution Avenue, linked the “tempos” on the Washington Monument grounds with the east side of the WWI structures. The cluster of “temporaries” located at the base of the Washington Monument grounds was expanded in 1943, when three wings were added to one of those buildings. With the influx of additional government workers to offices located in park areas, all-day parking was allowed in lots adjacent to the “temporaries” and along park roads in the monumental core. Over time, other changes to the Lincoln Memorial were proposed but were not approved. One was for the installation of light posts adjacent to the Reflecting Pool for

Notwithstanding the commission's recommendations, the temporary buildings and the accompanying parking lots and fencing remained on both sides of the Reflecting Pool and at the base of the Washington Monument for many more years, prohibiting the development of these areas for "passive" recreation. However, the bridges crossing over the pools were removed during the immediate post-war period.

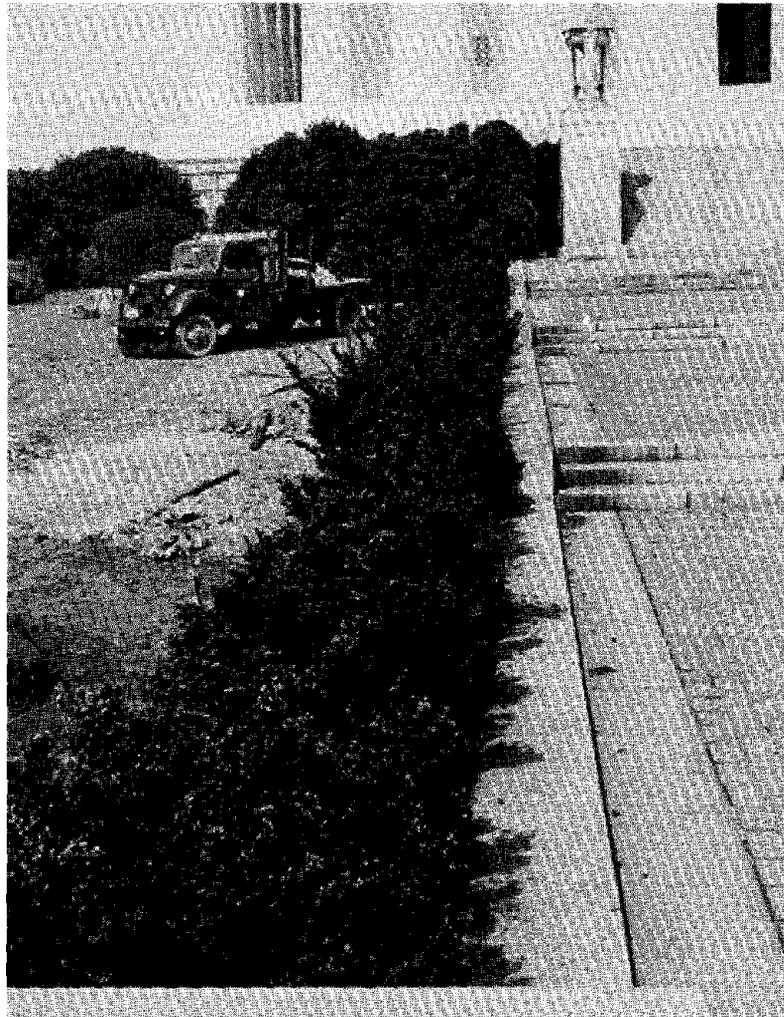
*Figure 28 - The rough form of the new yews planted on the south side of the approachway, changed the character of the approachway hedge, May 3, 1944. MRC 2-96.*

The National Capital Parks worked to improve the appearance of the landscape around the Lincoln Memorial wherever possible. Some of the boxwood shrubs located adjacent to the retaining wall and the main approachway were thin and scraggly in appearance. In the spring of 1944, Irving Payne, the former OPBG landscape architect who had worked on previous memorial projects, recommended that the park service modify the original plan by changing the arrangement of evergreens. In June, a partial installation of yew shrubs (*Taxus cuspidata* 'Nana') replaced the dwarf boxwood hedge located on the south side of the approachway. By the summer of 1945, 348 yews had been planted on both sides of the approachway. The beds of dwarf boxwood flanking the entrance to the approachway and facing the circular sidewalk were rehabilitated with additional and replacement boxwood shrubs. A select number of larger boxwood shrubs on the front side of the raised terrace wall were also treated under this "program to rehabilitate" the Lincoln grounds. Among the 12 boxwoods brought in for the project was a large American boxwood, approximately 200 years old, that had been found growing in a South Carolina cottonfield near the ruins of a former colonial residence. Park plans designated this specimen for the lawn area just south of the approachway. National Capital Parks completed the rehabilitation in 1947.

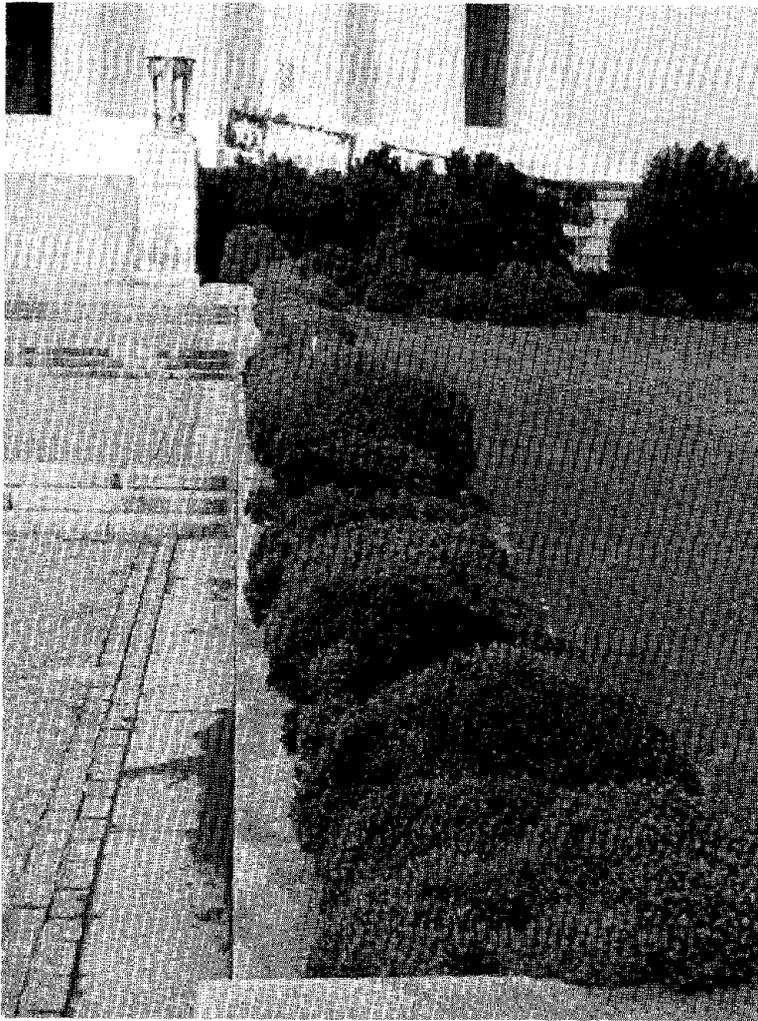
*Figure 29 - Original character of approachway hedge illustrated by the rounded form of the boxwood, May 3, 1944. MRC 2-97.*

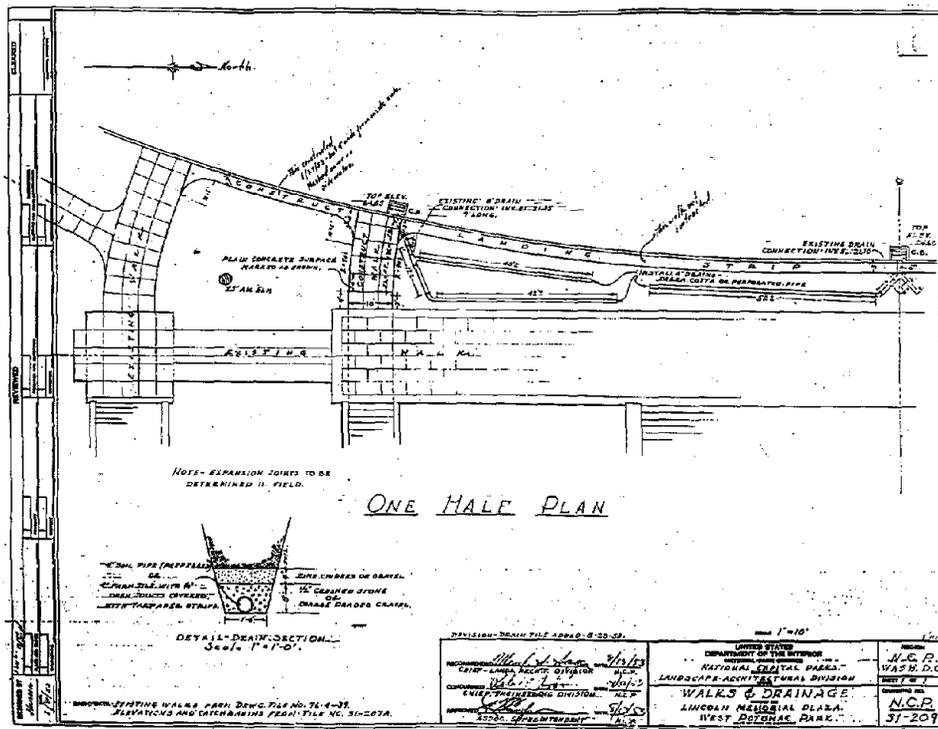
Map 8 - Construction plans showing new layout of shrub beds at top of Reflecting Pool steps, 1953. NPS Map 31-209.

As part of a 1953 repaving of the circular roadway, National Capital Parks eliminated the rectangular edge of the circle’s outer curb at the Reflecting Pool steps in favor of creating a continuous curb edge. Since the 1922 dedication, the rectangular section had been gradually adapted into an area for parking. The presence of parked automobiles, in addition to taxicab stands and the three bus stops allocated to the city’s private bus companies, marred the area between the memorial and the pool and hindered pedestrians crossing from one to the other. Two triangular planting beds, shaped by the outline of the new and old curbs and new sidewalk connections, flanked the landing at the top of the steps. The beds, which were planted in boxwood, replaced most of the parking area and completed the changes made at this time.<sup>68</sup>

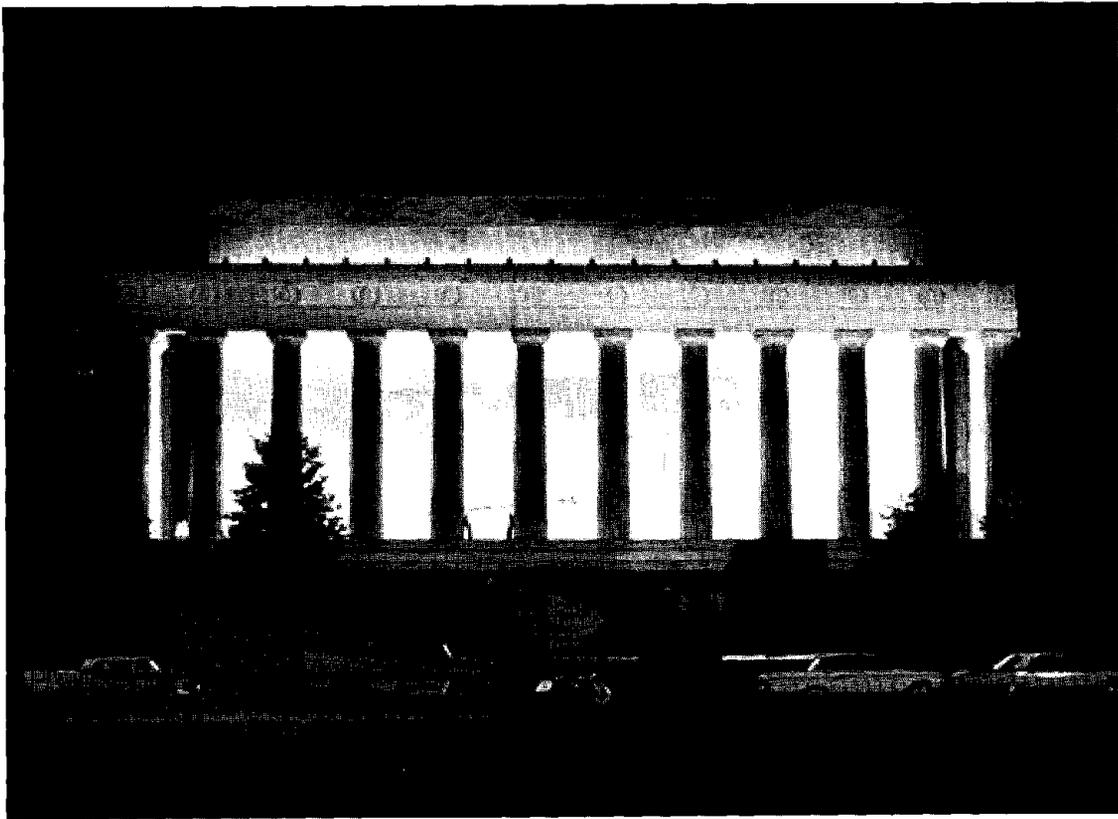
*Figure 31 - Lighting effect on west colonnade of Lincoln Memorial, June 7, 1966. MRC 3-44.*

Throughout the late 1960s and early 1970s, The Commission of Fine Arts reviewed the effectiveness of the original interior and exterior lighting at the memorial. New exterior lighting around the perimeter of the building was in place by the time of the Nixon Inaugural in January 1969. The incandescent spotlamps used to light the main steps were installed on both sides of the approachway in large rectangular box units. Their installation necessitated the removal of selected yew and box shrubs from the front facade planting. Two sets of lamps mounted on poles were also placed in the vegetation to cast light on the north and south sides of the building. Two other pole units were installed among the trees and shrubs on the west side. No evidence of alterations to the planting are documented for these pole installations. Floodlights located on the top of the marble column capital, around the base of the structure itself, directed light toward the colonnade of the memorial.<sup>70</sup>

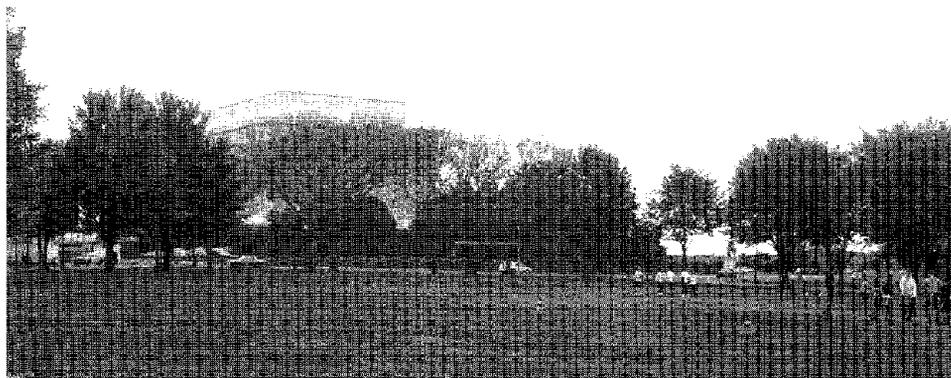
*Figure 36 - Grassy area north of Lincoln Memorial is used for active recreation, November 1996. LINC 11-29.*

Passive recreation is still the primary use of this commemorative landscape. Active recreational uses have continued into the present, but are maintained in open spaces away from areas of major tourist visitation. To separate diverse uses, park officials have designated fields for wide range of recreational opportunities. Use of the Lincoln Memorial grounds as a public forum developed over time, and considering the historical significance of the events staged there, precedence for such use has become well established. Large demonstrations and public assemblies will inevitably continue to be staged there for some time. See *Map 9 Overall Landscape - Land Use* for delineation of use areas.

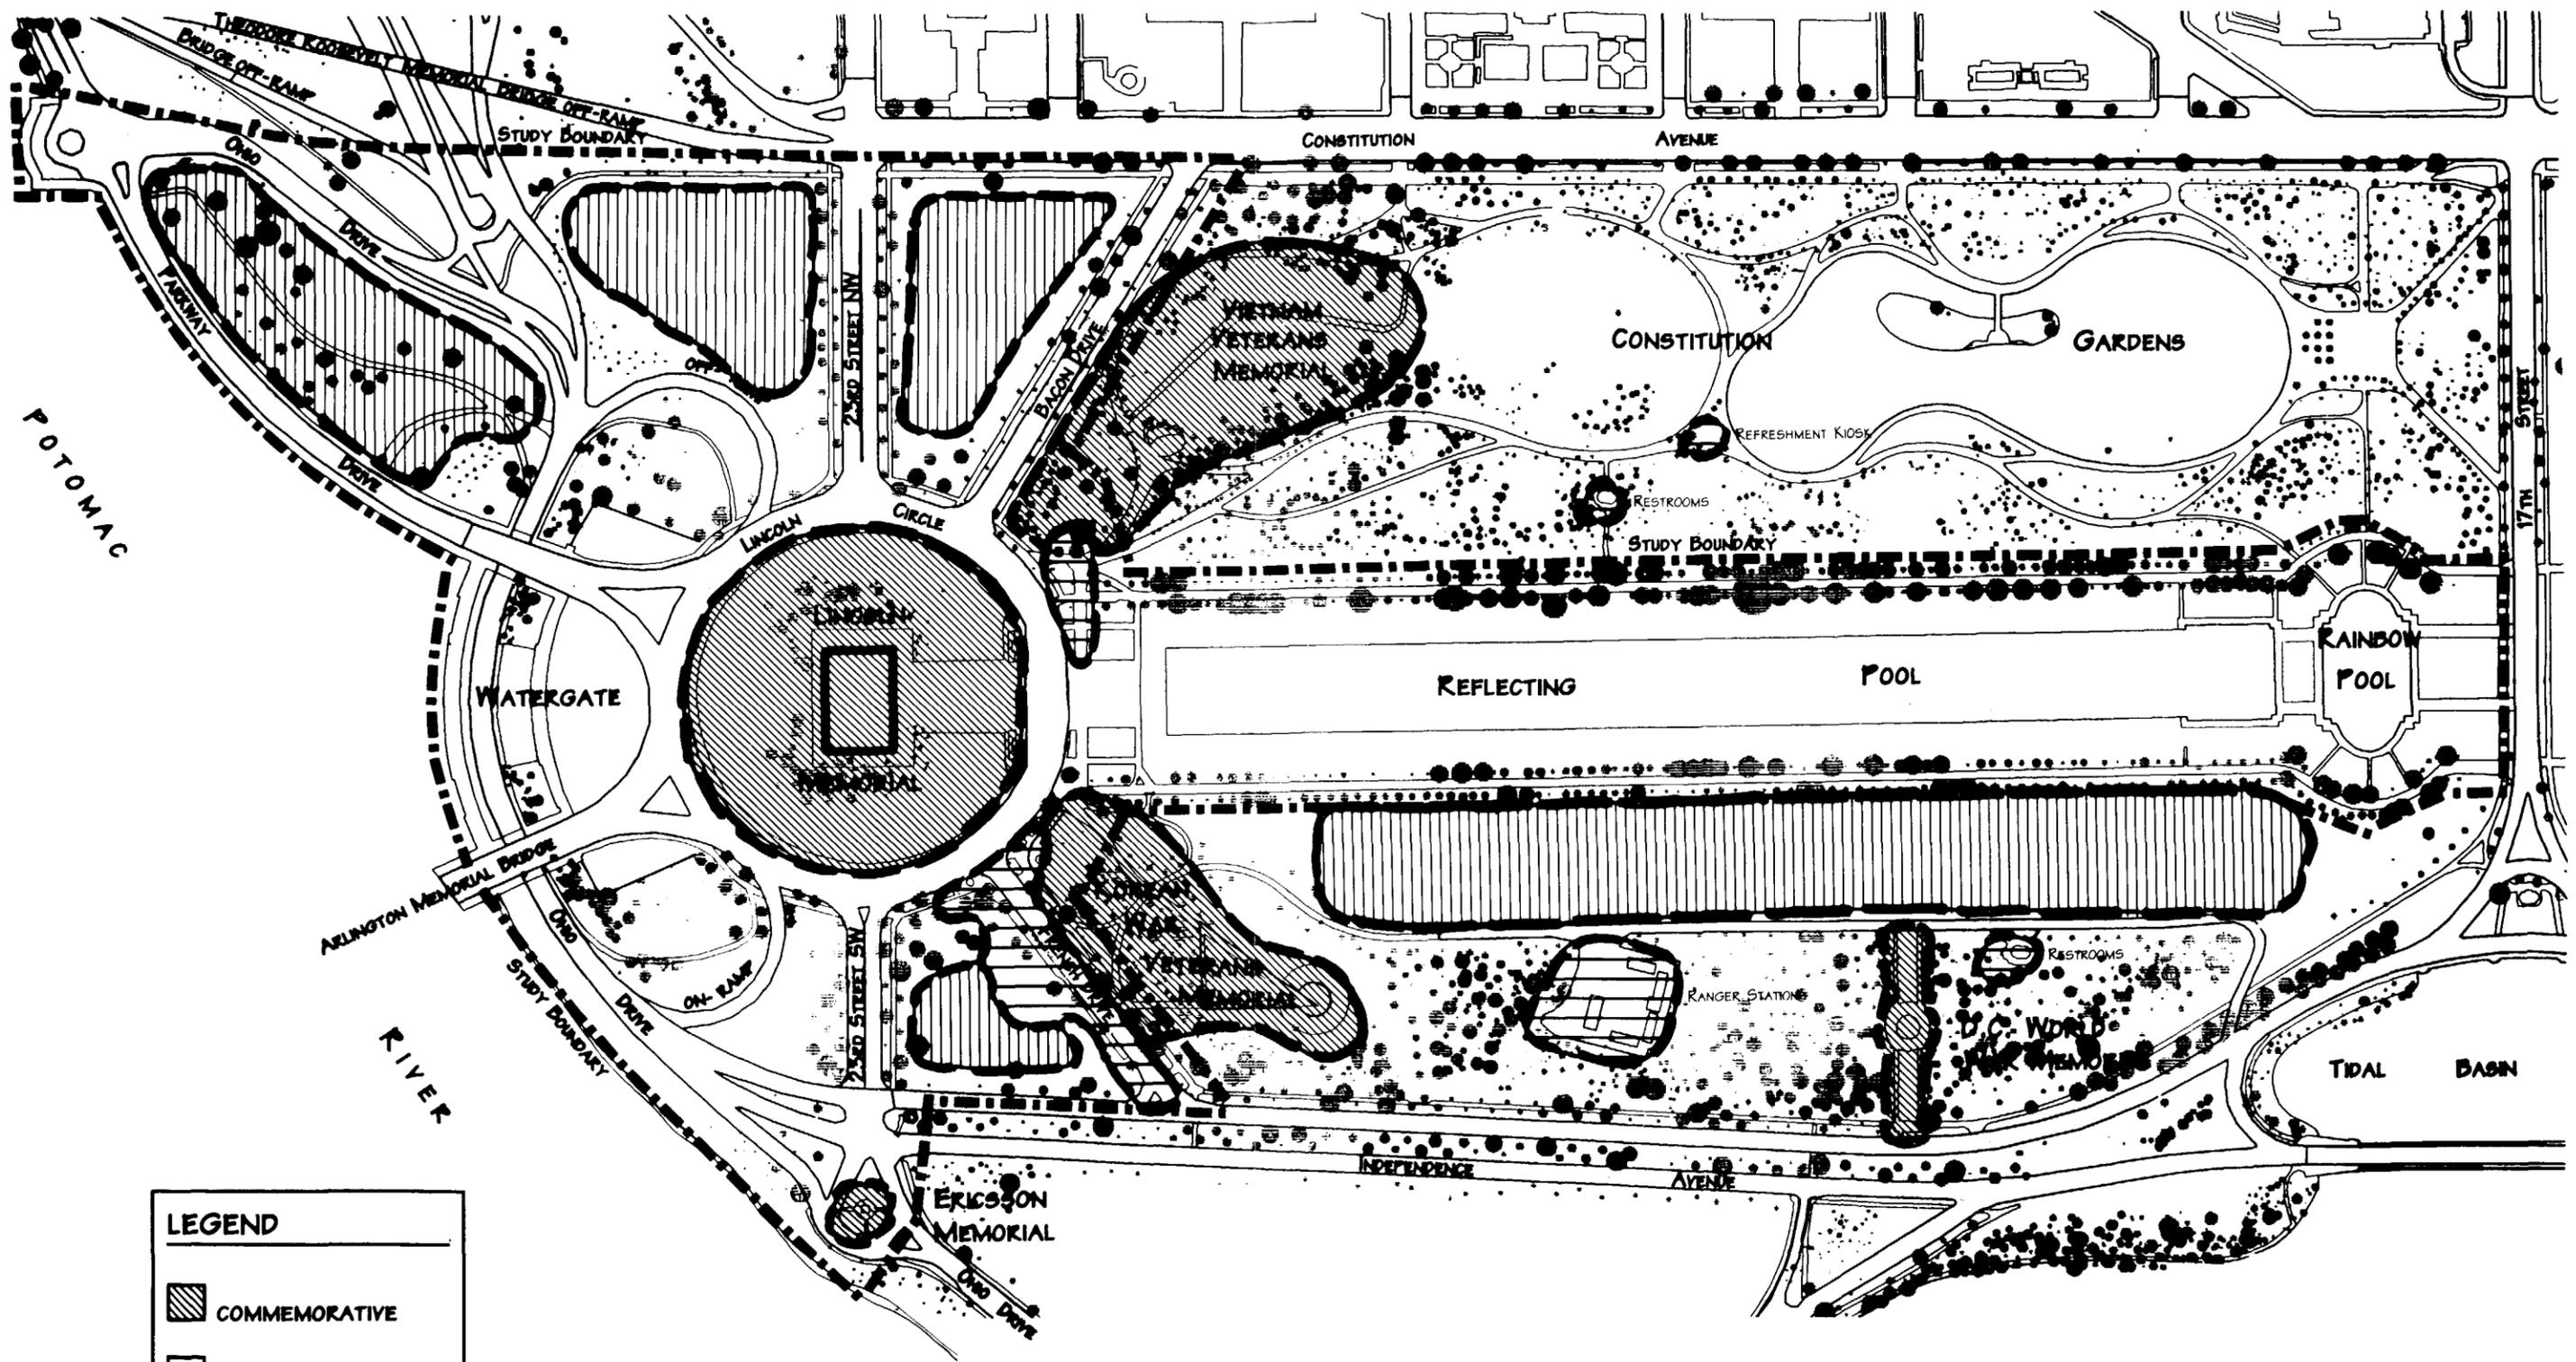
**LAND USE**  
**OVERALL LANDSCAPE**

<b>Contributing Features</b>	<b>Noncontributing Features</b>
1. Lincoln Memorial commemorative landscape 2. Reflecting Pool passive recreation 3. Watergate area active recreation 4. Active recreation within grass panels, Lincoln Memorial radial roads	1. Service oriented area, French Drive, outside curb of Lincoln Circle
