# Cultural Landscape Report

## West Potomac Park Lincoln Memorial Grounds National Capital Parks Central August 1999

Part 1: Site History,  
Analysis and Evaluation  
and Design Guidelines

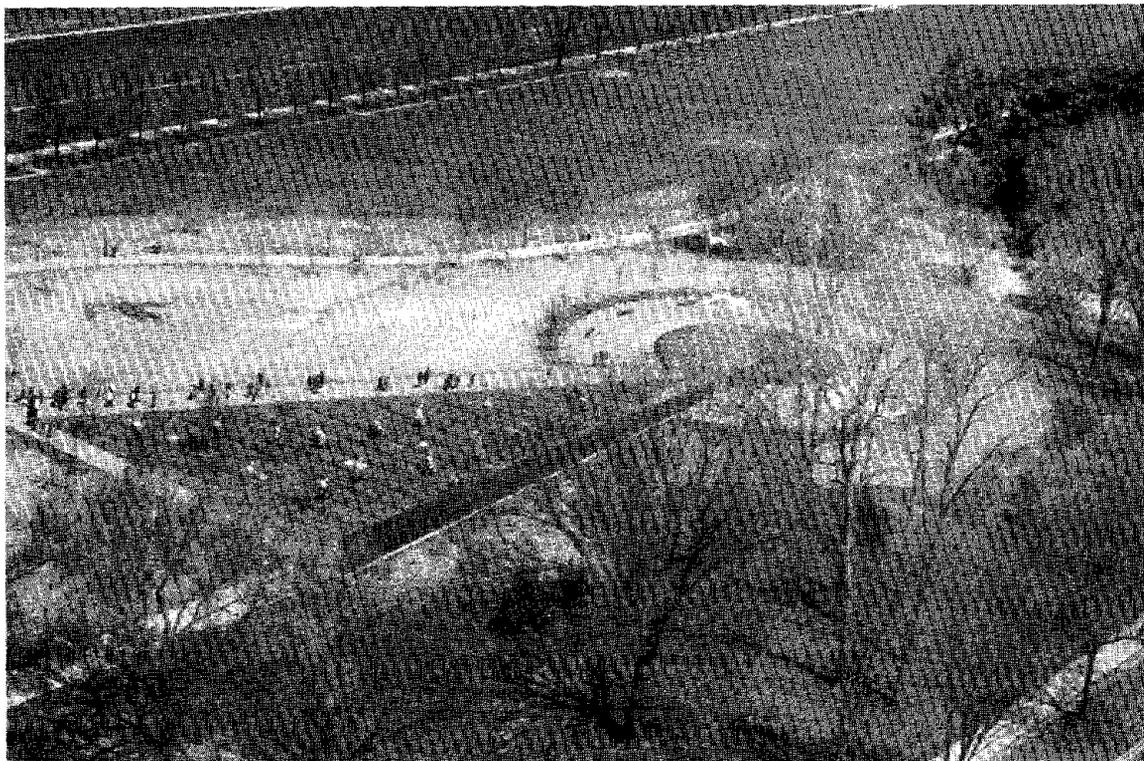
*Figure 38 - Aerial view of the Korean War Memorial and its impact on the open grassy area south of the Reflecting Pool, April 1996. LINC 3-32.*

Although the Vietnam and Korean memorials and Constitution Gardens are known for their distinct designs and cultural value, these were developed independently of the historic Lincoln Memorial grounds. In addition, the change in land use from passive to active recreation on the south side of the Reflecting Pool detracts from the original design planned for this area. See Map 9 *Overall Landscape - Land Use* for delineation of adjacent use areas.

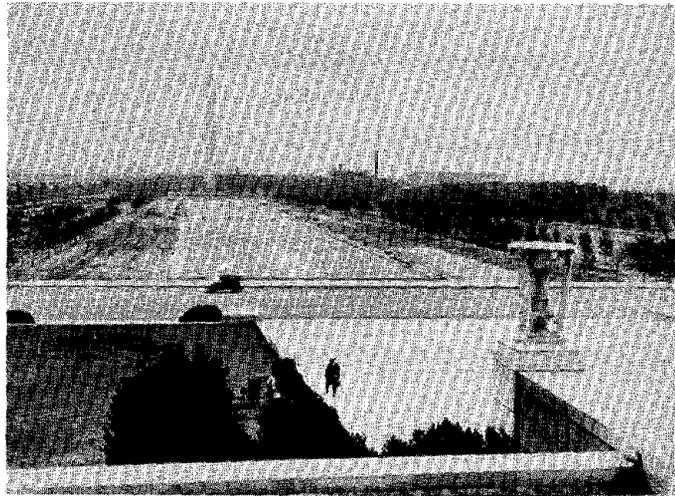
*Figure 39 - Main mall axis view from the raised terrace of the Lincoln Memorial to the Washington Monument, October 27, 1922. MRC 3-2.*

As defined in the 1791 L'Enfant plan and subsequent McMillan Commission Plan of 1901, the most important designed vista is the main mall axis, from the steps of the Lincoln Memorial east to the Washington Monument and then from the Capitol to the Washington Monument to the Lincoln. To help frame the view and provide an unobstructed vista, double rows of elms were planted on either side of the Reflecting Pool. The vista narrowed at 17<sup>th</sup> Street where the street trees (American elm) framed the view to a controlled 160-foot opening (the same width of the Reflecting Pool). A continuation of this axis went from the west side of the Lincoln Memorial to the Watergate steps and across to the Virginia shoreline. Two other sight lines radiated from the rear side, or west side, of the Lincoln Memorial to maintain the symmetry of the design. One was to the southwest across the Potomac River to Arlington Cemetery and Arlington House, and the other was to the northwest to Parkway Drive. The fan-shaped view zone to the west is framed by white pines and elms, planted on the outside edge of the bridge and parkway approaches to Lincoln Circle. Views from the Ericsson Memorial, south of the Lincoln and along 23<sup>rd</sup> Street NW to the north provide secondary views to the Lincoln Memorial. All of these significant view zones are evident today in various degrees. However, the foundation plantings around the Lincoln Memorial are encroaching upon the openings at the base of the raised terrace wall on the north and south facades. This is more evident on the center of the north side of the memorial where the branches of hollies are arching over lower, horizontal-growing yews. After the completion of the Lincoln Memorial grounds in the 1930s, additional views from subsequent memorials to the Lincoln Memorial were emphasized based on their relationship to the Lincoln. This is evident from the Jefferson, Vietnam Veterans, and Korean War Veterans Memorials. Since these offsite views do not relate to the original design intent of the Lincoln Memorial grounds, they are noncontributing features to the overall

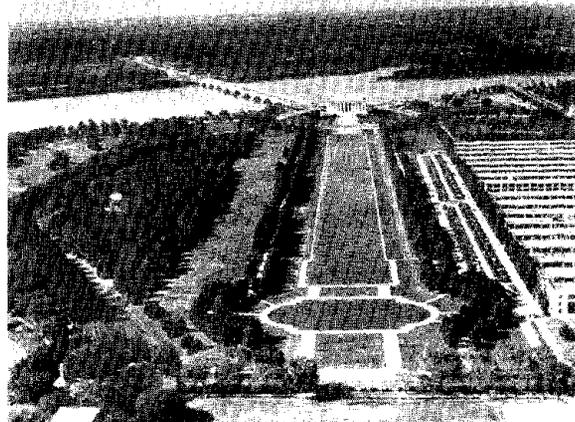
*Figure 40 - View from the Washington Monument to the Lincoln Memorial, c. 1930. Trees along 17<sup>th</sup> Street left an opening for the main mall axis view. MRC 3-26.*

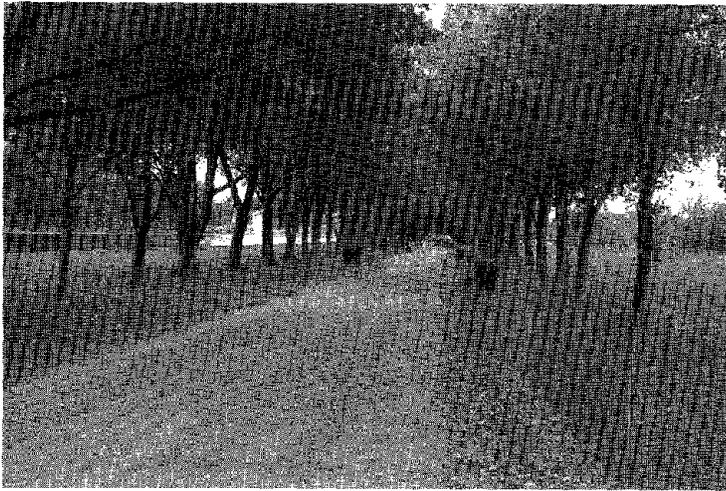
Figure 45 – Elm walk on south side of Reflecting Pool, November 10, 1996. LINC 11-35.

been planted originally.<sup>85</sup> Presently, most of the Reflecting Pool elms are Dutch elms with a few smoothleaf, American, English and Scotch elms (*Ulmus carpinifolia*, *Ulmus americana*, *Ulmus procera*, *Ulmus glabra*) planted in between. Olmsted's elm selection suggests a conscience decision to define a different tree form for this area. English elms that did not survive have been replaced in the same locations, but with other more sturdy and Dutch elm disease-resistant species. Such replanting has created a corridor of trees of varying heights, crowns and circumferences. The smaller number of mature elms on the south side of the Reflecting Pool may be due to compacted soil in this area. High levels of pedestrian traffic passing between the trees to the adjacent athletic fields, as well as the trees proximity to flood prone areas of the park, may have brought about this condition. On the north side there are more mature elms. These elms are subject to less drainage problems and less compaction from recreational and pedestrian activity. The presence of a flood control berm also discourages walking between the trees to Constitution Gardens. Only a few designated paths cross over the berm, which limits impact to the elms in this area.

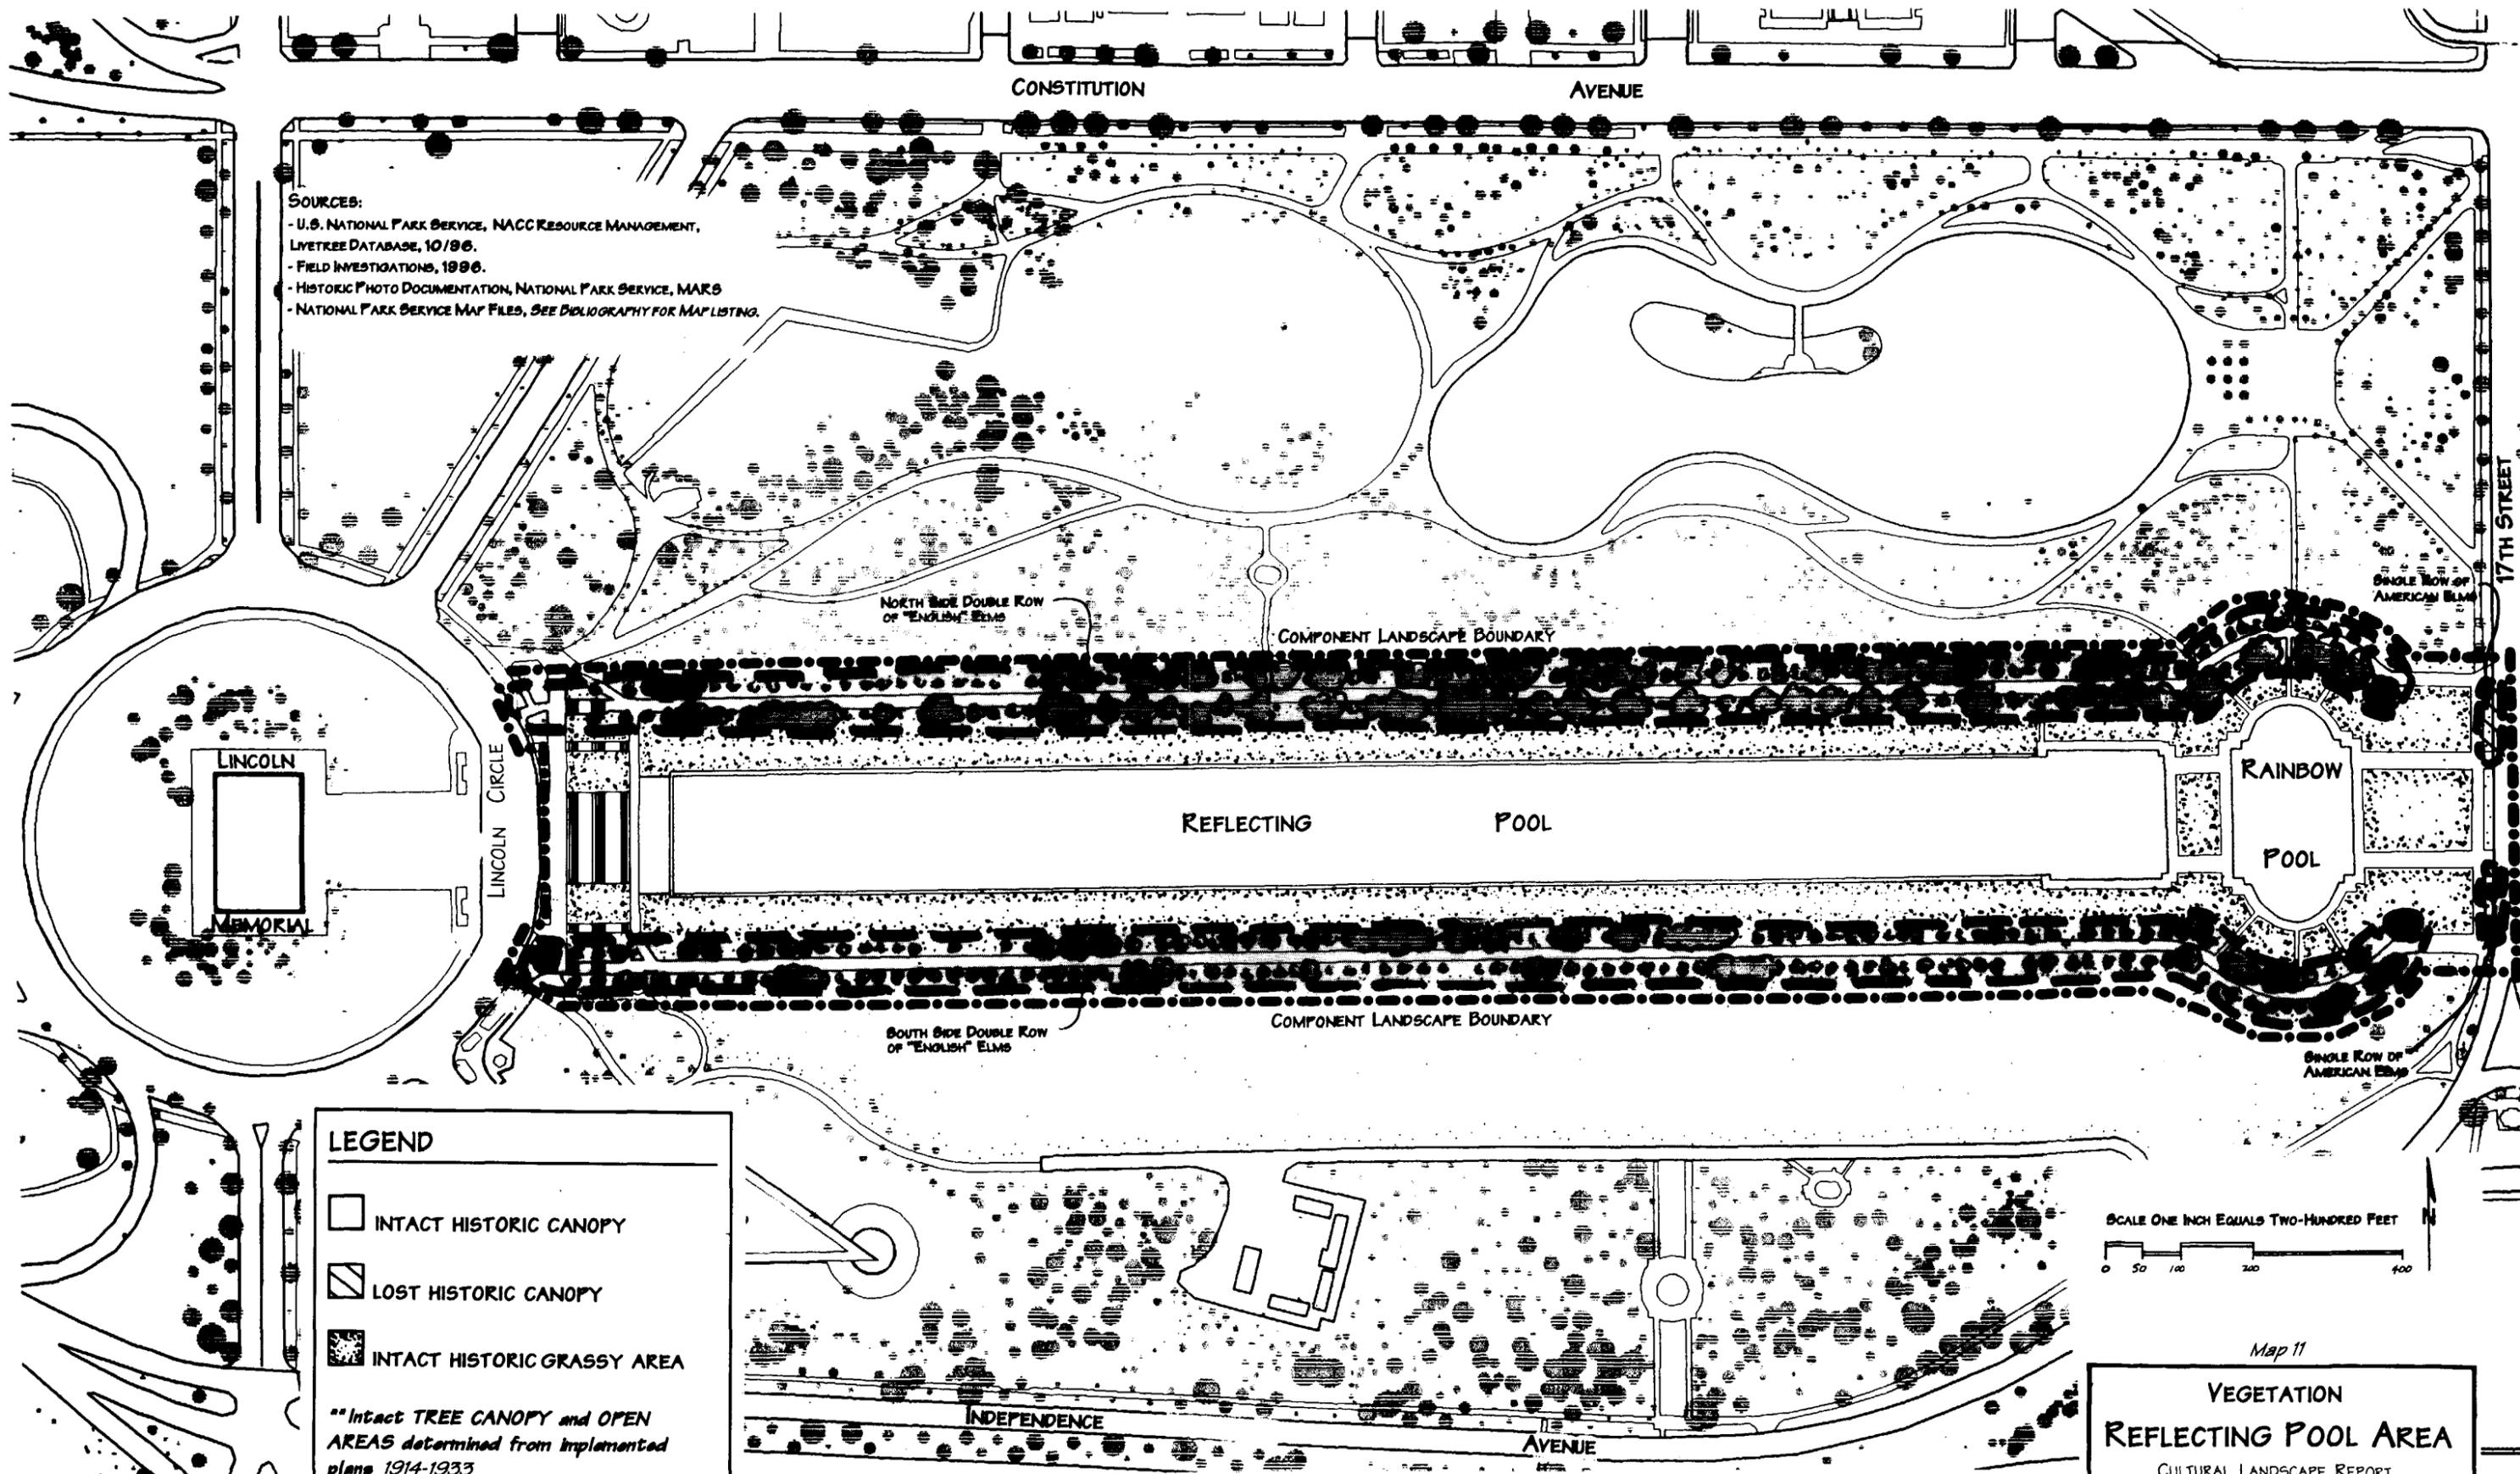
Map 11  
**VEGETATION**  
**REFLECTING POOL AREA**  
 CULTURAL LANDSCAPE REPORT  
 LINCOLN MEMORIAL GROUNDS  
 PREPARED BY: M. JOSEPH DATE: OCTOBER 1986

The Reflecting Pool area is divided into three vegetation zones. These zones define the spatial composition of the tree canopy of the north and south paths, 17th Street corridor, and the lawn area. By breaking the vegetation into smaller areas, there is a better sense of the integrity from the original plans. See Map 11 *Reflecting Pool area - Vegetation* map for graphic representation.

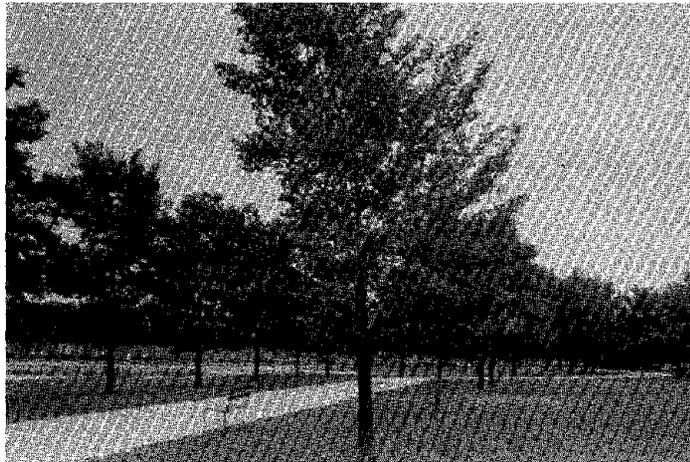
*Figure 46 – Young elms line concrete walks by Reflecting Pool, May 1929. MRC 2-40.*

Pedestrian circulation in the Reflecting Pool area has had a few minor changes since the paths were first laid out. The original plan called for two 15-foot-wide concrete paths situated under the double row of elms, running east to west to serve as the primary pedestrian route along the pools. On the west end of the walkway, two sets of steps brought pedestrians from the lower pool area up to the memorial circle. Sometime before 1964, an additional

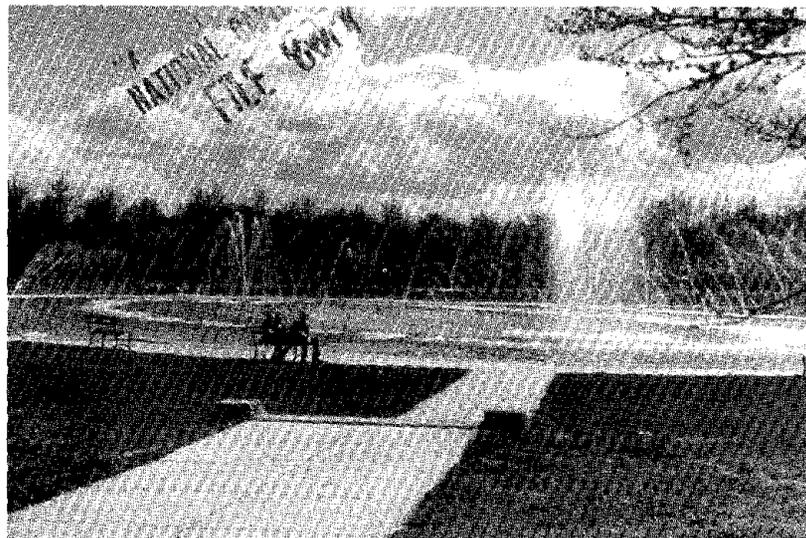
*Figure 47 - Concrete walks radiating from the Rainbow Pool, April 1933. MRC 2-126.*

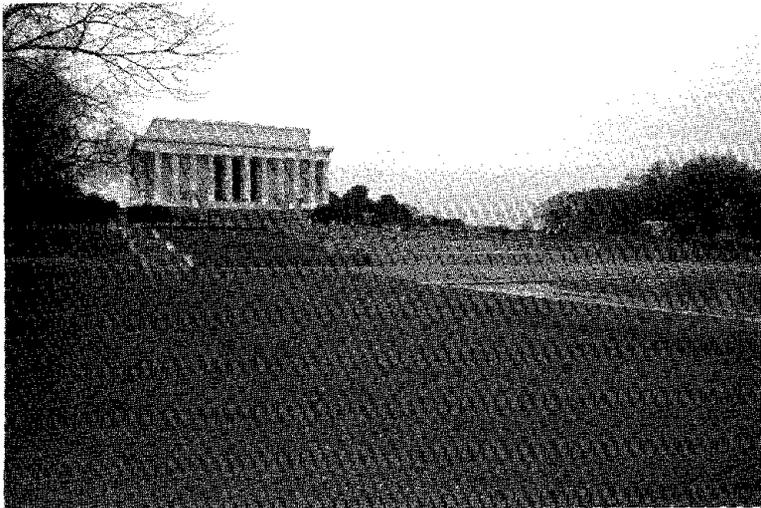
*Figure 48 – Reflecting Pool steps and plaza on west end of pool, November 11, 1996. LINC 11-13.*

Access to the Reflecting Pool from the memorial consists of a series of granite steps descending from the circle and adjacent sidewalk down to the pool's western

edge. The line of these steps continues the line established on the opposite side of the circle by the main approachway leading up to the memorial structure. One broad stairway and two narrow stairs comprise the series. In 1924 a flagstone paver walk, leading from the set of narrow granite stairs and across the grassy strip bordering the pool, connected the descent to the granite coping. These pavers were removed in the 1970s, and in their place a new plaza was installed. As discussed earlier, two other sets of stairs, constructed of concrete, flanked the larger granite series. These steps connected the concrete paths between the double rows of elm trees with the walk around the memorial circle.

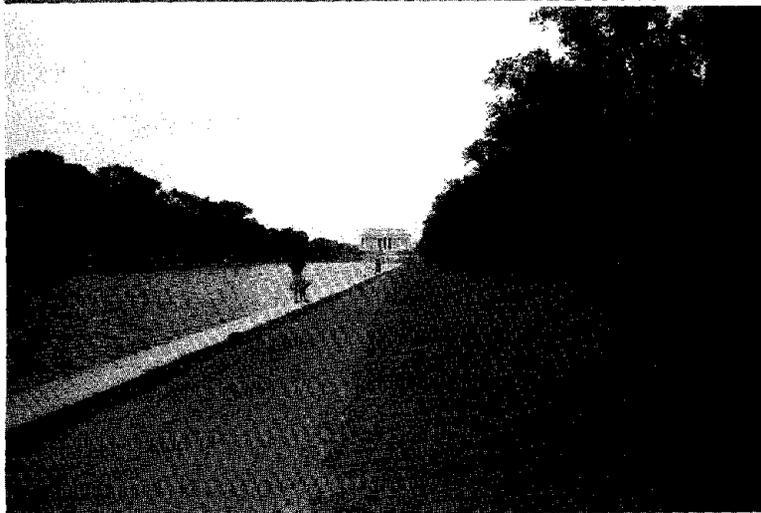
*Figure 49 – Worn path adjacent to granite coping, June 1996. LINC 9-23.*

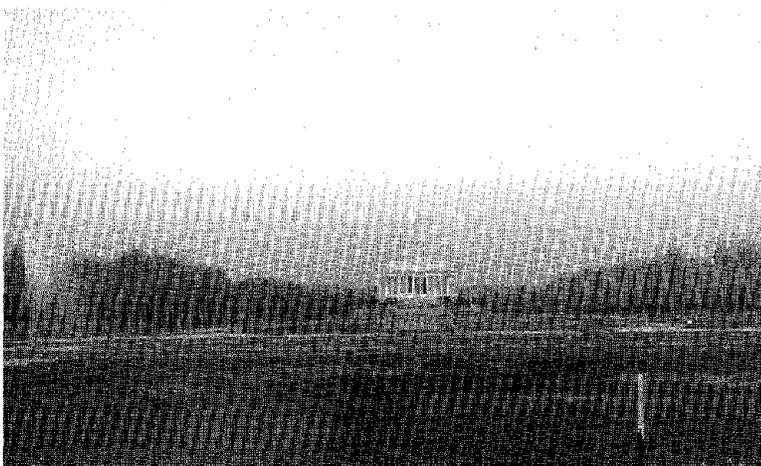
*Figure 50 – Rainbow Pool fountain display, April 20, 1934. Photo by Kelly. MRC 2-108.*

Fountains were installed in the smaller pool, in 1924. An oval pattern of 124 nozzles sprayed approximately 25 feet in the air towards the middle of the pool creating a rainbow affect on sunny days. In addition to these jets, two other clusters of nine jets on the north and south side of the pool towered above forming a fountain 40 feet high. A year later, the Commission of Fine Arts inspected the fountain and indicated that the fountain's height and intensity of spray obscured the views to the Lincoln Memorial and Washington

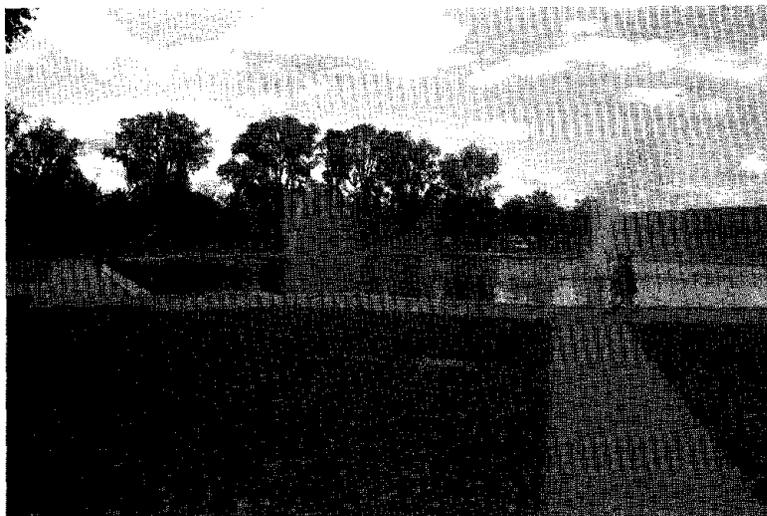
Monument. A series of tests were conducted in 1934 to determine the most appropriate and effective display and to meet the CFA's requirements. In 1990 some of the nozzles were replaced with a straight head type. It is unknown if this has altered the jet display that was originally approved by the Commission of Fine Arts in the 1930s. Currently only the two clusters of jets on the north and south side of the pool are operating and the oval pattern on the outer edge of the pool is not used. Because of this the fountain no longer sprays at the height required to exhibit a rainbow effect but instead appears as a weak imitation of the past display.

*Figure 51 – Rainbow Pool fountain as it appeared on November 11, 1996. LINC 11-10.*

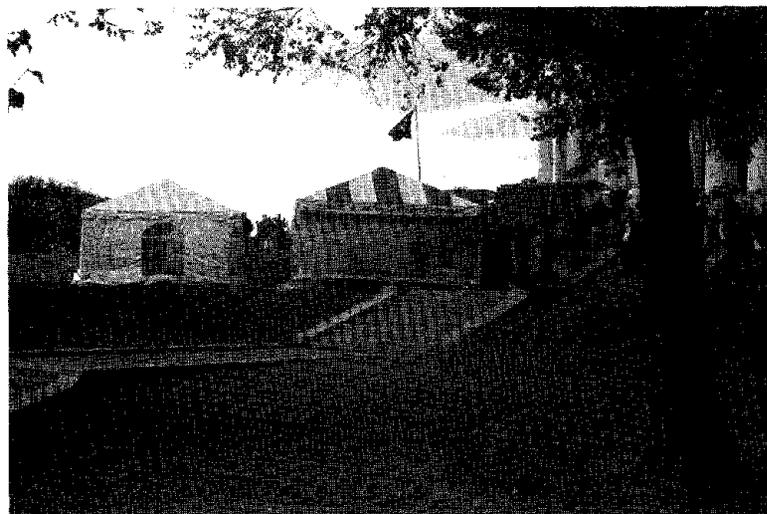
*Figure 52 - Temporary structures on grassy terrace by Reflecting Pool steps, November 11, 1996. LINC 11-22.*

the plaza at the top of the granite stairs. These are owned by vendors who have obtained a special use permit to sell t-shirts and other products under a First Amendment ruling. To reduce the impact on cultural and natural resources the NPS has tried to limit where the vendors operate. The unsightly tents obscure the view along east/west axis from the memorial, the approachway, and the Reflecting Pool. See Map 13 *Reflecting Pool area - Structures* for location of structural features.

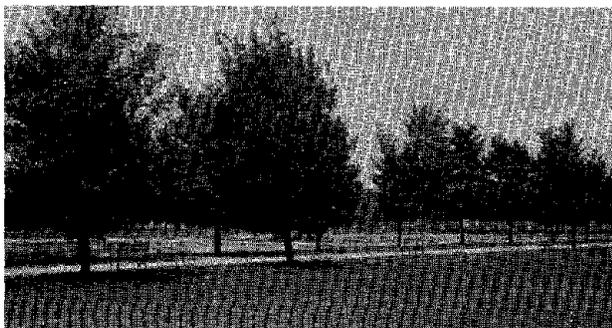
**Benches.** In the Reflecting Pool area, the earliest photographs show benches spaced evenly, approximately 50 feet apart, along the walkways and underneath the outer row of trees in the double rows of elms. A few benches were also placed under the inner rows of trees. All of the benches were situated facing the Reflecting Pool. Groups of benches were also placed around the Rainbow Pool for viewing the fountain in the summer months and for the use of ice skaters in the winter. The benches appear to have been moveable and not permanently mounted. The type of bench utilized during the 1920s and 1930s is similar to the present bench, a cast iron frame with a wooden slat seat and back. However, the smaller number of benches found along the walks today and their permanent, fixed positions reflect the change in contemporary uses. These changes include the removal of benches from around the Rainbow Pool and the reorientation of all seating underneath the inner rows of trees away from the Reflecting Pool, toward the walkways, facing the opposite benches under the outer rows of trees.

Figure 53 – Cast iron frame benches placed along elm walks, May 1929. MRC 2-48.

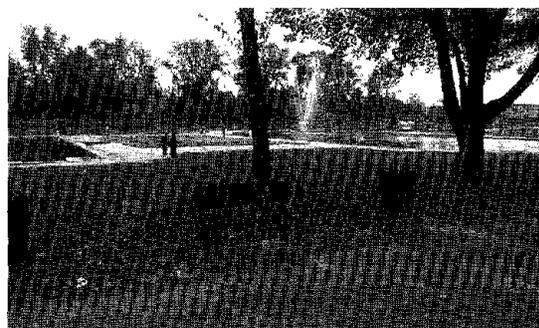
Figure 54 – Cast iron frame benches and tulip trash receptacles used today along elm walks, November 11, 1996. LINC 11-12.

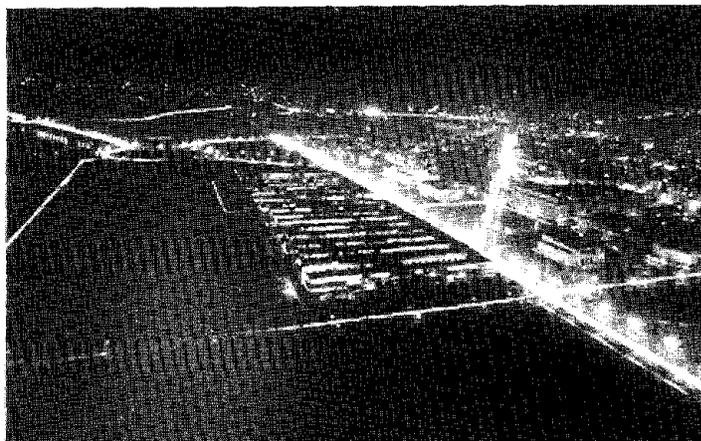
Lack of direct lighting around the pools accentuates their reflective quality. Because of the subdued effect, the reflection of the Lincoln Memorial and the Washington Monument at night is both a breathtaking and memorable experience. Light emanating from the memorial, which was first lit from the inside in 1929, and from the grounds of the Washington Monument reinforce the structures as focal points and provide the soft light for the pools. The contrast in light also underscores the visual relationship between the memorial and the monument. Exterior lighting for the Washington Monument was installed by 1931, while exterior lighting at the Lincoln was developed in 1969.<sup>86</sup>

*Figure 55 - Reflecting Pool area devoid of lights. View from Washington Monument, April 1941. MRC 3-28.*

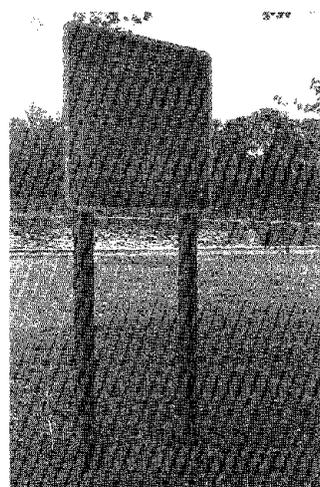
**Signs.** In the Reflecting Pool area, the park has placed four large interpretive signs (two on each side) that describe the Reflecting Pool. The large metal signs (white lettering on brown background) block the view of the feature they are describing and are out of scale with the surrounding landscape. New interpretive signs are proposed for this area and will be a low-profile, tamper-resistant type, wayside.

*Figure 56 - Oversized interpretive signs by the Reflecting Pool, November 11, 1996. LINC 11-16.*

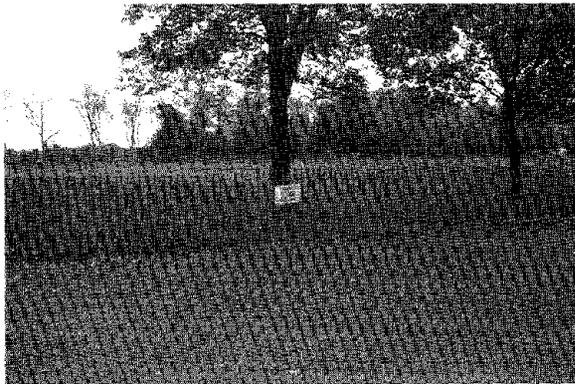
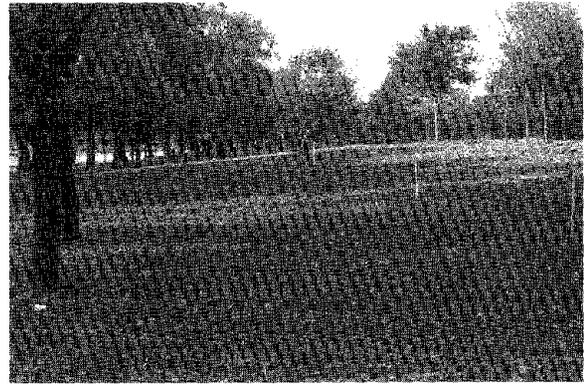
**Pedestrian Barriers.** In pedestrian areas, three different types of barriers are used within the Reflecting Pool area: stake-and-rope; snow fence; and chain-link fence. Park maintenance has installed these fences for a variety of reasons but mostly for the control of visitor circulation. The stake and rope and/or snow fence provide temporary protection of newly seeded areas and control circulation during special events. Also the stake-and-rope appears to be a permanent feature around the Rainbow Pool, which marks a secure area around a helicopter landing pad on a grassy panel between 17<sup>th</sup> Street and the Rainbow Pool. Other temporary barriers are used seasonally, such as the chain-link fence, to prevent visitors from walking on newly seeded areas along the Reflecting Pool or to prevent visitors from entering the fireworks staging area in the Rainbow Pool area.

*Figures 57 & 58 - Temporary snowfencing installed along pedestrian corridors to protect grass areas. Stake and rope installed on the flood berm to mark secure area for landing pad, November 11, 1996. LINC 11-11 & LINC 11-14.*

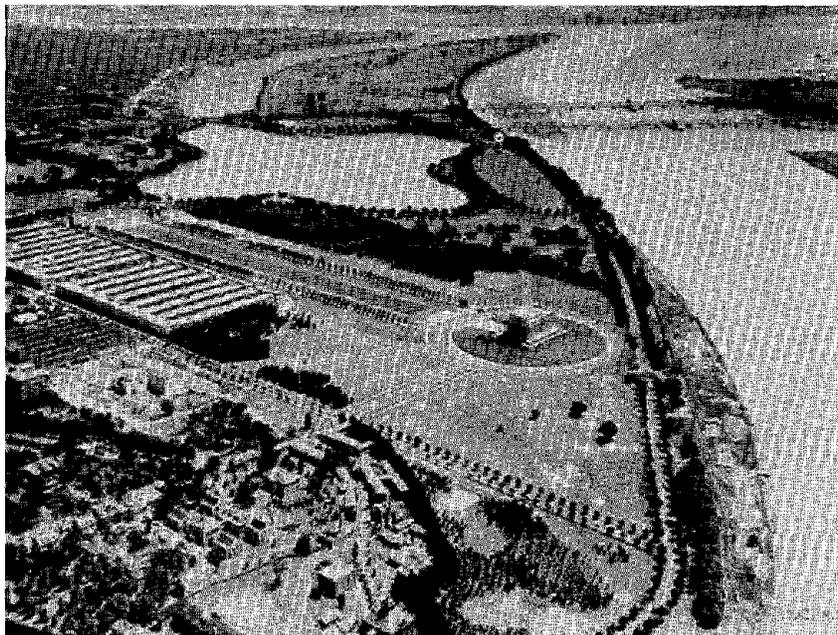
Figure 59 - Aerial view of first phase of planting American elms along the radial and eastern side of Lincoln Circle, 1927. MRC 1-54.

When the first phase of the plan was implemented in the 1920s in the area east of 23<sup>rd</sup> Street, American elms (*Ulmus americana*) had been selected for the planting. Many trees were planted as "memorial trees" dedicated to outstanding individuals or groups as a living memorial. At that time, the proposed double row of oppositely planted trees on the radial roads was scaled back to planting in alternate positions, which reduced the number of trees and the density of the vegetation. The circular band of trees was followed

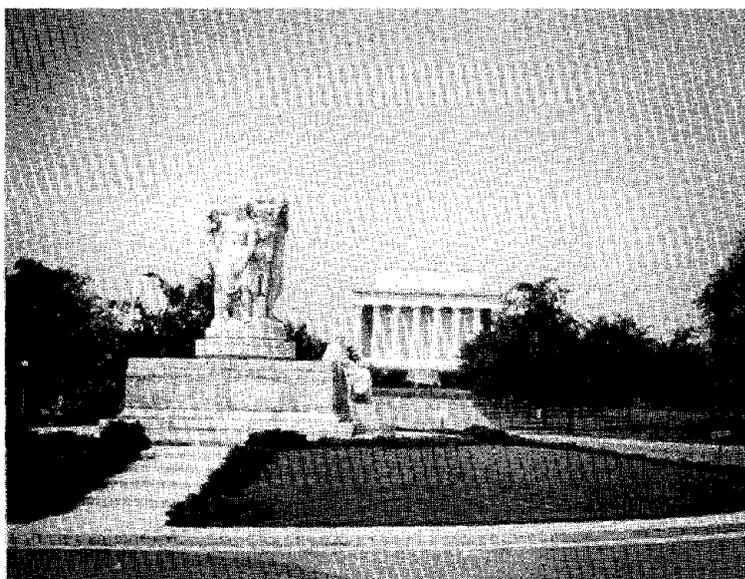
One other area beyond the memorial circle, the Ericsson Memorial site, received its own landscape treatment. When the Ericsson site was completed at the terminus of 23<sup>rd</sup> Street SW in 1932, the granite platform for the statue and the four sets of steps radiating out from the base, were enhanced with conifers. Three types of junipers (*Juniperus horizontalis*, *Juniperus sabina* var. *tamariscifolia*, *Juniperus squamata* 'Meyeri'), each displaying different growth habits, were planted.

*Figure 60 - Ericsson Memorial and newly planted junipers around base, c. 1932. MRC 1-136.*

9. The landscape around the Ericsson Memorial should be restored based on the original implemented plan from the 1930s (See historic photo documentation *Figure 60* and "Ericsson Memorial, Suggestion Planting Plan, West Potomac Park," 1932, #801/80165.) Replanting in this area should be based on an understanding of the historic design intent and original selection of type, size, shape and texture of plants.

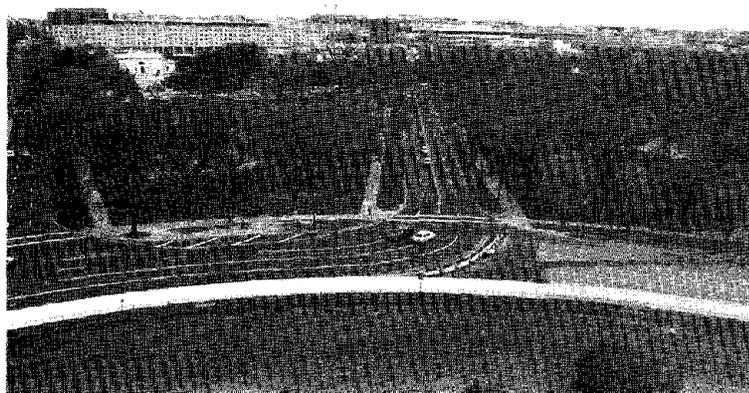
*Figure 61 - Remnant concentric row of elms around Lincoln Circle, between 23rd Street NW and Bacon Drive, March 1996. LINC 6-27.*

Since the National Park Service's stewardship began in 1933, it has attempted to maintain the original planting plan for the radial roads. Because Dutch elm disease (DED) has killed many American elms around the Lincoln Memorial, disease-resistant varieties have been planted to replace quite a few original trees. Although the number of mature trees growing along the radial roads varies, the spreading canopy of these trees remains an effective design element in the landscape.

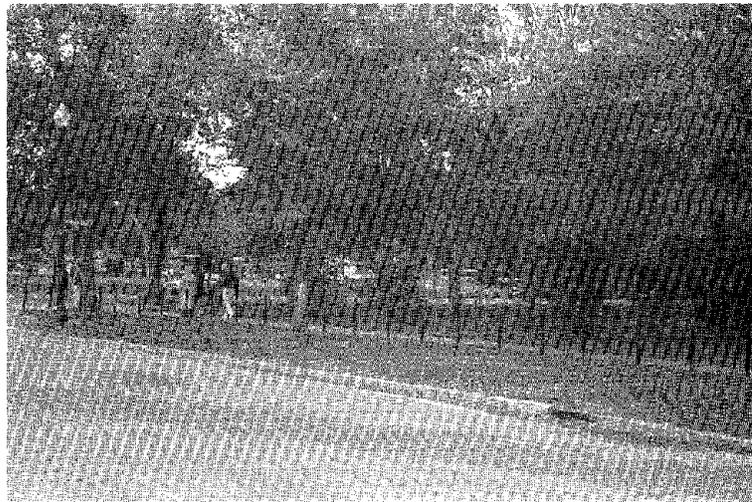
*Figure 62 - Inappropriate trees and shrubs, planted under canopy of American elms, November 11, 1996. LINC 11-27.*

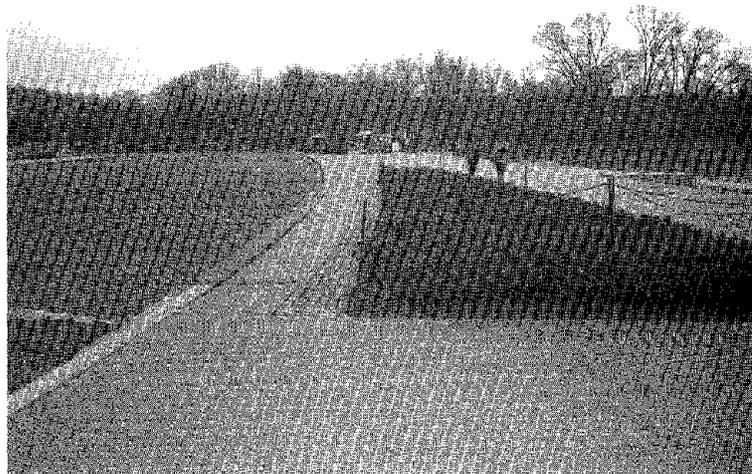
*Figure 63 - Shrub planting at top of Reflecting Pool steps, December 1996. LINC 17-35.*

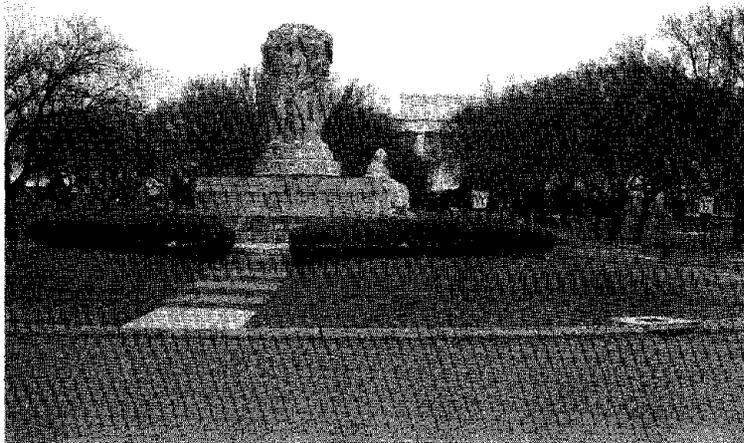
*Figure 64 – Replacement shrubs around Ericsson Memorial changes the character of the original planting, February 1997. LINC 18-8.*

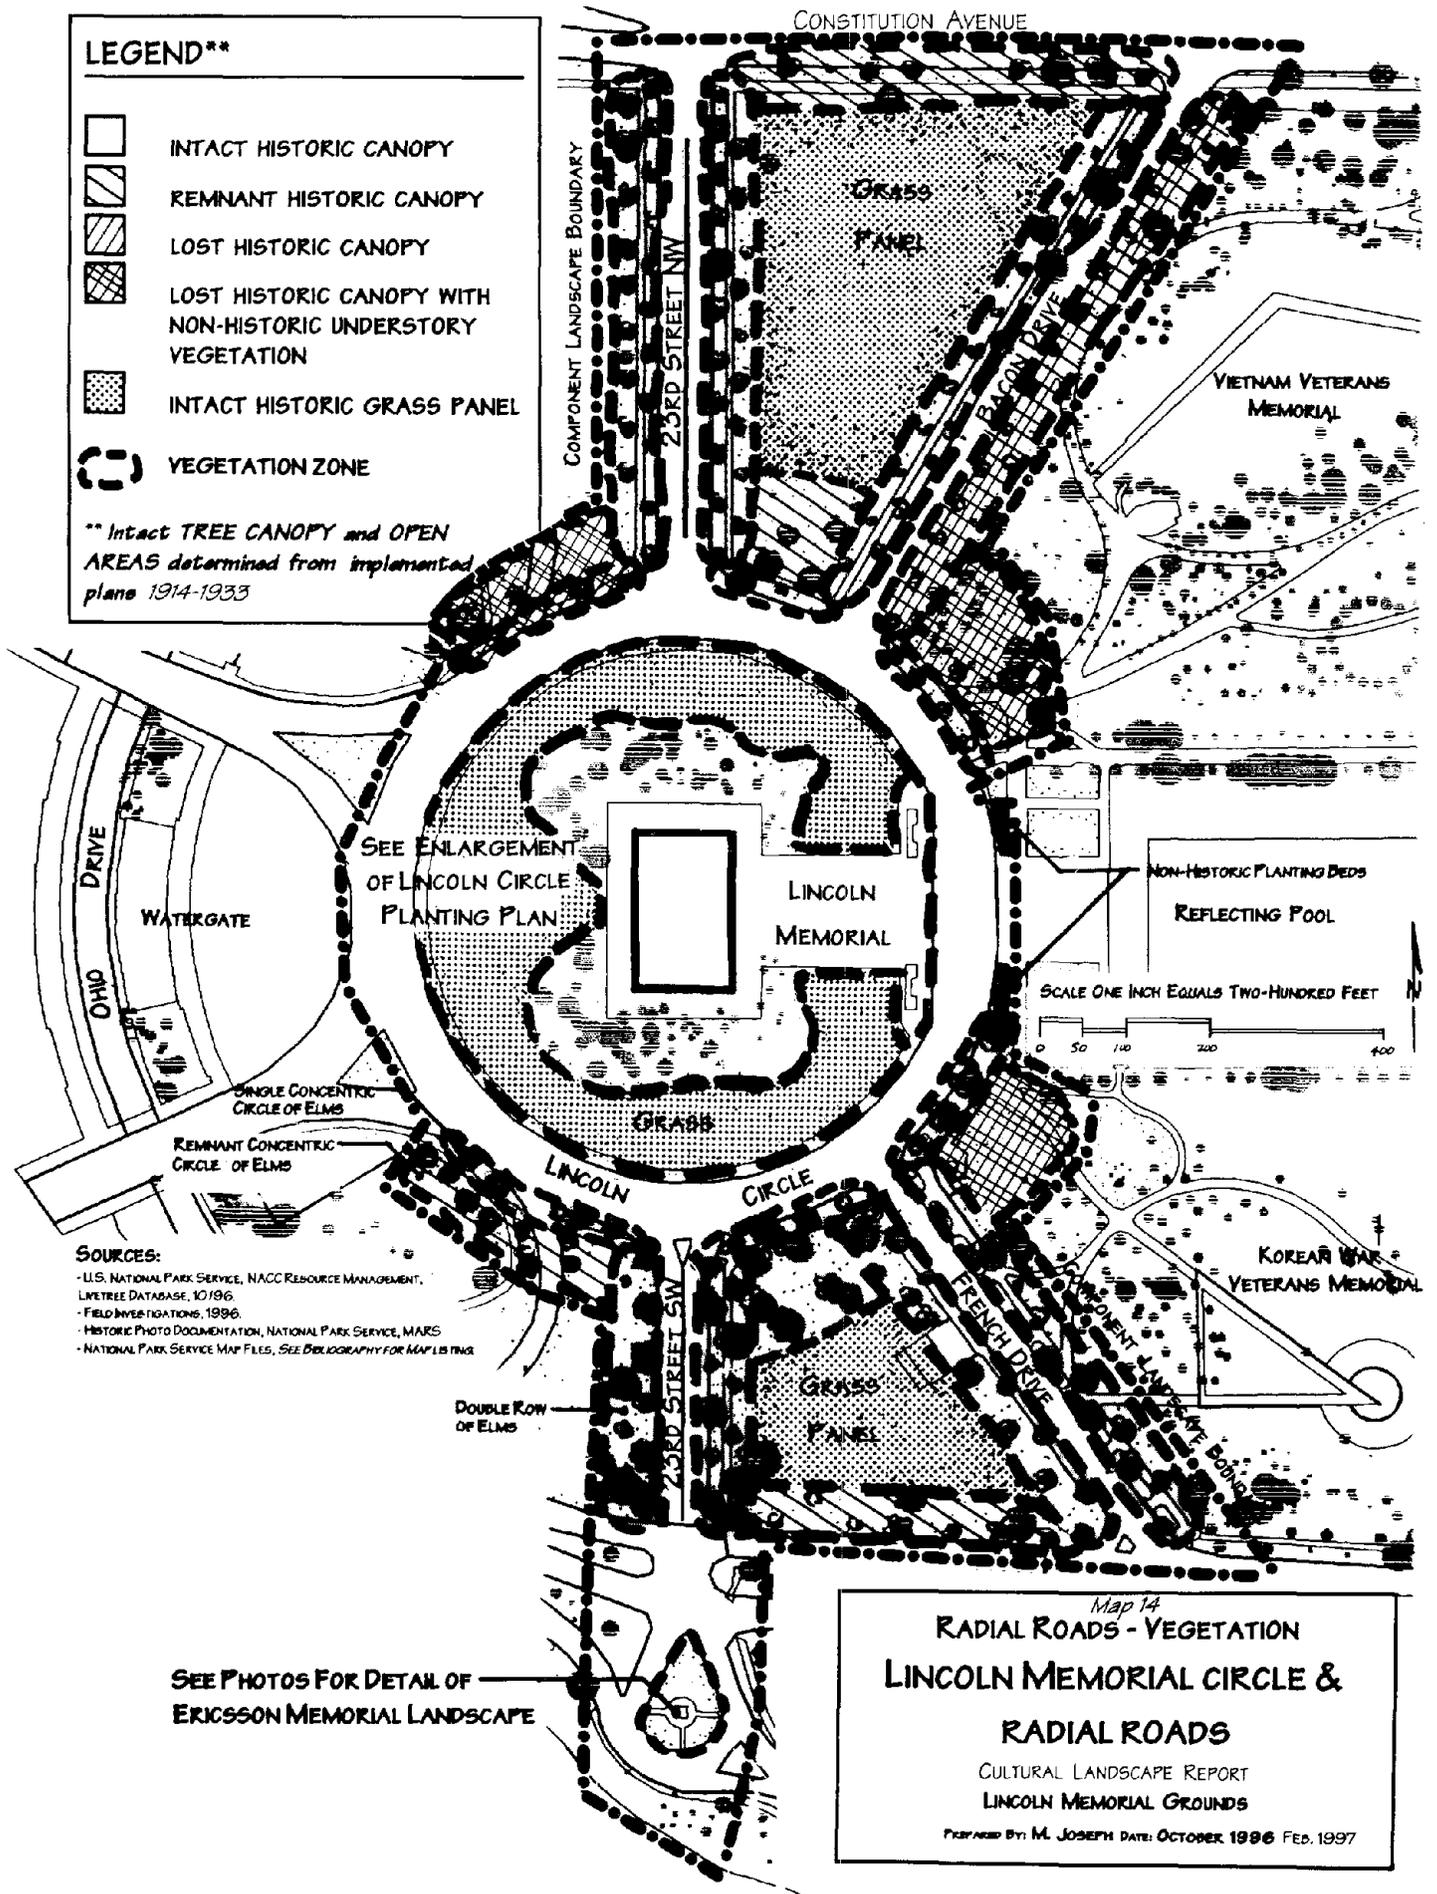
Map 14  
**RADIAL ROADS - VEGETATION**  
**LINCOLN MEMORIAL CIRCLE &**  
**RADIAL ROADS**  
 CULTURAL LANDSCAPE REPORT  
 LINCOLN MEMORIAL GROUNDS  
 PREPARED BY: M. JOSEPH DATE: OCTOBER 1996 FEB. 1997

\*\* Intact TREE CANOPY and OPEN AREAS determined from implemented plans 1914-1933

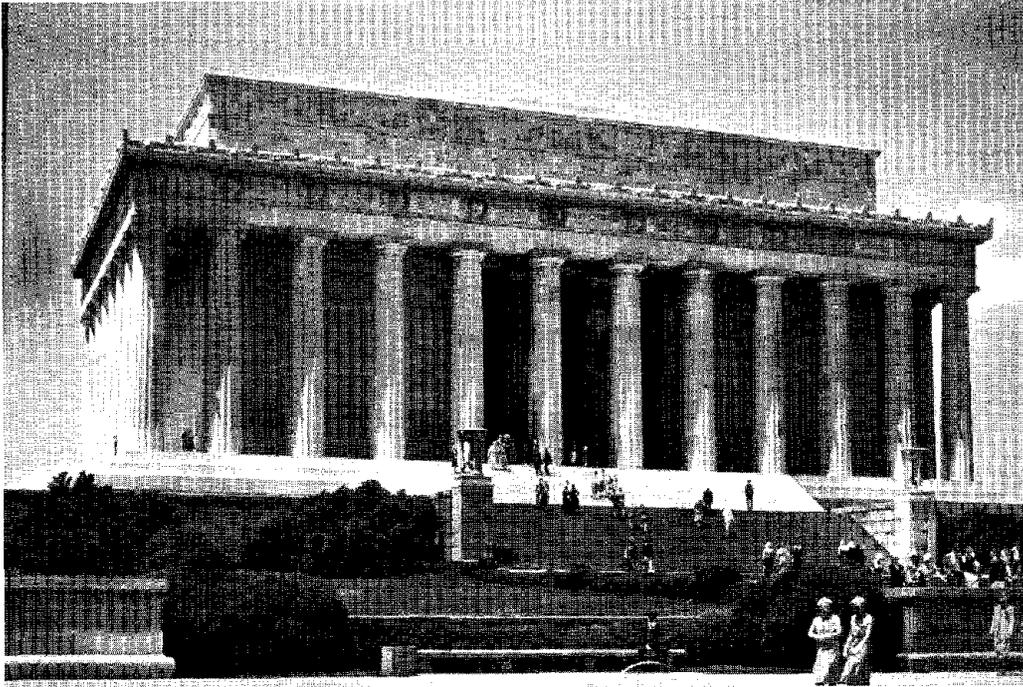
Figure 65 - East side of Lincoln Memorial showing mature boxwood and yew shrubs, 1935, by Orren R. Loudon. Used by permission from the National Geographic Society.

The first approved plan from 1920 showed plantings for the inner circle concentrated on the front, or east, side of the building, with a few shrubs along the north, south, and west sides. On the east side of the inner circle, two rectangular planting beds, each containing a granite bench and surrounded on three sides by walls of granite block, framed the entry to the memorial approachway. Two mature dwarf boxwood (*Buxus sempervirens* 'Suffruticosa') shrubs were planted within each of the walled beds beside the benches. Behind the benches a short dwarf box hedge served as a backdrop. An additional mature dwarf boxwood was placed adjacent to the far, outside wall of each planting bed. Behind the entry planting beds, hedges of dwarf boxwood lined the outer edges of the pavement along the entire length of the approachway. To accentuate the grade changes that occurred in the approachway, the design called for a larger dwarf boxwood to be placed adjacent to the successive sets of steps that marked each change in level. At the base of the raised terrace wall, groups of common boxwood (*Buxus sempervirens*) and English, Canadian, and Japanese yew (*Taxus* sp.) were planted. In addition to these massings, dwarf boxwood were planted in front of some the groups. The corners of the raised terrace wall were emphasized on the northeast and southeast with plantings extending out from the wall into

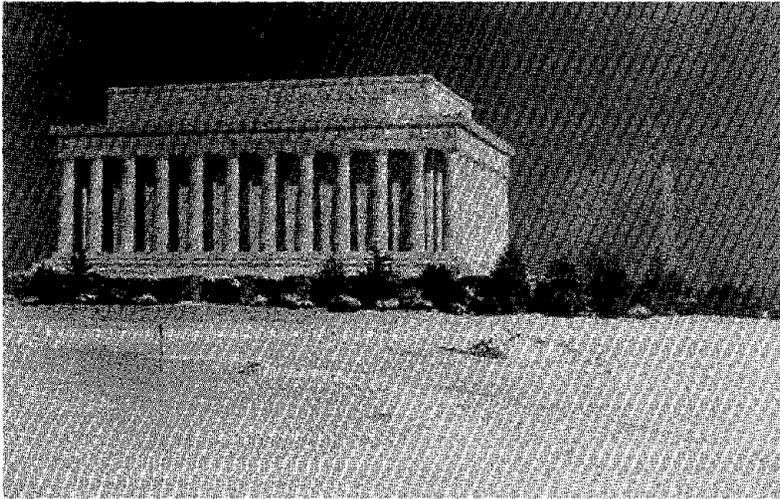
Figure 66 - West side or rear of Lincoln Memorial showing newly planted foundation plantings, c. 1932. MRC 2-20.

The design in the second approved plan from 1931 was primarily for the rear of the memorial. Several broadleaf evergreen trees were selected for this side to supplement the overall planting and to create a different effect than that on the front. In addition to common box and dwarf box, American holly, and southern magnolia (*Magnolia grandiflora*) were used to complete the palette. To anchor the rear, magnolias were strategically sited, American hollies were intermixed near the magnolias and common and dwarf boxwood were massed in front of them. This arrangement also projected into the rear lawn area, at the corners of the raised terrace wall, as it did in the front. According to the plan, an area located at the mid-point along the rear side of the raised terrace wall was to be free of planting, leaving an opening in the vegetation and an unobstructed view from the top of the raised terrace out to the river and toward the Virginia shoreline.

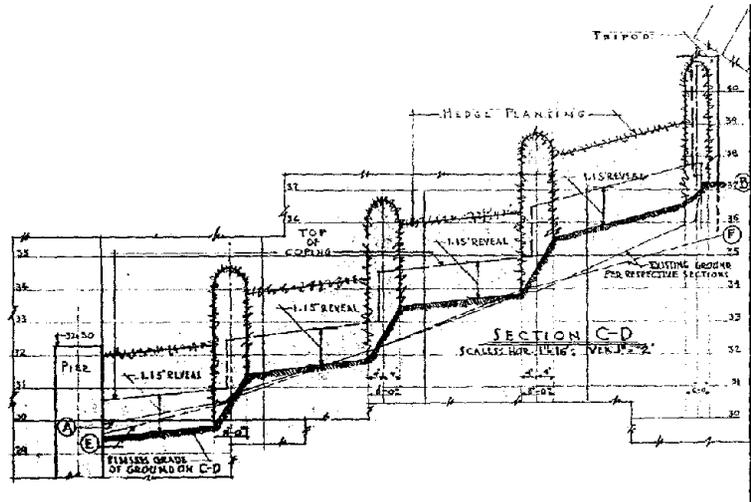
Figure 67 - Section showing desired character of replacement hedge along approachway, 1944. NPS Map 801/80347.

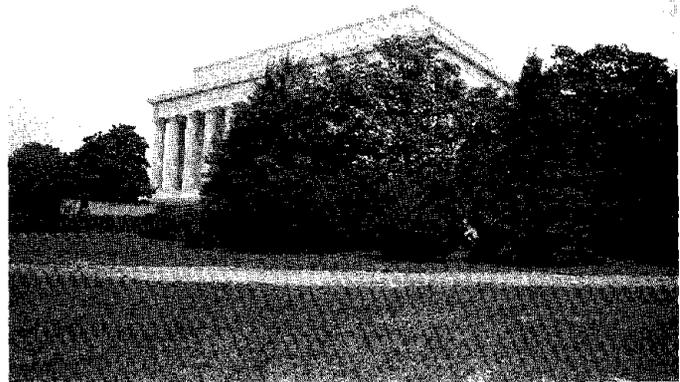
The trees and shrubs surrounding the memorial currently exhibit different degrees of health and reflect a range of growing conditions. Along the front or east side, the plantings have suffered greatly from the effects of repeated construction activity and preparation for large-scale public events that have occurred in this area over time. The 1995-96 construction on the approachway has caused further damage to the foundation plantings. The lack of routine maintenance and regular pruning has also caused some of the plantings to appear ragged or

Figure 68- Existing west side foundation plantings, July 23, 1996. LINC 10-17.

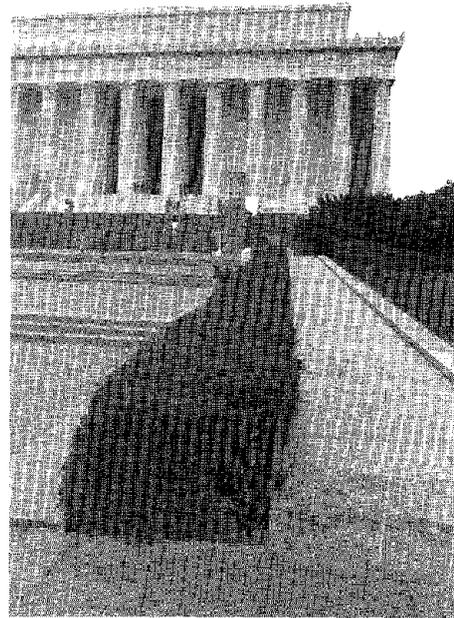
*Figure 69 - Existing yew hedge along approachway and accessible ramp, January 3, 1997. LINC 16-21.*

overgrown. When the park revised the original plans by replacing the boxwood hedges with yews in 1945, they altered the character of the entry planting, yet retained some of the historic integrity by keeping a band of green hedge growing on both sides of the approachway. However, the addition of an American holly and the Japanese hollies to the front side and massings of yews to screen floodlights have further compromised the character of the planting design. Because replacement plantings have deviated from the original design, the landscape on the front side retains a lower degree of integrity. On the sides and rear of the memorial, the integrity of the plantings is mostly intact, although some boxwood planted near the magnolias and close to the raised terrace have been shaded out and are unhealthy, or have died. At the midpoint of the north and south sides, two thick masses of *Taxus cuspidata* 'Nana' provide the horticultural transition between the character of the two different planting areas. Even though these yews were planted to replace the original mugo pines, the design intent of keeping a lower growing conifer mass in this area is still evident. In other areas overgrown plant material, like some American hollies that were planted on either side of the horizontal-growing yew mass on the north face of the memorial, are encroaching upon the designed opening above the raised terrace. See Map 15 and Map 16 *Lincoln Circle - Vegetation* for the graphic representation of the front and back plantings.

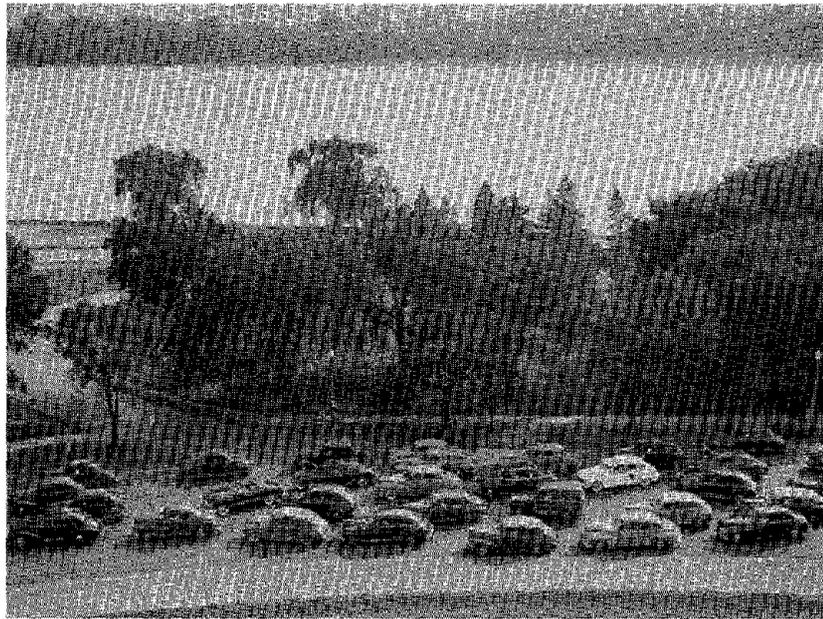
*Figure 70 - Rush hour traffic around Lincoln Circle, c. 1944. MRC 2-4.*
