# Cultural Landscape Report

## West Potomac Park Lincoln Memorial Grounds National Capital Parks Central August 1999

Part 1: Site History,  
Analysis and Evaluation  
and Design Guidelines

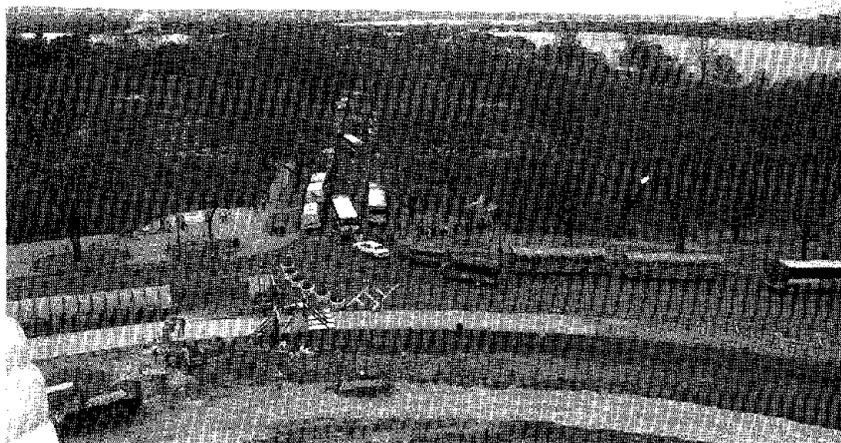
*Figure 71 - Traffic congestion on French Drive and Lincoln Circle, March 1996. LINC 6-34.*

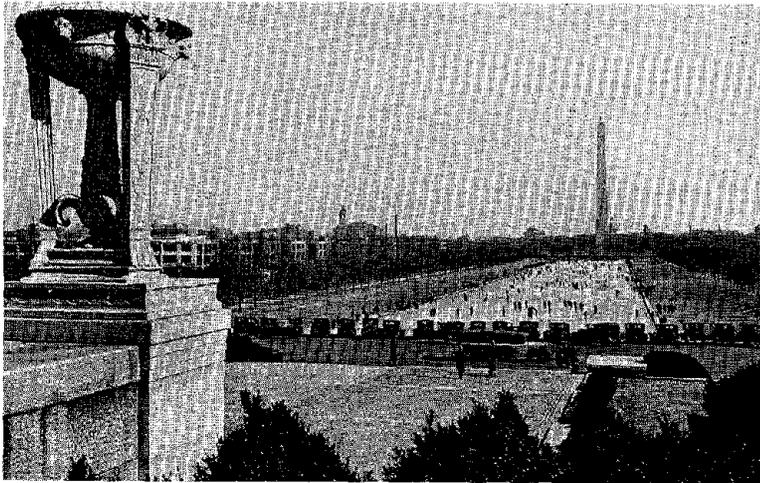
*Figure 72 - Unofficial parking area at top of Reflecting Pool steps and Lincoln Circle, 1929. Used by permission from the National Geographic Society.*

**Parking Areas.** West Potomac Park has always had a limited number of parking spaces in the areas surrounding the memorials and the Washington Monument. Onstreet parking is not only limited in the Lincoln Memorial study area, but also is restricted around the circle and the radial roads. Although a few spaces once existed on the circle where the outer curb line was squared by the design of the Reflecting Pool steps (these had never been designated for automobiles during the initial or subsequent planning). However photo documentation indicates longstanding use of this area in front of the memorial for diagonal and, later, parallel parking. In 1953 the squared curb edge was removed to create a continuous circular curb around the outside of the roadway.

The curb change displaced that small parking area.

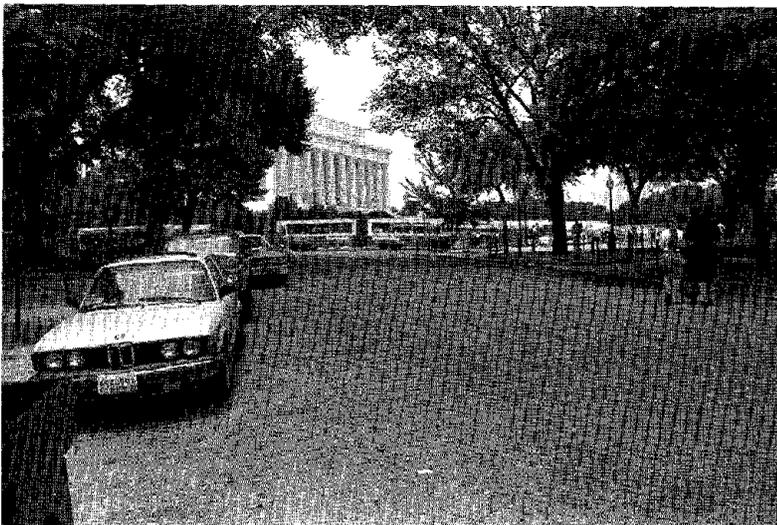
*Figure 73 - Bus and taxi drop off along French Drive, July 23, 1996. LINC 10-14.*

and French Drive and along the eastern side of 23<sup>rd</sup> Street SW. Other tour buses and taxis are directed to French Drive for all dropoffs and pickups, making this area very congested. See Map 17 *Lincoln Memorial circle and radial roads - Vehicular Circulation* for location of parking areas.

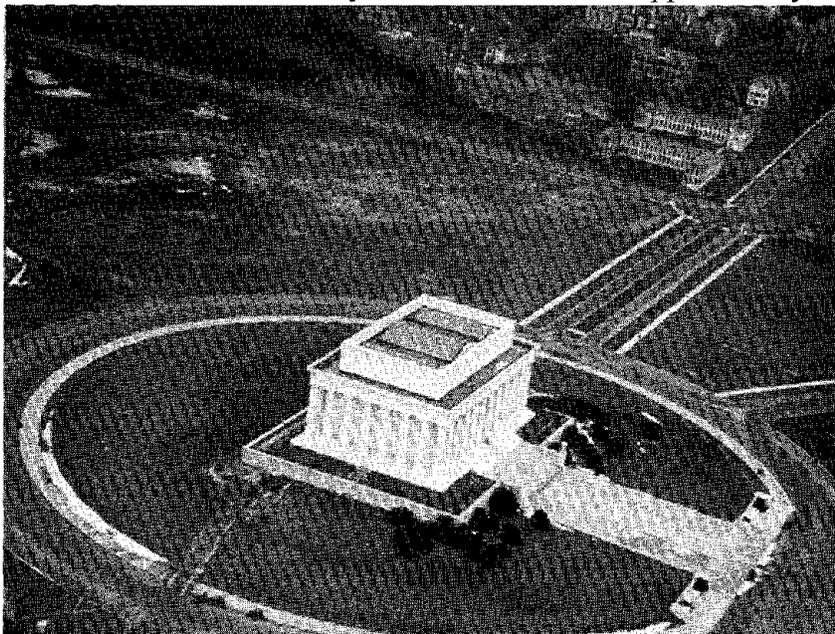
*Figure 74 - Initial sidewalk installation, February 13, 1922. U.S. Navy photo. MRC I-61.*

**Pedestrian Circulation.** The 1916 plans developed for the memorial and the surrounding areas showed a range of treatment for the various types of proposed pedestrian and vehicular routes. The plans established a hierarchy of circulation for both use and materials, with the more formal in the immediate vicinity of the memorial. The main entry to the memorial, the approachway, was paved with granite and cobblestone, creating a stately surface (further detail is presented in the “Structures” discussion for the Lincoln Memorial circle and radial roads). Around the Lincoln Circle the material changed, a 15-foot-wide concrete sidewalk was placed along the inside circumference, while a concrete sidewalk, only 8 feet wide, was placed between the first and second circular band of elms, along the outside circumference. Lawn surrounded both walkways. Along the radial roads, the proposed concrete walks paralleled both sides of the four different streets. Each sidewalk was lined by a row of elms planted in an alternate design. Lawn also surrounded these walks. For the first phase of construction in the 1920, sidewalks were installed on both sides of 23<sup>rd</sup> Street NW and Bacon Drive, around the entire inner circle and on the eastern portion of the outer circle, between 23<sup>rd</sup> Street NW and SW. The final construction phase for the circle sidewalks did not occur until 1973, when an 8-foot-wide concrete walk was installed on the western circumference of the outer circle between 23<sup>rd</sup> Street NW and SW, replacing a temporary granite paver surface installed about 1950. Since 1973, portions of this walk have been replaced and repaved with bituminous asphalt. Circulation along French Drive has the least amount of design integrity of all the radial roads. Here, the proposed sidewalk alignment was never fully implemented. On one side of the road the walkway was placed between the alternating rows of elms, but on the opposite side (southwestern curb) the walk was installed in the 1960s along the curb edge.

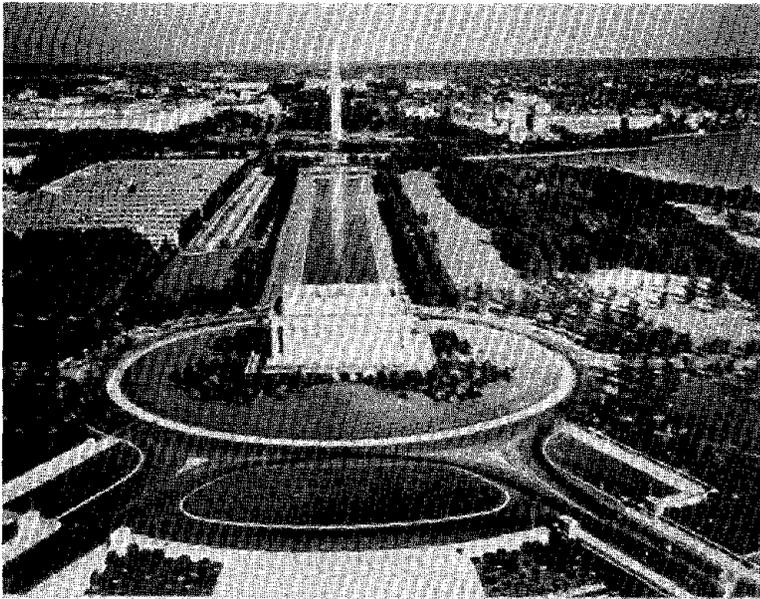
*Figure 75 - Painted crosswalks from Lincoln Circle to the sidewalks along the radial roads and approaches, 1934. MRC 1-67.*

At Lincoln Circle, pedestrian crosswalks were painted at all intersections with the radial roads and the approachway (1932 photo documentation). However, from that time forward, pedestrians crossing from any point on the circle encountered hazardous traffic conditions, especially on the east side of the memorial. To provide a safe, unimpeded place for crossing, the National Park Service began limiting vehicular traffic to the eastern segment, between French and Bacon Drives, during the 1972 tourist season.

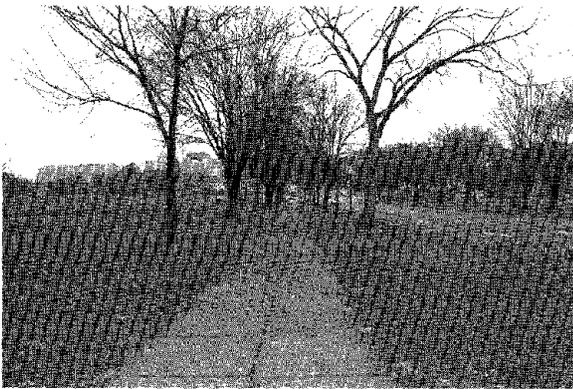
*Figure 76 - Eight-foot wide sidewalk along 23rd Street NW, January 3, 1997. LINC 16-13.*

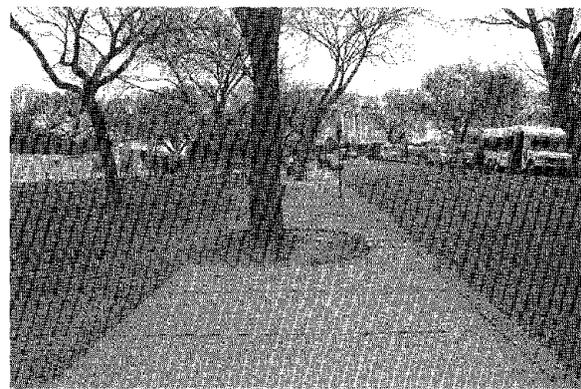
*Figure 77 - Nonhistoric layout of sidewalk along west side of French Drive, December 5, 1996. LINC 13-13.*

changes included extending sidewalks to the curb edge, the creation of individual tree planting beds with raised curb edges, and the addition of post and chain barriers to protect both the trees and the adjacent lawn. Many of the changes to the outer circular sidewalk and French Drive have been compounded with further additions brought on by the Korean War Veterans Memorial and by the perpetuation of nonhistoric site features. On the opposite side of the Reflecting Pool steps, at the Vietnam Veterans Memorial, the sidewalk width has been maintained, but it too is edged

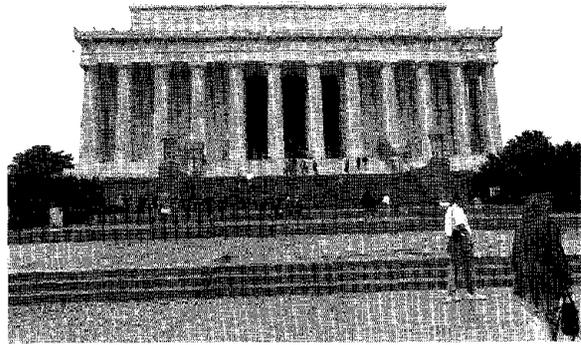
*Figure 78 - Approachway and Lincoln Memorial, January 3, 1997. LINC 16-20.*

Since the opening ceremonies in 1922, the Lincoln Memorial, dedicated to honor Abraham Lincoln, has been a symbol of the national capital and also a symbol of the reconciliation between North and South. It is the most important structural feature in the study area. Only a few structural changes have occurred since 1922, and these have been concentrated on the eastern face of the memorial. A series of steps and platforms, which make up the approachway, serve as the main entrance to the memorial. The approachway descends toward Lincoln Circle in a series of four platforms, each separated from the next by three granite steps. Each platform is a tripartite composition of a central area paved with granite, flanked by panels of smooth cobblestone, set in mortar bed, surrounded by granite block pavers. The bottom section consists of eight granite steps flanked on both sides by granite pedestals. The entire approachway system is supported by a concrete structure, pinned to bedrock.

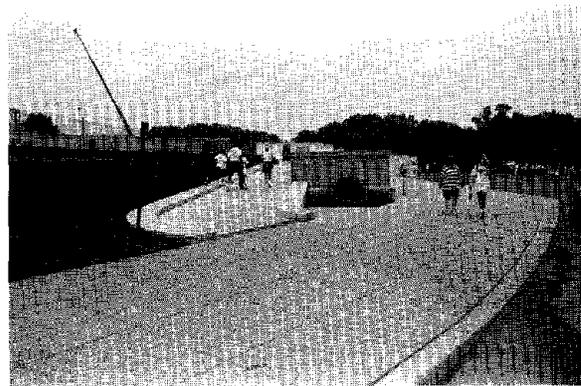
*Figure 79 - Reconfigured accessible ramp to Lincoln Memorial, July 23, 1996. LINC 10-7.*

Improvements were made to the approachway entrance in the 1970s, based on the Commission of Fine Arts approval. On the north and south sides, ramps, paved in exposed aggregate concrete, were installed to make the memorial more accessible for people unable to use the approachway steps. The ramps began at the outer granite pedestals at the inner circle sidewalk and continued behind the planting beds and turned 90 degrees to run parallel to the approachway along the outside edge of the yew hedges. They ended at the base of the raised terrace. The southeast entrance in the raised terrace wall led to an elevator and an exhibit space, as well as the restrooms. The northeast entrance was closed to the public.

Through the years the cobblestone panels have deteriorated, mostly due to freeze-thaw cycle. Park maintenance has responded by patching the deteriorated areas with a variety treatments. The unsightly appearance of this repair work for the cobblestone and safety concerns for visitors walking on the irregular surface, in addition to the structural problems, poor drainage, and lack of expansion joints, prompted the National Park Service to restore the entire approachway structure in 1995-1996. A few additions and alterations were made to the approachway area during this project. The cobblestone panels were removed and constructed in the same fashion as the original, with the exception that the stones were set to a greater depth in mortar to deter the

stones from dislodging. Also the ramps were redesigned to meet current accessibility standards according to the Americans with Disabilities Act (ADA) and provide a wider path for visitors. The new ramps have a more gentle slope (5%) and are 9 feet wide, 3 feet wider than the old ramps. As a result of the reduced slope of the ramps, the coping on the planting bed retaining walls needed to be raised 11 inches. Another course of granite and new granite coping (due to the deteriorated state of the original coping) were placed on top of the existing walls. The last change to the structure was the realignment of the ramps where they met the inner circle sidewalk. The previous ramps had a blind curve where the ramp and sidewalk came together. This situation was corrected to give visitors a clearer view when descending the ramp. Although the ramps are not historic, the National Park Service treated this area with the same respect for the historic fabric as they did for the main entrance steps by integrating the redesign of the ramp into the original approachway design. By using granite paving instead of exposed aggregate for the ramp surface, and by defining the edge of the ramps with granite coping, the ramps appear to be a part of the approachway.

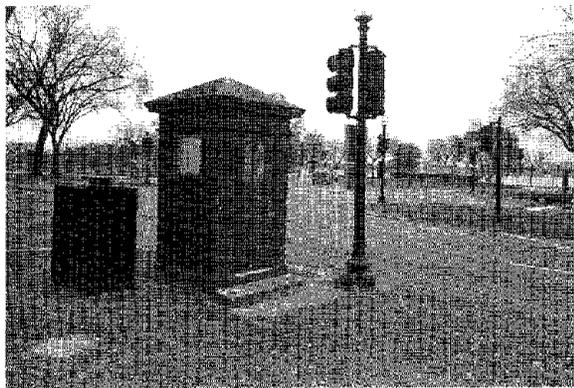
Another minor structure is a guard stand at the intersection of Independence Avenue, Ohio Drive, and 23<sup>rd</sup> Street SW. After the completion of Independence Avenue in the 1940s, the National Park Service placed this 5-foot by 5-foot structure to provide shelter for a traffic officer. The officers controlled the traffic light and setup barricades at this intersection to direct one-way traffic on the Rock Creek and Potomac Parkway during rush-hour. It is rarely used today. See Map 19 *Lincoln Memorial circle and radial roads - Structures* map for location of structural features.

*Figure 82 - Guard Stand at the intersection of Independence Avenue and 23rd Street SW, December 5, 1996. LINC 13-8.*

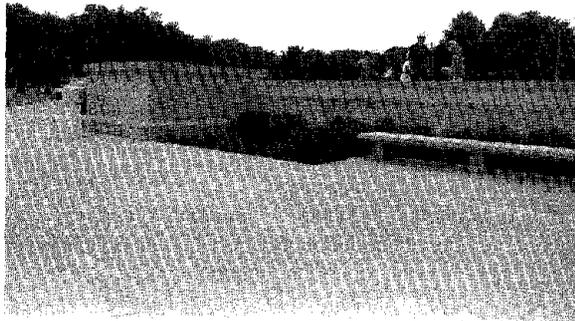
*Figure 84 - Two types of trash receptacles located in the front planter by a granite bench, July 23, 1996. LINC 10-5.*

the receptacles were also moved to French Drive. Generally trash receptacles and receptacles for recyclables are placed next to every bench that is along French Drive. Wire-type trash receptacles have been placed near ballfield backstops located in the grassy areas on the north between the radial roads. A variety of trash receptacles were found on the approachway during a study conducted in the early 1990s. The selection found there at that time included the "tulip," a pre-cast concrete trash receptacle and an upright metal type. These same three types are still used along the approachway. A tall white metal cylinder-type stands at the base of the approachway steps. A "tulip" has been positioned in both of the approachway planting beds on either side of the granite benches. And several pre-cast concrete trash receptacles are positioned at every elevation change for the approachway. None of the receptacles are compatible with the formal setting of the Lincoln Memorial.

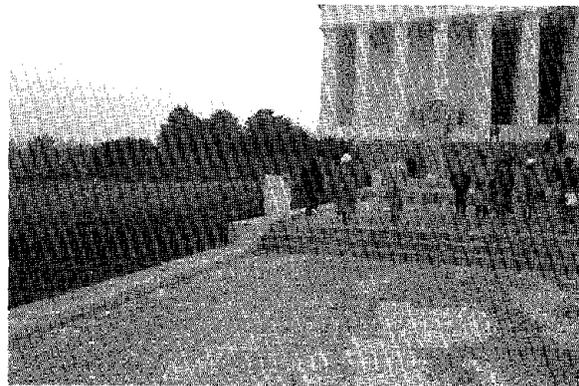
*Figure 85 - Pre-cast concrete trash receptacles along approachway, December 15, 1996. LINC 13-24.*

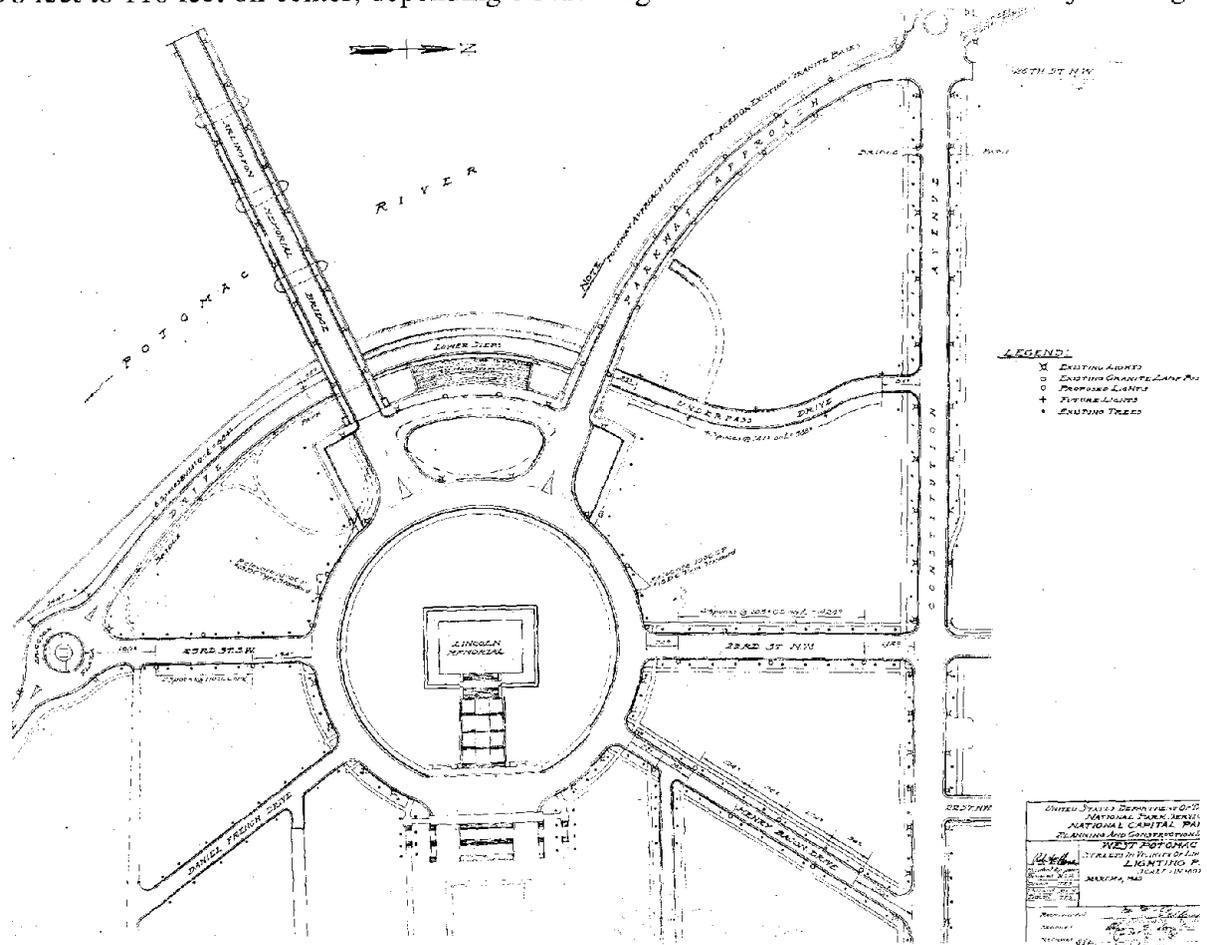
Map 20- Lighting Plan for West Potomac Park, 1940. NPS Map 76-321

**Lighting.** In Henry Bacon's original vision for the Lincoln Memorial, the structure and the surrounding grounds were to be lit exclusively by moonlight. Shortly thereafter, Bacon conceded to the installation of street lamps around the outer circumference of the Lincoln Circle and along the radial roads. The "Washington Globe" lights were selected. These were made up of an acorn, lamp style, and a cast-iron post. The post was painted a light gray color. Spaced approximately 75 feet apart on the traffic circle, the primary function of the streetlights was to provide illumination for the roads and walkways around the Lincoln Memorial, and not to light the interior of the memorial. Eighteen-foot high lampposts were placed around the circle to provide greater amount of illumination, since they were to be placed only along the outer circle. Subsequent improvements to the lighting occurred in 1927 when the CFA approved a plan to provide lighting in the statuary chamber. Another street lighting plan developed in 1940 refined the first plan. A few existing posts were relocated along the outer edge of the circle and a shorter version of the "Washington Globe" streetlight was installed along all the radial roads except French Drive. Shorter 16-foot posts were spaced alternately at even intervals, varying between 96 feet to 110 feet on-center, depending on the length of the radial road. The last major change

was in 1969, when flood and spot lights were installed near the raised terrace wall to illuminate the exterior of the memorial structure. In 1972 the National Park Service proposed a lighting plan for French Drive, but it was never implemented. At some point after 1933, the lamppost were painted black, which differs drastically from the original light gray color.

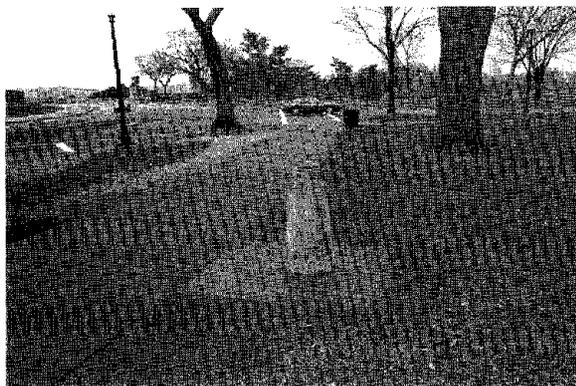
Figure 86 - Concrete drinking fountain located between 23rd Street NW and Bacon Drive, January 3, 1997. LINC 16-16.

**Drinking Fountains.** The 1916 design did not specify the use of drinking fountains, but according to photo-documentation, the Office of Public Buildings and Public Parks did installed drinking fountains along the outer circle by 1927. In 1996 two of the original concrete drinking fountains were documented to be adjacent to the outer sidewalk on the segment located between Bacon Drive and 23<sup>rd</sup> Street, NW and near the southwest corner of the intersection of Constitution Avenue and 23<sup>rd</sup> Street, NW. An accessible drinking fountain was installed at the lower end of each of the two ramps constructed along the memorial approachway in 1976. However, these were removed when the ramps and approachway were rehabilitated in 1995-1996. When reviewing the proposed modifications to the approachway, the CFA commented on the inappropriate design of the fountains at this particular location. Presently, the two old concrete fountains, a single accessible drinking fountain located southwest of the southern Reflecting Pool walk (1995), as well as accessible fountains near the adjacent playing fields on the south, and at the entrances to the Vietnam and Korean War Memorials all provide water to visitors. The newer fountains conform to current design standards for West Potomac Park and the Mall.

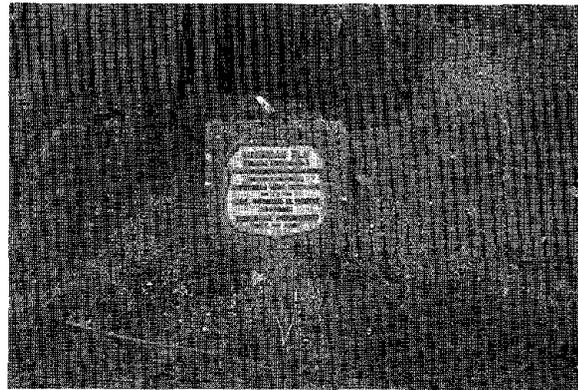
*Figure 87 - Memorial planting shield located along the Lincoln Circle, April 1996. LINC 7-2.*

**Signs.** In the 1930s, the National Park Service continued the efforts of the Office of Public Buildings and Grounds (OPBG) and Office of Public Buildings and Public Parks (OPBPP) by providing a marker for the majority of memorial trees within the Lincoln Memorial area. A bronze shield, inscribed with the names of the dedicated individual or group, were embedded into a concrete base. There were three different installations proposed for the markers; flush to the ground; raised up above the ground on a slant; and a post above ground, straight. Over the years the markers have been damaged and removed or buried by grade increases near the base of the trees. Repair and replacement of the damaged markers stopped in the 1960s. Because of the lack of support for the maintenance of the memorial tree program in the Lincoln Memorial area, only two markers are left. Both of the markers are located between French Drive and 23<sup>rd</sup> Street SW. Since the creation of the first planting plan in the 1916 up until the implementation of the landscape design for the west side of the memorial in 1932, memorial trees and the markers have been an important site feature of the commemorative landscape.

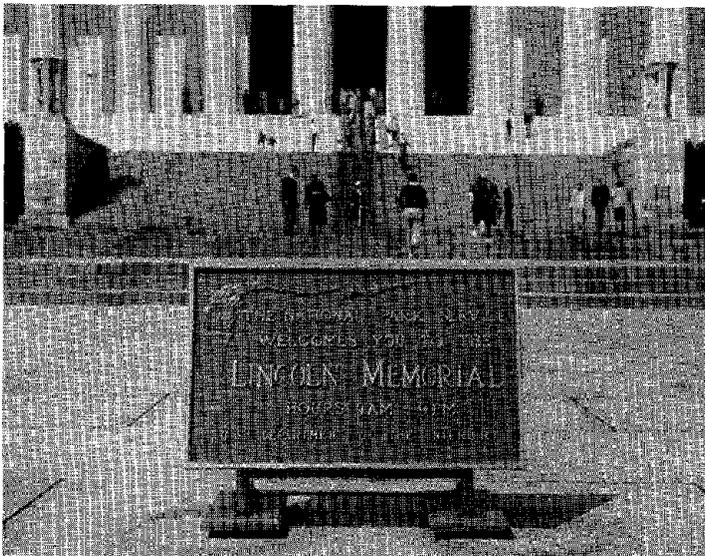
*Figure 88 - Bronze sign placed along approachway, April 16, 1952. MRC 1-44.*

In the 1950s and 1960s, a bronze sign placed in a central location on the approachway, indicated the visiting hours for the Lincoln Memorial. It appears that the low-profile sign was never permanently mounted to the paving.

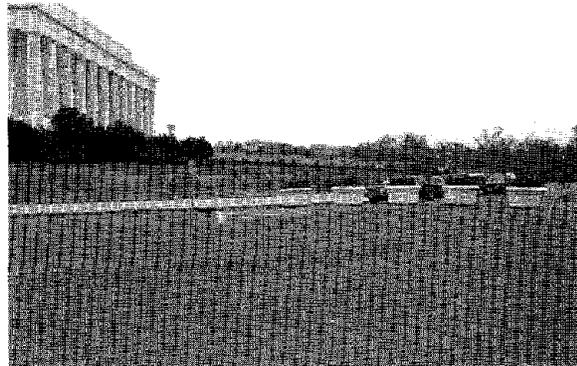
*Figure 89 - Planter barriers on Lincoln Circle, December 5, 1996. LINC 13-20.*

**Traffic and Pedestrian Barriers.** A variety of traffic barriers are used to control vehicular traffic around the circle. These include concrete planters, jersey barriers and flexible delineators. All the barriers add visual clutter and detract from the formal and geometric setting around the circle.

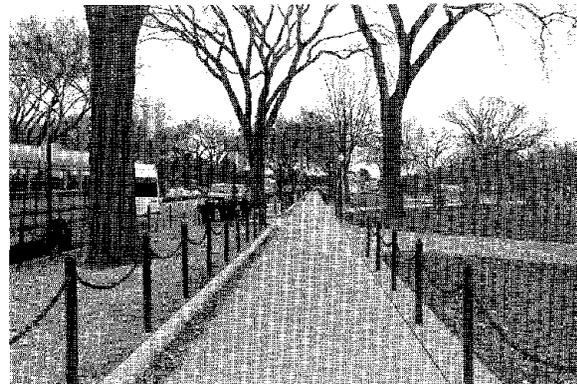
*Figure 90 - Stake and chain barrier along French Drive, December 5, 1996. LINC 13-15.*

For pedestrian areas, four different types of barriers are used: post and chain; stake and chain; stake and rope; and snow fence. Park maintenance has installed these fences for a variety of reasons, but overwhelmingly for the control of visitor circulation. The most formal and most predominant is the post and chain. Most of the posts are installed in a metal sleeve set in the ground for easy removal. Although the second type, the stake and chain, is less widely used, it also prevents pedestrians from walking on grass and in planting beds. The other types, the stake and rope and/or snow fence, provide temporary protection of newly seeded areas and control circulation during special events.

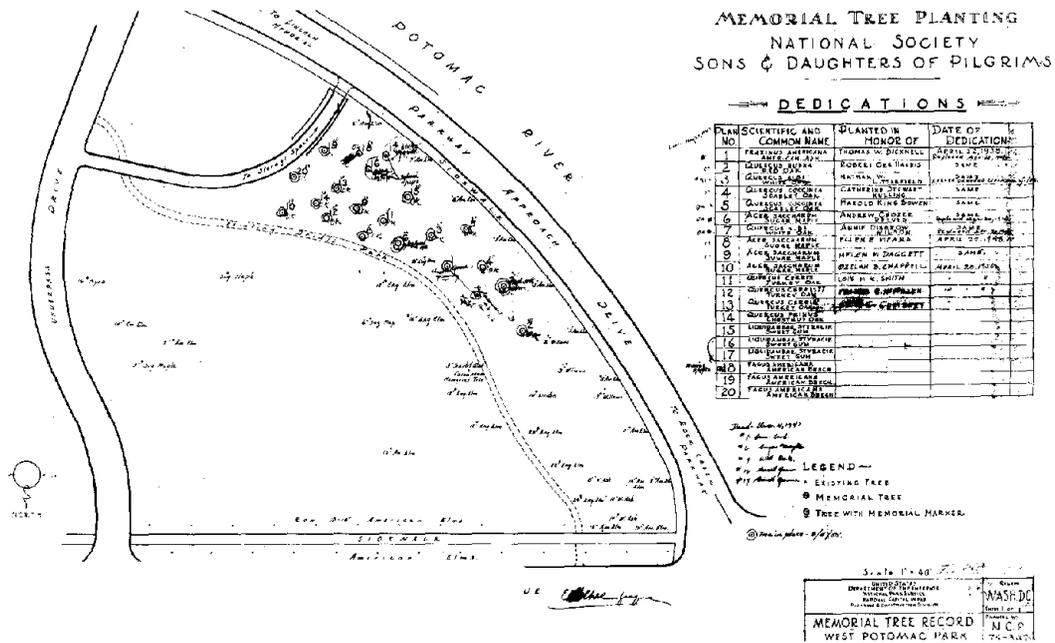
Map 21 - Memorial tree plan for naturalistic grove, 1938 rev. 1955. NPS Map 801/80235.

The greater the distance from the symmetrical design of the circle and the radial roads, the more informal the proposals for treatment became. The planting plans for the recreational areas west and northwest of the memorial were therefore informal in character. A grove of native, deciduous trees were planted here in the 1930s and 1940s as part of the memorial tree program. The exception to this was the row of American elms that lined the northeast side of Parkway Drive from the north Watergate wing wall to the terminus of Constitution Avenue. Again, as in the other informal areas, understory plantings were proposed but never planted during the initial stages of development. Subsequent additions

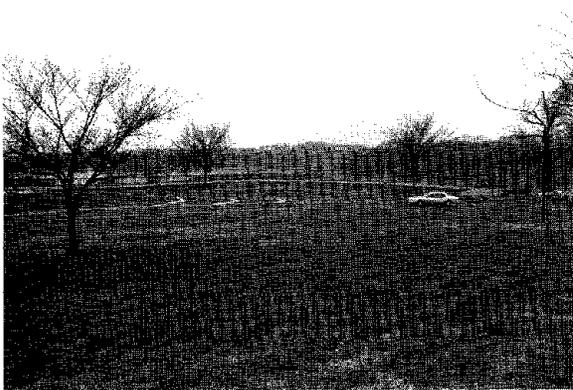
Figure 96 - Old Constitution Avenue terminus and remnant row of elms, January 3, 1997. LINC 16-5.

Along Constitution Avenue, a double row of American elms lined the road. At the western terminus, the formality continued. Two elms were planted in a small grassy area, and a circular planting bed surrounded by pavement marked the end of the avenue. Even after the realignment of Constitution Avenue in the 1960s, for the construction of the off ramps for the Roosevelt Bridge, a line of elms still follow the old alignment to the Potomac shoreline, where the terminus has remained unchanged since its construction in

the 1930s. The only possible change to the terminus are seasonal flowers that have been added to create interest to the formal circular bed. There is no documentation on how this circular area was proposed to be used after its installation.

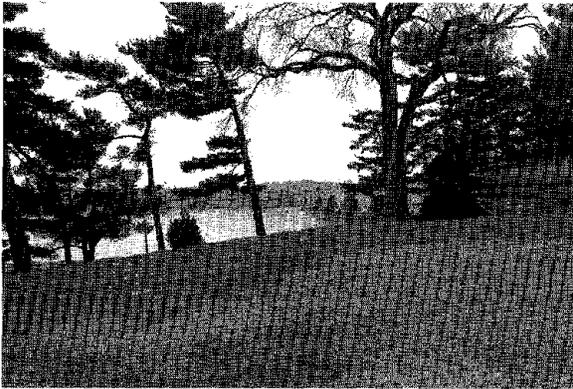
*Figure 97 - White pines, American elms and mugo pines frame view to Arlington Memorial Bridge, January 3, 1997. LINC 16-31.*

Even with the changes in the landscape, much integrity from the original Arlington Memorial Bridge Commission planting plan remains. The transition from the more formally planted drives to the informal groupings of shrubs and trees on the grassy slopes is still intact. The tall picturesque white pines, bald cypress, and deodar

cedars continue to frame the view from the top of the Watergate steps across the Potomac to the Virginia shoreline. Some flowering dogwoods still survive underneath these large trees, though these natives have been replaced in recent years with Kousa dogwood, which have a different, less open growth habit.

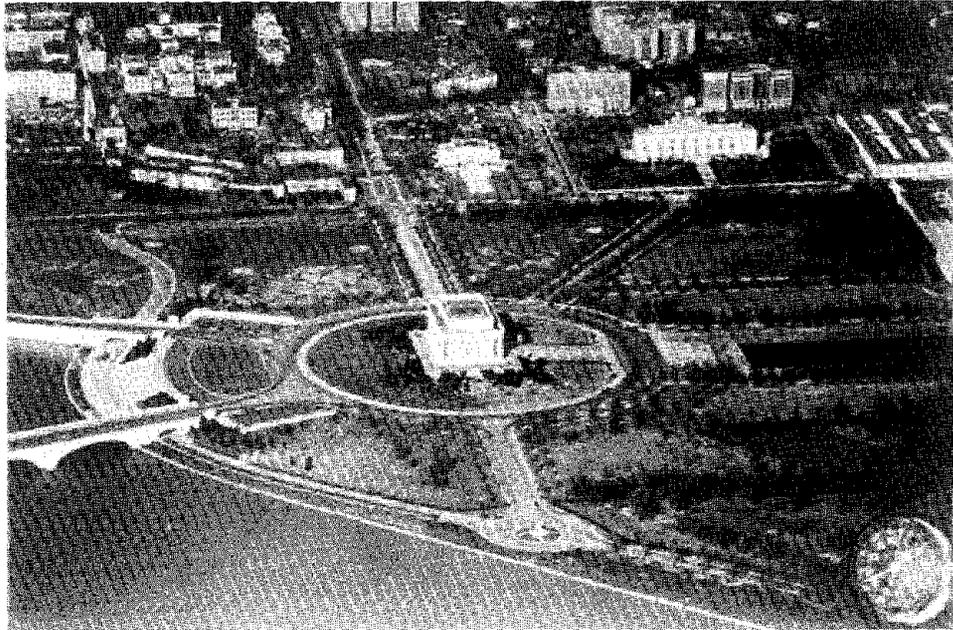
*Figure 98 - Aerial view of completed road system for the Watergate area, July 1937. U.S. Navy photo. MRC 1-64.*

**Vehicular Circulation.** The development of a shoreline drive, with bridle and foot paths, along the Potomac River shoreline in 1907, marks the beginning of road construction for this component landscape. When the development of more formal roads around the Lincoln Memorial occurred in the 1920s, the shoreline road was modified to accommodate these changes. Remnants of the old roadway are still visible along sections of present-day Ohio Drive, southeast of the Ericsson Memorial.

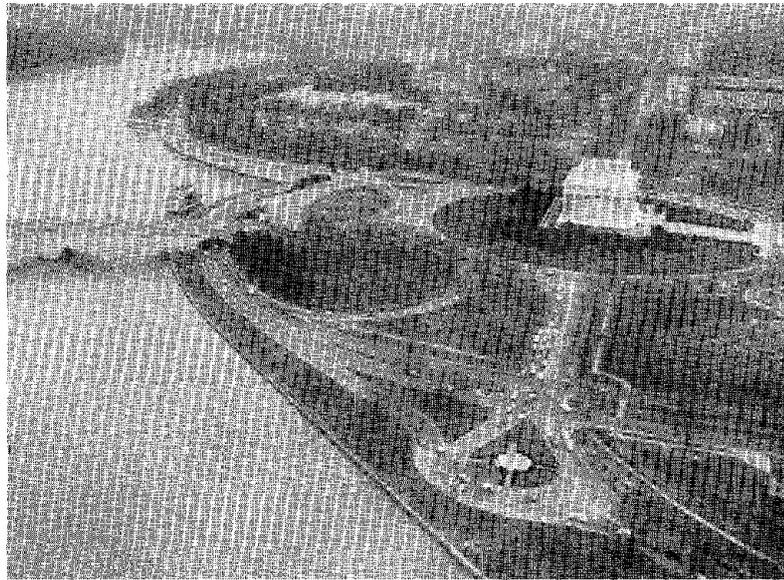
*Figure 99 – Aerial of Independence Avenue and cloverleaf pattern before construction of Theodore Roosevelt Bridge, January 27, 1960. MRC 1-108.*

Significant road improvements occurred in the 1940s when the D.C. Department of Highways and the Public Works Administration constructed the western extension of Independence Avenue through West Potomac Park. The new extension met the drive (Ohio Drive) north of the Ericsson Memorial and followed an easterly route on an alignment of an older east/west park road. At this time, a cloverleaf configuration was also constructed

north and south of the Watergate steps plaza to accommodate the increase in traffic and to provide safe on/off ramps from Ohio Drive to Lincoln Circle and the approaches. The traffic islands at the circle were enlarged at this time to control traffic from the approaches to Lincoln Circle. The previously granite block pavers filling in the islands were removed in favor of grass.

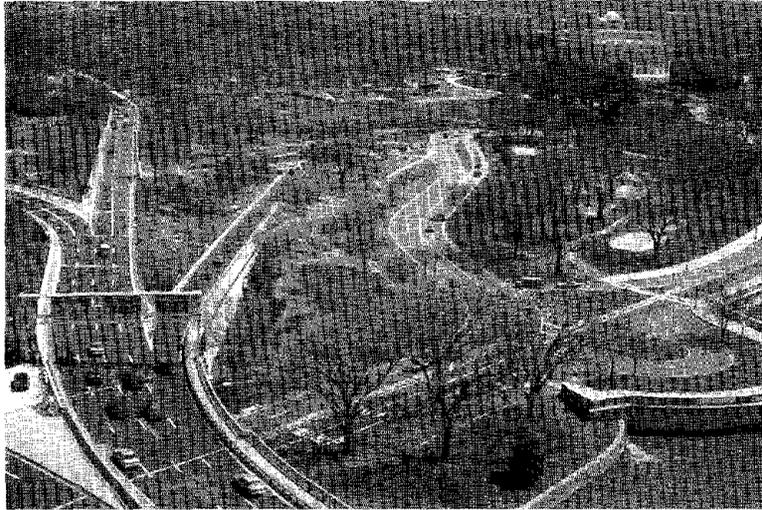
*Figure 100 - Aerial view of Roosevelt Bridge and its connection to Constitution Avenue and Ohio Drive, April 1996. MRC 3-27.*

The last major change in vehicular circulation occurred in 1964 with the completed construction of a segment of a proposed inner loop freeway and the Theodore Roosevelt Bridge across the Potomac River. The impact of a new network of roads on Constitution Avenue, west of 23<sup>rd</sup> Street, was significant. The on/off ramps required for the bridge and freeway made the previous configuration of Constitution Avenue impossible to maintain. The Constitution Avenue approach to the formal terminus was thus eliminated in favor of curving ramps and new access roads. In 1984 the road at the top of the Watergate steps was removed and sodded over, but the granite curb remained along the sidewalk's edge.

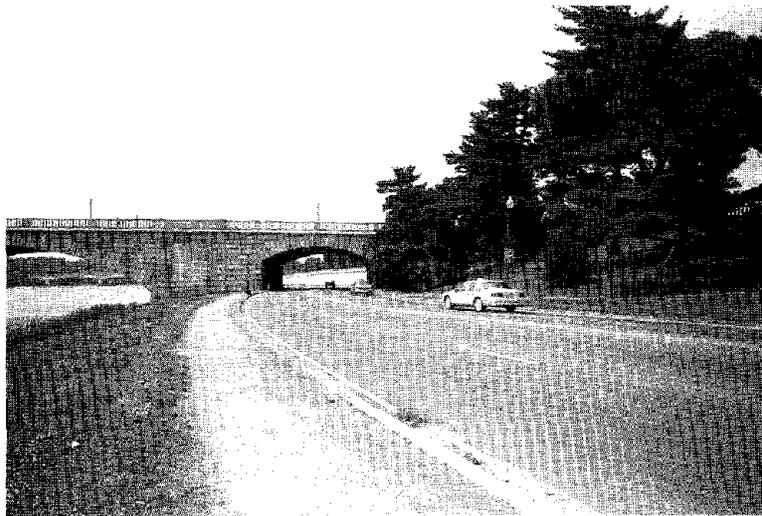
*Figure 101 - Ohio Drive (Riverside Drive) and underpass for Arlington Memorial Bridge, June 1996. LINC 9-11.*

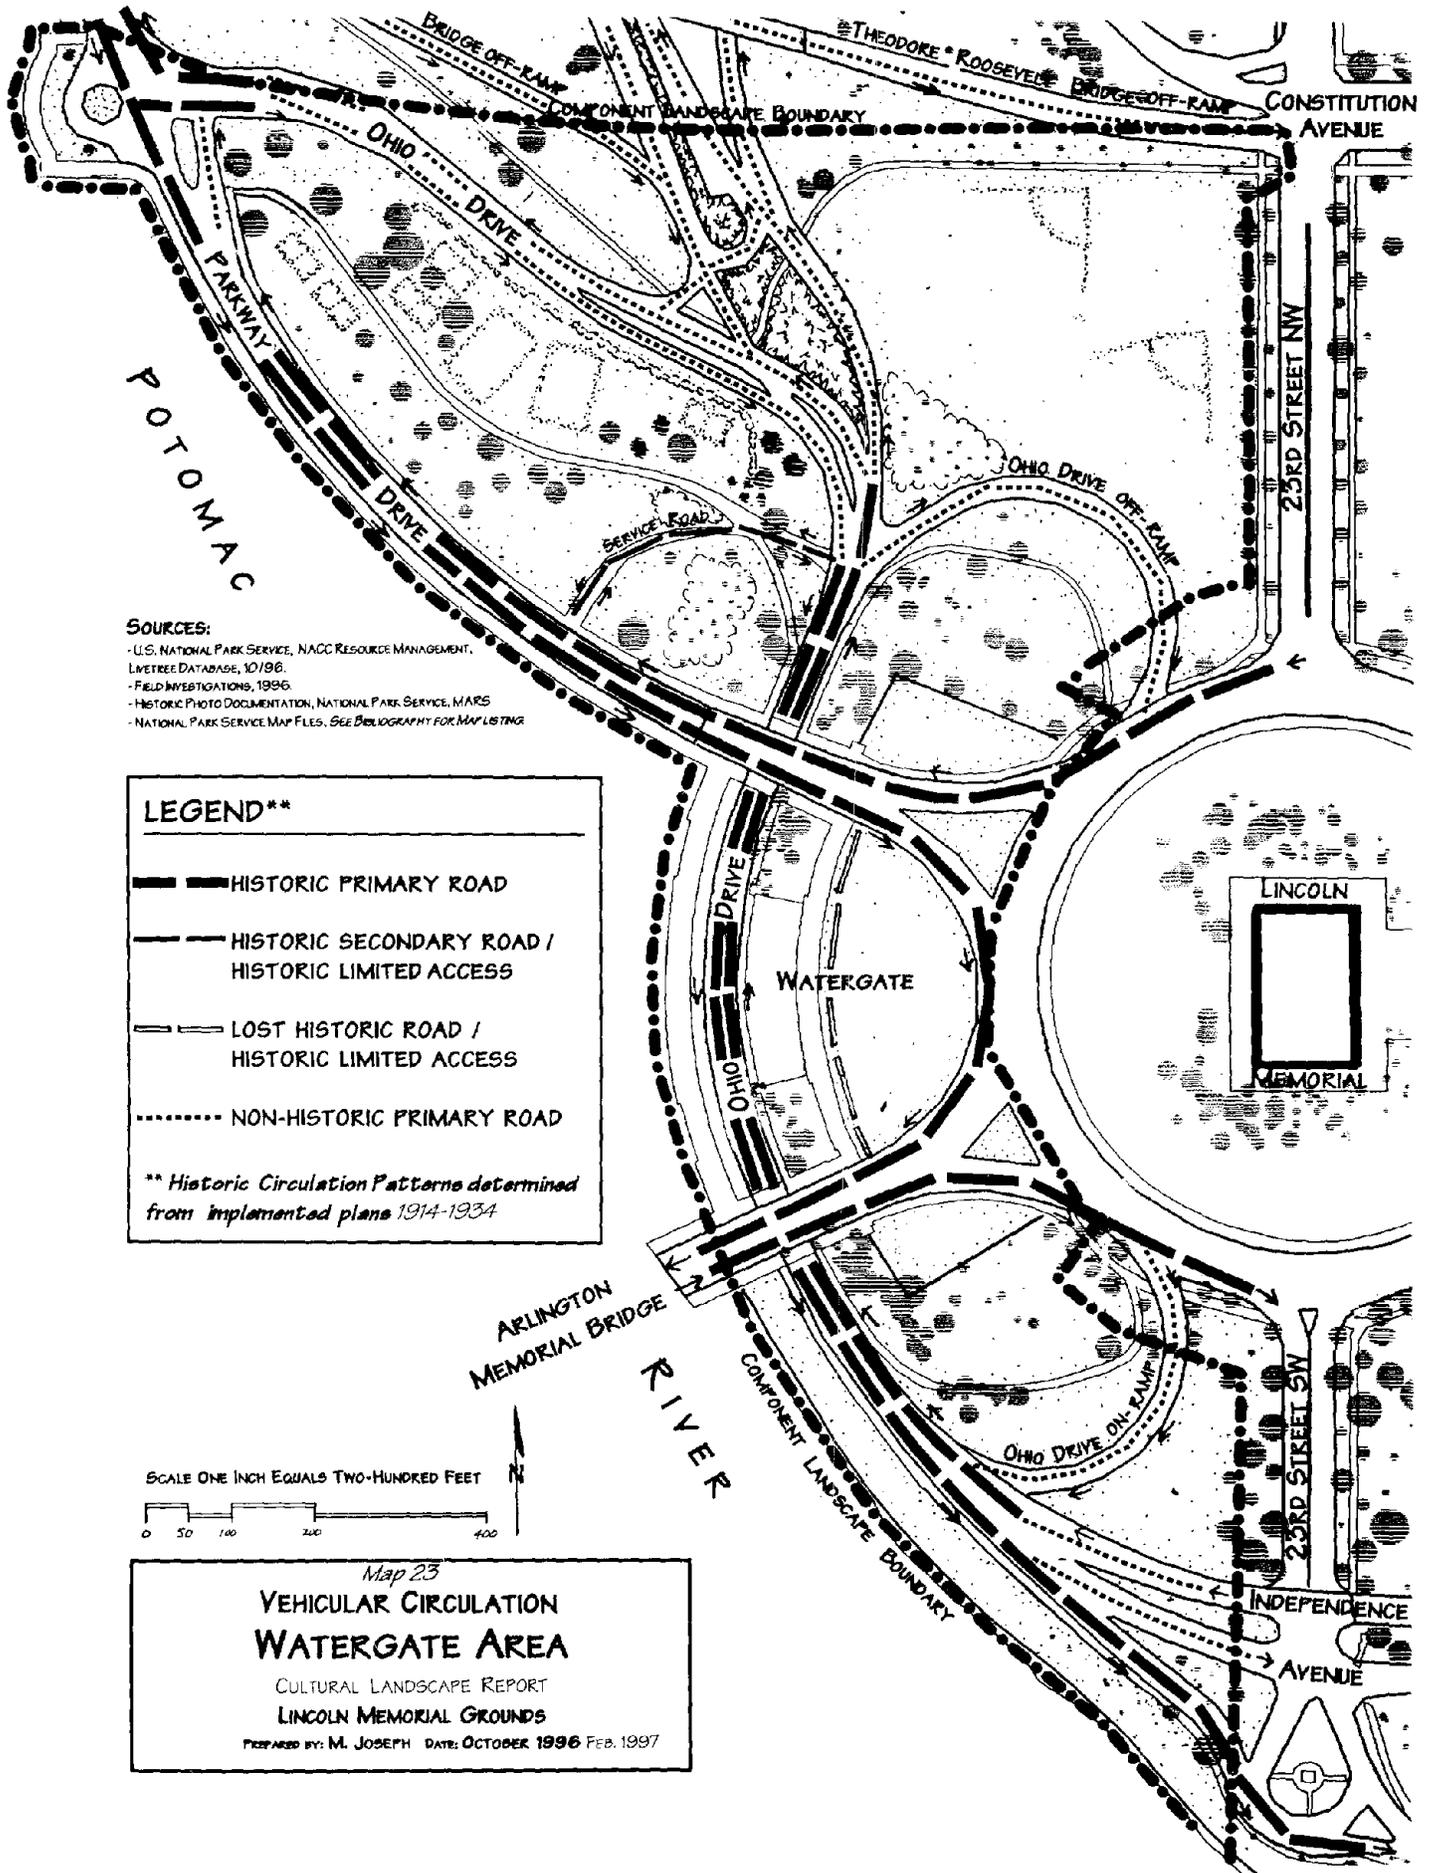
Map 23  
**VEHICULAR CIRCULATION  
 WATERGATE AREA**  
 CULTURAL LANDSCAPE REPORT  
 LINCOLN MEMORIAL GROUNDS  
 PREPARED BY: M. JOSEPH DATE: OCTOBER 1996 FEB. 1997

Contributing Features	Noncontributing Features
<ol style="list-style-type: none"> <li>1. Arlington Memorial Bridge</li> <li>2. Parkway Drive</li> <li>3. Ohio Drive</li> <li>4. Service road to storage area</li> <li>5. Remnant Constitution Avenue terminus</li> </ol>	<ol style="list-style-type: none"> <li>1. Independence Avenue extension</li> <li>2. On and off ramps at Ohio Drive (cloverleaf pattern)</li> <li>3. Theodore Roosevelt Bridge on and off ramps</li> <li>4. Size of traffic islands on Lincoln Circle</li> </ol>

on the landscape around Lincoln Circle. Here, only a cloverleaf ramp was constructed. See Map 23 *Watergate area - Vehicular Circulation* for graphic representation of contributing and non-contributing features.

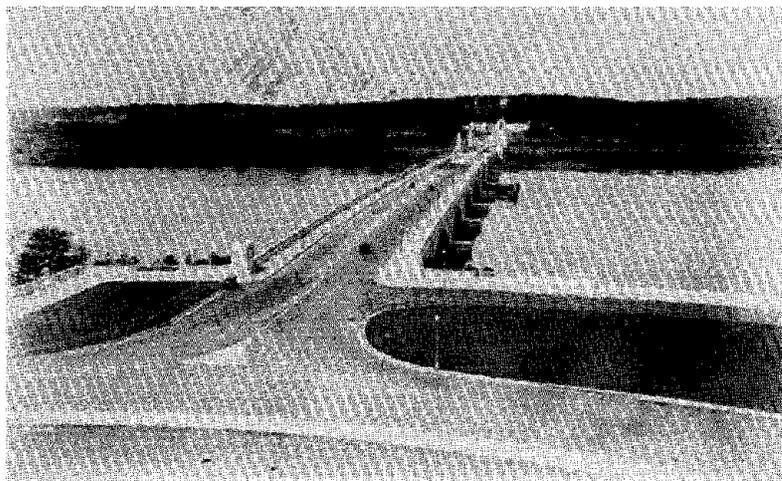
*Figure 102 - Completed sidewalk and bridle trail by south plaza wing wall, June 9, 1933. MRC 1-75.*

**Pedestrian Circulation.** As a part of the development of a shoreline drive after the turn of the century, bridle trails and pedestrian paths, designed to parallel the road, were incorporated into the overall plan for the roadway. The existing system of paths was modified in the 1930s when the layout of the roads was changed as part of the construction of Arlington Memorial Bridge and Rock Creek and Potomac Parkway. Plans called for a bridle trail to wind through the golf course area in the northwestern corner of West Potomac Park near the parkway, to cross the underpass drive on the north side of the bridge plaza, to pass directly in front of the Watergate steps, to continue southeast along the underpass drive along the slope, or to curve up around the slope of the south wing wall of the bridge plaza toward a second route, which followed the inbound lane on Arlington Memorial Bridge. Along its route, the trail surface was mostly a soil base. However, in the underpasses and in front of the Watergate steps, the trail was paved in square granite blocks.

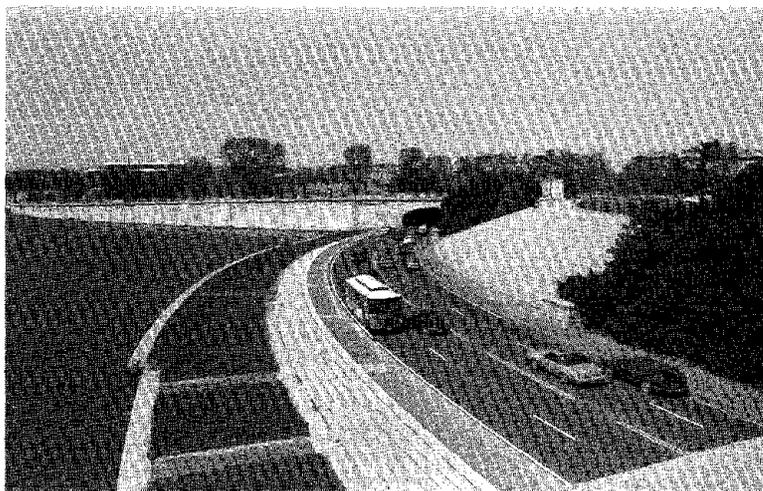
*Figure 103 - Walkway on either side of Ohio Drive at base of Watergate steps, April 1996. LINC 6-15.*

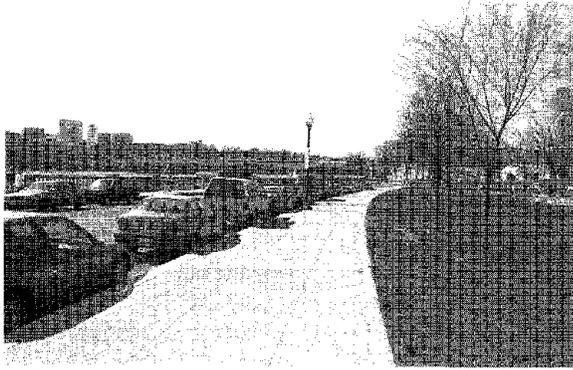
*Figure 104 - Sidewalk along Parkway Drive, April 1996. LINC 6-18.*

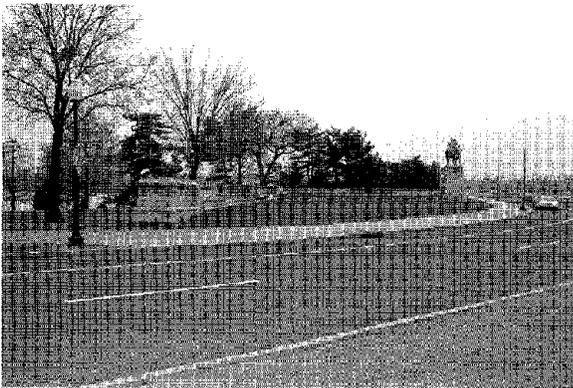
*Figure 105 - South plaza wing wall with new concrete path in same alignment as original bridle path, December 5, 1996. LINC 13-1.*
