# Cultural Landscape Report

## West Potomac Park Lincoln Memorial Grounds National Capital Parks Central August 1999

Part 1: Site History,  
Analysis and Evaluation  
and Design Guidelines

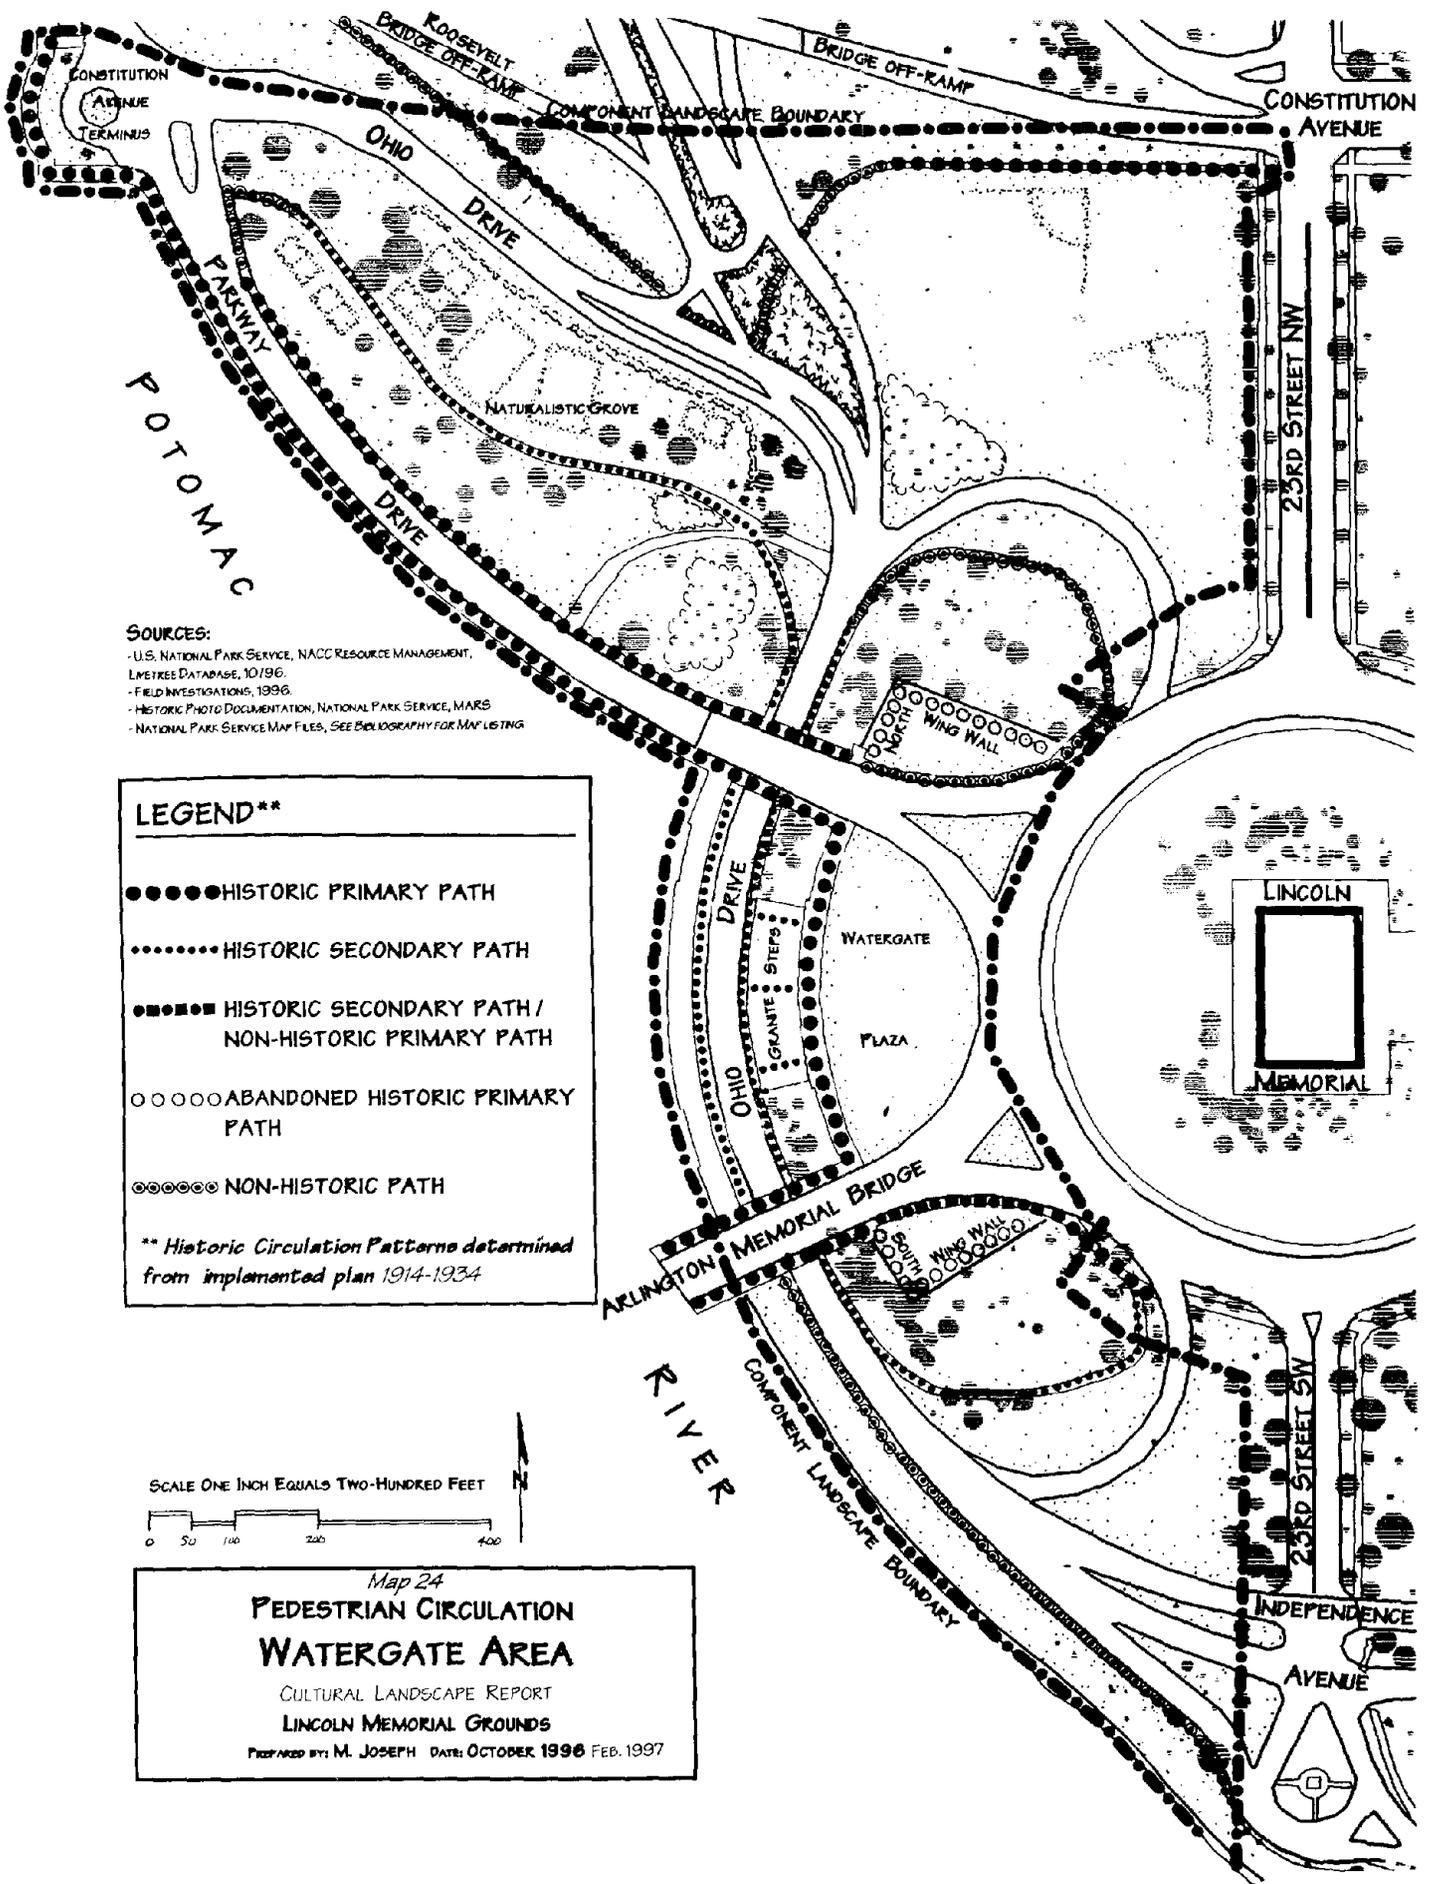
Map 24  
**PEDESTRIAN CIRCULATION  
 WATERGATE AREA**  
 CULTURAL LANDSCAPE REPORT  
 LINCOLN MEMORIAL GROUNDS  
 PREPARED BY M. JOSEPH DATE: OCTOBER 1996 FEB. 1997

<b>Contributing Features</b>	<b>Noncontributing Features</b>
<ol style="list-style-type: none"><li>1. Sidewalks on both sides of Arlington Memorial Bridge, and Parkway Drive</li><li>2. Sidewalk at top of Watergate steps</li><li>3. Path on both sides of Ohio Drive at base of Watergate steps</li><li>4. Path through naturalistic planting (old bridle path)</li><li>5. Portion of sidewalk along south side of Constitution Avenue</li><li>6. Path along southwest curb from Arlington Memorial Bridge to Lincoln Circle (old bridle path)</li><li>7. Path from southern plaza wing wall down to Ohio Drive (old bridle path)</li></ol>	<ol style="list-style-type: none"><li>1. Path from northern plaza wing wall down to Ohio Drive</li><li>2. Watergate plaza sidewalk along northwest curb from Parkway Drive to Lincoln Circle</li><li>3. Path along shoreline from Arlington Memorial Bridge underpass, south</li><li>4. Path to Theodore Roosevelt Bridge</li></ol>

To accommodate the changes in recreational use, the bridle paths were modified to serve as both a pedestrian path and as a bicycle trail. An asphalt pathway was installed along the slope in the area north of the parkway approach and connected to the system of walks around the outer circle. In response to patterns of use, the concrete sidewalks located along both the north and south wing walls were removed, and new concrete walks were constructed along the curving curb edge of the bridge and parkway approaches, where a worn dirt path had been created. Even though the use of some paths have changed, the majority of them still follow the same circulation patterns established in the 1930s. The pair of concrete sidewalks, removed from the top of the wing walls, are the major design elements no longer extant. See Map 24 *Watergate area - Pedestrian Circulation* for graphic representation of contributing and noncontributing features.

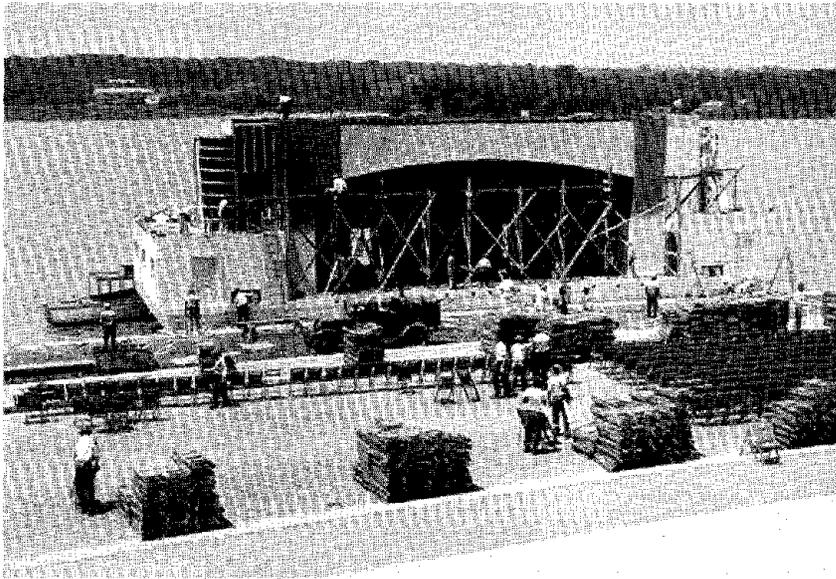
*Figure 106 - Watergate concert barge located at the base of the Watergate steps, July 19, 1939. MRC 1-1.*

Since the Watergate's original purpose as a ceremonial entry to the nation's capital never developed, other uses were sought for the area. An open-air summer series of concerts were proposed for the steps. An orchestra shell was constructed on a barge, secured to pilings, at the water's edge in 1937 and again in 1938. A third orchestra shell was

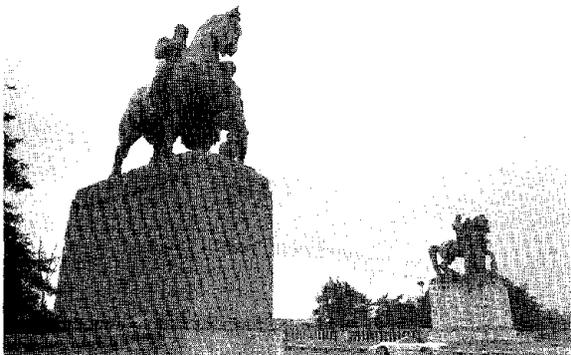
*Figure 107 - Valor and Sacrifice statues flank entrance to Arlington Memorial Bridge, February 1997. LINC 18-5.*

and south wing walls. At the entry from the plaza to the bridge and to the parkway approach, two pairs of granite pedestals were incorporated into the structure. These were intended to be the bases for four monumental sculptures. The pedestals stood empty, the sculptures awaiting funding, until 1951, when the installation and dedication finally took place. The large figural works of art were allegorical representations of Valor, Sacrifice, Music and Harvest, and Aspiration and Literature.

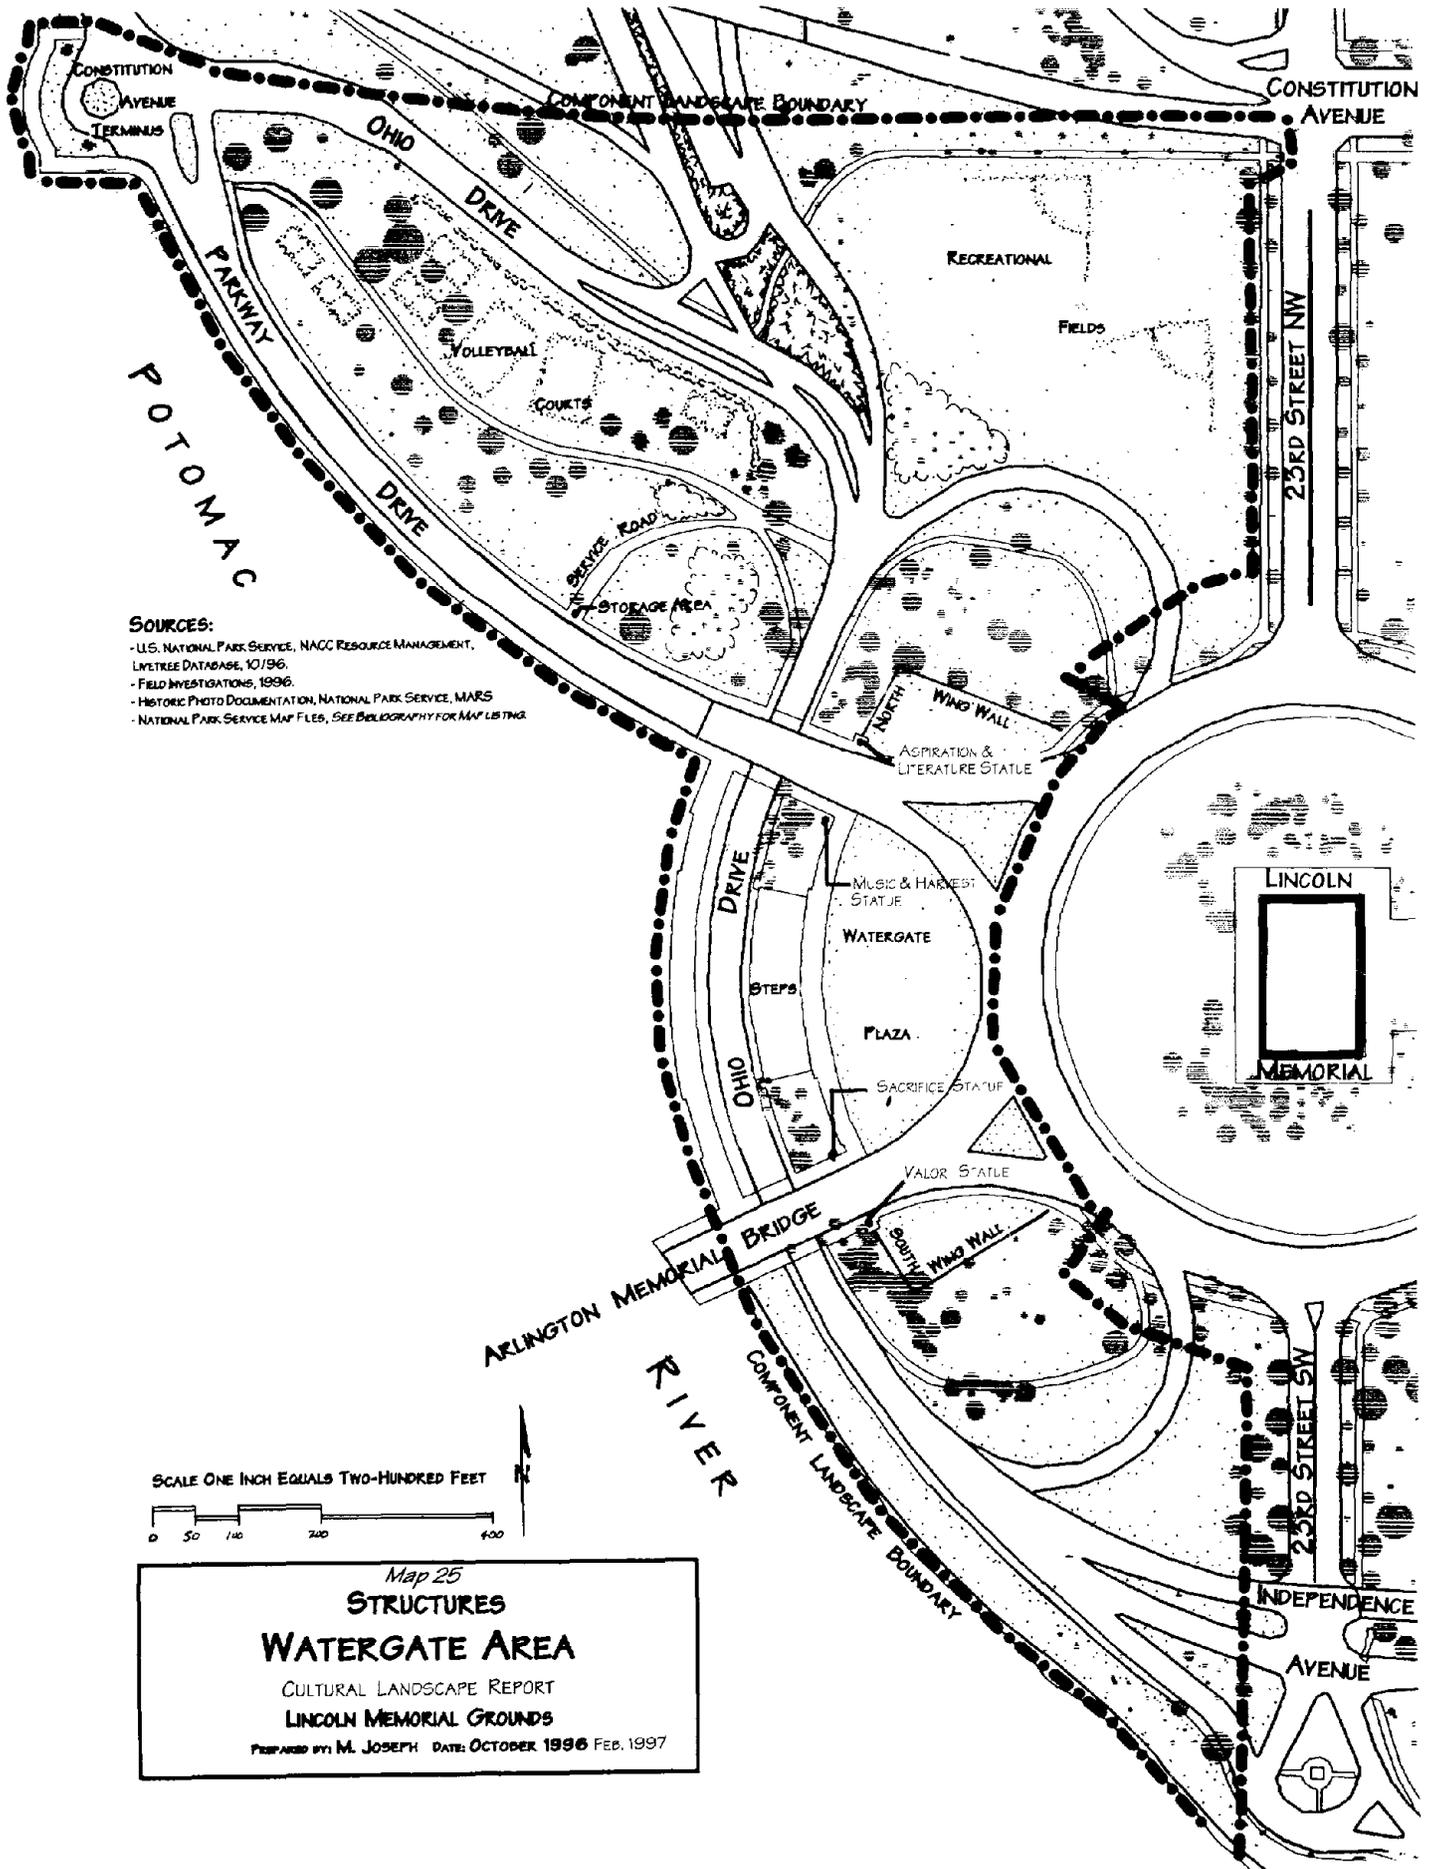
<b>Contributing Features</b>	<b>Noncontributing Features</b>
<ol style="list-style-type: none"> <li>1. Arlington Memorial Bridge abutment</li> <li>2. Watergate steps</li> <li>3. Parkway Drive abutment</li> <li>4. Statuary on approachway pedestals (Valor, Sacrifice, Music and Harvest, and Aspiration and Literature)</li> <li>5. Watergate plaza wing walls</li> </ol>

Both historic design intent and original structural integrity remain in the Watergate area. The only significant changes have been the elimination of the plaza access road, near the top of the main steps and the use of a different, non-historic color and texture on the concrete surface of the bridge sidewalks and the plaza sidewalks. See Map 25 *Watergate area - Structures* for location of structural features.

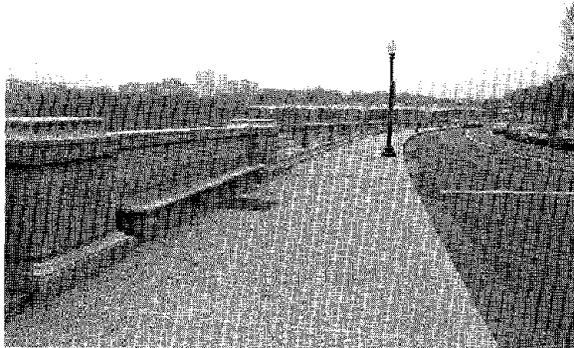
*Figure 109 - Granite bench built into river wall along Parkway Drive, January 3, 1997. LINC 16-3.*

**Benches.** Historically no provisions were made for free-standing park benches in the Watergate area. Even today, there are no free-standing benches provided for visitors, instead visitors can sit on the Watergate steps or use a more permanent seats where granite benches were built into the plaza wing walls and along the bridge approach walls for Parkway Drive and Arlington Memorial Bridge. Because the location of the granite benches along busy roads is unappealing to visitors, the benches are rarely used.

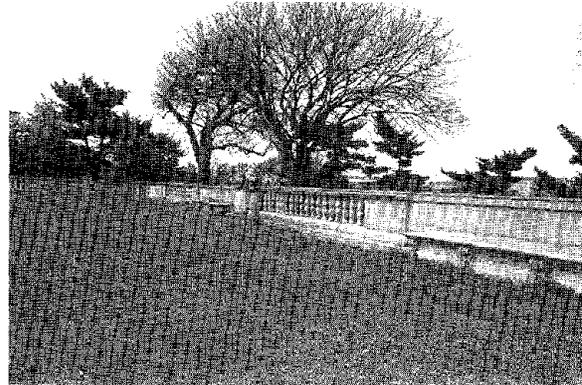
*Figure 110 - Granite benches built into Watergate plaza wing walls, April 1996. LINC 6-8.*

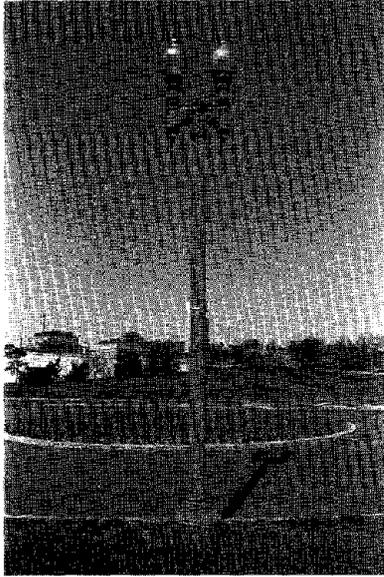
*Figure 111 - Twin-twenty lamppost at old terminus for Constitution Avenue, March 1996. LINC 6-20.*

**Lighting.** As with the Lincoln Circle and the radial roads, streetlights were limited to specific locations along routes for vehicles. Designs for Arlington Memorial Bridge and Parkway Drive incorporated the “Washington Globe” lamp and 18-foot post. On the bridge the lights were spaced evenly in opposite positions, while in all other locations they were set in an alternate arrangement. Along Parkway Drive the lampposts were originally planned to be on granite bases. Later the bases were removed and the posts were set on grade according to the established pattern of installation elsewhere in the Lincoln Memorial area. The “Washington Globe” lamp and post also illuminated the Watergate plaza area, at the top of the steps. Along Constitution Avenue at the northern boundary of the park, “Twin-twenty” lamps and posts were installed. This type of streetlight had been designated for all major city streets and avenues along the Mall and around the memorials. At the time of Constitution Avenue’s realignment for the freeway and bridge in the 1960s, highway planners retained only five “twin-twentics” near

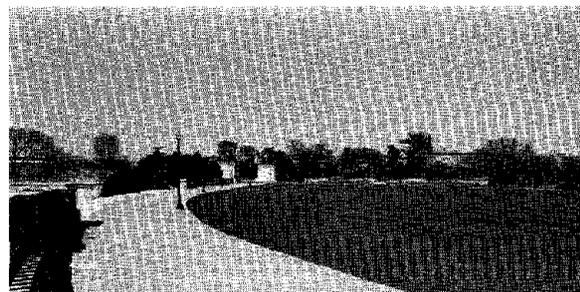
*Figure 112 - Washington Globe lamppost at the Watergate plaza, March 1996. LINC 6-14.*

The majority of the street lights installed in the 1930s and 1940s have remained in their original positions. A few lights were relocated within the Watergate plaza area, when it was reconfigured to accommodate the access ramps from Ohio Drive added during the construction of Independence Avenue in the 1940s. At

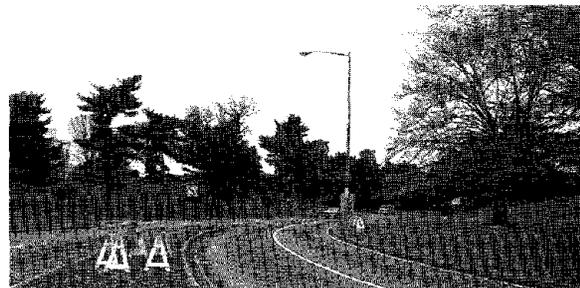
*Figure 113 - Cobra style lamppost along Ohio Drive, January 3, 1997. LINC 16-7.*

the western terminus point. “Cobra-style” highway lights, a standard light used for major roadway development at the time, were installed along the ramps and access roads associated with the design of the Theodore Roosevelt Bridge and the inner loop freeway.

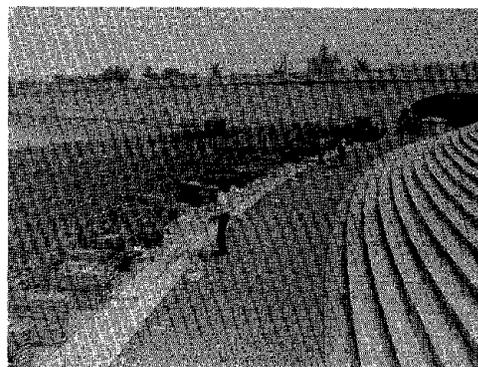
Figure 115 - Granite block pavers at base of Watergate steps, c. 1939. MRC 1-5.
