**Failure Analysis of OH-58 Kiowa Warrior
Drive Gear Shafts**

ARL-TR-3827

June 2006

U.S. Army Research Laboratory
Weapons and Materials Research Directorate
Aberdeen Proving Ground, MD 21005-5069

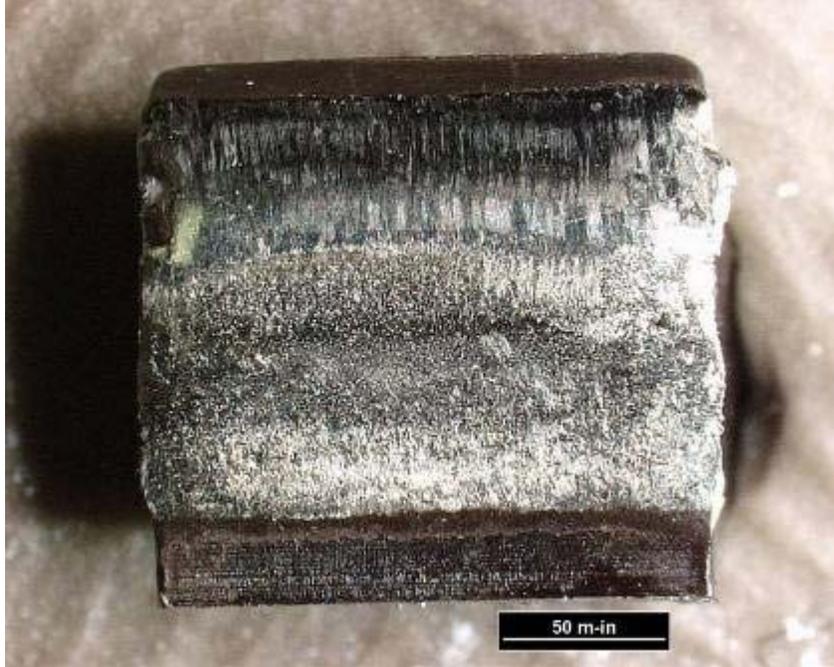
Figure 23. Drive side, tooth 18.

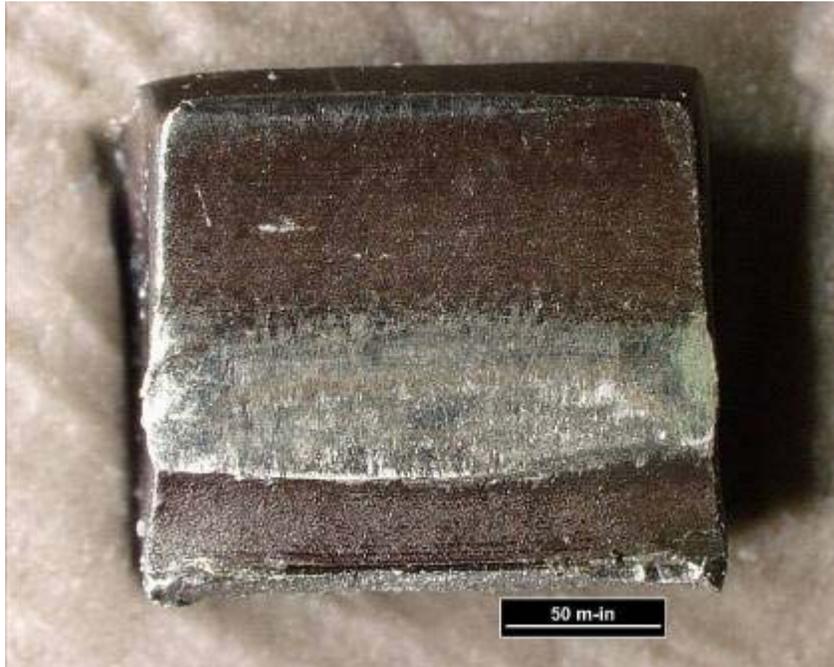
Figure 24. Coast side, tooth 18.

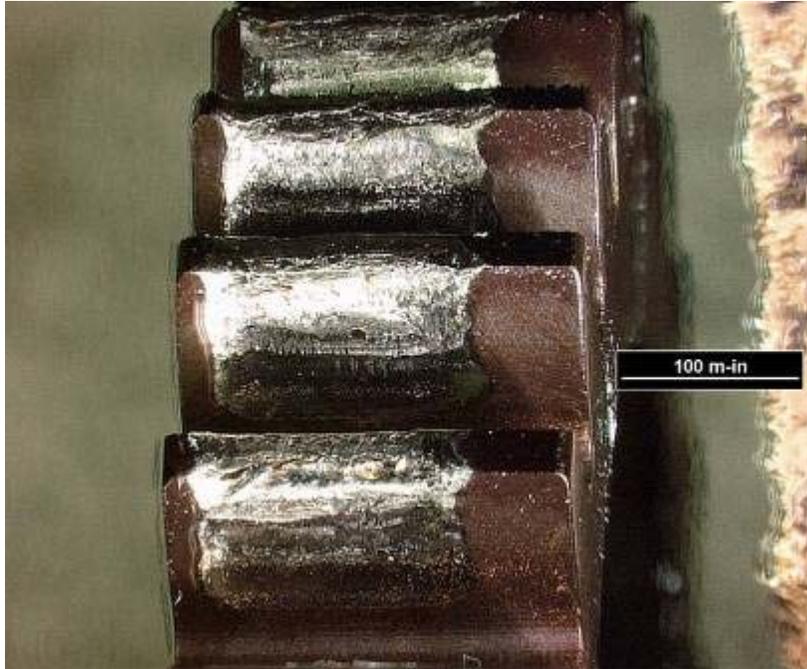
Figures 33 and 34 show the drive and coast sides of the mating pinion. Note that the wear pattern is offset, as the spare drive gear is not centered with respect to the pinion.

Figure 33. Drive side idler gear.
